Structural Integrity Reserve Studies

August 13, 2024

Re: Champenae Condominium  
3345 S. Atlantic Ave.  
Cocoa Beach, Florida 32931  
Brevard County Parcel ID 25-37-35-25-1-6.01  
UES Project No. 0311.2400001.0014  
UES Document No.

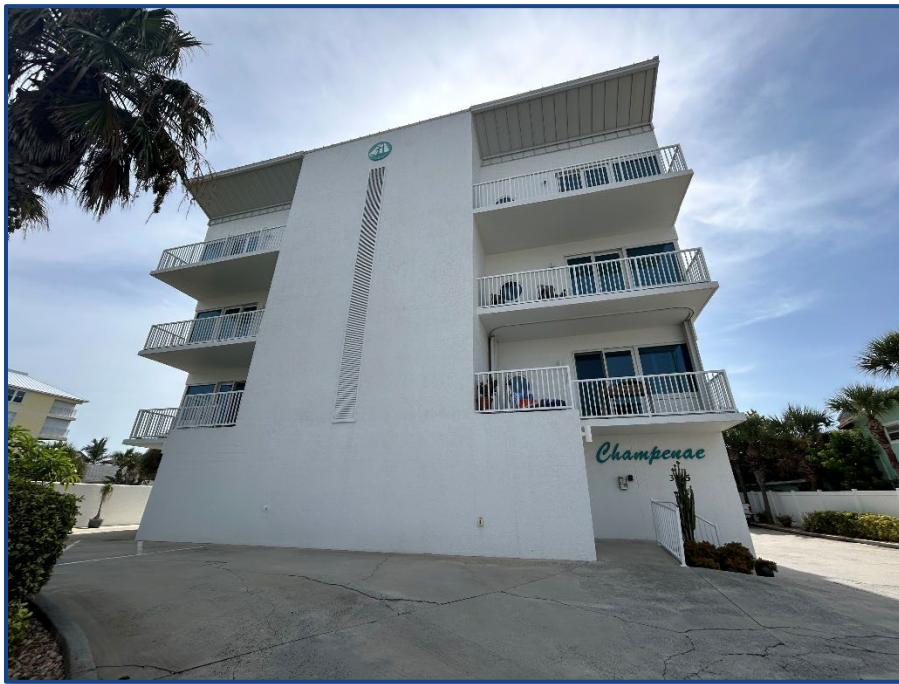
Photograph No. 1: Western elevation

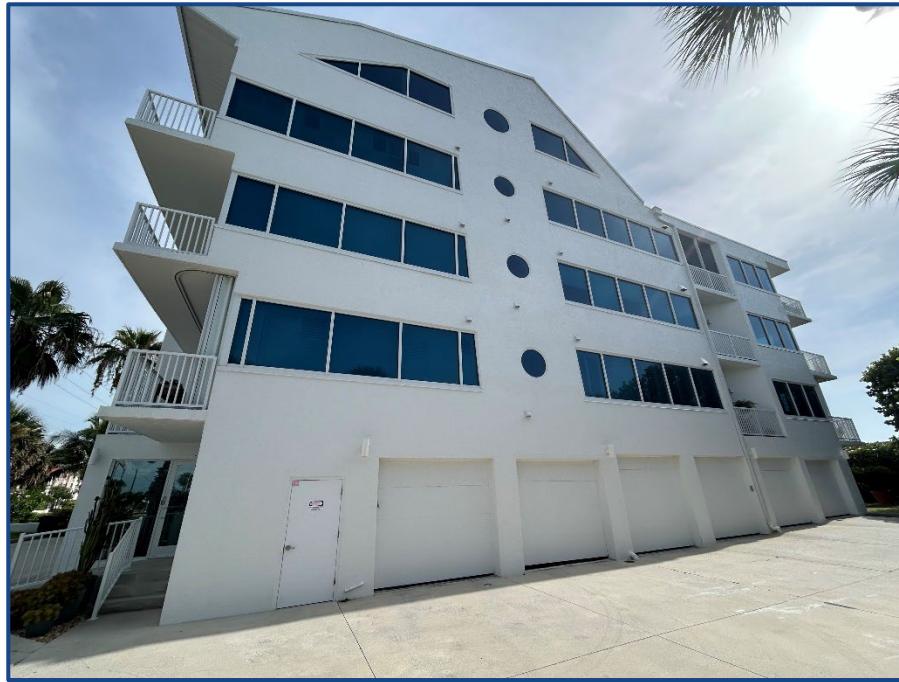
Photograph No. 2: Southern Elevation

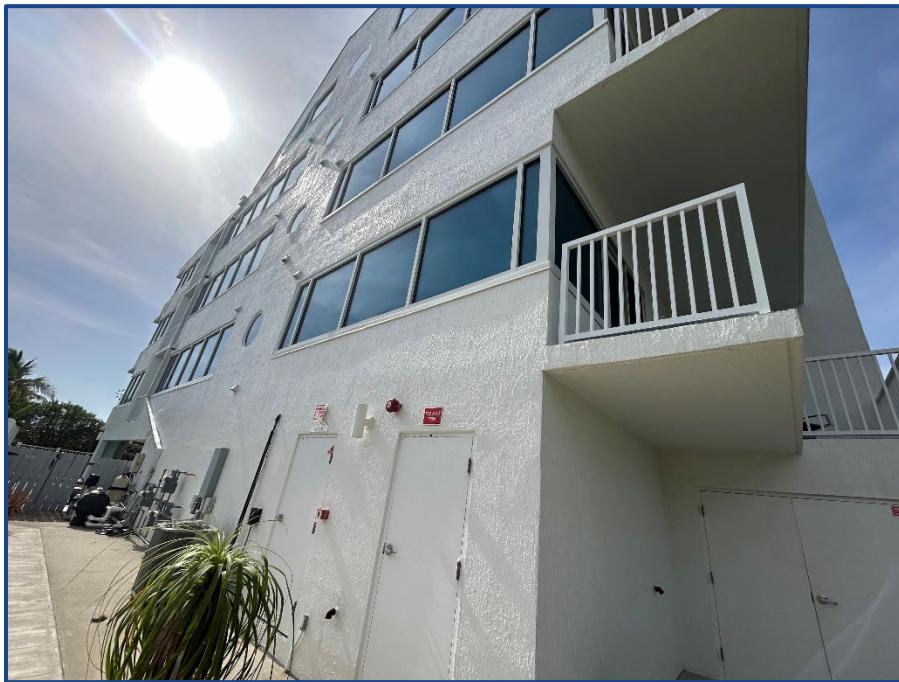
Photograph No. 3: Northern elevation

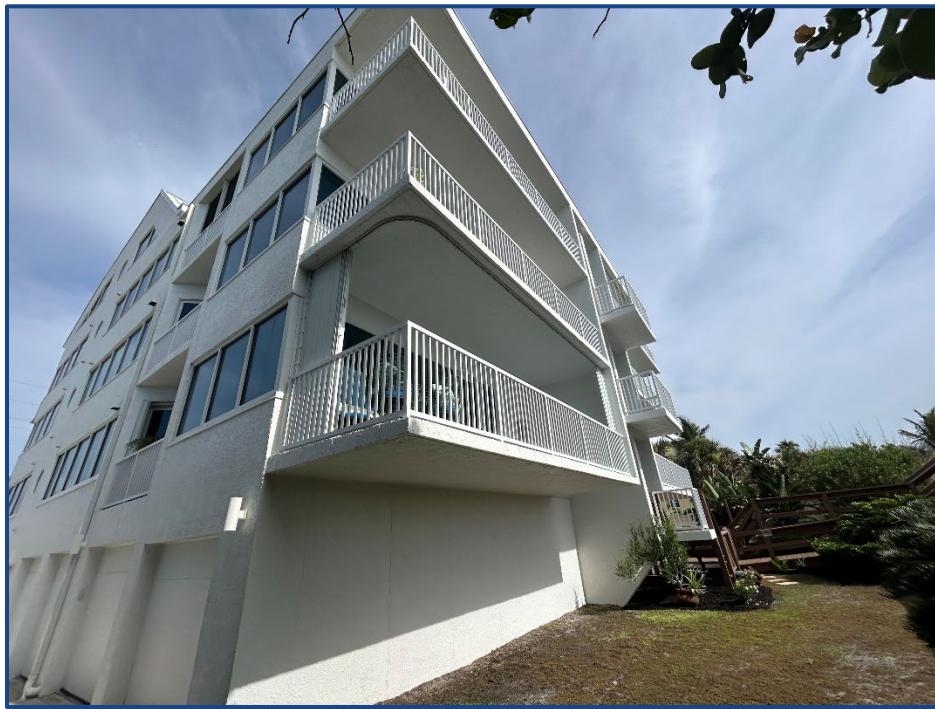
Photograph No. 4: Eastern elevation.

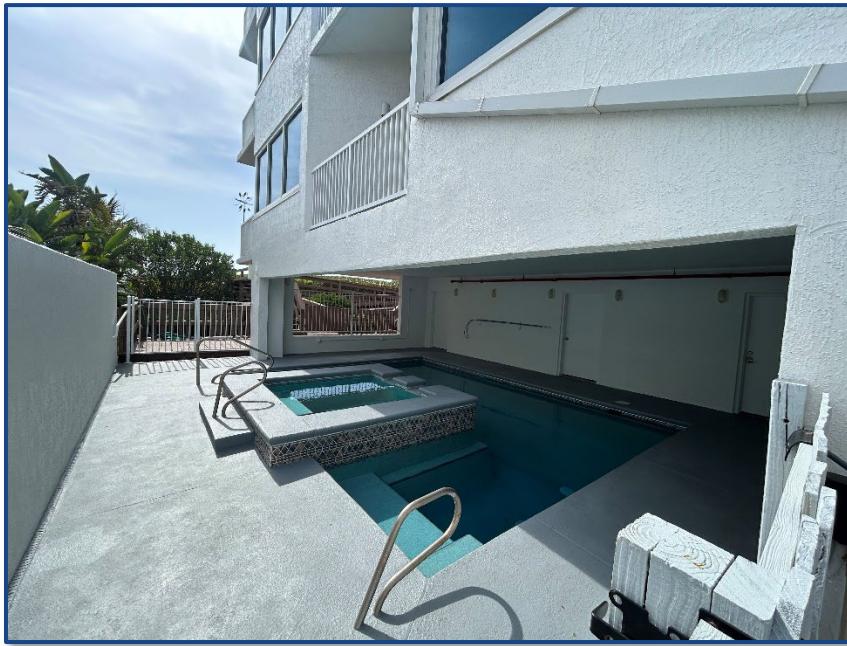
Photograph No. 5: Pool area located at the NE corner of the building.

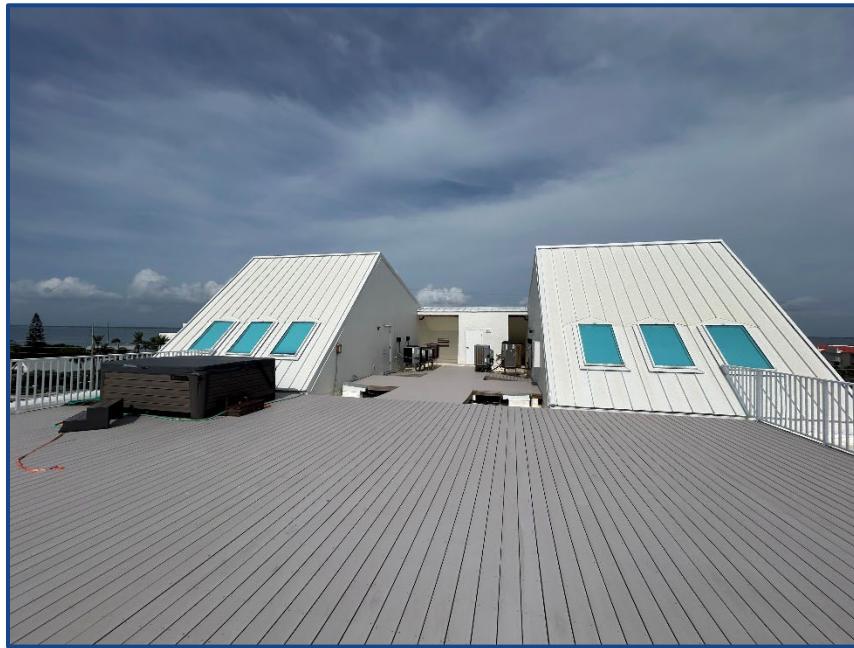
Photograph No. 6: Overall roof facing west. Corrugated metal roof panels on the west side of the building.

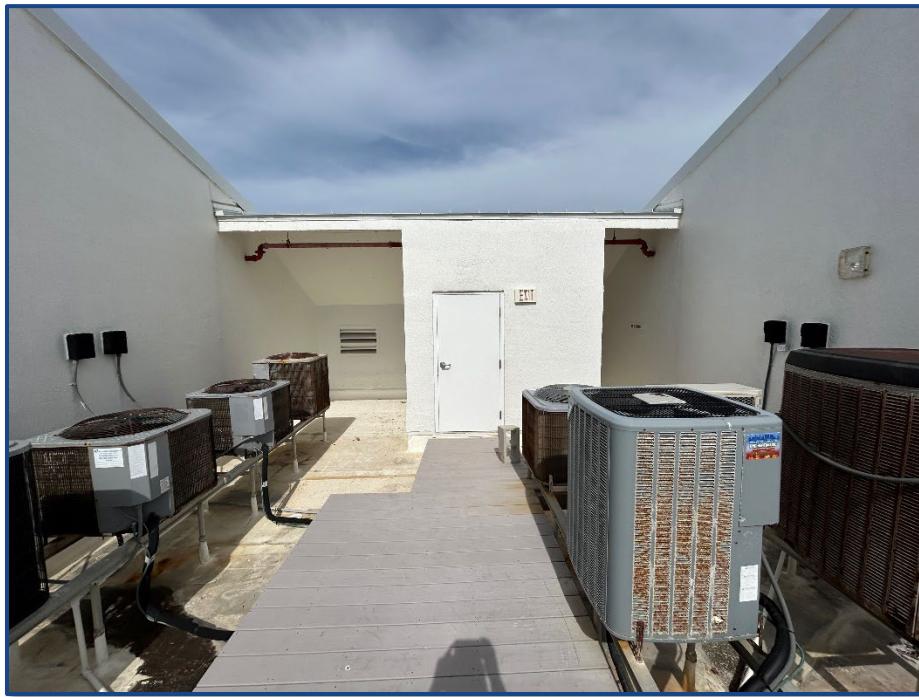
Photograph No. 7: Roof access door and typical AC units located at the west side of the building.

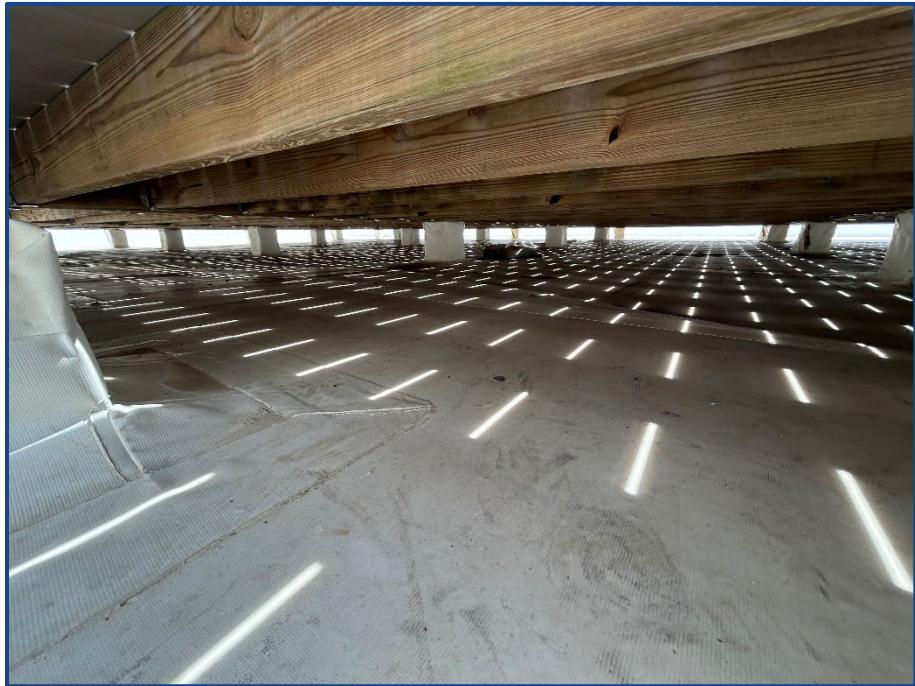
Photograph No. 8: Underneath the elevated deck at the east side of the building.

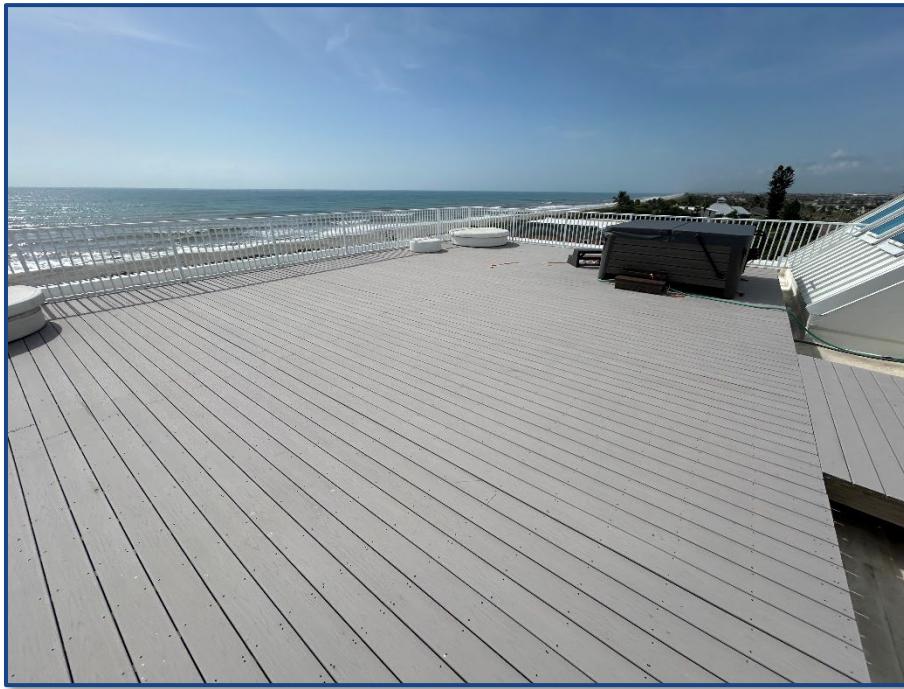
Photograph No. 9: Elevated deck located at the east side of the building.

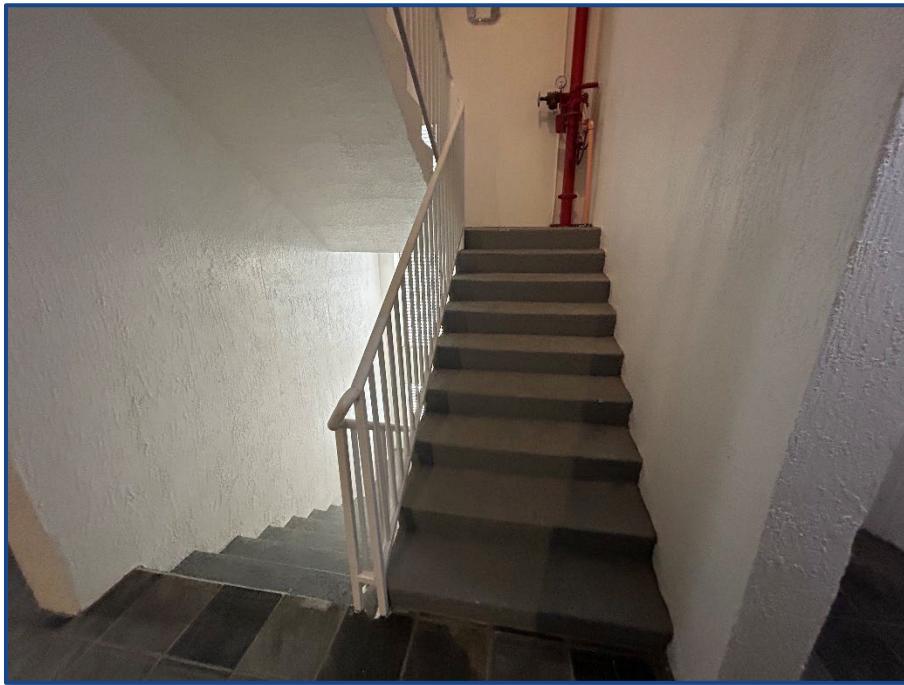
Photograph No. 10: Typical interior stairwell at the west side of the building.

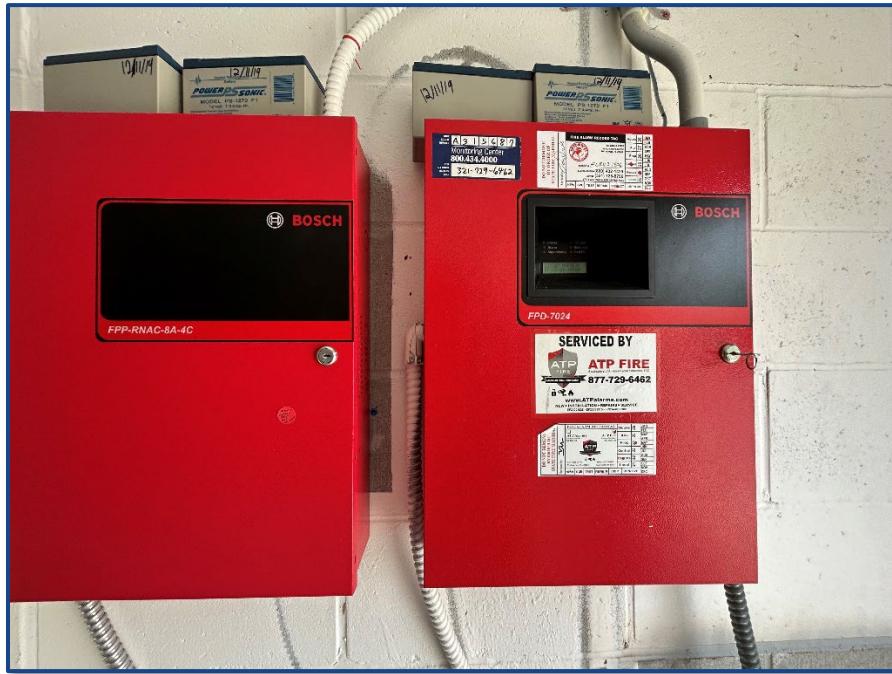
Photograph No. 11: Bosch fire pump and alarm control panels.

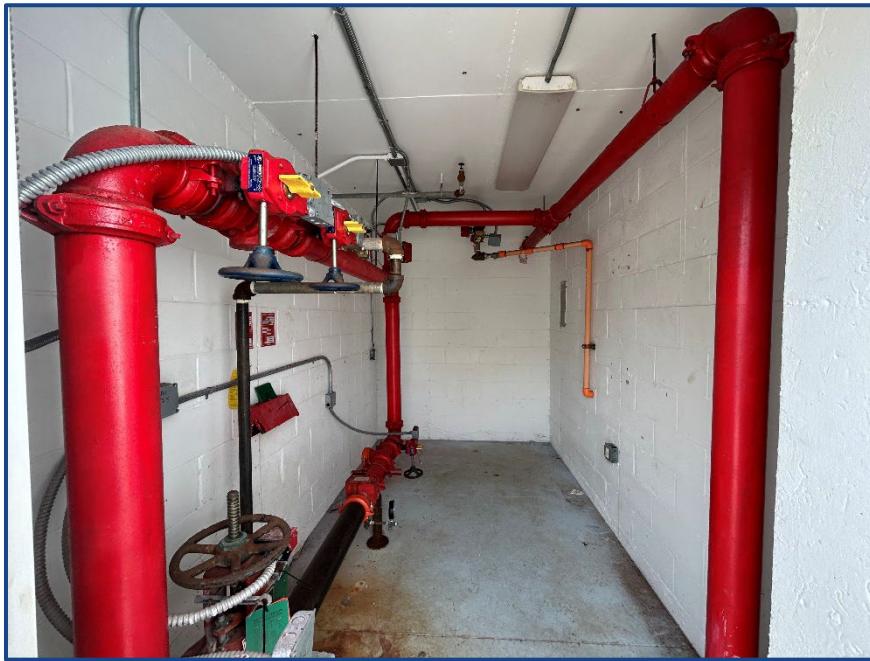
Photograph No. 12: Typical fire pump located in the pump room.

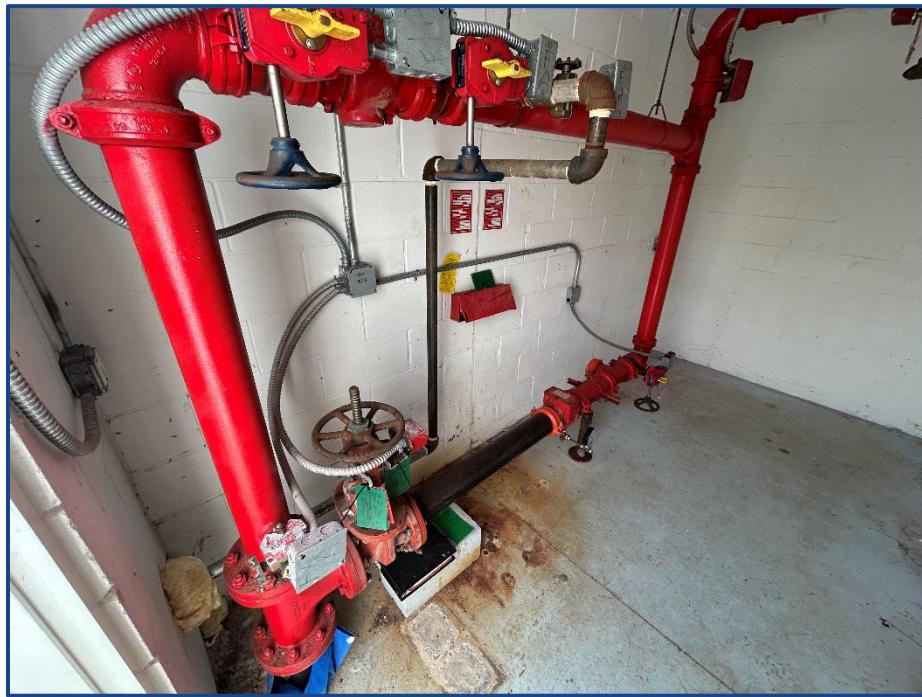
Photograph No. 13: Typical fire pump located in the pump room.

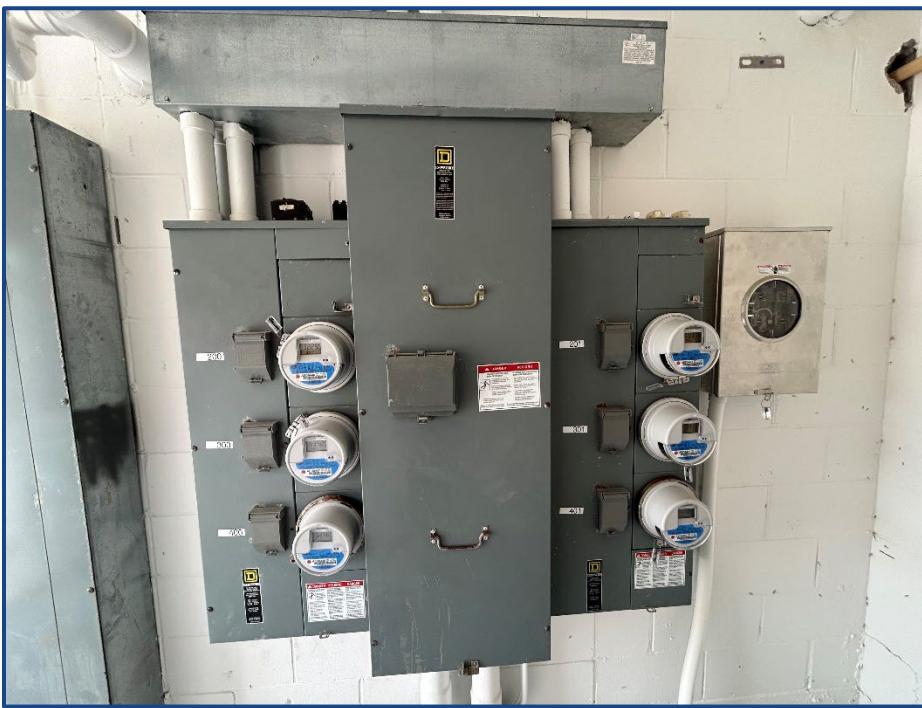
Photograph No. 14: Typical main electrical panel and unit meters.

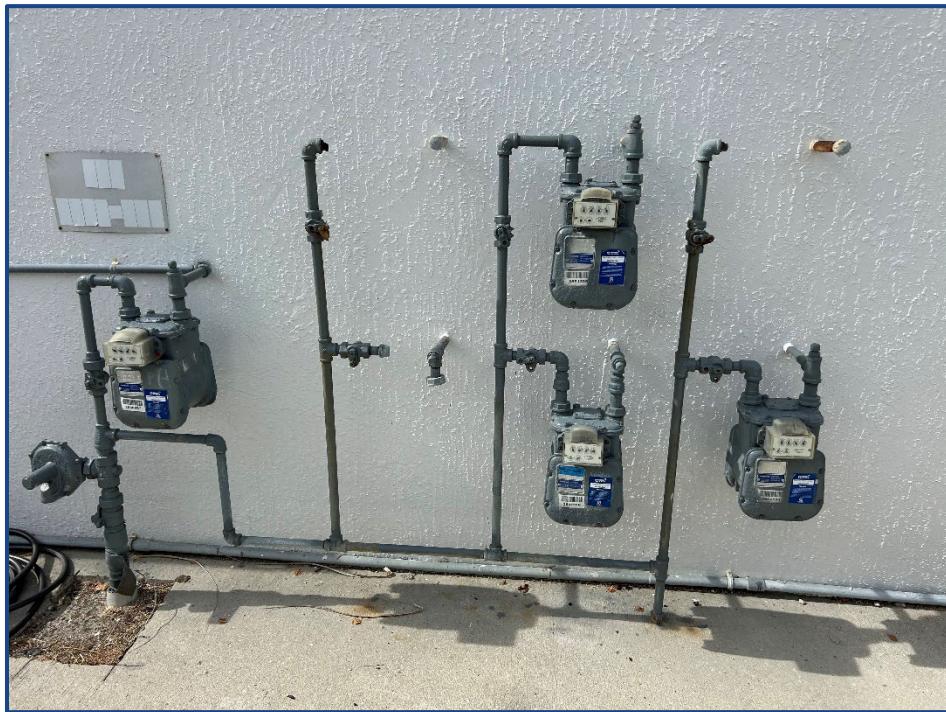
Photograph No. 15: Typical natural gas meters located at the north side of the building.

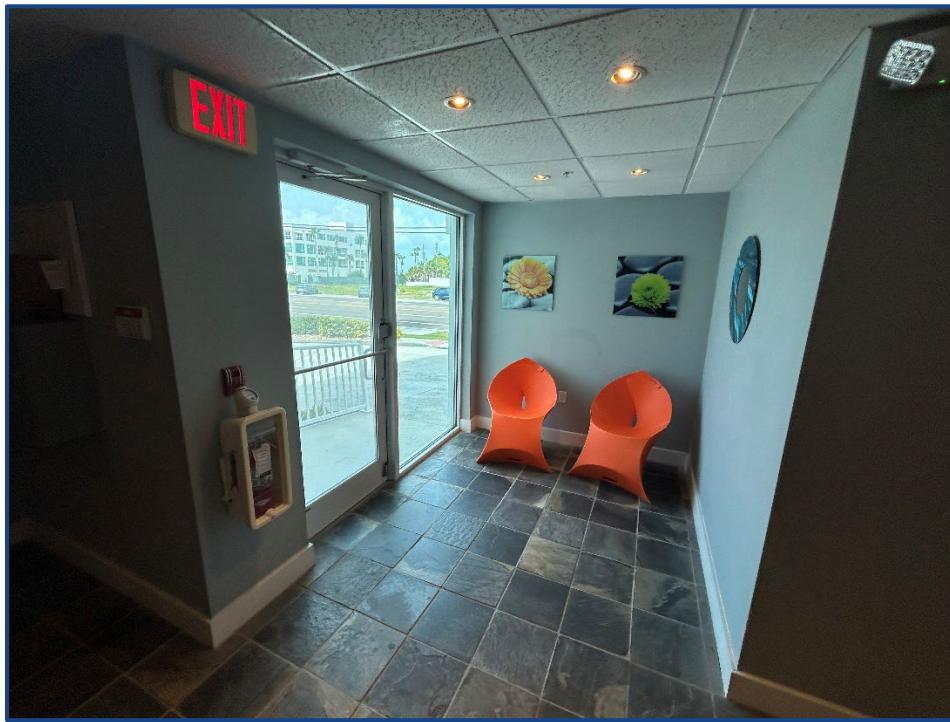
Photograph No. 16: Entrance lobby area with typical fire extinguisher and exit signs.

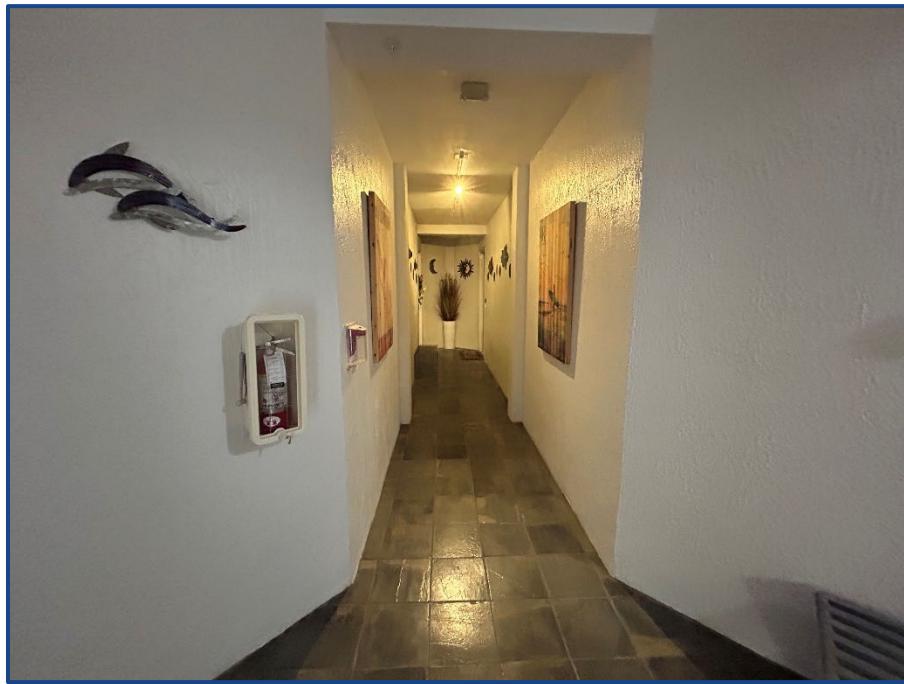
Photograph No. 17: Typical hallway at the first floor.

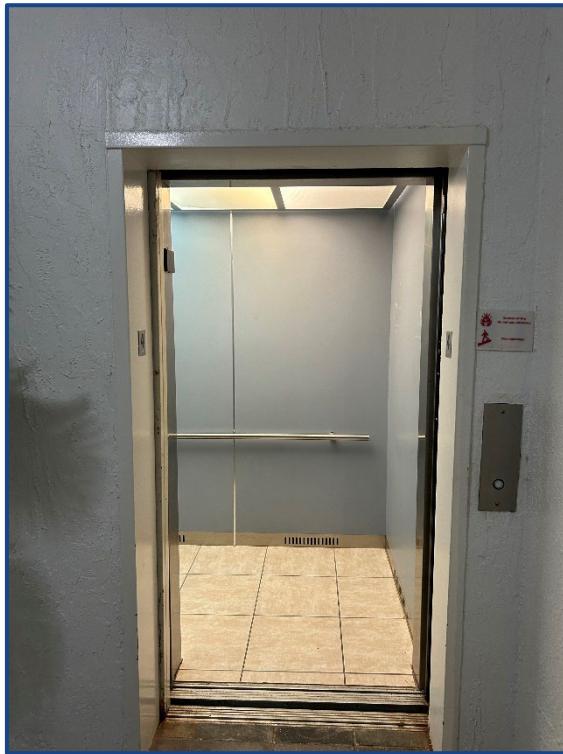
Photograph No. 18: Typical elevator entrance at the west side of the building.

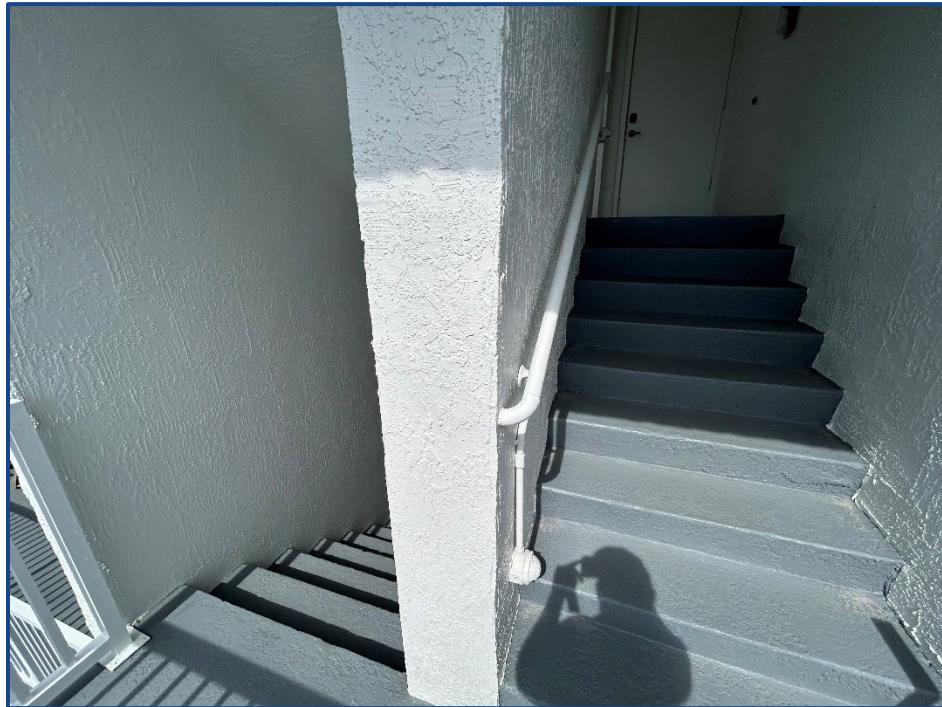
Photograph No. 19: Typical exterior stairwell at the east side of the building.

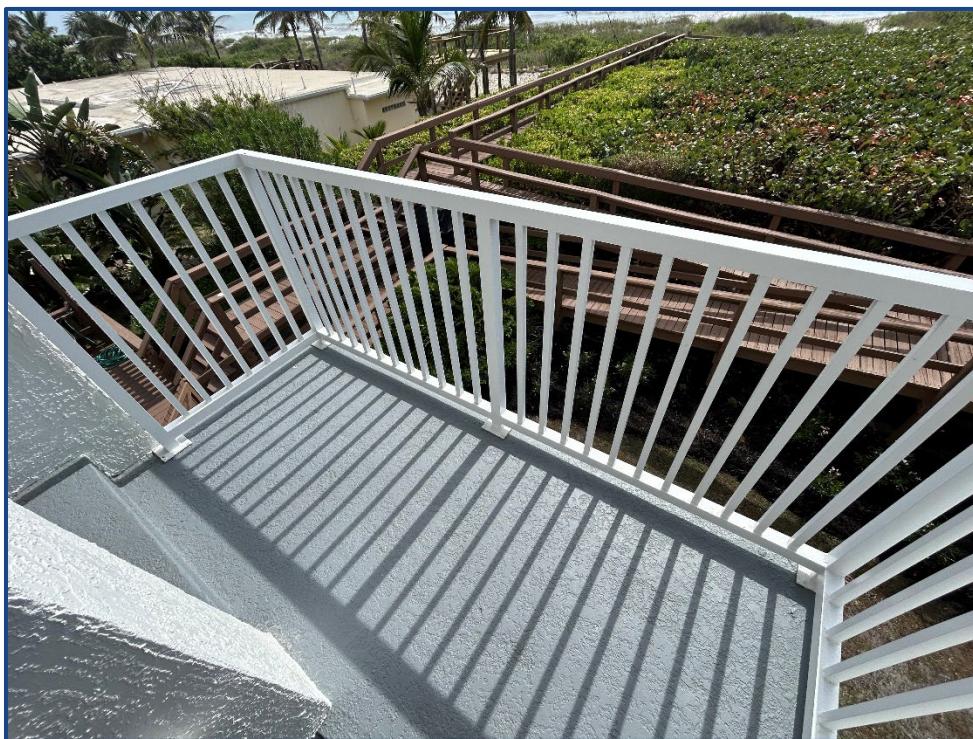
Photograph No. 20: Typical exterior stairwell at the east side of the building.

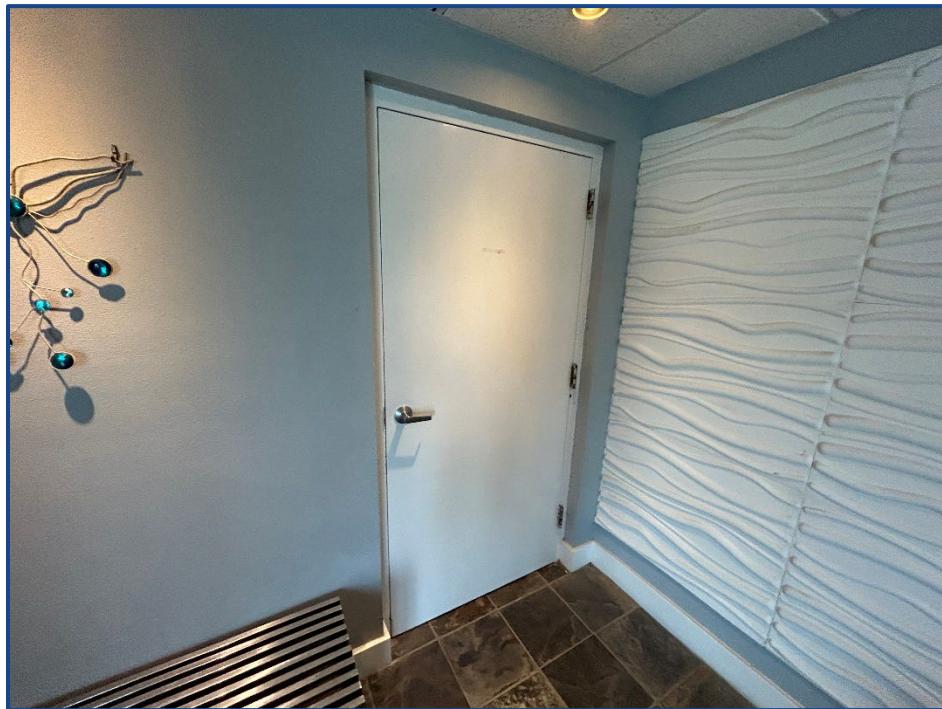
Photograph No. 21: Typical stairwell access door.

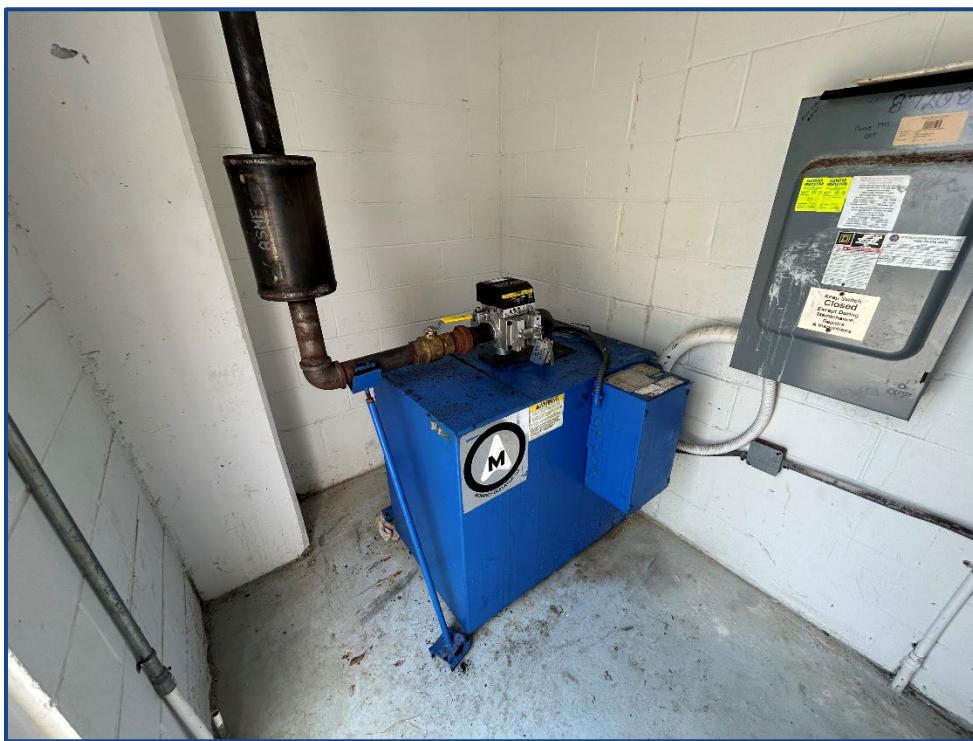
Photograph No. 22: Typical elevator hydraulic machine.
