August 30, 2024
Cocoa Cabanas Condominium Association
1915 S. Atlantic Ave.
Cocoa Beach, Florida 32931

Re: Cocoa Cabanas Condominium
1915 S. Atlantic Ave.
Cocoa Beach, Florida 32931
Brevard County Parcel ID 25-37-26-26-C-1.XA
UES Project No. 0311.2400001.0009
UES Document No.

UES Milestone Inspections, LLC (UES) has completed the mandatory Structural Integrity Reserve Study ("SIRS") as required for condominiums and cooperative buildings for the above referenced property. UES's assessment was performed in general accordance with Florida Statute (FS)718.112(2)(g) (or 719.106(3)(k) for Cooperatives) (effective May 26, 2022, and amended June 9, 2023) and local requirements of the Authority Having Jurisdiction (AHJ).

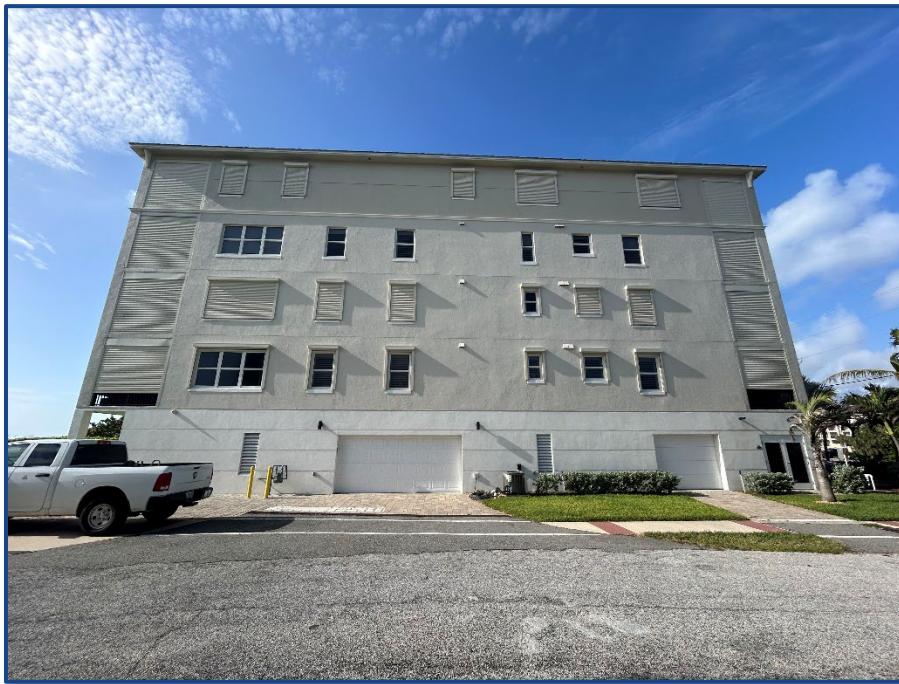
Photograph No. 1: Northern elevation

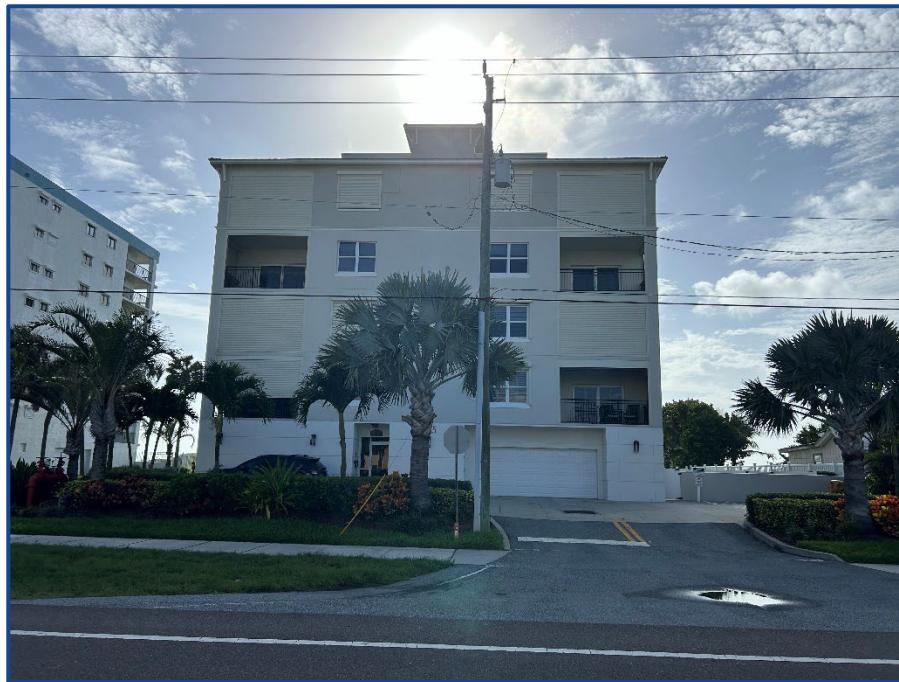
Photograph No. 2: Western Elevation

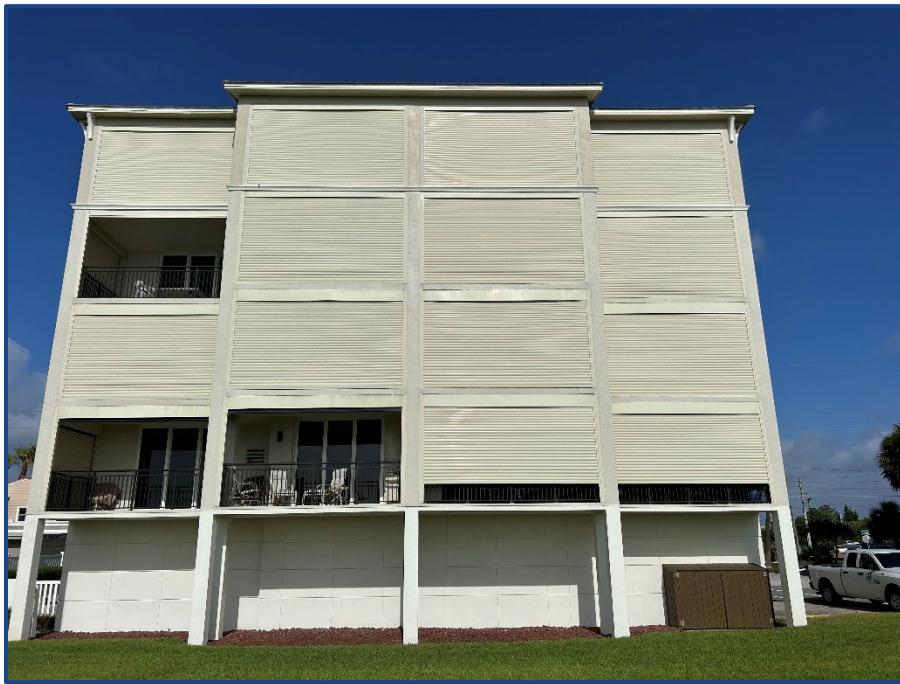
Photograph No. 3: Eastern elevation

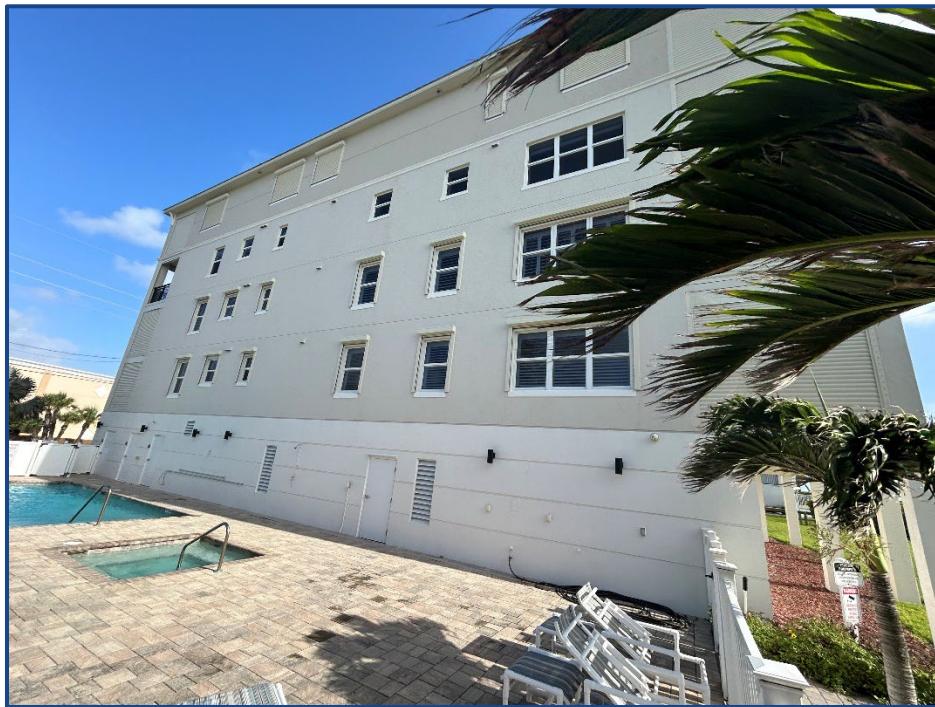
Photograph No. 4: Southern elevation

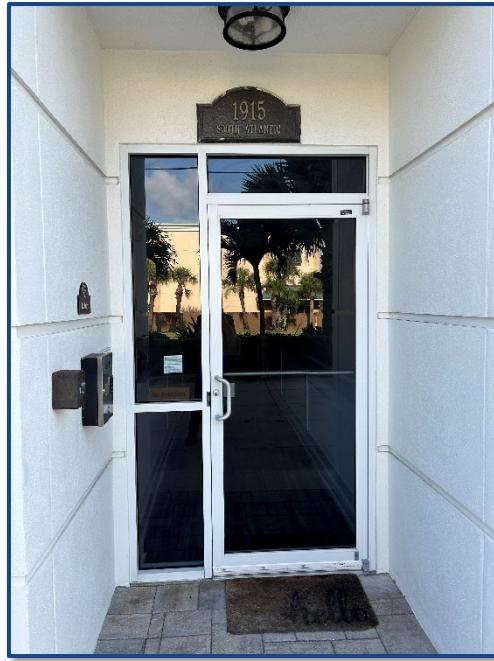
Photograph No. 5: Entrance door at the West side of the building.

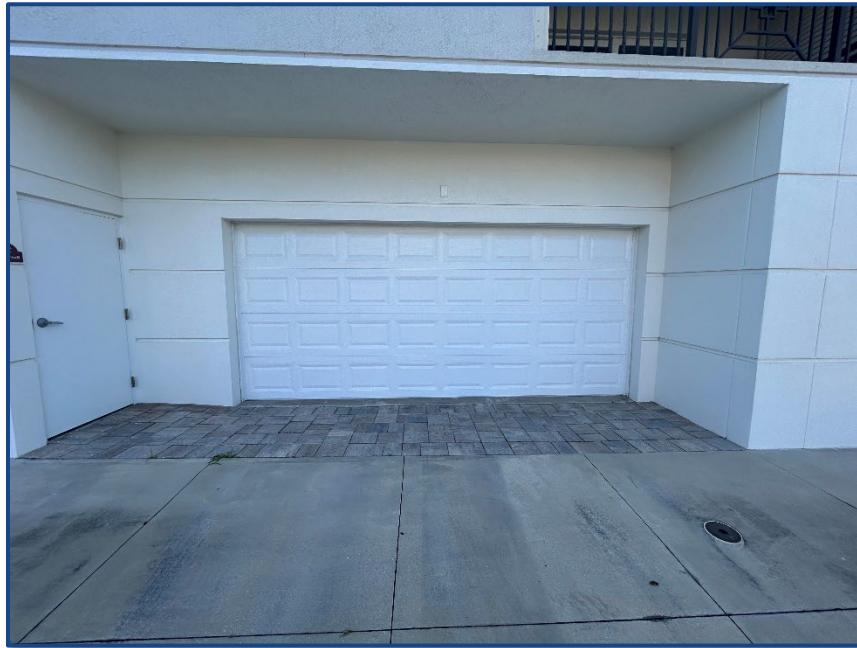
Photograph No. 6: Garage door located at the NE corner of the building.

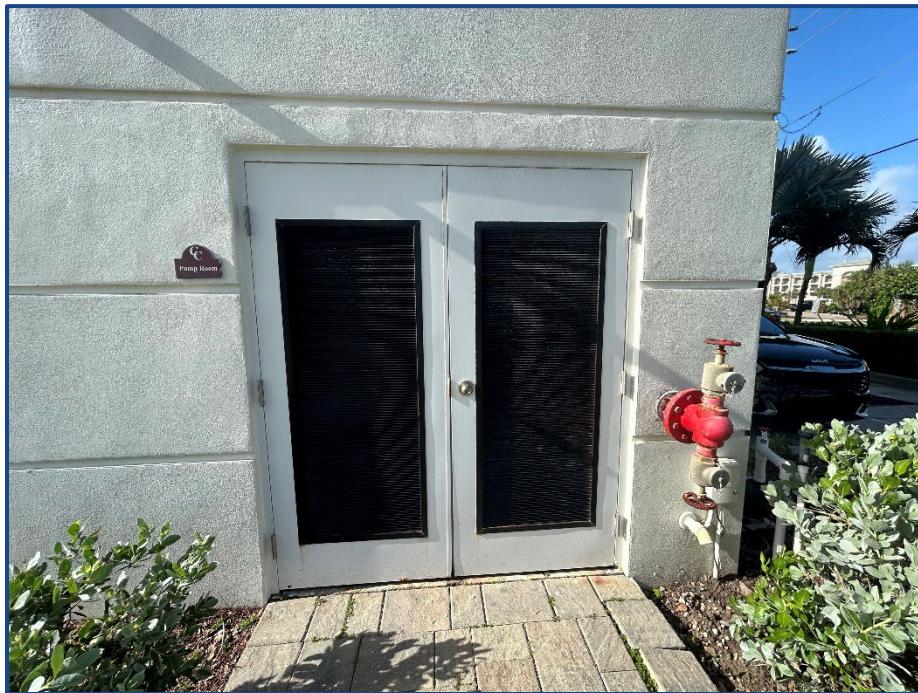
This condominium development was originally constructed in 2016. This building has a fire alarm and sprinkler system. All units have individual fire alarms that appeared to be in good condition at the time of inspection. The building has a fire pump located in the fire pump room at the NW corner of the building.

Photograph No. 7: Fire pump room at the NW corner of the building.

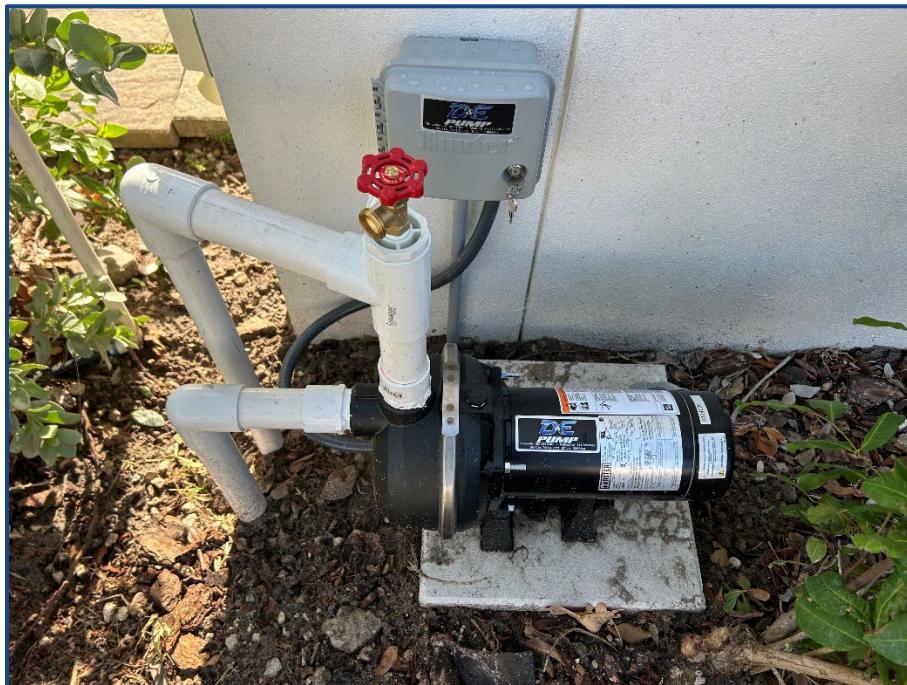
Photograph No. 8: Sprinkler pump located at the NW corner of the building.

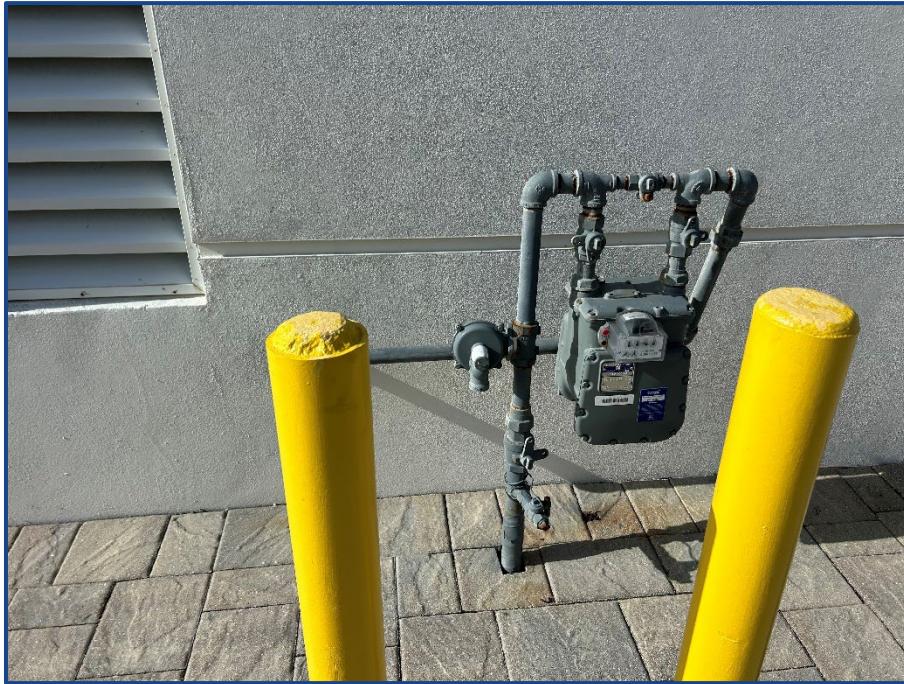
Photograph No. 9: Florida City Gas meter located at the north side of the building.

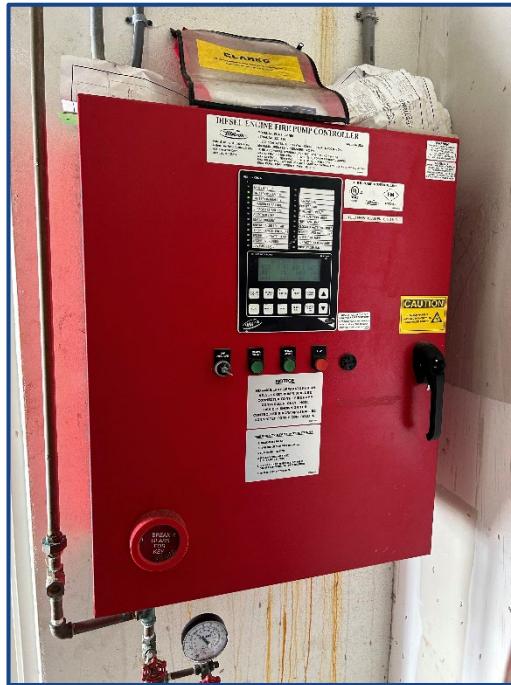
Photograph No. 10: Metron diesel engine fire pump controller.

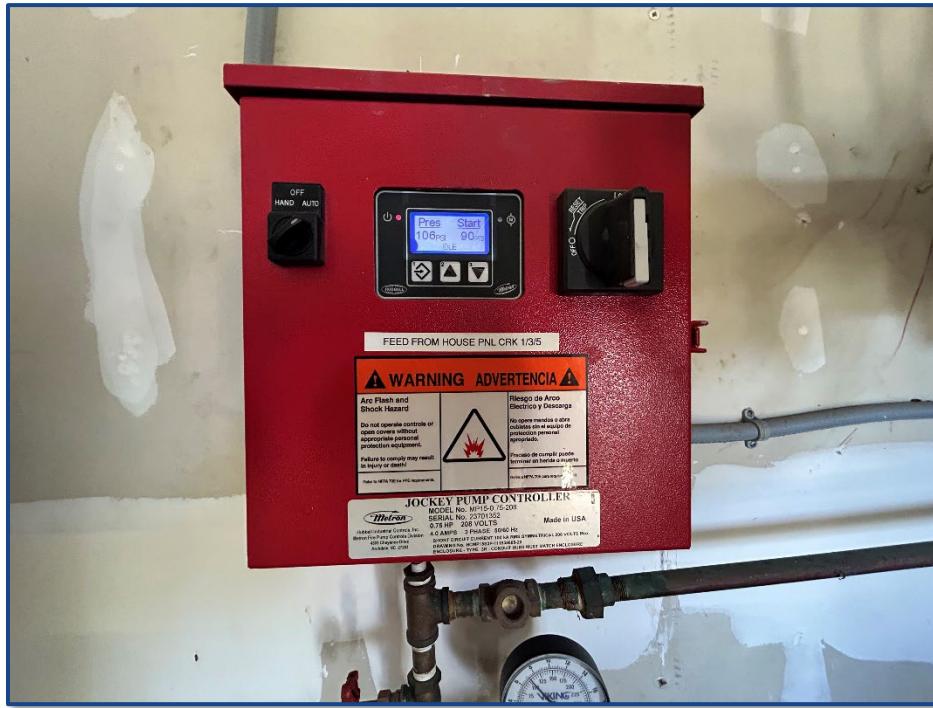
Photograph No. 11: Metron fire pump control panel.

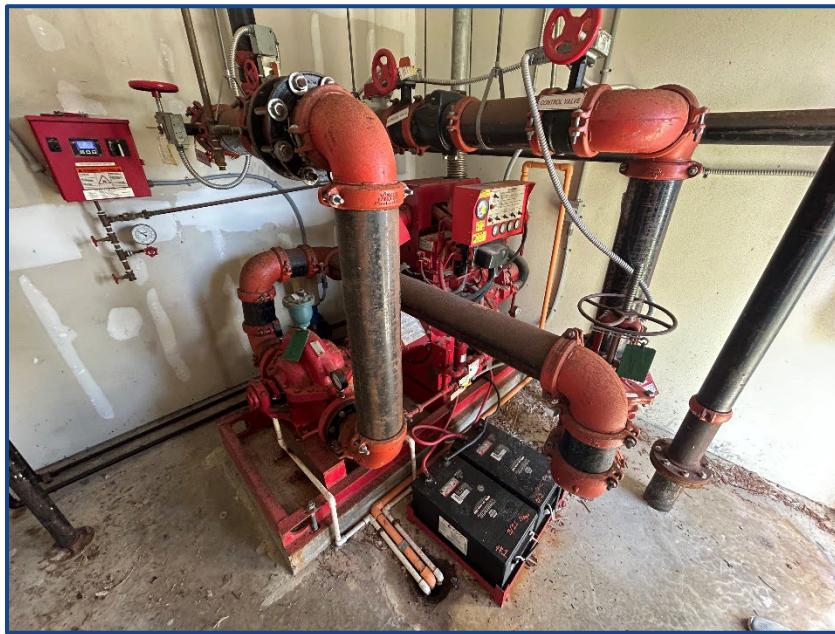
Photograph No. 12: Fire pump with pump control panel.

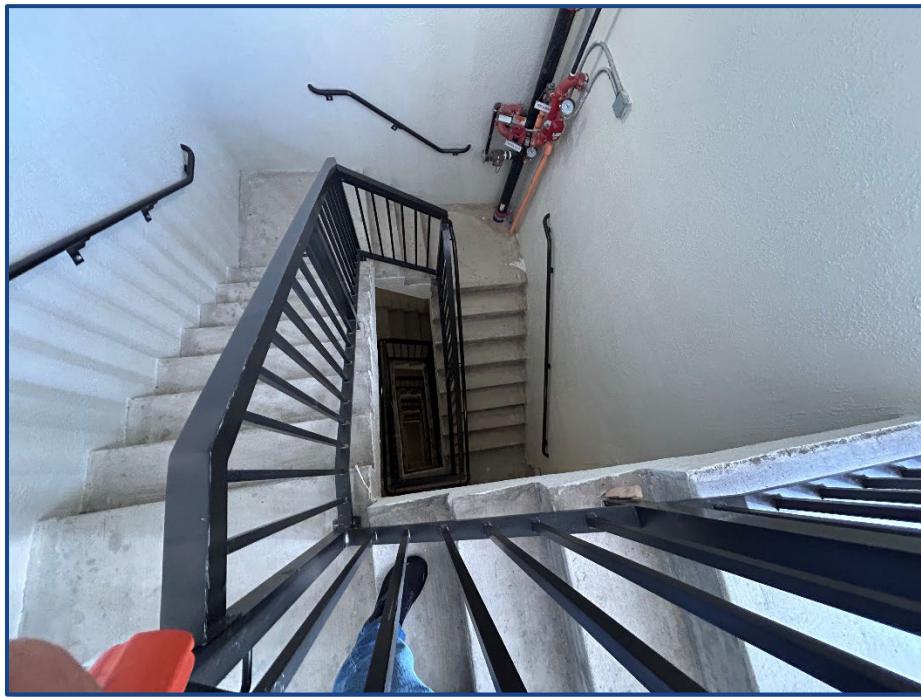
Photograph No. 13: Overall view of stairs from roof level.

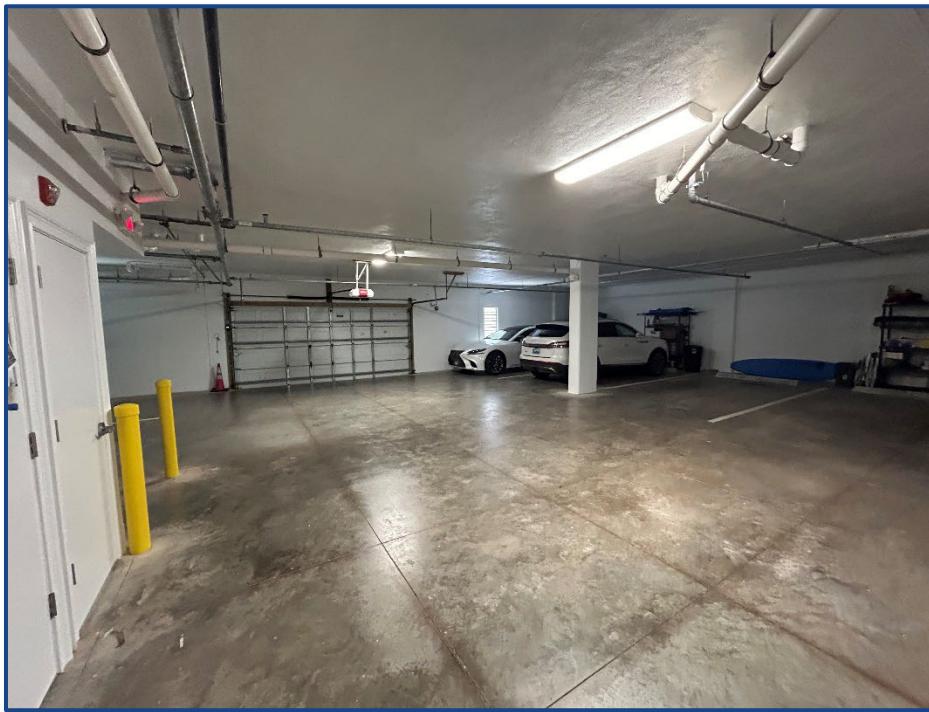
The building is composed of concrete masonry unit (CMU) load bearing walls, CMU shear/fire walls, concrete tie beams at each floor level, and cast-in-place post-tension concrete floor slabs. At the time of inspection, no damage (spalling, cracking, exposed steel reinforcement, etc.) was observed in the primary structural members; they are all in good condition. The exterior finishes are composed of painted stucco which at the time of inspection was in good condition. Guard rails and posts are made of aluminum, and they were in good condition, with no repairs required.

Photograph No. 14: Overall garage area with all visible structural members in good condition.

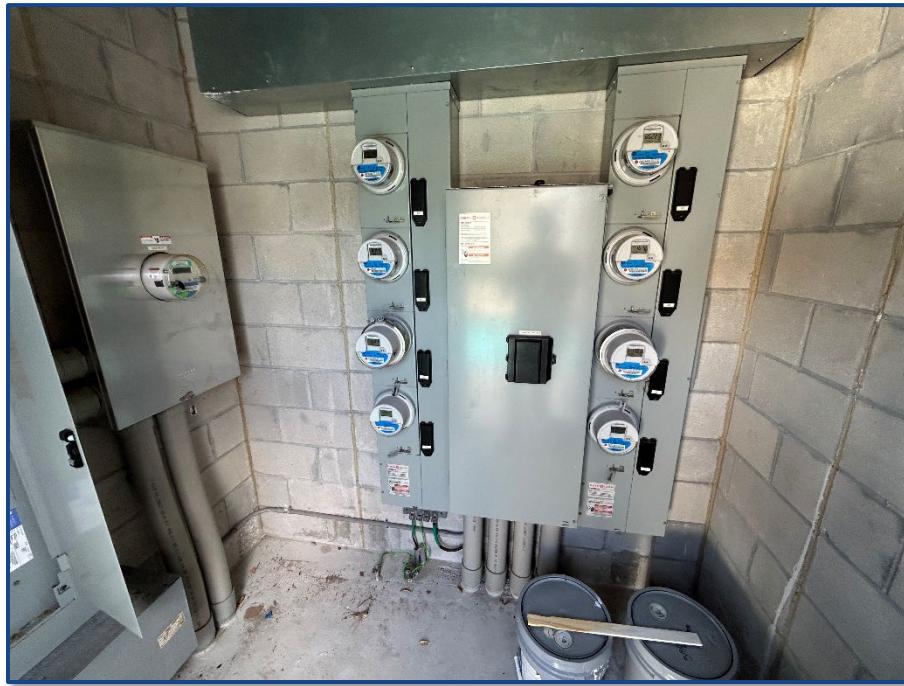
The visible electrical systems inspected at the time of inspection in the electrical room included the individual electrical meters and house panels. The main electrical service is 800 Amp, 240 volt, 3 phase, 4 wire service to the main disconnect. All power consumption meters, line gutters and electrical conduits are inside the utility room at the south side of the building and are kept separate from the elements. At the time of inspection, no deficiencies were observed to the electrical systems. There may be other issues that may occur during the next 10 years, requiring some small maintenance reserves.

Photograph No. 15: Electrical room unit meters

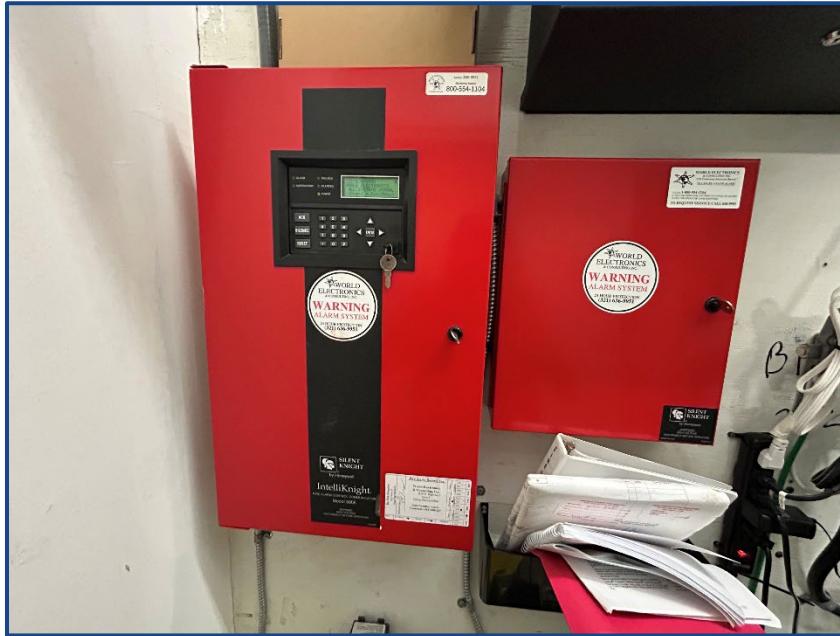
Photograph No. 16: Silent Knight fire alarm control panel.

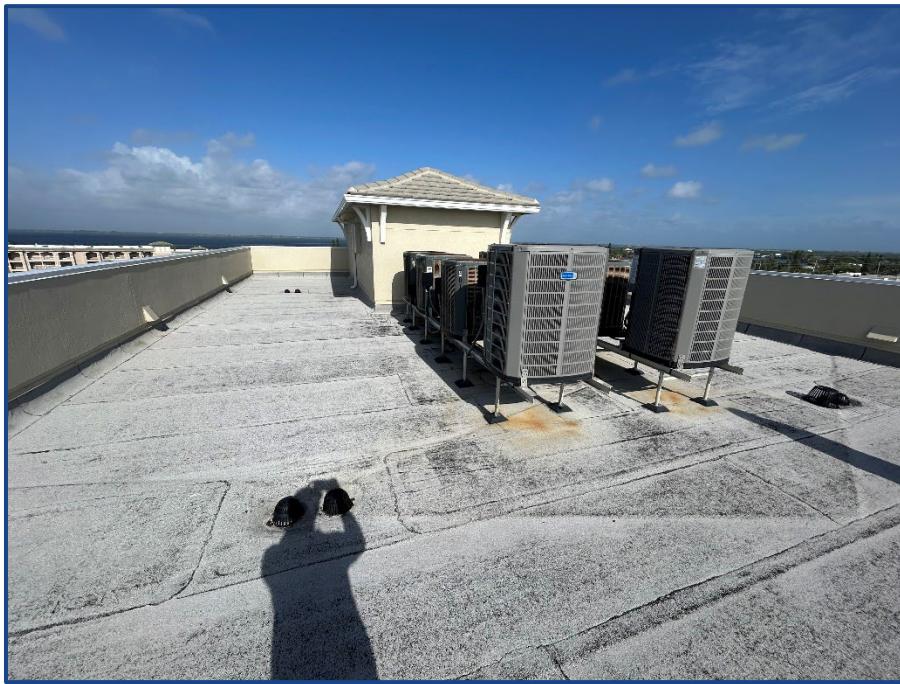
The building's roof system is composed of a mansard roof with clay tiles covering the perimeter sloped sections and a built-up-roof at the center flat area. Interior roof drains were observed in good condition at the center section of the roof. All components of the roof are from the original construction in 2016.

Photograph No. 17: Overall roof facing west.

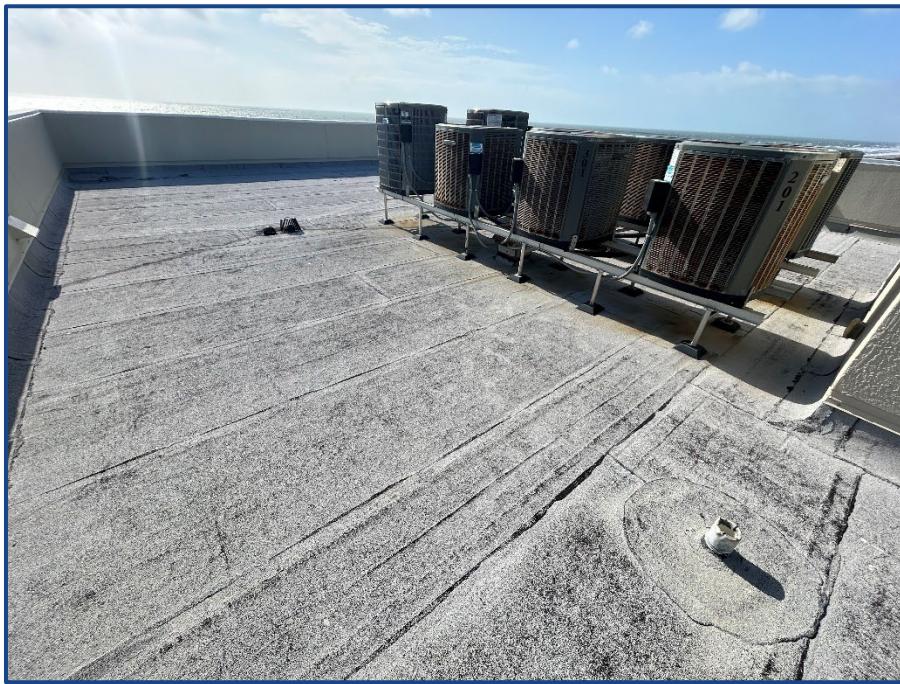
Photograph No. 18: East side of the roof with AC units at the center.

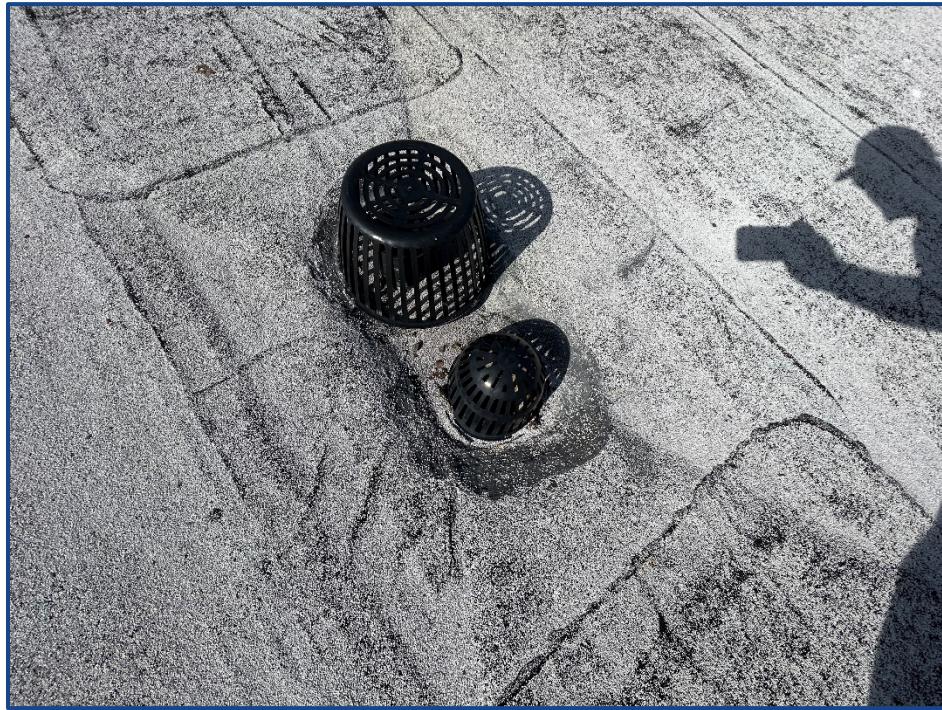
Photograph No. 19: Typical interior roof drains with covers in good conditions.

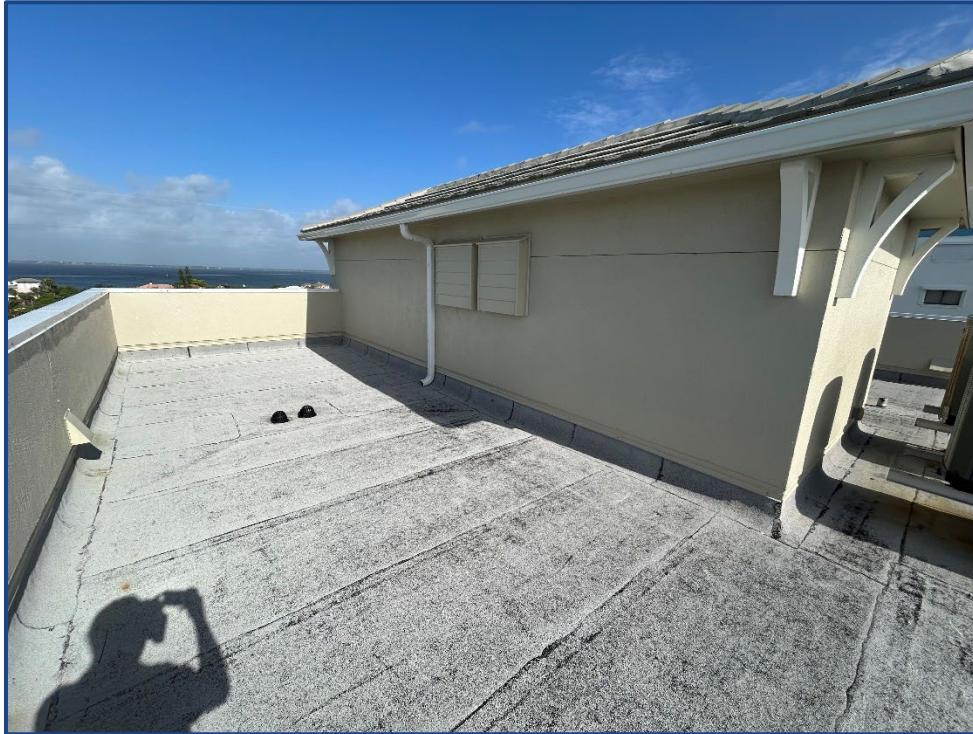
Photograph No. 20: SW corner of the building.

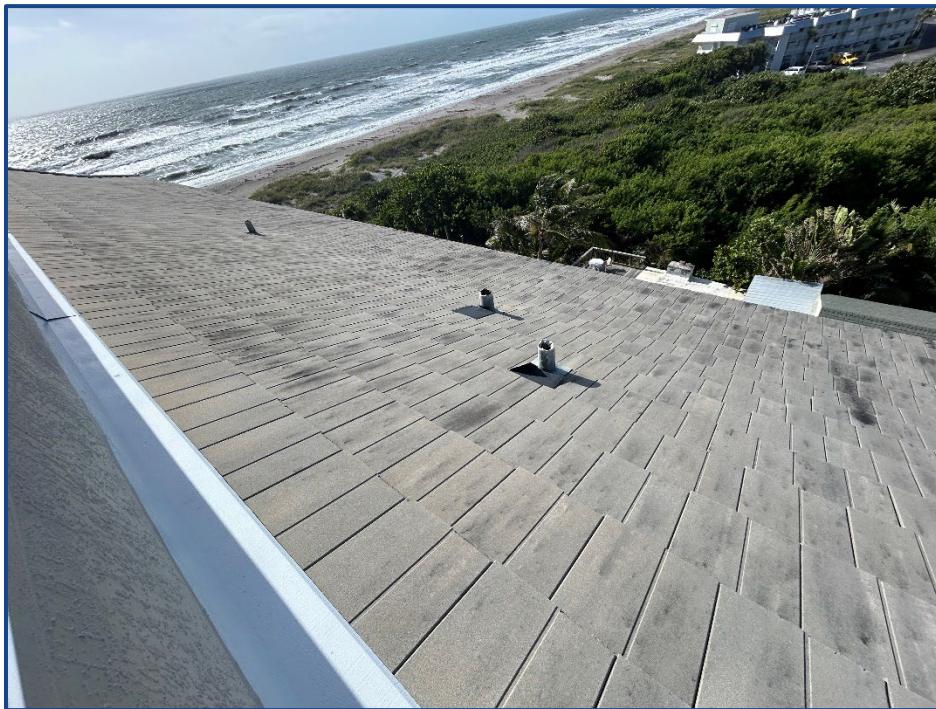
Photograph No. 21: Perimeter shingle roof section in good condition.

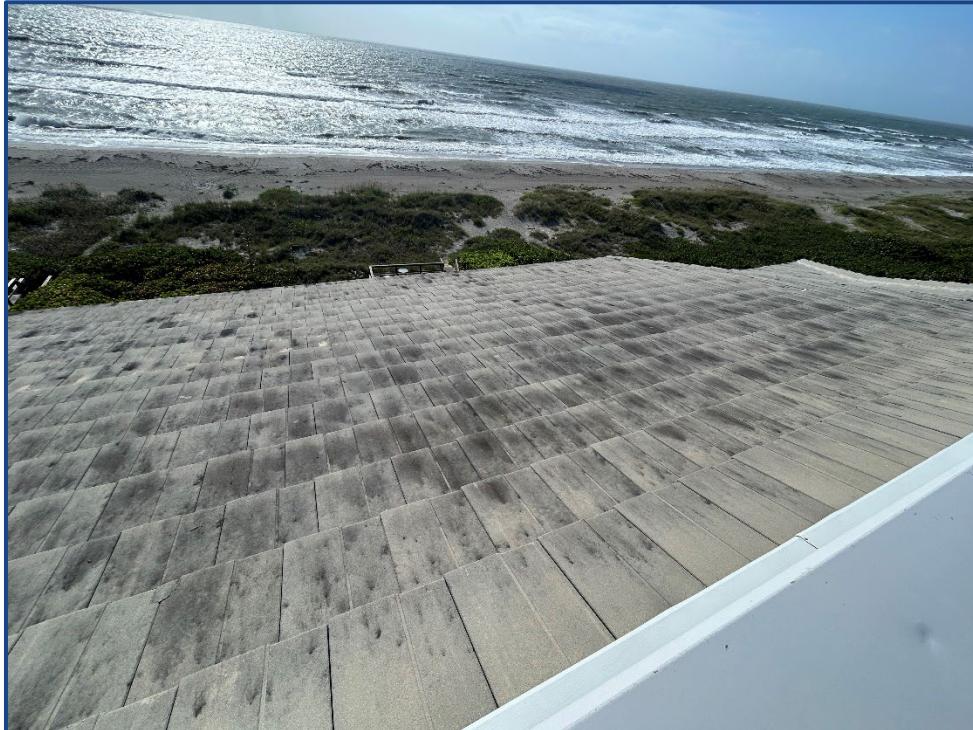
Photograph No. 22: Perimeter shingle roof section in good condition.
