Commercial Property Inspection Report

December 20, 2017

RE: 80 Casey Ln
Gilroy, CA 95020

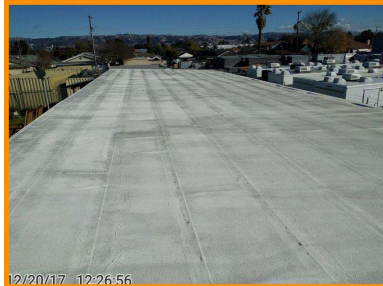
[FE] The roofing material appeared to be nearing the end of its useful life. This condition is conducive to moisture intrusion and damage to the building components. The roof could fail at any time. We recommend you consult with a roofing contractor to fully understand the costs should replacement be desired or become necessary.

[NOTE] Overall the low slope roofs appeared to be well installed yet near the end their service lives. Roof coating had been applied - this blocks our view and typically is done to extend the life of older roofs.

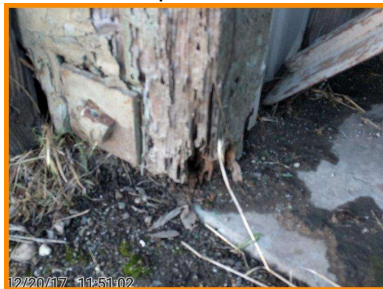
[FE] Several moisture damaged posts were observed at the garages. This condition is conducive to premature failure of the posts.

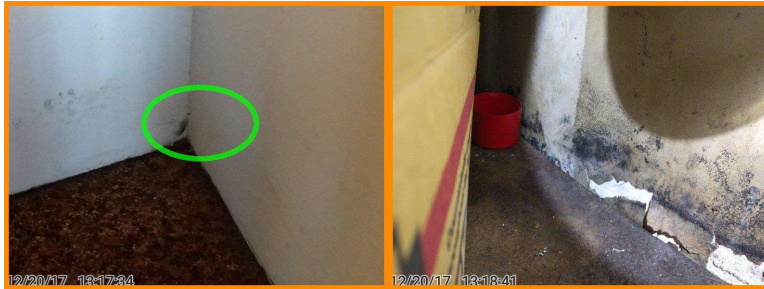
[FE] Possible microbial growth was noted on the walls in an entry closet (backs up to sink) and below the hall sink. This condition should be further evaluated by an environmental specialist in order to identify the staining, its source and appropriate removal.

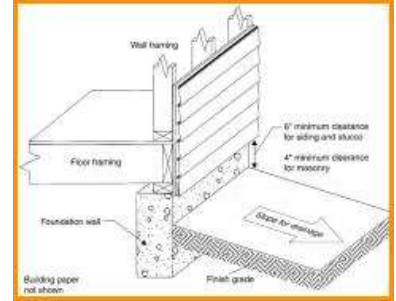
[NOTE] General building practices call for a minimum of 4 to 6 inches of clearance or separation between the soil/grade and any building framing or cladding materials. This separation helps to minimize the potential for moisture intrusion during periods of inclement weather when water may tend to collect or pond around the building. The degree to which this can be maintained greatly enhances the likelihood that the buildings materials will meet their intended service life.

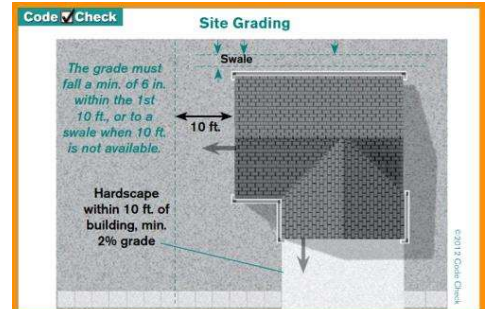
Site Grading

[CR] A reverse grade was present (sloped towards the structure) at the exterior (all sides) and garage. This means water/moisture will flow towards the building rather than away. This condition is conducive to moisture intrusion and/or deterioration of the building components. Evidence of moisture intrusion was observed at the garages. The grading should have a positive slope away from the building, dropping at least 6 inches in 10 feet or slope to a drainage system if the building is closer than 10 feet to the property line.

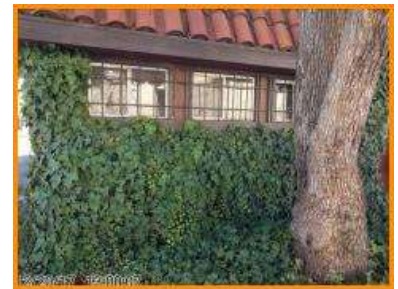
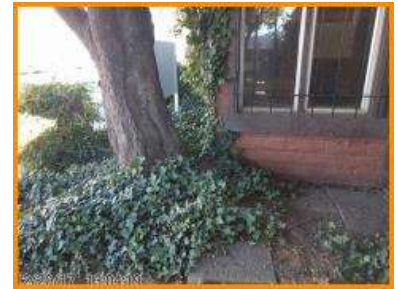
[CR] Vegetation was growing on the structure at the exterior (all sides). This condition limits the inspection, and is conducive to moisture intrusion/deterioration of the building components and provides ready access to rodents and insects.

[CR] Tree(s) were planted too close to the structure at the front. This condition limits the inspection, and is conducive to moisture intrusion/deterioration of the building components and provides ready access to rodents and insects.

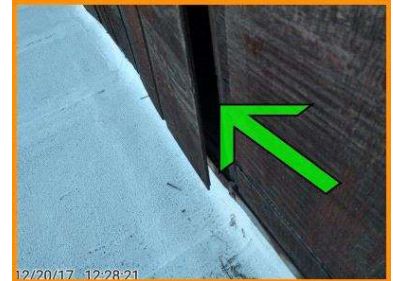
12/20/17 12:28:21
Garage, at the roof - Roof Wall Connection

[CR] Loose and open wood cladding was observed at the garage. This condition is conducive to moisture intrusion and deterioration of the building materials.

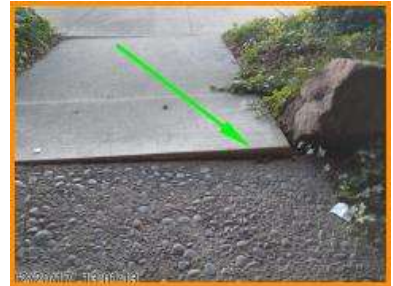
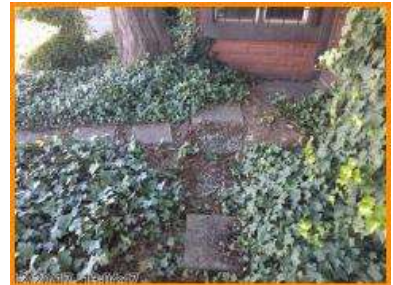
[SC] Uneven surfaces were noted in the walkway(s) at the front. This condition is considered a trip hazard.

[SC] Uneven surfaces were noted in the adjacent public walkways. This condition is considered a trip hazard. Although many believe that the local jurisdiction has liability, this is increasingly being shifted by the jurisdictions to the property owner. We recommend you check with your local authority.

[NOTE] Stepping stones were present. Stepping stones often present uneven surfaces which can become a trip hazard.

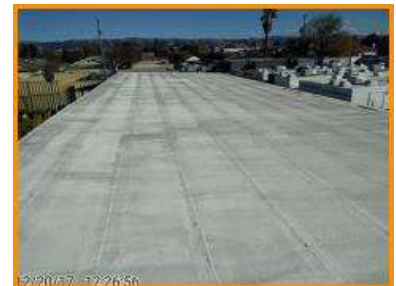
[FE] The roofing material appeared to be nearing the end of its useful life. This condition is conducive to moisture intrusion and damage to the building components. The roof could fail at any time. We recommend you consult with a roofing contractor to fully understand the costs should replacement be desired or become necessary.

[NOTE] Overall the low slope roofs appeared to be well installed yet near the end their service lives. Roof coating had been applied - this blocks our view and typically is done to extend the life of older roofs.

[NOTE] Although it had recently rained, and water was still on the roofs, we did not observe any leaks at the time of the inspection.

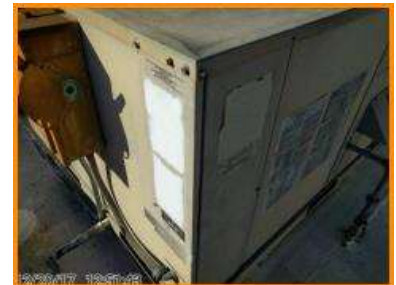
[FE]. The HVAC equipment appeared to be at or beyond its expected service life (the labels were not legible) - The only way to be completely sure of its safe/continued operation is with a full evaluation by a heating contractor. Due to its age we recommend a full evaluation by a heating contractor.

[NOTE] We were unable to read the labels on the unit, which had become sun damaged.

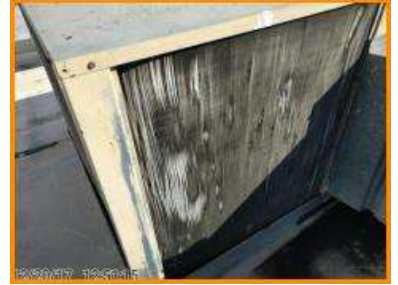
[CR] A number of the fins on the cooling-coil of the condensing unit were damaged and deteriorated. This condition reduces the cooling-coil's ability to dissipate heat thereby reducing the unit's overall performance.

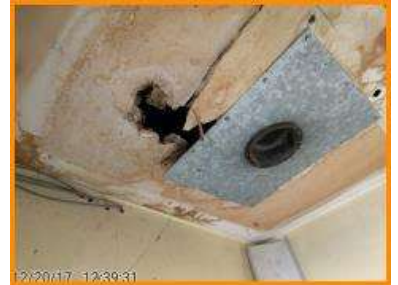
[FE] Dry moisture stains & damage were noted on the ceiling in the telephone closet. These appear to be old, thus we recommend inquiring with the current owner regarding the nature and history of these stains. Should they be current or uncorrected they could lead to additional damage.

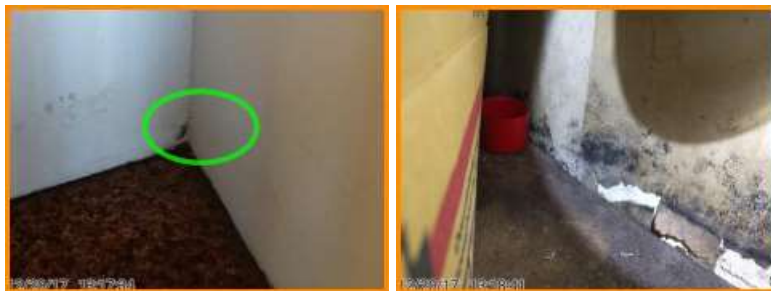
[FE] Possible microbial growth was noted on the walls in an entry closet (backs up to sink) and below the hall sink. This condition should be further evaluated by an environmental specialist in order to identify the staining, its source and appropriate removal.

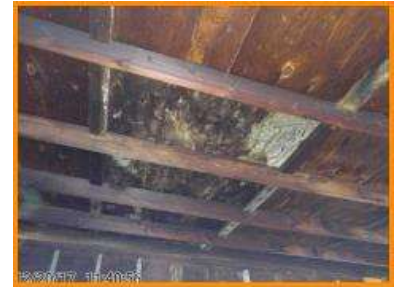
[FE] Moisture stains & damage were noted on the ceiling. These may be old or current, thus we recommend inquiring with the current owner regarding the nature and history of these stains. Should they be current or uncorrected their cause could lead to additional damage.

[CR] Moisture damage was noted in several posts at the garage. This condition weakens the framing and may reduce it's ability to support the weight from above during high-winds or seismic activity.

[CR] Open cracks were noted in the garage floor. This condition is conducive to moisture intrusion into concealed spaces which promotes deterioration.
