Commercial Property Inspection Report

123 Any Lane

Yourtown, CA 9111

Inspection Date: 12/20/2017

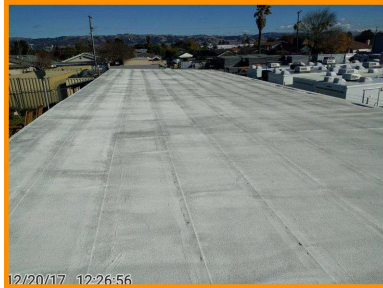
[FE] The roofing material appeared to be nearing the end of its useful life. This condition is conducive to moisture intrusion and damage to the building components. The roof could fail at any time. We recommend you consult with a roofing contractor to fully understand the costs should replacement be desired or become necessary.

[NOTE] Overall the low slope roofs appeared to be well installed yet near the end their service lives. Roof coating had been applied - this blocks our view and typically is done to extend the life of older roofs.

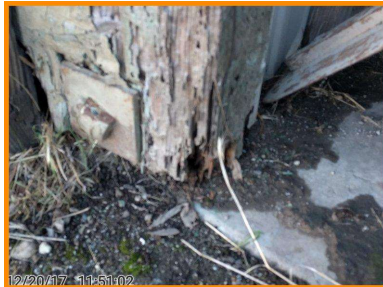
[FE] Several moisture damaged posts were observed at the garages. This condition is conducive to premature failure of the posts.

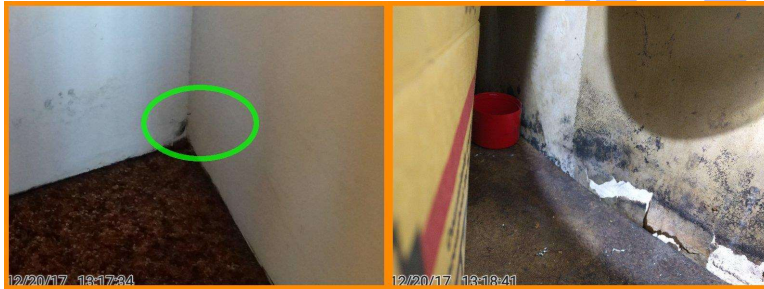
[FE] Possible microbial growth was noted on the walls in an entry closet (backs up to sink) and below the hall sink. This condition should be further evaluated by an environmental specialist in order to identify the staining, its source and appropriate removal.

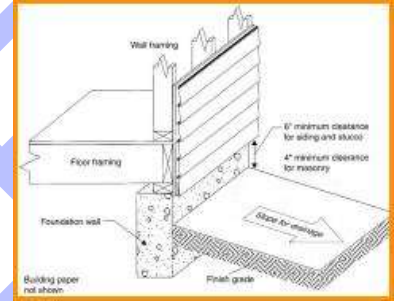
[CR] The exterior cladding was in contact with the soil at the garages. This condition is conducive to moisture related damage and deterioration. A four to six inch separation should be maintained to minimize the potential for damage due to moisture wicking from the soil into the framing members.

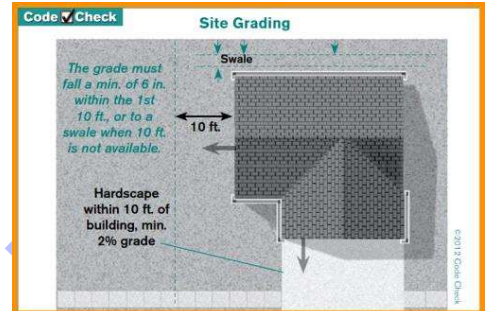
Site Grading

[CR] A reverse grade was present (sloped towards the structure) at the exterior (all sides) and garage. This means water/moisture will flow towards the building rather than away. This condition is conducive to moisture intrusion and/or deterioration of the building components. Evidence of moisture intrusion was observed at the garages. The grading should have a positive slope away from the building, dropping at least 6 inches in 10 feet or slope to a drainage system if the building is closer than 10 feet to the property line.

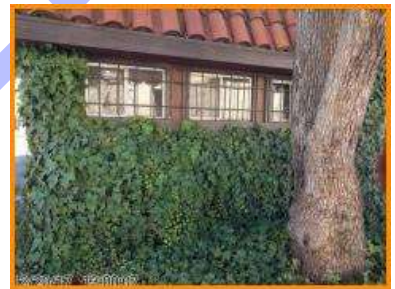
[CR] Vegetation was growing on the structure at the exterior (all sides). This condition limits the inspection, and is conducive to moisture intrusion/deterioration of the building components and provides ready access to rodents and insects.

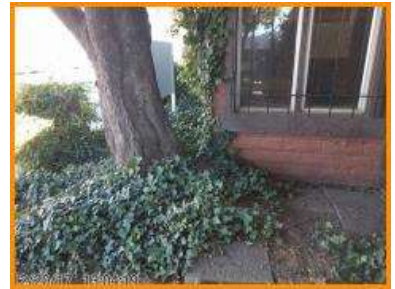
[CR] Tree(s) were planted too close to the structure at the front. This condition limits the inspection, and is conducive to moisture intrusion/deterioration of the building components and provides ready access to rodents and insects.

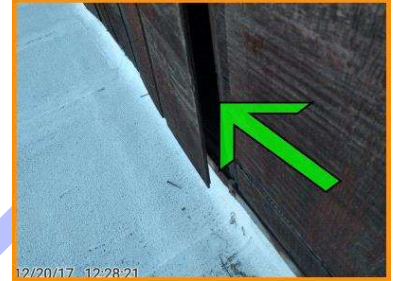
12/20/17 12:28:21
Garage, at the roof - Roof Wall Connection

[CR] Loose and open wood cladding was observed at the garage. This condition is conducive to moisture intrusion and deterioration of the building materials.

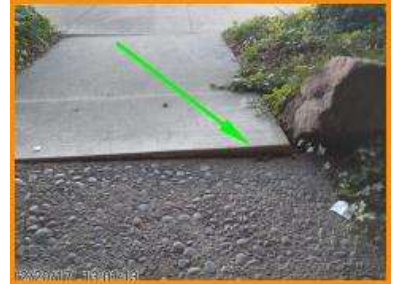
[SC] Uneven surfaces were noted in the walkway(s) at the front. This condition is considered a trip hazard.

[SC] Uneven surfaces were noted in the adjacent public walkways. This condition is considered a trip hazard. Although many believe that the local jurisdiction has liability, this is increasingly being shifted by the jurisdictions to the property owner. We recommend you check with your local authority.

[NOTE] Stepping stones were present. Stepping stones often present uneven surfaces which can become a trip hazard.

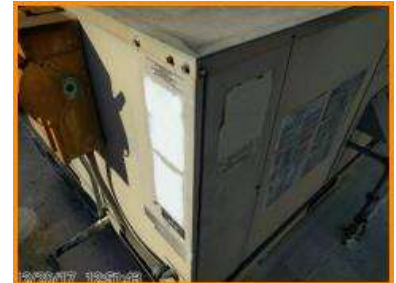
[FE]. The HVAC equipment appeared to be at or beyond its expected service life (the labels were not legible) - The only way to be completely sure of its safe/continued operation is with a full evaluation by a heating contractor. Due to its age we recommend a full evaluation by a heating contractor.

[NOTE] We were unable to read the labels on the unit, which had become sun damaged.

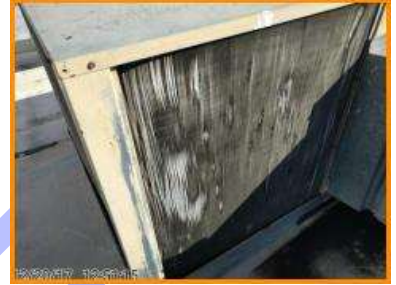
[CR] A number of the fins on the cooling-coil of the condensing unit were damaged and deteriorated. This condition reduces the cooling-coil's ability to dissipate heat thereby reducing the unit's overall performance.

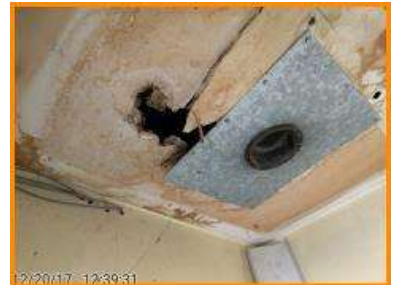
[FE] Dry moisture stains & damage were noted on the ceiling in the telephone closet. These appear to be old, thus we recommend inquiring with the current owner regarding the nature and history of these stains. Should they be current or uncorrected they could lead to additional damage.

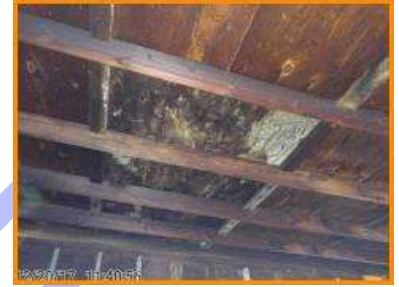
[FE] Moisture stains & damage were noted on the ceiling. These may be old or current, thus we recommend inquiring with the current owner regarding the nature and history of these stains. Should they be current or uncorrected their cause could lead to additional damage.

[CR] Moisture damage was noted in several posts at the garage. This condition weakens the framing and may reduce it's ability to support the weight from above during high-winds or seismic activity.

[CR] Open cracks were noted in the garage floor. This condition is conducive to moisture intrusion into concealed spaces which promotes deterioration.
