Date: 11/21/2022
Company Name: Schorr Architects, Inc.
Attention: Victoria Newell
230 Bradenton Ave.
Dublin, Ohio 43017

Project Name: Hannah Ashton School Investigation
SMBH Job #: 022-025.014
Re: Structural Assessment

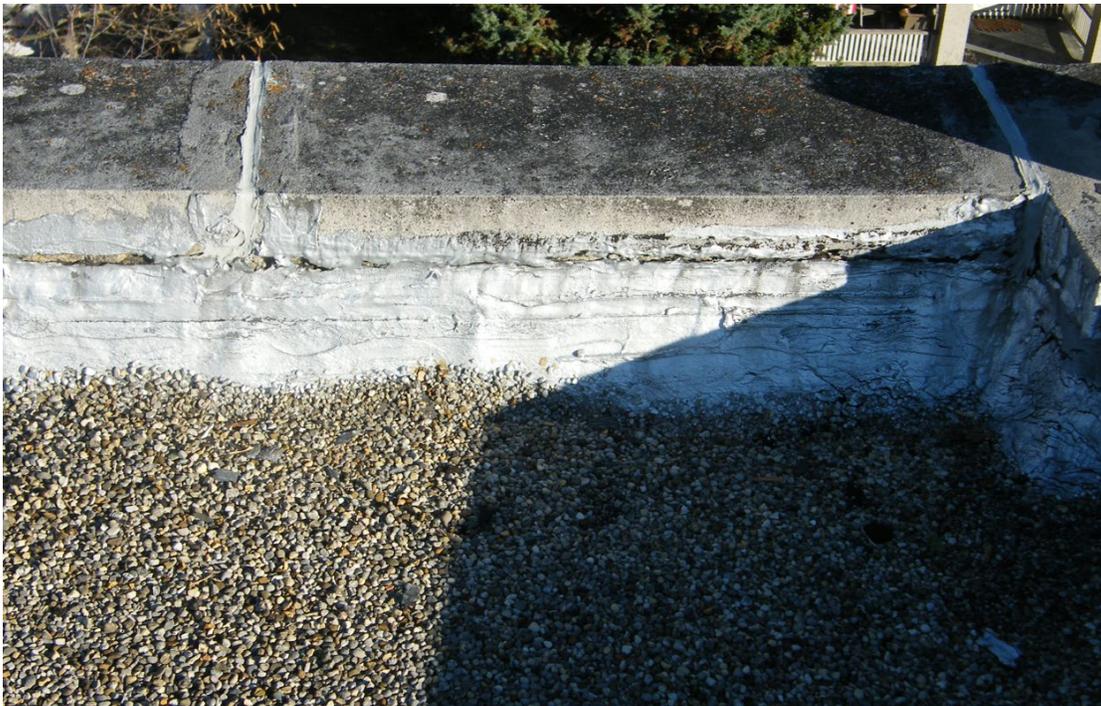
Cracked and damaged flashing at the parapets is allowing moisture to infiltrate the walls

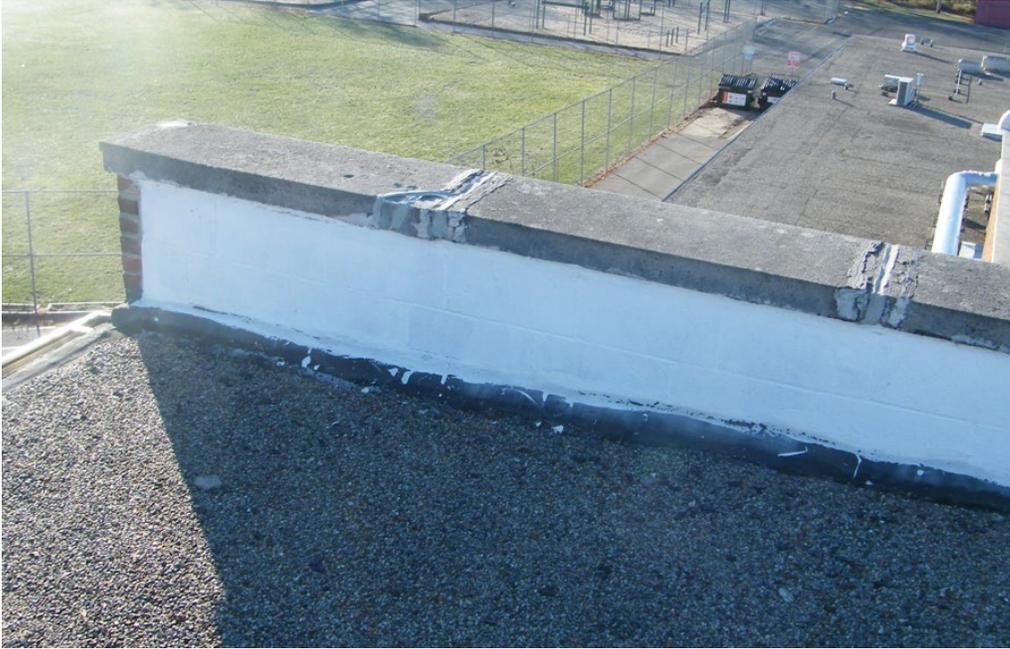
Cracked and damaged joint sealant between the coping stones is allowing water infiltration into the wall

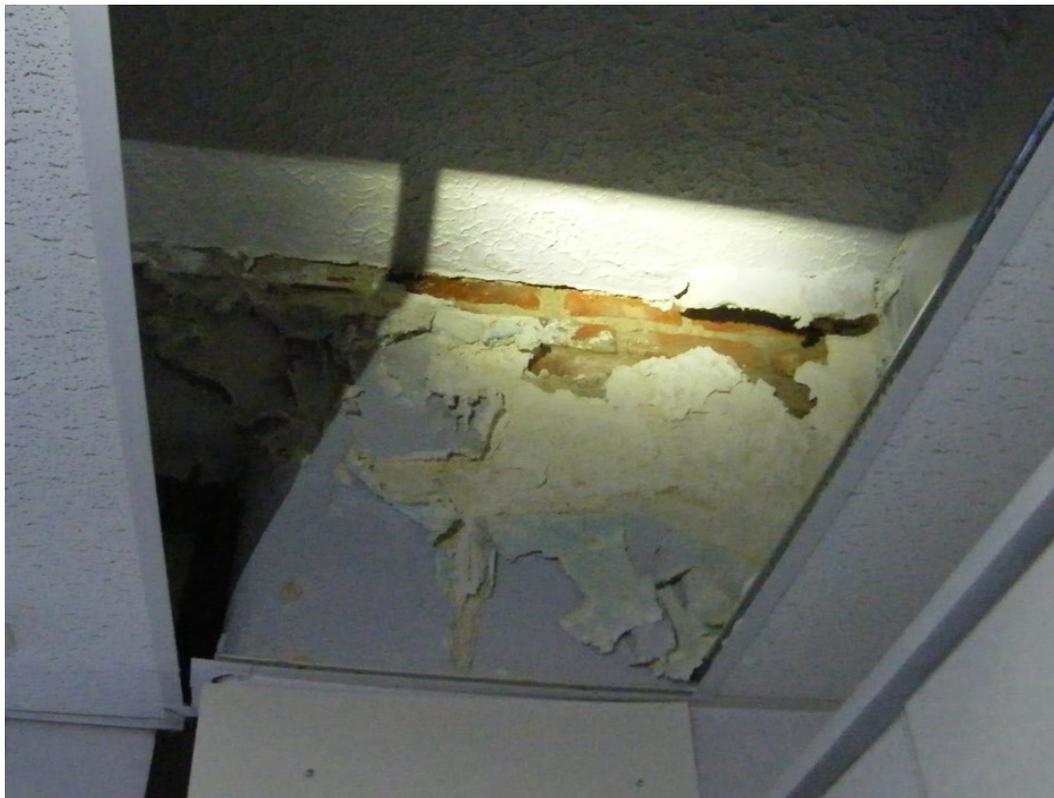
The roof and floor structure were not readily observable due to the plaster ceilings. There were indications of water infiltration at the perimeter walls. The walls in room 302 had spalling plaster due to the water infiltration that worsened at the second floor and the first floor. The water infiltration seemed to be the result of a faulty scupper

and downspout at the roof. See subsequent comments on this location. I did not observe any signs of deflection in the floors or the roofs and there were no indications of significant adverse structural defects.

Water infiltration near the north side scupper and downspout

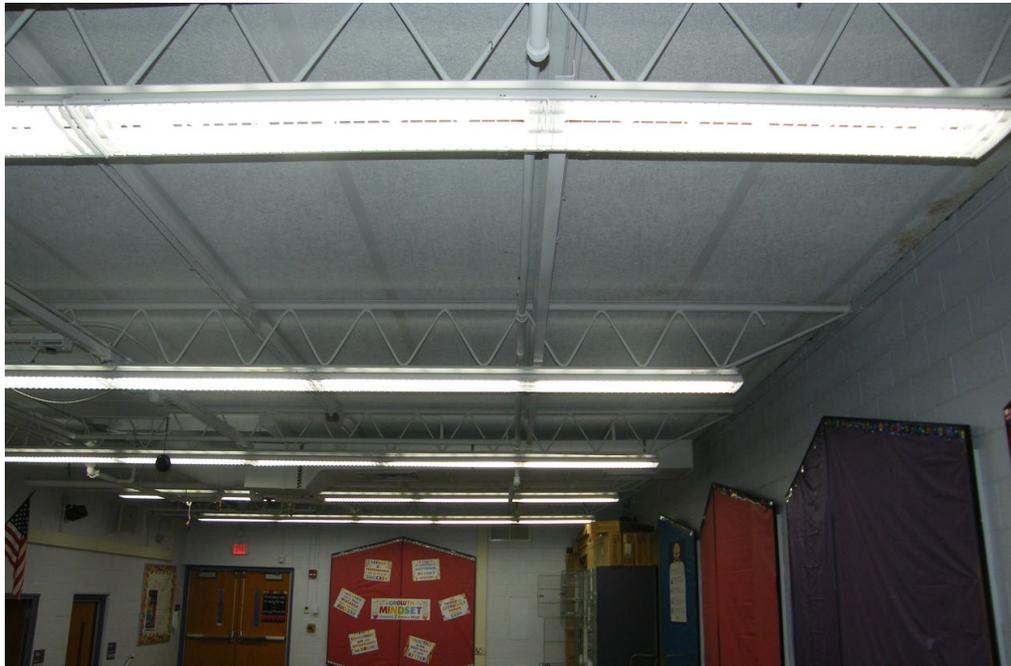
This structure had a tectum roof deck supported on steel joists that were supported on steel beams or concrete masonry walls. There were some indications of water infiltration but no obvious indications of significant adverse structural defects.

Tectum deck on steel joists on concrete masonry walls. Bob Hoyt noted that the roof on this 1964 building leaked.

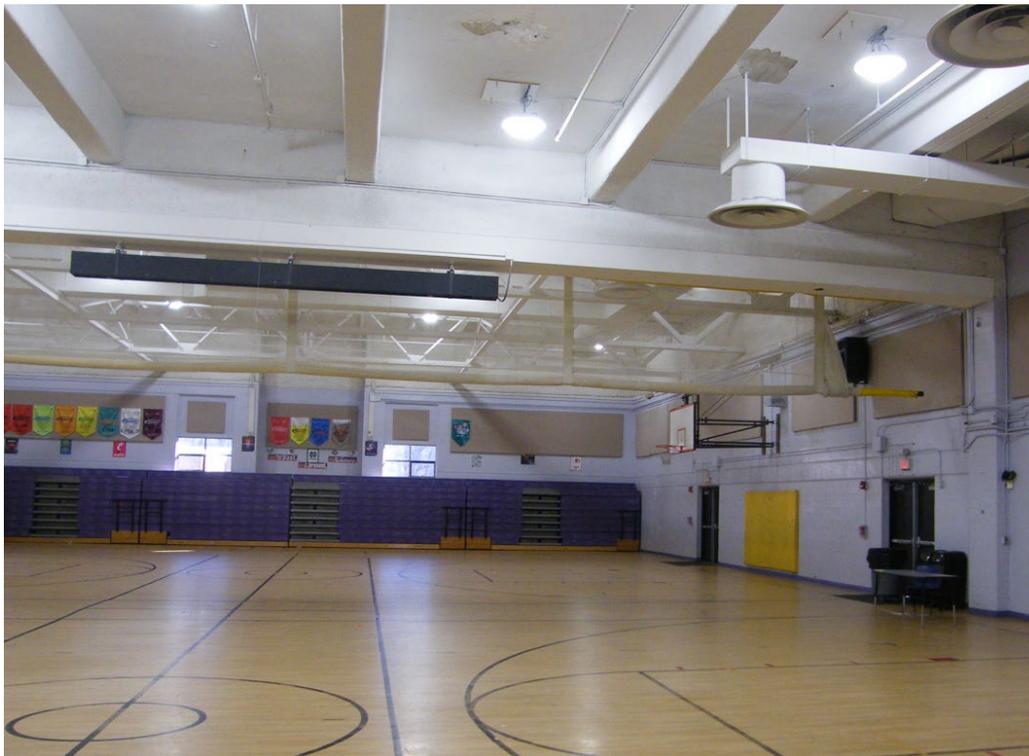
Original 1868 building converted to gymnasium space

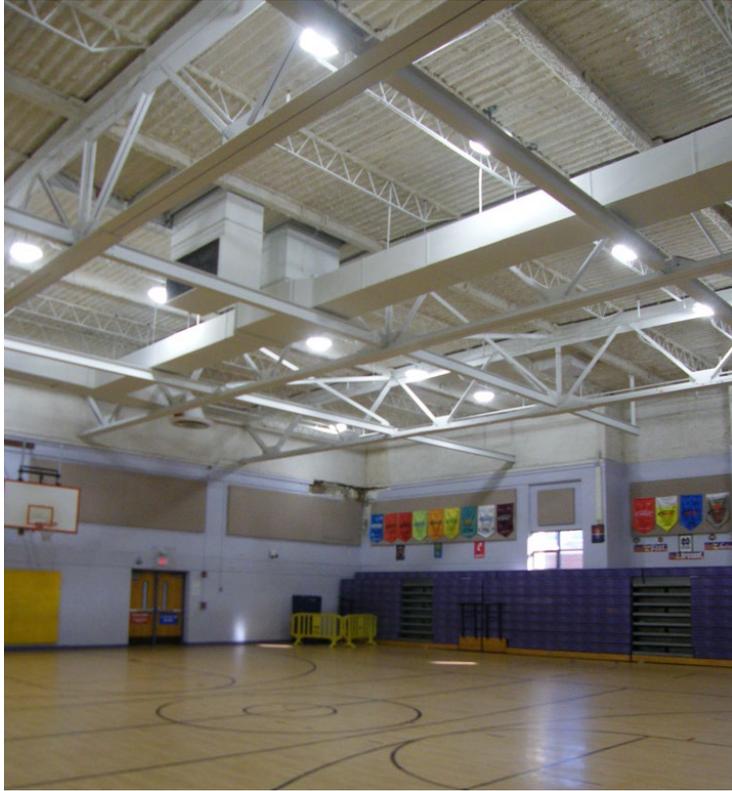
Addition to create the gymnasium with water infiltration at the back corner.

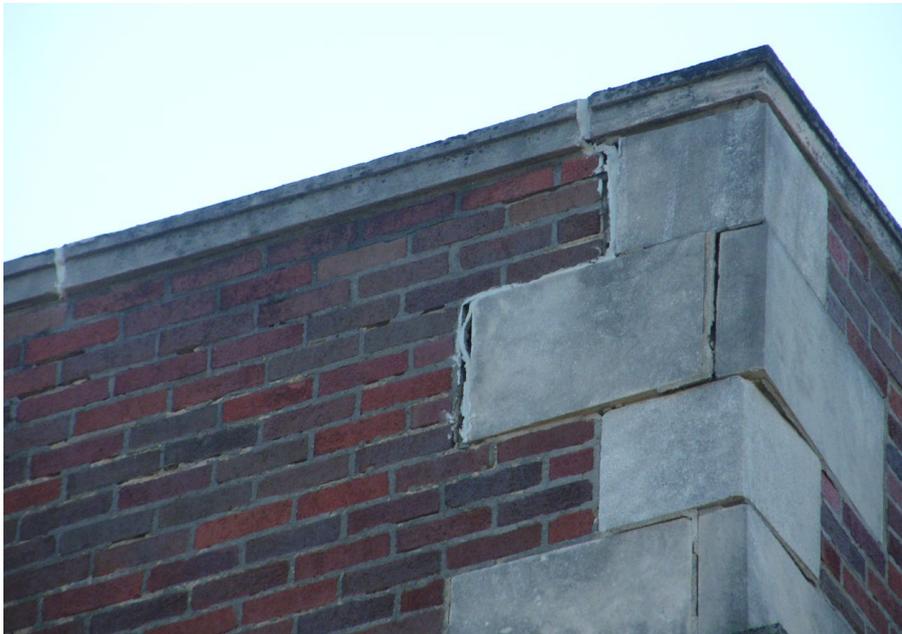
Cracked and missing mortar in the parapet walls allows moisture to enter the building. Displaced brick and stones as here on the northwest corner should be repaired or secured as soon as possible to prevent falling debris.

The WTI report is a comprehensive evaluation of the exterior walls, parapets and façade. The WTI report details many of the localized conditions of the walls around the perimeter of the building. Their report has specific recommendations for repairs with priorities based on the severity of the deterioration. Generally, the WTI report states that the older buildings have more significant deterioration than the newer buildings. While we agree with their recommendations that some areas should be repaired as soon as possible to mitigate safety hazards, we believe that the exterior walls have sufficient capacity to safely continue to support the gravity and lateral loads imposed upon them. One area of note that does need immediate attention is the loose stone at the parapet at the northwest corner of the building as indicated in the photo above.

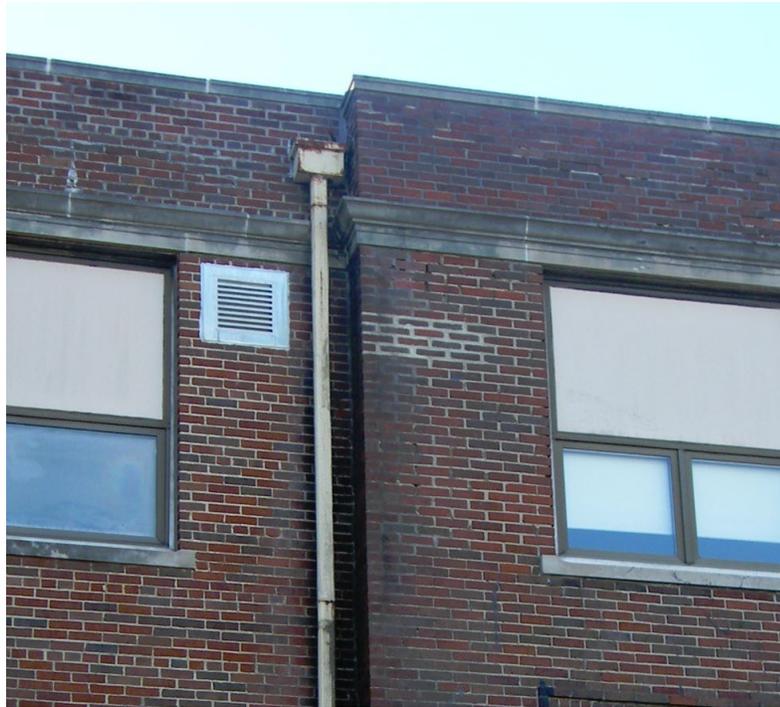
The faulty scupper and downspout is allowing water to enter the building through the wall at rooms 302 and 202 and below.

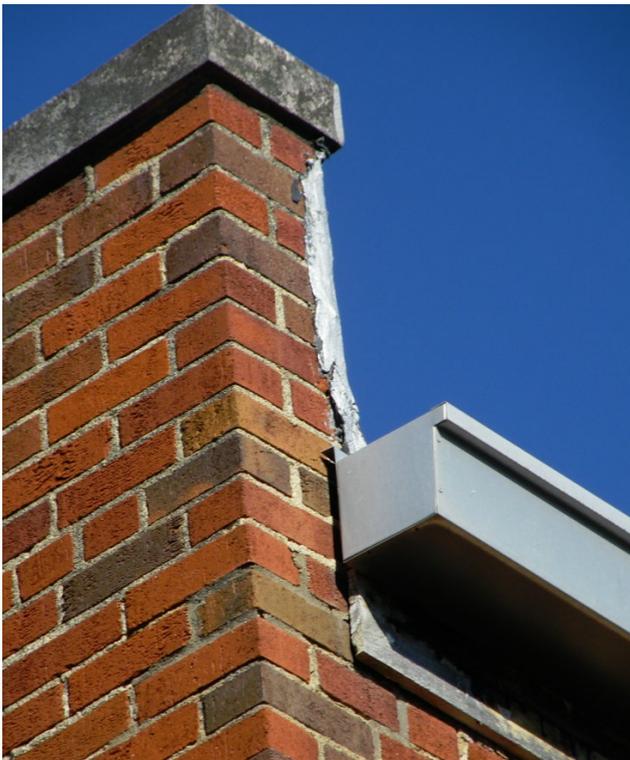
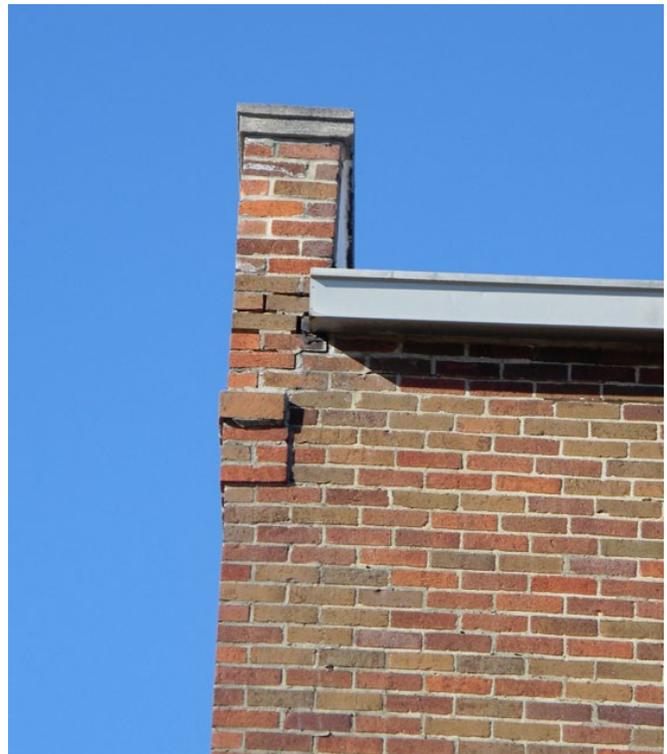
Parapets are generally two wythe and three wythe walls with heights less than 24 inches above the roof.

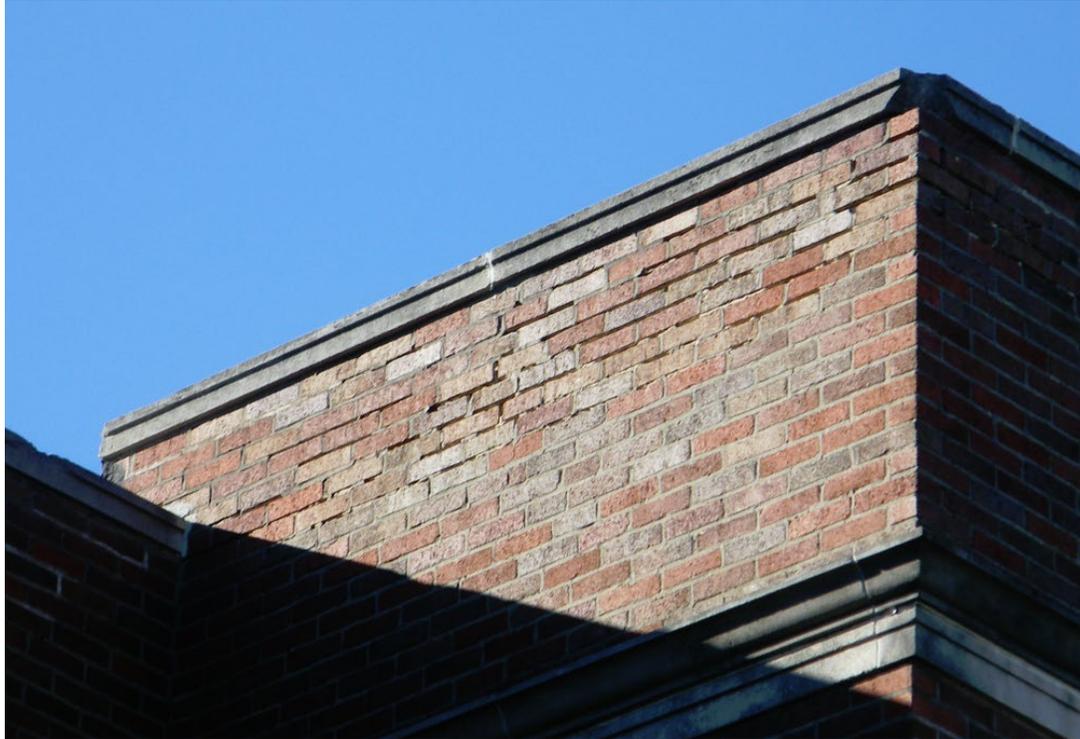
Parapets exhibited signs of cracked, loose and missing mortar. Some parapets leaned slightly inward but seemed to be firmly attached to the walls below. There is moisture infiltration in the parapet walls.

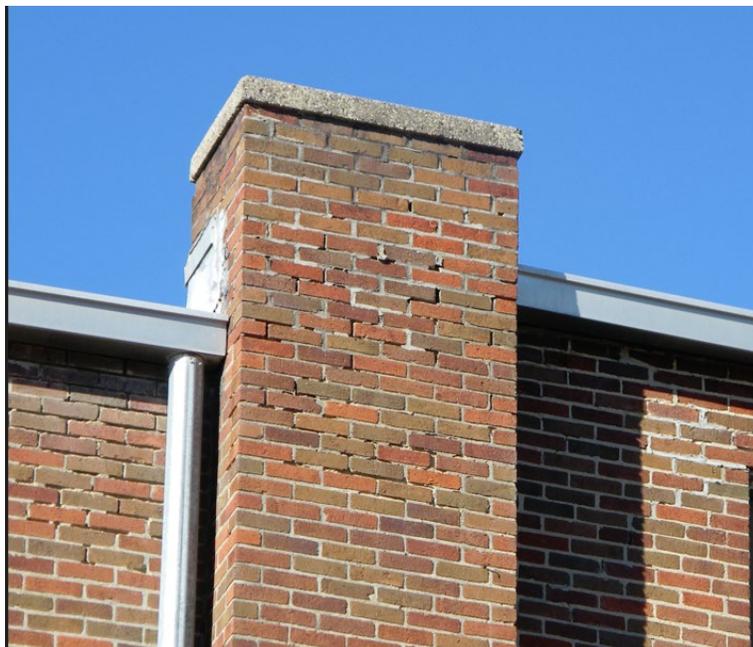
Cracked, loose and missing mortar allows moisture to infiltrate the building.
