Insured/Applicant Name:	ured/Applicant Name: Application / Policy #:				
Address Inspected: 123 Example street, Pompano Beach, FL 33064					
Actual Year Built: 1973					
Actual Year Built.		Date inspected			
Minimum Photo Requirements					
☑ Dwelling: Each side ☑ Roof: Each slope ☑		inder cabinet plumbing/d	rains, exposed valves		
✓ Main electrical service panel with interior doo	or label				
☑ Electrical box with panel off					
☑ All hazards or deficiencies noted in this report					
A Florida-licensed inspector must complete, sign and date this form.					
Be advised that Underwriting will rely on the inform	mation in this sample form	, or a similar form, that is	obtained from the Florida licensed professional of		
your choice. This information only is used to deter			e of the suitability, fitness or longevity of any of the		
systems inspected.					
Electrical System					
Separate documentation of any aluminum wiring r	remediation must be provide	ded and certified by a lice	ensed electrician.

Photos, Additional Comments or Observations

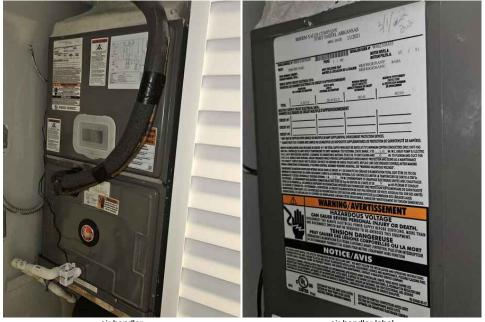
air handler
