## Existing Condition Assessment Report

### Royal Saint Andrew, Sarasota FL

Thornton Tomasetti

February 13, 2024

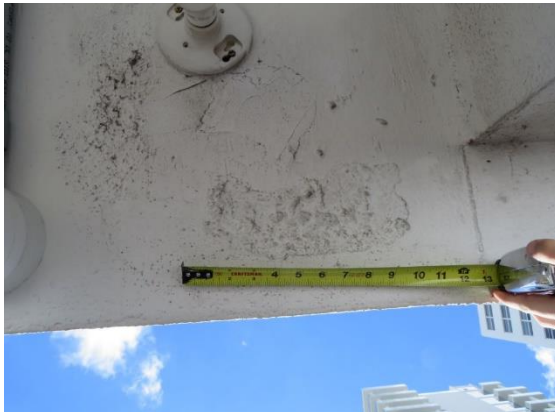
*Concrete Spalling at Underside of the Slab*

1. Excavate spalled concrete to expose reinforcing steel in spalled areas and perform repairs in accordance with International Concrete Repair Institute (ICRI) standards under the guidance of a qualified structural Engineer.
2. Inject Epoxy into nonmoving concrete cracks.
3. Remove and replace all failed waterproofing to protect concrete slab.
4. Monitor coating annually for additional bond failures.

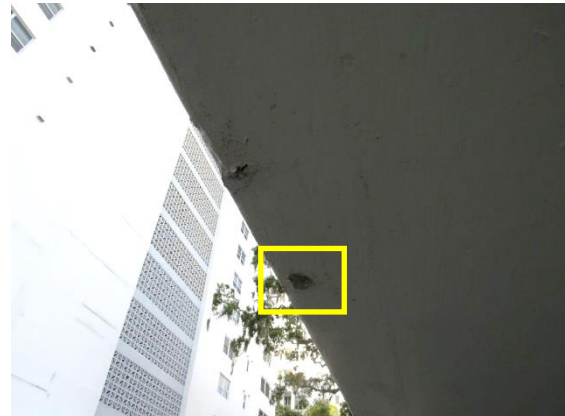
*Concrete Spalling at Underside of Slab*

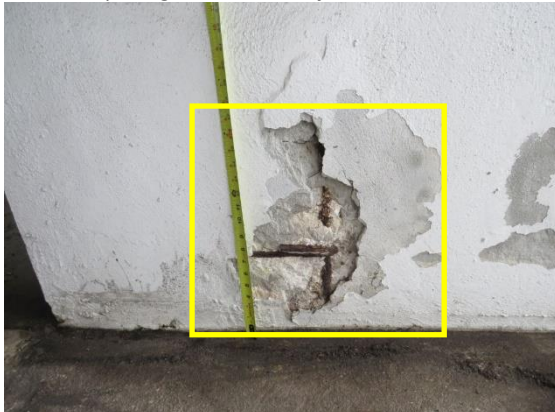
*Concrete Spalling at the Walls Adjacent to the Reported*

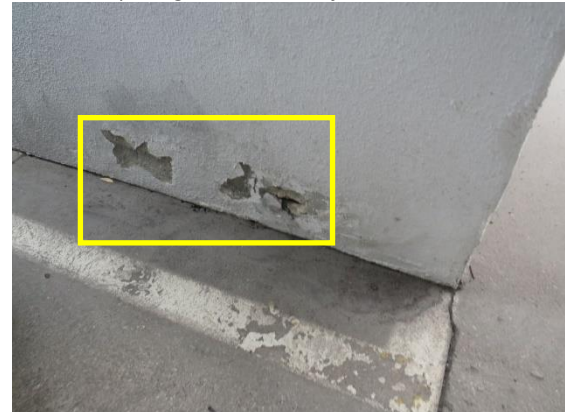
*Concrete Spalling at the Walls Adjacent to the Reported*

*Flooding*

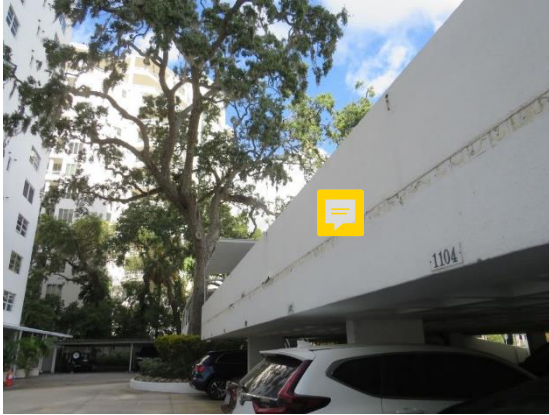
*Concrete Spalling at the Western Wall Where an Aluminum Canopy was Previously Installed*

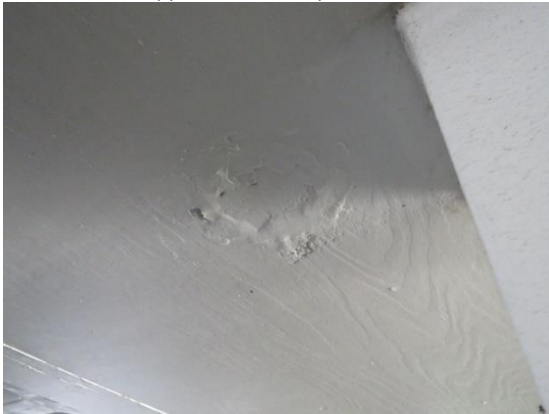
*Previous Repairs to the Underside of the Slab*

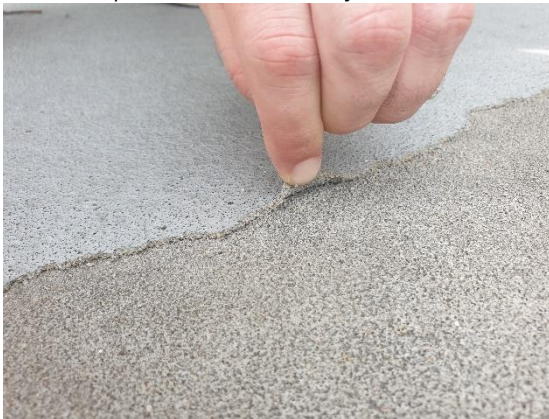
*Bond Failure Between Base and Topcoat*

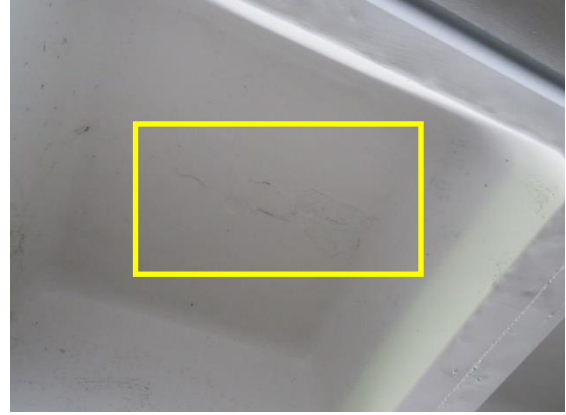
*Peeling Paint was Observed in the Slab Voids*

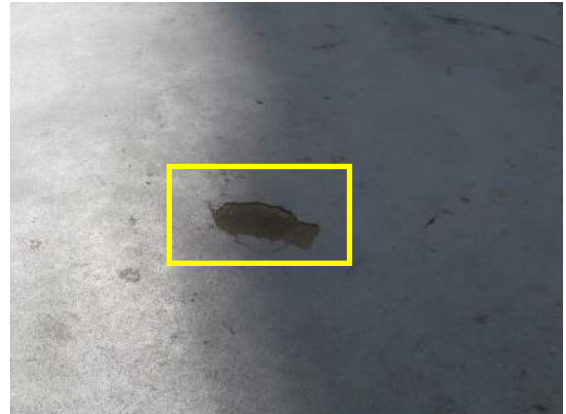
*Missing Waterproofing at Parking Slab*

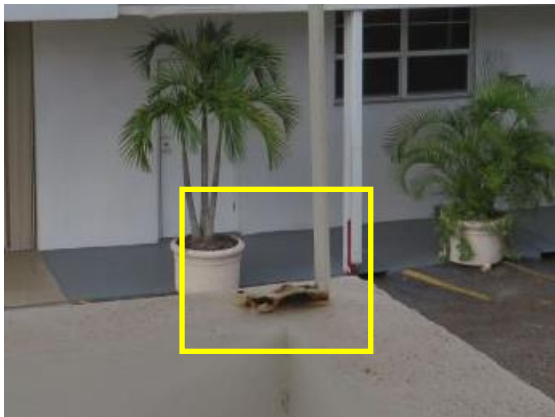
*Damaged Steel Canopy Support*

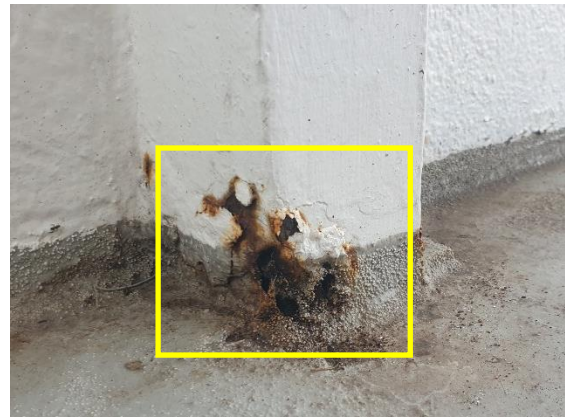
*Corrosion at Canopy Support, Voids in Waterproofing*

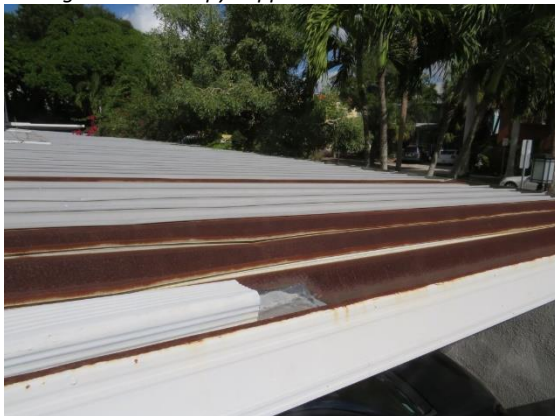
*Corroded Metal Deck*

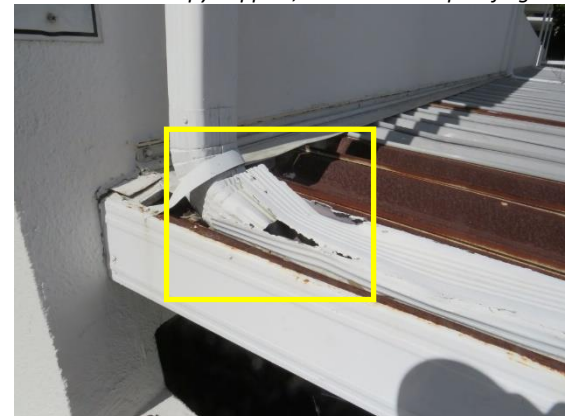
*Severe Corrosion / mis-installed Down Spout*

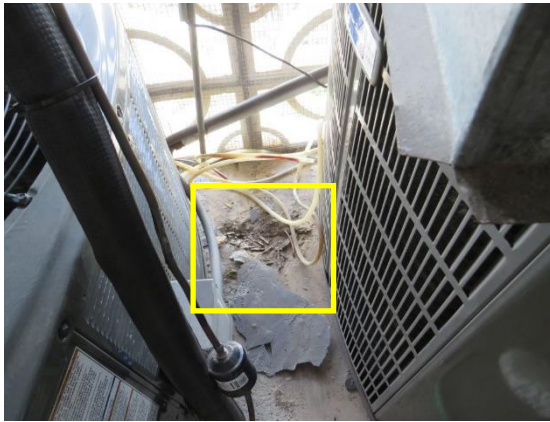
*Delaminated Slab Concrete*

1. Excavate spalled concrete to expose reinforcing steel that has lost bond to the surrounding per concrete and perform repairs in accordance with International Concrete Repair Institute (ICRI) standards under the guidance of a qualified structural Engineer.
2. Inject Epoxy into nonmoving concrete cracks.
3. Install new waterproofing membrane to protect the slab surfaces. Temporarily relocate and reinstall HVAC units as required.

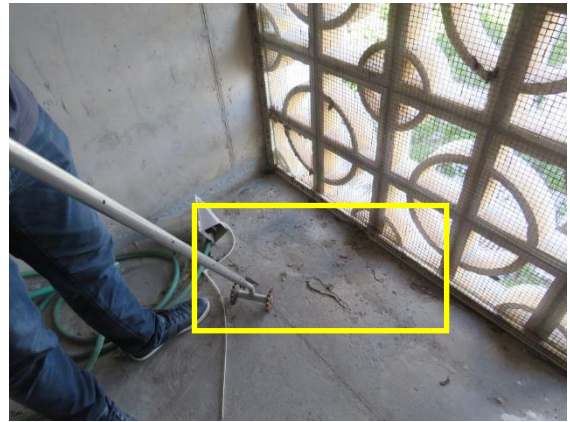
*Delaminated Concrete at the Slab Edge*

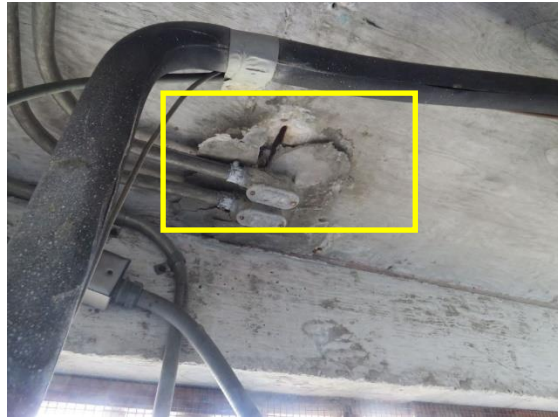
*Spalled Concrete to the Underside of the Slab Adjacent to the Conduit*

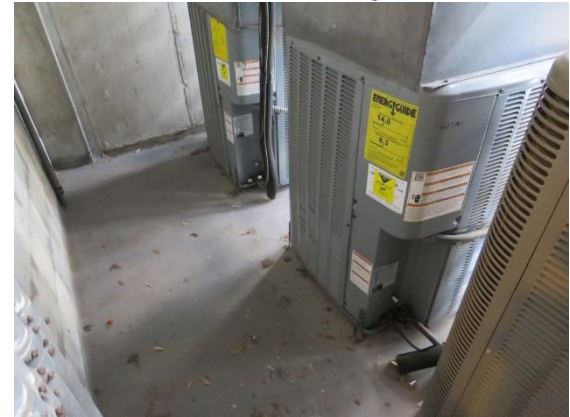
*No Waterproofing on the Concrete Slab*

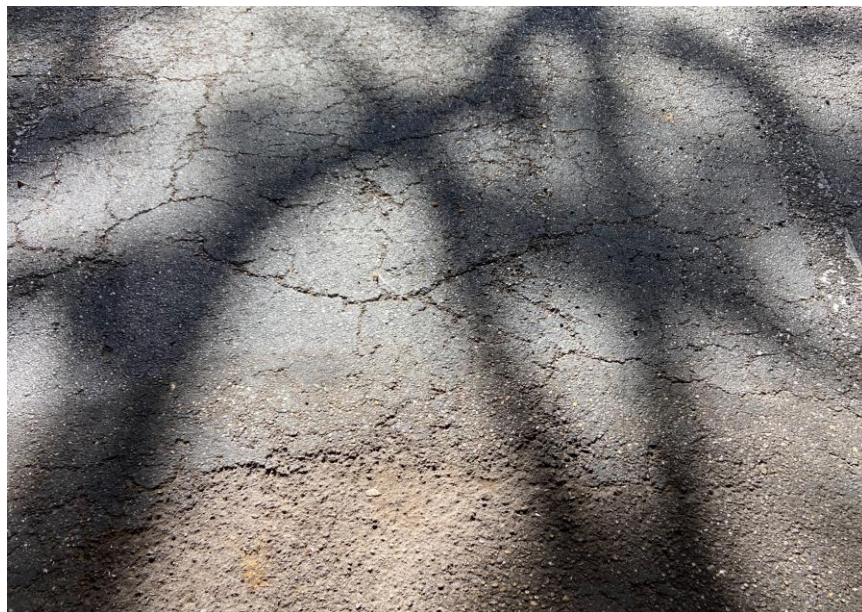
1. Extensive shrinkage cracks is consistent with oxidation, which occurs with pavements at the end of their functional life. The bitumen that binds the aggregates effectively gasses off. This is caused by a variety of factors, to include sunlight and heat. This process robs the asphalt of its flexibility, and it becomes brittle. It is likely that this pavement was resurfaced/reconstructed in 2003 rather than 1969 – asphalt paving typically has a functional life of 15 – 20 years unless it is consistently maintained and re-sealed to keep the bitumen from gassing off. Were this pavement 34 years old, in this climate, it would be in far worse condition. See Figure 3, below:

**Figure 3:** Lot shrinkage cracks.

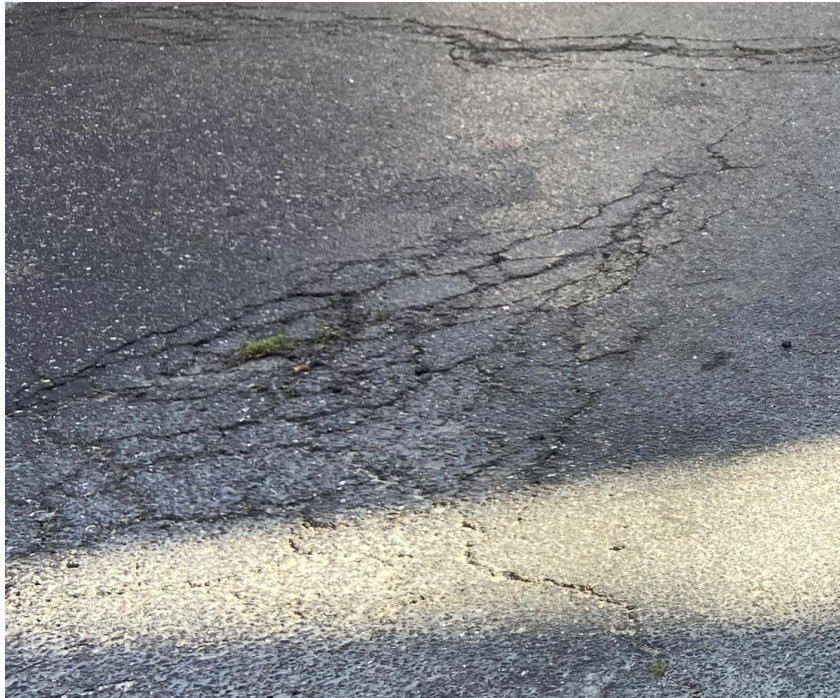
2. Localized areas of 'alligator cracking' are consistent with subgrade failure. This means that the soil below the pavement has compressed causing the pavement section to deflect beyond the asphalt's capacity to simply bend. See Figure 4, below:

**Figure 4:** Lot alligator cracking.

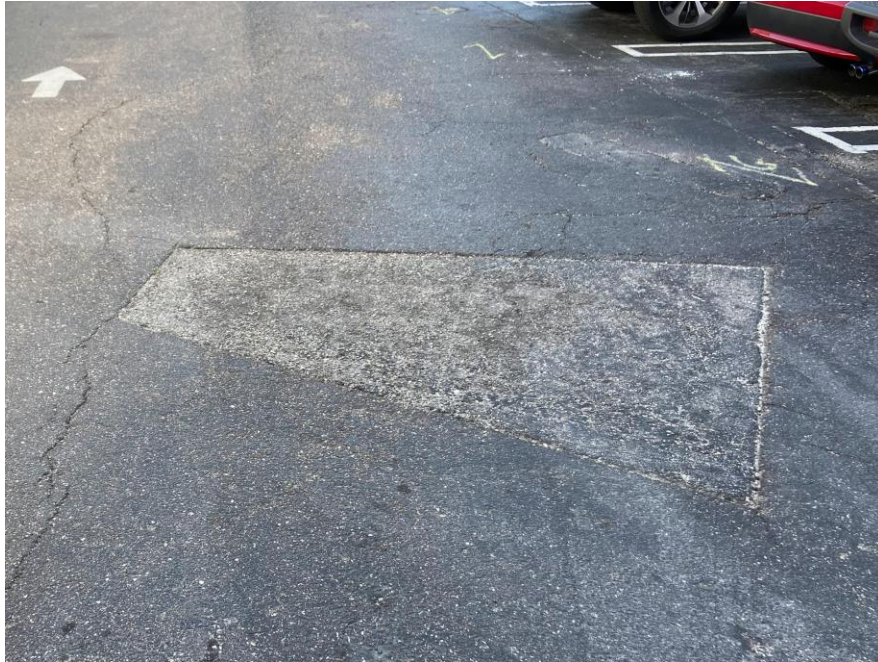
3. Patching suggests that there was once more alligator cracking that resulted on potholes that were sawcut, excavated, and restored. See Figure 5, below:

**Figure 5:** Lot alligator cracking.

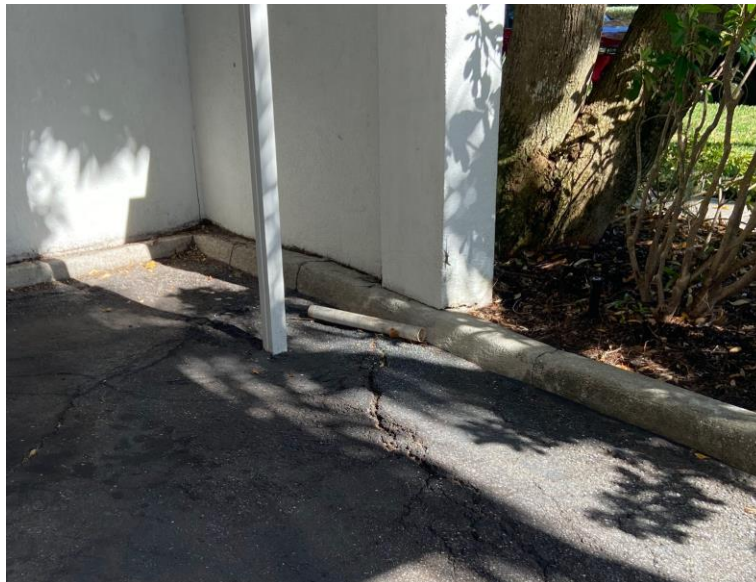
4. Tree roots seem to have undermined and damaged marginal areas of the asphalt portions of the lot. See Figure 6, below:

**Figure 6:** Asphalt cracks potentially caused by tree roots.

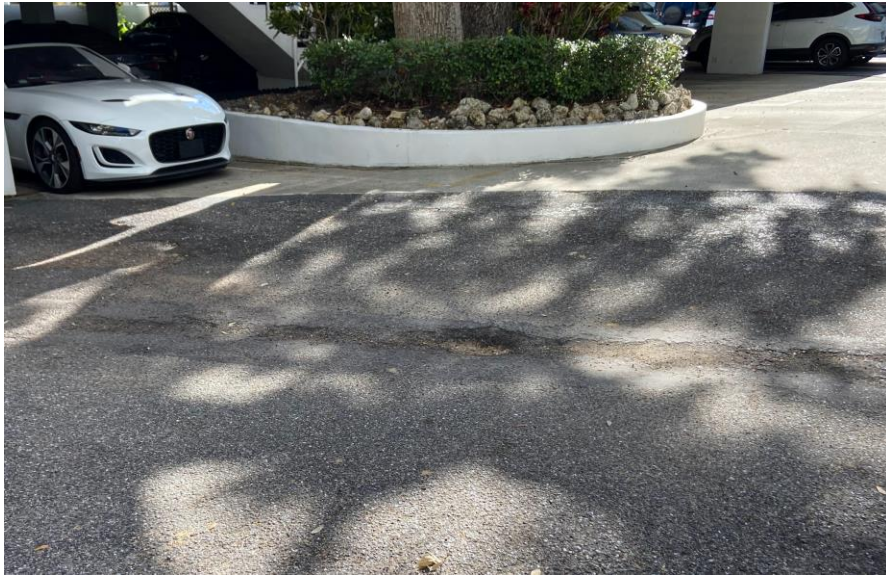
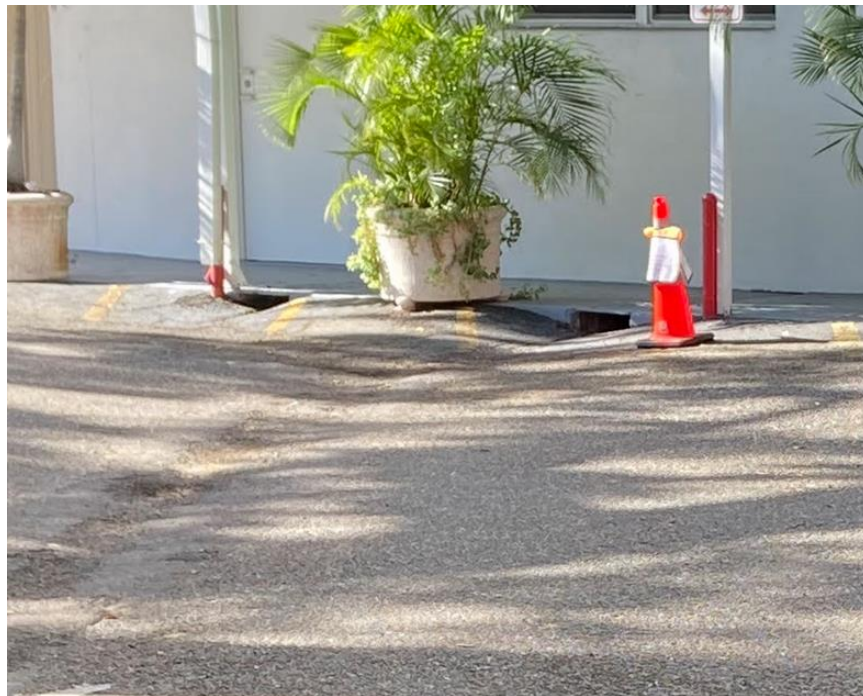
5. Stormwater flow over the northern portion of the asphalt lot has scoured and eroded the surface. This heavy and uncontrolled erosion starts at the outfall of the most northern roof downspout and continues all through until it meets the concrete pavement. See Figures 7A and 7B, below:

**Figure 7A:** Asphalt erosion, looking South.

**Figure 7B:** Asphalt erosion, looking West towards the building.

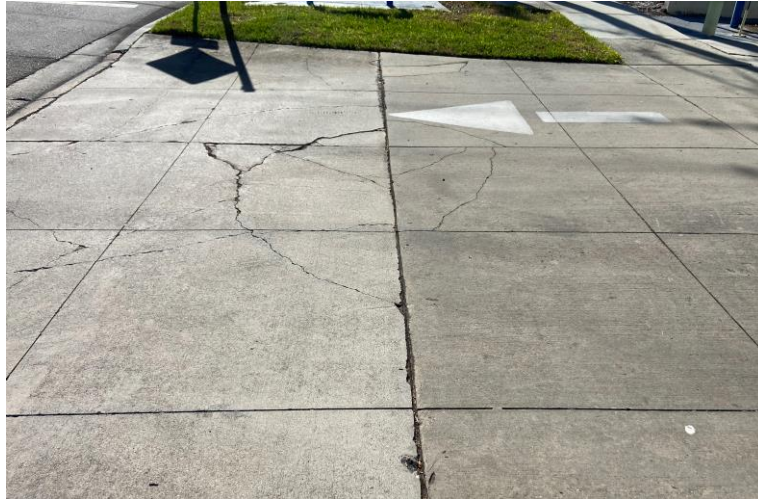
1. Driveways in the City Right-of-Way: While the north driveway exhibits limited cracks, the south driveway exhibits significant cracking consistent with compressible soil below the pavement. The rigid concrete pavement was unable to bridge voids beneath it when loaded by vehicles – note that this driveway is the only one that can accommodate trucks which impose significantly larger loads than cars. See Figure 8, below:

**Figure 8:** South Driveway.

- South Driveway and dropped curb: Remove, improve subgrade, replace with new concrete reinforced pavement to better withstand traffic. The intent would be to keep the existing dropped curb and carefully sawcut to remove the concrete at the driveway.
- Parking areas: If desired, have these areas cleaned and any cracks and joints re-sealed.
- Curbs: Replaced damaged sections, resolve tree root issues.
- Wheel stops: replaced damaged wheel stops.

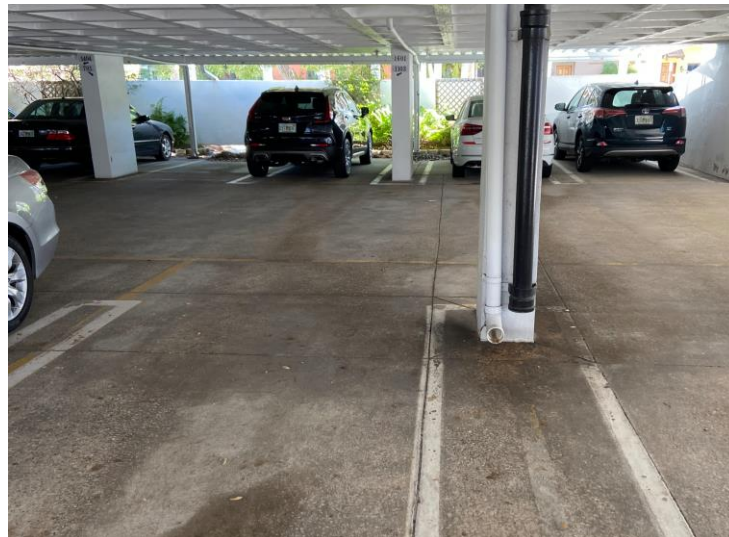
2. Parking Areas: While the surface of the concrete exhibits significant wear with exposed aggregate, and staining, it does not exhibit significant cracks or structural failure. See Figure 9, below:

**Figure 9:** Parking areas.

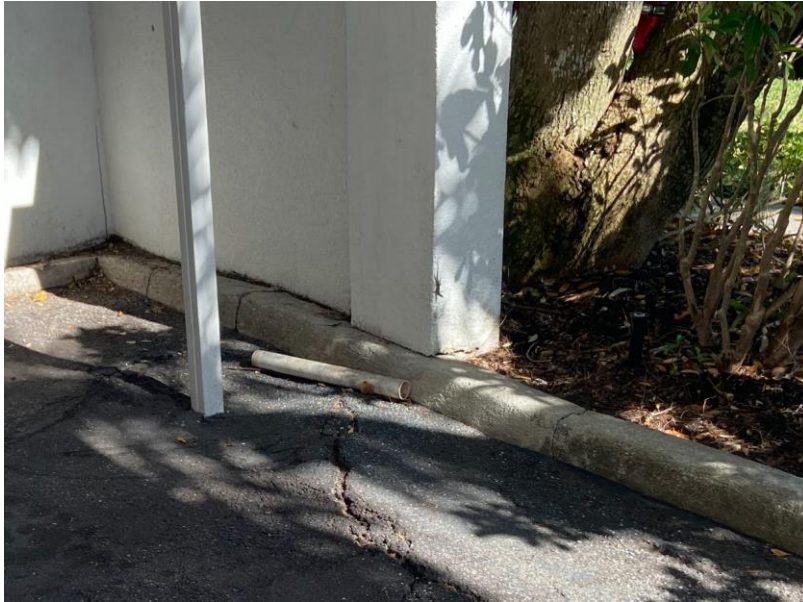
3. Curbs: There are localized areas where the concrete curbs have cracked, a such as this area where the asphalt is also failing due to undermining roots. See figure 10, below:

**Figure 10:** Cracked curbs.

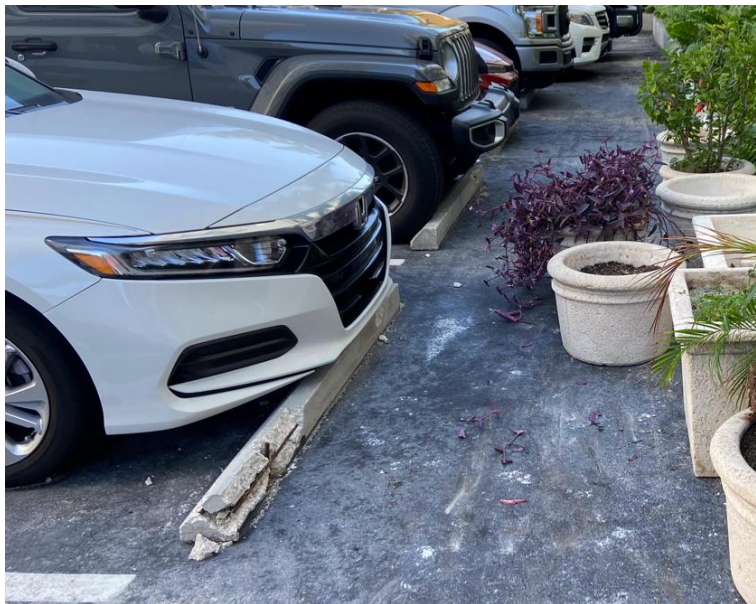
4. Concrete wheel Stoppers: Some wheel stoppers are broken to the point where rebar is being exposed. See Figure 11, below:

**Figure 11:** Broken wheel stoppers along South portion of the site

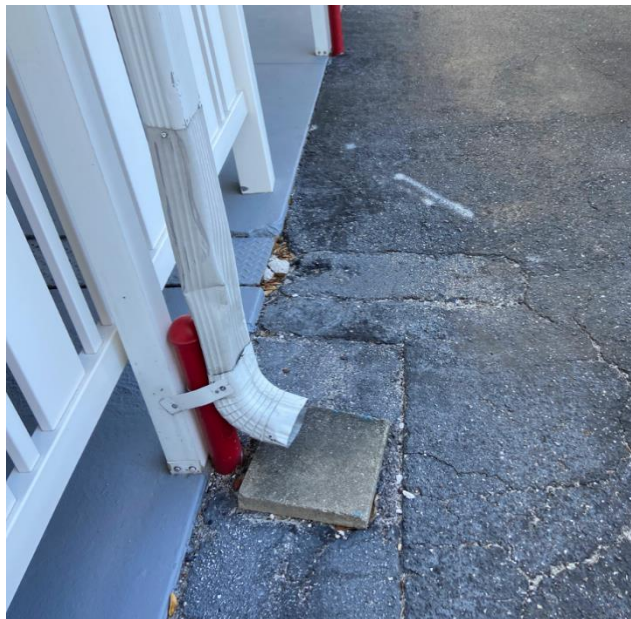
1. Downspout locations – there are a series of downspout pipes conveying runoff from the canopy roof over the pedestrian walk onto the parking lot pavement. There are also downspout pipes conveying the runoff from the second level parking to the ground level pavement.
- 1.1 The location depicted in Figure 12 below shows one of the downspouts adjacent to the pedestrian path with a concrete block placed under the downspout. Perhaps the concrete block was placed here to serve as a splash block.

**Figure 12:** Downspout for small roof covering pedestrian path

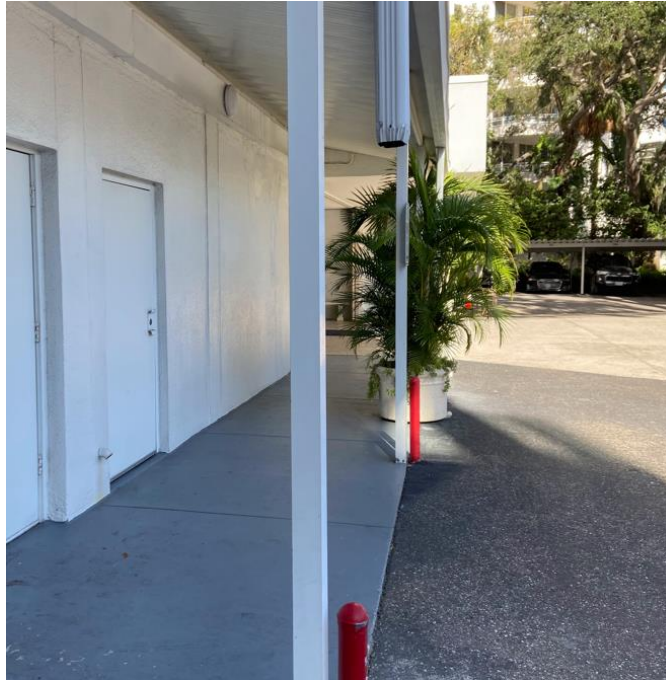
- 1.2 Figure 13 also shows one of the downspouts adjacent to the pedestrian path, however this one has been cut off at approximately 6 feet above ground level.

**Figure 13:** Broken downspout for small roof covering the pedestrian path

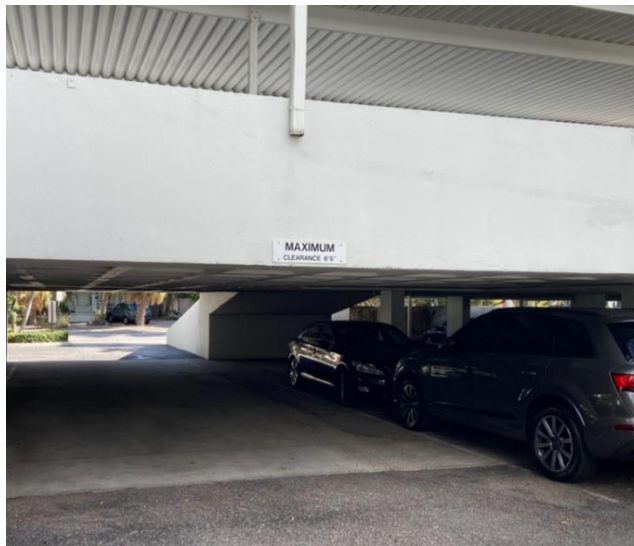
- 1.3 There were other downspouts that have been cut and are shooting the water straight unto the asphalt pavement by the elevated concrete parking lot structure. See Figure 14 below.

**Figure 14:** Broken downspout from second level parking

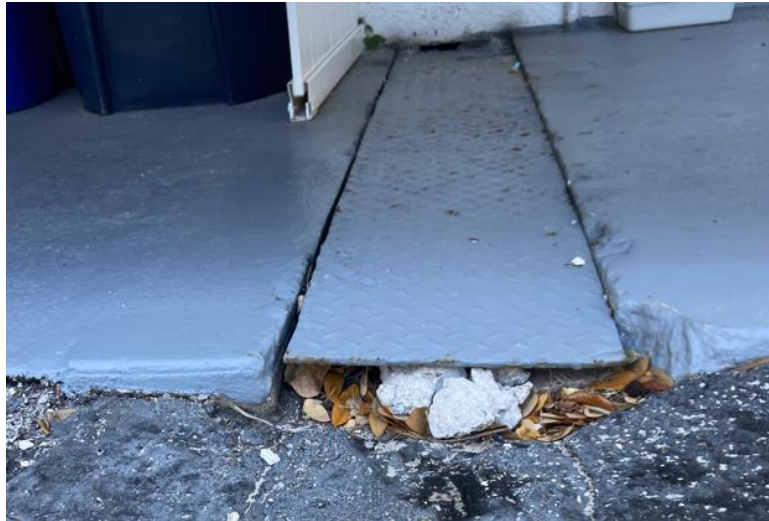
- 1.4 The entire building roof also discharges onto the parking lot asphalt pavement at three downspout locations under the pedestrian path. The below photo shows the outfall farthest to the South end. The opening is clearly obstructed by debris and possibly not functioning as intended.

**Figure 15:** Outfall for South roof drain

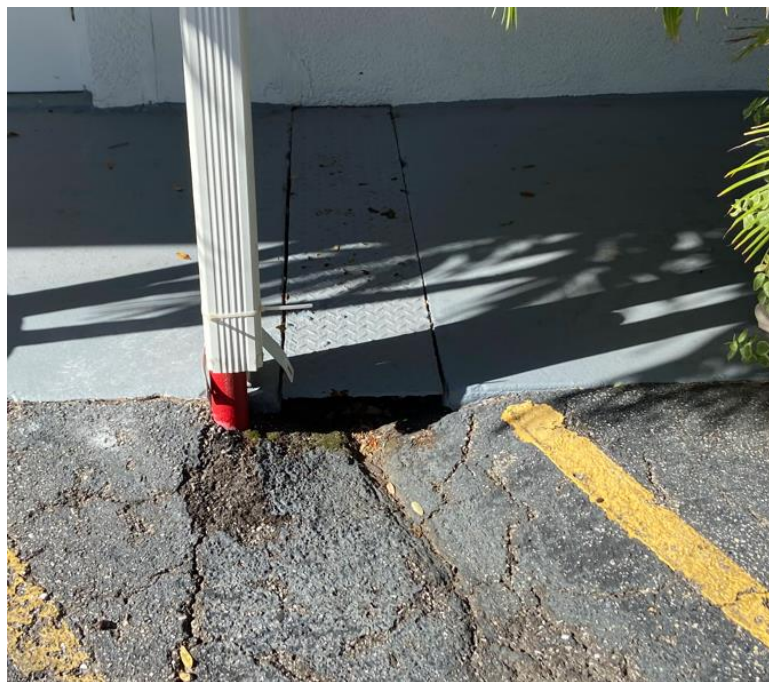
- 1.5 The second roof downspout discharges North of the main entrance. Based on field observations, the opening at the time of the site visit seemed unobstructed. Heavy eroded and cracked asphalt was noted at this location where the water has formed a channel through the asphalt pavement. See Figure 16.

**Figure 16:** Outfall for roof drain North of entrance

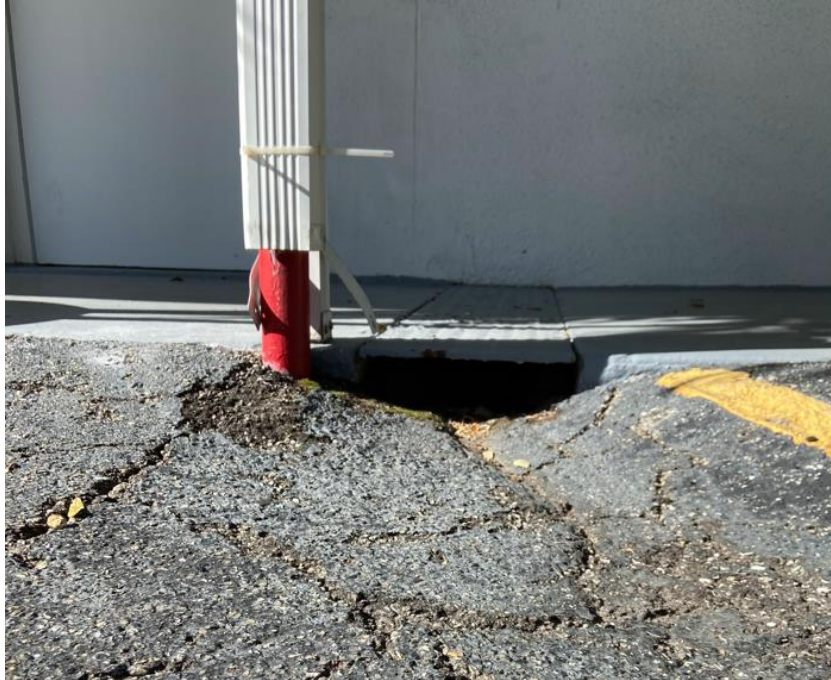
- 1.6 The third roof downspout discharges just North of the second downspout. Its opening did not seem obstructed at the time of the field visit. Without comparison, this outfall is the one that has caused the worst heavy erosion and cracks in the asphalt. A channel in the pavement was also observed at this location all the way from the exit point to the concrete pavement down the site. See Figure 17. The runoff water that exits the building at the North side flows down towards the concrete pavement (under the second level parking) and seems to split where some water exits the lot through the North driveway and some water is channeled under the covered parking lot and towards the grass area located between the two ramps.

**Figure 17:** Outfall for roof drain at farthest North side

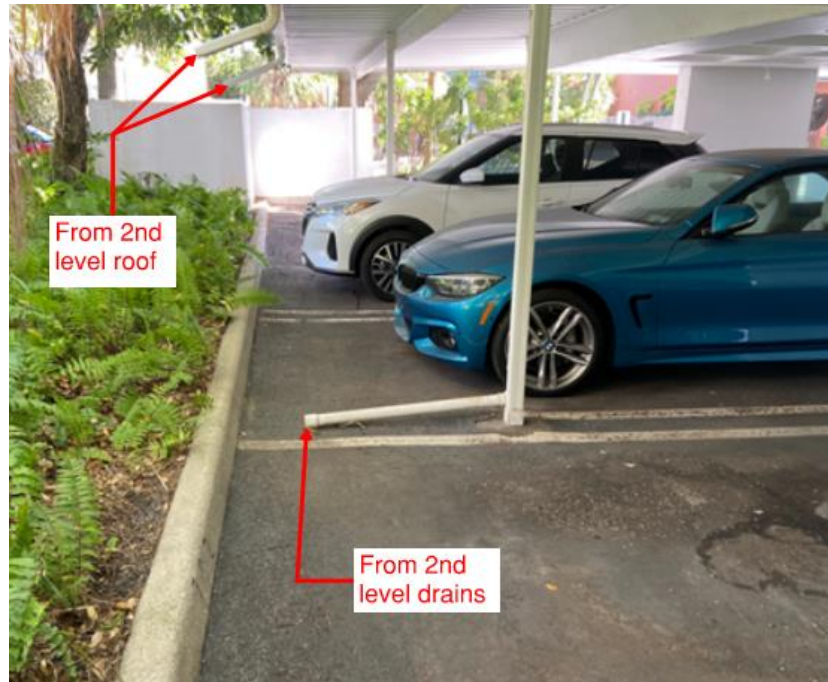
- 1.7 The ground level also receives stormwater from the second level roof parking that discharges to the North planter areas. In addition, the ground level pavement also receives stormwater from the second level drains. See Figure 18.

**Figure 18:** Upper-level drainage discharge (North of site)

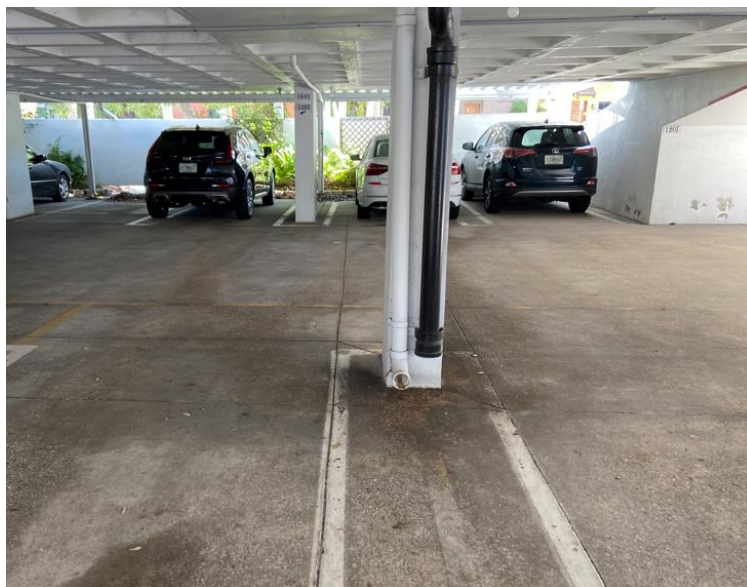
- 1.8 Below in Figure 19 is another instance where the second level stormwater discharges to the ground level concrete pavement that later drains towards the planted area between the two ramps.

**Figure 19:** Upper-level drainage discharges to ground level

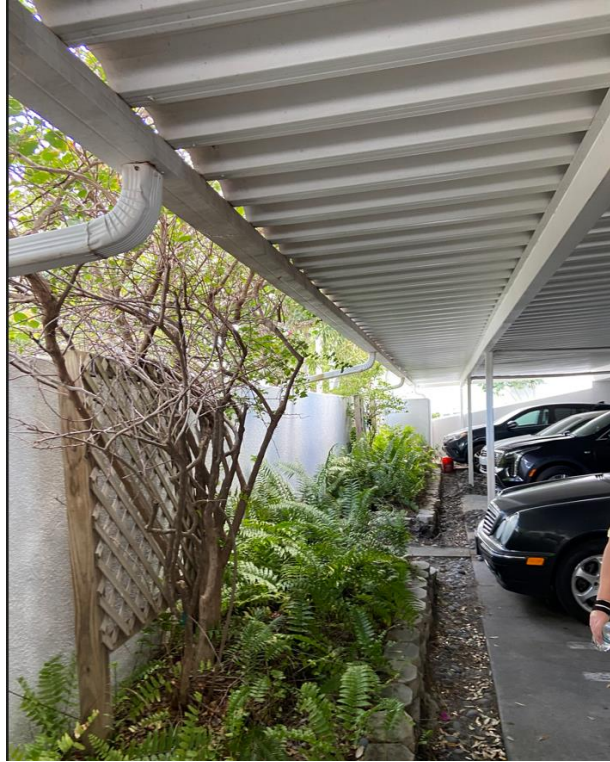
- 1.9 Towards to mid-east side of the lot, the second level parking lot discharges over the existing green space and unto the City Right of Way over the existing wall and through downspouts as depicted in Figure 20.

**Figure 20:** Upper-level drainage discharge at mid-east point
