**The Royal St. Andrew Association**  
**Non-SIRS Components**  
***Sarasota, FL***

Report #: 51189-0  
Beginning: January 1, 2025  
Expires: December 31, 2025

**RESERVE STUDY**  
**"Full"**

December 6, 2024

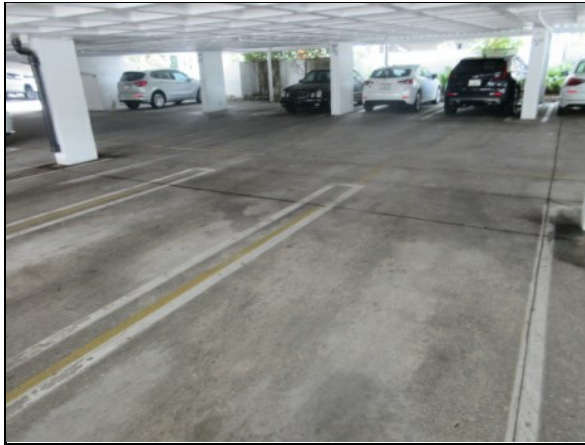
Useful Life:  
4 years

Remaining Life:  
1 years

Lower allowance to repair
