**The Royal St. Andrew Association**  
**SIRS Components**  
***Sarasota, FL***

Report #: 51189-0  
Beginning: January 1, 2025  
Expires: December 31, 2025

**RESERVE STUDY**  
**"Full"**

December 6, 2024

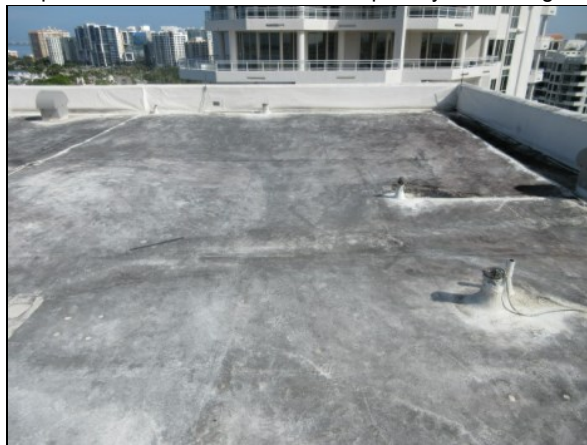
Useful Life:  
20 years

Remaining Life:  
19 years

Best Case: \$ 252,000

Worst Case: \$ 312,000

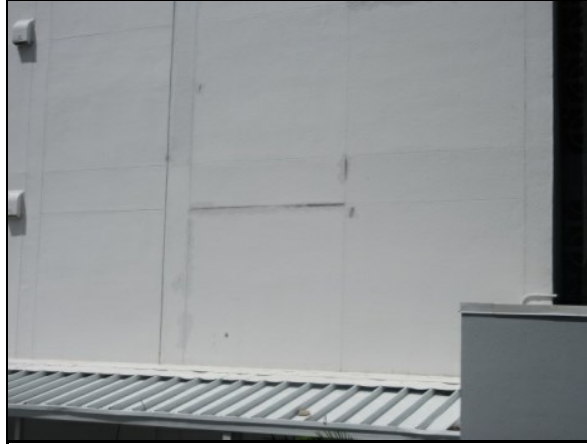
Remaining Life:

0 years

Best Case: \$ 15,000

Worst Case: \$ 25,000

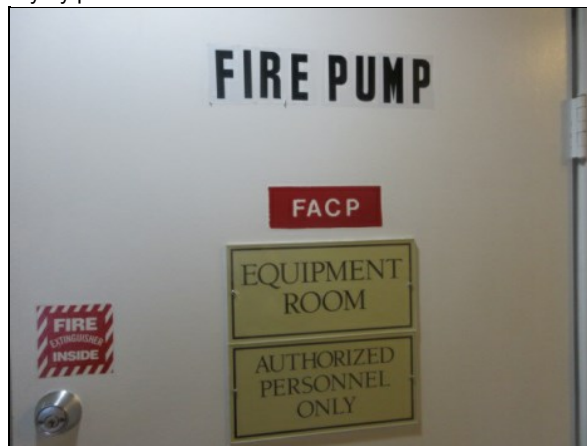
Useful Life:  
20 years

Remaining Life:  
14 years

Best Case: \$ 42,200

Worst Case: \$ 52,200

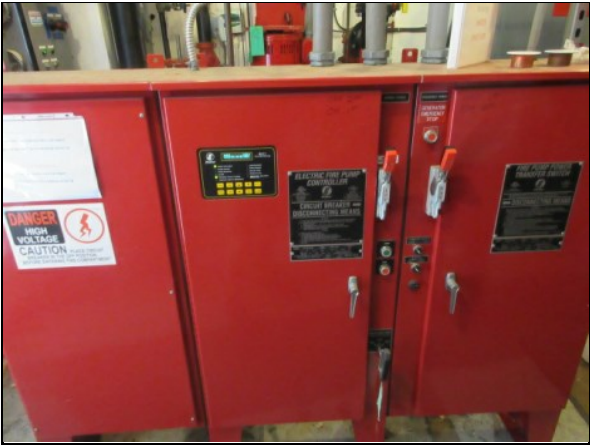
Useful Life:  
40 years

Remaining Life:  
18 years

| Best Case: \$ 35,000 | Worst Case: \$ 45,000 |

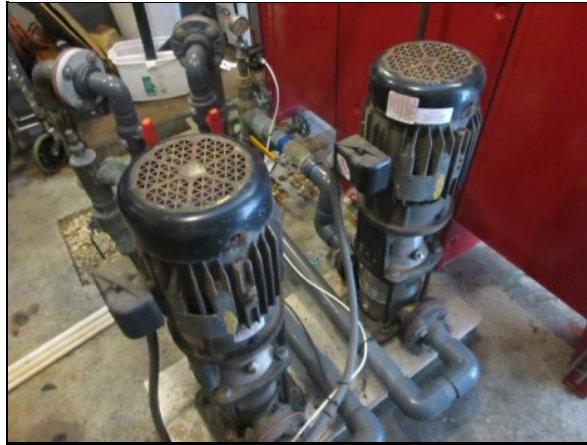
Useful Life:  
20 years

Remaining Life:  
10 years

Best Case: \$ 40,000

Worst Case: \$ 60,000

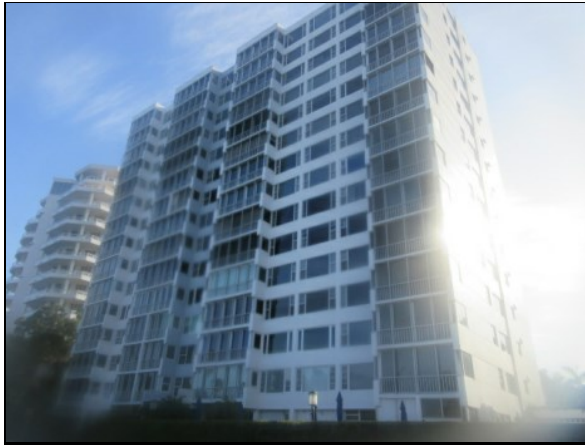
Useful Life:  
1 years

Remaining Life:  
0 years

Best Case: \$ 10,000

Worst Case: \$ 20,000

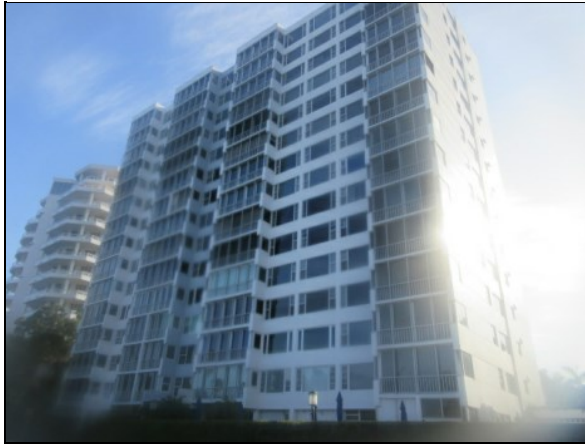
Useful Life:  
10 years

Remaining Life:  
4 years

Best Case: \$ 18,500

Worst Case: \$ 24,500

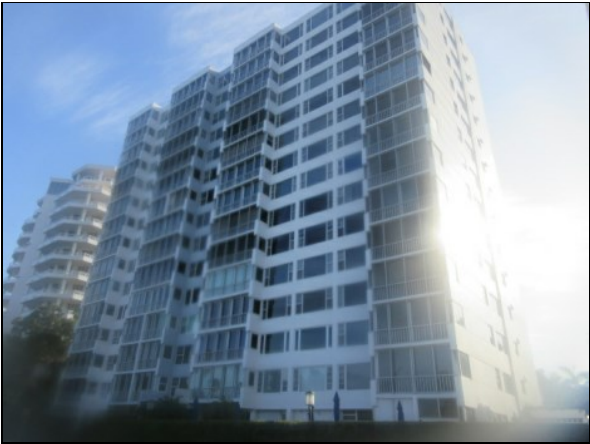
Useful Life:  
5 years

Remaining Life:  
4 years

Best Case: \$ 18,500

Worst Case: \$ 24,500

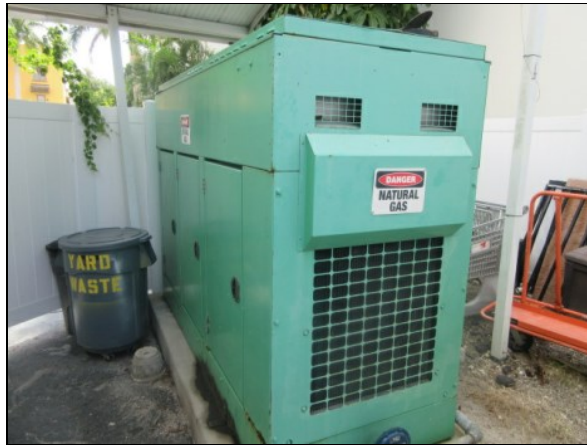
Useful Life:  
20 years

Remaining Life:  
0 years

Best Case: \$ 115,000

Worst Case: \$ 145,000

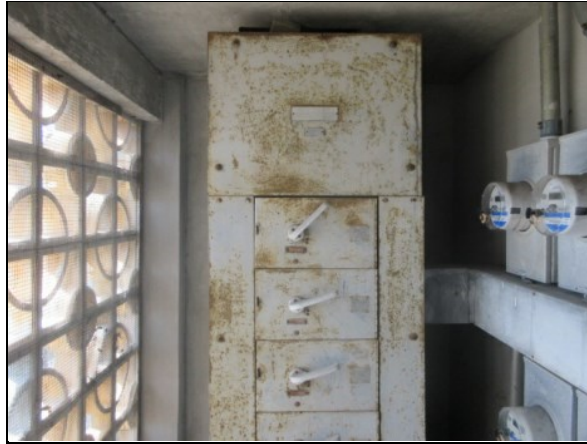
Remaining Life:

6 years

Best Case: \$ 100,000

Worst Case: \$ 140,000

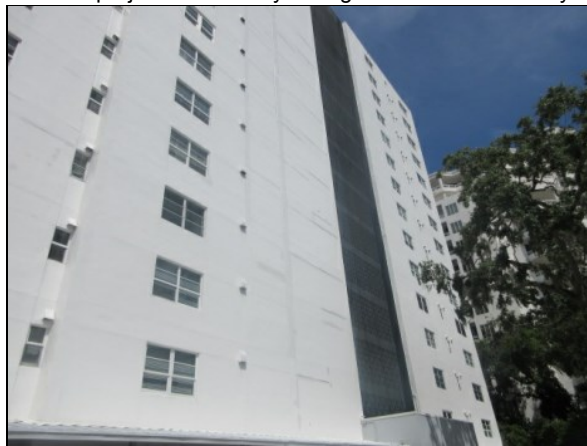
Remaining Life:

0 years

Best Case: \$ 110,000

Worst Case: \$ 140,000

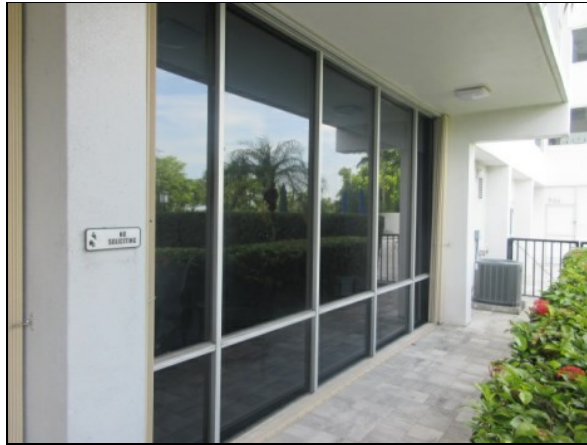
Remaining Life:

10 years

Best Case: \$ 98,000

Worst Case: \$ 139,000

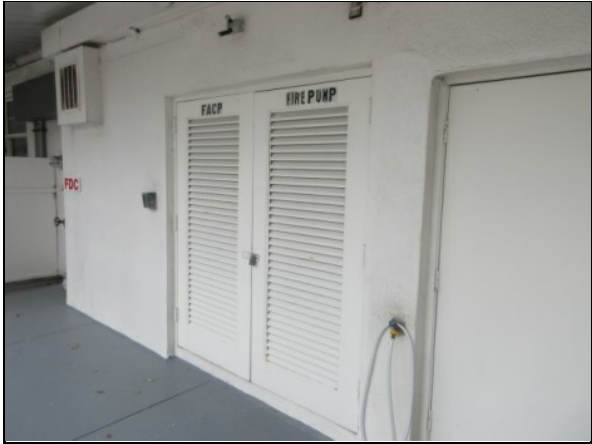
Useful Life:  
40 years

Remaining Life:  
5 years

Best Case:    \$ 47,500

Worst Case:    \$ 57,500

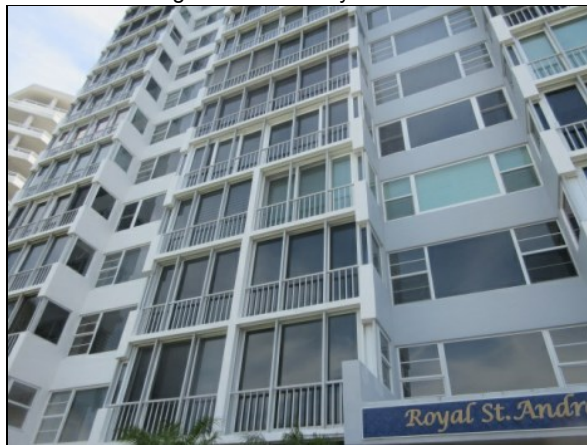
Useful Life:  
32 years

Remaining Life:  
4 years

Best Case: \$ 251,000

Worst Case: \$ 312,000

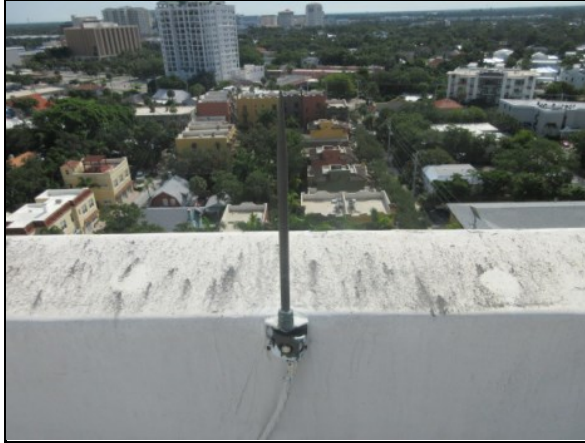
Useful Life:  
20 years

Remaining Life:  
19 years

Best Case: \$ 11,500

Worst Case: \$ 15,600
