November 24, 2021

Royal St. Andrews  
C/O Randy Peachey  
555 S Gulfstream Ave.  
Sarasota, Florida 34236

On November 22, 2021 Windemuller Technical Services completed an Infrared Inspection of Royal St. Andrew's electrical distribution system. The electrical distribution was inspected using a Flir Systems model EXX75 Thermal Imaging System. All of the information that has been gathered during the scan is accurate to the time we were doing the scan. All data has also been stored on a flash drive for further review.

## A Qualitative Infrared Thermographic Survey of Electrical System Components

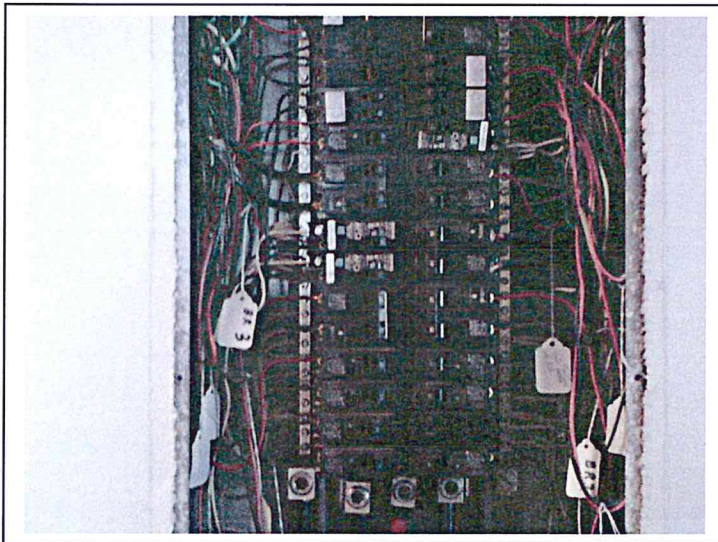
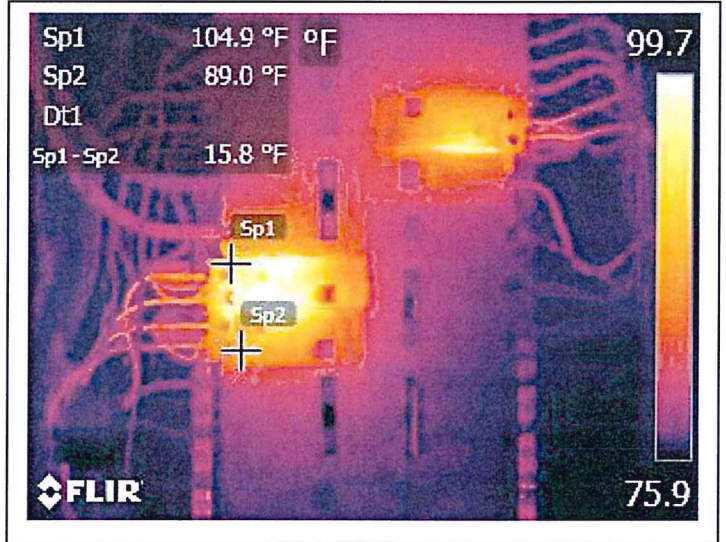
| Location | Unit 205 | Equipment | Panel |

| TIME | REPORT | LOCATION | EQUIPMENT | DESCRIPTION |
|---|---|---|---|---|
| 12:25 | 1 | Unit 205 | Panel | Breaker 15 is warming up possible loose connection |

| Camera Model | FLIR E-75 | Hot spot temperature | 104.9 Degrees F. |
| Image Name | FLIR 8816 | Delta T (difference) | 15.8 Degrees F. |

| 1. Repair Next Maintenance | X | 2. Repair as Schedule Permits | 3. Urgent attention required |

Breaker 15 is warming up, may indicate a loose connection.

Recommend shutting off power and tightening the lug to manufacturer's specifications, then restoring power.

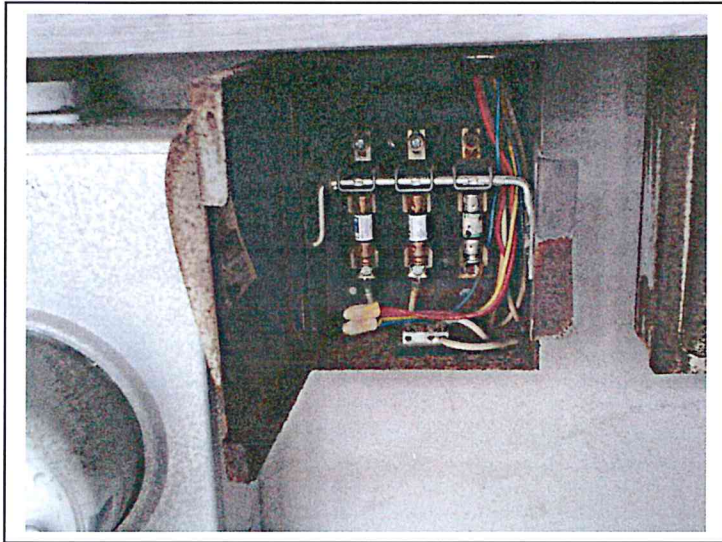
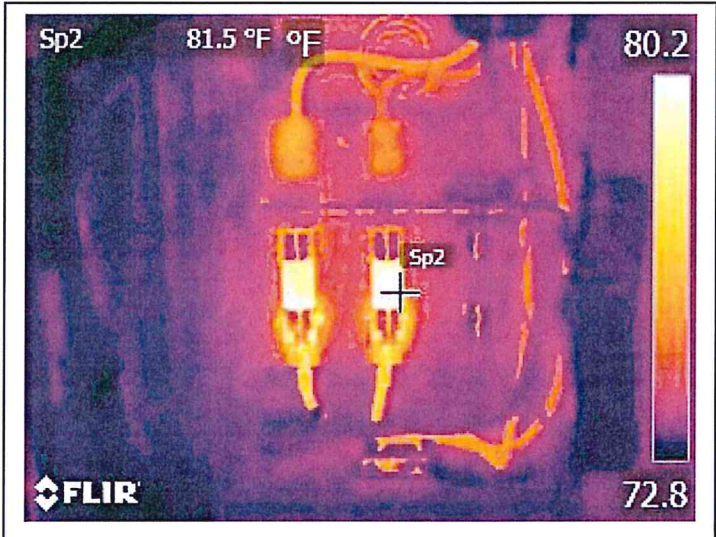
| <b>Location</b> | 14 <sup>th</sup> Floor | <b>Equipment</b> | Unit 1503 Disconnect |

No problems found.

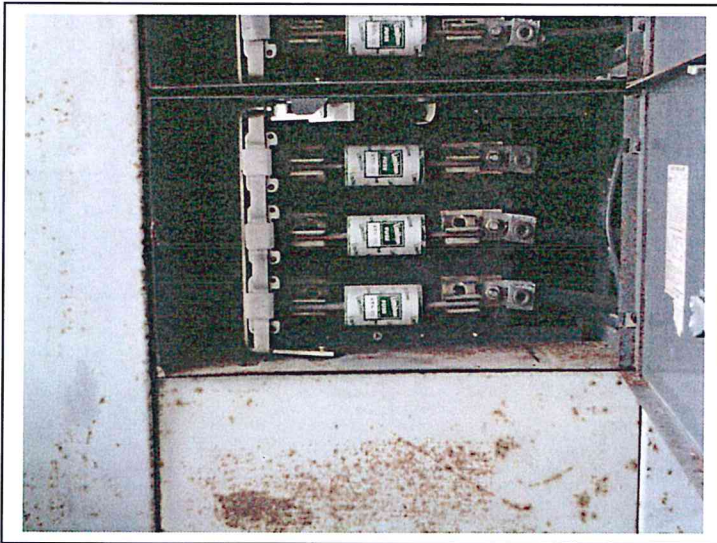
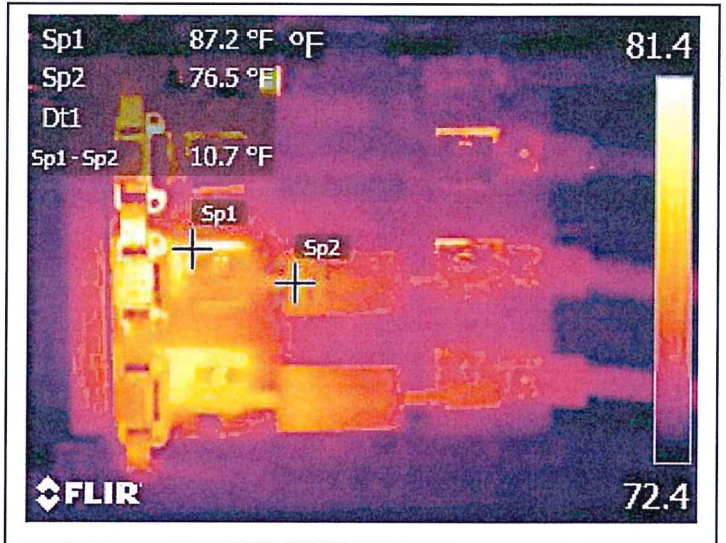
| <b>Location</b> | 15 <sup>th</sup> Floor | <b>Equipment</b> | MDP |

No problems found.
