# Existing Condition Report

**KEG File: 18RS-0416**  
**October 8, 2018**

***Royal St. Andrew Association,  
Inc.***

**RE:    *Royal St. Andrew  
KEG Project P18RS-0416 REV02  
Professional Engineering Services – Existing Conditions Survey***

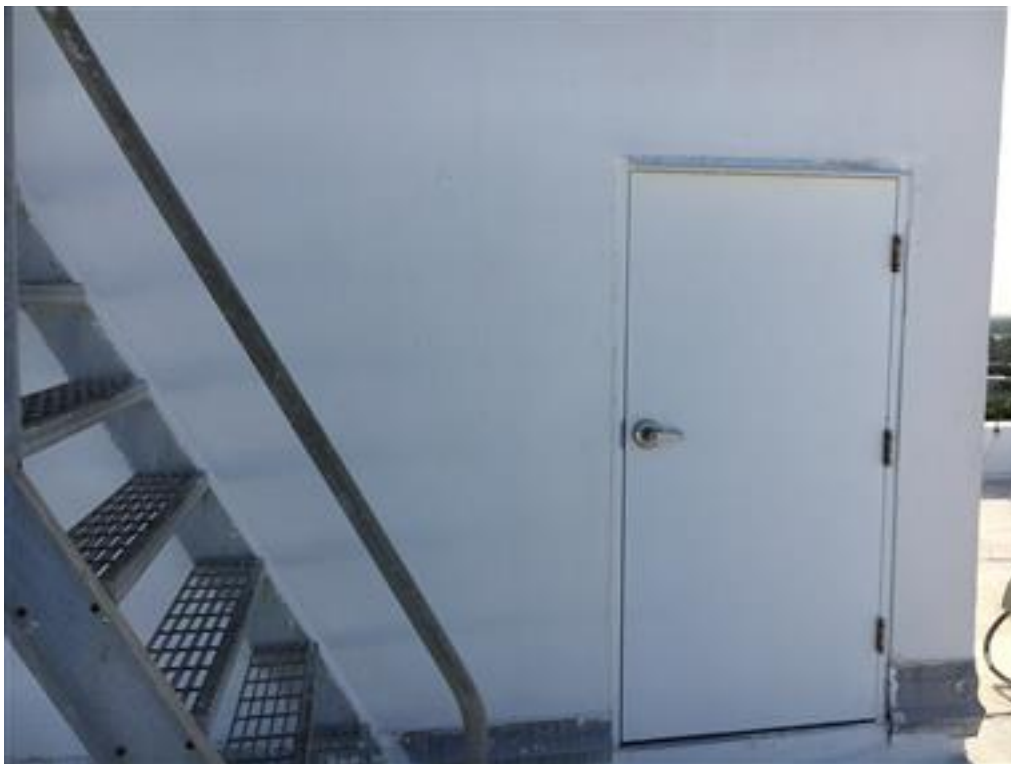
Photo 19-Elevator penthouse, good condition, west

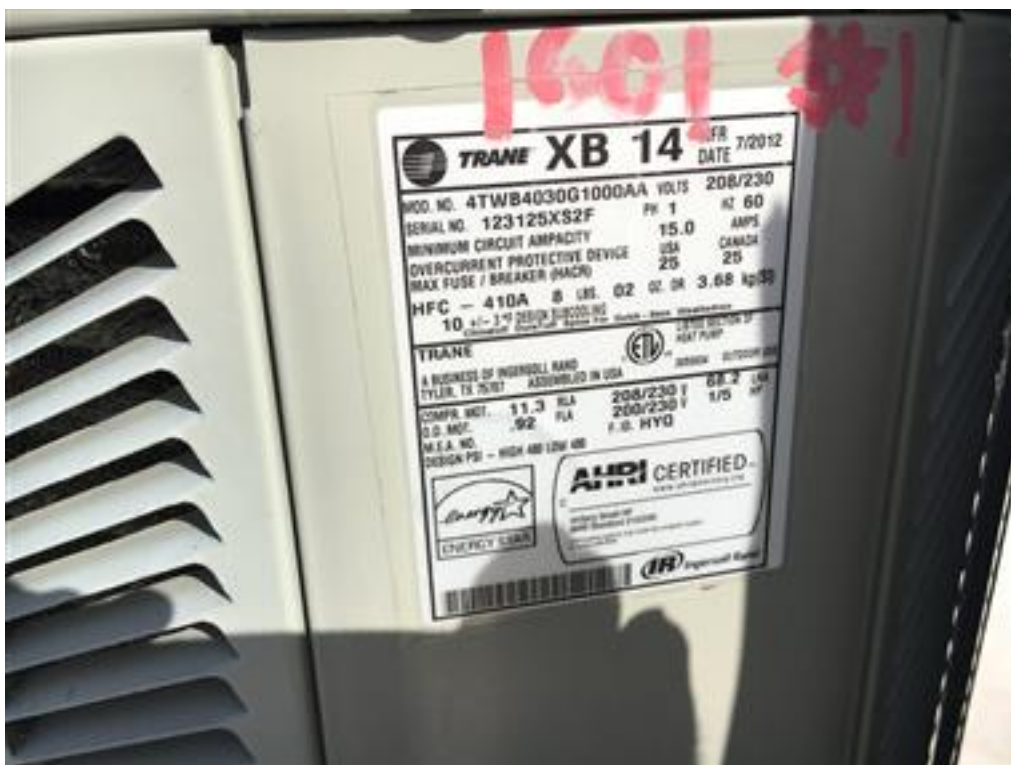
Photo 35-Unit 1602, loose panel

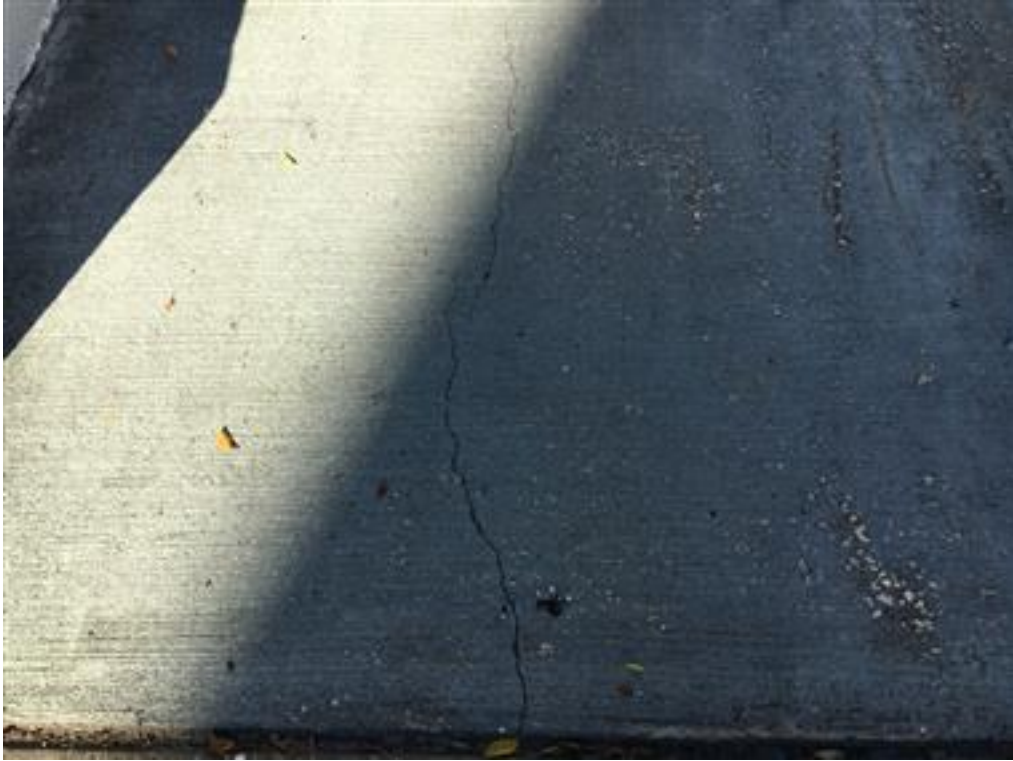
Photo 2-EXIT RAMP- TYPICAL CRACKS

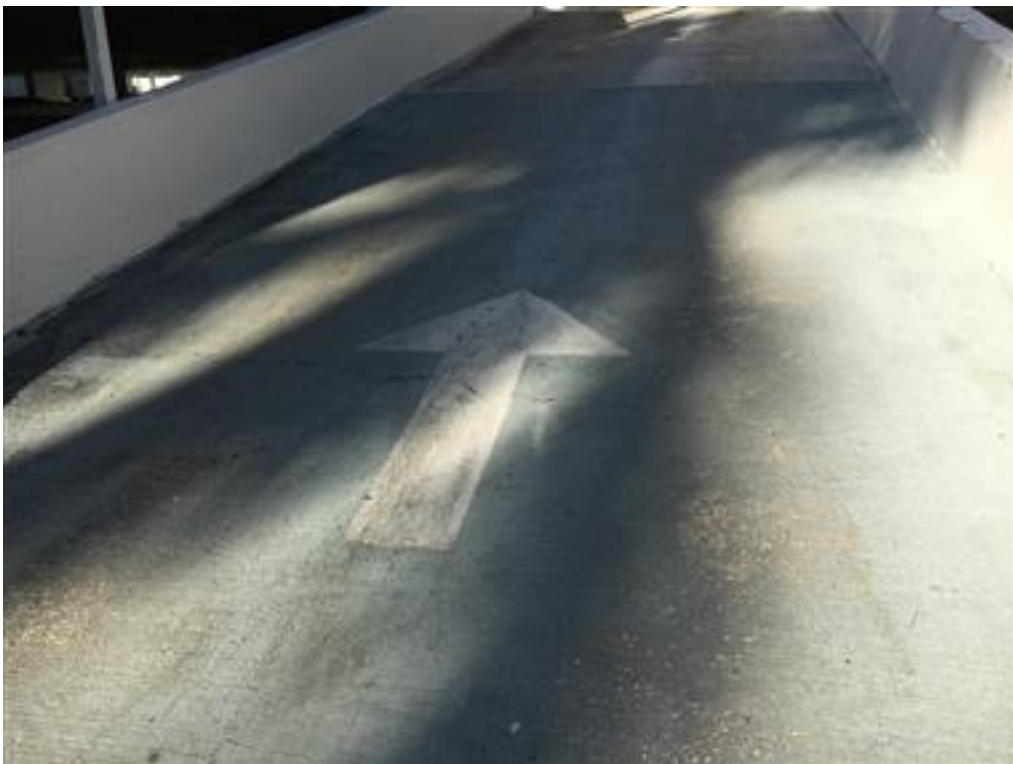
Photo 11-UPPER LEVEL WALLS- TYPICAL

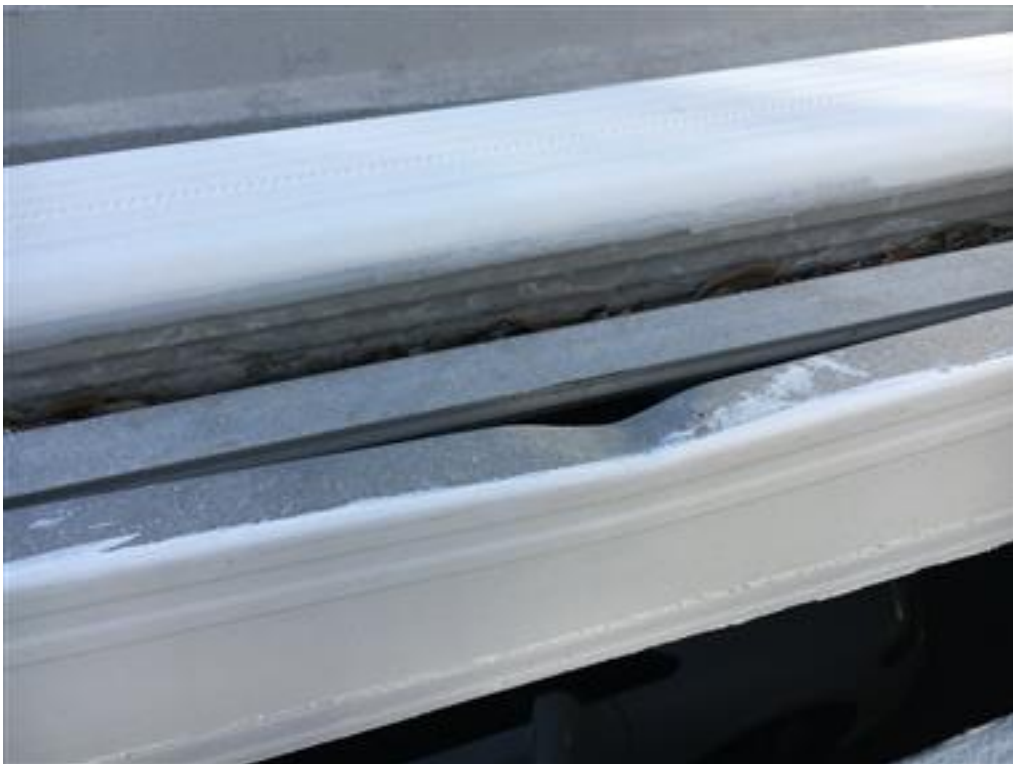
Photo 23- UPPER LEVEL-TYPICAL CRACKS

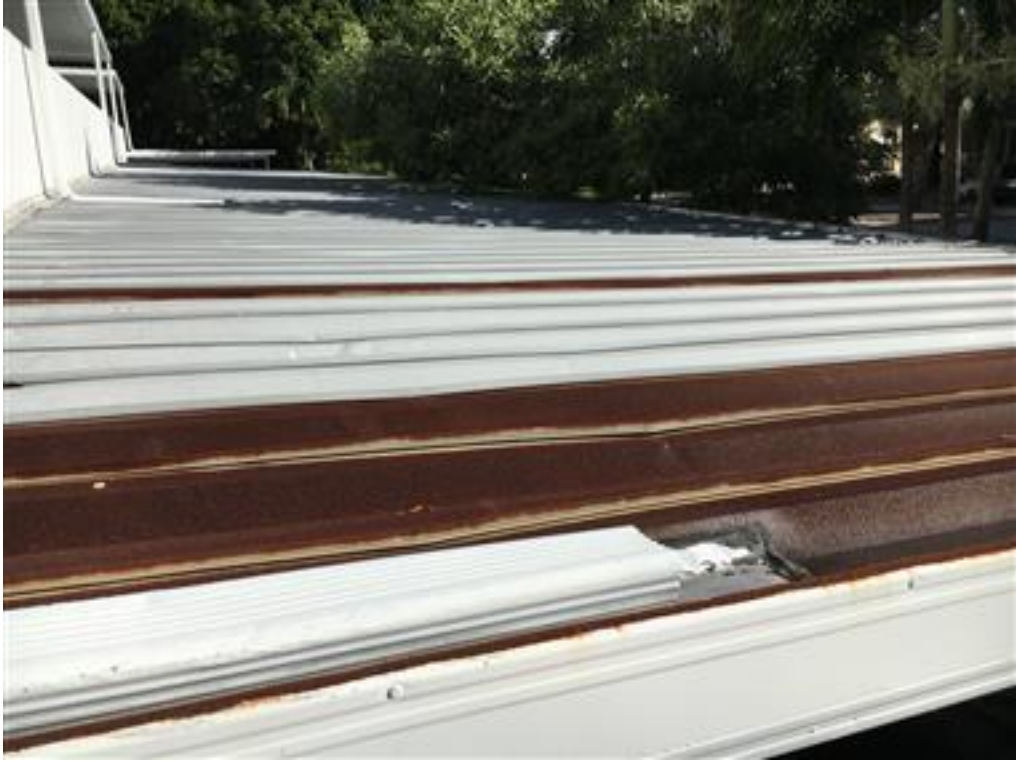
Photo 24-DENT AT ENTRANCE RAMP CARPORT ROOF

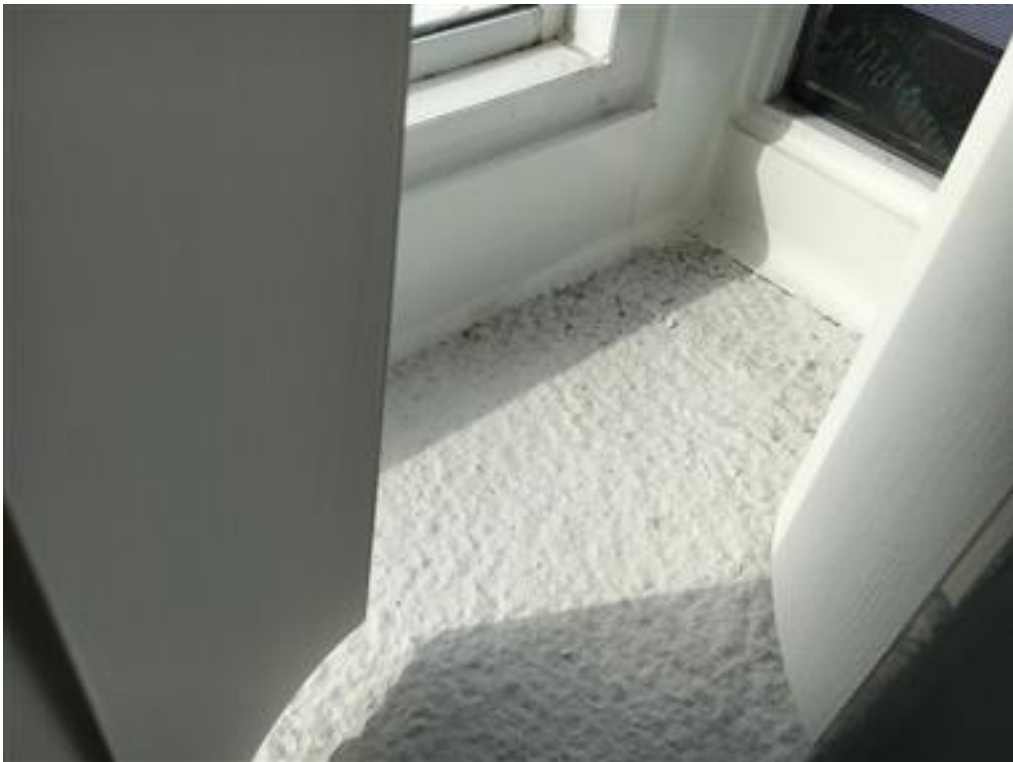
Photo 25-Unit 1404, Water damage at sill, typical

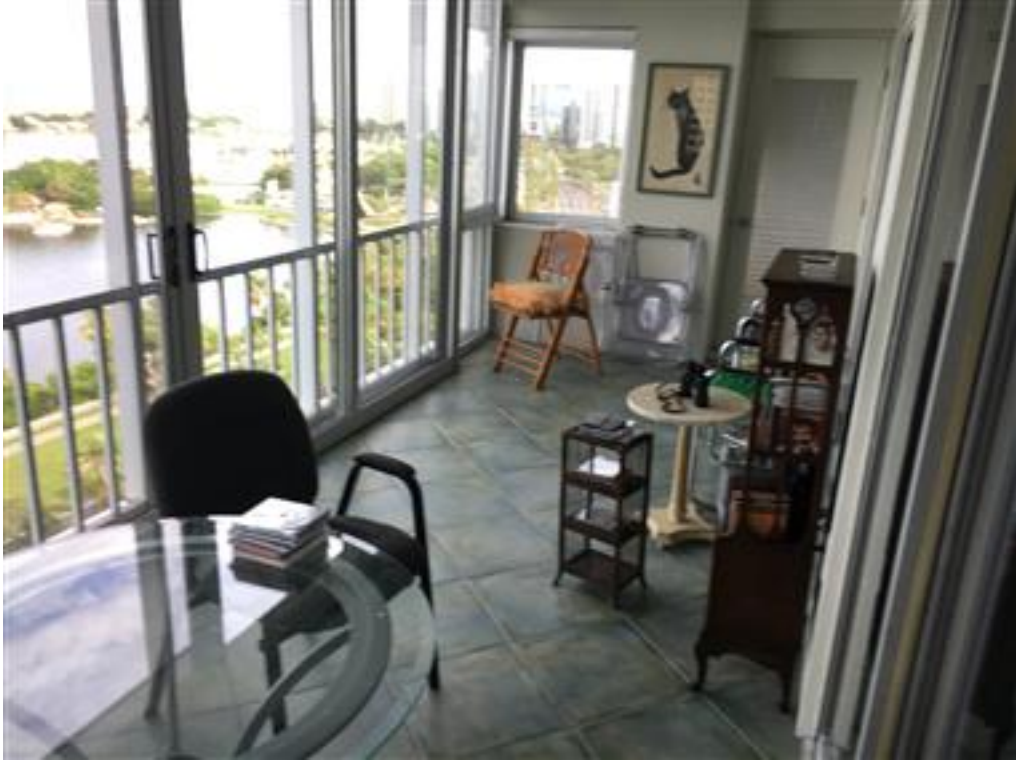
Photo 26-Unit 1404, Water damage at sill

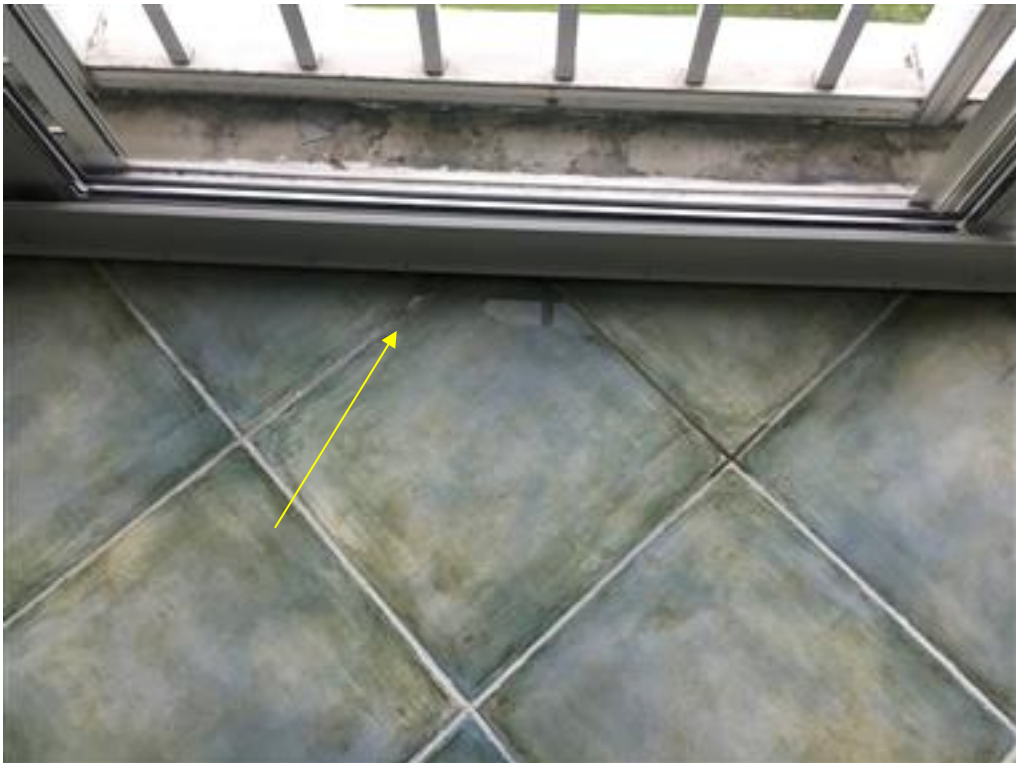
Photo 29-Unit 1404, evidence of water intrusion

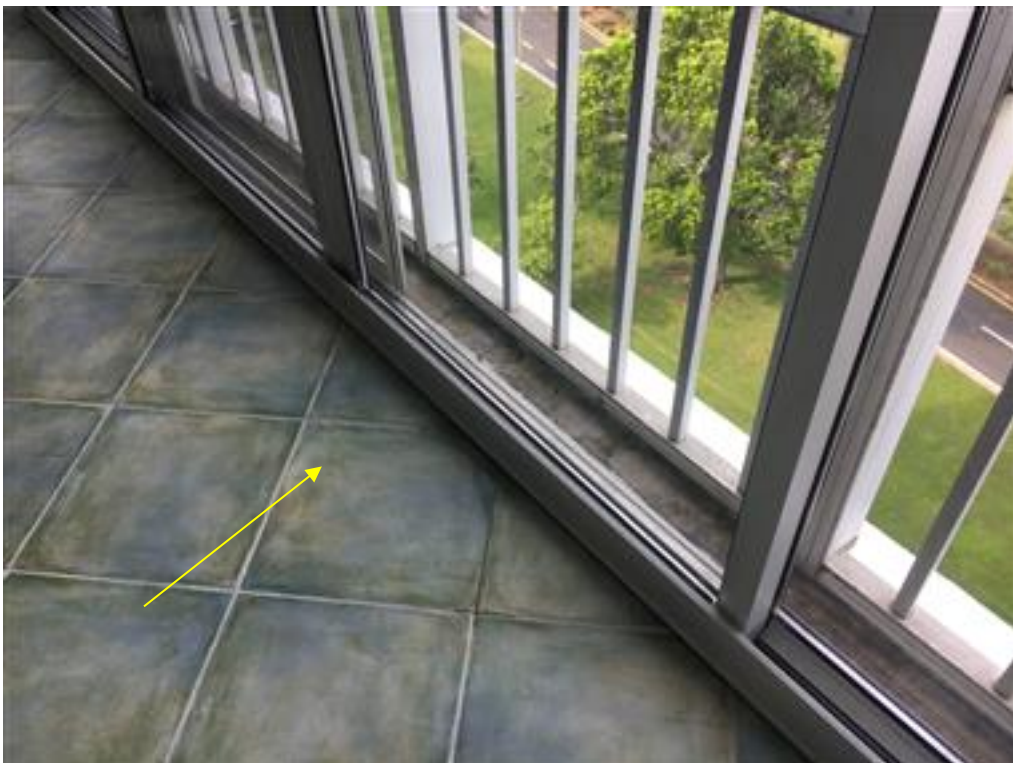
Photo 31-1404, evidence of water damage

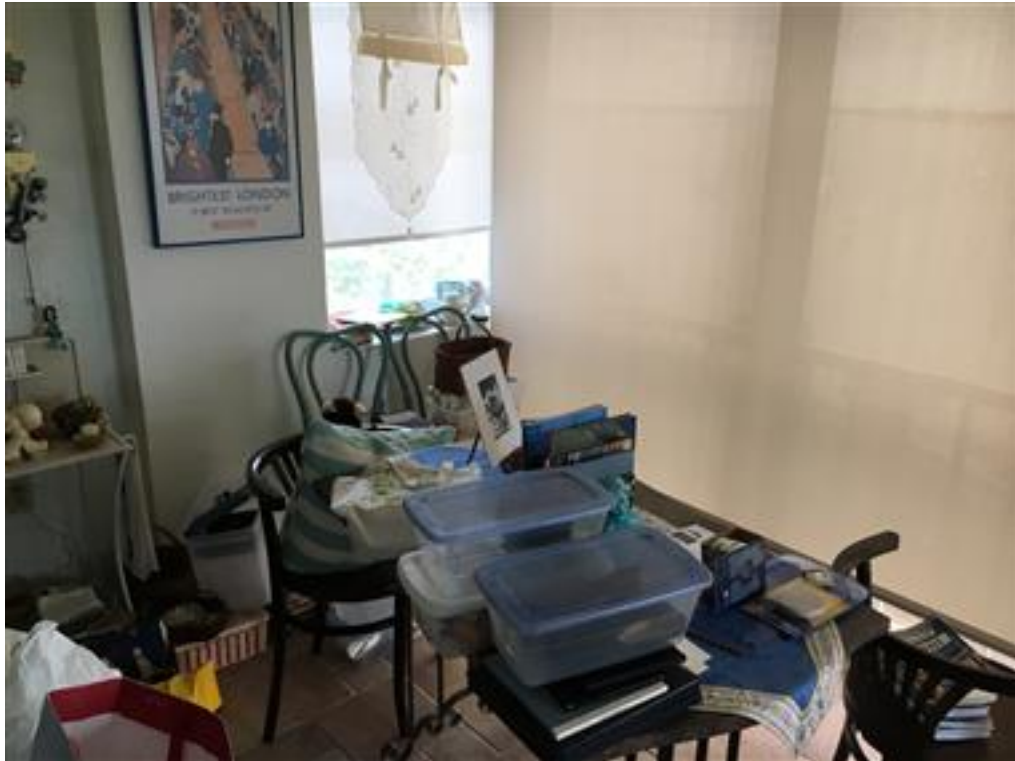
Photo 32-1404, alternate view of water leak at SGD

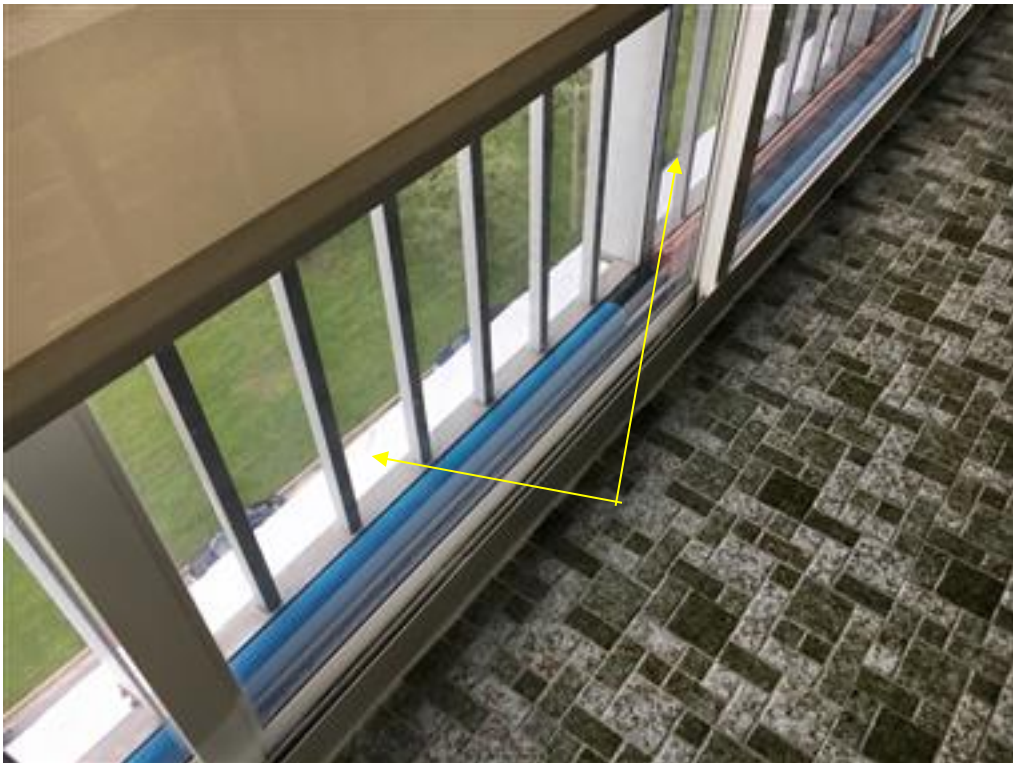
Photo 39-Unit 1203, sealant joint failure

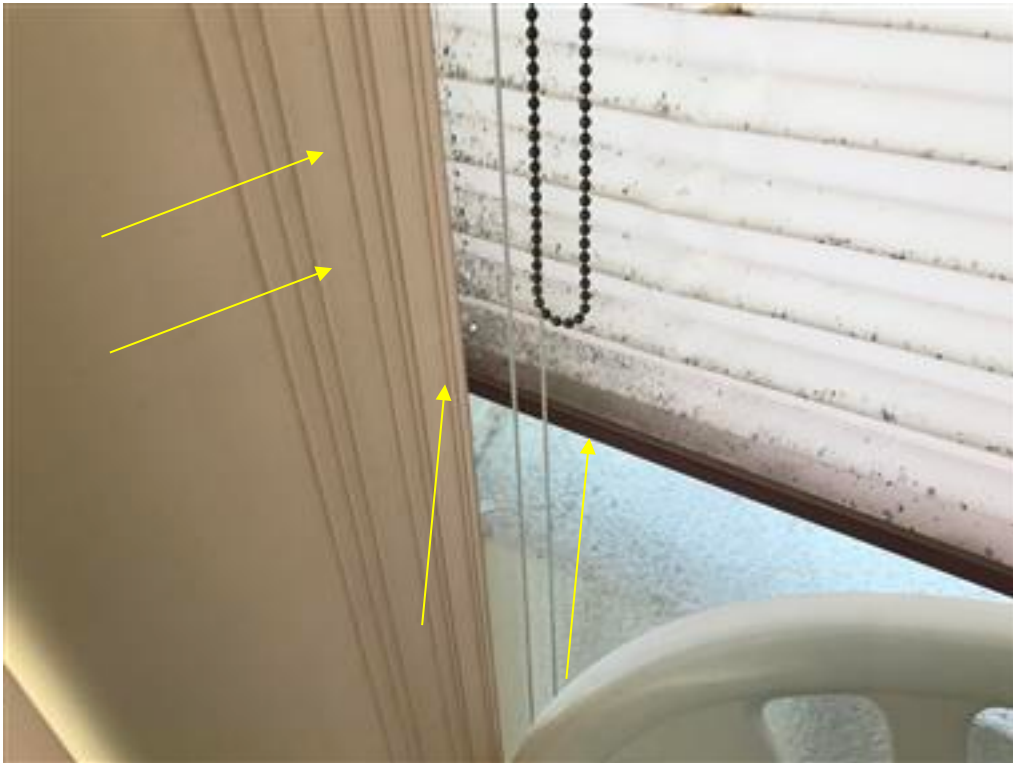
Photo 78-Unit 904, water stain on curtain due to water infiltration

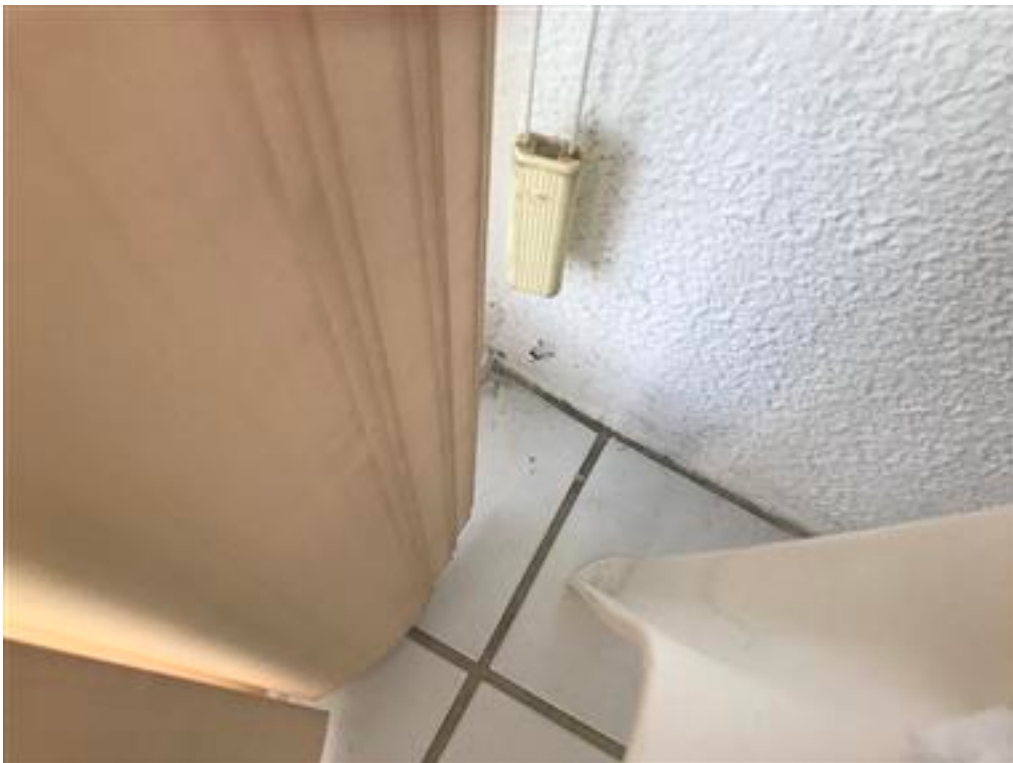
Photo 79-Unit 904, mold bloom

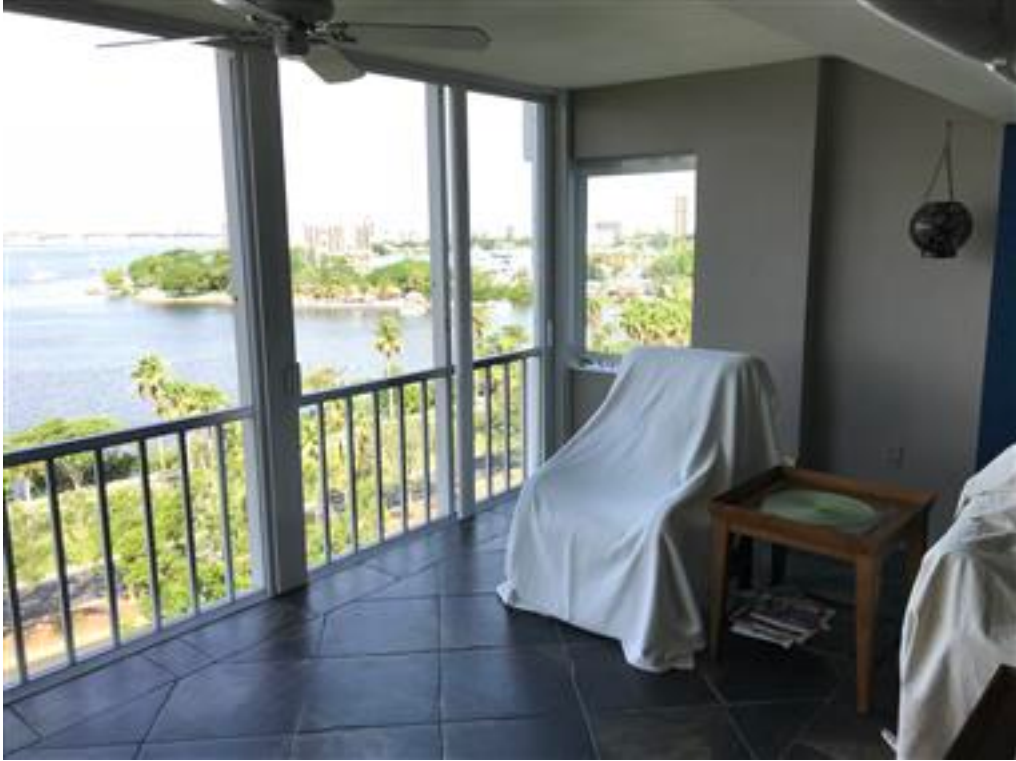
Photo 80-Unit 904, blistering paint due to water infiltration

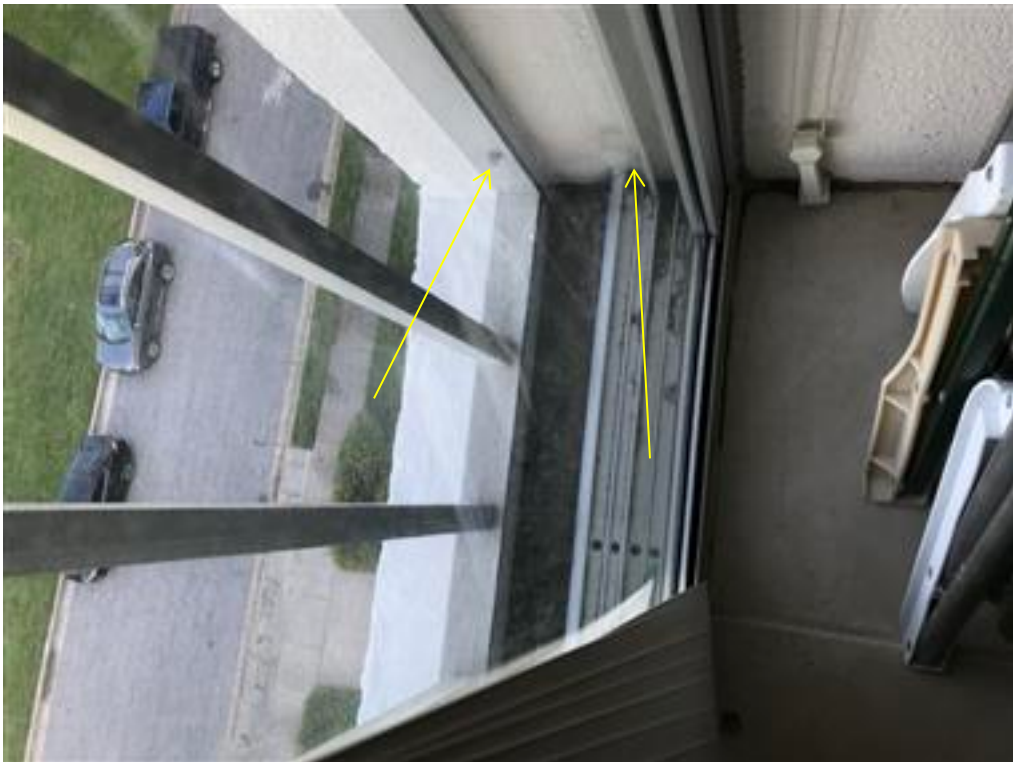
Photo 85-902, paint peeling due to water infiltration

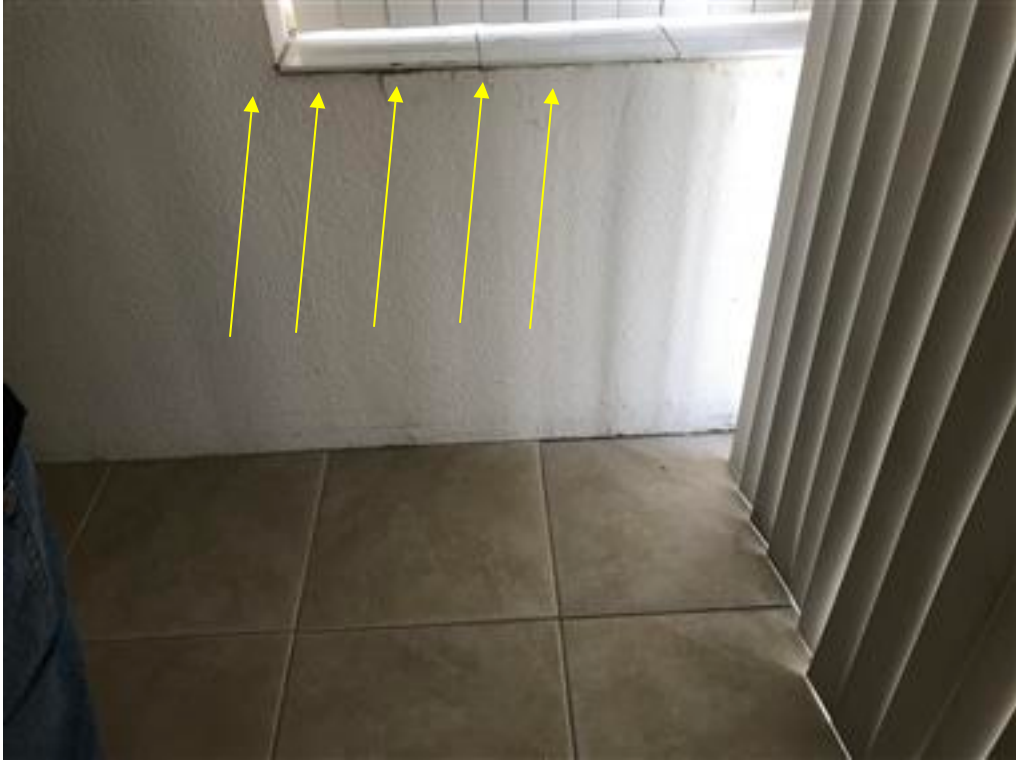
Photo 86-902- water damage at wall

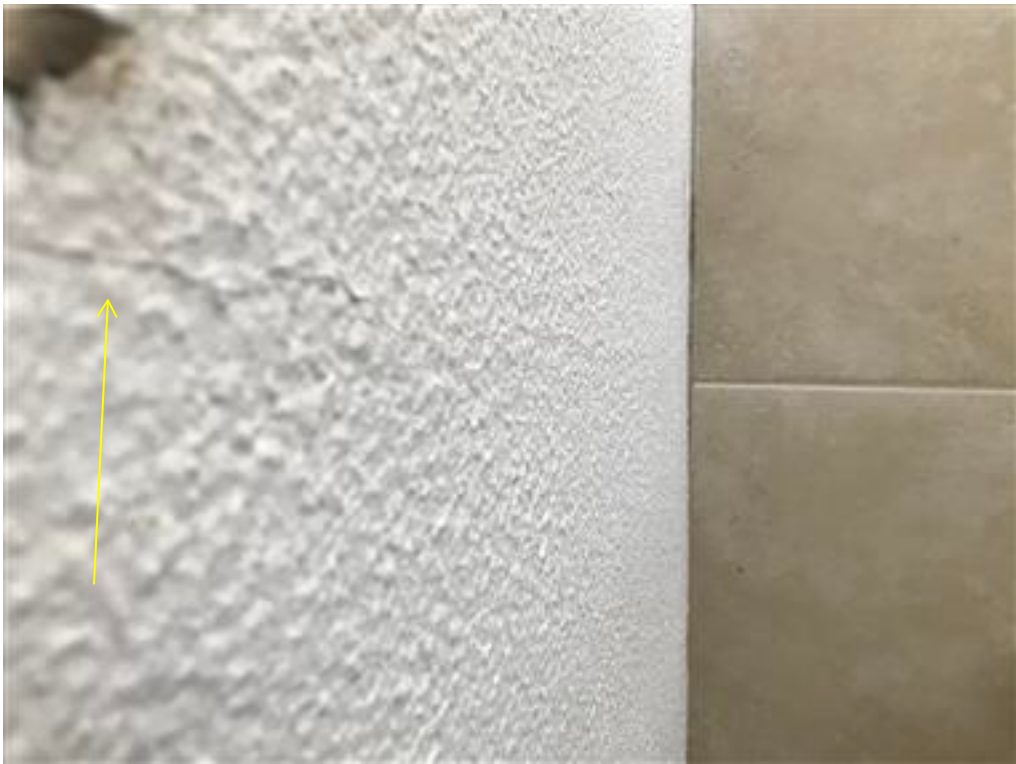
Photo 87-902, paint peeling due to water infiltration

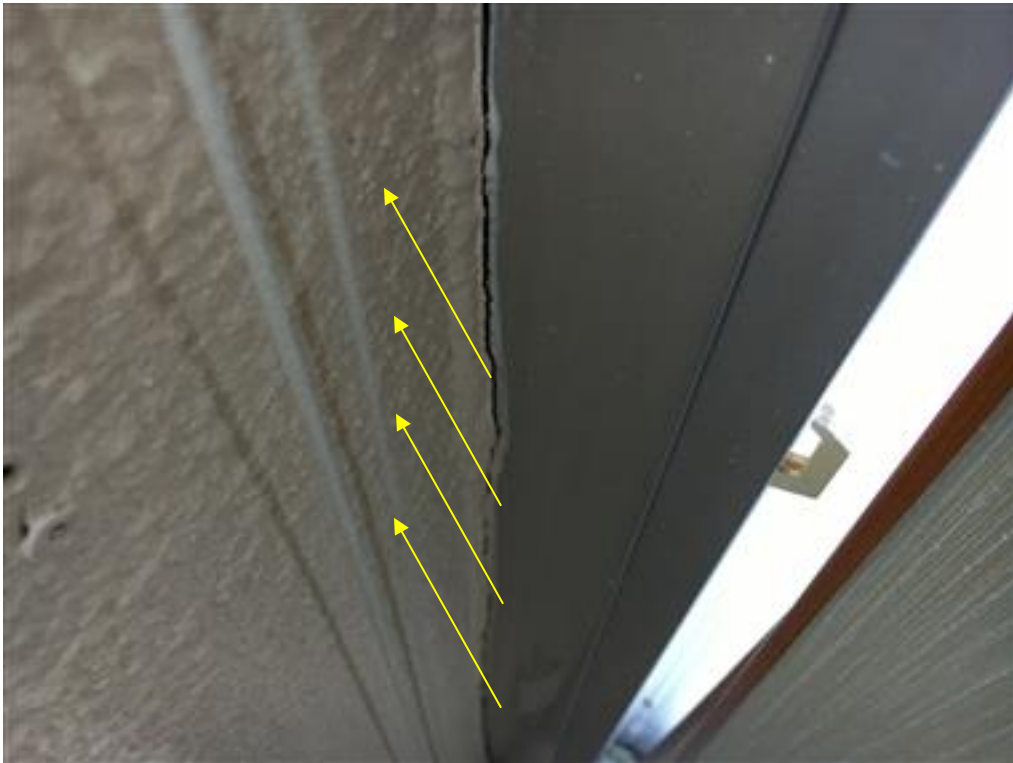
Photo 111-Unit 702, vertical crack at SGD, typical

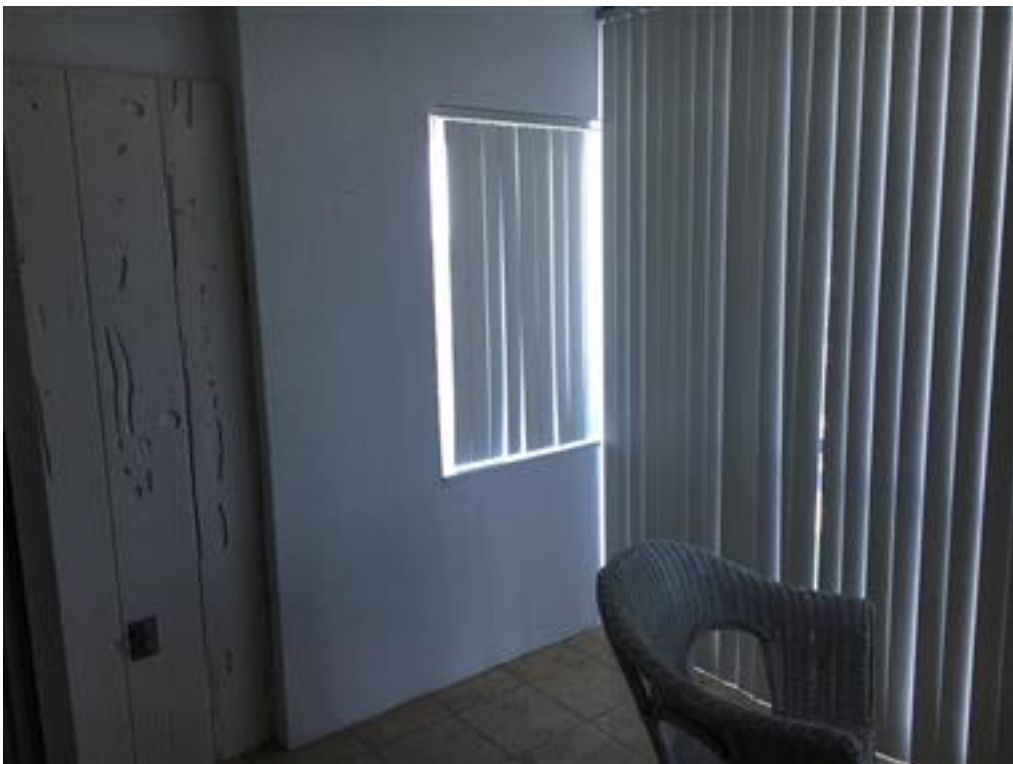
Photo 112-Unit 702, vertical crack at SGD

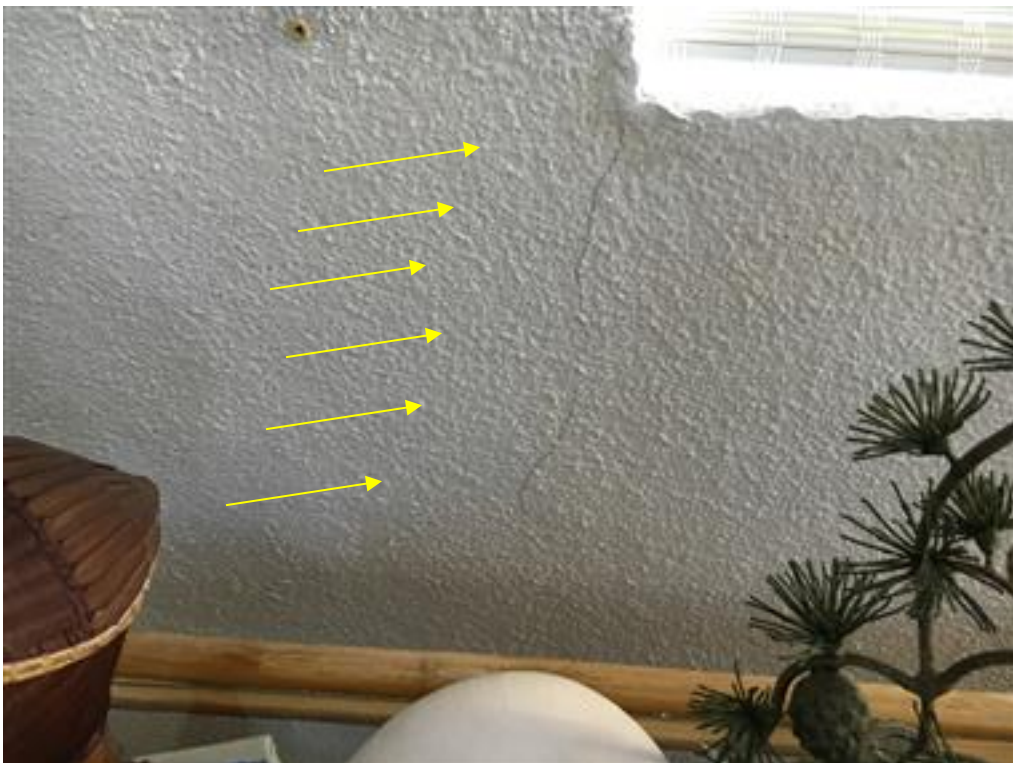
Photo 124-Unit 504, hairline crack at window sill, typical

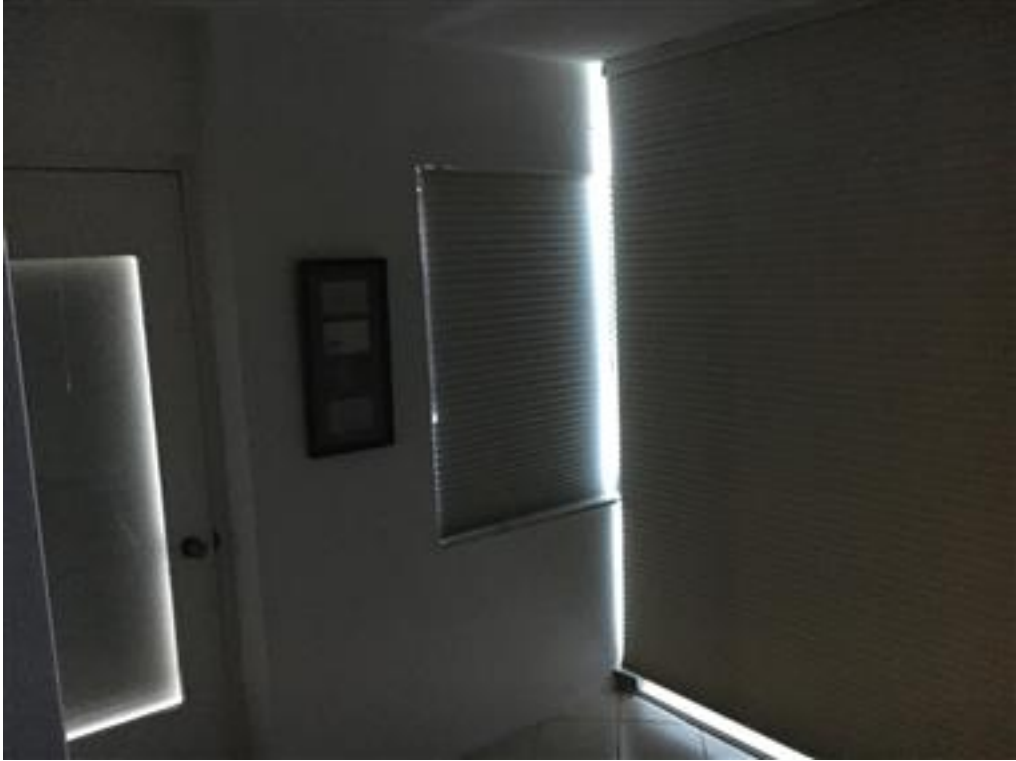
Photo 125-Unit 504, hairline crack at window sill

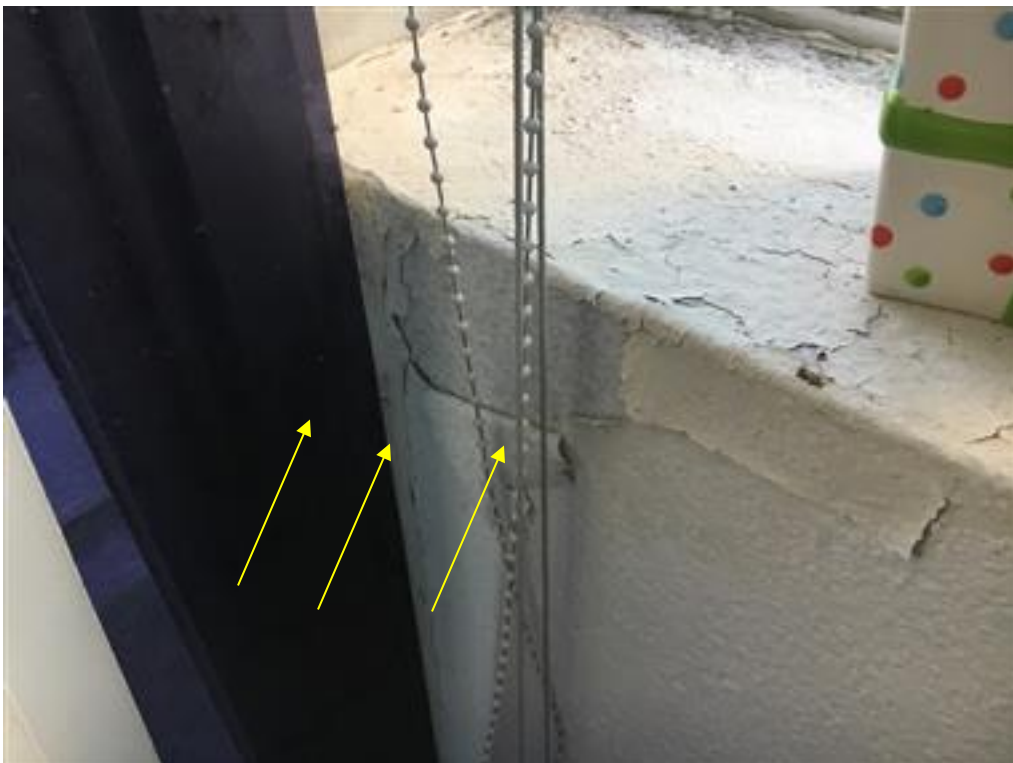
Photo 130-Unit 501, water damage at window sill, typical

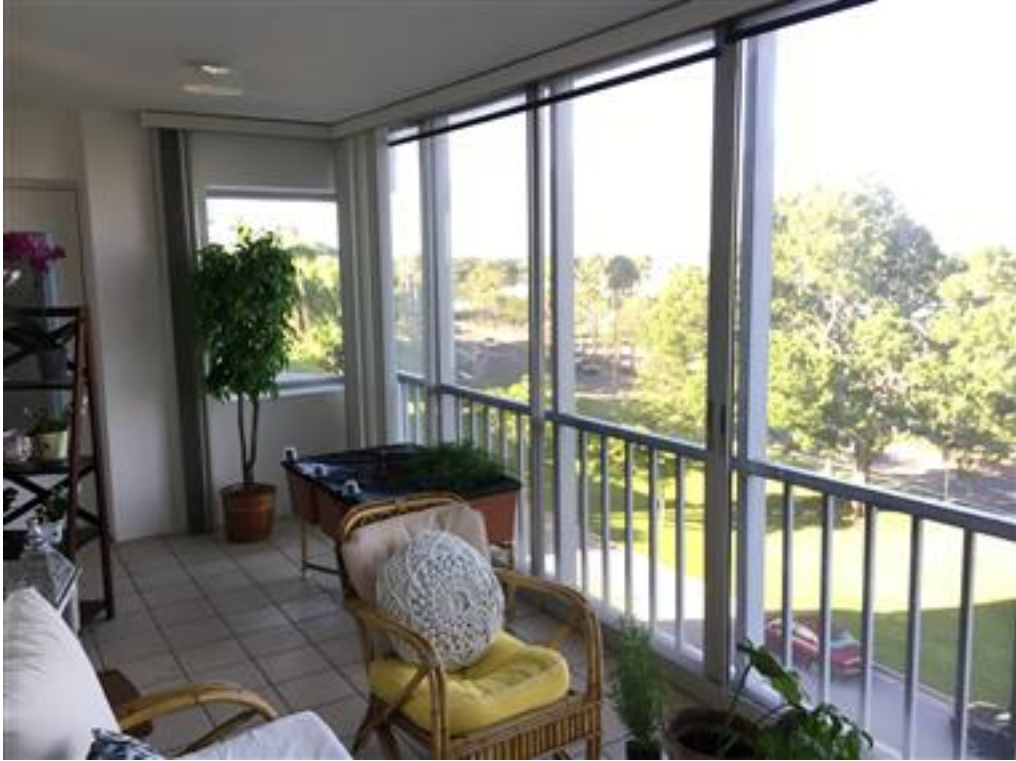
Photo 131-Unit 501, water damage at window sill

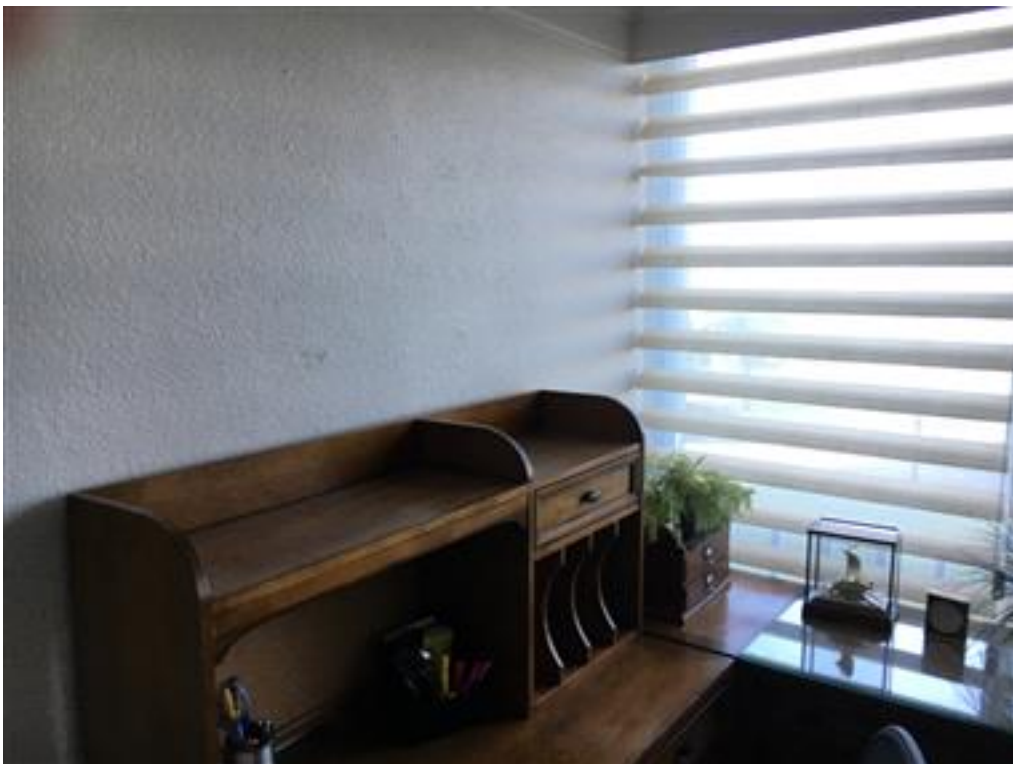
Photo 134-Unit 501, water damage at window sill

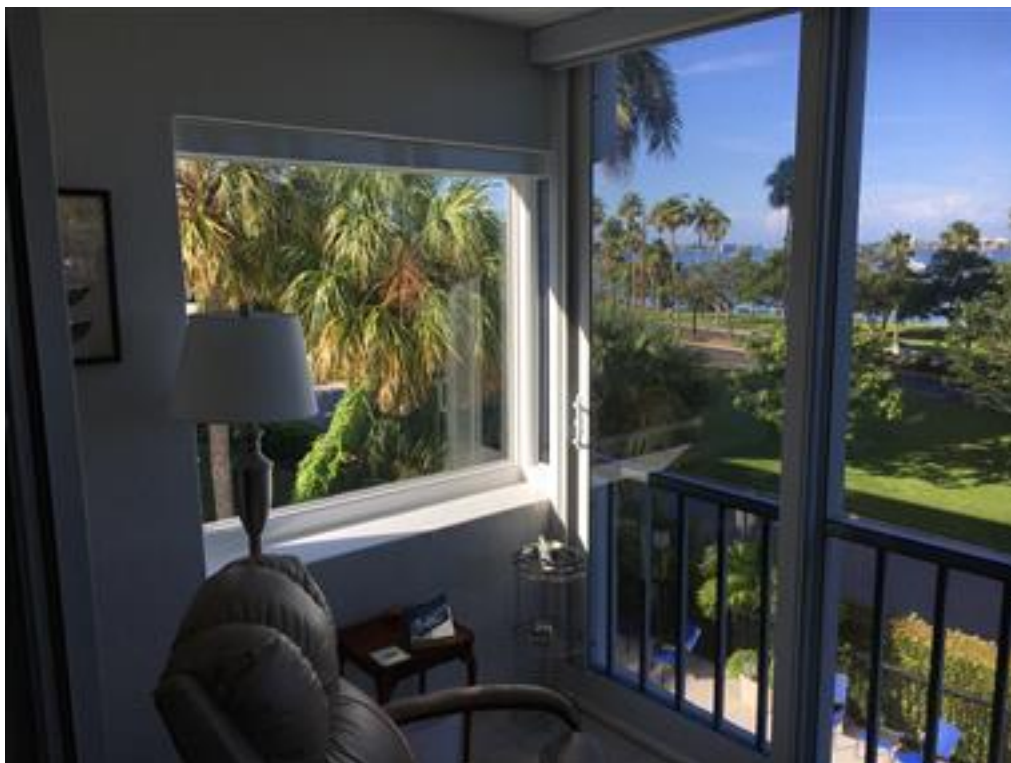
Photo 147-Unit 405, open crack at SGD below window

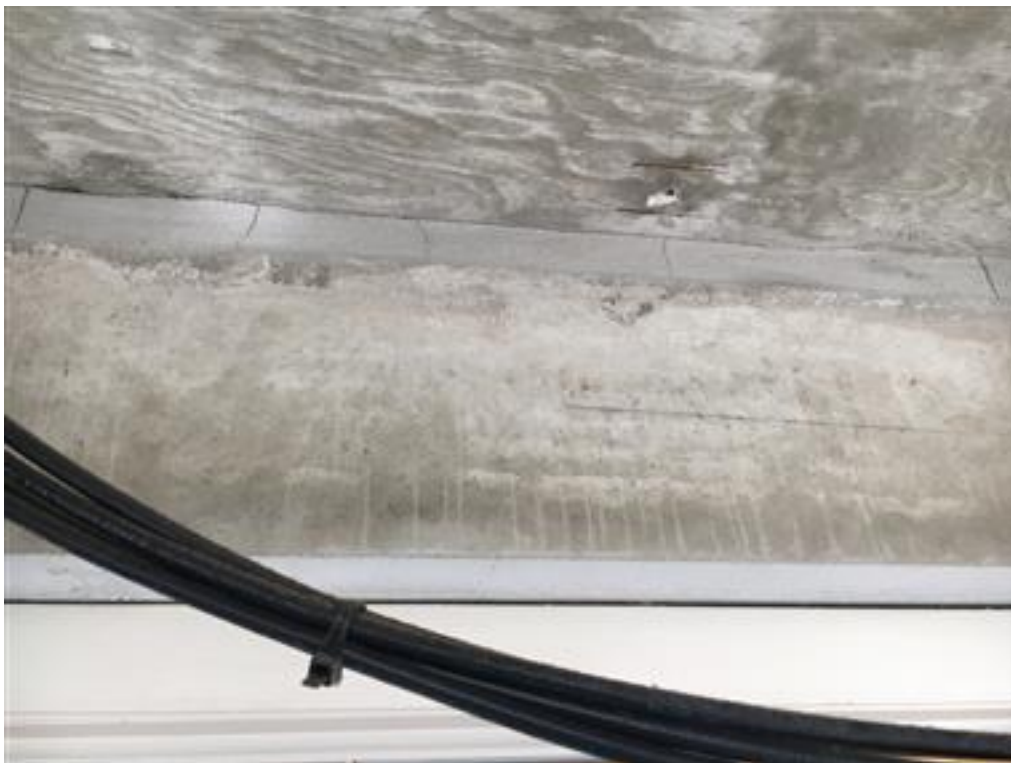
*Photo 19-8<sup>th</sup> FLOOR- AC LEAK*

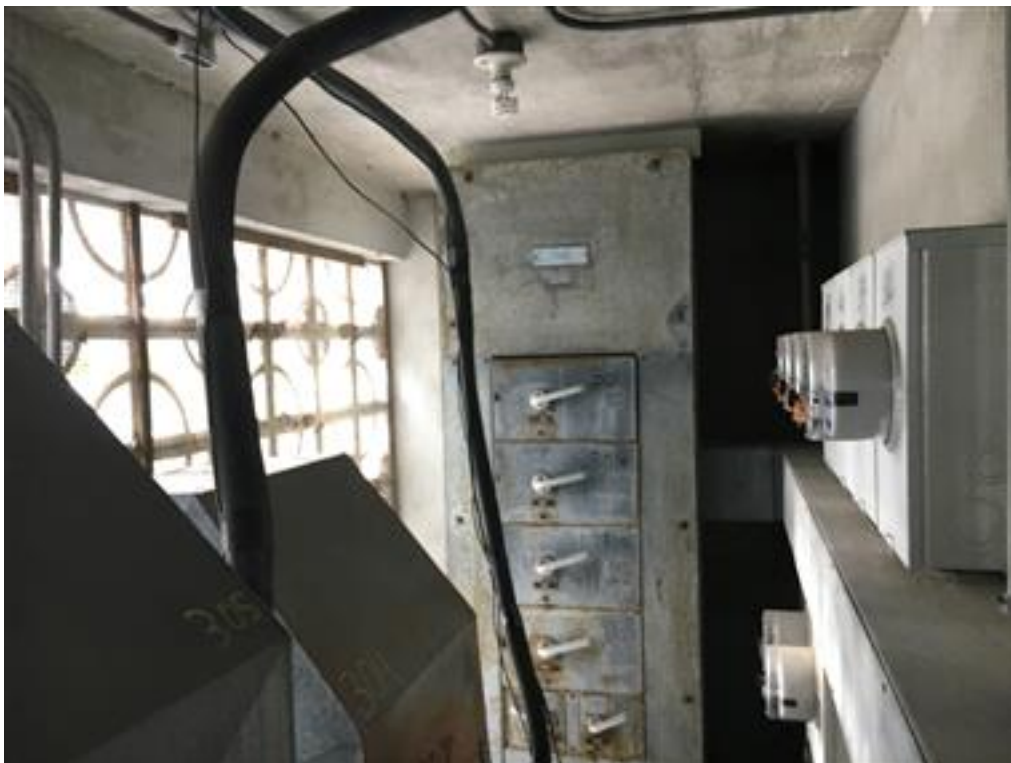
*Photo 33-4<sup>th</sup> FLOOR- CRACKS*

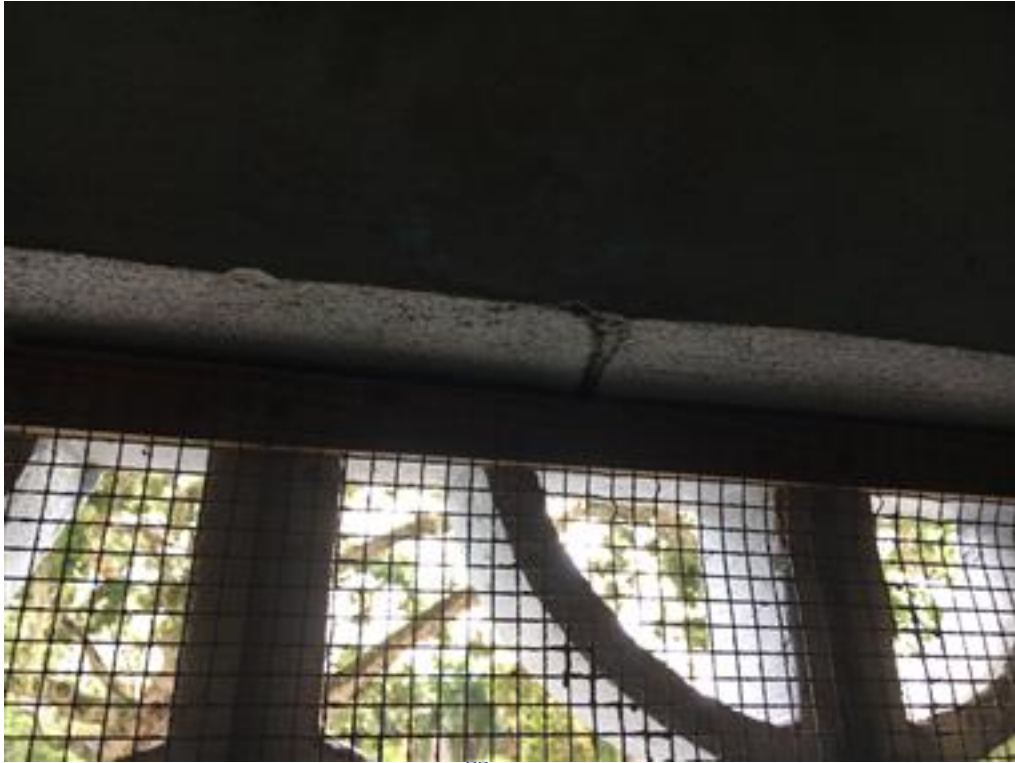
*Photo 36-3<sup>RD</sup> FLOOR- CRACK*
