# Existing Condition Report

**KEG File: 18RS-0416**  
**October 8, 2018**

***Royal St. Andrew Association,  
Inc.***

**RE:    *Royal St. Andrew  
KEG Project P18RS-0416 REV02  
Professional Engineering Services – Existing Conditions Survey***

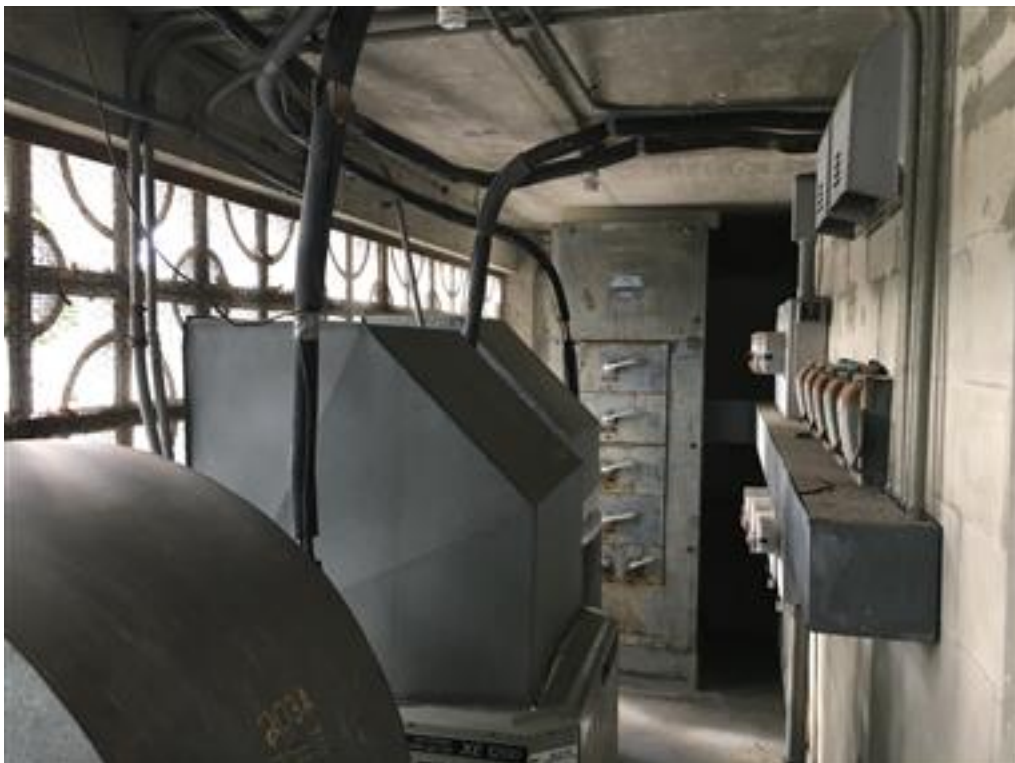
*Photo 37-3<sup>RD</sup> FLOOR- CRACK*
