## **SB 4-D Milestone Inspection Report**

### **Royal St. Andrew Condominium**

**555 S. Gulfstream Avenue, Sarasota, Florida**

## **RE: PHASE 1 MILESTONE STRUCTURAL INTEGRITY ASSESSMENT**

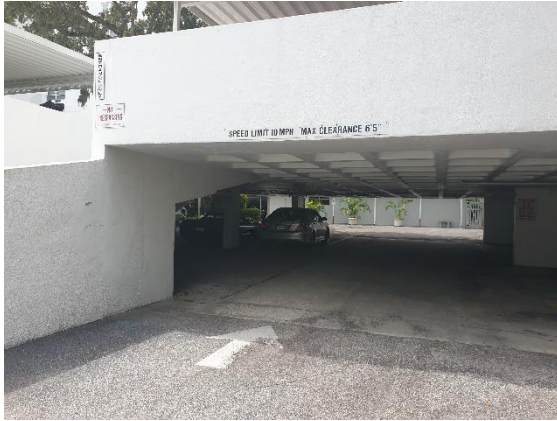
Photo 1: Overall View of Parking Garage

TT recommends that a concrete restoration project be performed on the parking garage to repair all concrete deterioration in accordance with the International Concrete Repair Institutes (ICRI) guidelines and Florida Building Code.

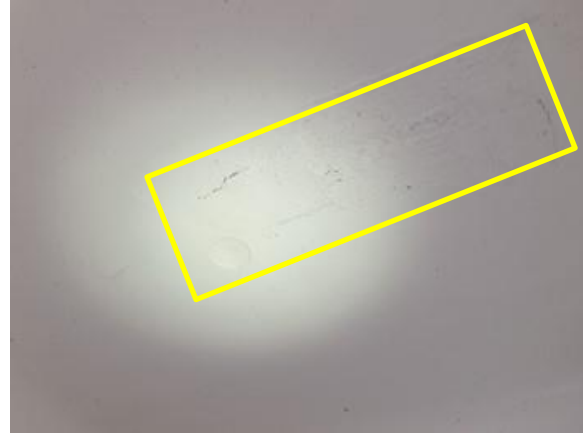
- The concrete at the underside of the second-floor parking garage slab was observed to be spalling in multiple locations. **(Photo 1 – Photo 4)**
- TT observed failures of the waterproofing membrane at the top level of the parking garage. The waterproofing topcoat was missing in several locations where inter-layer bond failures occurred between the base and the topcoat. **(Photo 5)**

Photo 2: Concrete spalling at the Underside of the Slab.

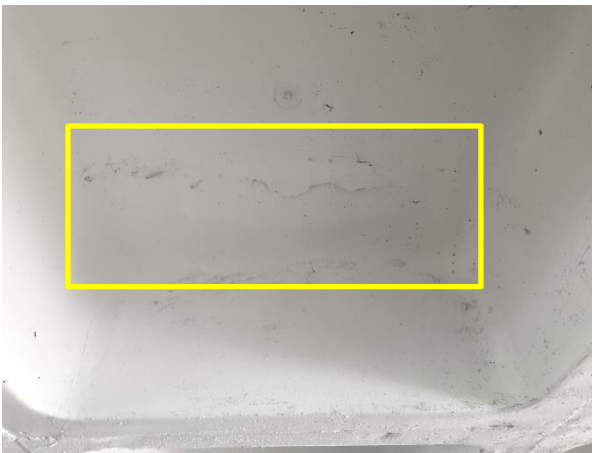
Photo 3: Peeling paint between the slab ribs

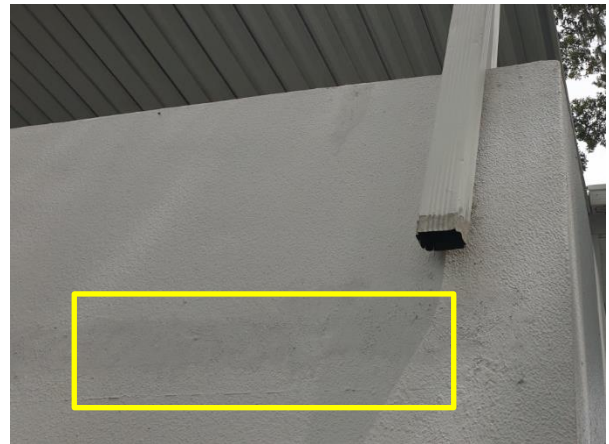
Photo 4: Previous concrete repair to the exterior of the parking garage

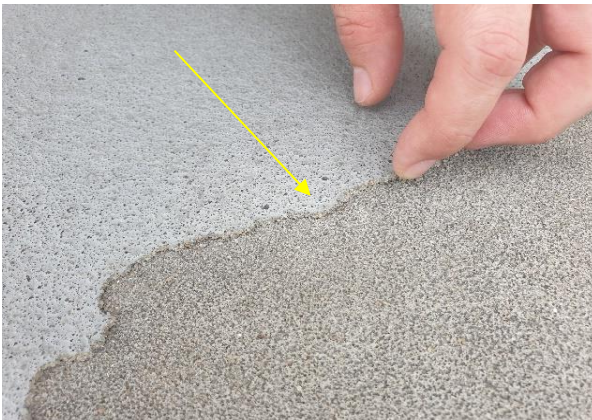
Photo 5: Bond failure between base and topcoat

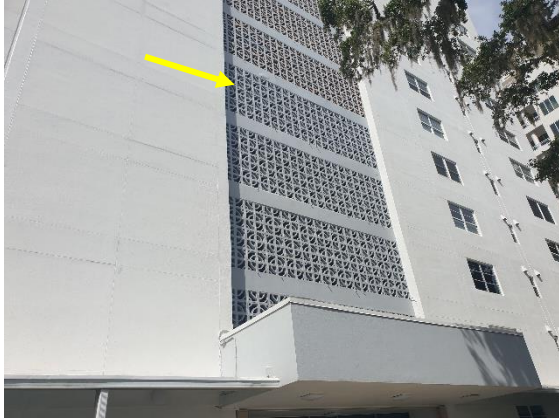
- Bulging stucco was observed at the west face of the building in the area where air conditioner condenser units are housed. Additionally, the slab finish underneath the MEP units was observed to be deteriorated. **(Photo 6 – Photo 9)**
- TT observed tile finishes on enclosed balconies that were up to 3 inches in height. This condition was later analyzed and found to be acceptable for the original structural design.

Photo 6: Overall Photo of Exterior Showing Damaged Stucco

- Remove delaminated and bulging stucco to prevent fall hazards.
- Perform ICRI compliant concrete and stucco repairs.
- It is recommended to apply waterproof coating at AC condenser slab areas to protect concrete from further exposure to weather and spalling and to add drainage to allow water entering the area to be wept to the exterior. This work is elective.

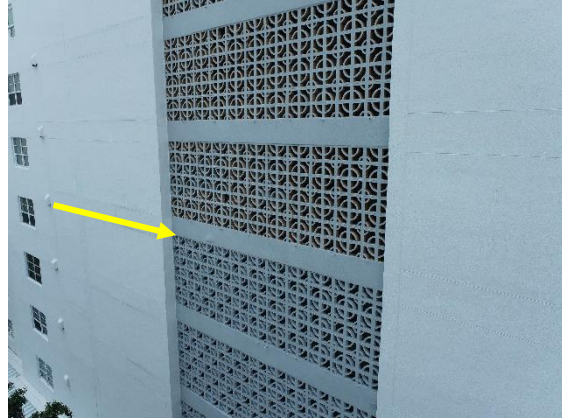
Photo 7: Overall Photo of Exterior Showing Damaged Stucco

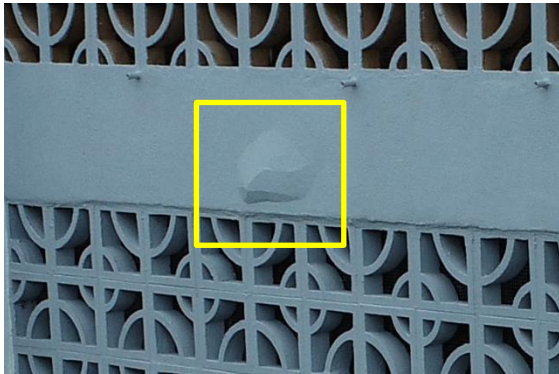
Photo 8: Bulging stucco adjacent to the MEP slab.

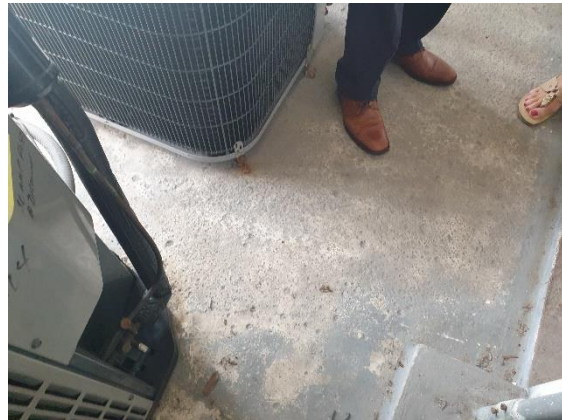
Photo 9: Condition of the slab under the MEP

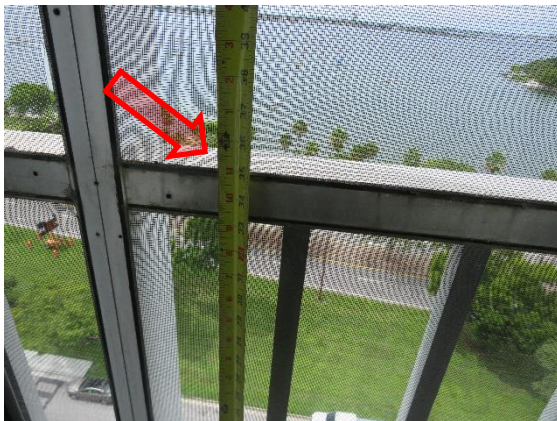
- Units were observed in which balcony floor finishes had been built up to match the elevation of the interior spaces without modifications being made to the guardrails. This condition has decreased the railing height above the finish floor to less than 36 inches, which was the code requirement at the time of construction. **(Photo 10 – Photo 11)**

Photo 10: Guard rail below code required height.

In the units where this condition exists, the Condominium Association should confirm that the AHJ has provided the stated variances to allow guardrail heights that do not meet current code requirements. If there are units that require guardrail modifications, TT recommends the following:

- As a temporary solution: Restrict access where guardrails are less than 36 inches above the finished floor surface. Lock off sliding glass doors to prevent occupants from opening them.
- Alternatively, install new railing sections to provide the 42-inch height above the finished floor. Railings to meet FBC required loads and geometry to bring the railing into code compliance.

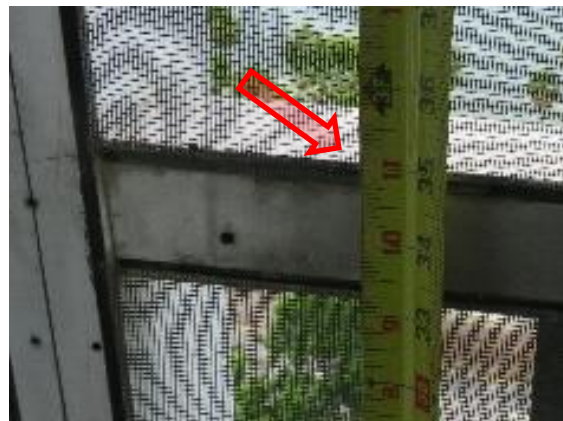
Photo 11: Guard rail below code required height
