## Condition Assessment Report

### Royal Saint Andrew, Sarasota FL

Thornton Tomasetti

**October 15, 2021**

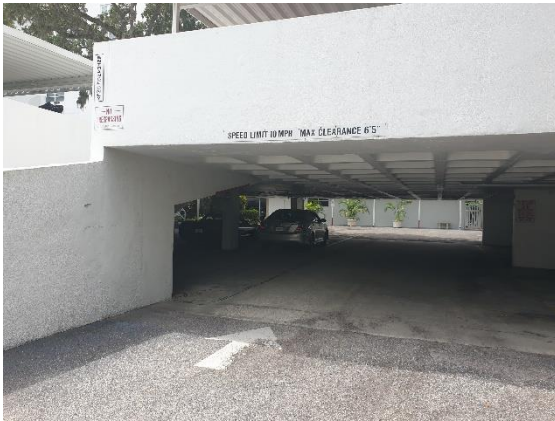
- The concrete at the underside of the second-floor parking garage slab was observed to be spalling in several locations.
- Additional peeling of paint was observed along the wall at the parking garage entrance.
- TT observed evidence of previous concrete repairs throughout the parking garage.

*Garage Entrance Overall Photo*

1. Excavate spalled concrete to expose reinforcing steel that has lost bond to the surrounding per concrete and perform repairs in accordance with International Concrete Repair Institute (ICRI) standards under the guidance of a qualified structural Engineer.
2. Epoxy inject areas of nonmoving concrete cracks.

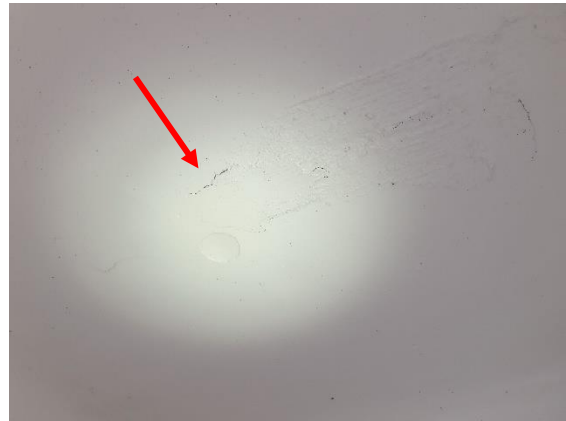
*Concrete Spalling at Underside of Slab*

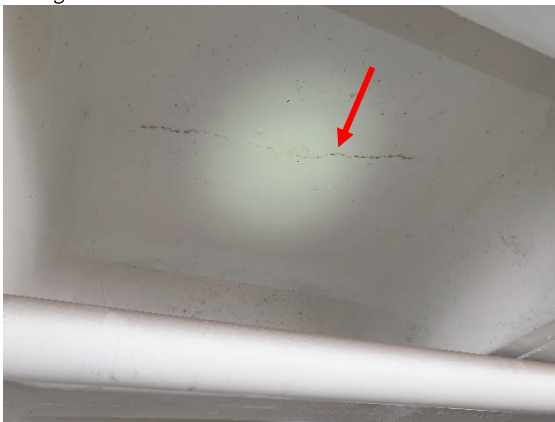
*Additional Concrete Spalling*

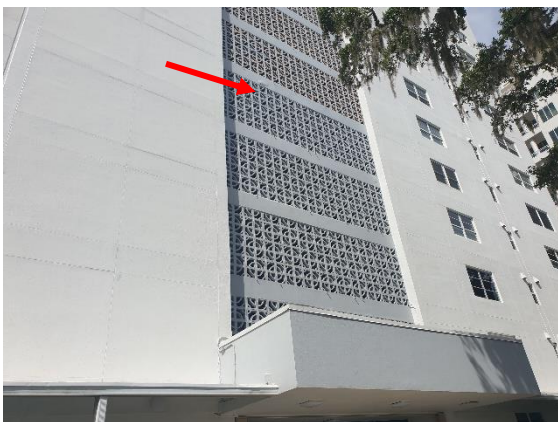
- Bulging stucco was observed at the west face of the building in the area where air conditioner condenser units are housed.
- This condition is likely a symptom of concrete spalling underneath the stucco at the slab edges.

Overall Photo of Exterior Showing Damaged Stucco

1. Remove delaminated and bulging stucco, perform ICRI compliant concrete repairs and replace stucco and paint.
2. Apply waterproof coating at AC condenser slab areas to protect concrete from further exposure to weather and spalling.
3. Add drainage to allow water entering the area to be wept to the exterior.

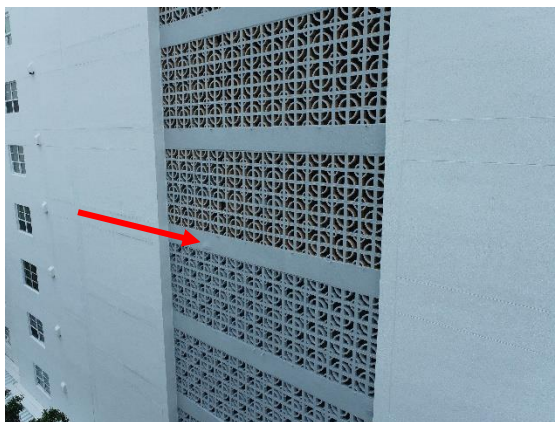
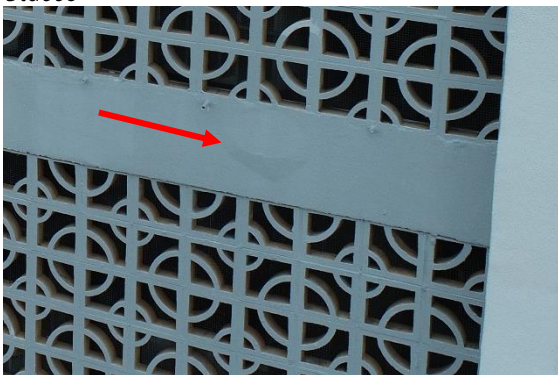
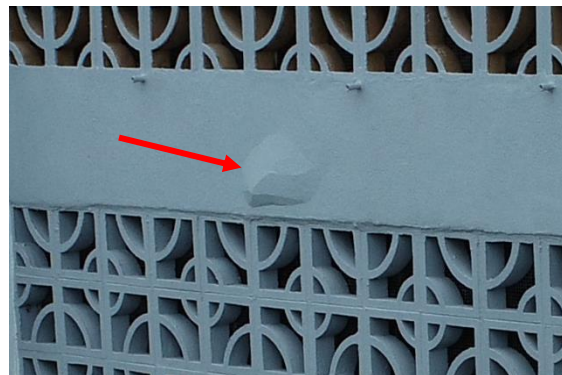
Bulging Stucco at Slab Edge

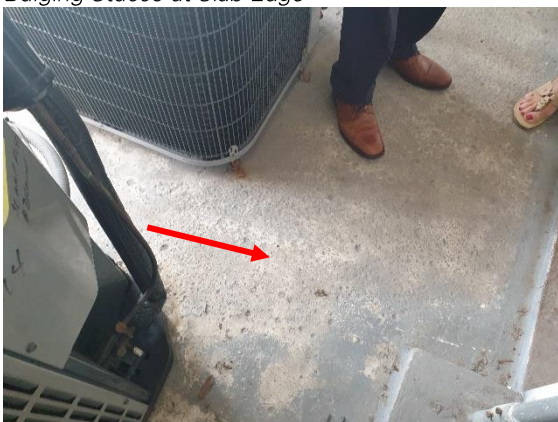
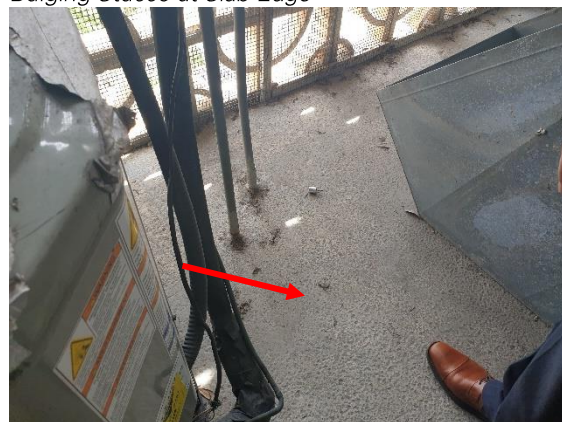
AC Condenser Area Slab Condition

AC Condenser Area Slab

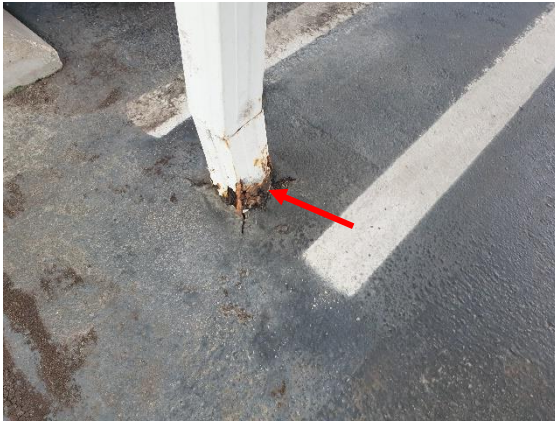
- Carports throughout the ground level parking area and the second floor of the parking garage are covered with a metal canopy structure. The existing steel posts supporting the canopy and tie down straps were observed to be damaged and/or corroded at several locations.
- The damage to the posts was observed to be concentrated at the base of the posts.
- Numerous posts showed evidence of previous repair and strengthening work.

*Damaged Steel Canopy Support*

1. Provide adequate temporary shoring to support canopy framing above while repairs are performed.
2. Remove damaged and/or corroded segments of steel posts and replace with new spliced-in steel members, or cast-in-place concrete members.
3. For corroding areas that don't require strengthening, Remove loose corrosion, treat with corrosion inhibitor and coat with high performance metal paint.
4. Patch waterproofing membrane in areas where membrane has voids from corroded metal substrate.

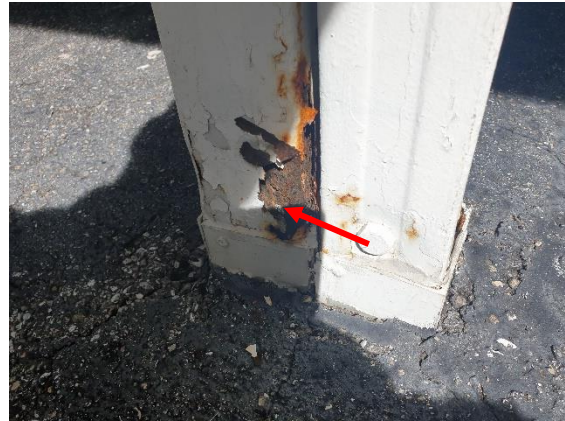
*Corrosion at Canopy Support*

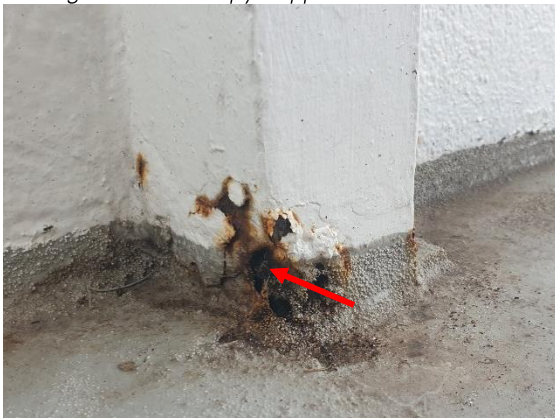
*Corrosion at Canopy Support, Voids in Waterproofing*

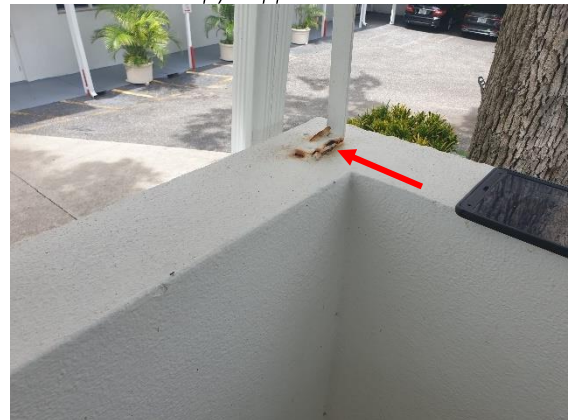
*Corrosion at Canopy Tie Down Strap*

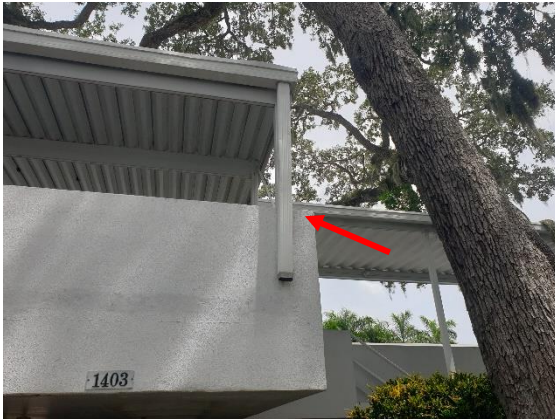
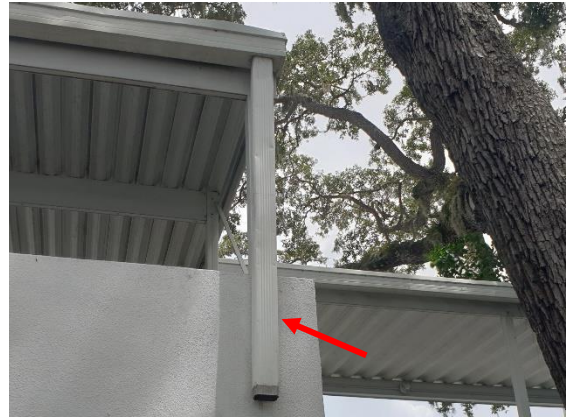
- Loose gutter downspouts were observed.

1. Install strapping to prevent downspouts from detaching during windstorms.

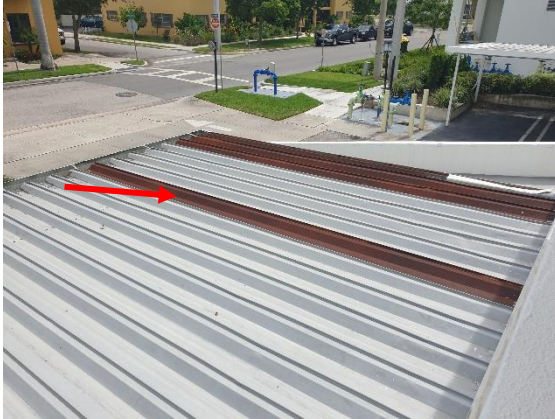
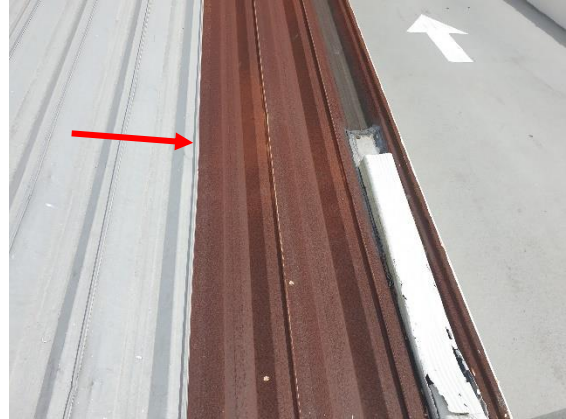
- Segments of the existing metal deck covering a portion of the parking garage structure are corroded.

*Corroded Metal Deck*

1. Remove corroded segments of the metal roof decking.
2. Replace with new corrosion resistant galvanized metal roof deck, matching the size and gauge of the existing decking.

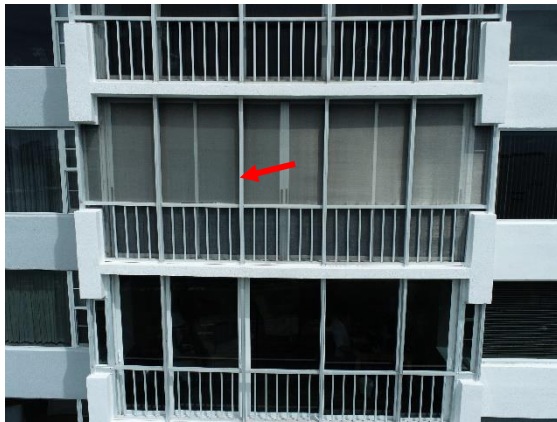
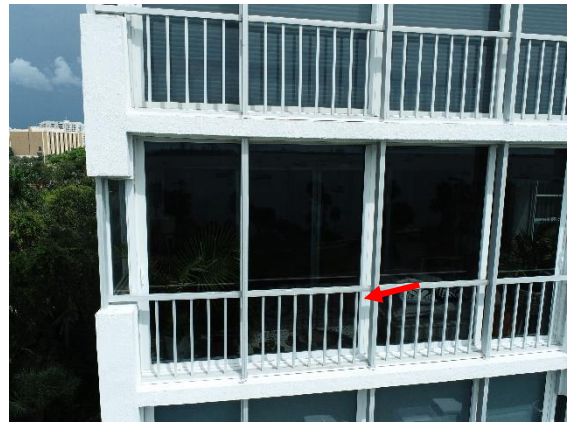
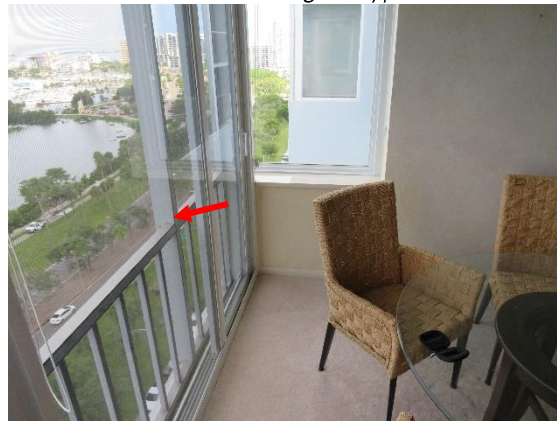
- When sliding glass doors were installed to enclose the unit balconies, framing for the previous screen enclosures was left in place. Approximately 5 units were observed which were still using the screen enclosures
- The concrete fasteners used to attach the framing create penetrations into the concrete slabs which can allow moisture and chlorides into the concretes. This can lead to concrete deterioration over time.
- The guardrails integrated into the screen enclosure do not meet the current building code height requirements. (Refer to Item 7 below).

*Screen Enclosure Framing at Typical Balconies*

*Interior Photo of Screen Enclosure Framing*

1. Remove screen enclosure framing members and patch concrete slab penetrations from fasteners.

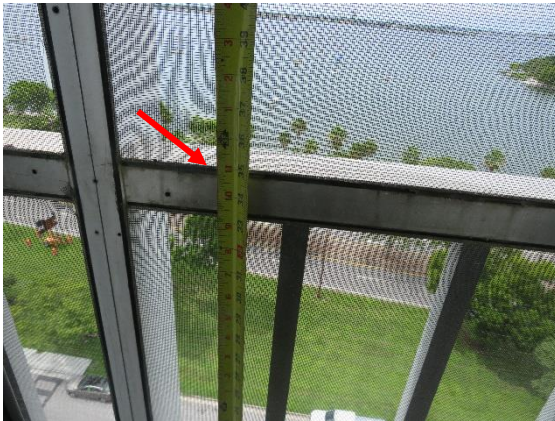
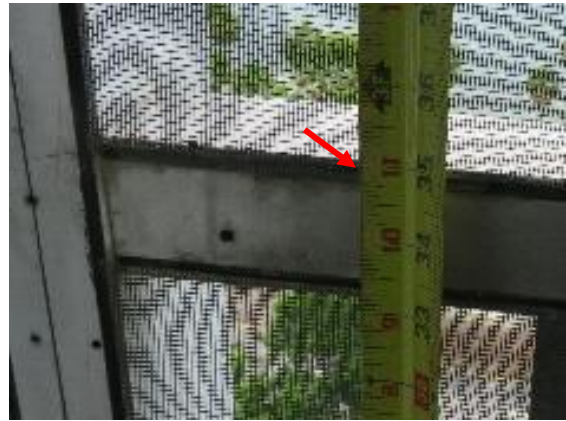
- The code required minimum guardrail height at the time of the building's construction was 36 inches measured from the finished floor surface.
- Units were observed in which balcony floor finishes had been built up to match the elevation of the interior spaces without modifications being made to the guardrails. This condition has decreased the railing height to less than 36 inches.
- The current code required minimum height for new construction and alterations to existing construction is 42 inches measured from the finished floor surface.
- TT was informed that the relevant Building Department / Authority Having Jurisdiction (AHJ) had provided variances on previously performed balcony renovation projects in various units. These variances reportedly allowed the existing railing heights to be less than 36 inches above the finished floor level.

*Guardrail Below Code Required Height*

In the units where this condition exists, the Condominium Association should confirm that the AHJ has provided the appropriate variances to allow guardrail heights that do not meet current code requirements. If there are units that require guardrail modifications, TT recommends the following:

1. As a temporary solution for locations with impact-resistant sliding glass doors: Restrict access where guardrails are less than 36 inches above the finished floor surface. Lock off impact resistant sliding glass doors to prevent occupants from opening them.
2. Alternatively, install an additional horizontal rail at 42-inch height to bring the railing into code compliance. This can be implemented at locations with impact-resistant and non-impact resistant sliding glass doors.
3. Consider a railing replacement project in the near future to change the guardrails to meet the current code requirement of 42-inch height and remove abandoned screen enclosure framing.

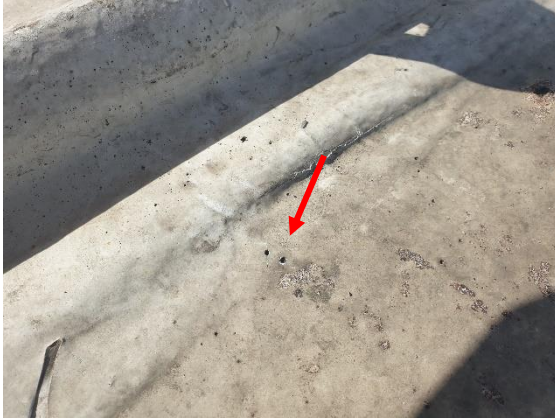
- The existing roofing membrane is a Fibertite Ketone Ethylene Ester (KEE) single ply membrane which was reported to be approximately 25 years old. The roof was coated with a fluid applied material in 2016 which was reported to carry a 10 year warranty.
- The roof coating showed signs of aging including divots and small tears.
- A liquid applied coating was recently applied to low points experiences ponding to extend the life of the membrane.
- Wrinkling and delamination of the roof membrane was observed at the vertical parapet walls surrounding the main roof of the building. This condition is due to long-term shrinkage and exposure of the roof membrane.

*Voids and tear in roof coating*

1. Perform a roof moisture survey to determine if there are areas of the roof that are saturated but have not leaked through to occupied space below.
2. Monitor the roof membrane at the vertical parapet walls to ensure there are no separations or openings in the membrane, particularly at the interface between the vertical parapet walls and the roof of the building.
3. Budget for roof replacement project in the next 5 years.

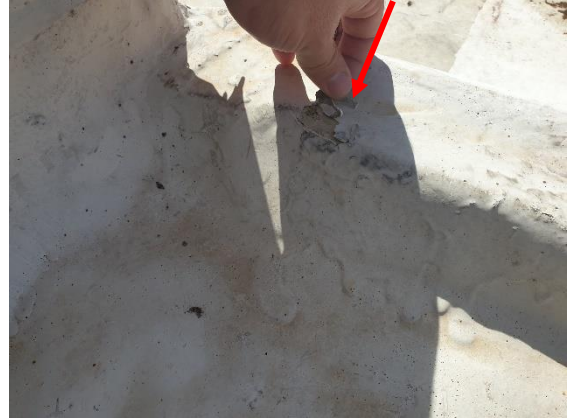
*Tear in roof coating*

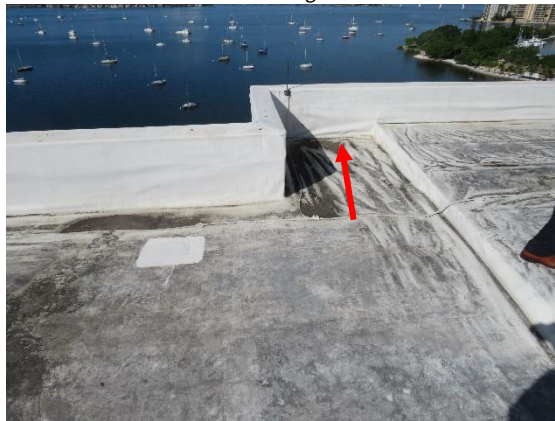
*Wrinkling of Roof Membrane*

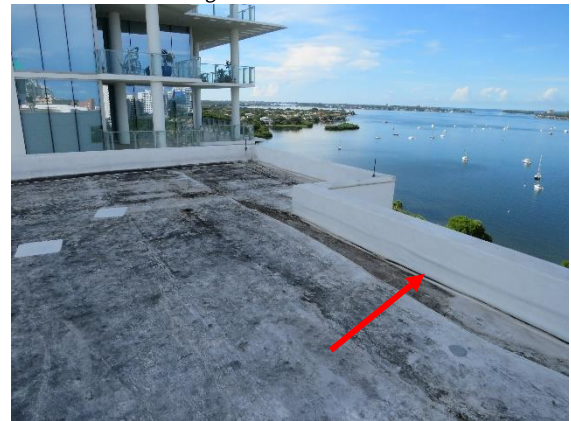
*Wrinkling of Membrane at Parapet*

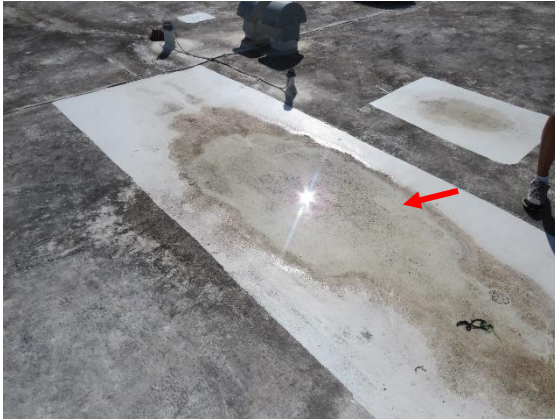
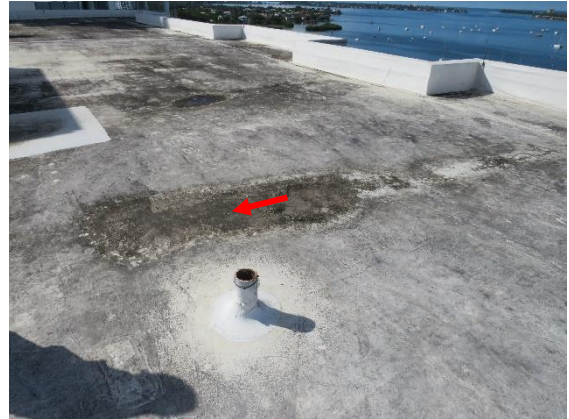
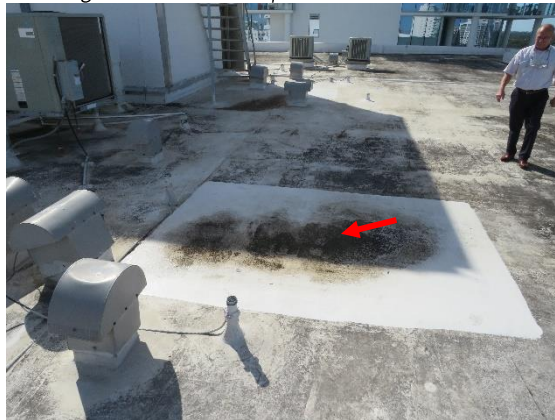
- Ponding water was observed at several locations on the main roof of the building.

*Ponding Water at Rooftop*

1. Monitor ponding to ensure that the roof coating does not deteriorate to the point that it allows leaks into the occupied space below.

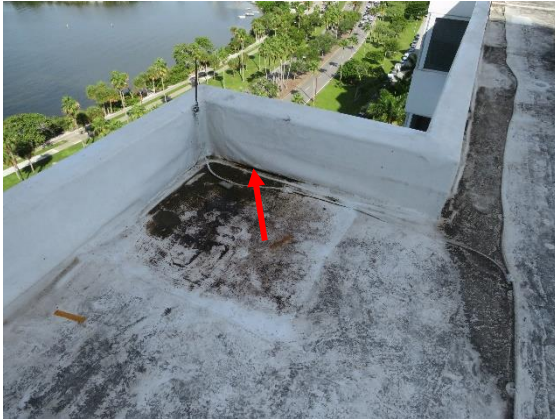
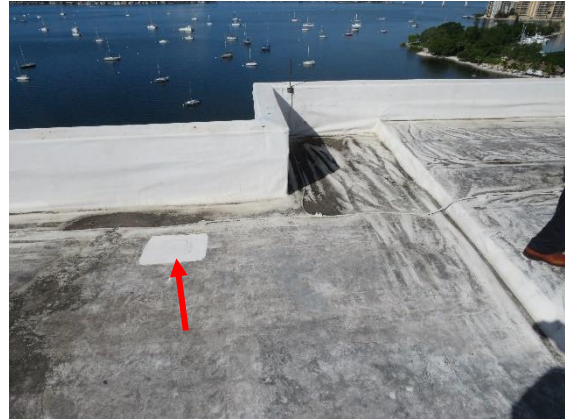
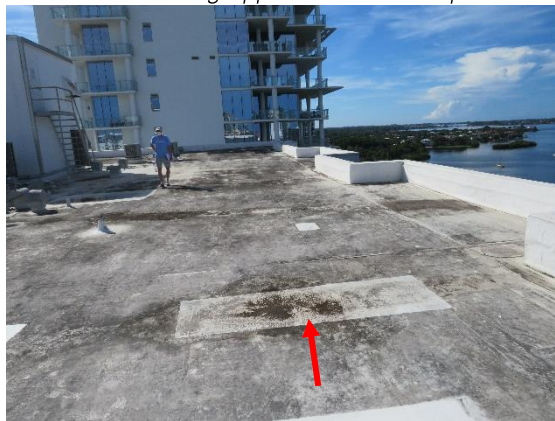
- Multiple locations with previous patches or elastomeric coating applications were observed on the main roof of the building.

*Elastomeric Coating Application at Rooftop*

*Patched Area of Coating at Rooftop*

1. Monitor the patches/elastomeric coatings to ensure that the roof coating does not deteriorate to the point that it allows leaks into the occupied space below.

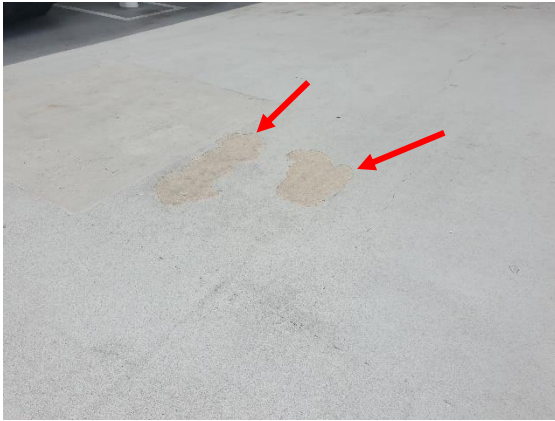
- TT observed failures of the waterproofing membrane at the top level of the parking garage.
- The waterproofing topcoat was missing in several locations where inter-layer bond failures occurred between the base and the topcoat.
- It was reported that the failed areas were to be replaced in the near future as warranty work.

*Missing Waterproofing at Parking Slab*

1. Remove and replace all failed waterproofing to protect concrete slab.
2. Monitor coating annually for additional bond failures.

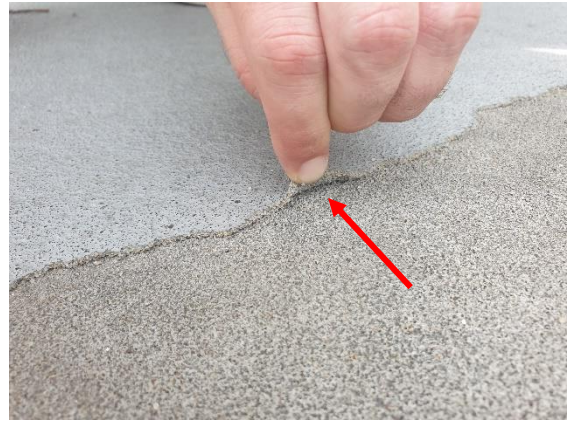
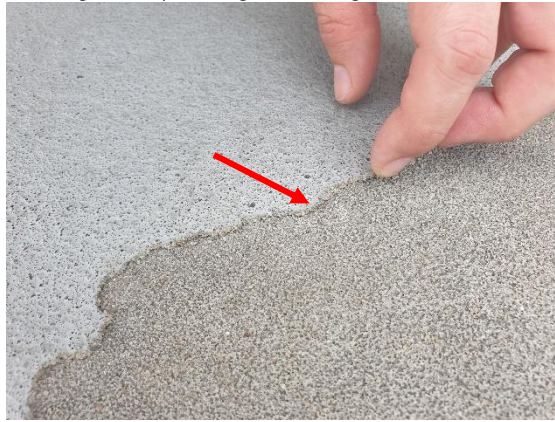
*Bond Failure Between Base and Topcoat*

*Additional Area of Bond Failure*

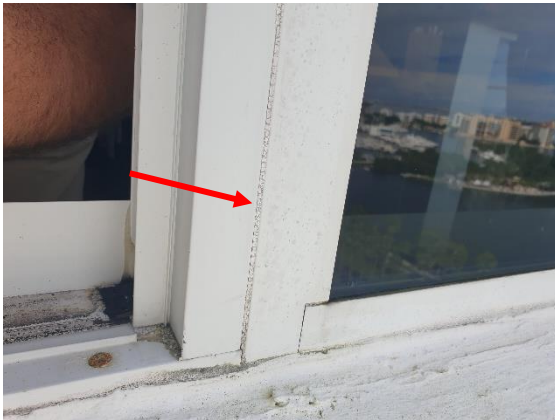
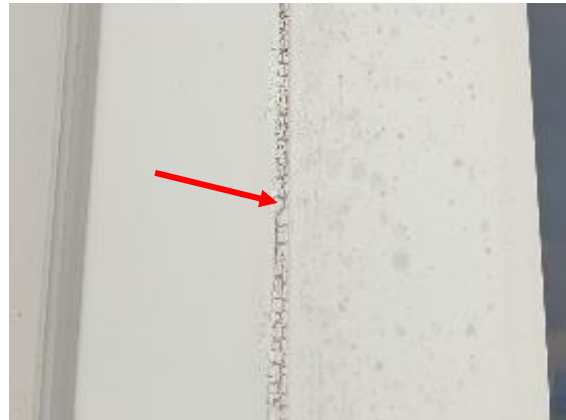
- Maintenance staff reported that metal to metal sealants were not replaced during the recent window perimeter sealant replacement project.
- The metal-to-metal sealant was observed in numerous locations to have reached the end of its useful life.

*Failing Metal to Metal Sealant*

1. Perform a comprehensive metal-metal joint sealant replacement project.

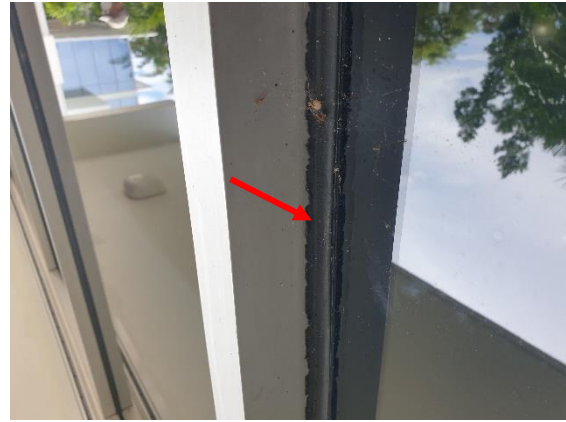
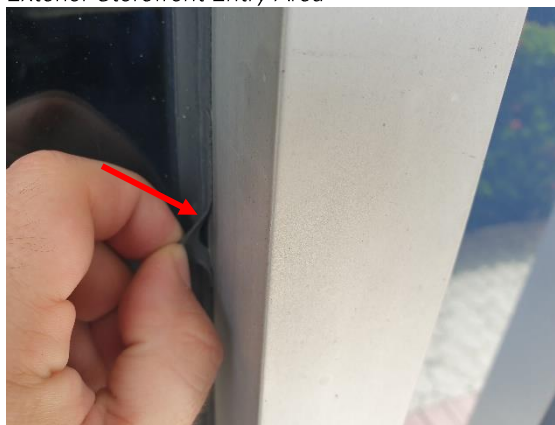
- The glass to metal sealants in the storefront entry system are deteriorating and debonding from the aluminum extrusions.
- Sealant has reached the end of its useful life.

*Failing Sealant at Storefront*

1. Remove and replace sealant at storefront entry glass to prevent moisture infiltration into building.

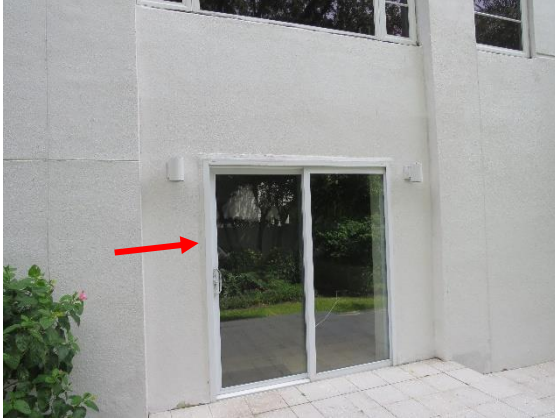
- TT observed an existing non-structural infill wall that was reported to have been modified with the addition of an opening with a sliding glass door. This was located at the first-floor unit on the north side of the building.
- The Association requested that TT review to determine if this modification is of structural concern.

*New Opening in Infill Wall*

1. This condition does not affect the structural integrity of the structure.
2. TT did not have access to and did not review any aspects of the structural attachment of the sliding glass door or adequacy of the sealants.

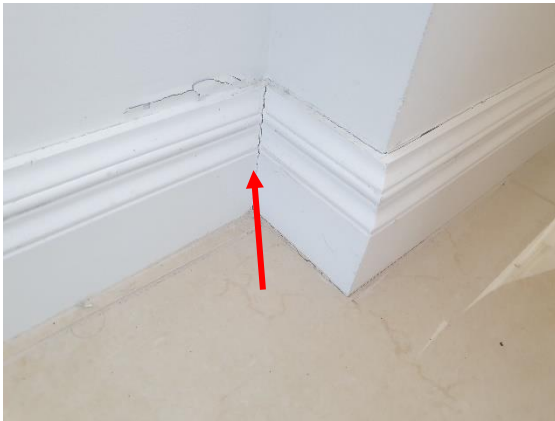
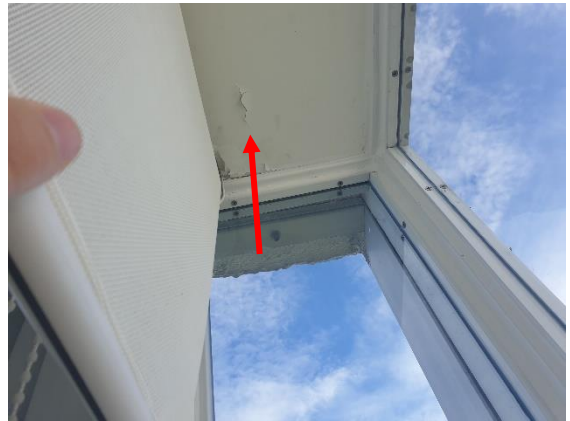
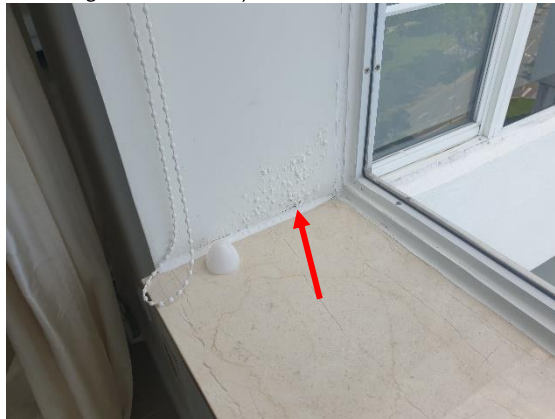
- Drywall cracking or other water-related distress was observed at multiple locations throughout the inside of the building.
- TT also observed failures at exterior window seals.
- Peeling and/or blistering paint was observed at enclosed balconies in various locations.
- See Item 12 for notes regarding the metal-to-metal sealant at windows.
- Inactive water stains were observed on interior finishes adjacent to fenestrations in the building.
- The distress observed throughout the building was typically in a similar condition to what was visible in the photographs of the Karins Assessment from 2018.

*Cracking at Interior Drywall and Baseboards*

*Water Damage at Interior Drywall*

*Water Damage of Interior Drywall*

1. Further investigation required to determine potential source(s) of leaks. Potential investigation methods could include destructive examination of the fenestrations and/or water testing of the fenestration assemblies (sliding glass doors and windows). This testing would be required to isolate leaks and make specific recommendations to address the moisture intrusion issues.
2. Replace window seals as required to prevent further moisture infiltration.
3. Repair cracked or damaged drywall as required. Repaint interior finishes as required.
4. Follow repair recommendations related to Item 12 to prevent further moisture intrusion through windows.

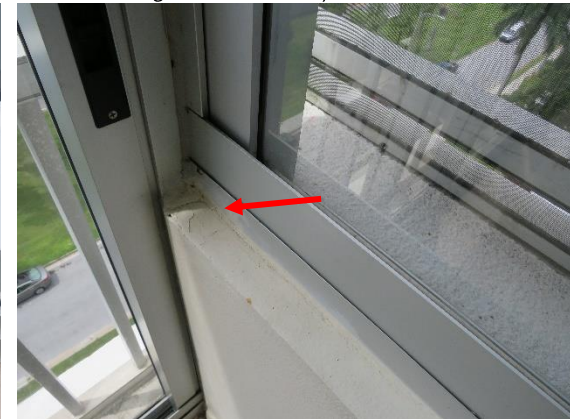
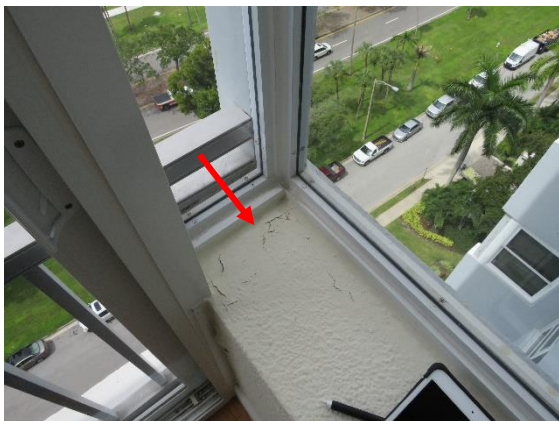
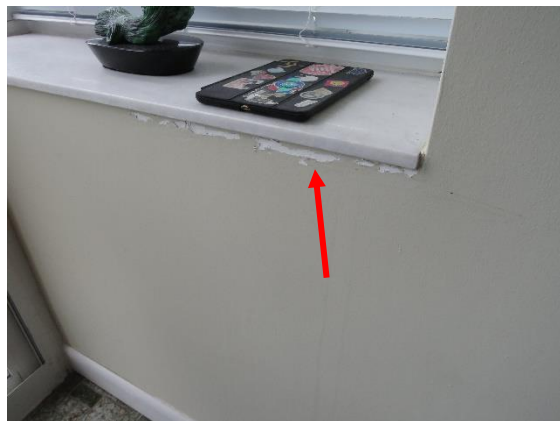
*Blistering Paint at Enclosed Balcony*

*Peeling Paint at Enclosed Balcony*

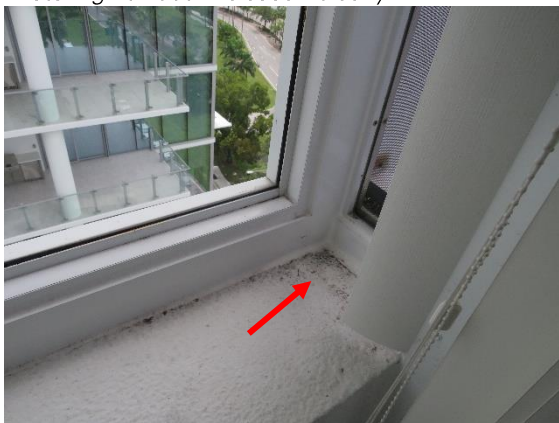
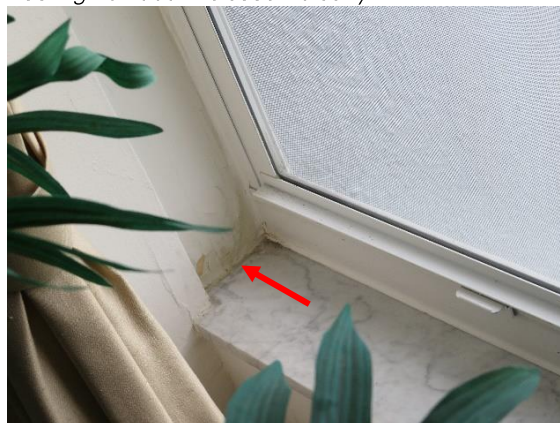
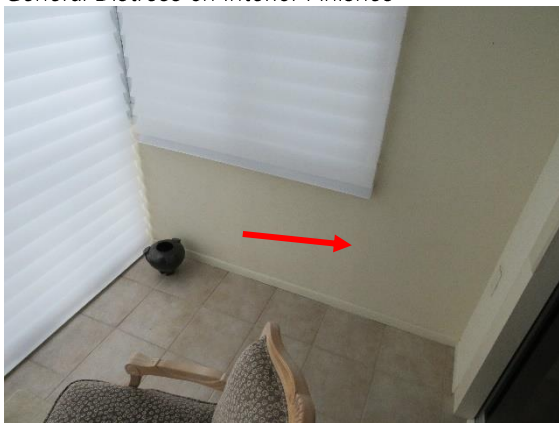
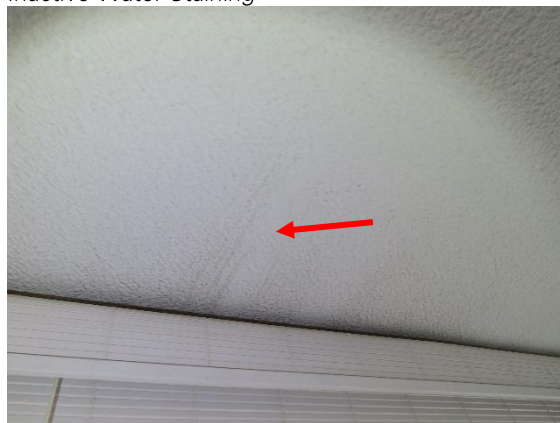
*General Distress on Interior Finishes*

*Inactive Water Staining*

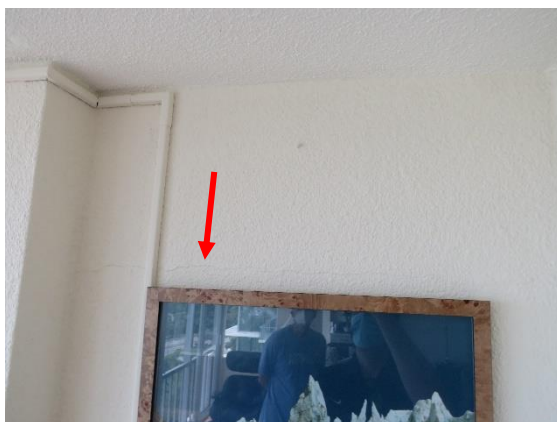
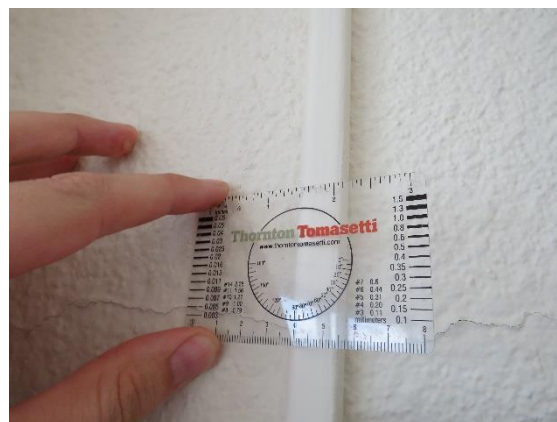
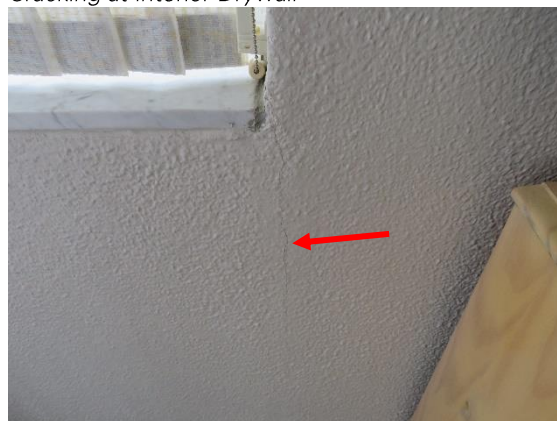
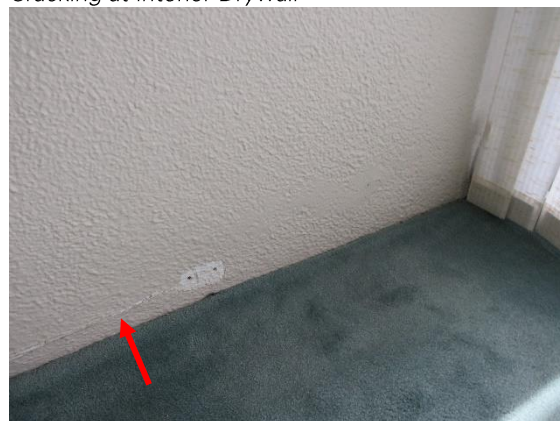
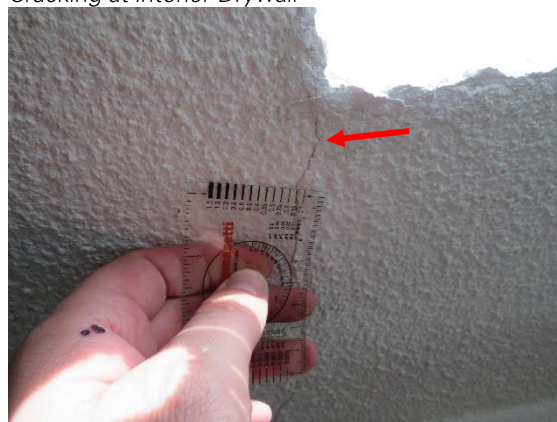
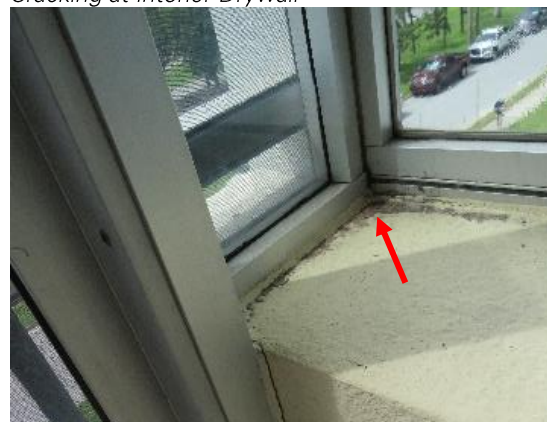
- Drywall cracking and/or other damage was observed at multiple locations throughout the inside of the building.
- The drywall distress observed throughout the building was typically in a similar condition to what was visible in the photographs of the Karins Assessment from 2018.

*Cracking at Interior Drywall*

1. Repair cracked or damaged drywall as required.
2. Repaint interior finishes as required.

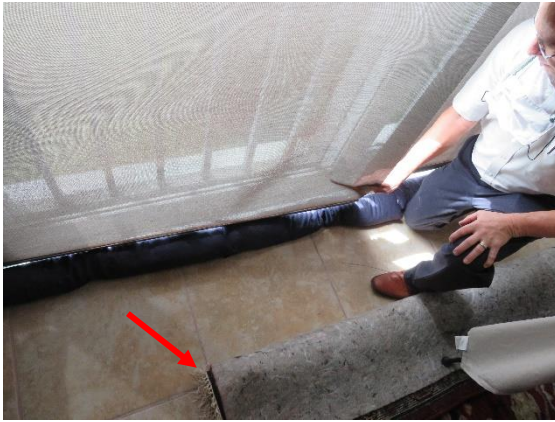
- Cracked and debonded tile finishes were observed in Unit 204.
- The tile at this location was installed with no control joints and was observed to be flush against the exterior walls.

*Cracked and Debonded Tile*

1. Remove and replace heaved tile. Install control joints to allow thermal expansion and contraction in accordance with the Tile Council of North American Standard EJ171.

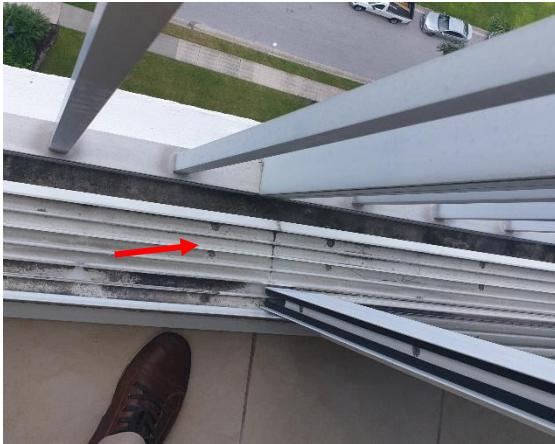
- TT observed tile finishes on enclosed balconies that were up to 3 inches in height.

*Tile Height*

1. TT recommends that this condition be reviewed by a structural Engineer to confirm that this weight does not exceed the design capacity of the cantilever Balcony

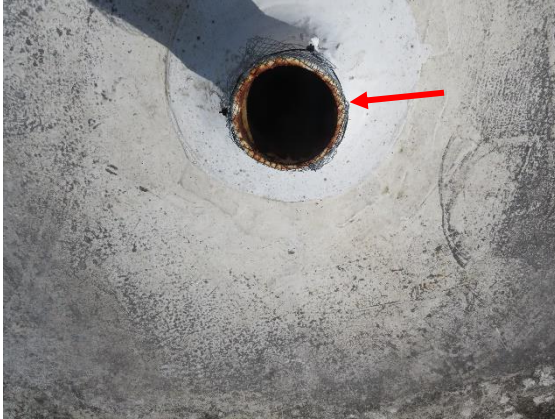
- A hole was observed in a screen cover of a plumbing penetration at the main roof of the building.

Hole in Penetration Screen Cover

1. Replace screen cover.

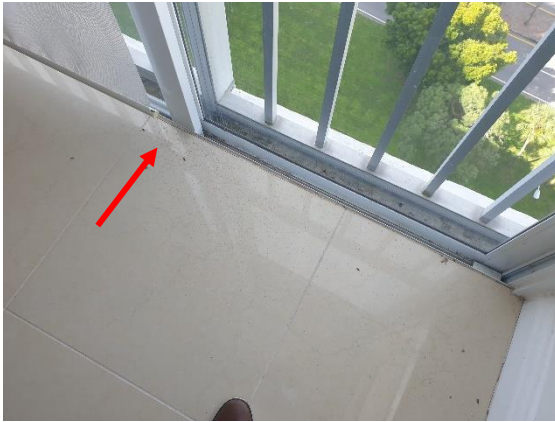
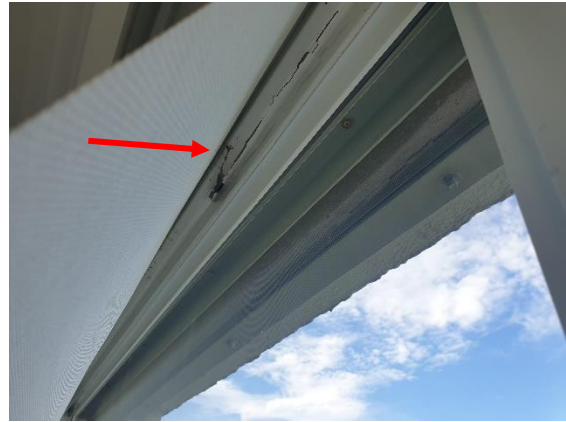
- Evidence of termites was observed inside the building at Unit 1601.
- Visible insects and areas of rotted and/or deteriorating wood were observed in the interior space of a unit.

*Termites Present in Unit*

*Wood Frame Showing Evidence of Termites*

1. TT recommends the building be inspected and the condition be treated by a pest control expert.
2. Remove and replace termite damaged wood bucking.
