2019 ROOF INSPECTION REPORT

Las Casas Contentas
8450 N. 59th Avenue
Glendale, Arizona 85302

July 10, 2019

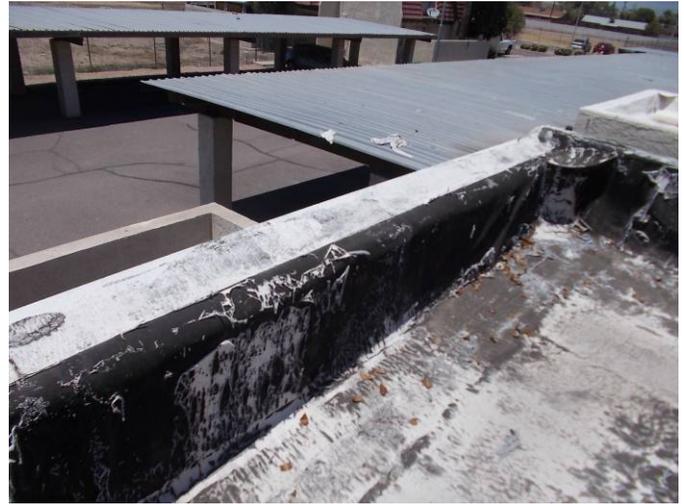
The coating on this BUR roof system has completely deteriorated.

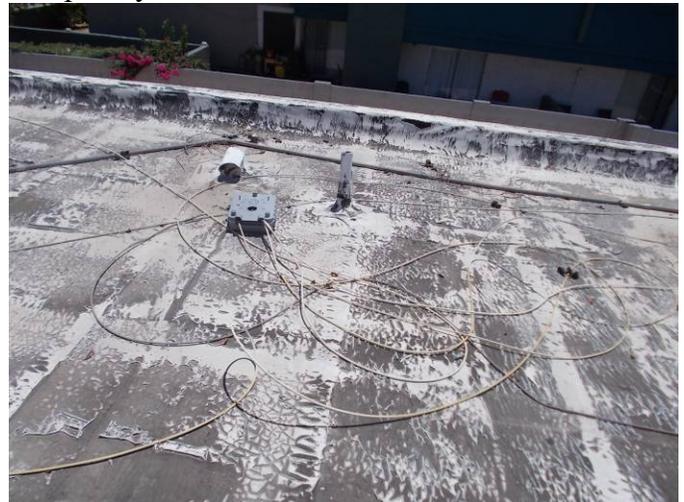
Numerous cracks and splits in the roofing membrane were found. Lots of debris on roof

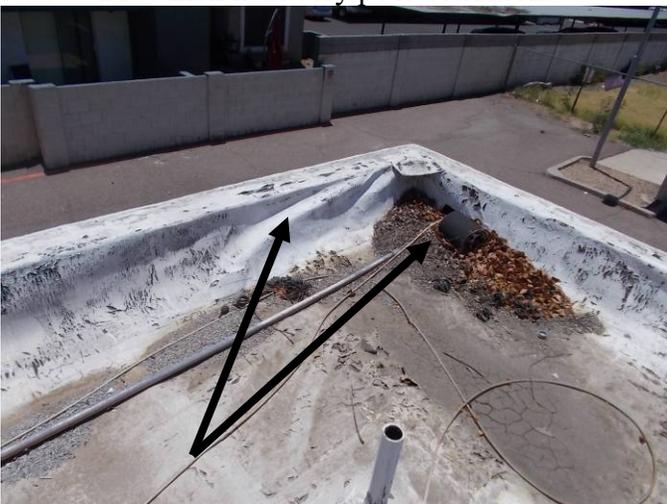
The PVC line is run through the scupper contributing to the debris build up which is impeding proper drainage. Wall flashing buckled.

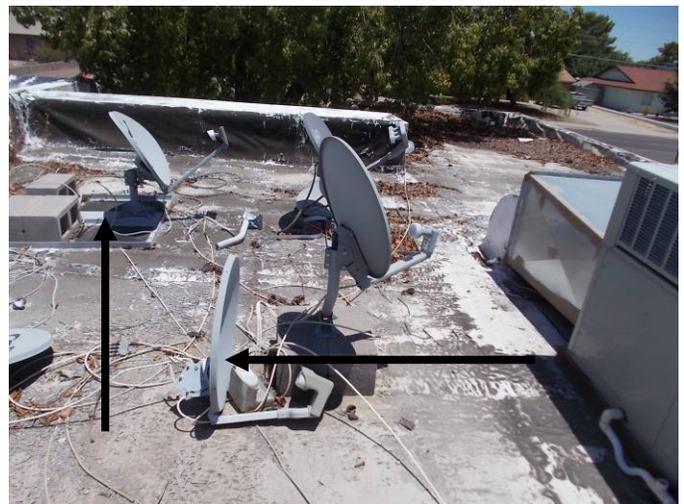
There are abandon TV dishes on this roof which present a puncture hazard to the roofing membrane. The dish mounts don't have slip sheets under them.

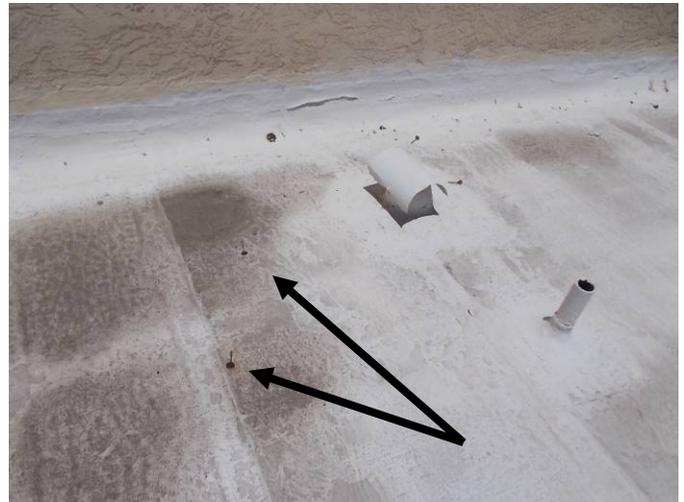
These are fasteners from previous work on the building that have been left on the roof and pose a puncture hazard to the roof system.

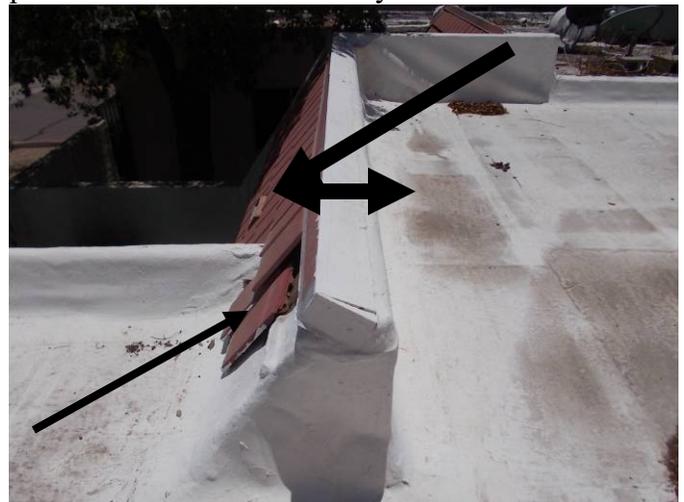
The tile on the tile mansard is missing and slipping. The scupper seen here coming from out the tile mansard has been roofed over inside the wall.

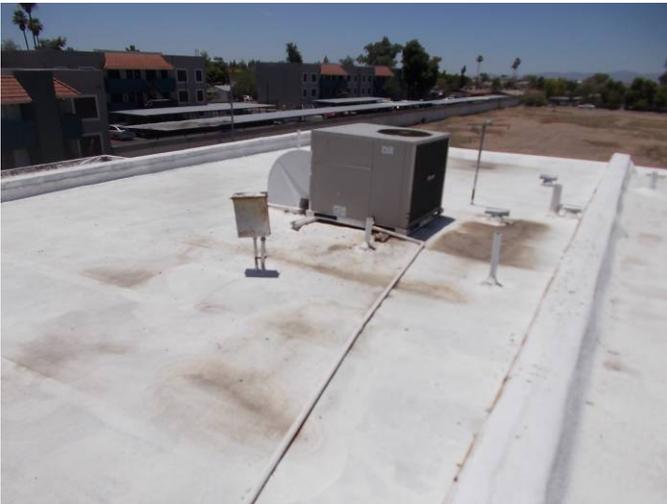
This is an overview of the BUR system which is in fair to poor condition on 8323 N. 59th Dr.

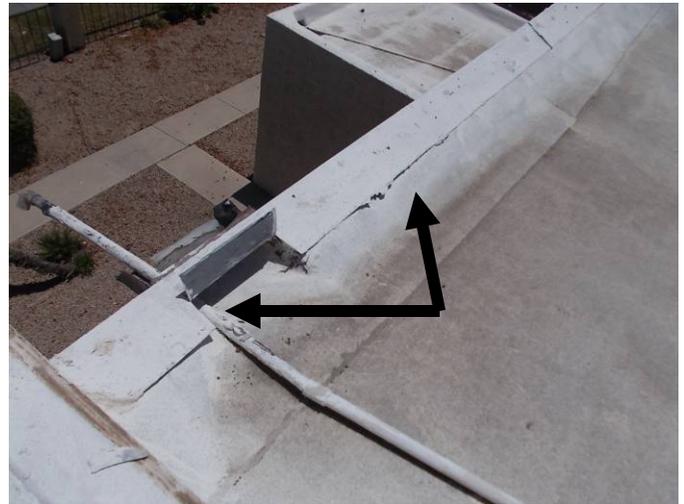
The PVC line should not be run through the scupper as it impedes the proper flow of water off the roof. Coping metal is pulling away from membrane & tile

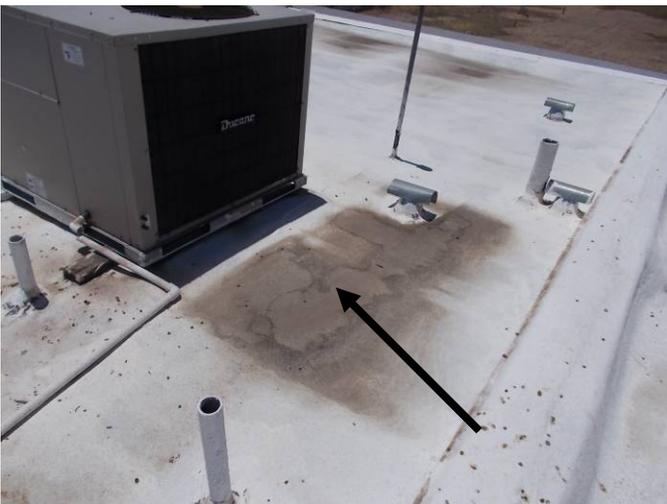
The coating is deteriorated and peeled away in this area due to water ponding.

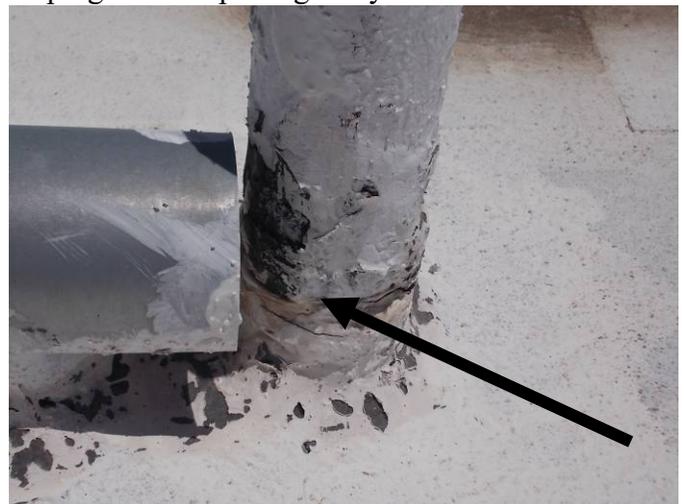
The seal around the pipe roof penetration is not watertight.

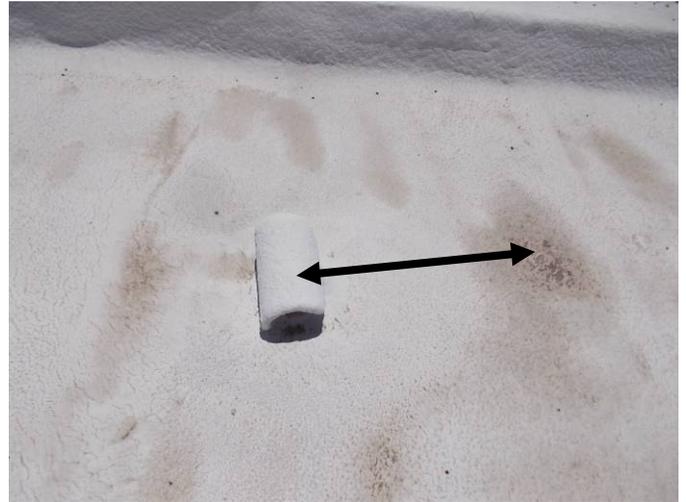
The t-top does not extend 8" above the roof deck as it should. Some ponding and coating deterioration taking place.

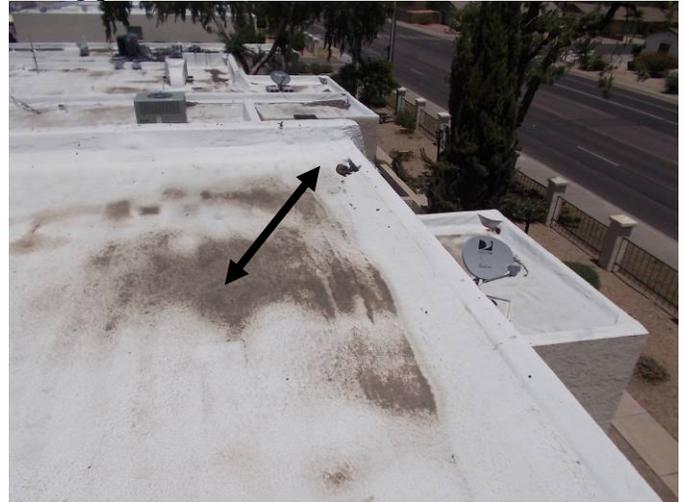
The east side of the roof deck ponds a considerable amount of water. Dead bird plugging scupper.

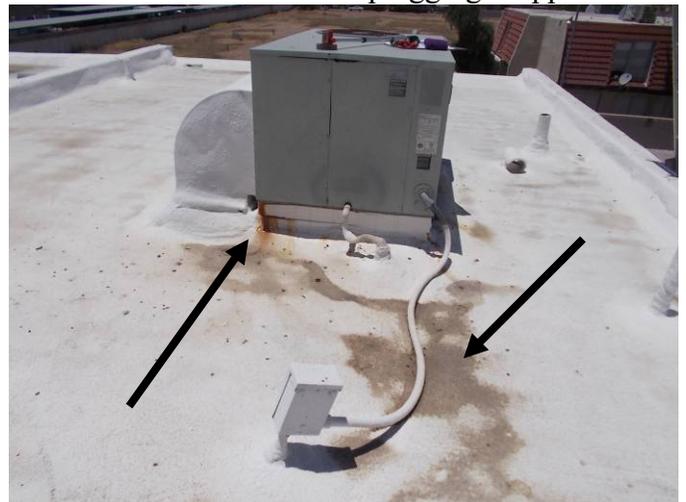
The rust from the malfunctioning HVAC condensate line is compromising the integrity of the roof coating. Ponding taking place.

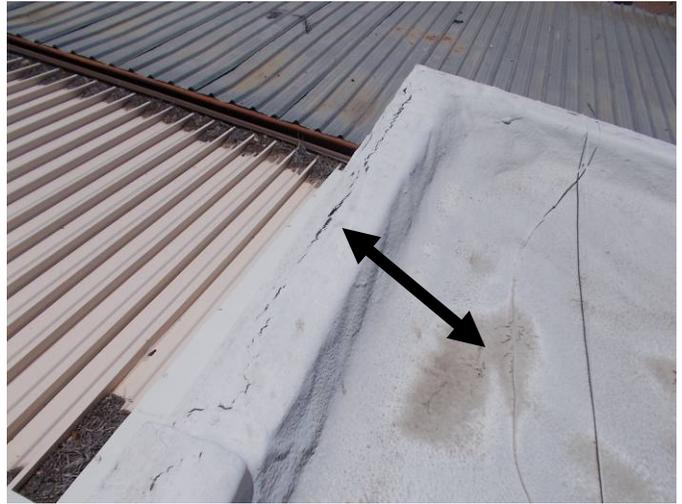
The top of the wall flashings are cracking and pulling apart. Cracking in deck coating.

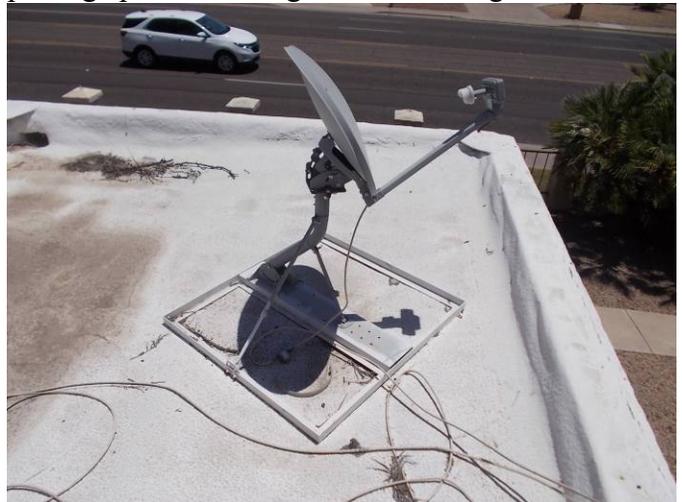
There are numerous areas which pond water on this deck. The TV dish mounting platform does not have a protective slip sheet under it posing a puncture risk to the roof system.

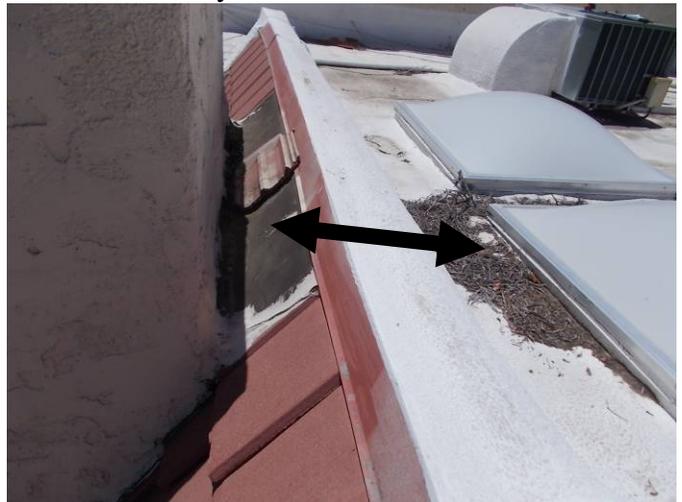
Debris built up by the skylights. The area behind the chimney on the mansard is missing tile.

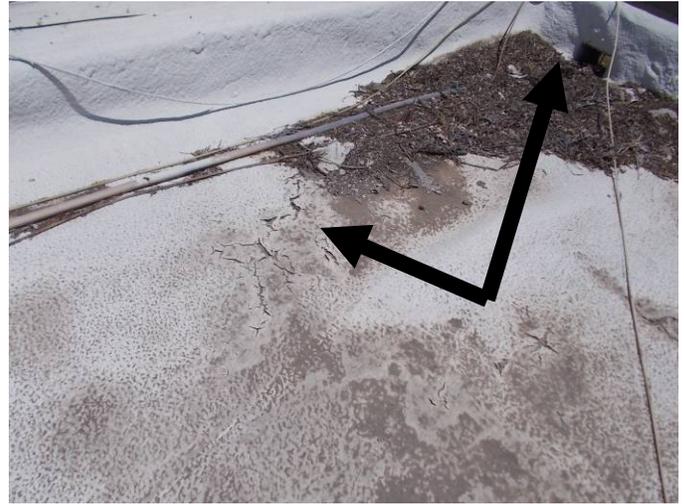
The PVC line is run through the scupper and is promoting debris build up and impeding water flow off the roof. Coating is cracked and peeling.

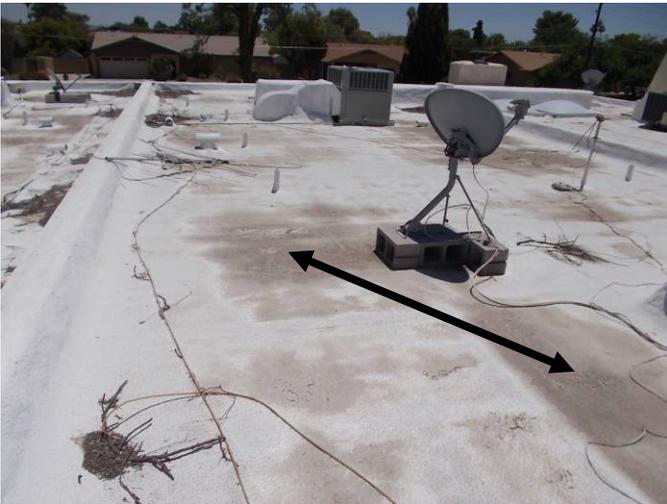
This is an overview of the foam roof system on 8335 N. 59th Dr. which is in poor condition. Considerable ponding occurring and debris build up

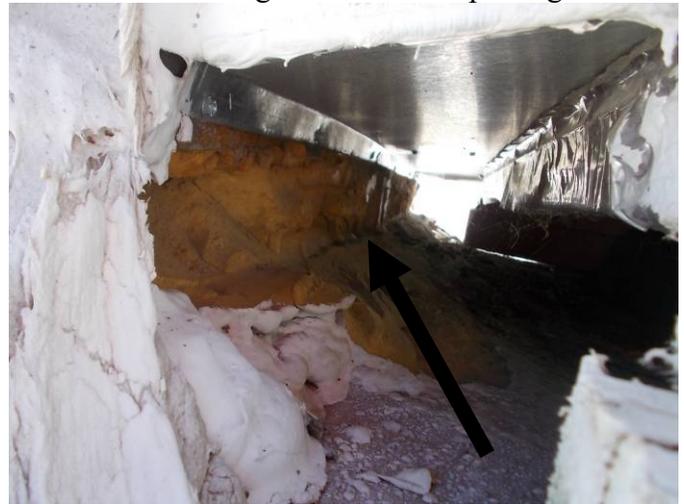
Underneath the HVAC unit at the duct work is not coated and not sealed in a watertight manner.

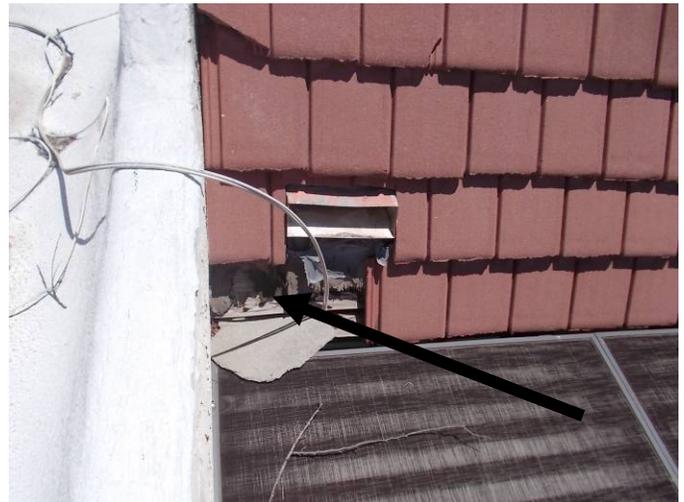
The area around the outside of the scupper on the tile mansard is not watertight. Decking is exposed.

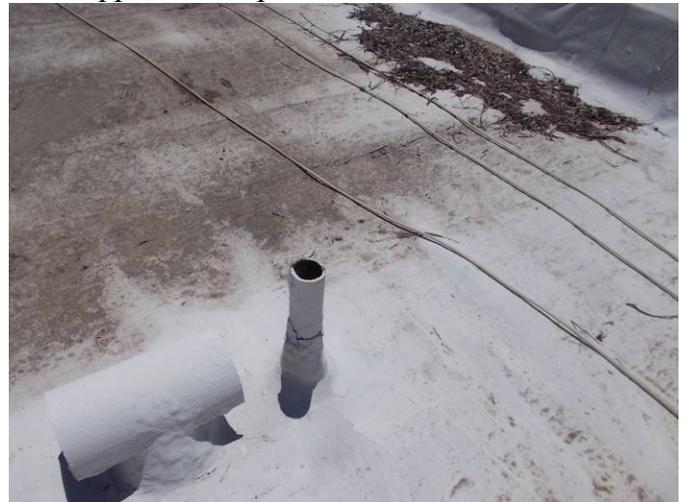
The seal around the pipe penetration has cracked apart and is not watertight.

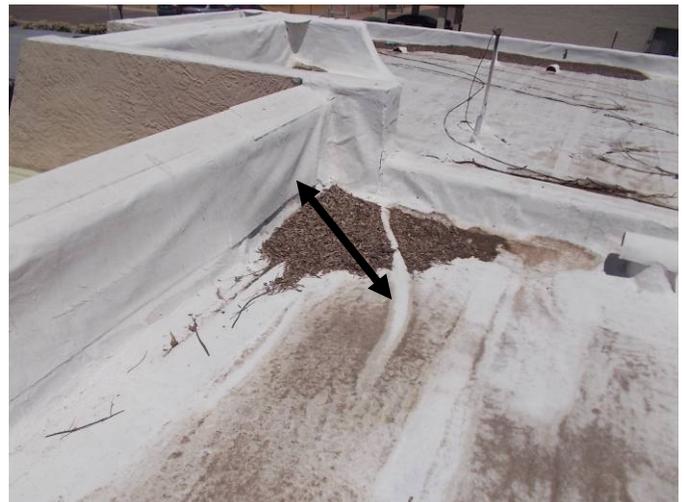
Severe ridging and buckling occurring in the field membrane as well as the wall flashings.

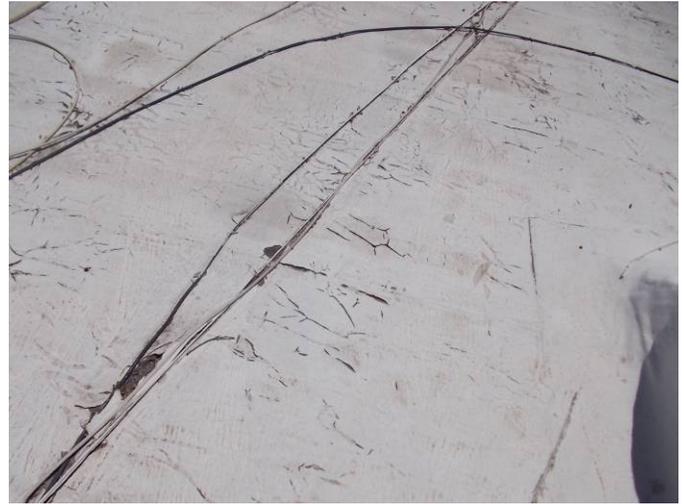
Numerous cracking and splitting of the coating and the roofing membranes which is susceptible to water penetration.

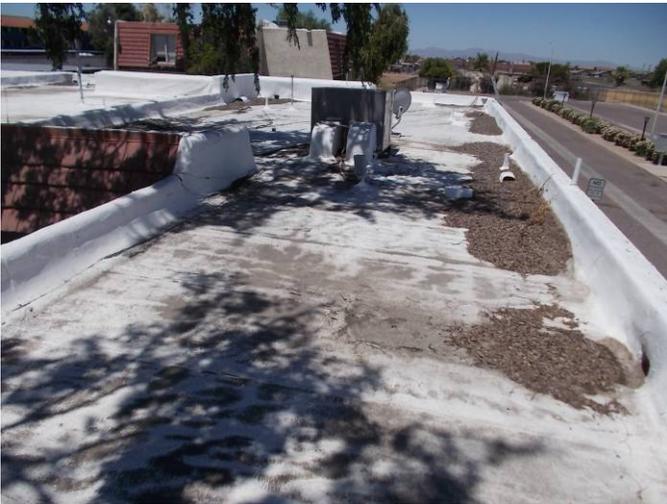
This is an overview of the BUR system on 8343 N. 59th Dr. which is in poor condition.

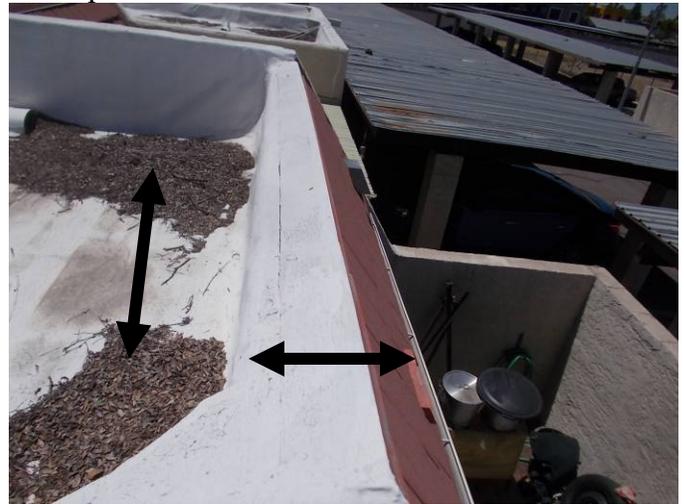
Excessive debris on this deck. Dormant scupper seen on tile mansard none on BUR deck.

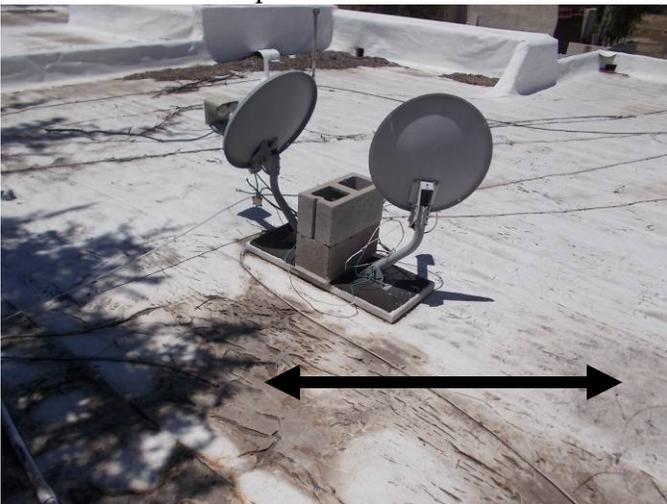
This area which ponds water has deteriorated coating which is no longer protecting the roofing membrane below it.

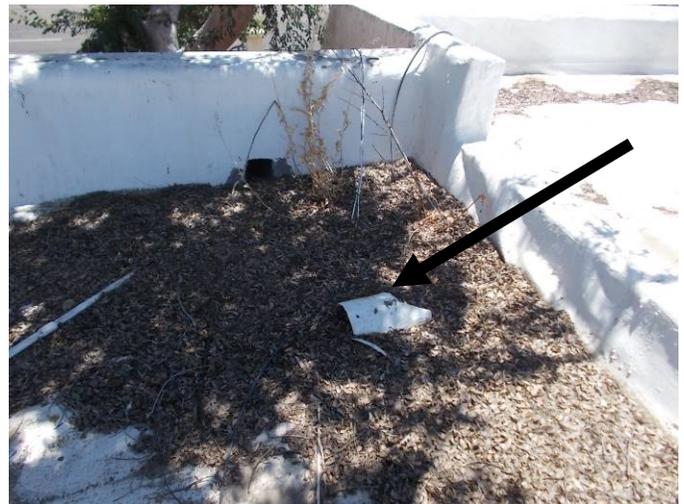
The debris has completely covered a t-top and water is not draining properly off the roof. Coating deterioration is accelerated.

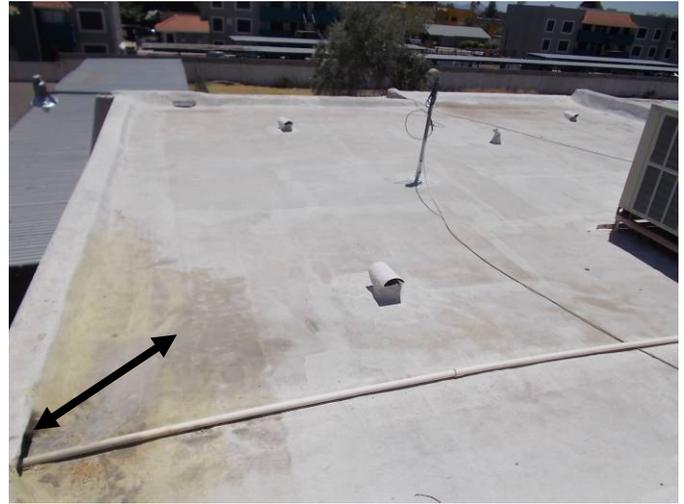
The coating is deteriorated due to ponding water near the parapet wall and scupper. The PVC through the scupper is impeding water flow.

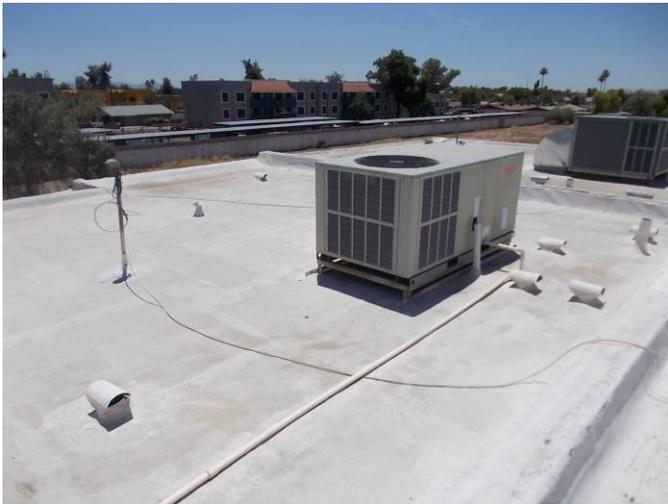
This is an overview of the BUR system on 8328 N. 59th Drive. It is in fair to poor condition.

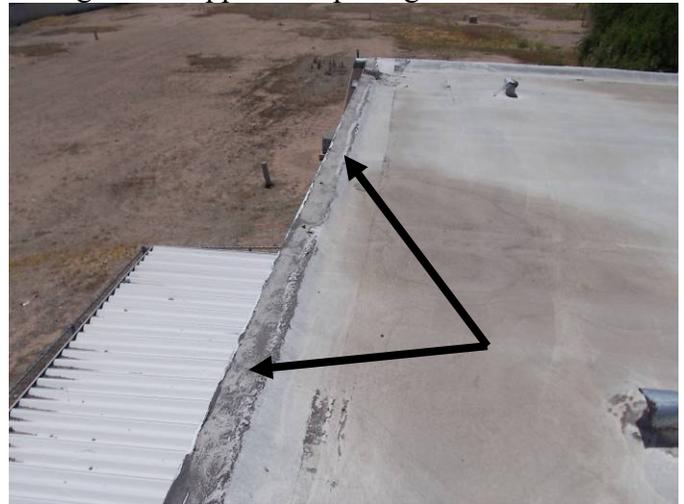
The coating at the top of the wall flashings have deteriorated and the seal along the wall is splitting.

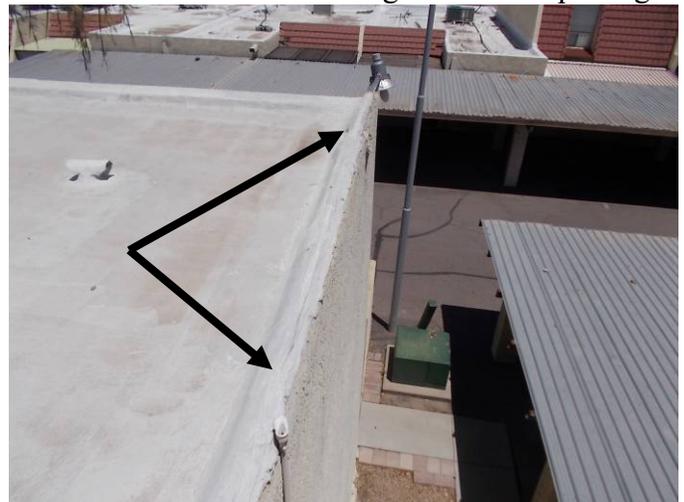
It is unacceptable to have the street light electrical conduit encapsulated by the roofing material.

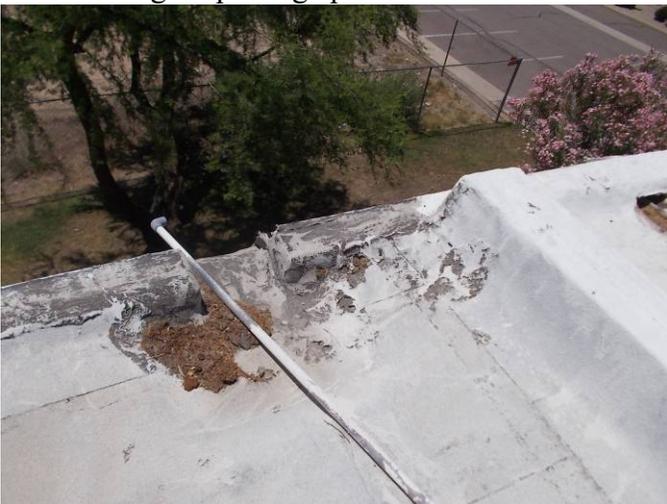
The PVC line is impeding the flow of water off the roof and contributing to debris build up and deterioration of the coating.

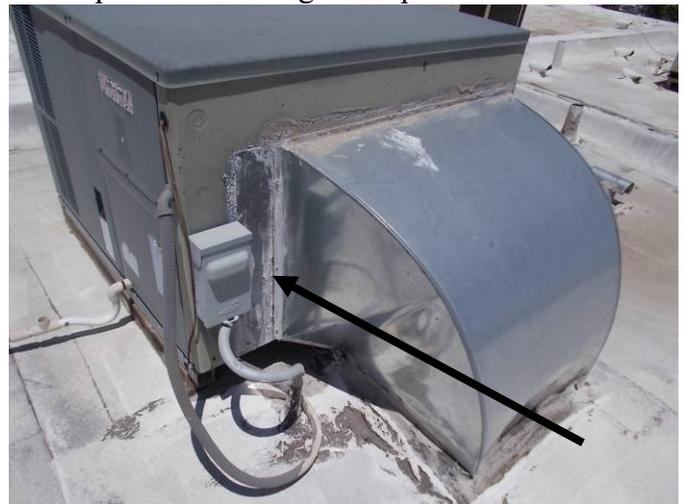
The seal at the duct work/HVAC unit joint is not sealed in a watertight manner.

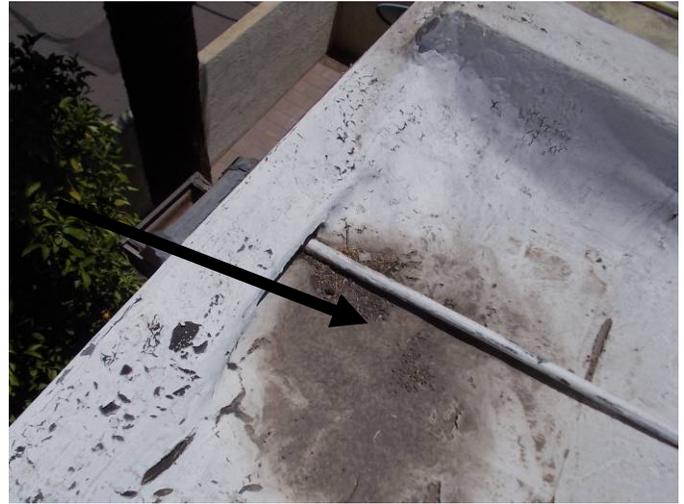
Ponding water in front of the scupper partially caused by PVC line in scupper. Coating deteriorated.

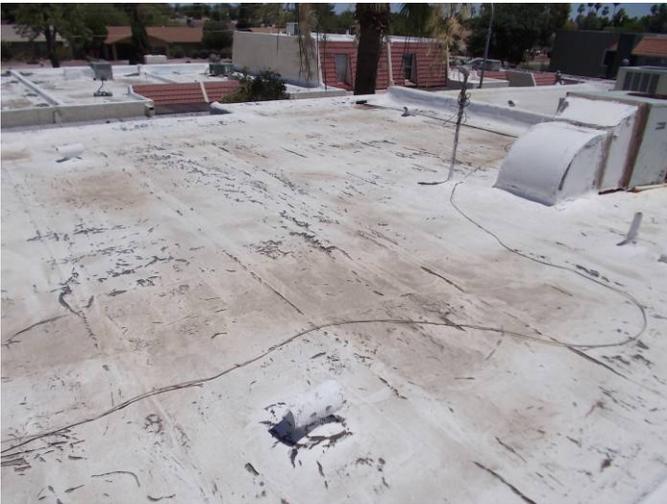
This is an overview of the Modified Bitumen roof system on 8336 N. 59th Dr and it is in very poor condition.

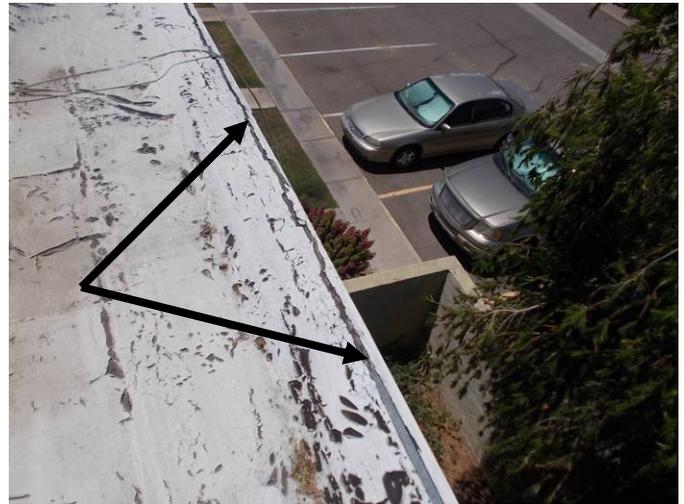
The roofing membrane is separating from the edge metal and is susceptible to water penetration.

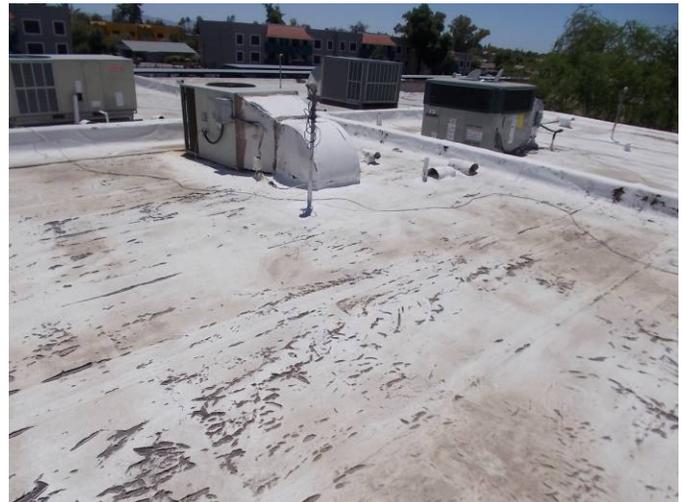
Substantial splitting and cracking of coating and roofing membrane occurring.

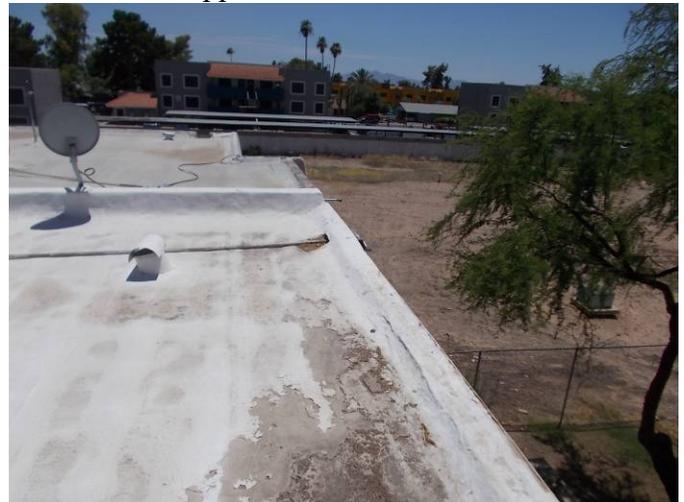
The coating has peeled away and deteriorated due to ponding water. The PVC line is run through the scupper and is impeding water flow.

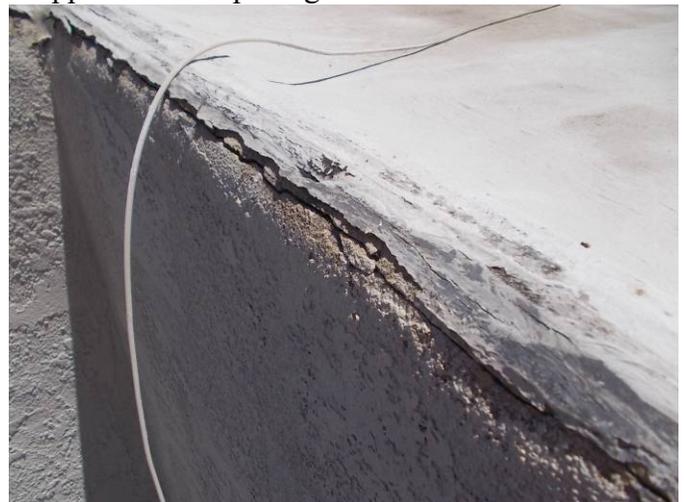
The top of the parapet wall on the north side is cracked wide open and allowing water penetration.

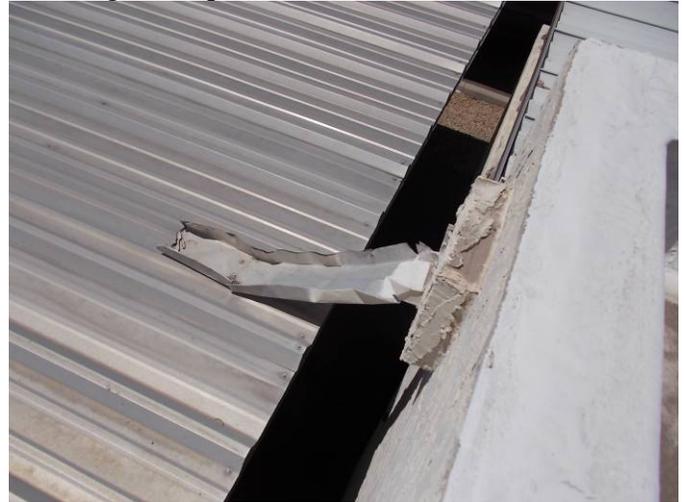
A make shift scupper extension has been installed on the west end. The exterior stucco pop-out is cracked open and susceptible to water penetration.

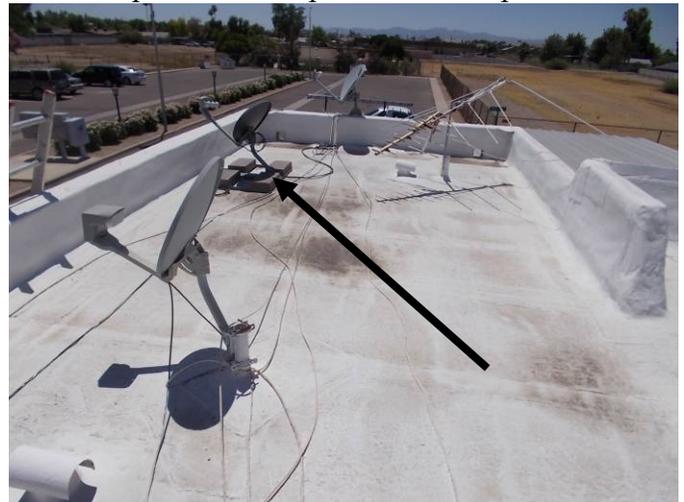
There is an excessive amount of TV dishes on this deck and there is no protective slip sheets used.

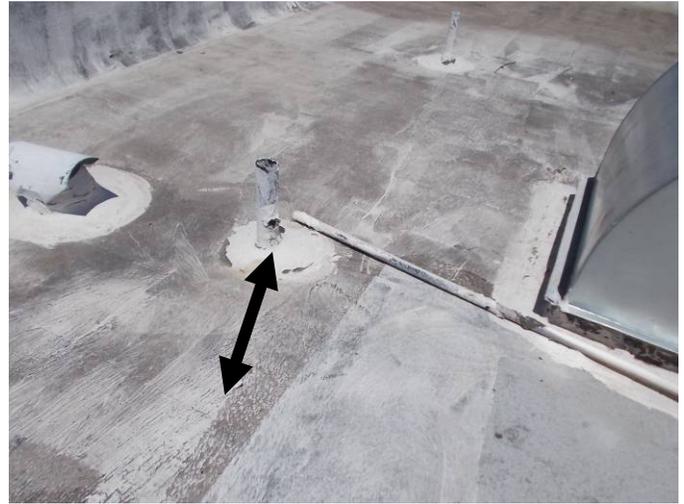
There is a hole in the side of the pipe penetration and is allowing water to leak. Roofing membrane coating is alligatoring.

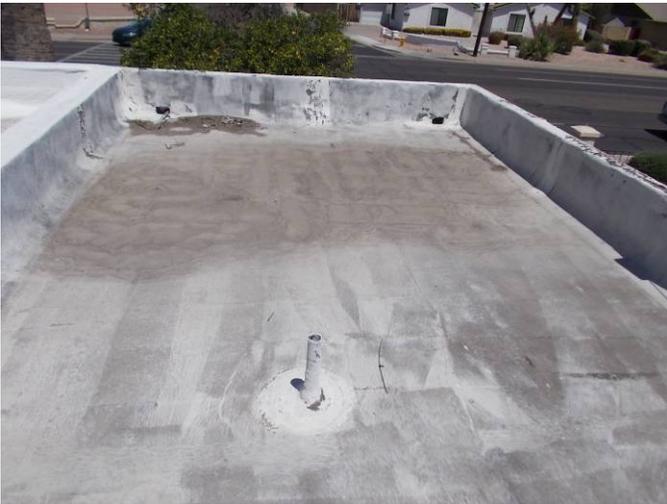
This is an overview of a single BUR system on 8405 N. 59th Drive. It is in poor condition.

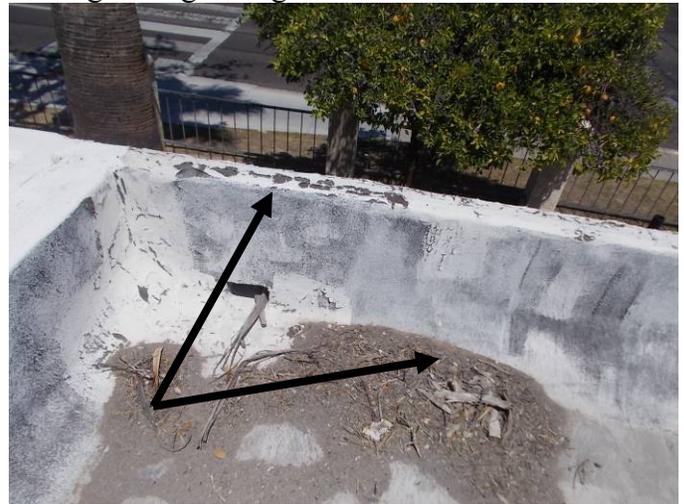
Water is ponding in area of scupper and debris is built up as well. Top of wall flashings failing.

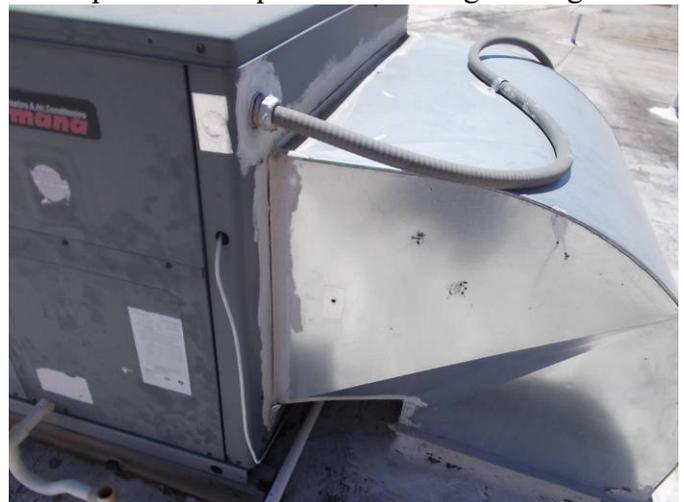
The joint between the duct and the HVAC unit is not sealed in a watertight condition and is allowing water to penetrate.

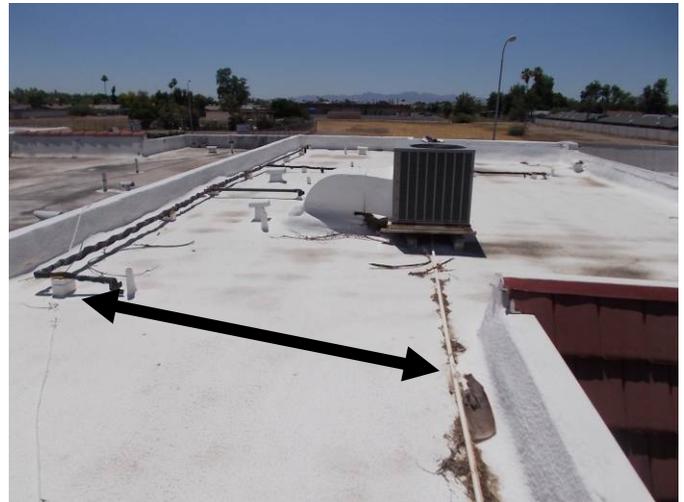
No blocks under PVC. Blocks under other pipes but no protective slip sheet under blocks. Blocks keep the pipes off the roof for free flow of water.

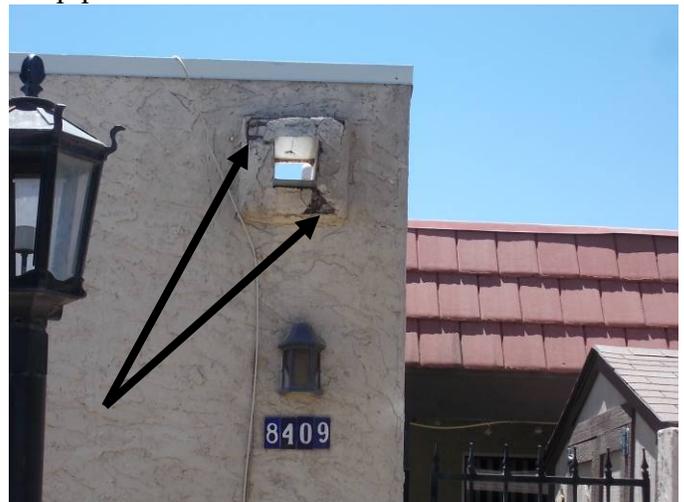
The stucco pop-out around the scupper is cracked and not watertight, thus allowing water penetration.

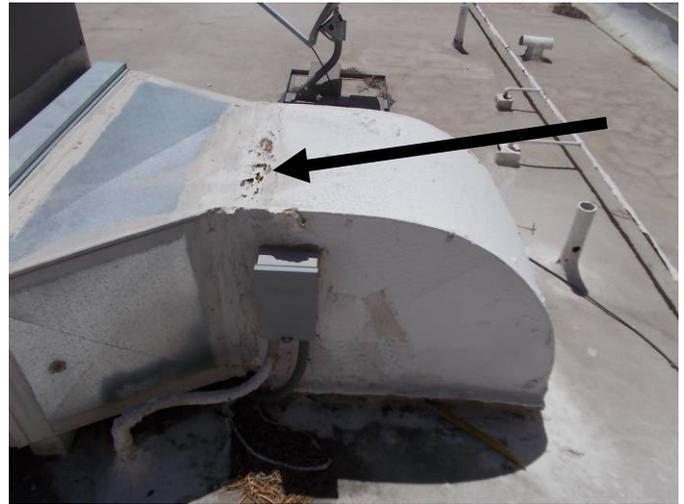
The joint between the duct and the HVAC unit is not sealed in a watertight condition and is allowing water to penetrate.

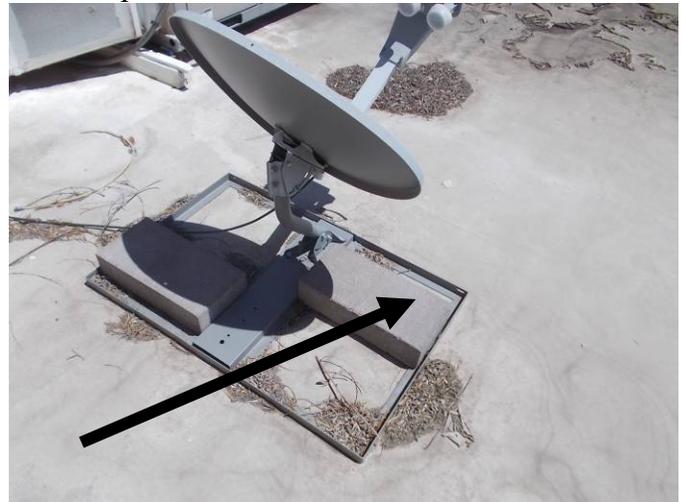
The TV dish mounting stand does not have a protective slip sheet under it which poses a puncture risk to the system.

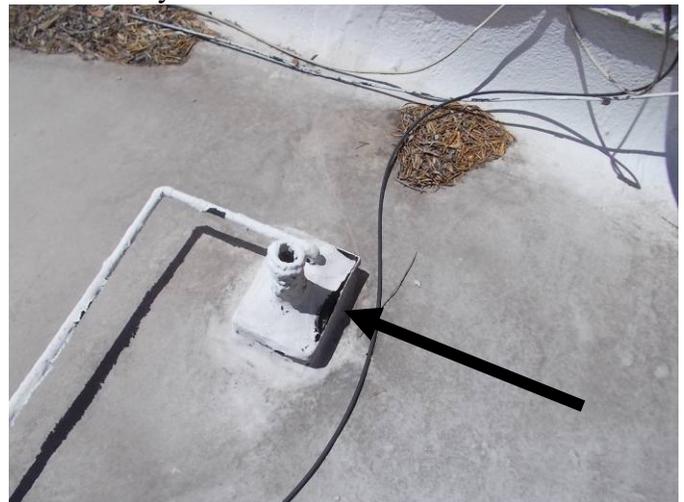
The pitch pan is not in a watertight condition and is susceptible to water penetration.

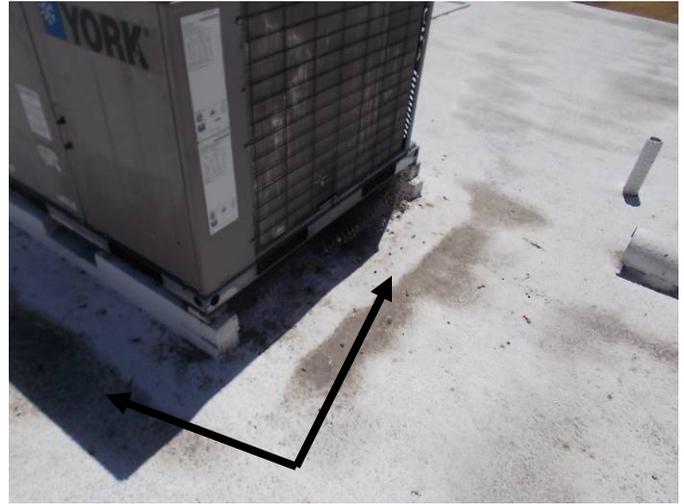
The coating in the area of the HVAC unit is deteriorating.

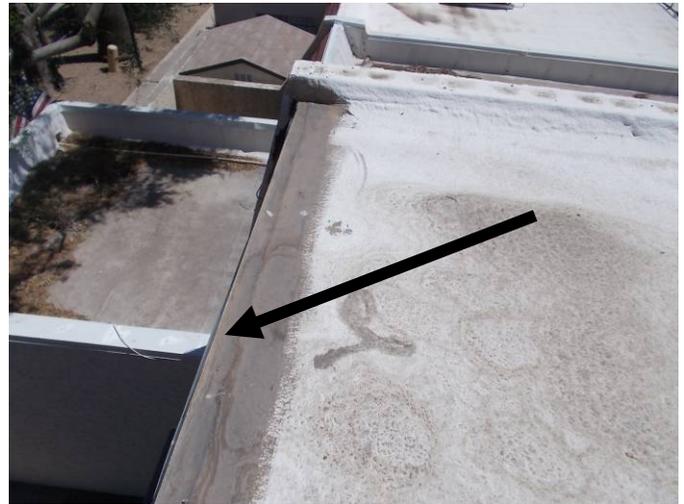
There has been a repair performed along the edge metal with materials that are not compatible with foam. The repairs is starting to fail and damage roof

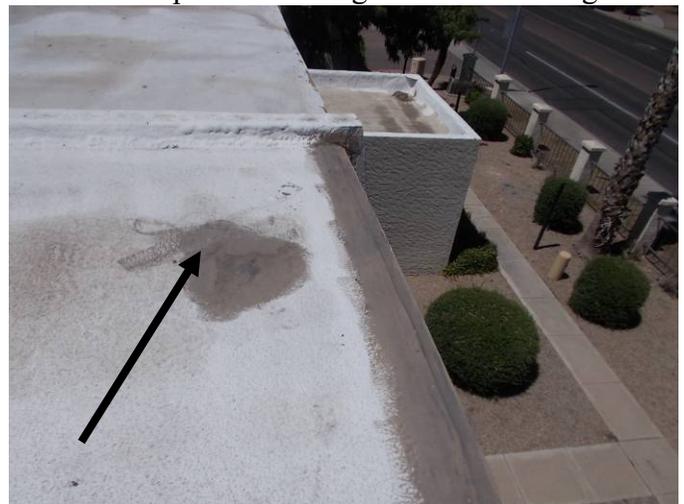
This is another area that was repaired with materials incompatible with foam.

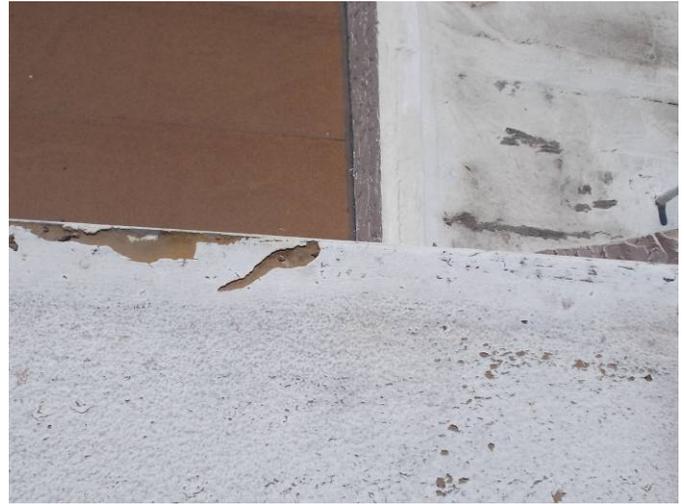
The foam is exposed and cracked along the metal edge and susceptible to water penetration.

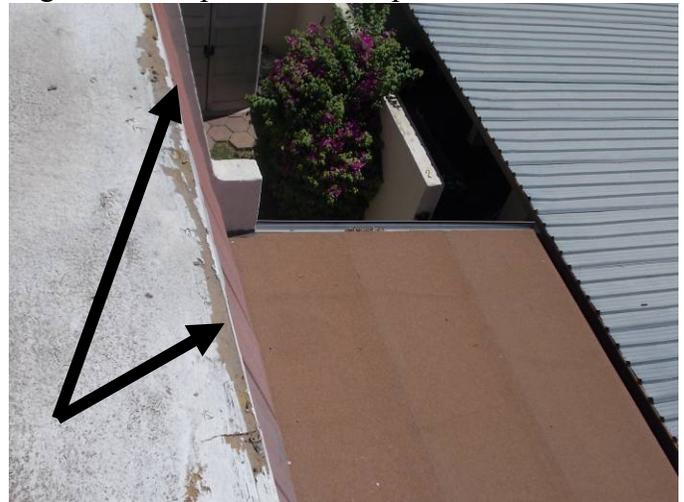
The roof has deteriorated along the metal edge and is allowing water penetration.

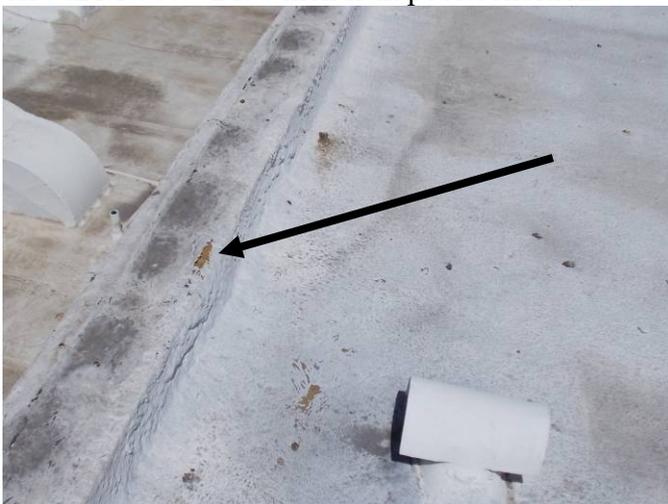
The coating is deteriorated to the point where the foam is exposed to UV rays which will accelerate the deterioration of the roof system.

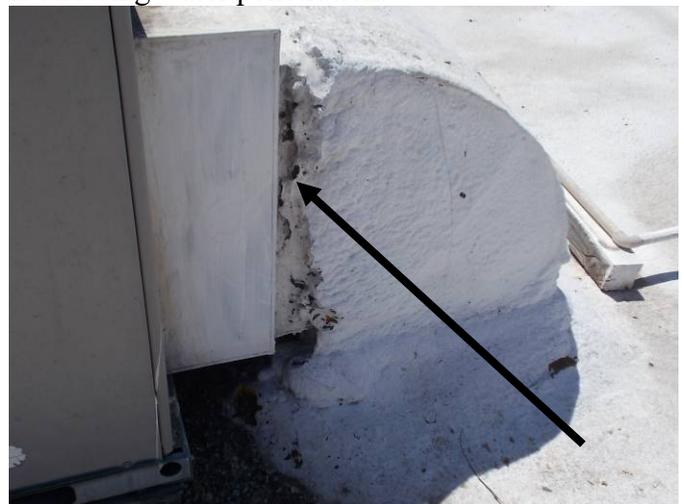
The joint between the duct and the HVAC unit is not sealed in a watertight condition and is allowing water to penetrate.

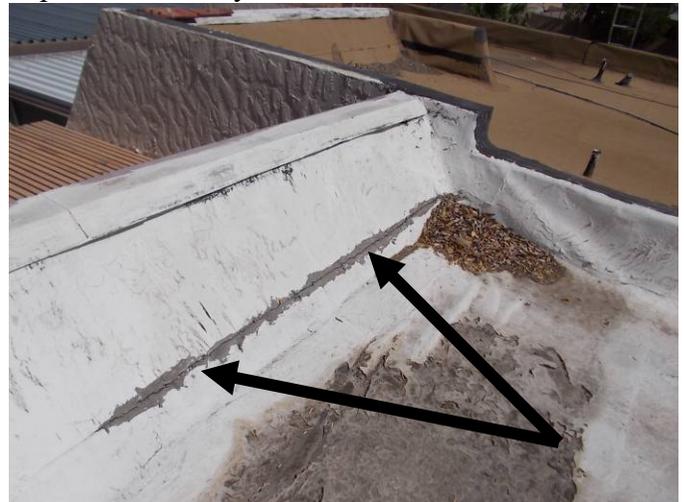
The wall flashings have split apart and separated. The repair that was attempted has failed.

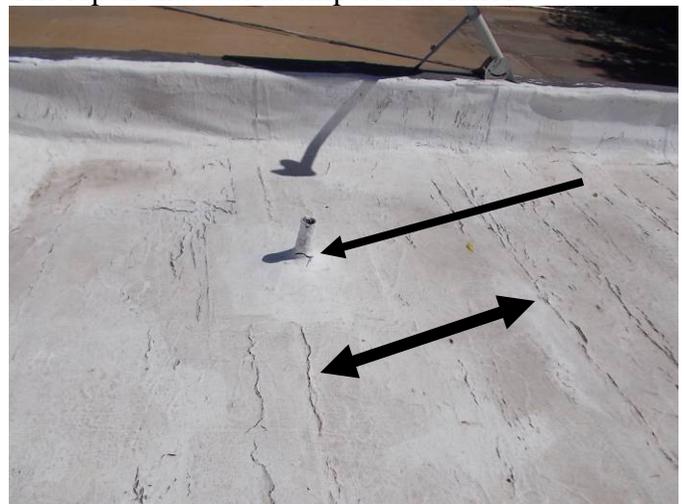
The seal around the pipe penetration is not watertight. The roofing membrane is splitting apart.

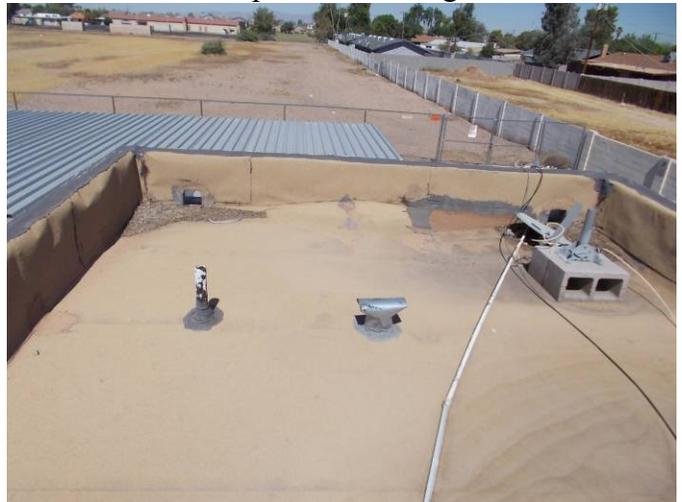
The seals around the roof penetrations are not watertight. The wall flashing has been repaired around the scupper and abandon TV dish debris is blocking water flow to the scupper.

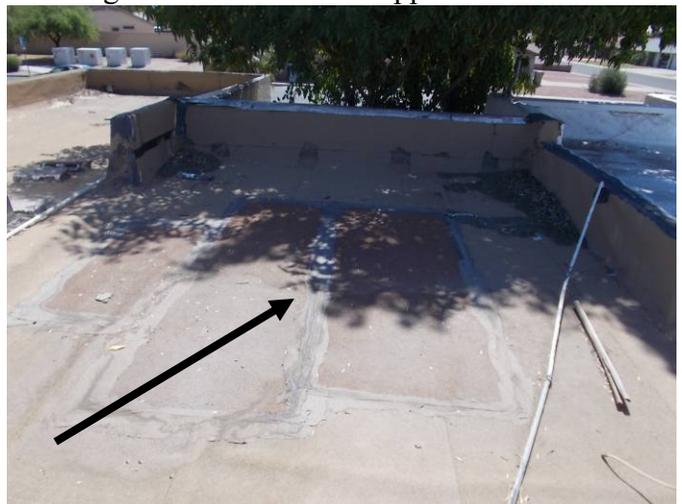
A large area on this roof deck has been repaired and the repair is showing signs of failing.
