# Joint Services Wiring Action Group

Primary Support Clamp

Deformation

Date: 01 JUL 24

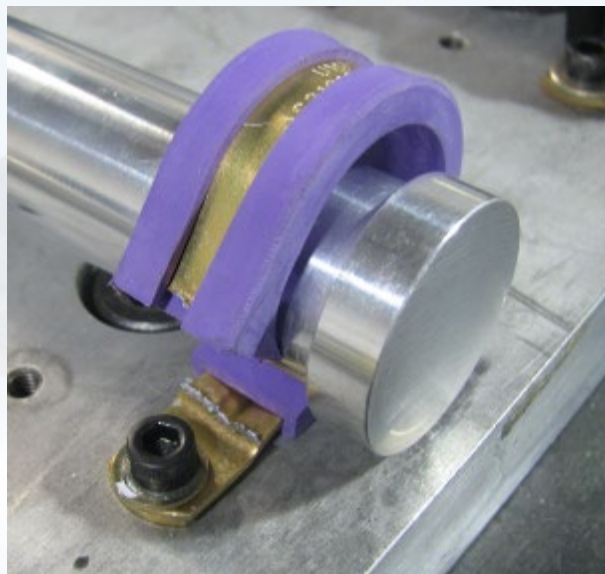
- NAVAIR conducted clamp testing in 2013:
  - Due to the AS21919 Clamp not having performance requirements for qualification
    - This led to establishing the baseline vibration requirement for the AS23190/4 clamp as well as the MIL-DTL-85052/6-11 clamps
  - Failures identified were fractures of the metallic band.
  - Failure location on every clamp was in transitional region of band between foot of fastener location and loop.
