# C5 Horizontal Stabilizer EWIS Analysis, AWT Testing, and Physical Audit

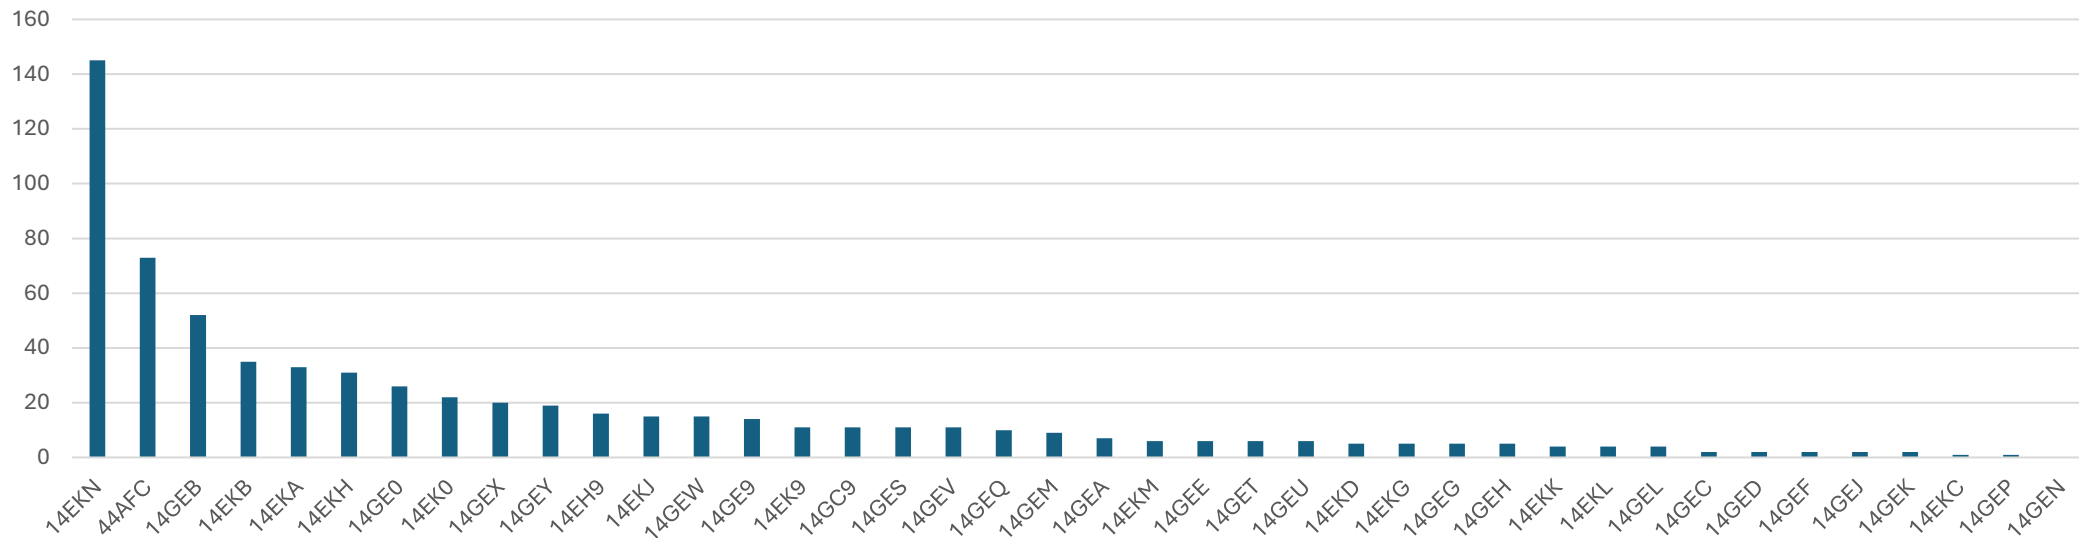
C-5 Pitch EWIS Failures 2017-2025

- Pitch Trim System Wiring and Connectors (14GEW) and Stabilizer Trim Position Indicator (14GEX) lead write ups
- Total Maintenance Manhours: 2,873
- While write ups have decreased over Study period, reliability is decreasing as well

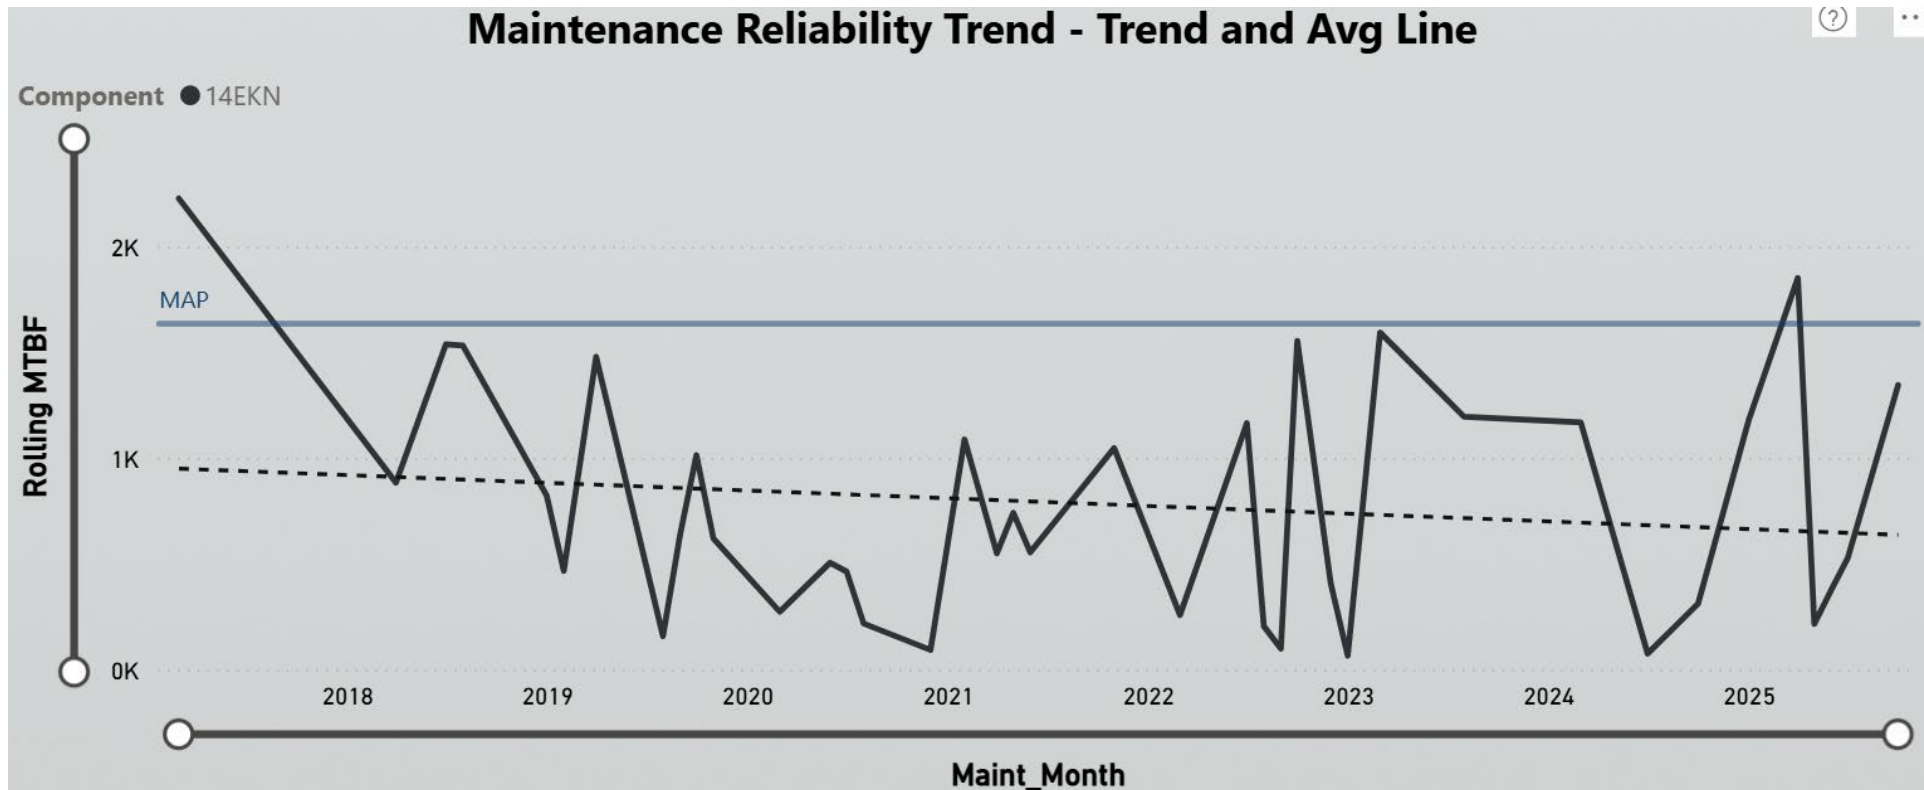
## 14EKN – Elevator Control Wiring and Connectors

- Elevator Control Wiring Reliability shows steady decreasing trend (dotted line) across study period
- Consistently fails our Minimal Acceptable Performance (MAP) level as shown by solid blue line

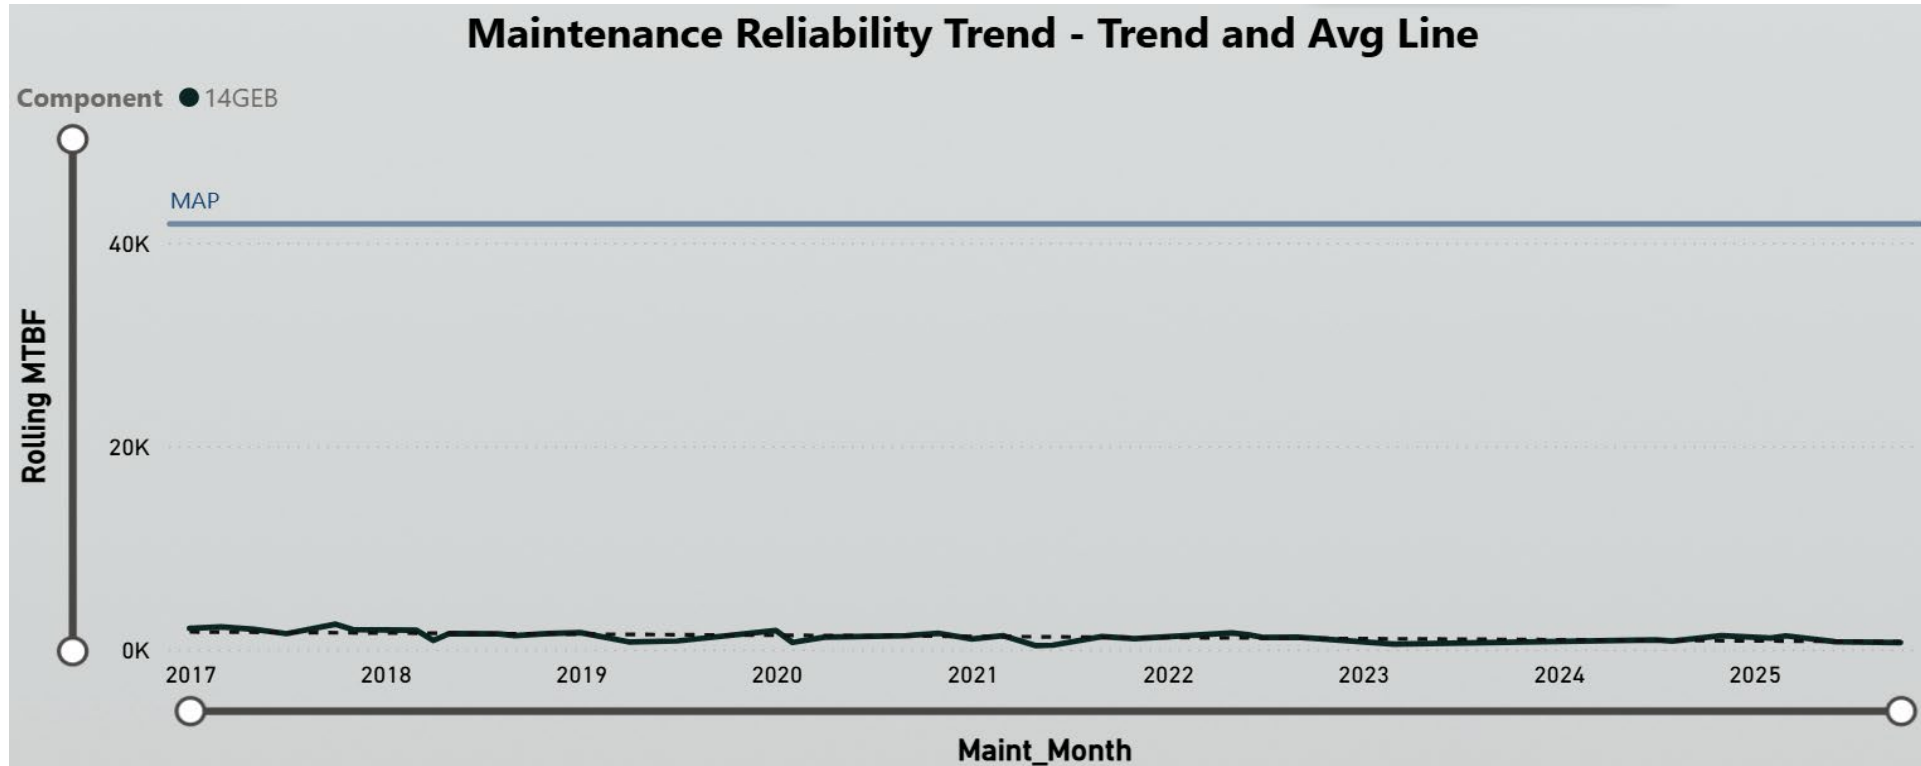
## 14GEB – Stab Trim Position Transmitter

- Stab Trim Position Transmitter significantly below target set by SPO

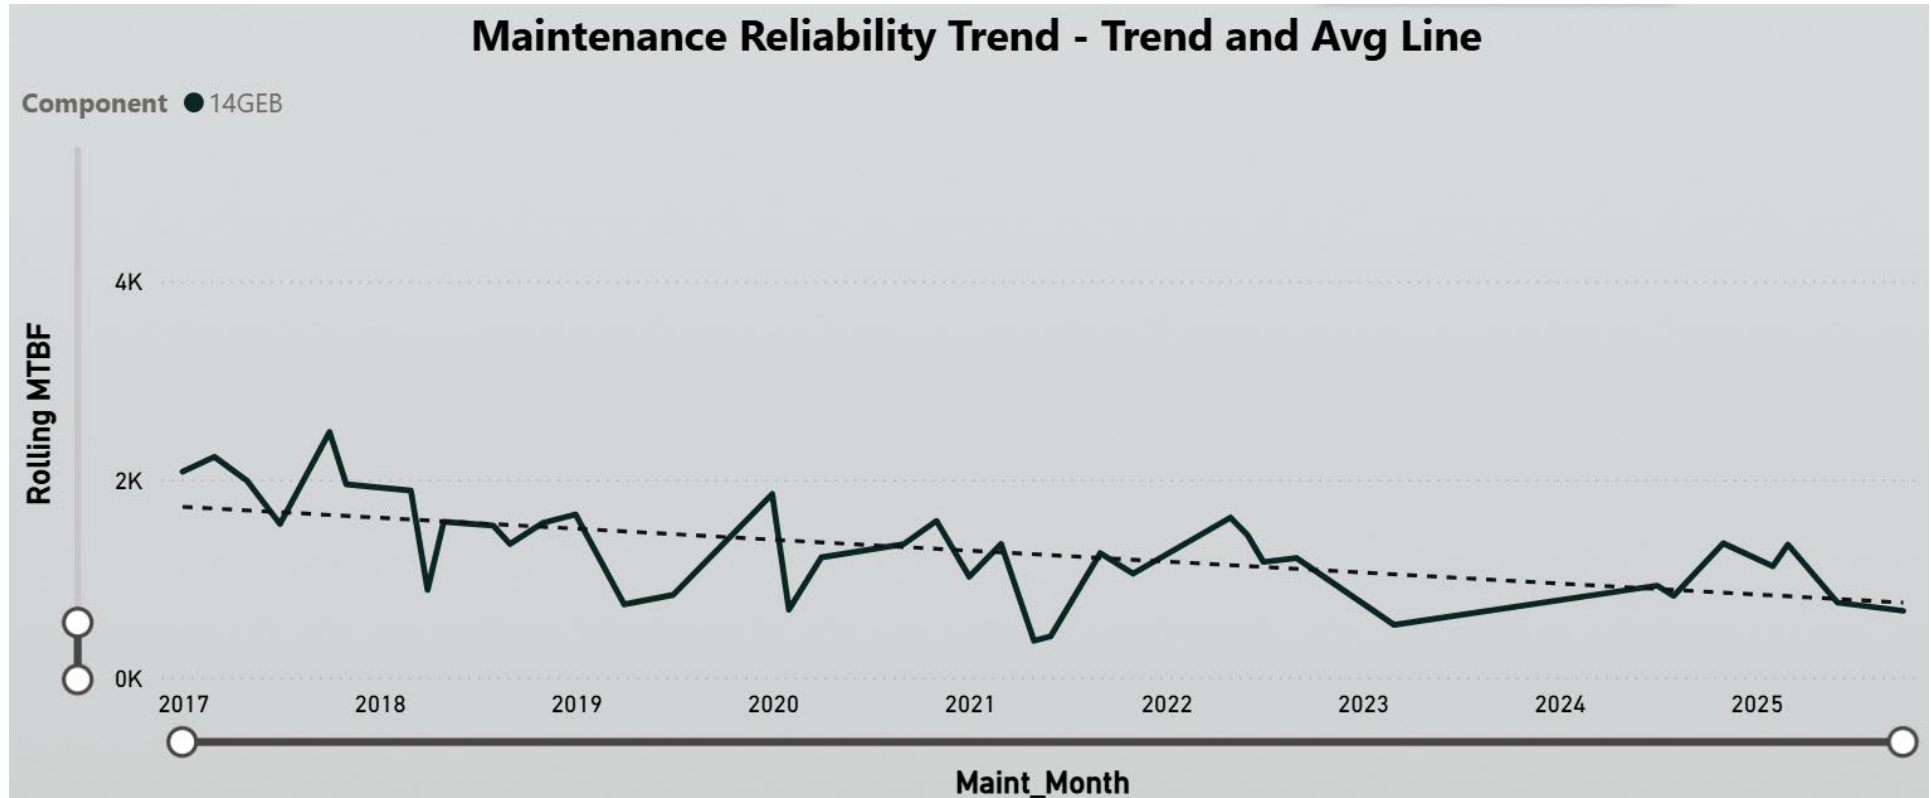
## 14GEB – Stab Trim Position Transmitter

- Stab Trim Position Transmitter significantly below target set by SPO study in 2020
- Steadily decreasing reliability

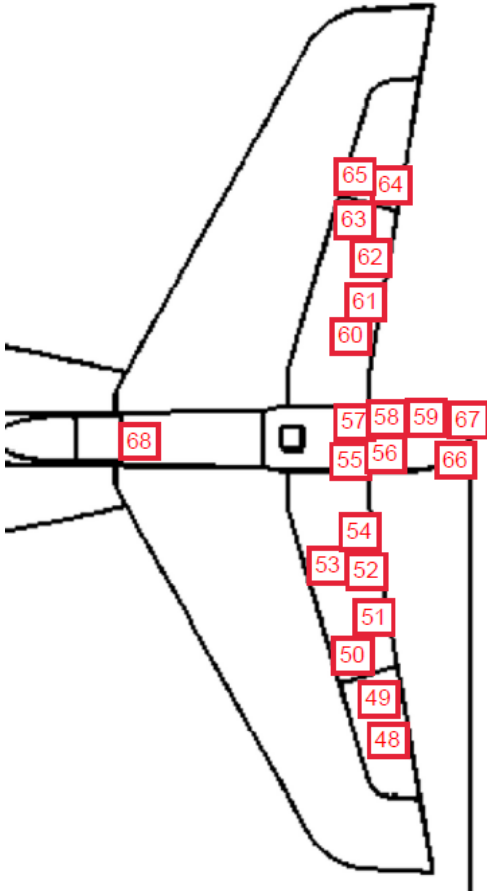
- 21 findings were attributed to the Horizontal Stabilizer of Tail 3
- Common findings were improper splices, Corrosion, brittle wiring, damaged insulation
- Cannon plugs connecting Horizontal Stab to Vertical Stab showed particularly bad corrosion, evidence of water submersion
- AWTs Test finding corresponded to audit findings

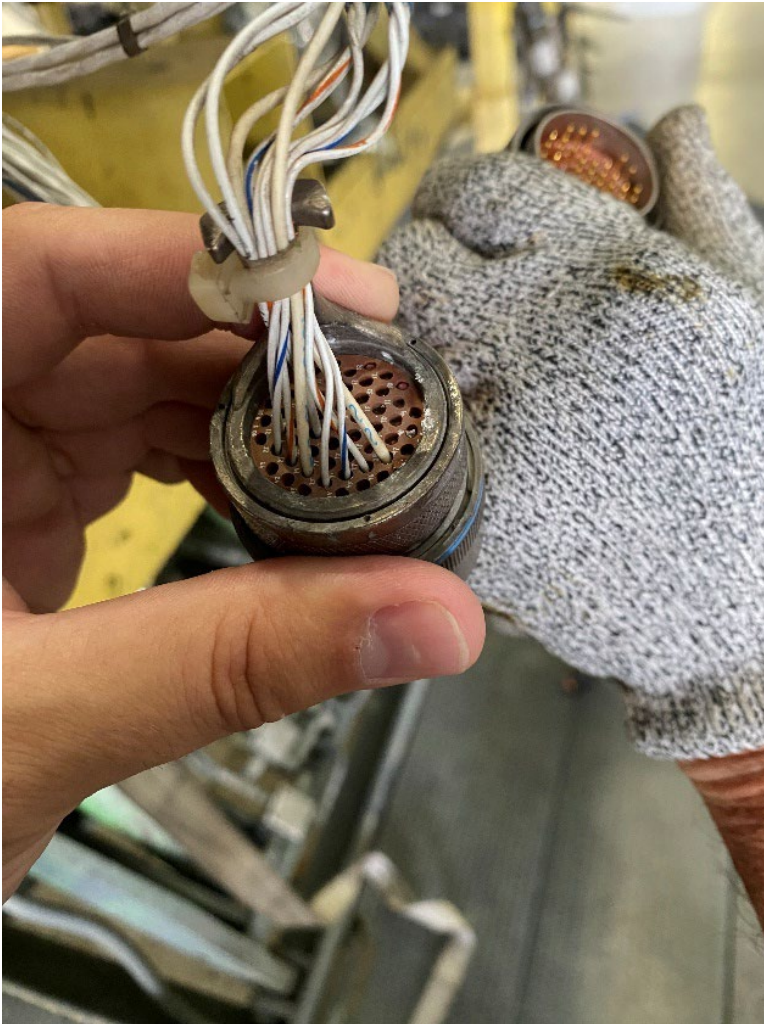
# Horizontal Stabilizer AWTs Test Data Tail 3 Physical Audit HS Discrep. #66

- Connector P20AS (Central connector)
- Shows heavy corrosion, signs of water submersion
- This finding corroborates results from AWTs Tests

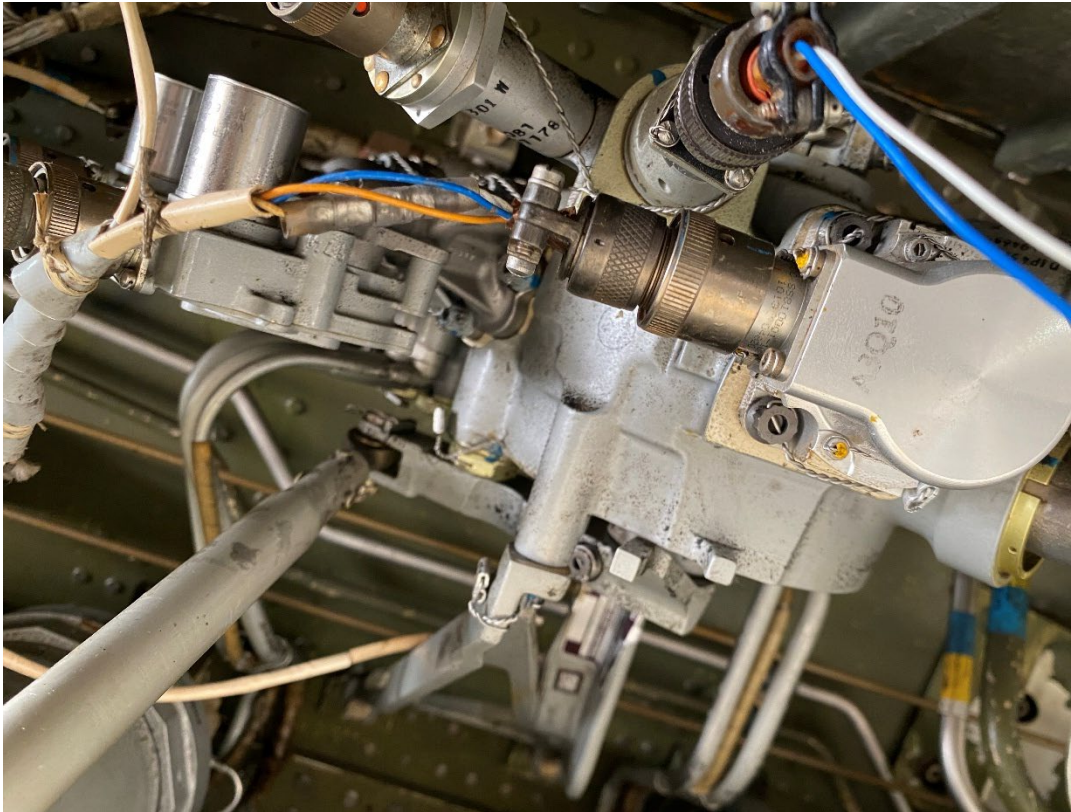
Discrepancy 52 – incorrect splice  
and torn insulation

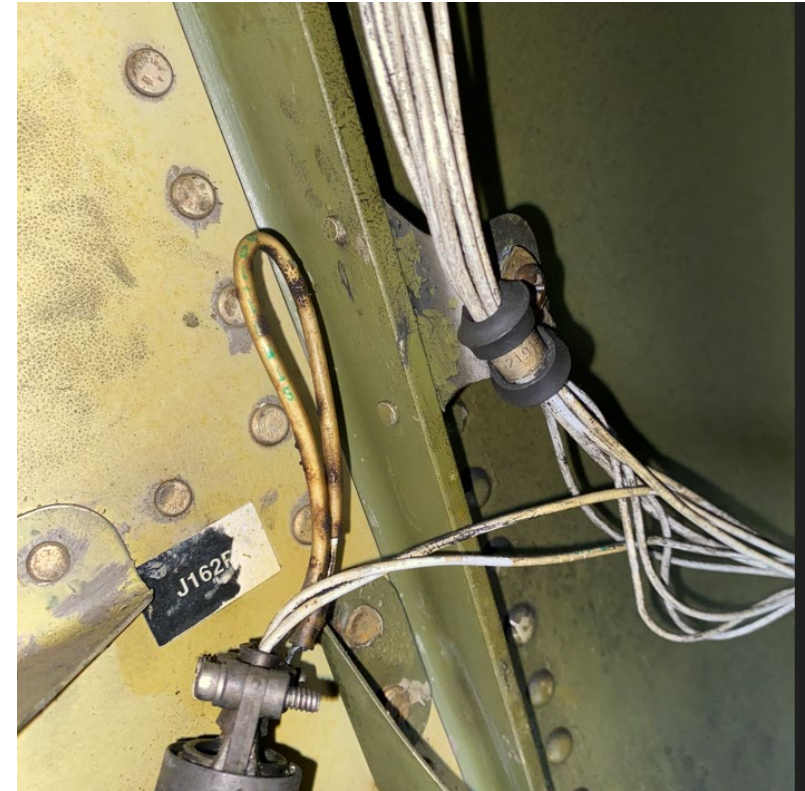
Discrepancy 32 – Extremely  
Severe cable bend could lead to  
premature conductor damage
