# C5 Stability Augmentation Subsystem Reliability Analysis, AWTs Testing, and Physical Audit

Joseph Ronca  
SR Database Engineer | WSIRD Team Lead  
Kihomac INC  
[Joseph.ronca.ctr@us.af.mil](mailto:Joseph.ronca.ctr@us.af.mil)  
[Joseph.ronca@kihomac.com](mailto:Joseph.ronca@kihomac.com)

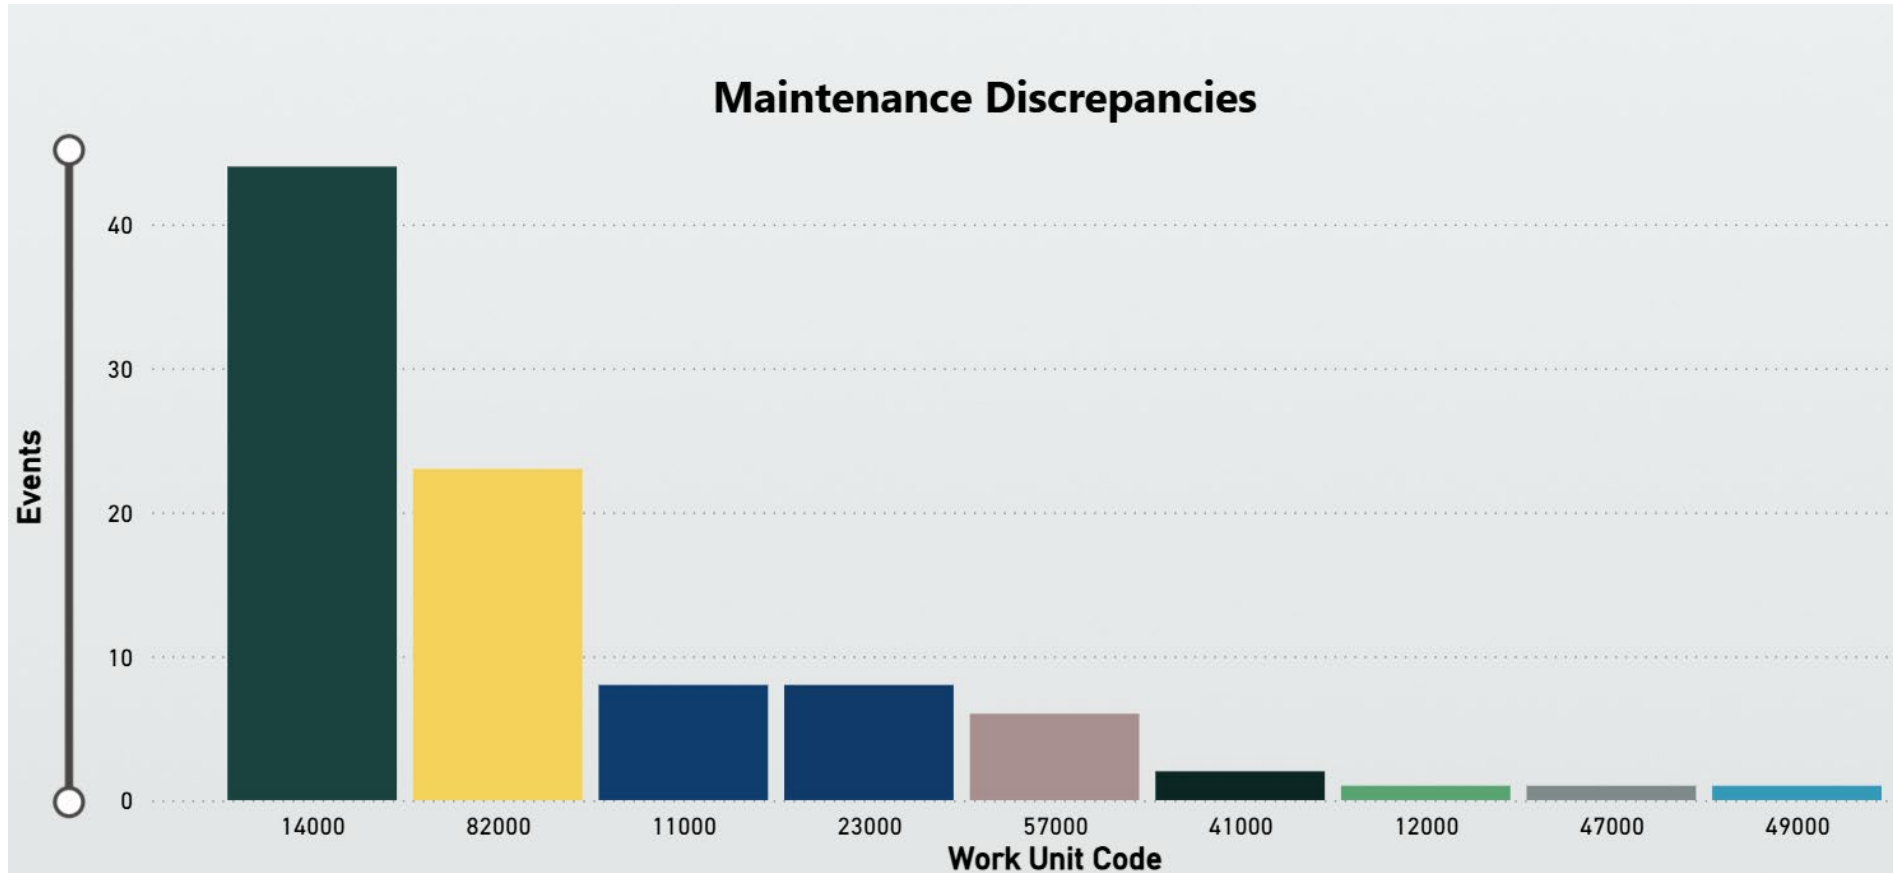
# “Uncommanded Yaw”

432 Man hours, 11 Distinct JCN's, 33 Distinct Work Unit Codes.

6 Tails effected, 60% of write-up against a single tail (Shut-off Valves, Bypass Valves, LVDT's, VIA's R2'ed)

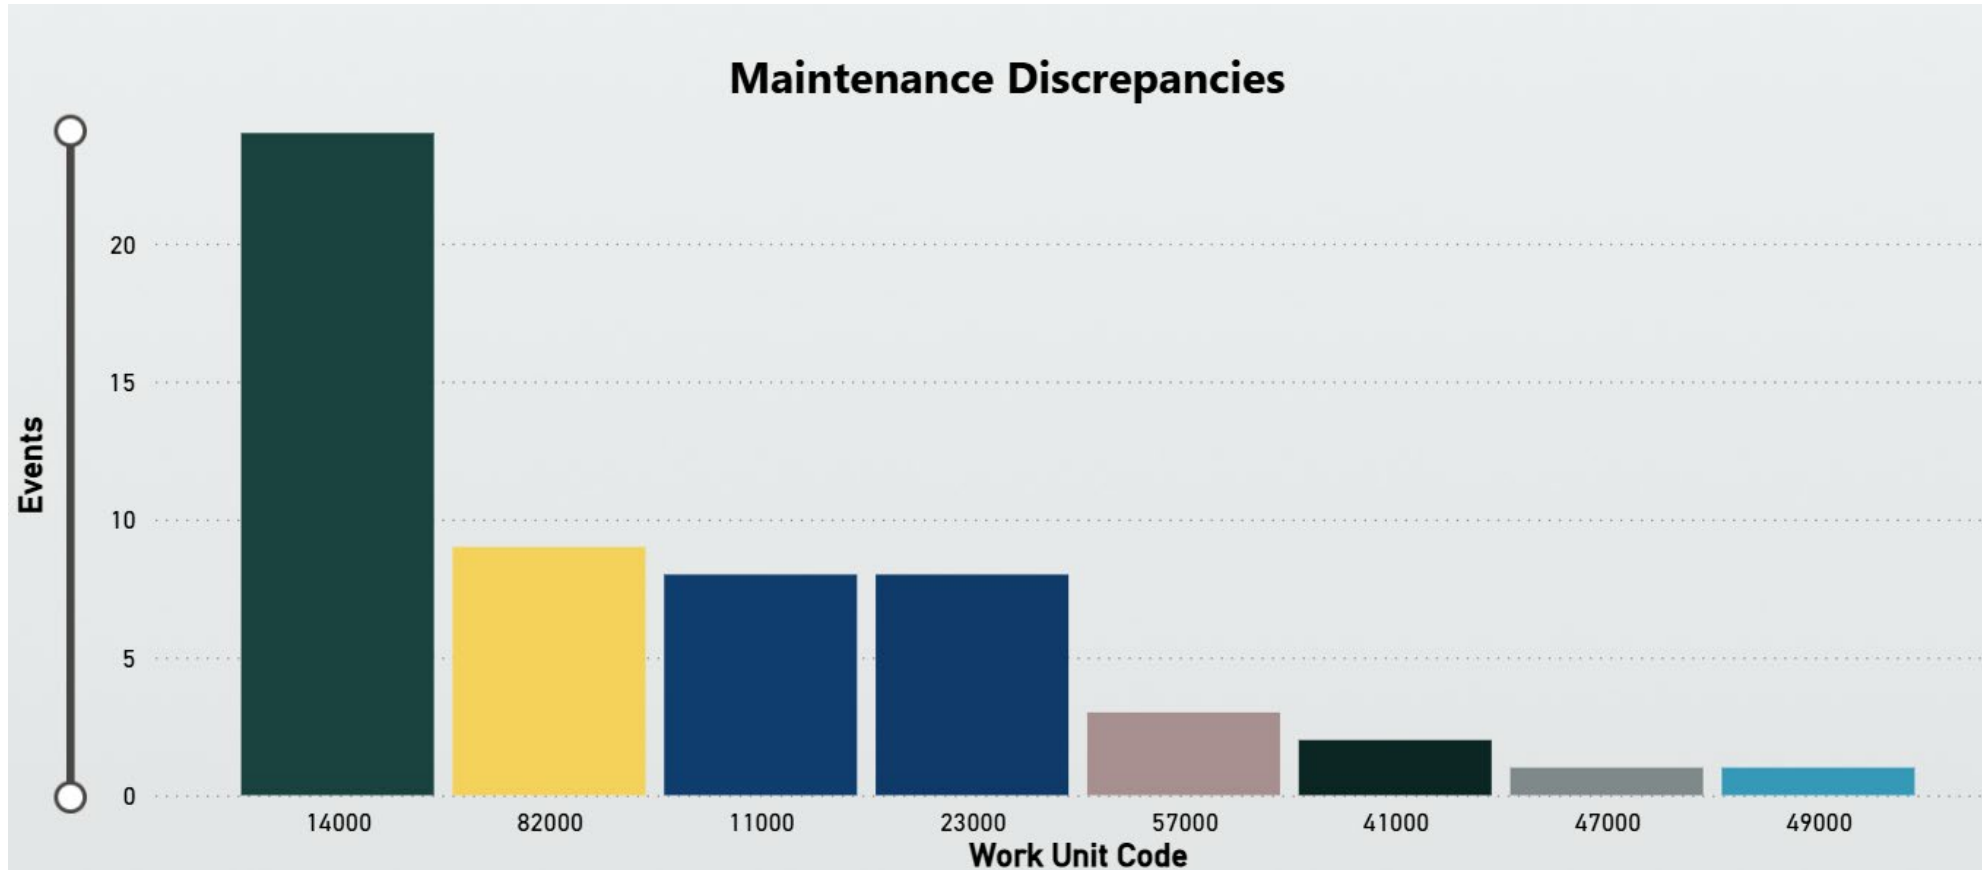
# Tail 1 Work Unit Codes

- 37 NMC Hours, 97 MMHrs

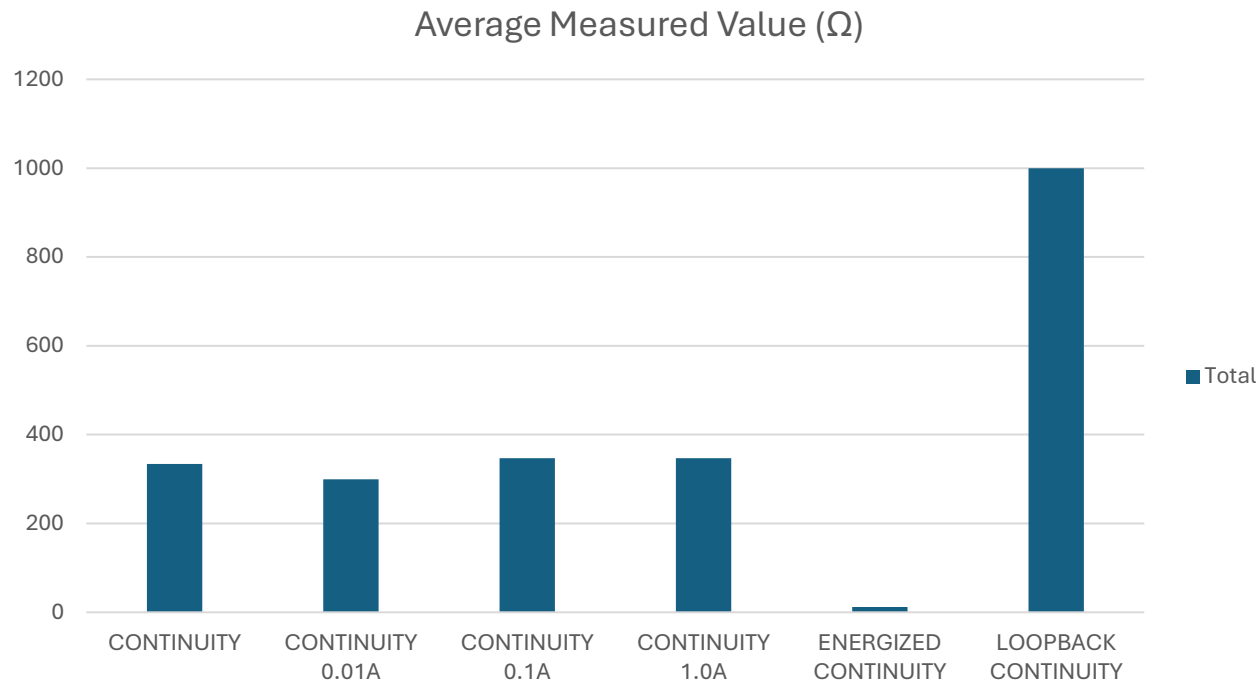
# Failed Yaw AWTs Tests Tail 3

- Results from Tail 3 summarized due to high failure count
- Continuity Outliers measuring  $>1 \text{ M}\Omega$  removed for visualization services
- Expected Values are .5, 2, and  $5 \Omega$

- All Yaw failures due to high resistance across tails tested
- Tail 3 and Tail 4 showed significant issues with Yaw Augmentation circuits
- Even after removing outlier data, Tail 3 and Tail 4 measurements are highly suspicious
- Failures indicate poor wiring health: corrosion, damaged conductors, interruptions in wire path

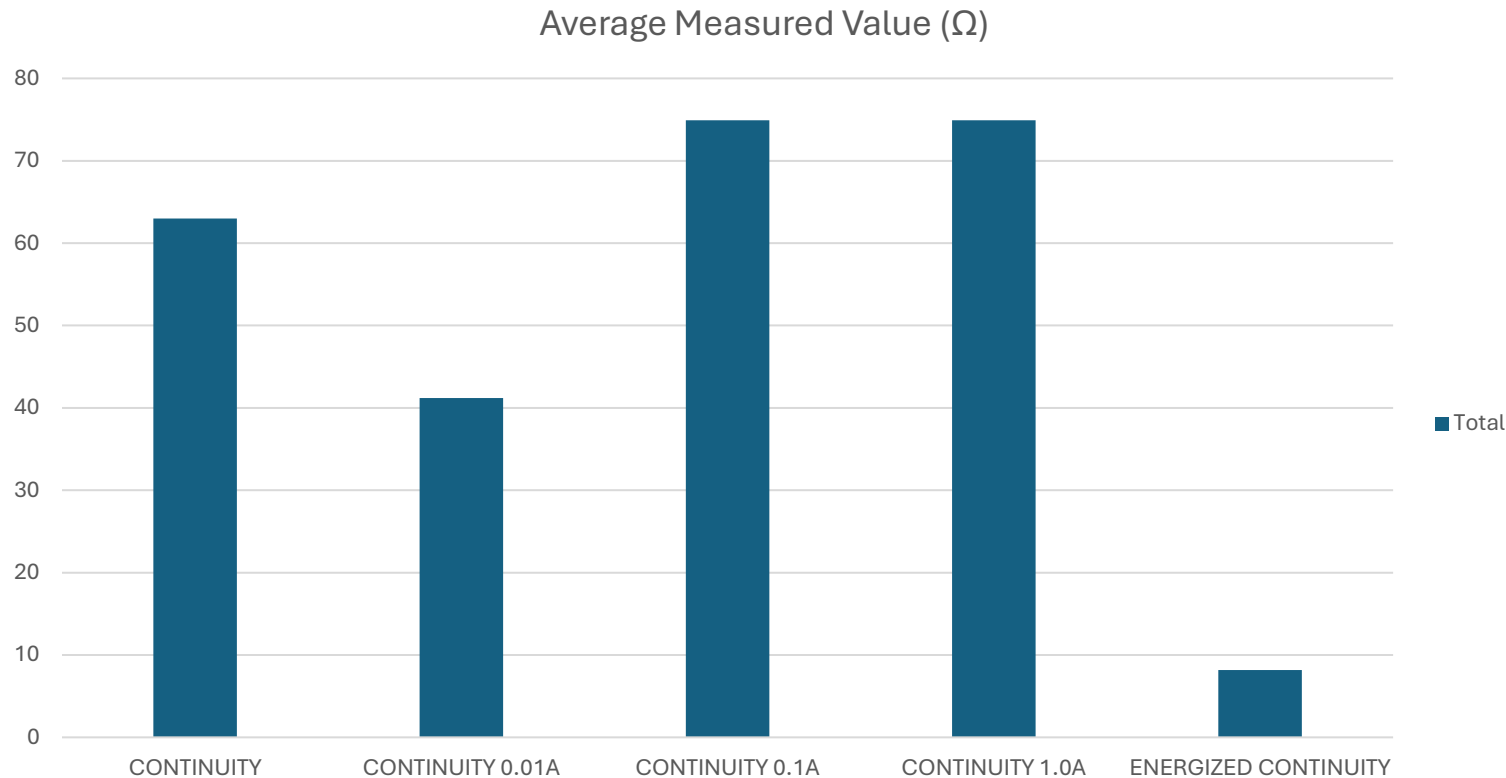
# Failed Yaw AWTs Tests Tail 4

- Results from Tail 4 summarized due to high failure count
- Continuity Outliers measuring  $>1\text{ M}\Omega$  removed for visualization services
- Expected Values are .34, 2, 4.4, and  $5\text{ }\Omega$

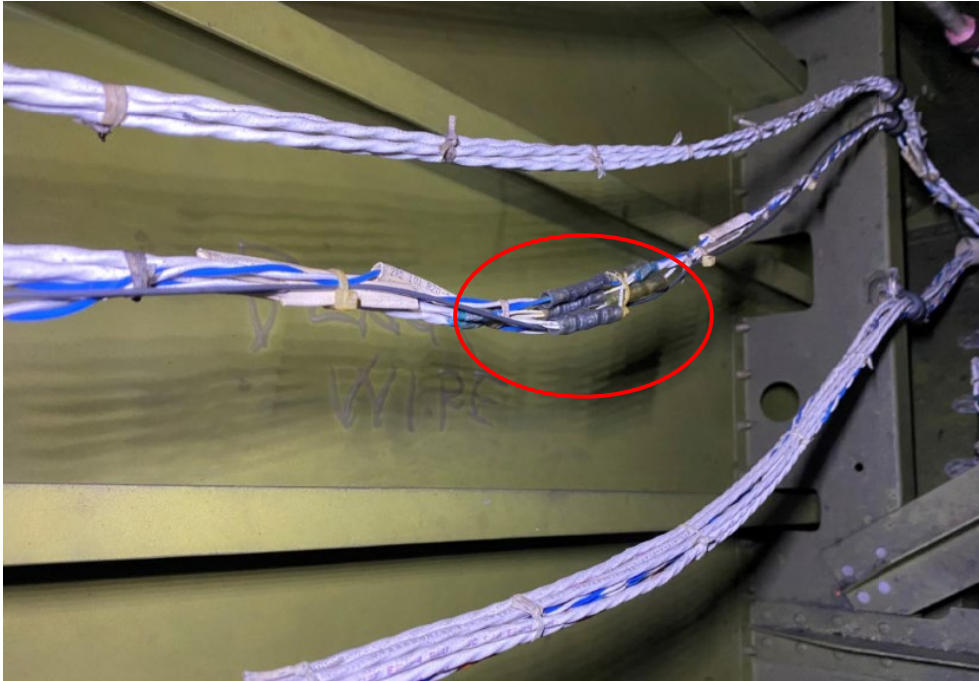
- Non-environmental splices, splices not staggered

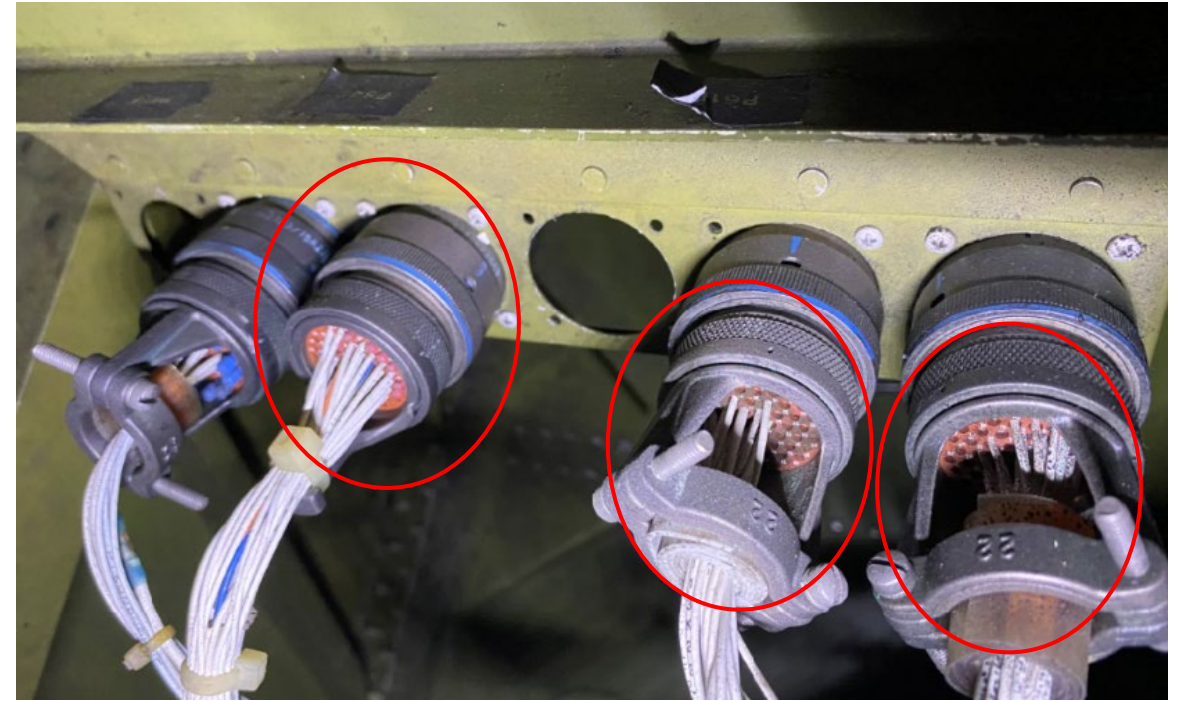
- Multiple Cannon-Plugs missing sealing pins

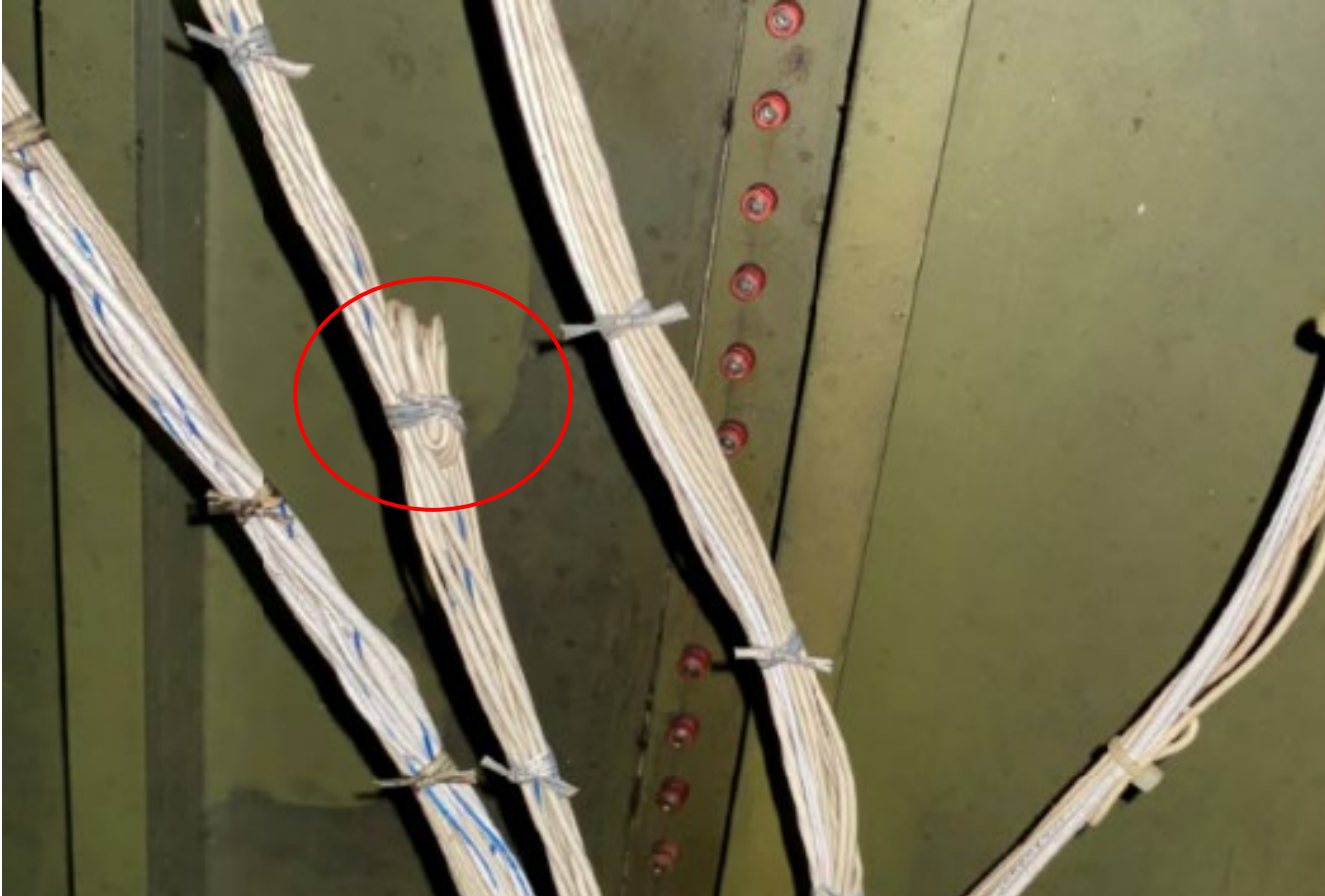
- Extreme wire bend radius

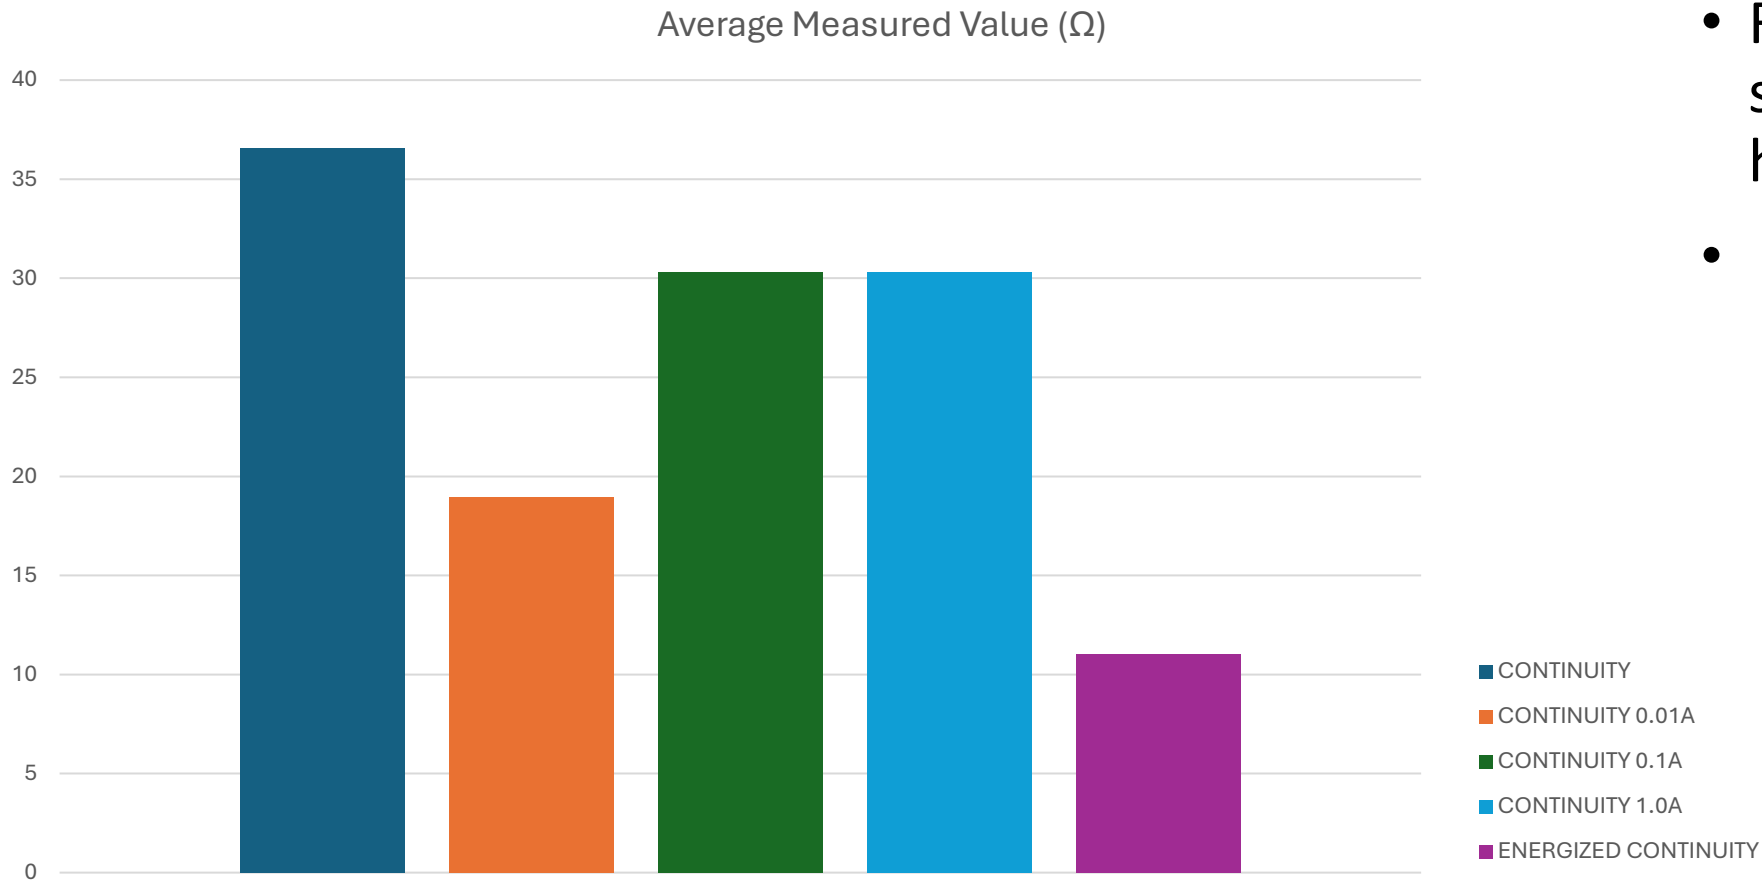
# Failed Lat AWTs Tests Tail 4

- Results from Tail 4 summarized due to high failure count
- Expected Values are 2 & 5  $\Omega$
