RV Inspection Report

**Prepared for: Michelle P
2003 THOR FUNMOVER**

**Inspection Date / RV Model:
Nov 16, 2024-2003 Thor Fun Mover**

Mobiltek RV Services LLC

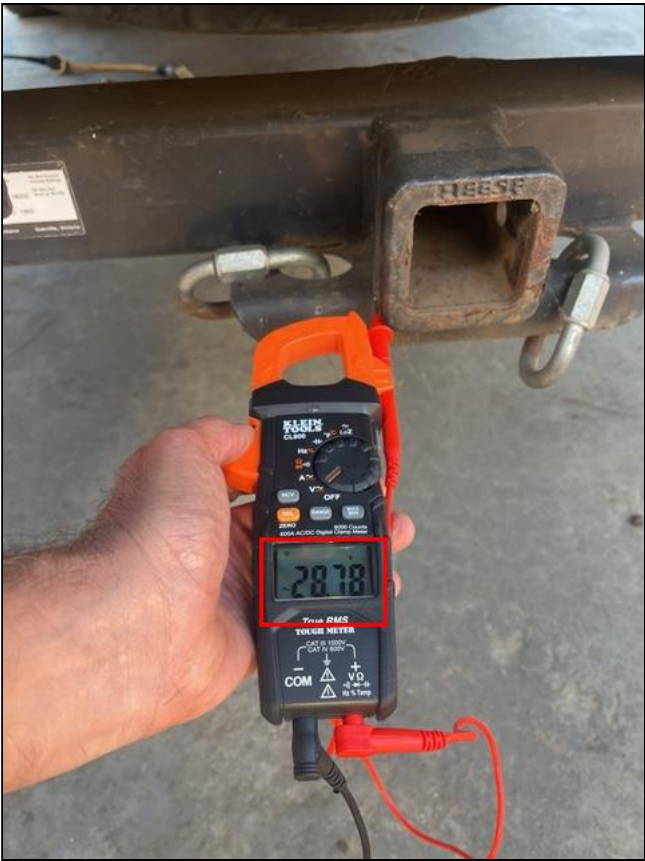
Hot Skin Test

There is over 5 volts AC on the chassis , frame and running gear . This is a LIFE SAFETY issue. It is recommended that this be further evaluated by qualified RV technician prior to occupancy.

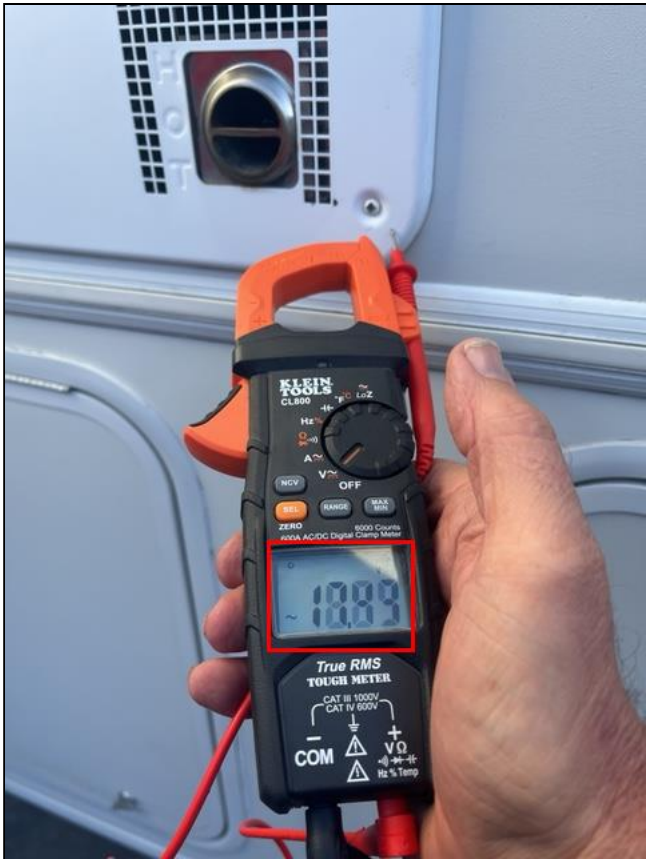
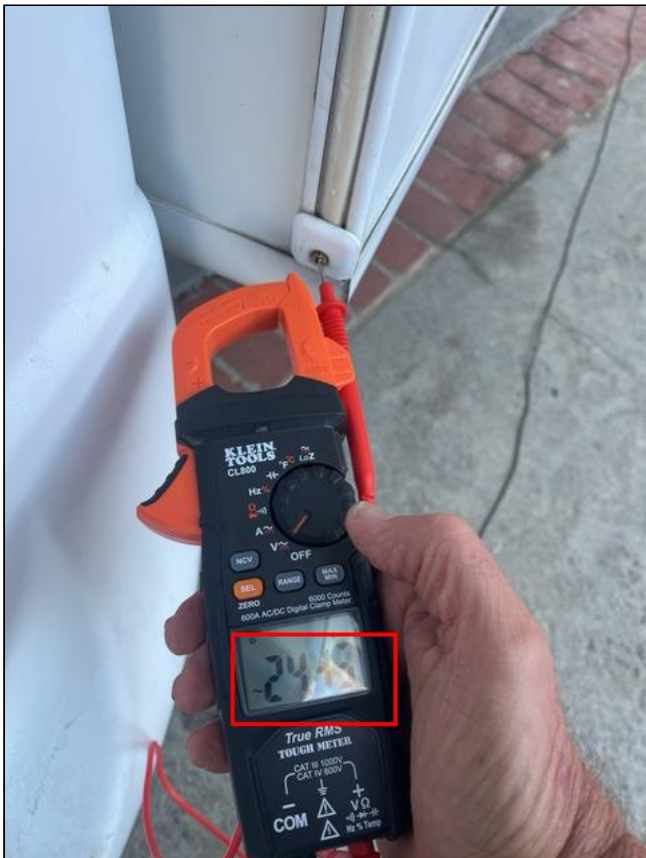
Hot Skin Test

(1) There is over 5 volts AC on the tested exterior walls.. This is a LIFE SAFETY issue. It is recommended that this be further evaluated by qualified RV technician prior to occupancy.

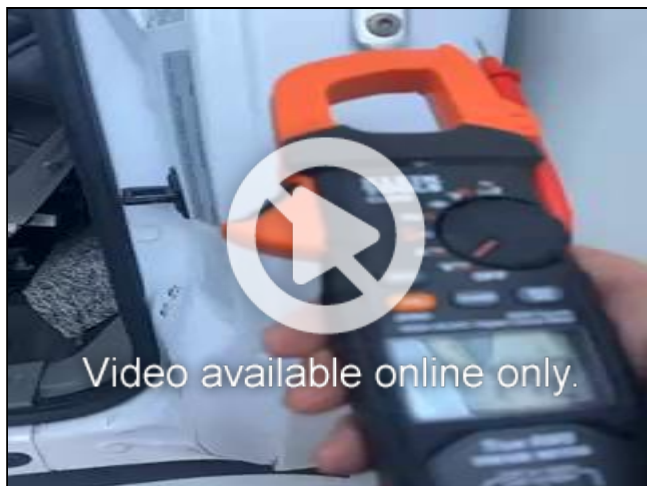
Hot Skin Test Video

(2) This hot skin test video show minimal stray voltage of 1.4 volts prior to contacting the exterior wall adjacent to the driver door. The voltage immediately increases to over 26 volts upon contact. This is a LIFE SAFETY issue. It is recommended that this be further evaluated by qualified RV technician prior to occupancy.

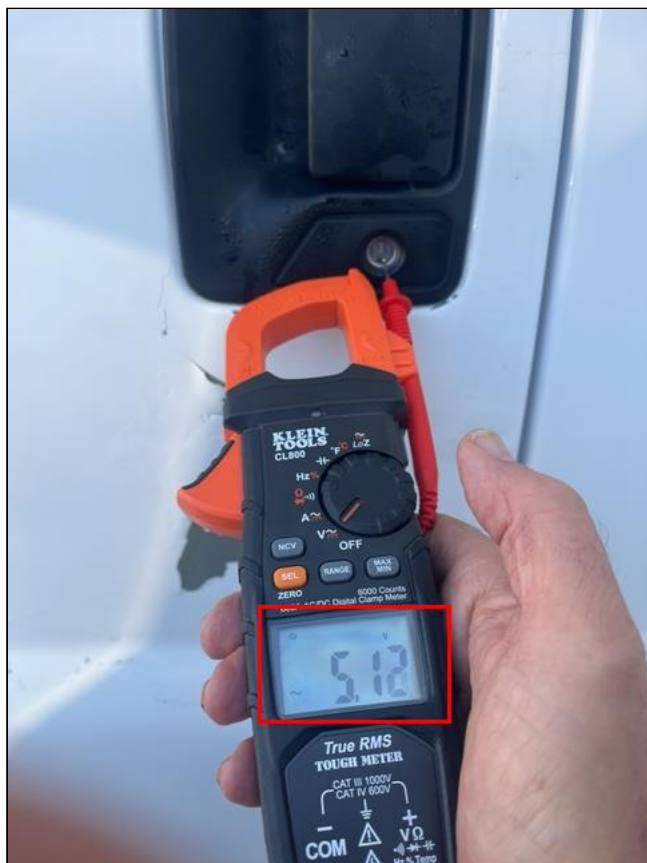
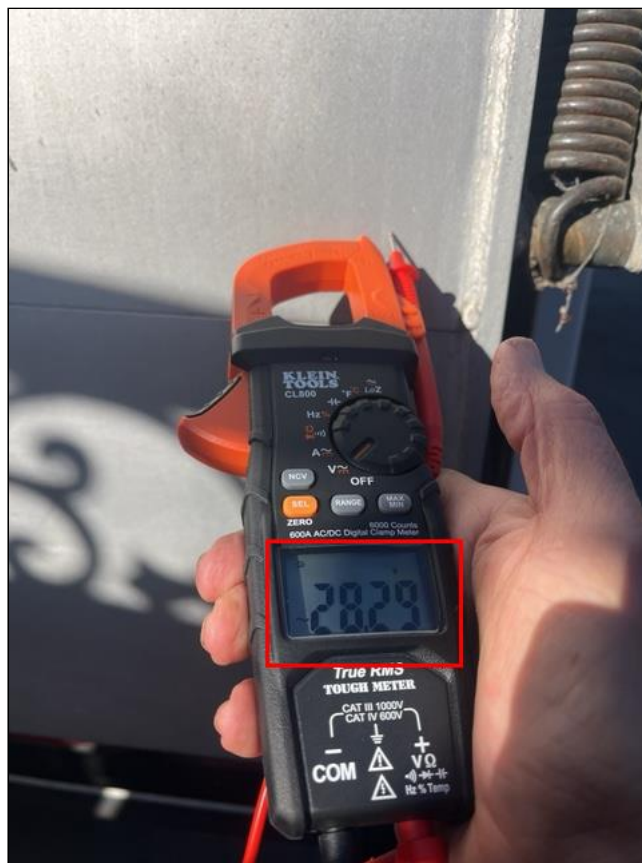
Hot Skin Test

There was over 28 volts on the rear lift gate door.

There is over 5 volts AC on the tested door handles and frames. This is a LIFE SAFETY issue. It is recommended that this be further evaluated by qualified RV technician prior to occupancy.

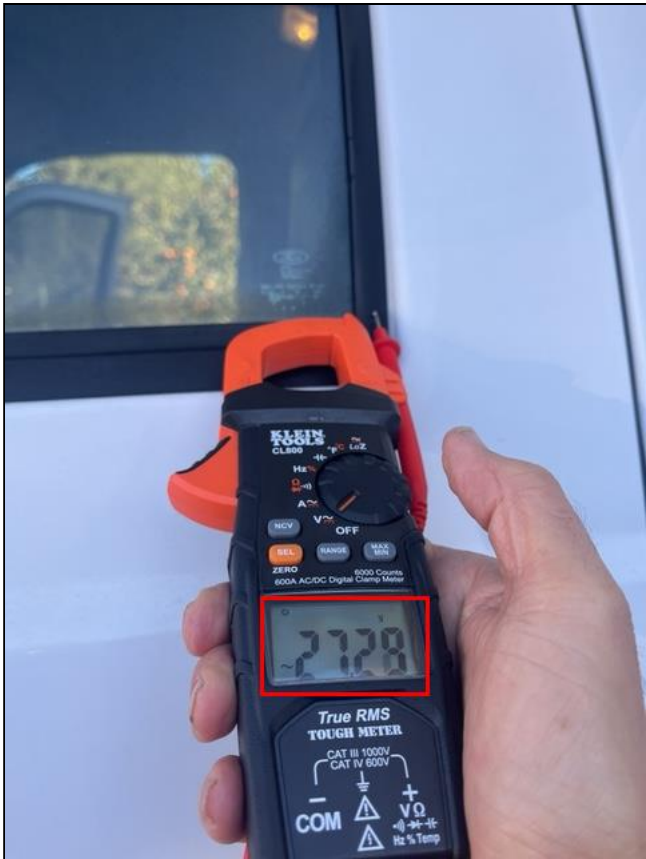
Hot Skin Test

There is over 5 volts AC on the tested windows and frames. This is a LIFE SAFETY issue. It is recommended that this be further evaluated by qualified RV technician prior to occupancy.

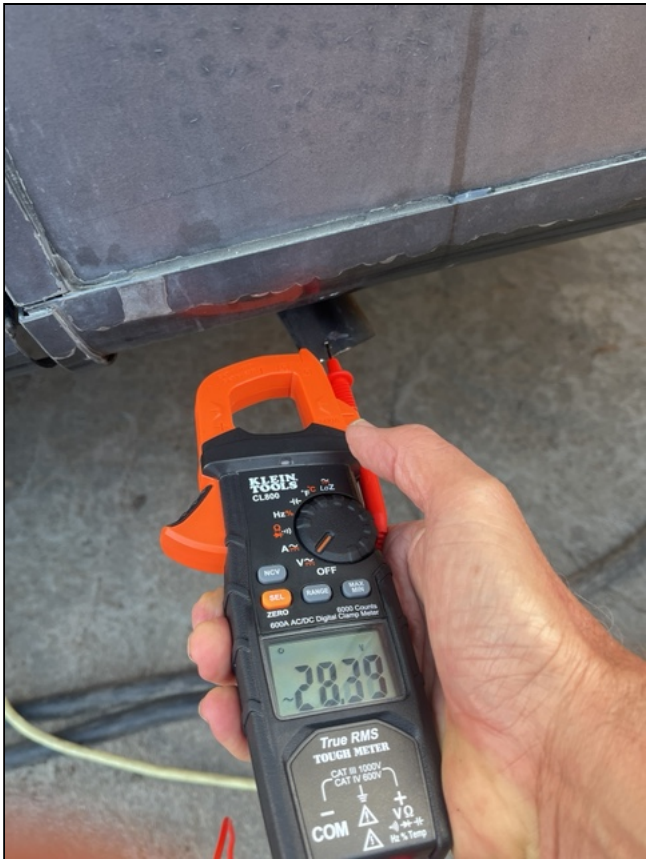
Hot Skin Test

There is over 5 volts AC on the tested "other " voltage. This is a LIFE SAFETY issue. It is recommended that this be further evaluated by qualified RV technician prior to occupancy.

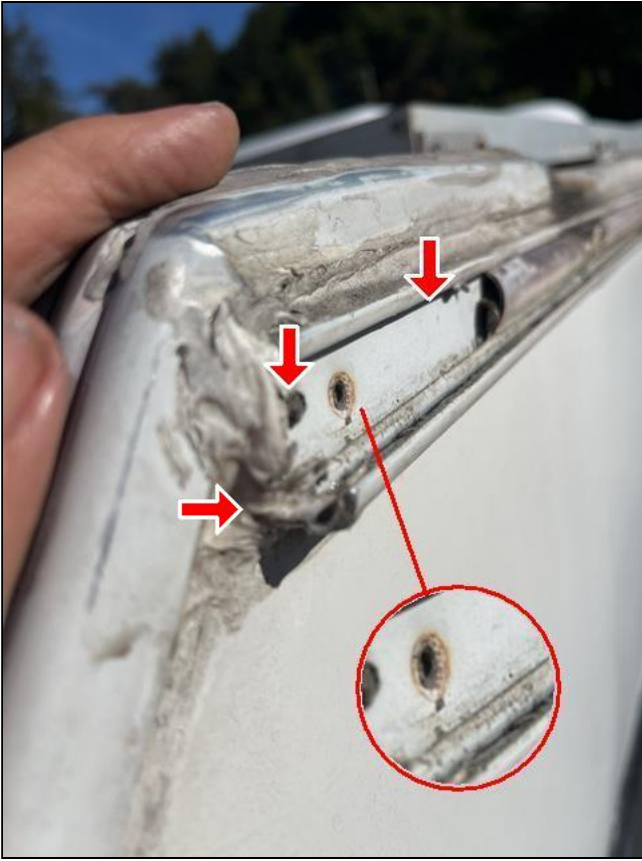
Streetside Trim Rail at Front Cap

(2) There is trim missing and are two holes at the trim rail over driver door. There is excess sealant blocking free draining of the rail as water runs over and through. This is the segment that the puddle on roof drains over. This could allow water intrusion. It is recommended that this be further evaluated by a qualified RV technician.

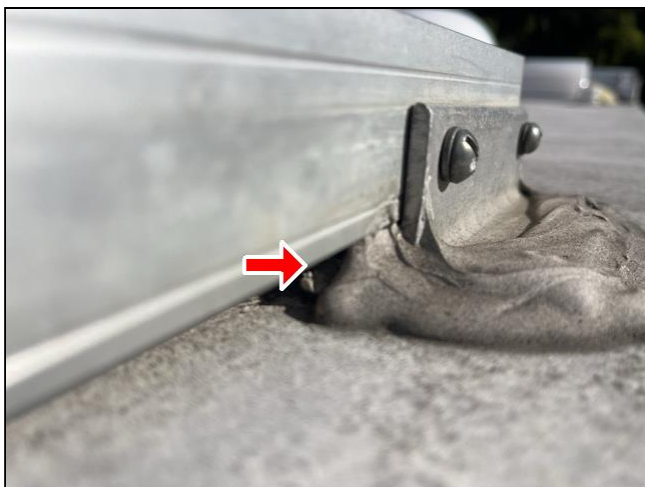
Solar Panel Mount

The lap sealant on the interior side of ALL solar panel mounting brackets is missing. . This could allow water intrusion. It is recommended that this be further evaluated by a qualified RV technician.

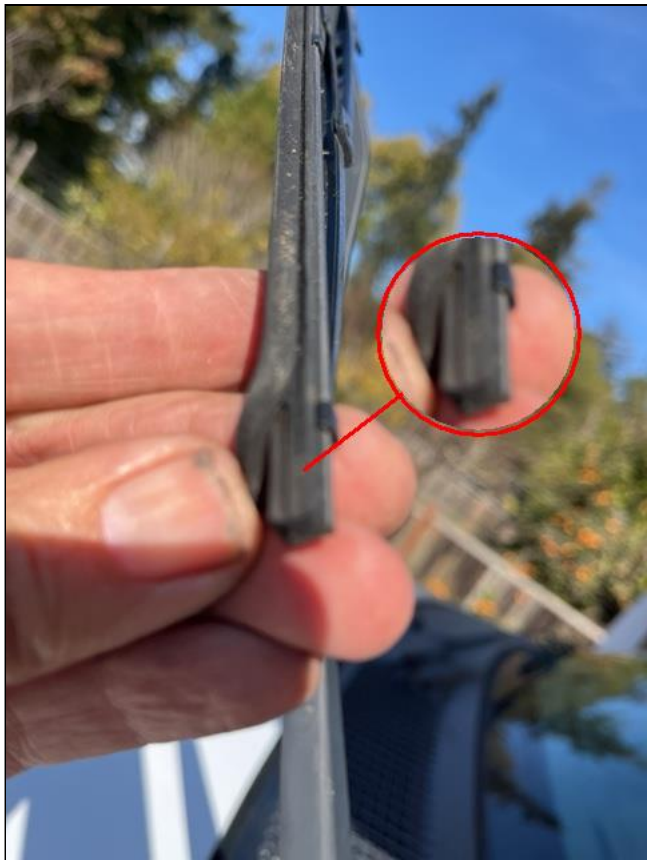
Driver Side Wiper Blade

(3) The wiper blade on the driver side is dried and fraying

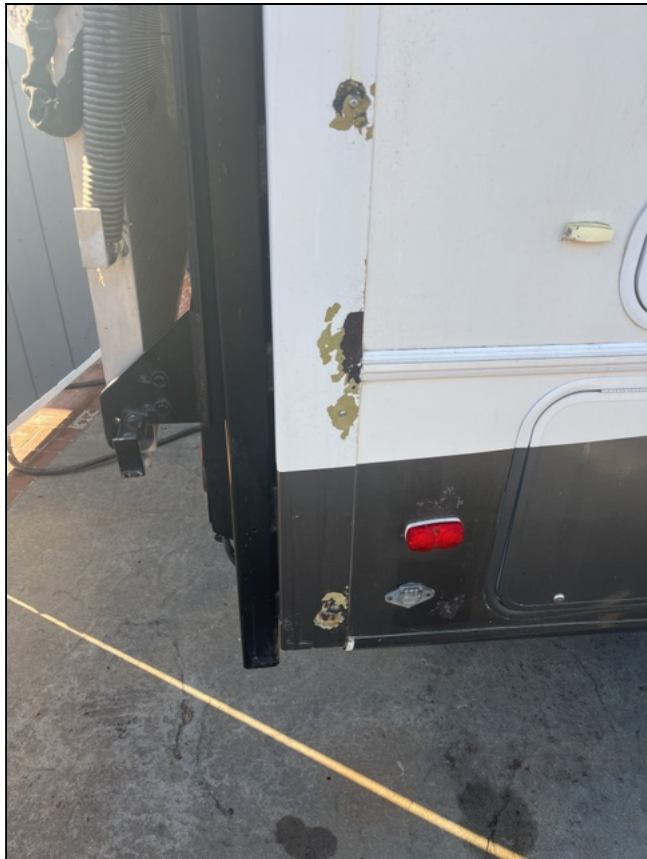
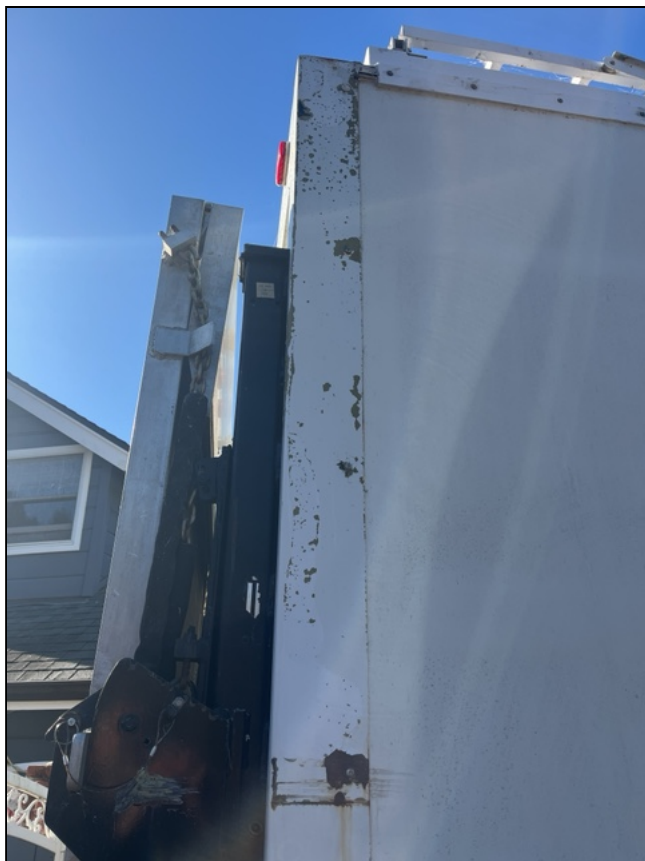
Curbside Sidewall

(1) There is paint missing on the rear of the curbside sidewall at the liftgate.

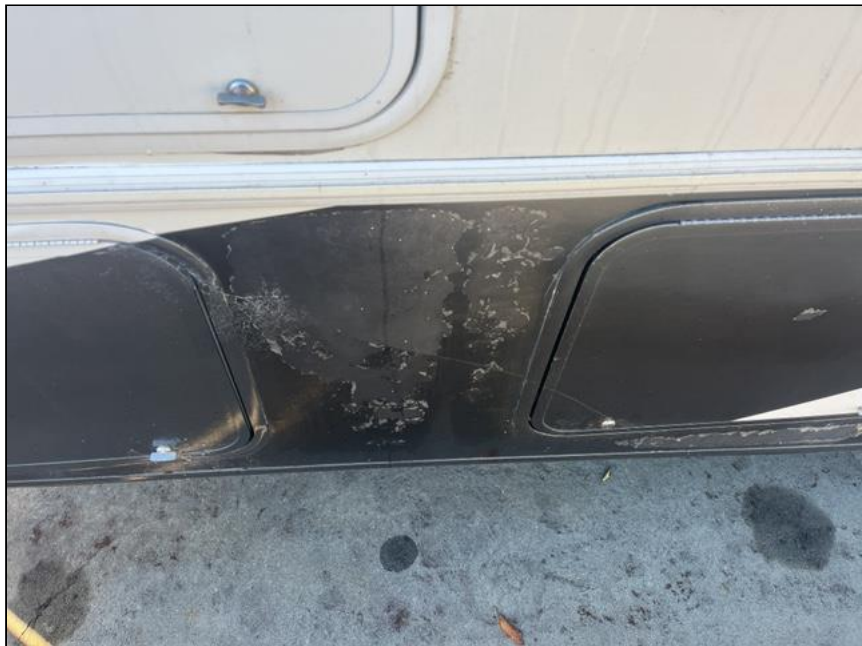
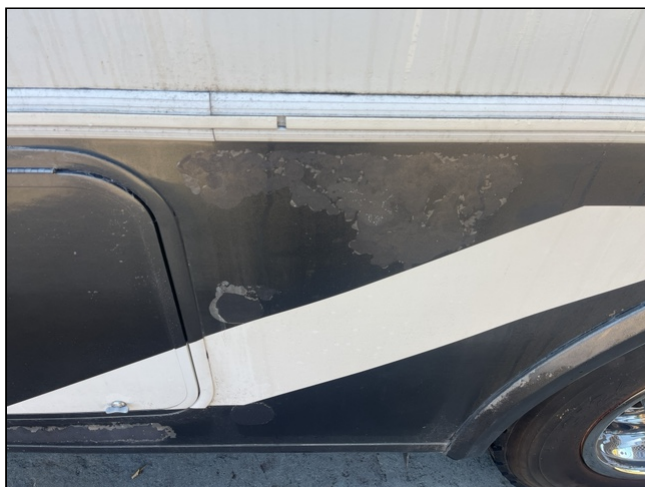
Curbside Sidewall

(2) There is paint missing from the sidewall around the cargo bay doors

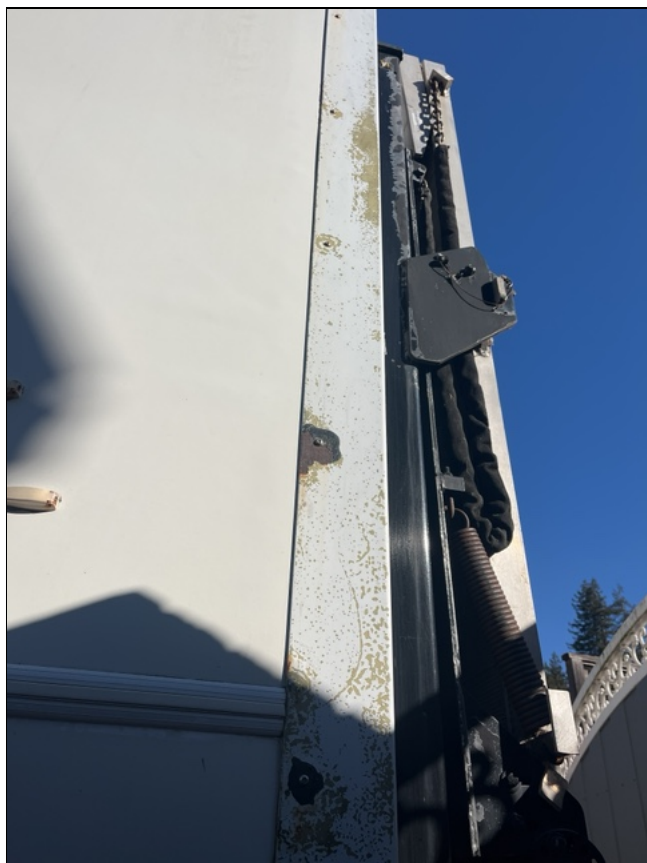
Streetside Rear Sidewall

There is paint missing from the streetside rear sidewall at the liftgate.

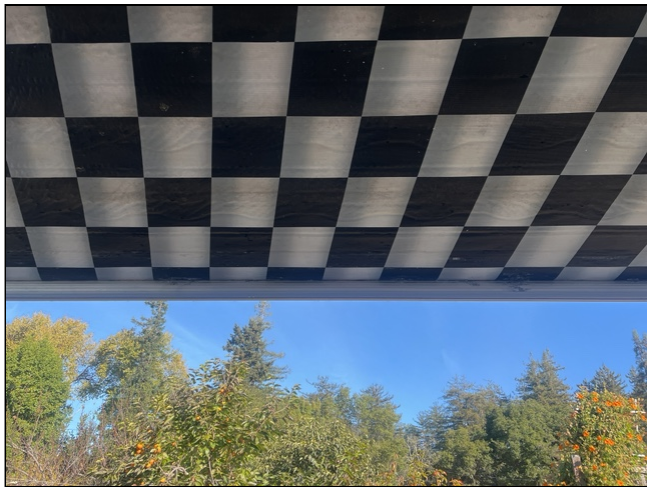
Awning Fabric

Fabric condition of awning is good. It is dirty and some stains.

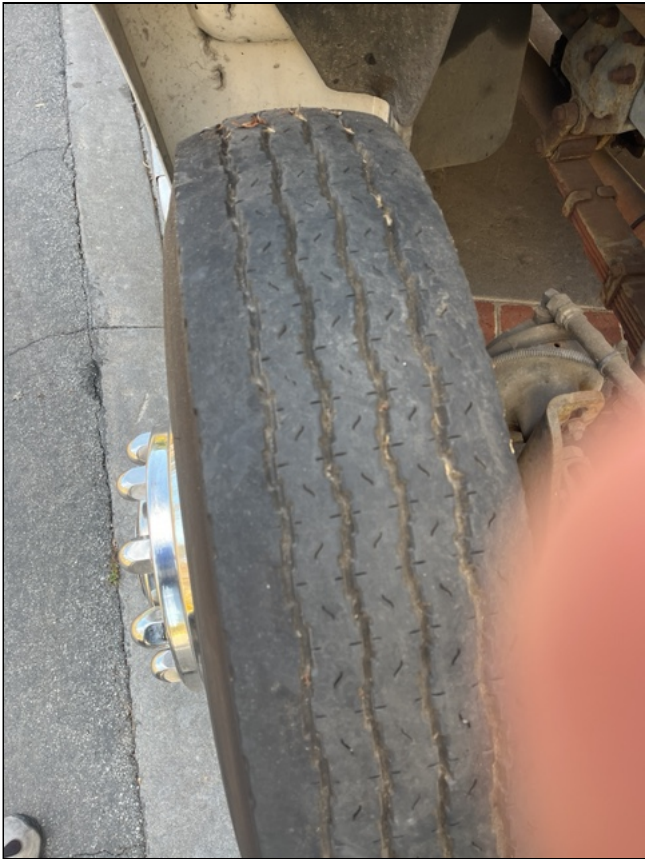
Curbside Front Tire Tread

The curbside front tire tread is cracked, has divots and bumps and tread is wearing low on the outer portion. This is a life safety issue. It is recommended that this be further evaluated by a tire specialist prior to operating.

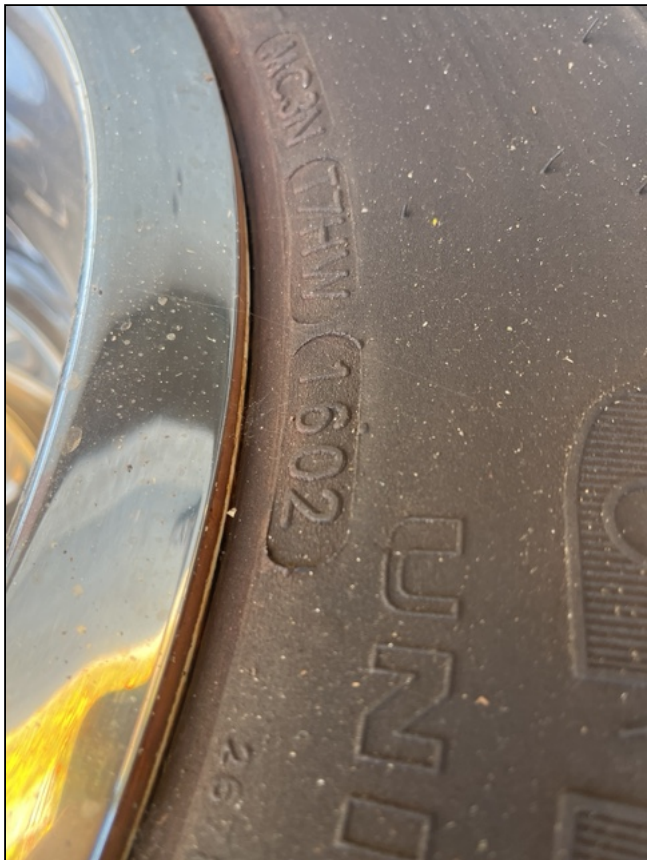
Curbside rear DOT date code

The age of the tire is listed as week 16 of the year 2002, which is beyond the NTSB and some tire manufacturer's replacement age. It is recommended that this be further evaluated by a qualified tire technician. This is a LIFE SAFETY ISSUE.

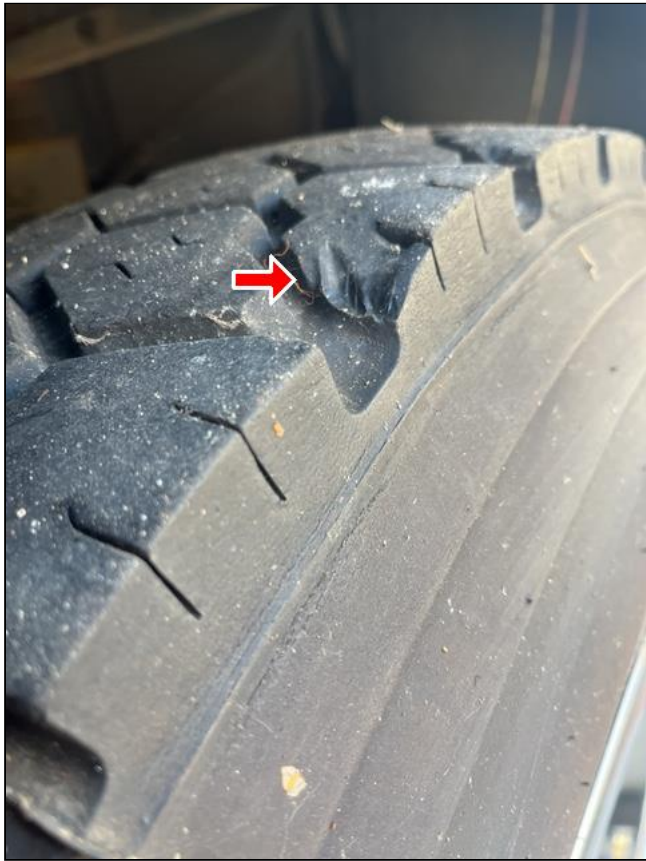
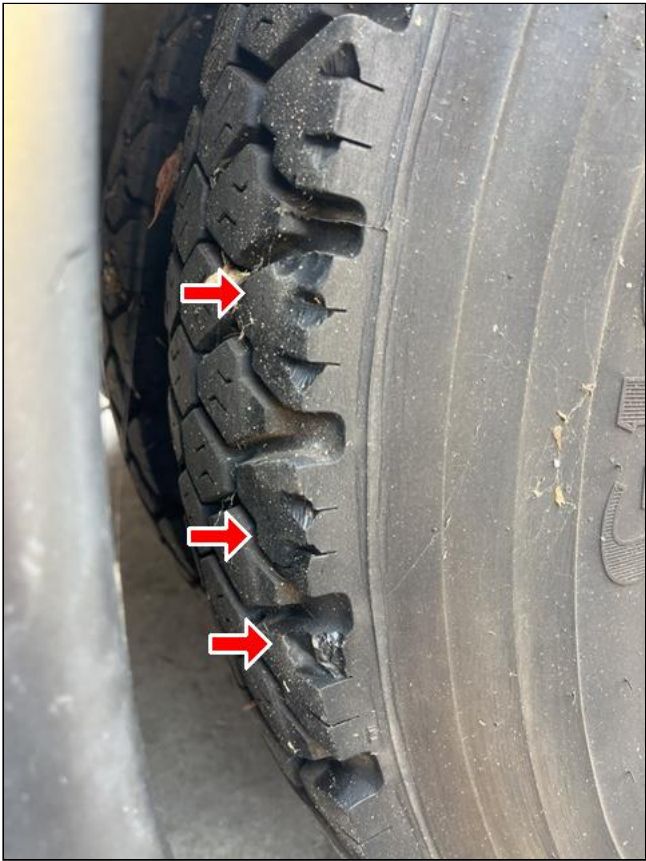
Curbside Rear Outer Tire

(2) The tread on the outer curbside rear tire is chipped and broken. It is recommended that this be further evaluated by a qualified tire technician. This is a LIFE SAFETY issue.

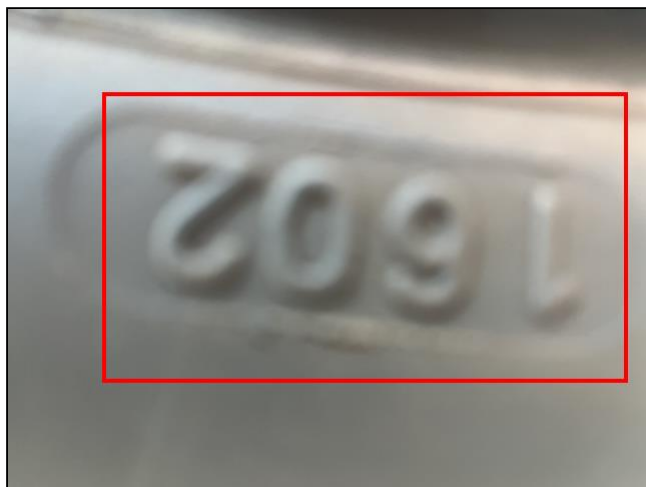
Curbside Rear Inside DOT Date Code

The age of the tire is listed as week 16 of the year 2002, which is beyond the NTSB and some tire manufacturer's replacement age. It is recommended that this be further evaluated by a qualified tire technician. This is a LIFE SAFETY ISSUE.

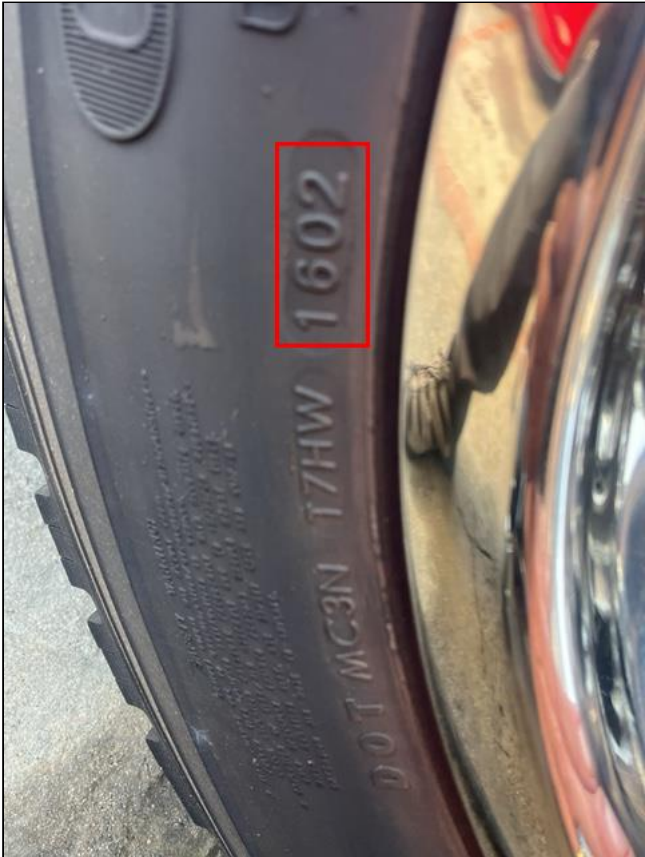
DOT Date Code

Poor
DOT date code is 1602

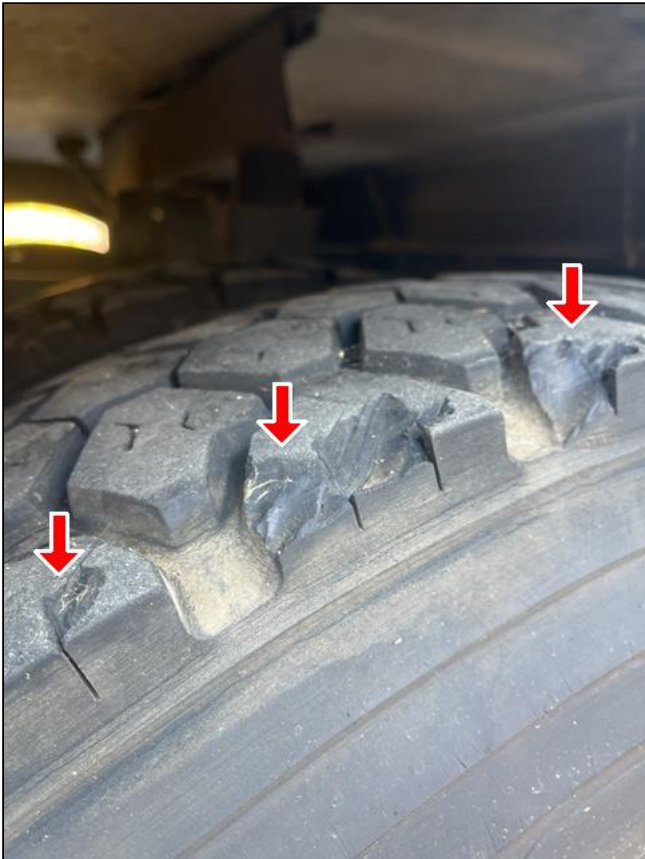
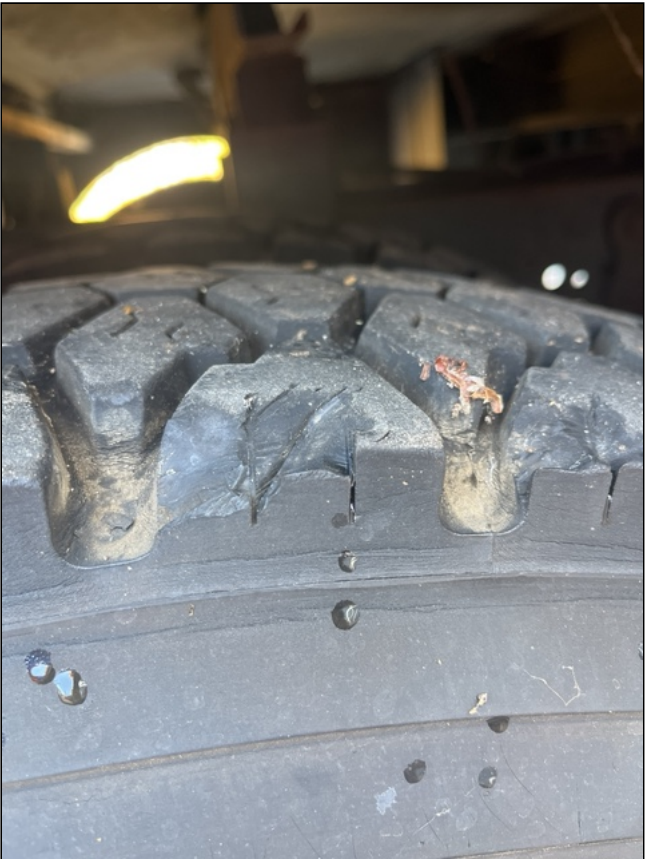
Streetside Rear Outer Tire

The tire has cracks and chips missing on the tread. It is recommended that this be further evaluated by a qualified tire technician. This is a LIFE SAFETY issue.

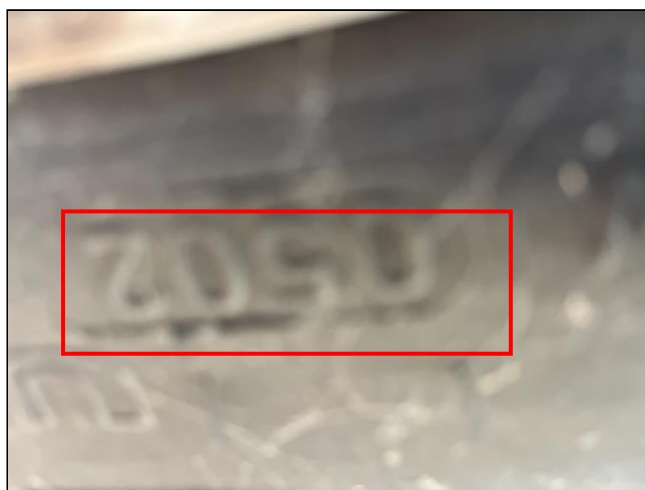
Streetside Rear Inside Tire DOT Date Code

The age of the tire is listed as week 5 of the year 2002, which is beyond the NTSB and some tire manufacturer's replacement age. It is recommended that this be further evaluated by a qualified tire technician. This is a LIFE SAFETY ISSUE.

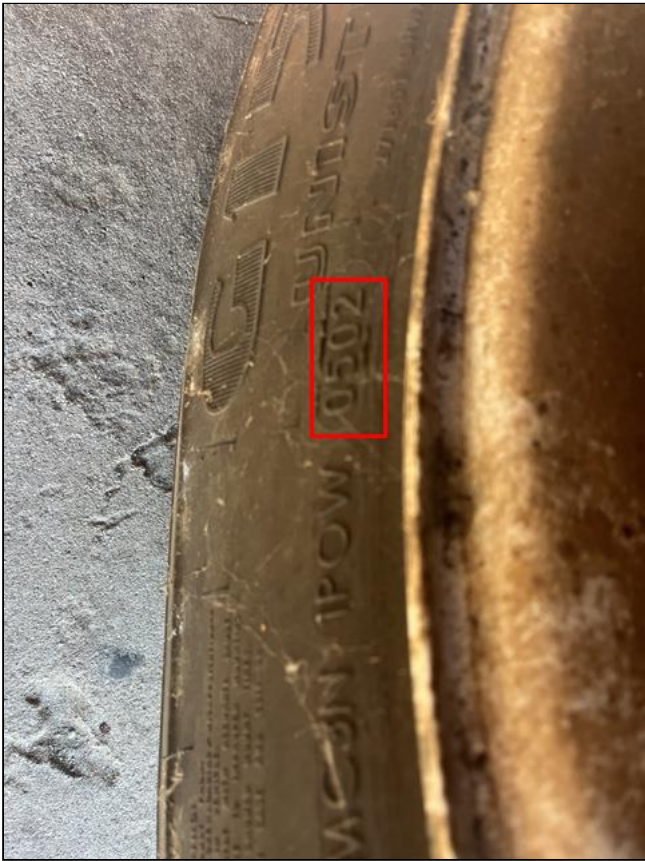
Streetside Front Tire DOT Date Code

The age of the tire is listed as week 5 of the year 2002, which is beyond the NTSB and some tire manufacturer's replacement age. It is recommended that this be further evaluated by a qualified tire technician. This is a LIFE SAFETY ISSUE.

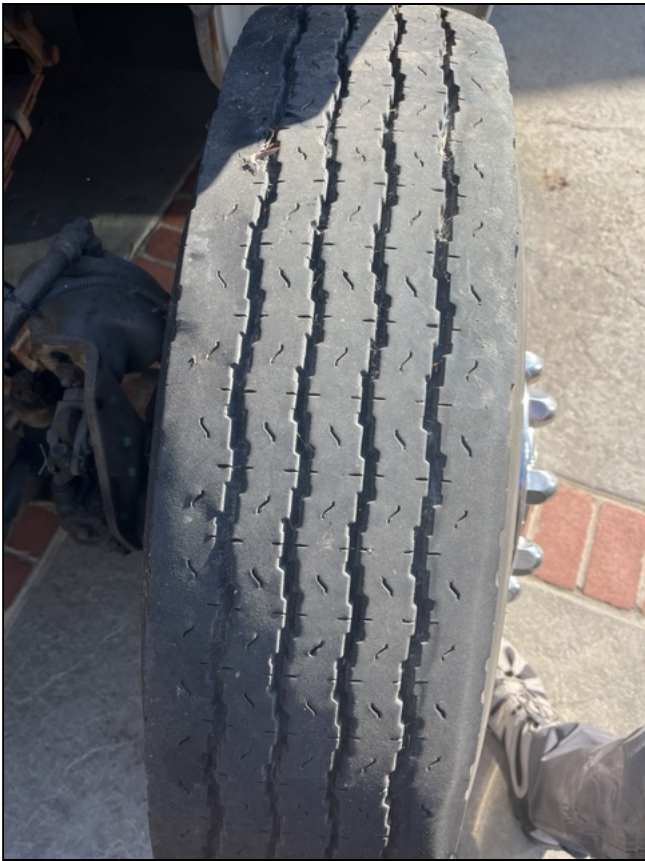
Streetside Front Tire Tread

The tire has scuffs, divots and cracks on the tread. It is recommended that this be further evaluated by a qualified tire technician. This is a LIFE SAFETY issue.

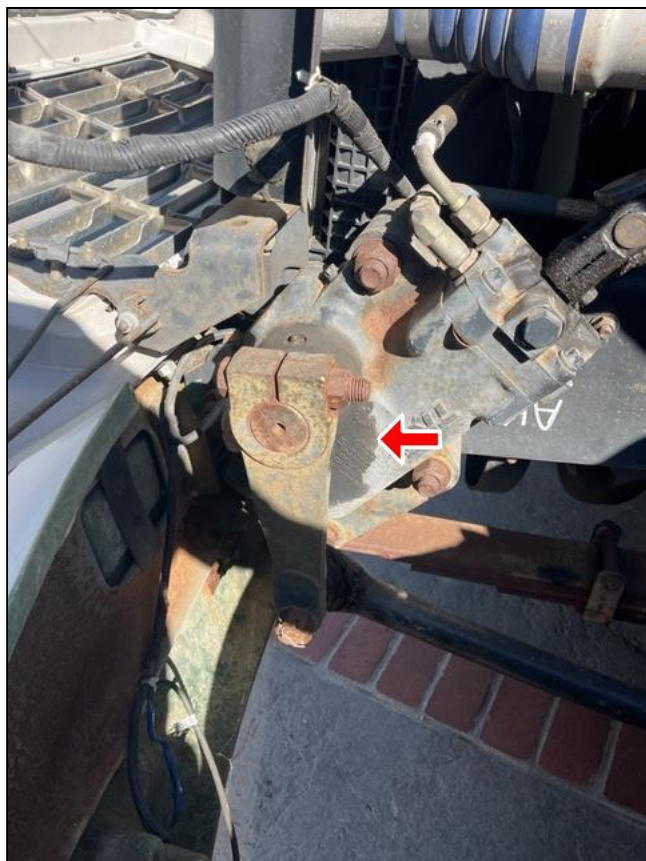
Steering Gear Box

(1) There are signs of leaking at the steering gear box

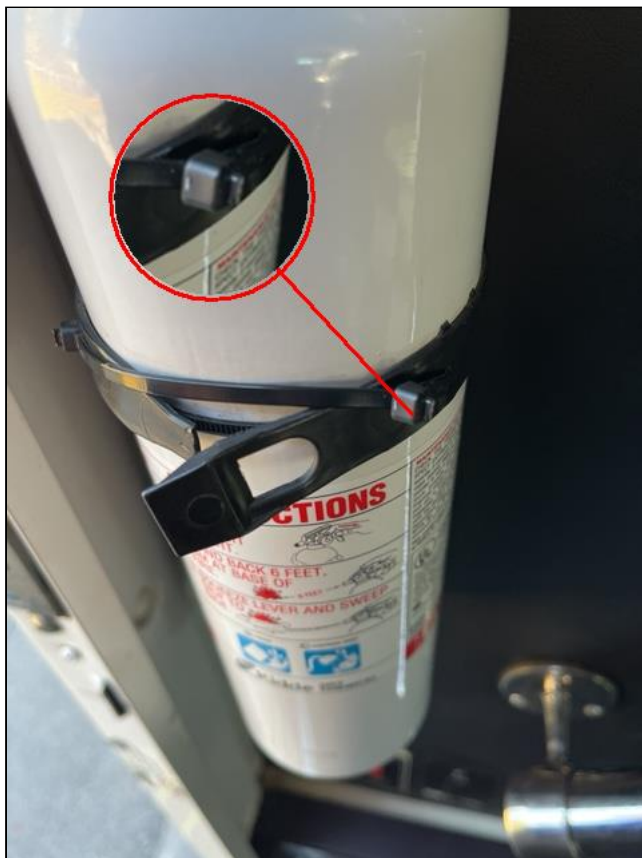
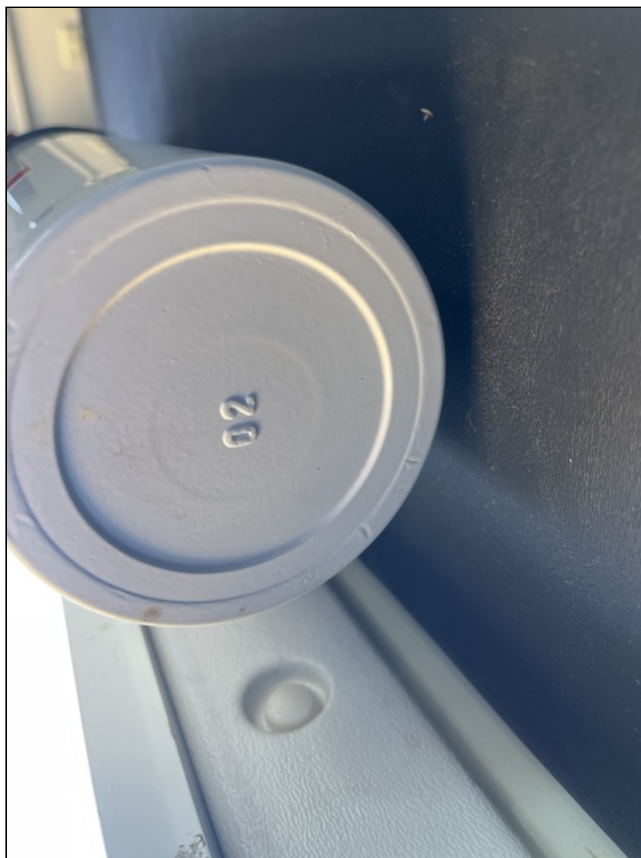
Zip Tie on Fire Extinguisher

(1) There is a zip tie securing the fire extinguisher. This is a life safety issue. It is recommended that this be further evaluated by a qualified RV technician prior to occupancy.

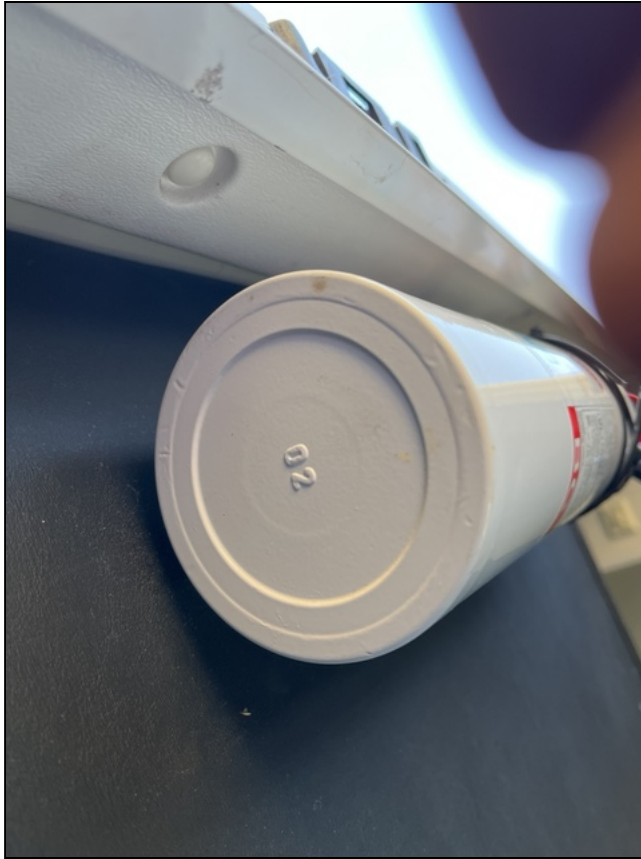
Date of Manufacture 2002

(2) The extinguisher is almost 23 years old. This is a life safety issue. It is recommended that this be further evaluated by a qualified RV technician prior to occupancy.

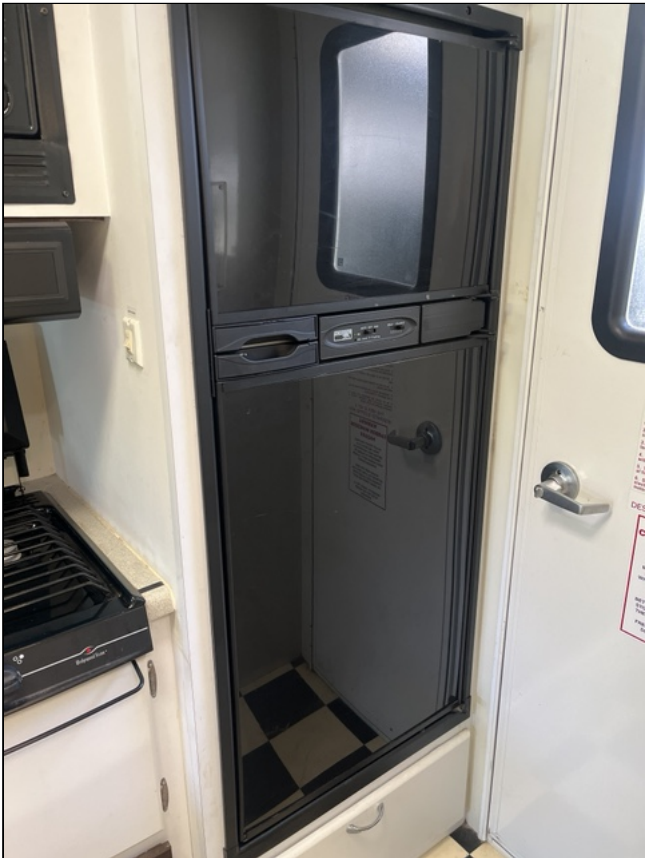
Exterior of refrigerator.

19.5 Refrigerator - Condition
Acceptable
Some markings on the exterior of the refrigerator

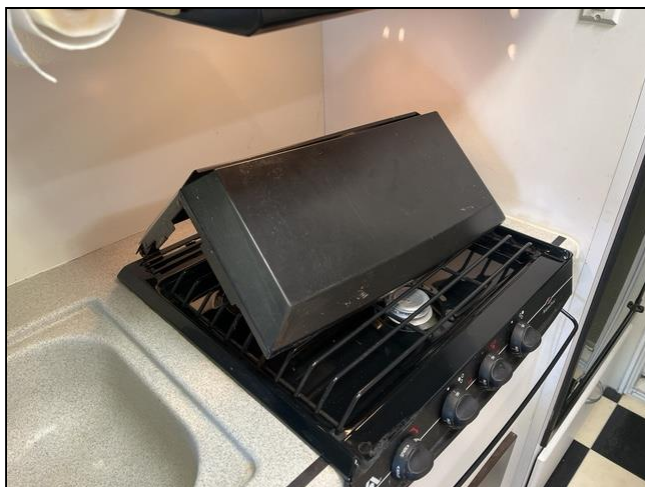
Cooktop Cover

The cooktop cover bent, and it does not work

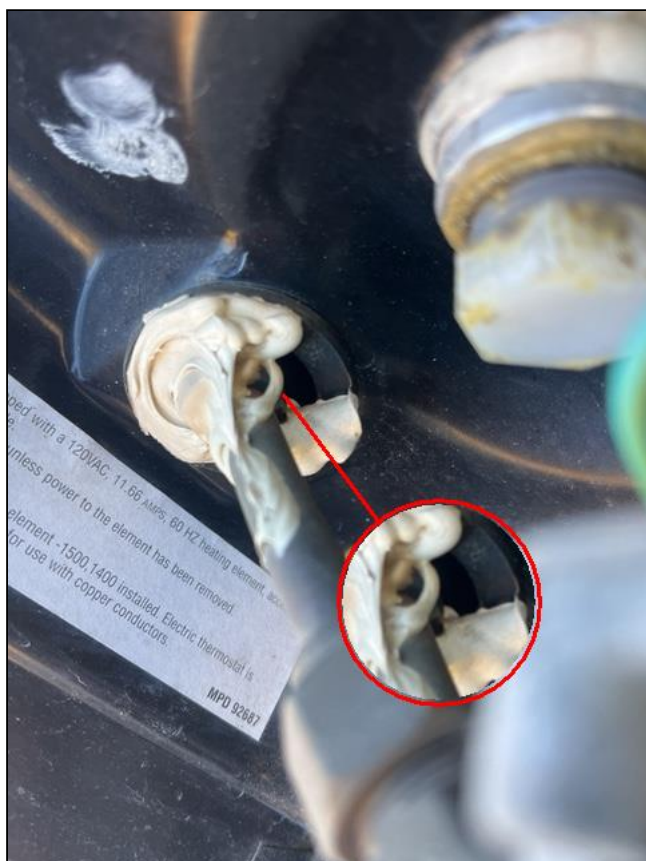
Water heater rubber grommet

The rubber grommet is not properly sealed. This could allow carbon monoxide to enter the living compartment. This is a life safety issue. It is recommended to be further evaluated by a qualified RV technician prior to occupancy

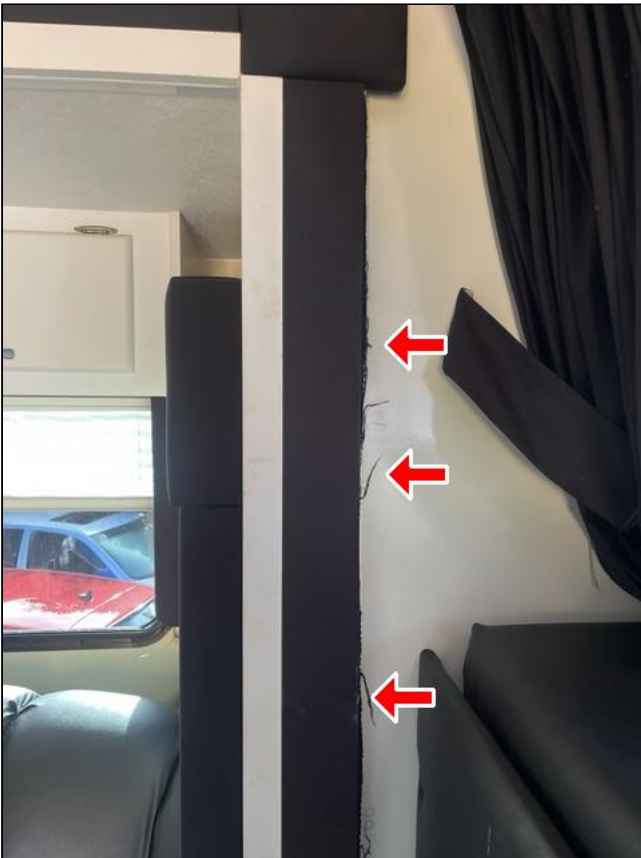
(2) Slide out trim interior is frayed on the right side

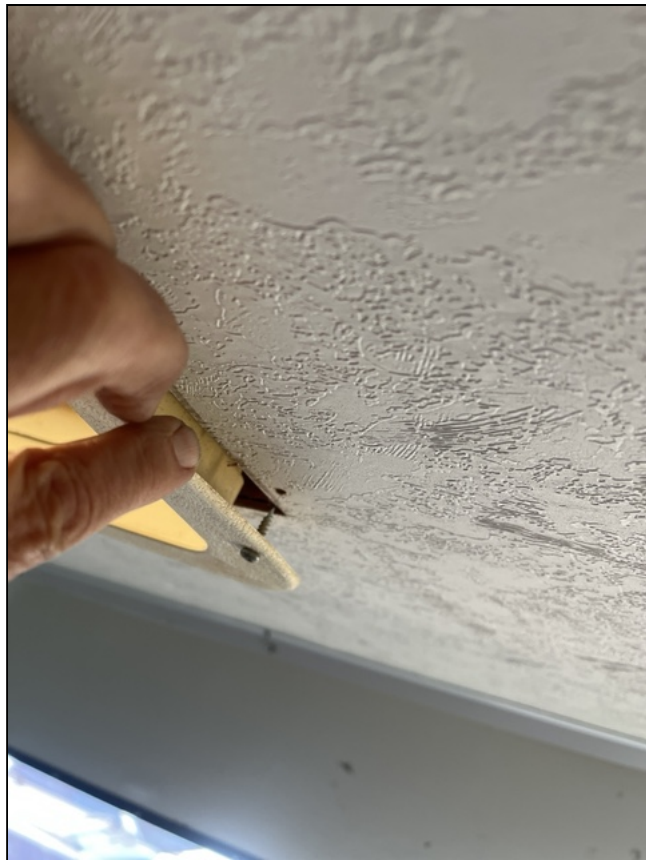
(1) Front crank vent is loose.

Front crank vent is loose.

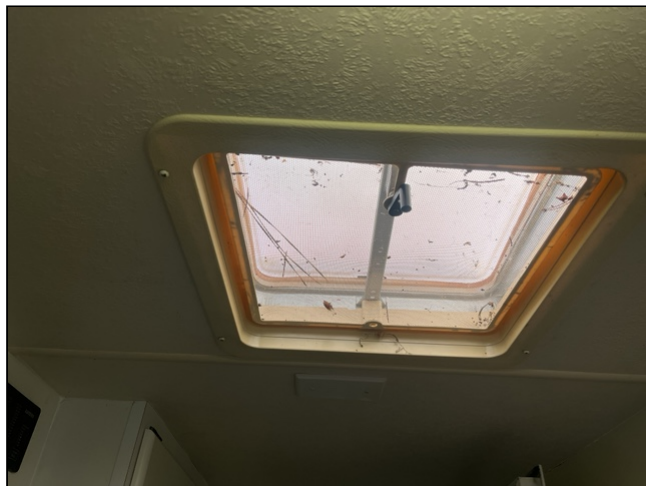
Vent in kitchen

(2) The vent in the kitchen is dirty

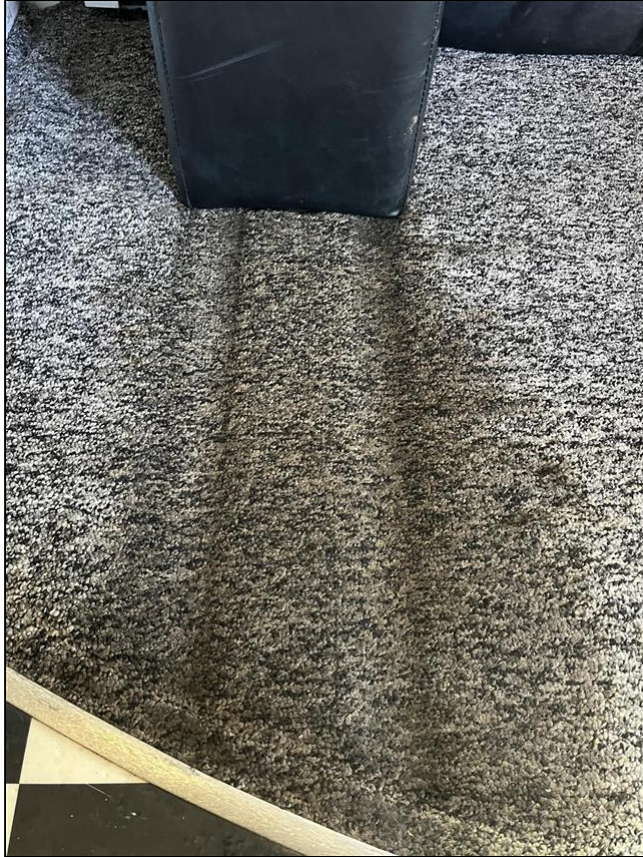
Carpet at Rear of Sofa

Heavy Staining on the carpet at rear sofa leg. There is also excessive wear along the slideout rail of the carpet

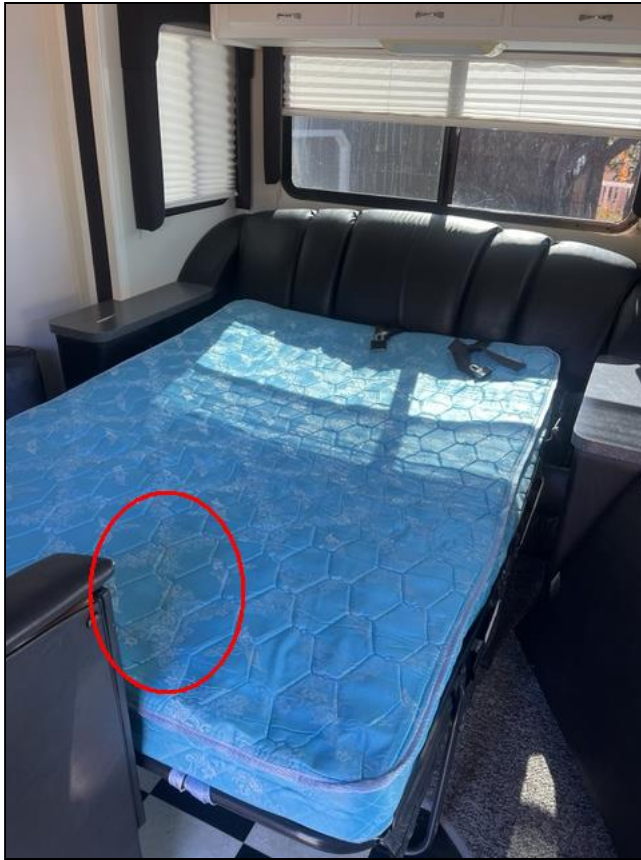
Sofa Bed

The mattress is worn and there is some staining
