RE: Northern Avenue Bridge Superstructure Removal Project
City of Boston, Suffolk County
Submittal of Project Notification Form

Project Notification Form

Northern Avenue Bridge Superstructure Removal Project

Northern Avenue Bridge
Over
Fort Point Channel

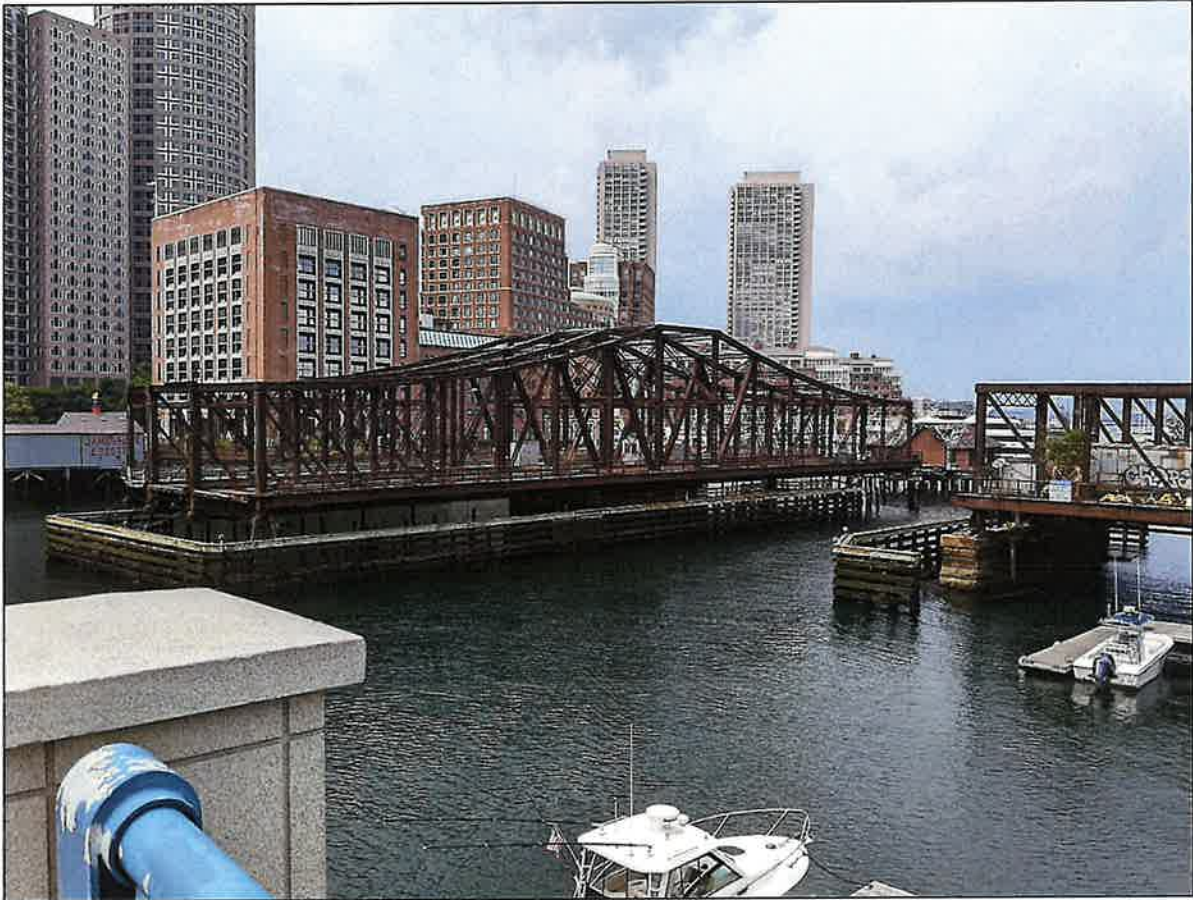
Photograph 1: Open swing span with unsupported ends and span 2 (easterly fixed, approach span at right) from Seaport Blvd. bridge over Ft. Point Channel. View north (August, 2024).

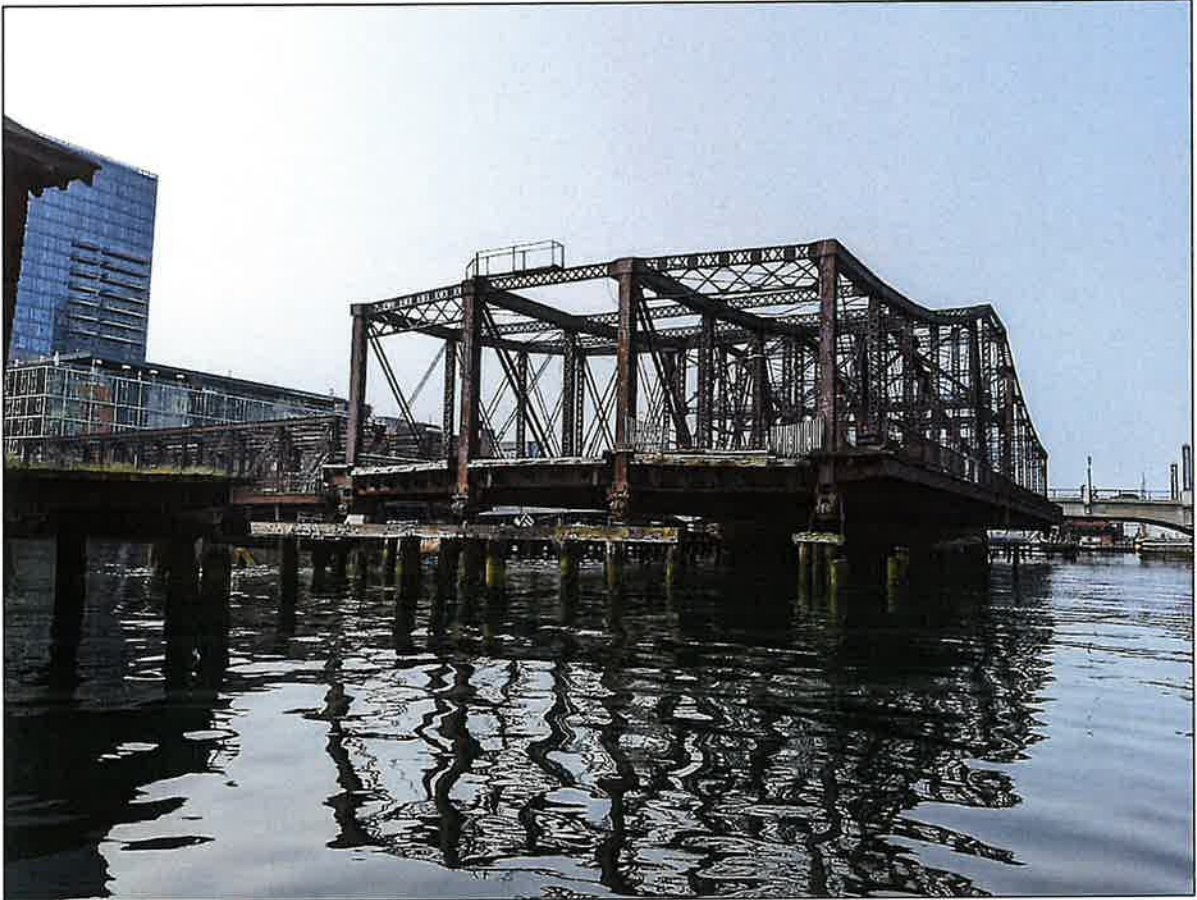
Photograph 2: North portal of open swing span, looking south. Note the unsupported ends of the swing span (August, 2024).

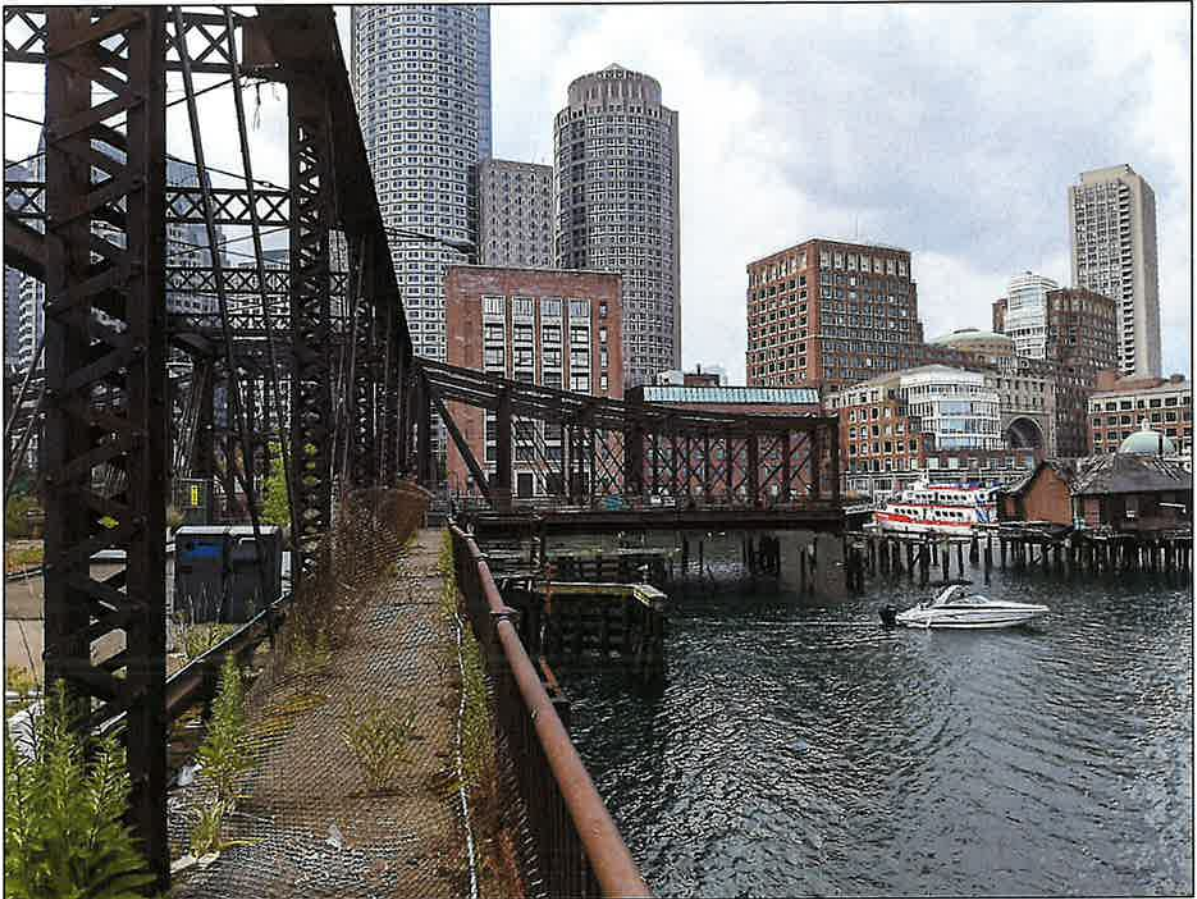
Photograph 3: View of open swing span from sidewalk on span 2, looking northwest. Note unsupported end of swing span (August, 2024).

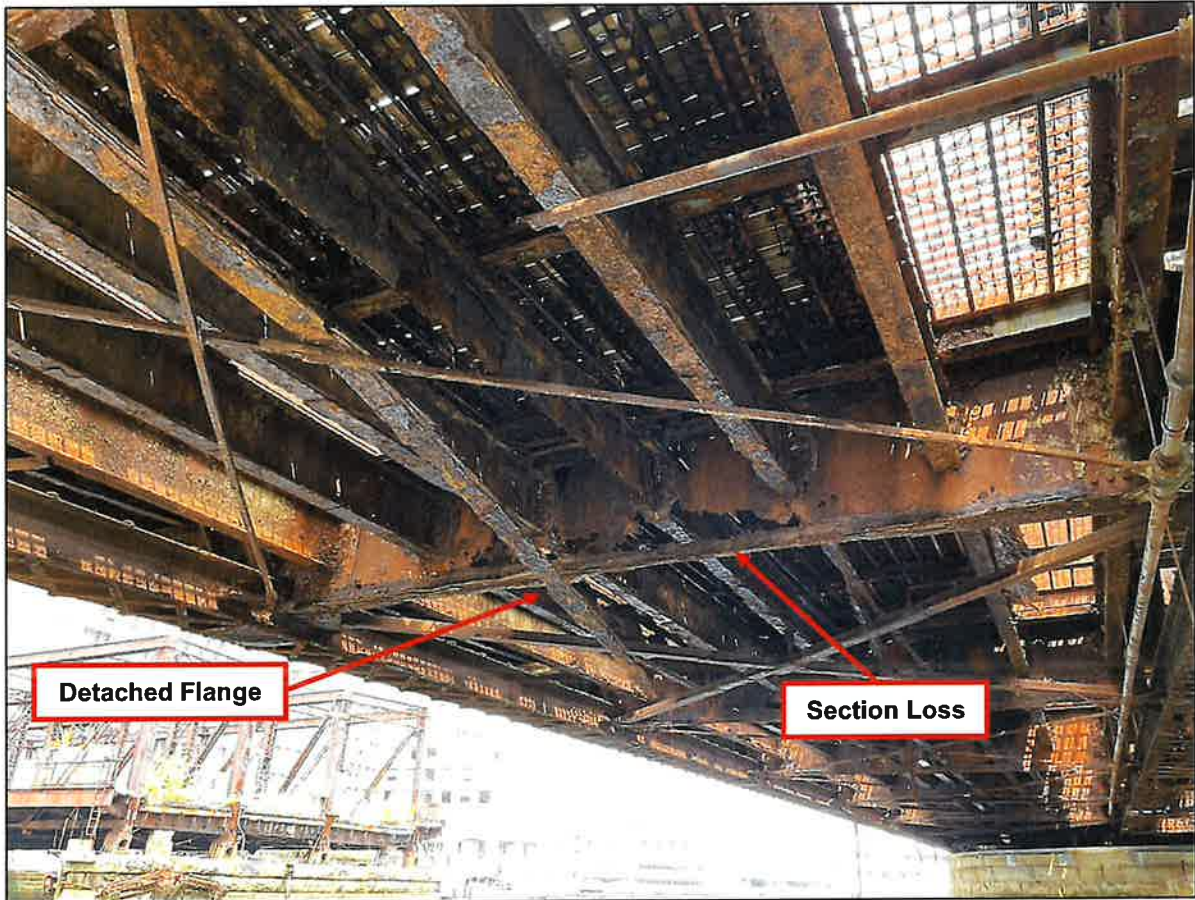
Photograph 4: Underside of swing span looking north. Note section loss in floor beam and detached flange from stringer (August, 2024).

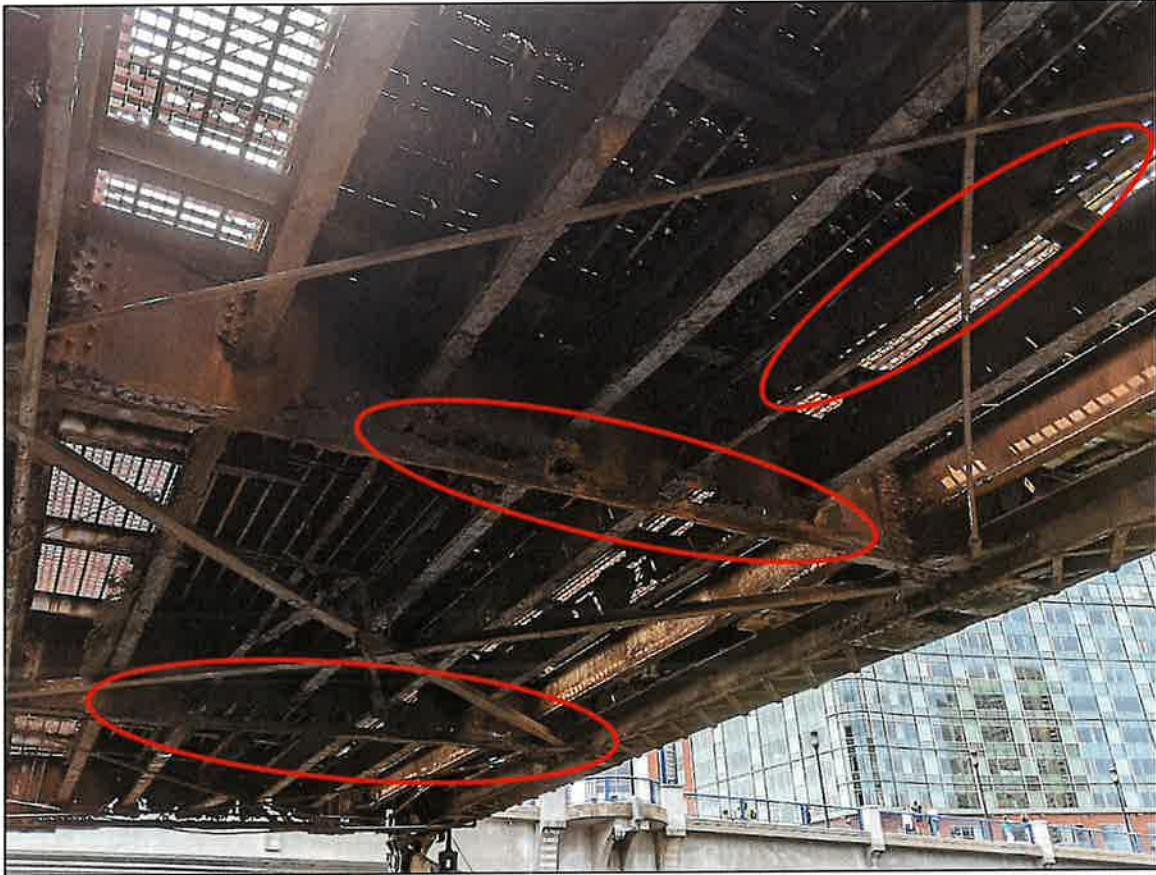
Photograph 5: Section loss at stringers and floor beams of swing span, looking southwest. (August, 2024).

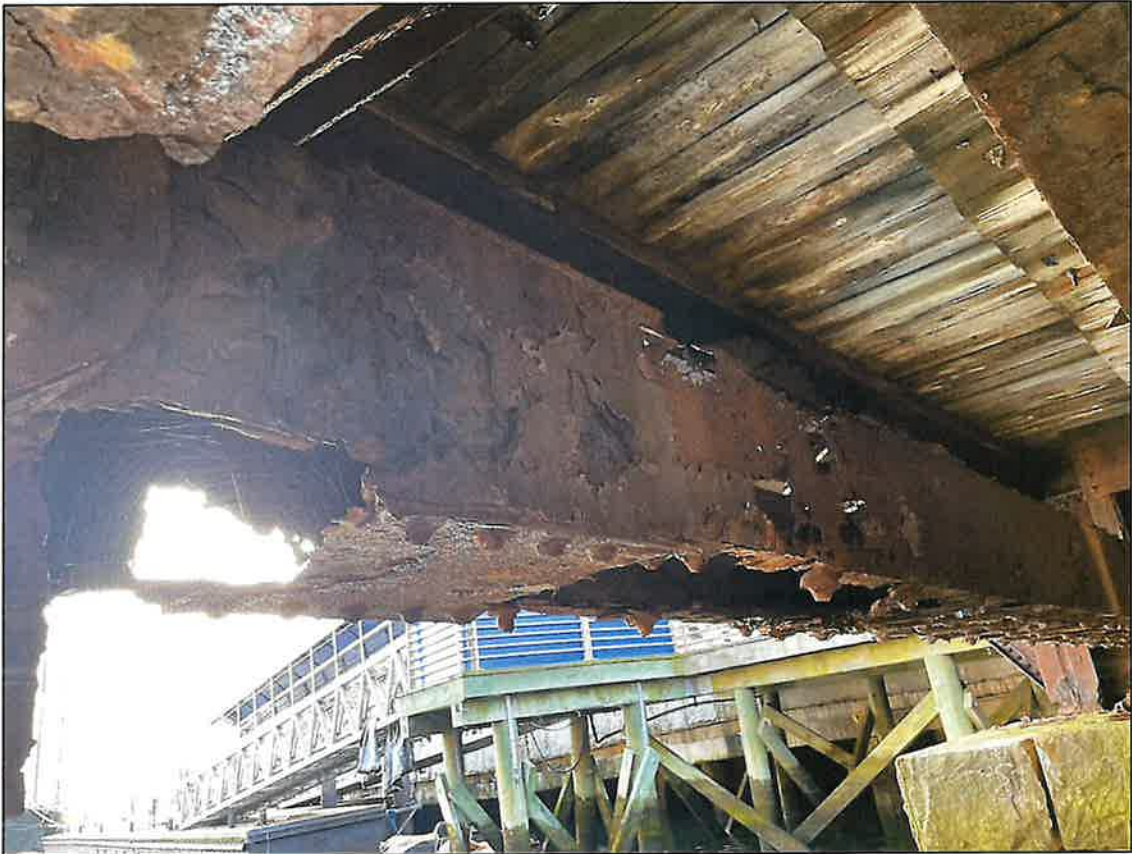
Photograph 6: Detail of stringer deterioration at span 2 (easterly fixed, approach span), and missing mortar from pier 3 looking northeast (August 2024).

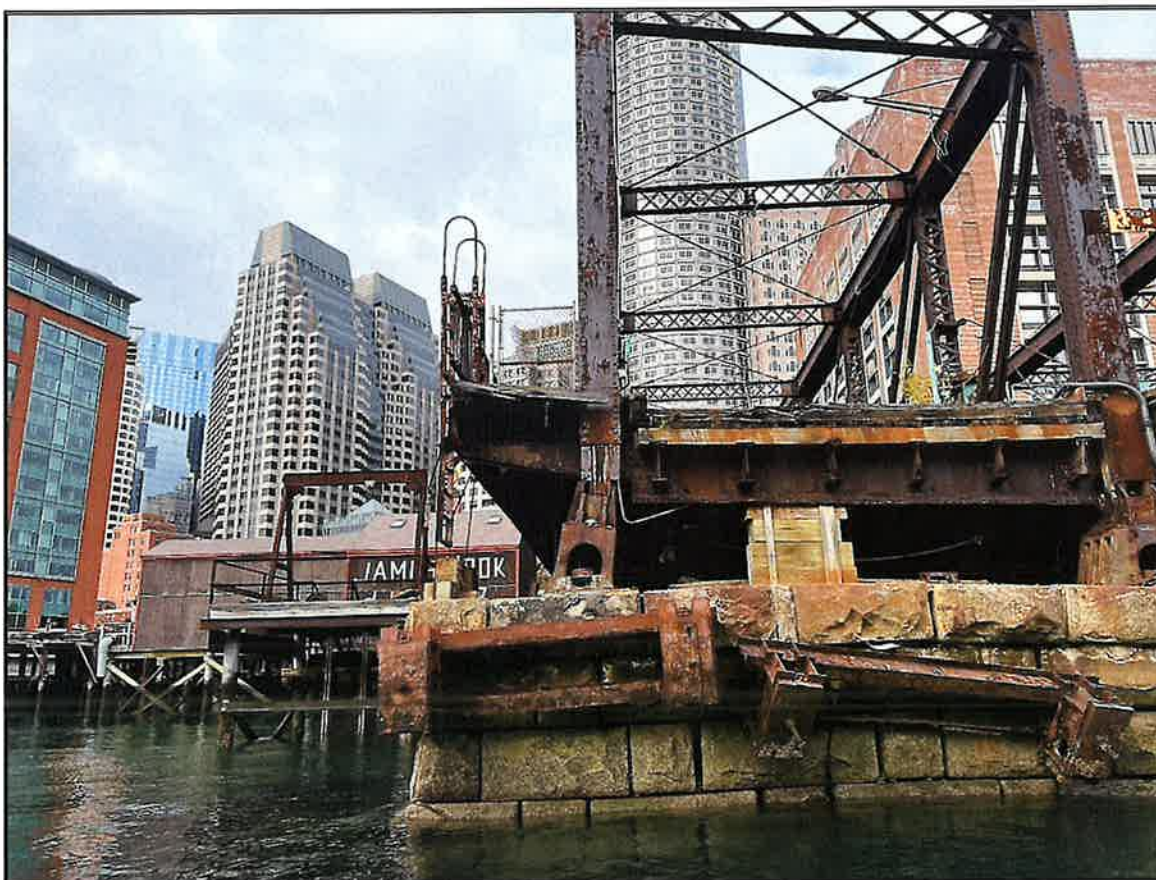
Photograph 7: Pier 1, looking west toward span 1 (westerly fixed, approach span). View of failed lagging repair and rotated bearing at pier (November, 2022).

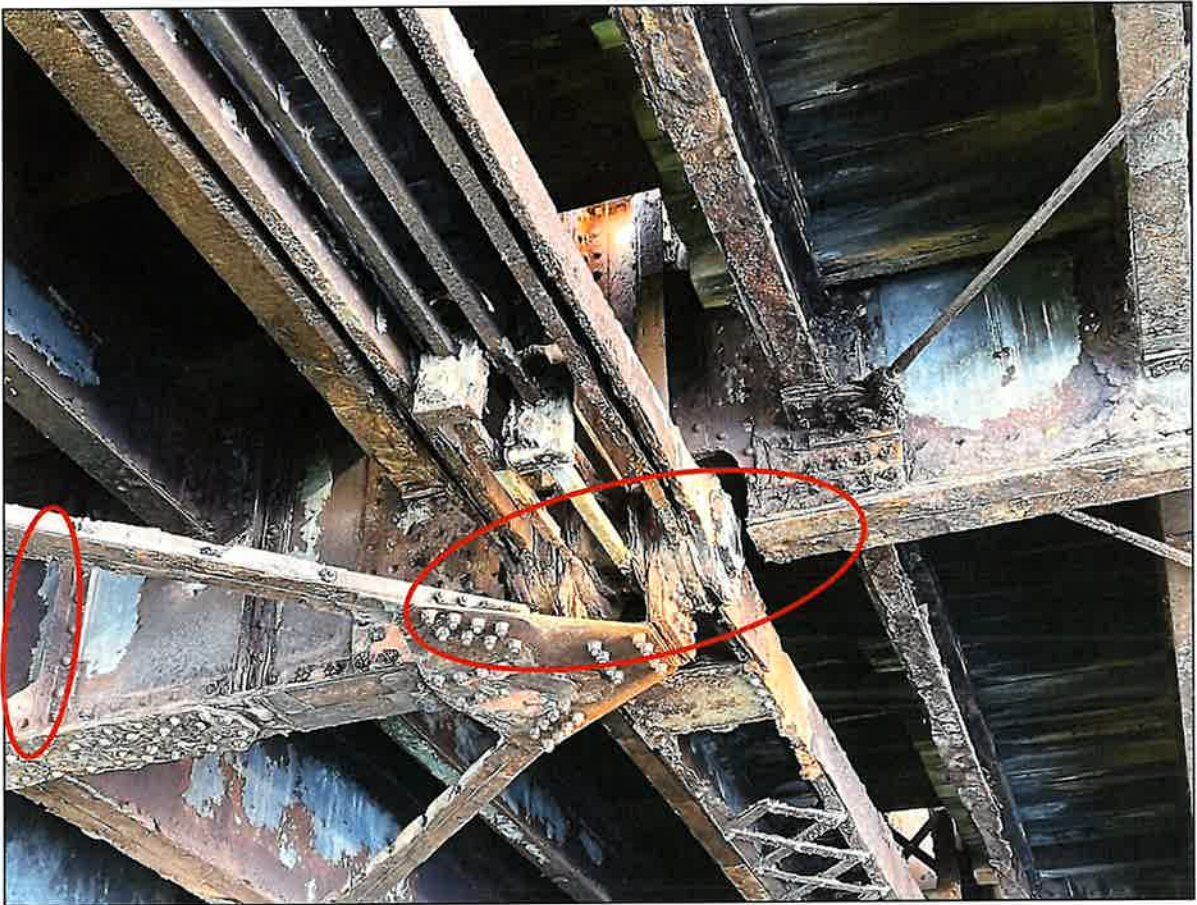
Photograph 9: Typical deterioration, section loss, and pack rust at pin connection (November, 2022).

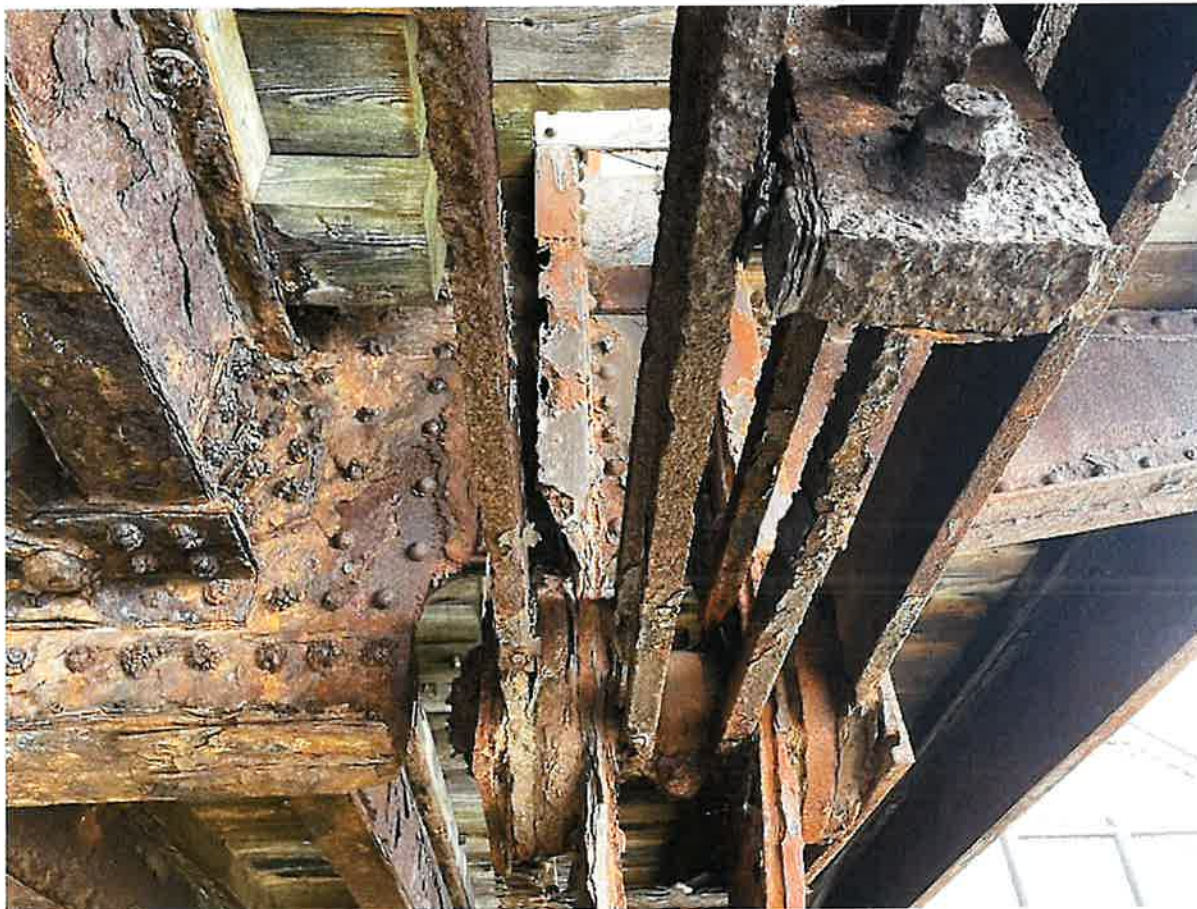
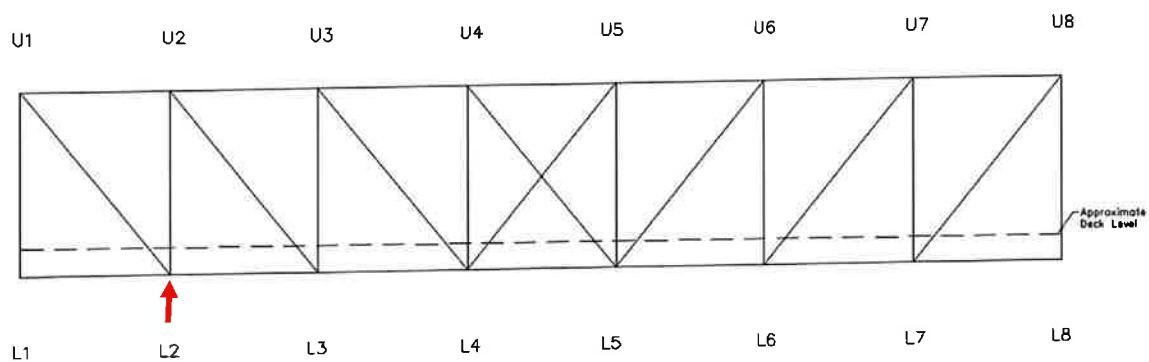
Photo 1. Span 1, North Truss, Lower Chord, L2-L3 (Looking West)

The original chords at the eyebar connection have 50% section loss by full height. The losses are typical throughout the entire member length. The lower chords have U-shaped repair bars around the pin. These bars also have section loss down to 45% square remaining.

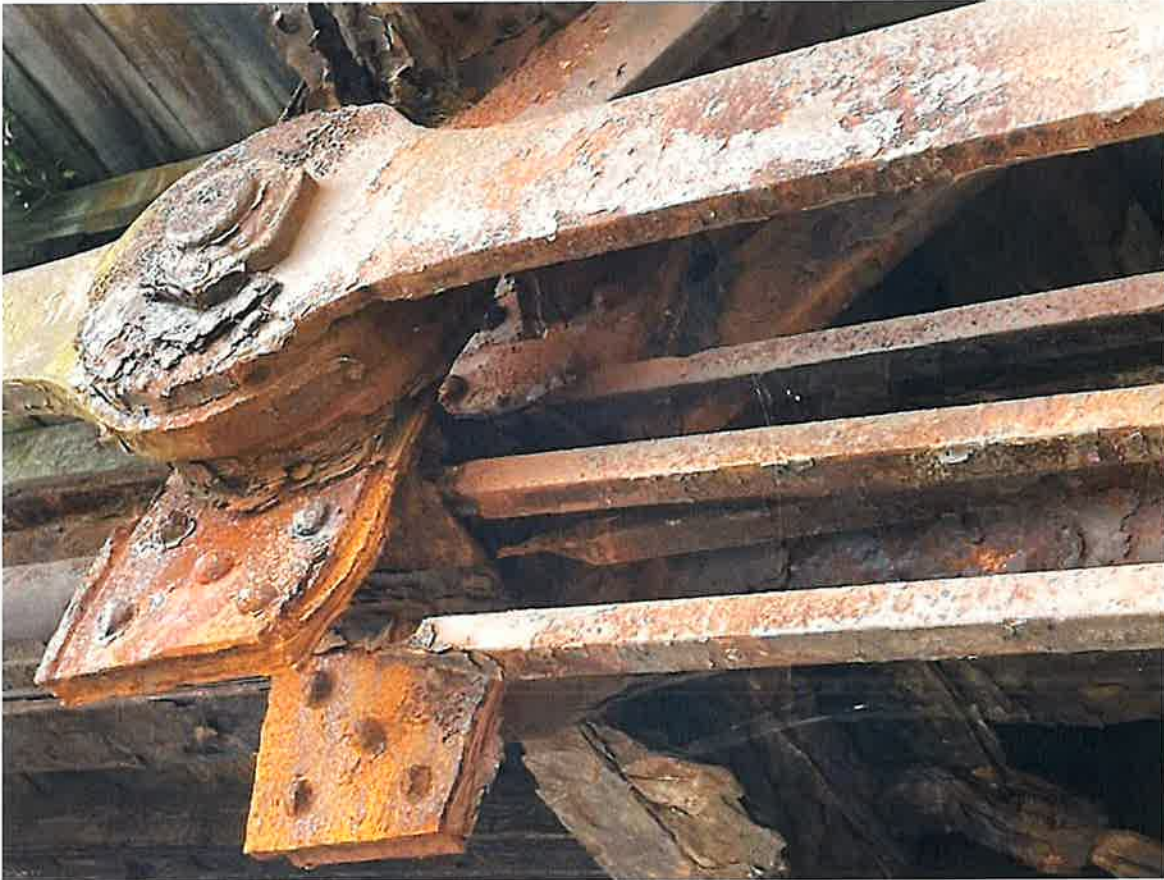
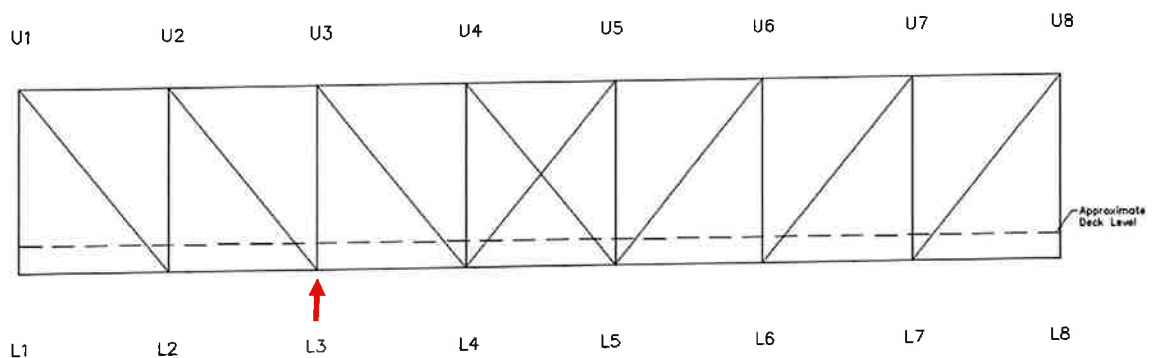
Photo 2. Span 1, North Truss, Lower Chord, L2-L3 (Looking East)

The original lower chords have loss down to 50% average remaining by full height. The lower chords have U-shaped repair bars around the pin. The south U-shaped bar bottom leg has failed/broken. The remaining north U-shaped bar bottom leg has losses down to 14% square remaining and requires immediate attention. If this lower chord and repair fail, the entire L2-L3 chord will fail since both ends are in critical condition.

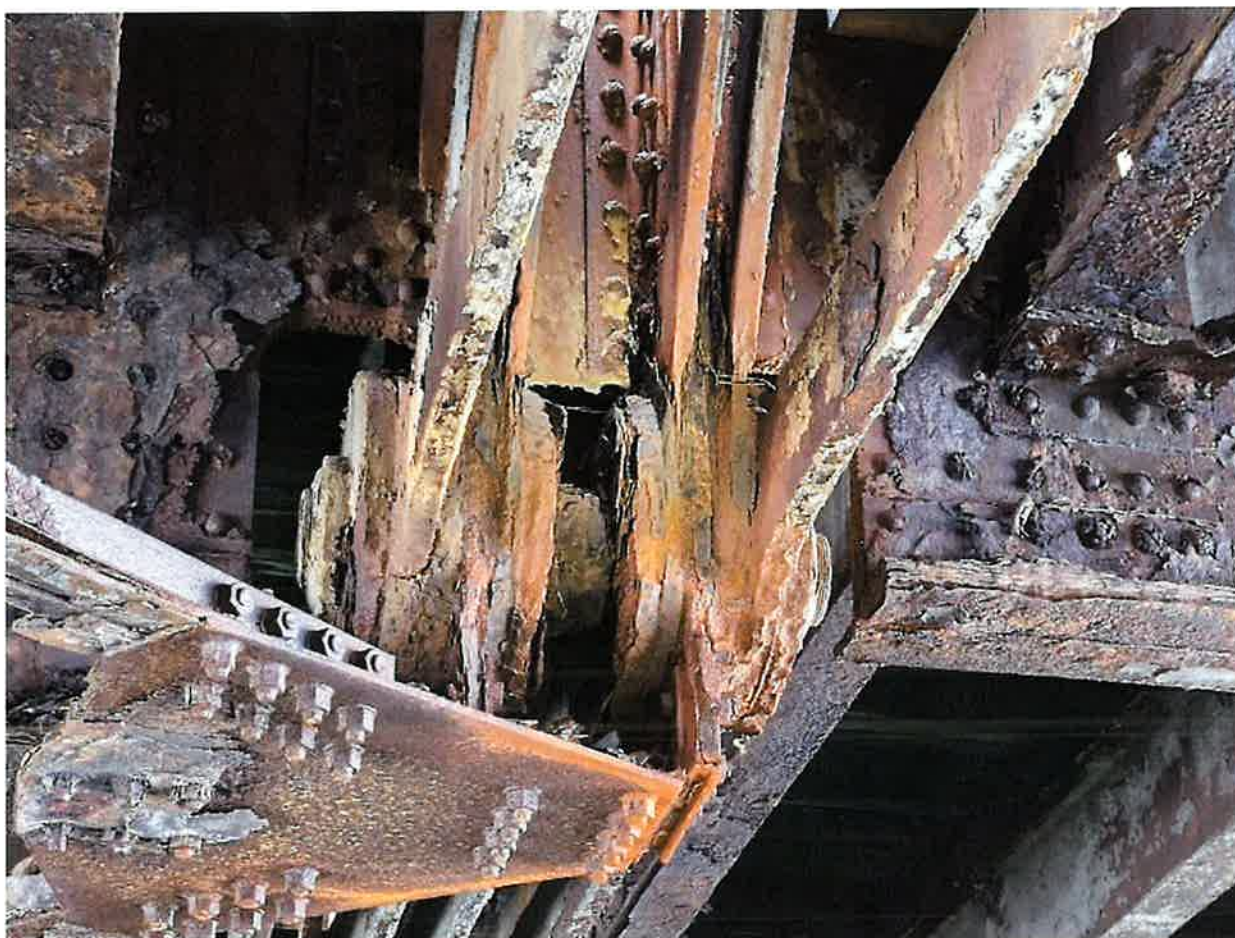
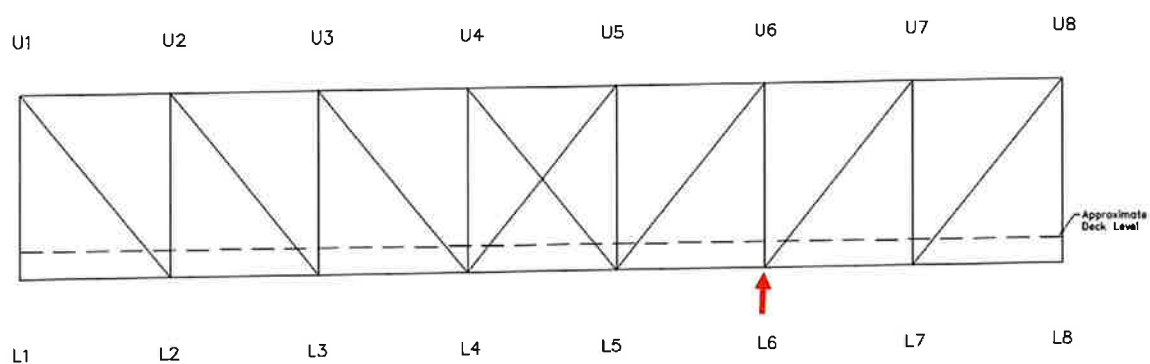
Photo 3. Span 1, Center North Truss, Diagonal, L6-U7 (Looking West)

All four diagonals have losses ranging from 15% remaining to 70% remaining. The south center diagonal has a rust hole by $1/2"$ H along the bottom edge.

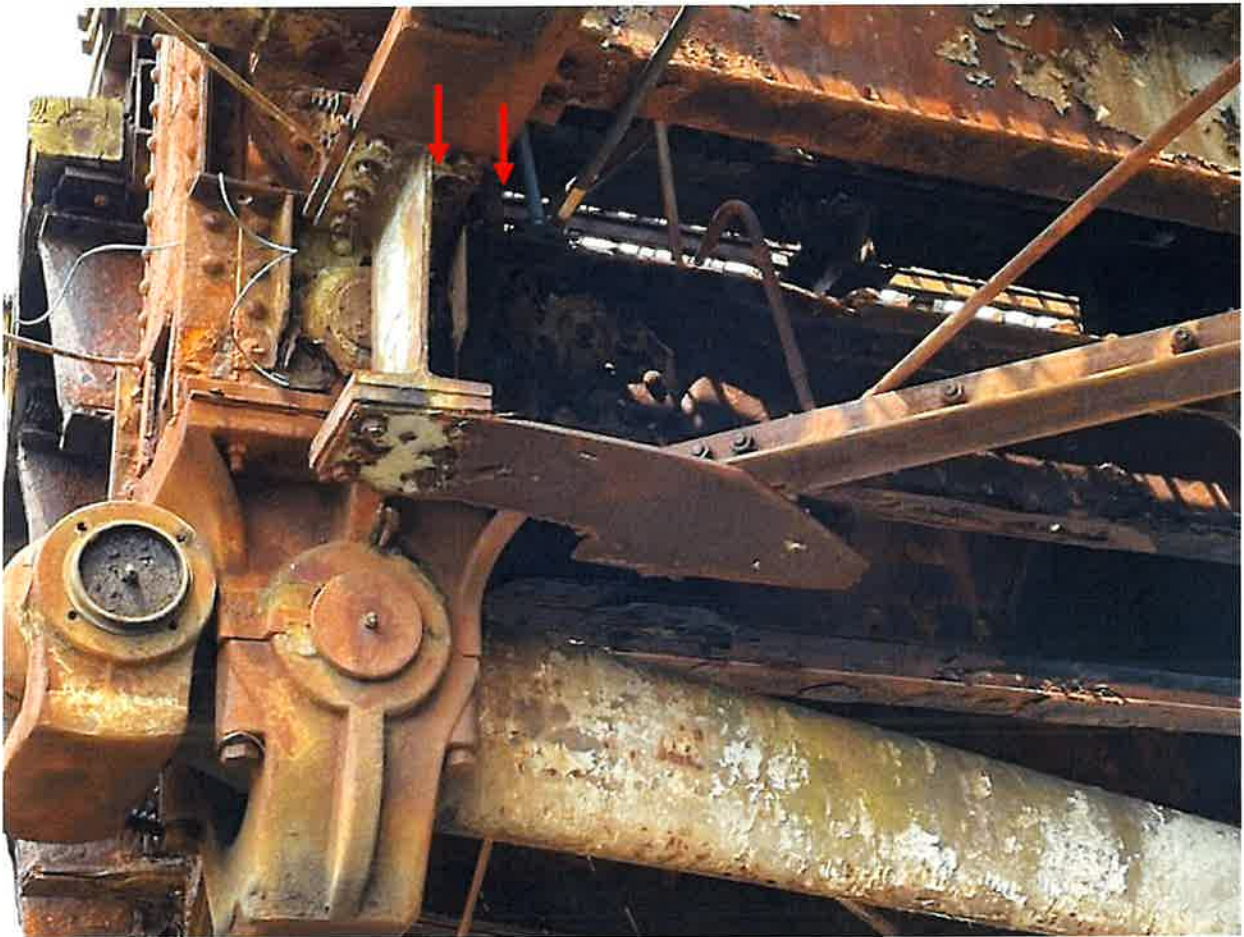
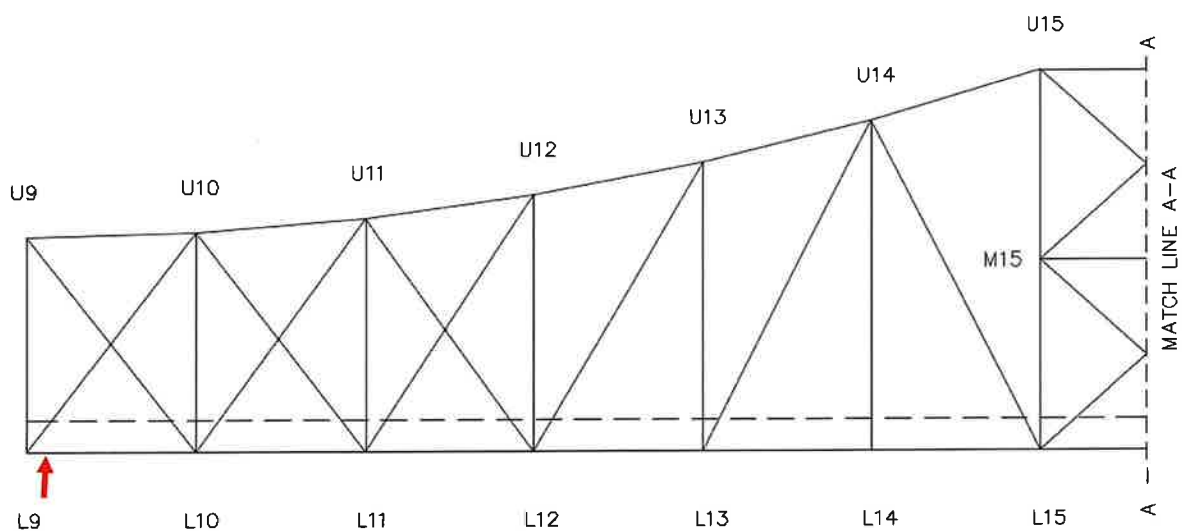
Photo 4. Span Swing, Center North Truss, Lower Chord, L9-L10 (Looking True North)
The south channel web and top flange are buckled. Channel webs have up to 1/4" loss. The top and bottom flanges have rust holes

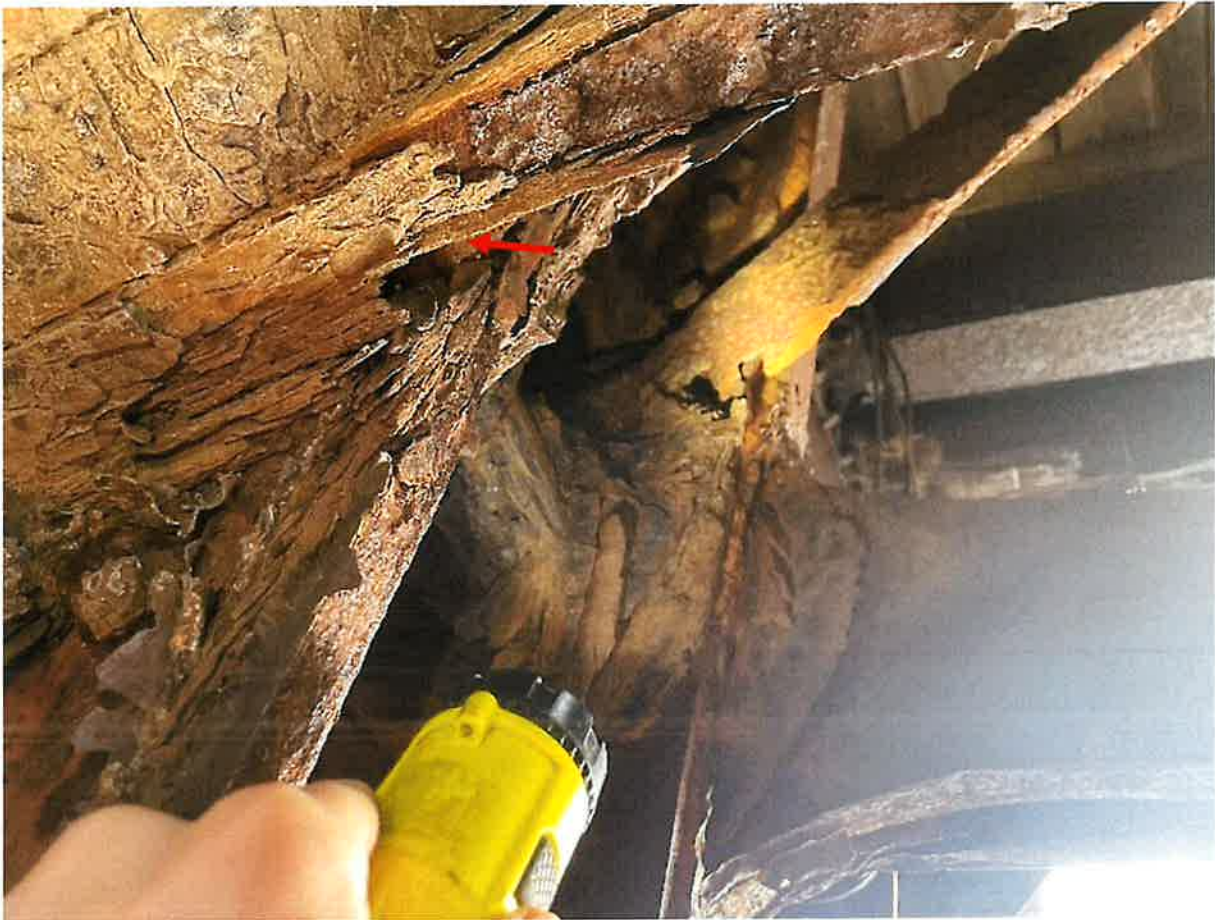
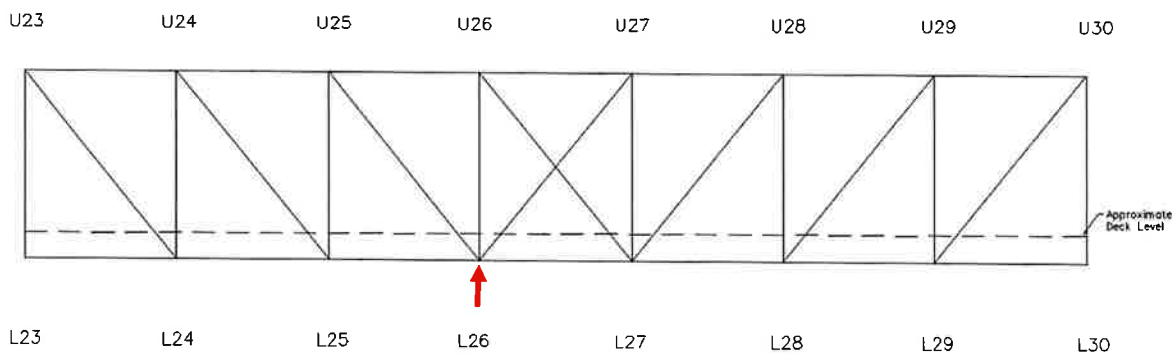
Photo 5. Span 2, North Truss, Diagonal, L26-U27 (Looking Northwest)

The north diagonal bar has a 3" W x 3" H rust hole at the bottom with 1-1/2" for the remaining width. The south diagonal bar has 1/4" average remaining by full width. If the north diagonal bar fails, the south diagonal bar will have torsional forces.

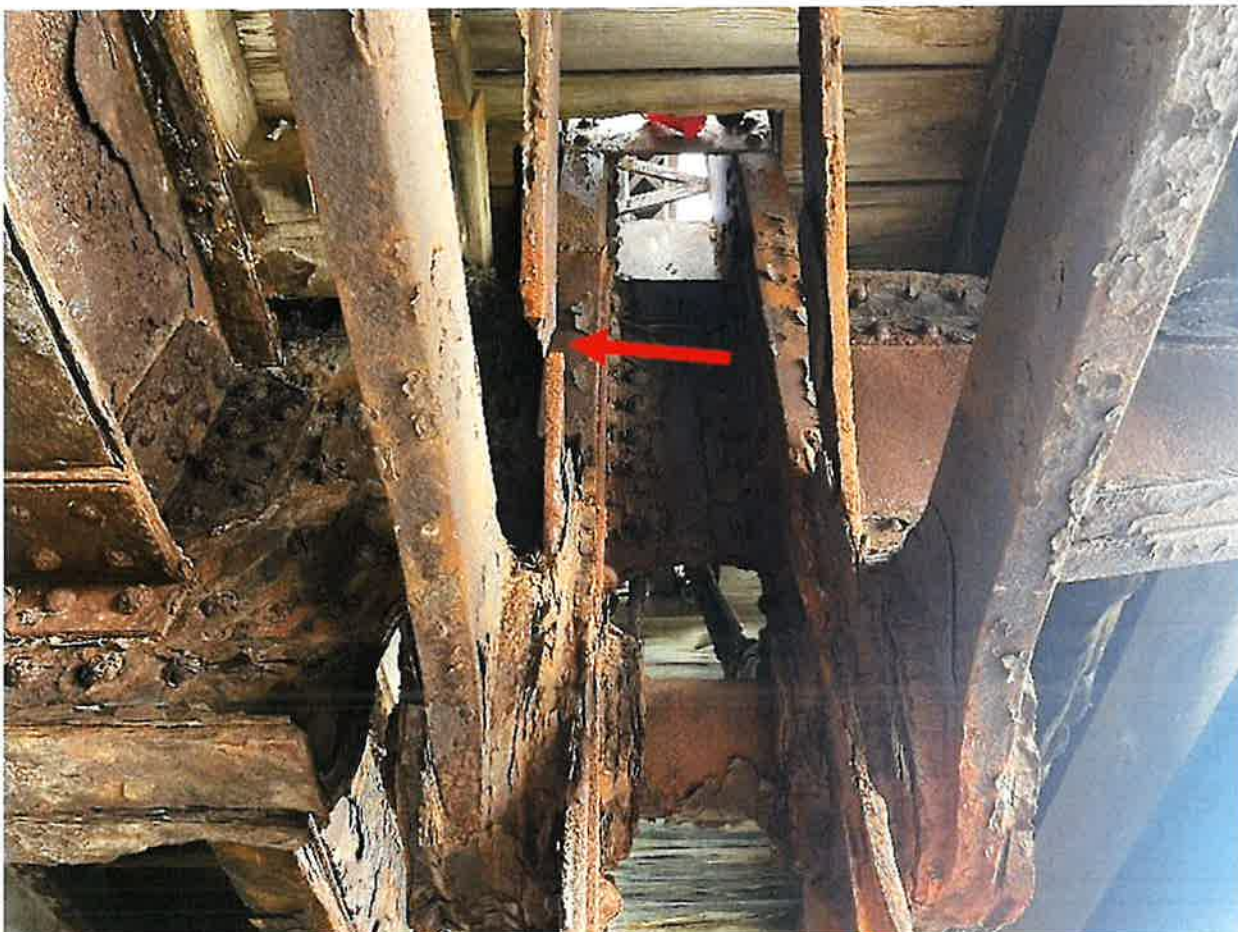
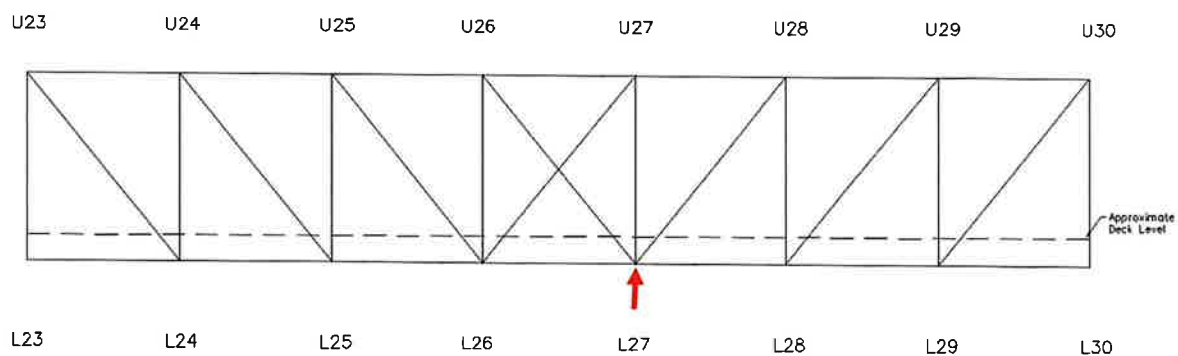
Photo 6. Span 2, North Truss, Diagonal, L27-U28 (Looking West)

The north diagonal has 5/8" remaining average by FW. The south diagonal has completely fractured just above the eyebar connection. The north diagonal has torsional forces applied.

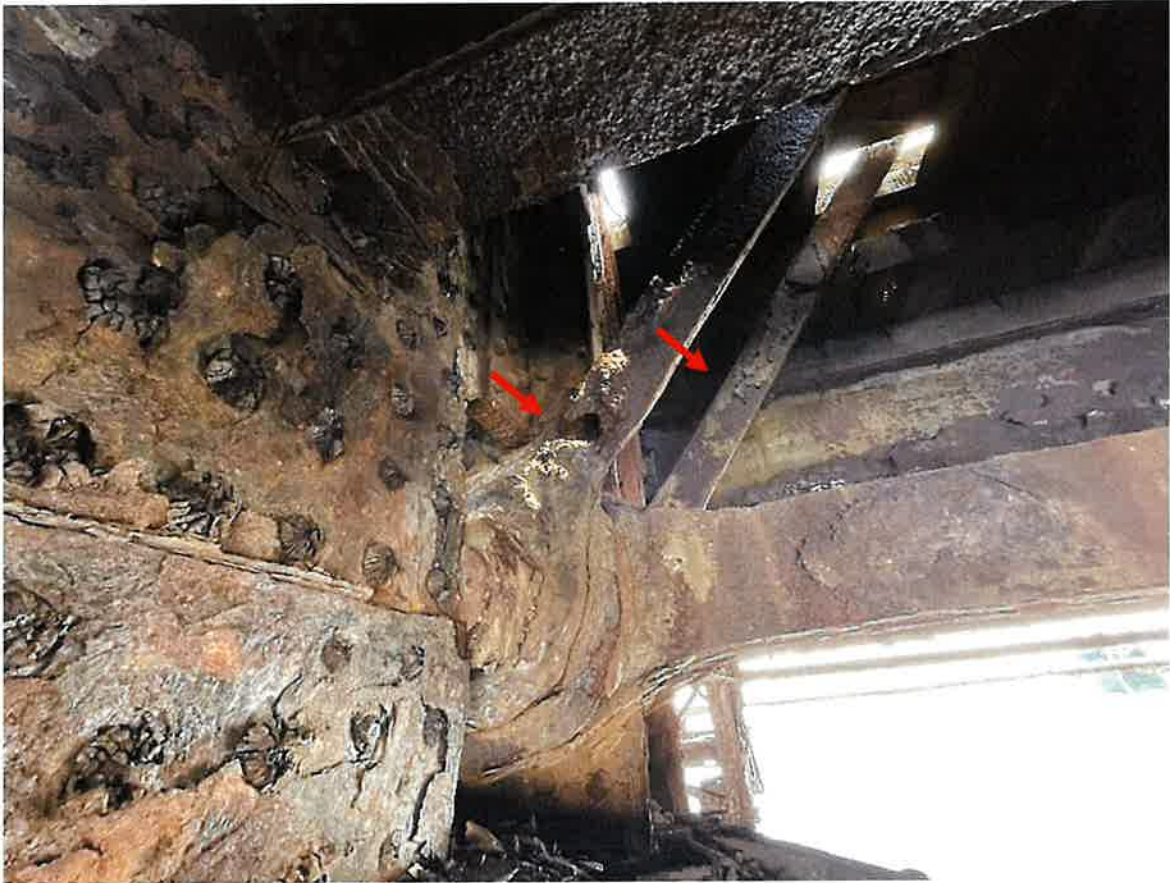
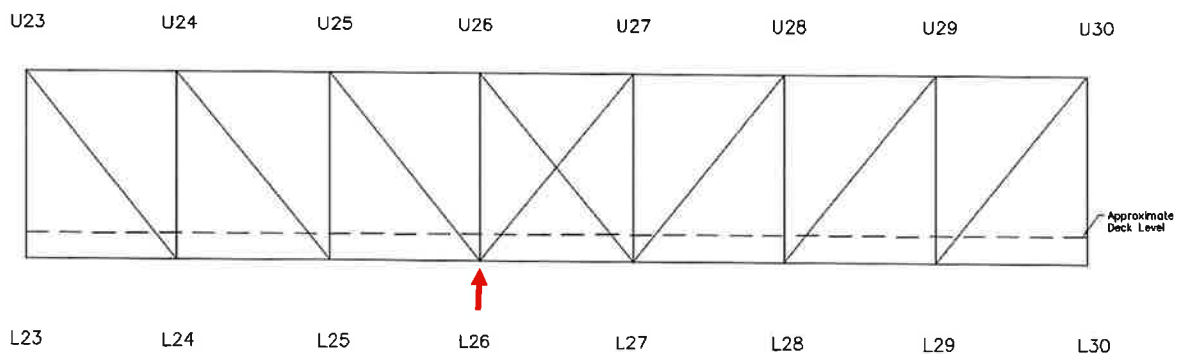
Photo 7. Span 2, Center North Truss, Diagonal, L26-U27 (Looking Northwest)

The north diagonal bar has between 90% to 75% remaining by FW. The south diagonal bar has two rust holes up to 4" W with less than 50% to knife edge remaining for the remaining width. If the south diagonal bar fails, the north diagonal bar will have torsional forces.

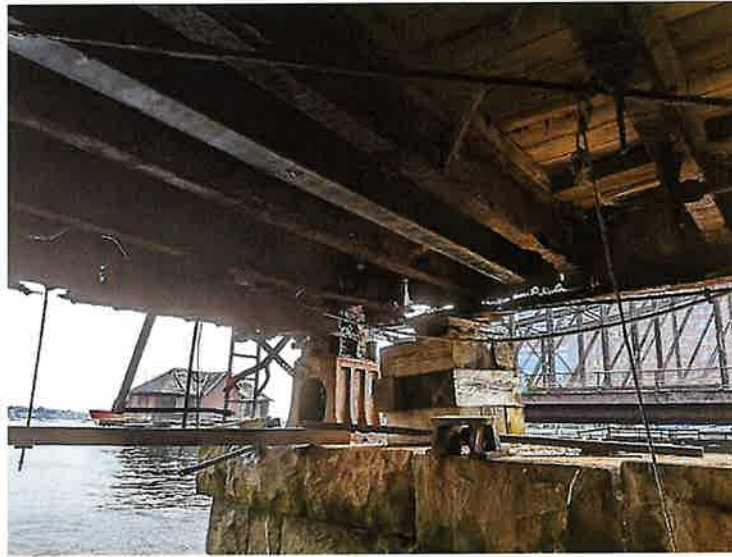
Photo 9: Approach Span 1, Pier 1, North Bearing L8 (Looking Northeast)
The pier bearings typically have adjacent timber cribbing.

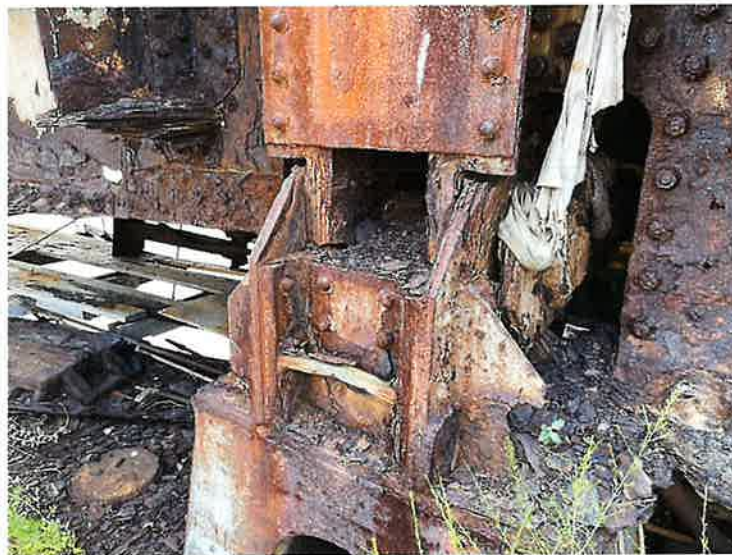
Photo 10: Approach Span 2, Pier 2, Center North Bearing L23 (Looking East)
The pier bearings typically advanced deterioration with rust holes and pack rust.

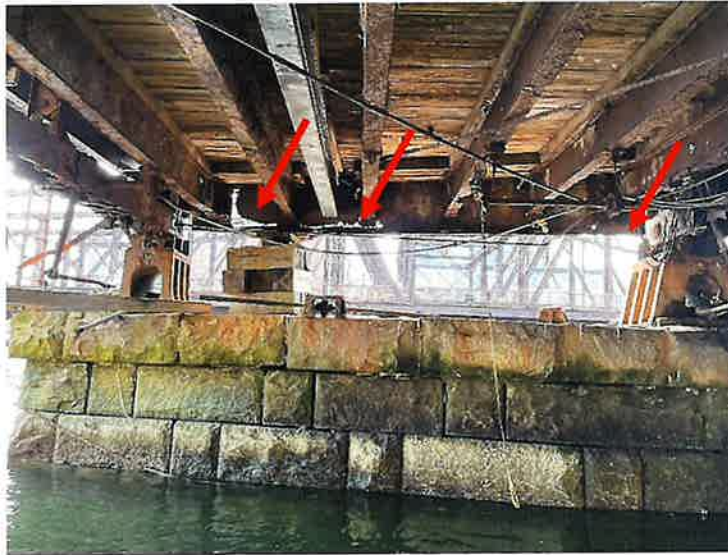
Photo 13: Approach Span 1, Pier 1, Floorbeam FB8 (Looking East)

Between the A2N bearing and the timber cribbing, the end floorbeam has a rust hole with adjacent paper-thin remaining section. The bottom of the web south of the timber cribbing has several rust holes. Adjacent to bearing B2N, the floorbeam has missing sections of the bottom flange.

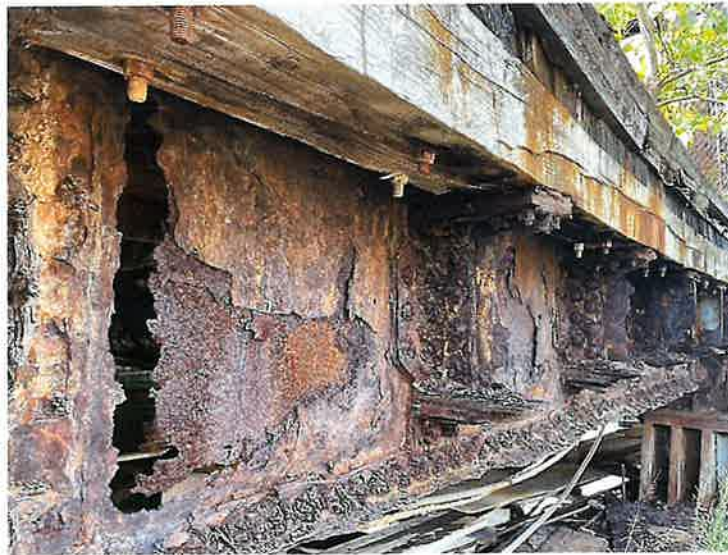
Photo 14: Approach Span 2, Pier 2, Floorbeam FB23 (Looking East)

South of the A2N bearing, the end floorbeam has a rust hole with adjacent paper-thin remaining section. The bottom flange has knife edge section for the full length of the floorbeam.

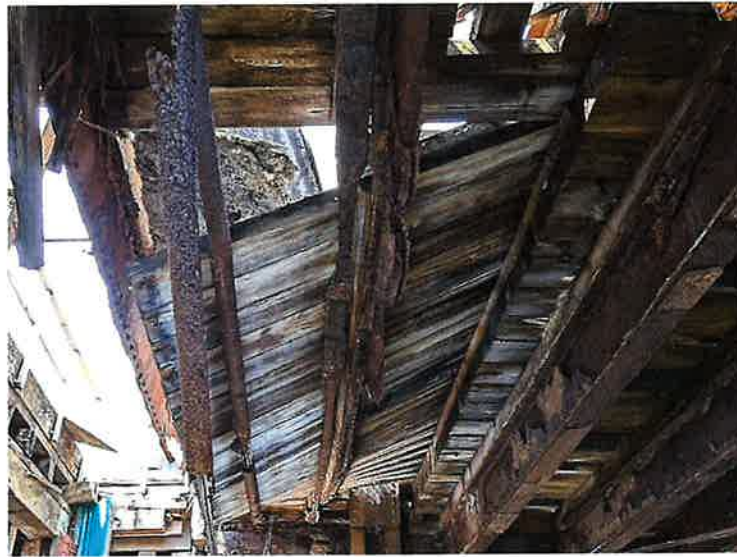
Photo 15: Approach Span 1, South Bay, Between Floorbeams FB1 and FB2, Deck and Sidewalk Stringers (Looking West)

An area of sidewalk caving in due to severely deteriorated sidewalk stringers, sidewalk cantilever brackets, and sidewalk planks. This area is considered to be in "imminent failure".

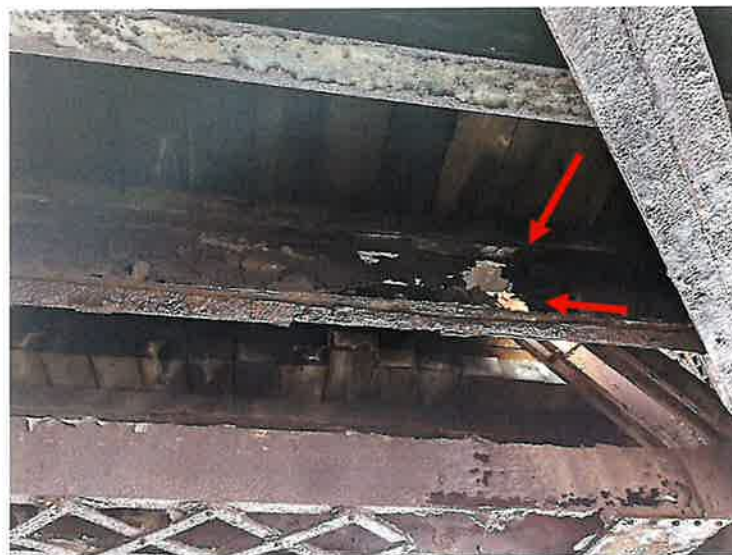
Photo 16: Approach Span 1, Center Bay, Between Floorbeams FB2 and FB3, Stringer 6 (Looking North)

The stringers typically have large rust holes on the flanges and web with paper-thin remaining section of the remaining width of the bay.
