RE: Northern Avenue Bridge Superstructure Removal Project
City of Boston, Suffolk County
Submittal of Project Notification Form

Project Notification Form

Northern Avenue Bridge Superstructure Removal Project

Northern Avenue Bridge
Over
Fort Point Channel

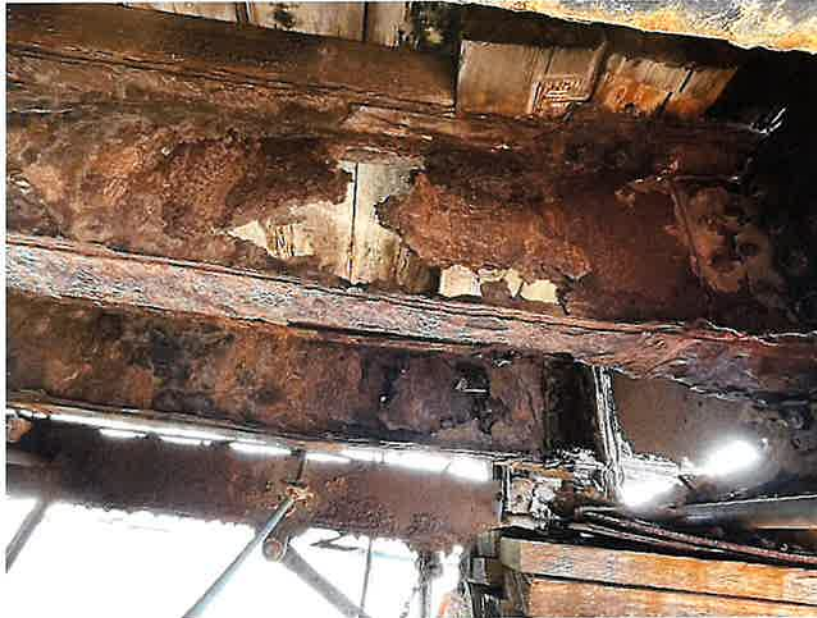
Photo 17: Approach Span 1, North Bay, Between Floorbeams FB7 and FB8, Stringer 5 (Looking East)

The stringers at the end floorbeam FB8 have large rust holes along the webs.

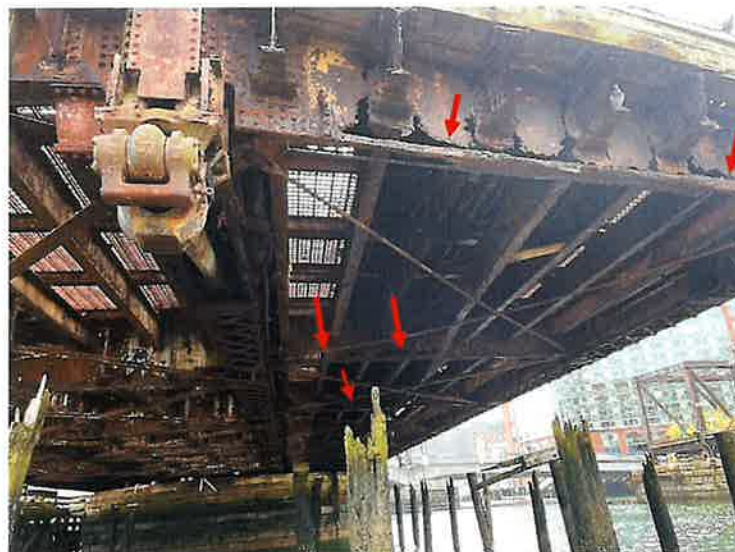
Photo 20: Swing Span, North Bay, Between Floorbeams FB21 and FB22 (Looking True South)
Swing Span floorbeams typically have large web rust holes with paper-thin remaining for the remaining web.

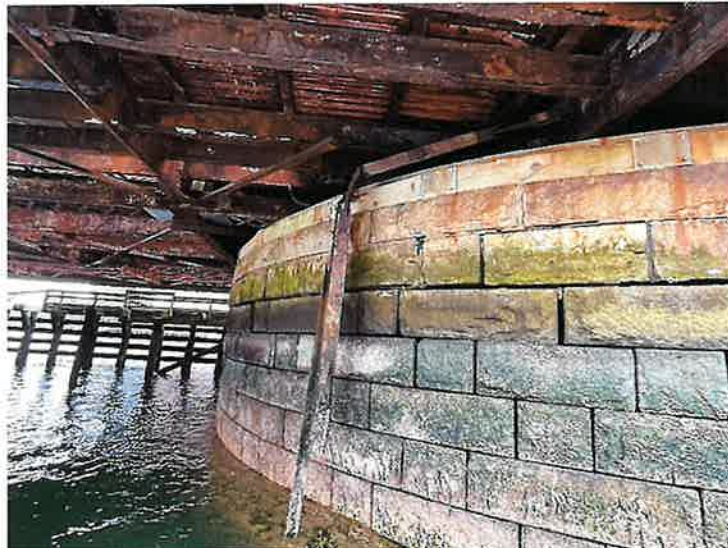
Photo 22: Swing Span, Center Bay, Between Floorbeams FB16 and FB17, Floor System Bracing (Looking True South)

The swing span has several floor system bracings in "critical" or failed" condition.

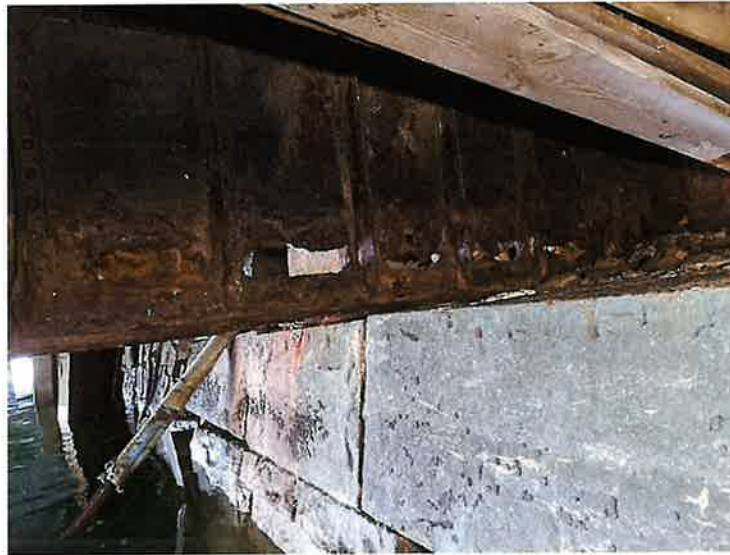
Photo 23: Approach Span 3. Girder P, Between Floorbeams FB5 and FB6 (Looking North)
The approach fixed span girders typically have rust holes at the bottom of the webs and severely deteriorated bottom flanges.

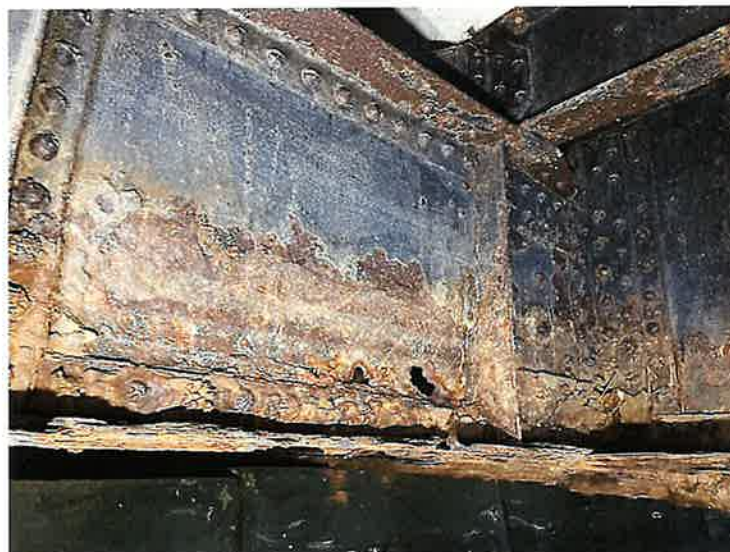
Photo 24: Approach Span 3. Floorbeam FB5, Between Girders GO and GP (Looking East)
The approach fixed span interior floorbeams typically have small rust holes and section loss along the bottom of the web

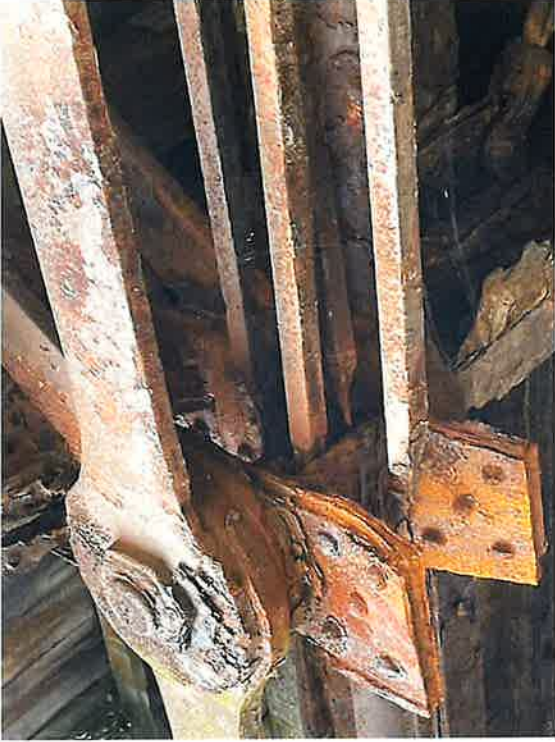
North Truss at L2-L3 (2024)
*Continuous deterioration of remaining U-Bar will cause failure of lower Chord L2-L3

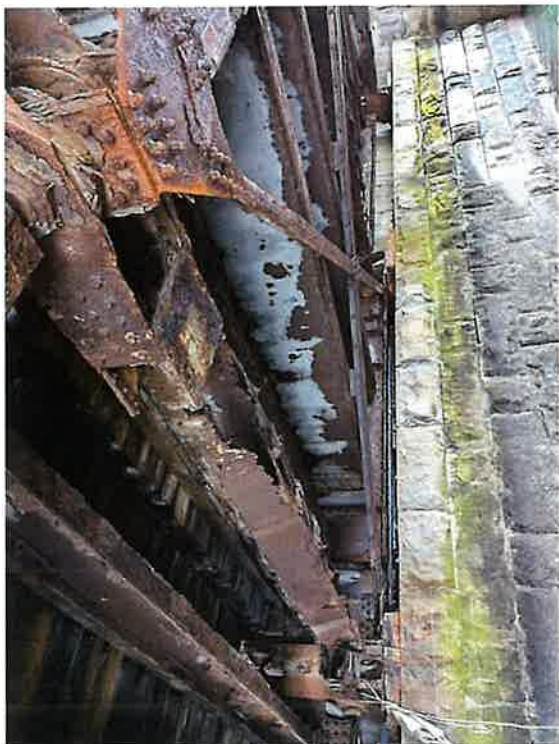
Center South Truss at L1-L2 (2024)
*Continuous deterioration of end strut will cause a falling hazard. This end strut is not part of the load path.

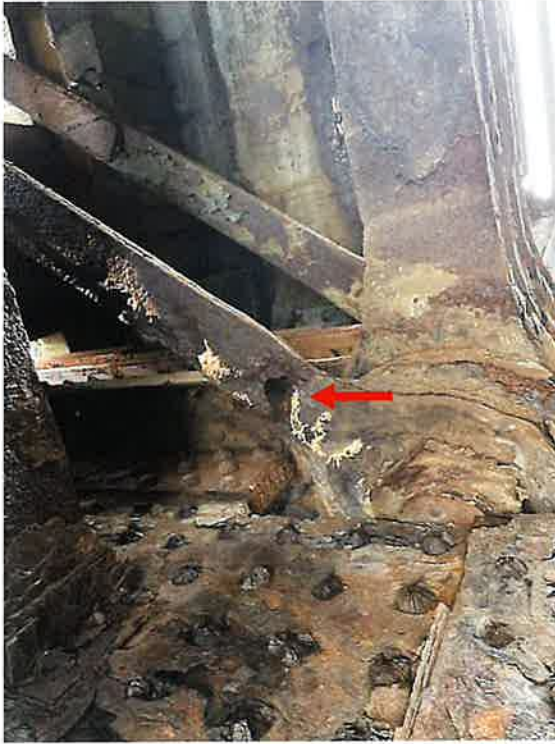
Center North Truss at L26U27 at L26 (2024)
*Continuous deterioration of diagonal member will lead to failed/fractured member

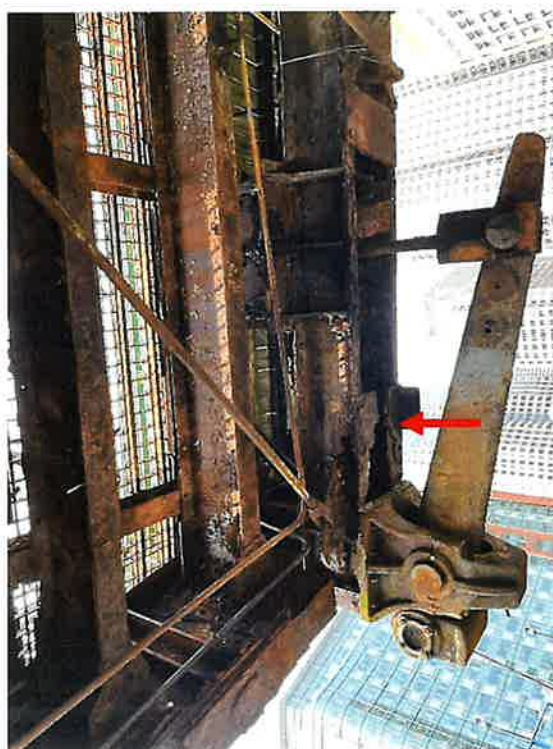
North Truss at L9L10 at L9 (2024)
*Advanced deterioration of existing rust hole since the 2017 inspection.

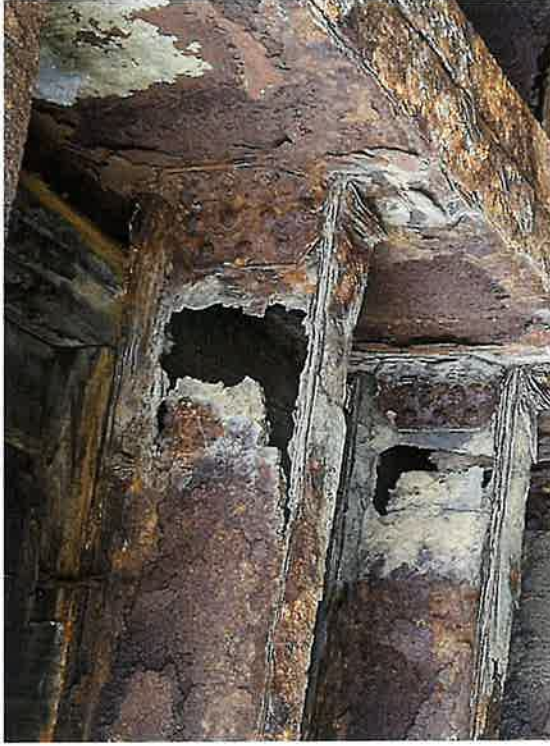
North Bay, Btw FB2 & FB3 – Stringer S4 (2024)
*Progressive deterioration of existing rust hole since the 2017 inspection.

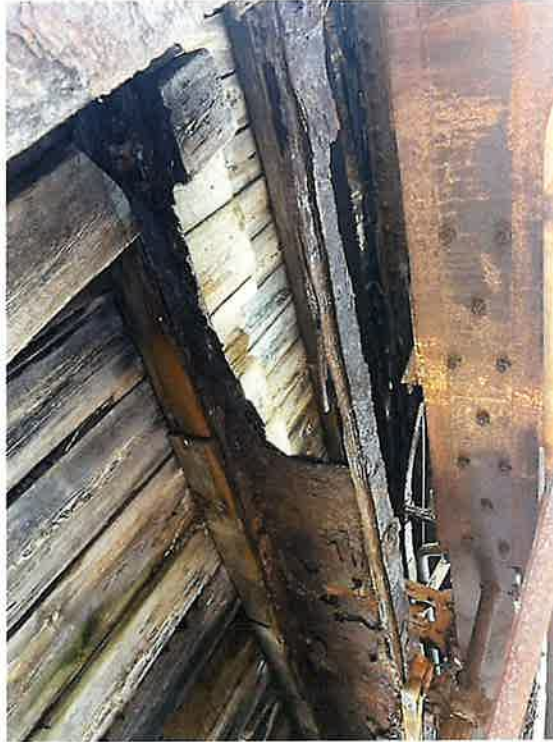
South Bay, Btw FB23 & FB24 – Stringer S1 (2024)
*Advanced deterioration of existing rust hole since the 2017 inspection.

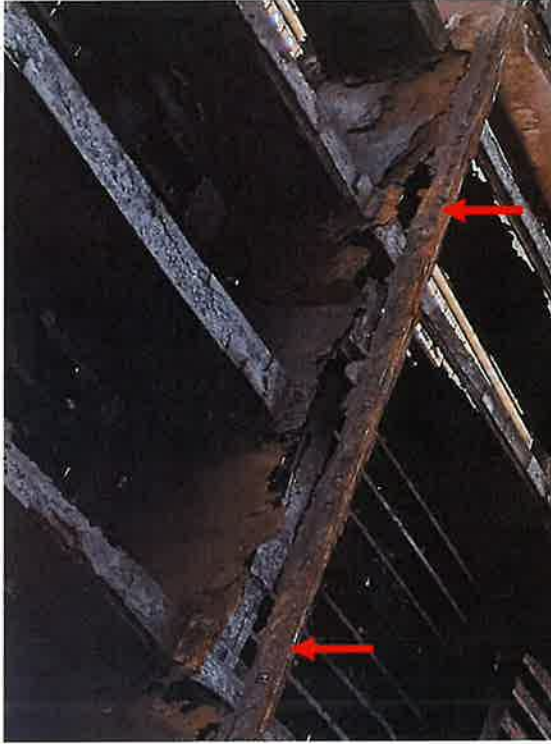
Swing Span , North Bay - Floorbeam FB17 (2024)
*Advanced deterioration of existing rust hole since the 2017 inspection.

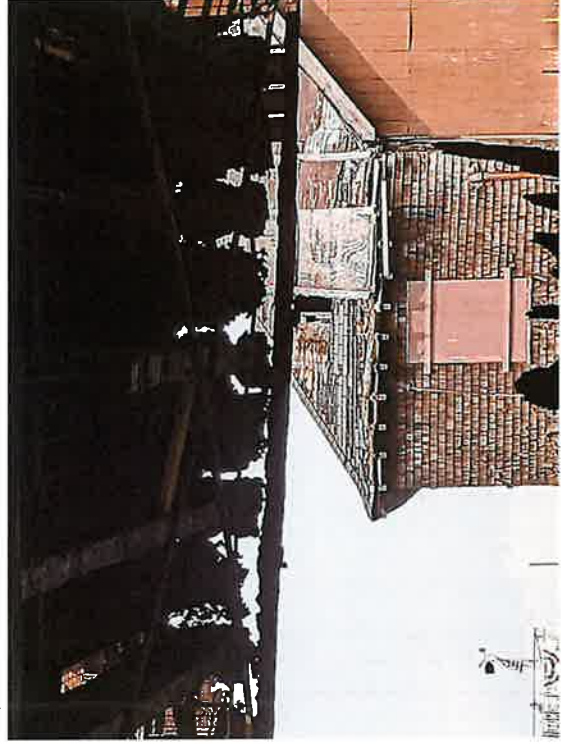
Swing Span, North Bay - Floorbeam FB22 (2024)
*Advanced deterioration of existing rust hole since the 2017 inspection.
