ZR Inspection Services, a year in review.

## Year In review for 2024

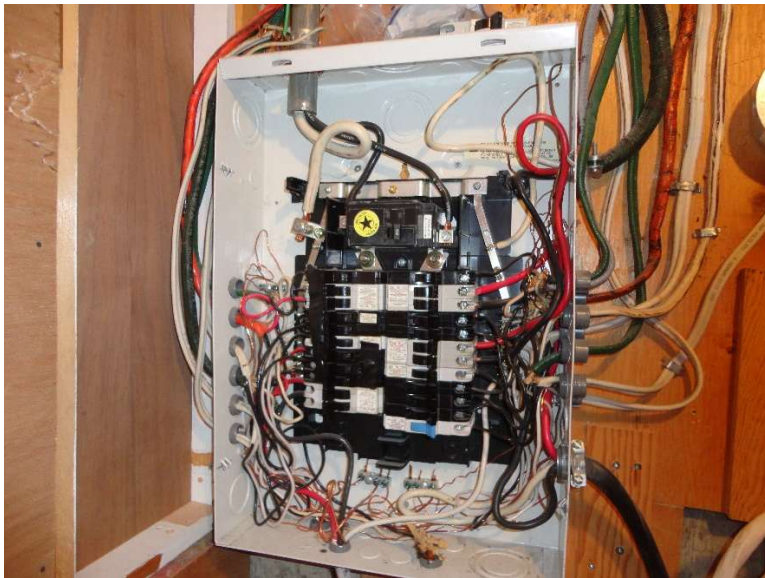
- 1) Electrical service reported as “100” amp, with a reputable electrical contractor inspection report saying there “was no non code compliance items found” I found numerous items in the panel alone. Not only was the listed service incorrect, the wires were also over-fused. This poses a possibly dangerous condition where overheating or fires could occur. According to the homeowner, they were unaware that the service was 60 amp only.

Some insurance companies do not cover 60 amp electrical services on single family detached homes (condos/apartments/mobile homes are generally fine). If you’re buying a detached home with a 60 amp service, consider upgrading and inquire with your insurance provider.

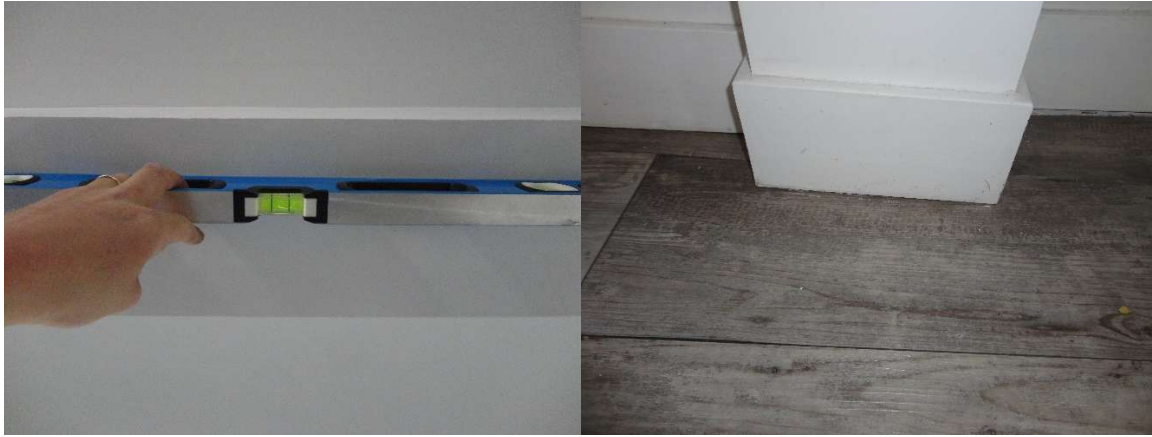
- 2) Older home with removed walls. Quite common practice today with homes 80+ years old. Open concept provides more space so it make sense. Was the renovation done correctly? How would you be able to tell?

The beam was undersized and did not appear to be correctly point loaded. The floor was starting to become crushed around the column. The beam was also sagging in the center. If you look at either sides of the column/floor intersection, the flooring is starting to crush/sag.

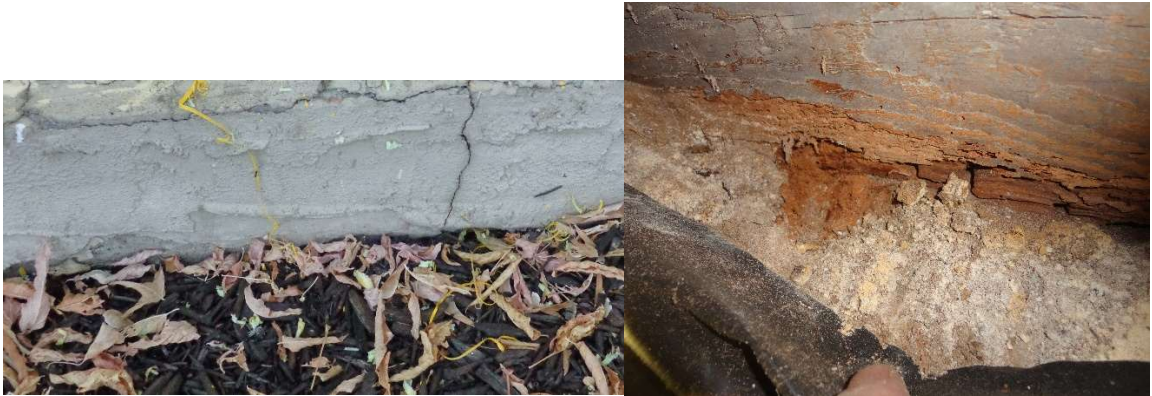
- 3) Concrete “curb” hiding a wood foundation at the exterior. The foundation appeared to be concrete at first when walking around the exterior.

Yes the wood foundation was rotten, with sloping floors as a implication of the settling/rotting foundation.

This would not have been found without crawling In the low access, dirt floor, crawlspace. Multiple rotted framing members were found throughout this crawlspace.
