August 2, 2022

You commissioned Flooring Warranty Services to inspect your floating resilient flooring for unusual marks, cleanability, and lifting/ separating end joints. The initial inspection was performed May, 9th 2022. Samples were collected and additional testing was performed at Professional Testing Laboratory in Dalton, GA. A follow up inspection and test cleaning was performed July 27th, 2022.

Problem Description:

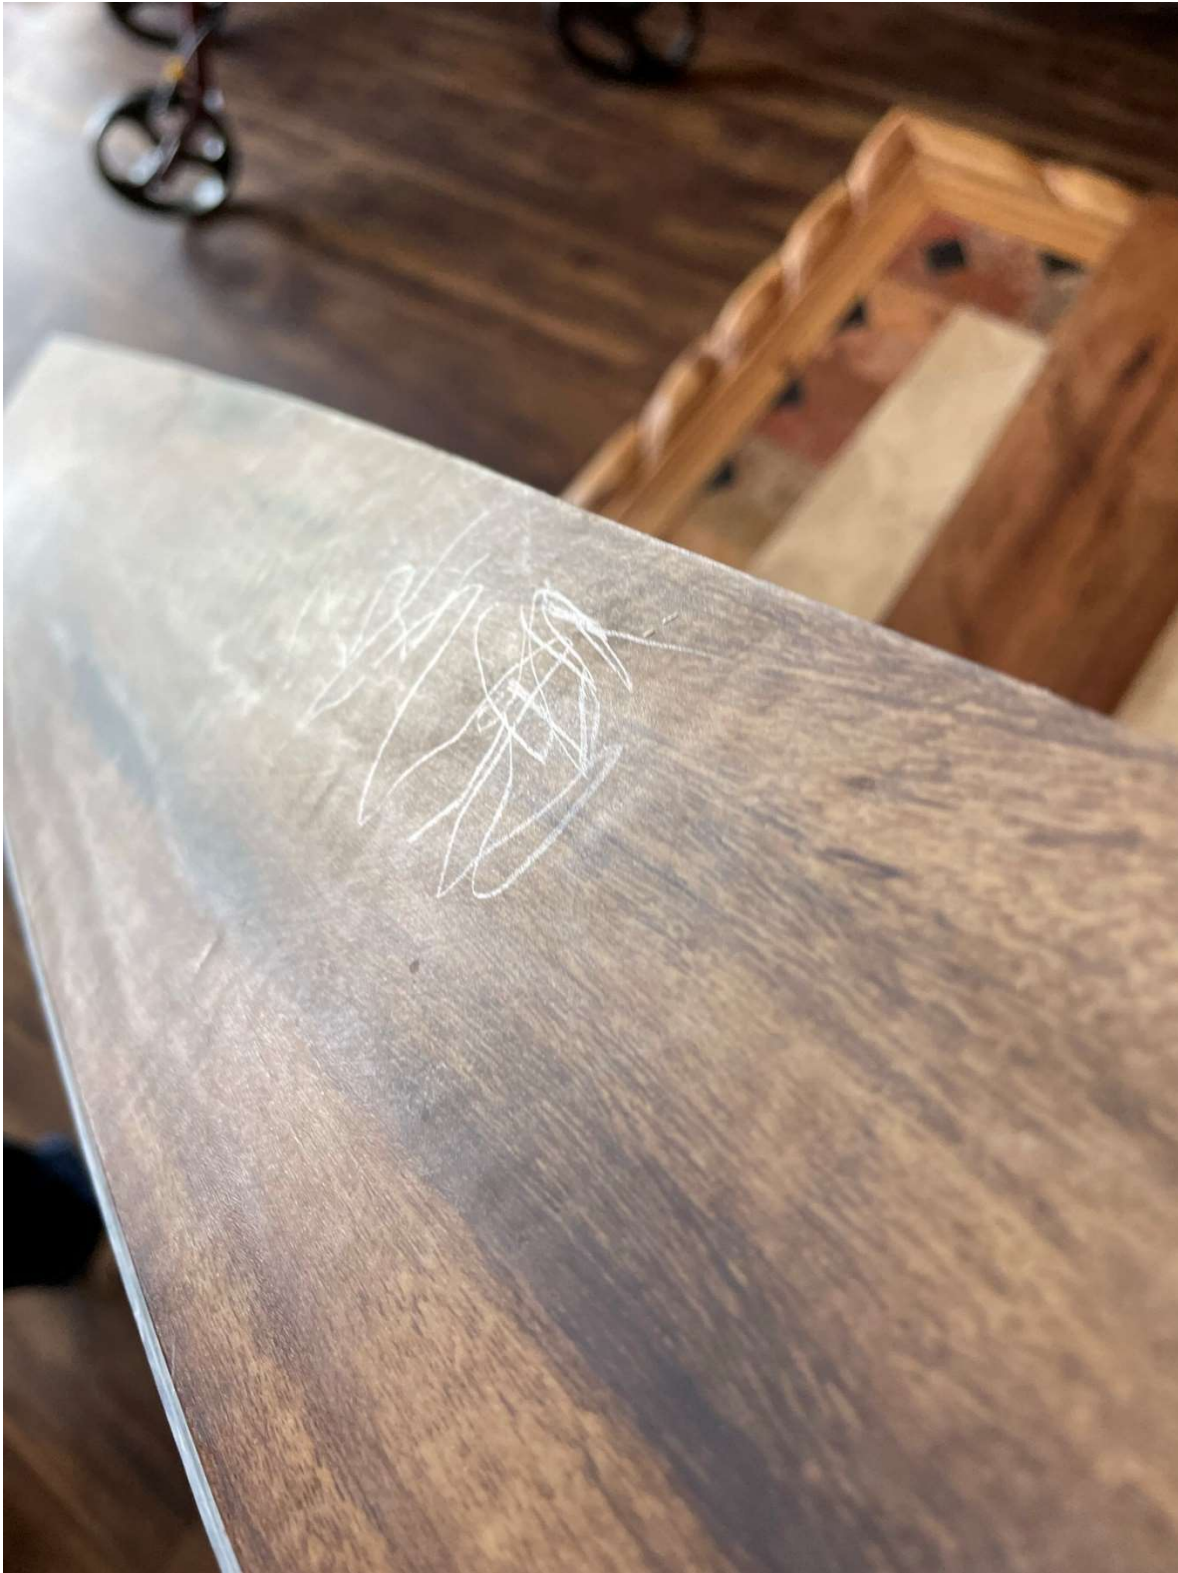
The scuff marks were apparent from a standing position and could be seen most easily when light fell across them from the side. One side of the living room has several large windows that let in a lot of ambient light. The customer also demonstrated on an uninstalled board how, when rubbed with a fingernail, the spot would become glossier and stand out more.

Scuff marks in wear layer- Made with customer's fingernail for demonstration.

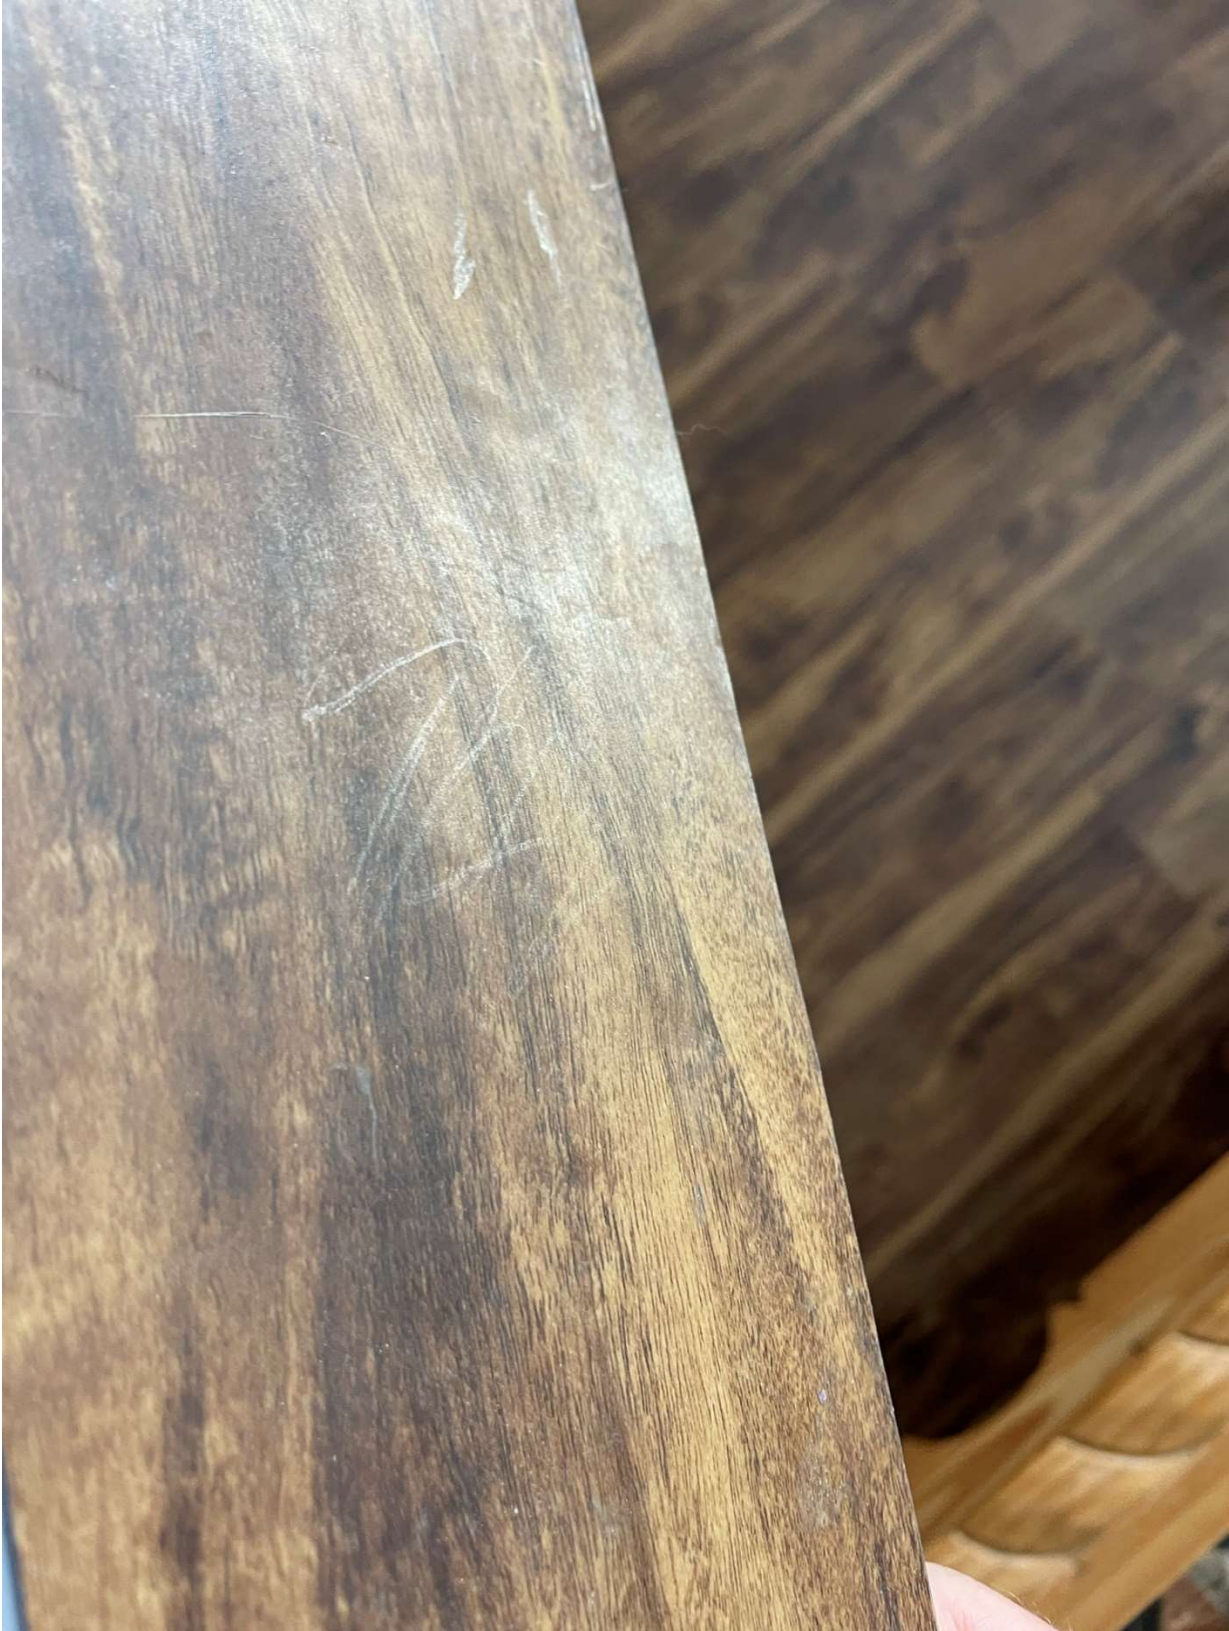
Scff Marks

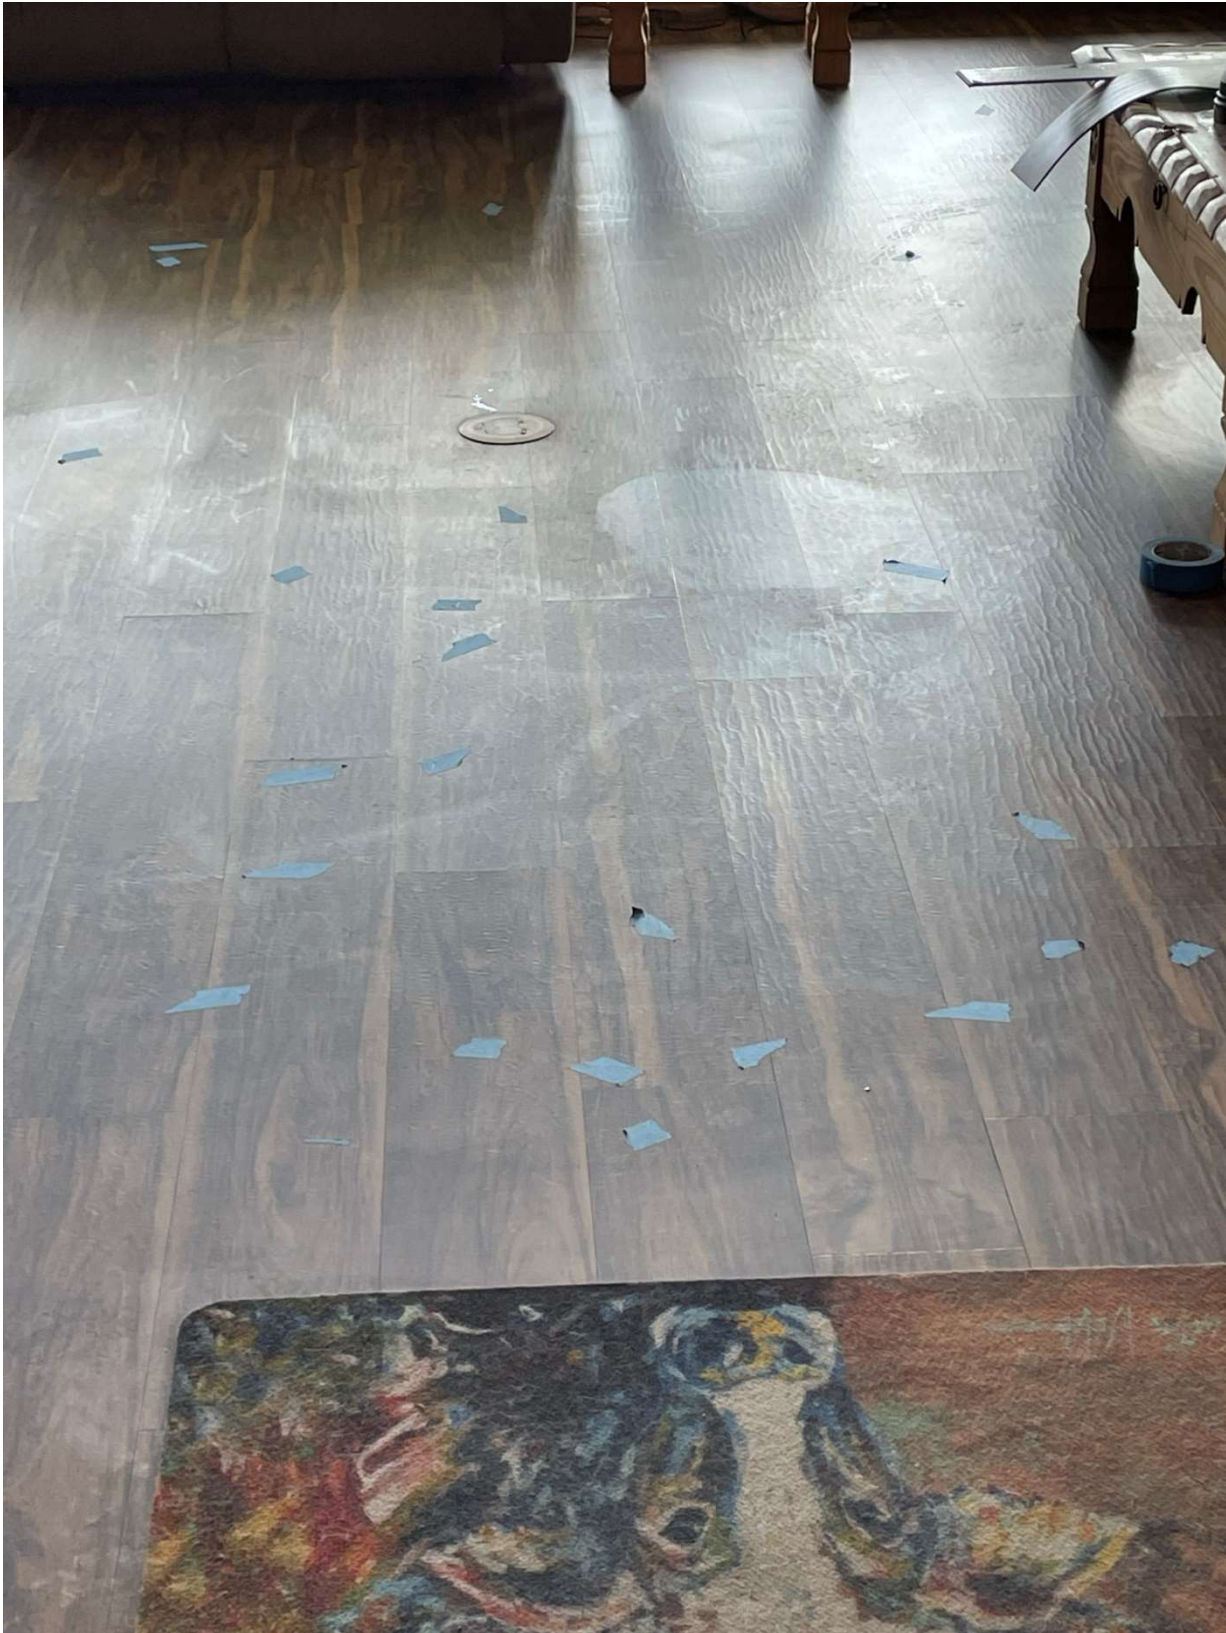
At the time of inspection, the floor had a hazy appearance throughout, including a small area cleaned by the customer prior to my arrival. The newly cleaned area showed was also hazy but was more uniform and has fewer signs of tracking or scuff marks. A small section was cleaned with the customer's cleaning solution of vinegar and water, then rinsed with water, then rubbed dry. Each time, an orange-brown substance transferred to the paper towels. Each additional treatment showed less

Haze on product after cleaning, Small spot shows test cleaning by customer.

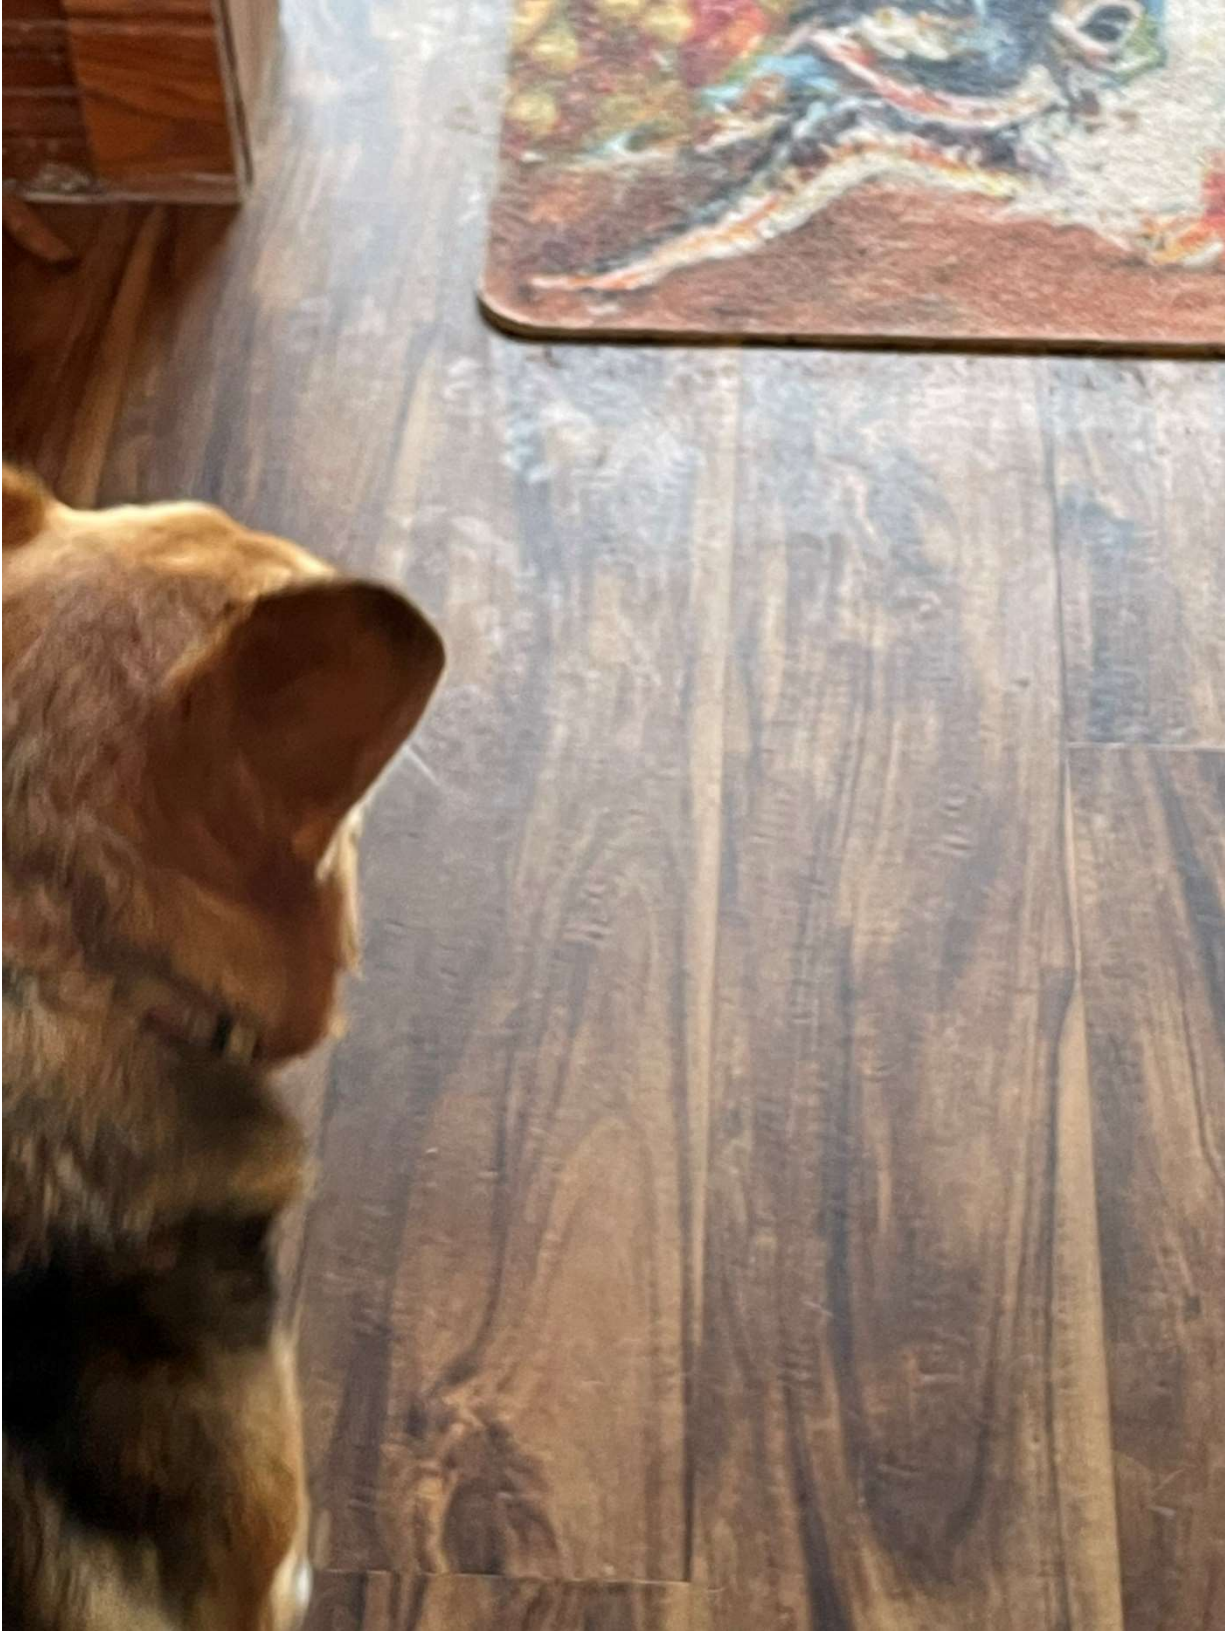
Prints visible near walkoff mat

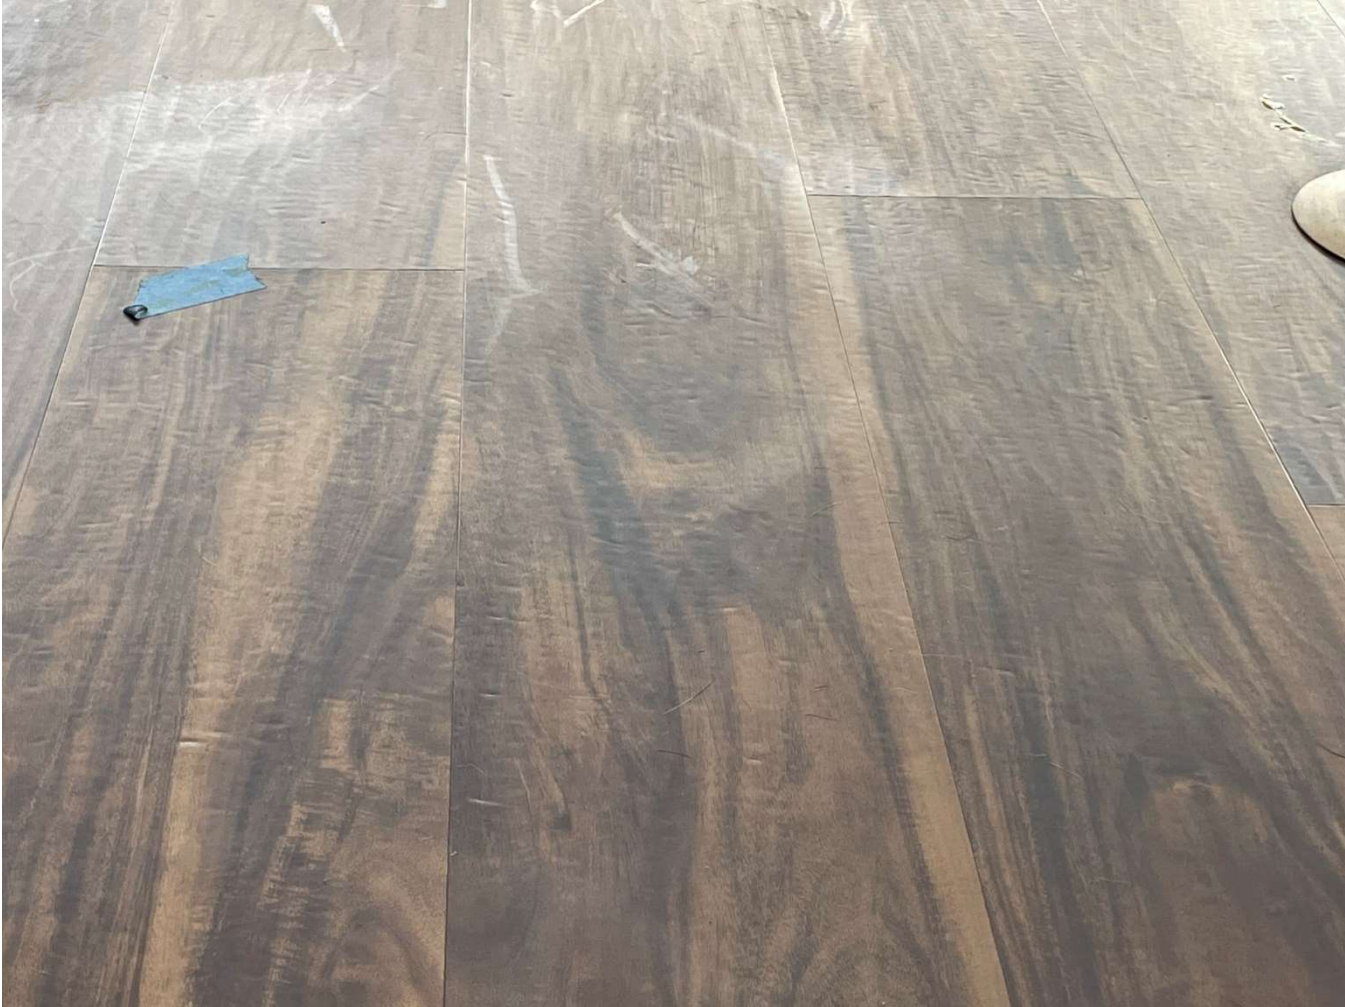
Scuff Marks

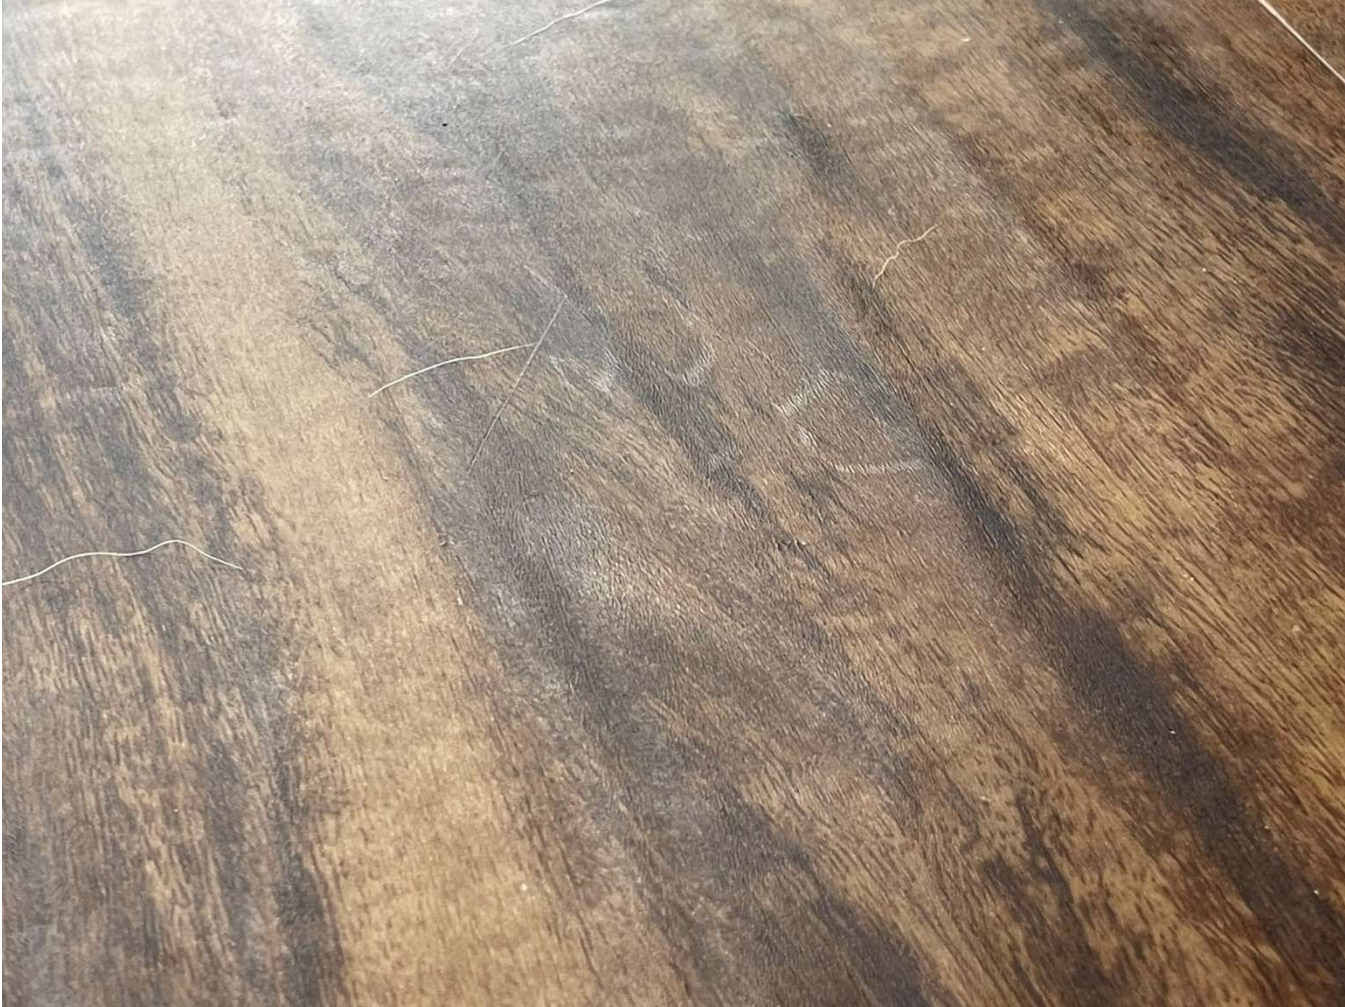
Scuff Marks

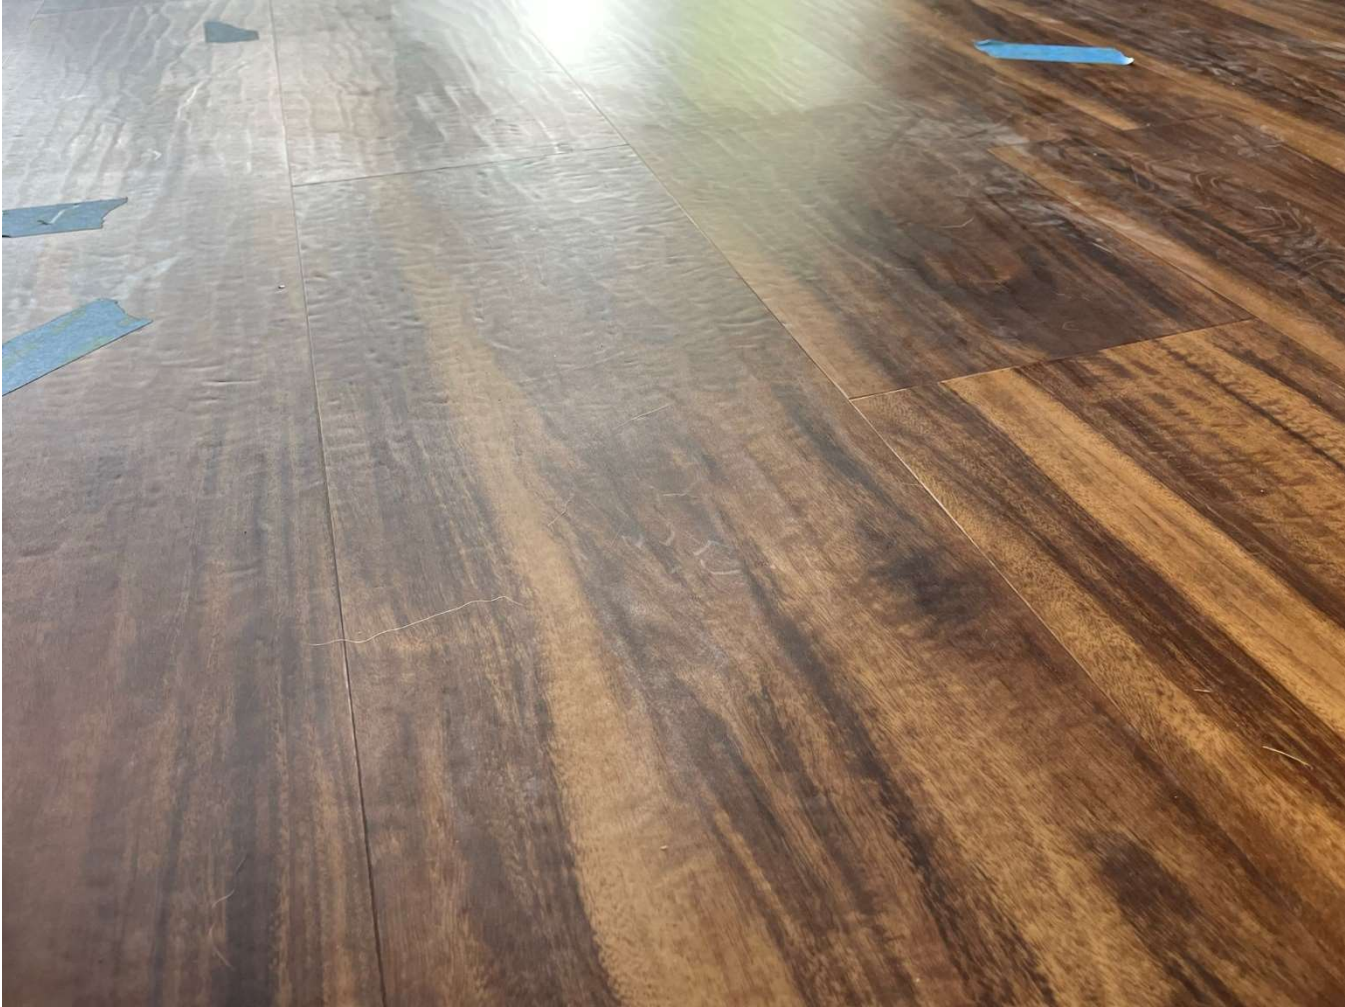
Scuff Marks- cleaned area

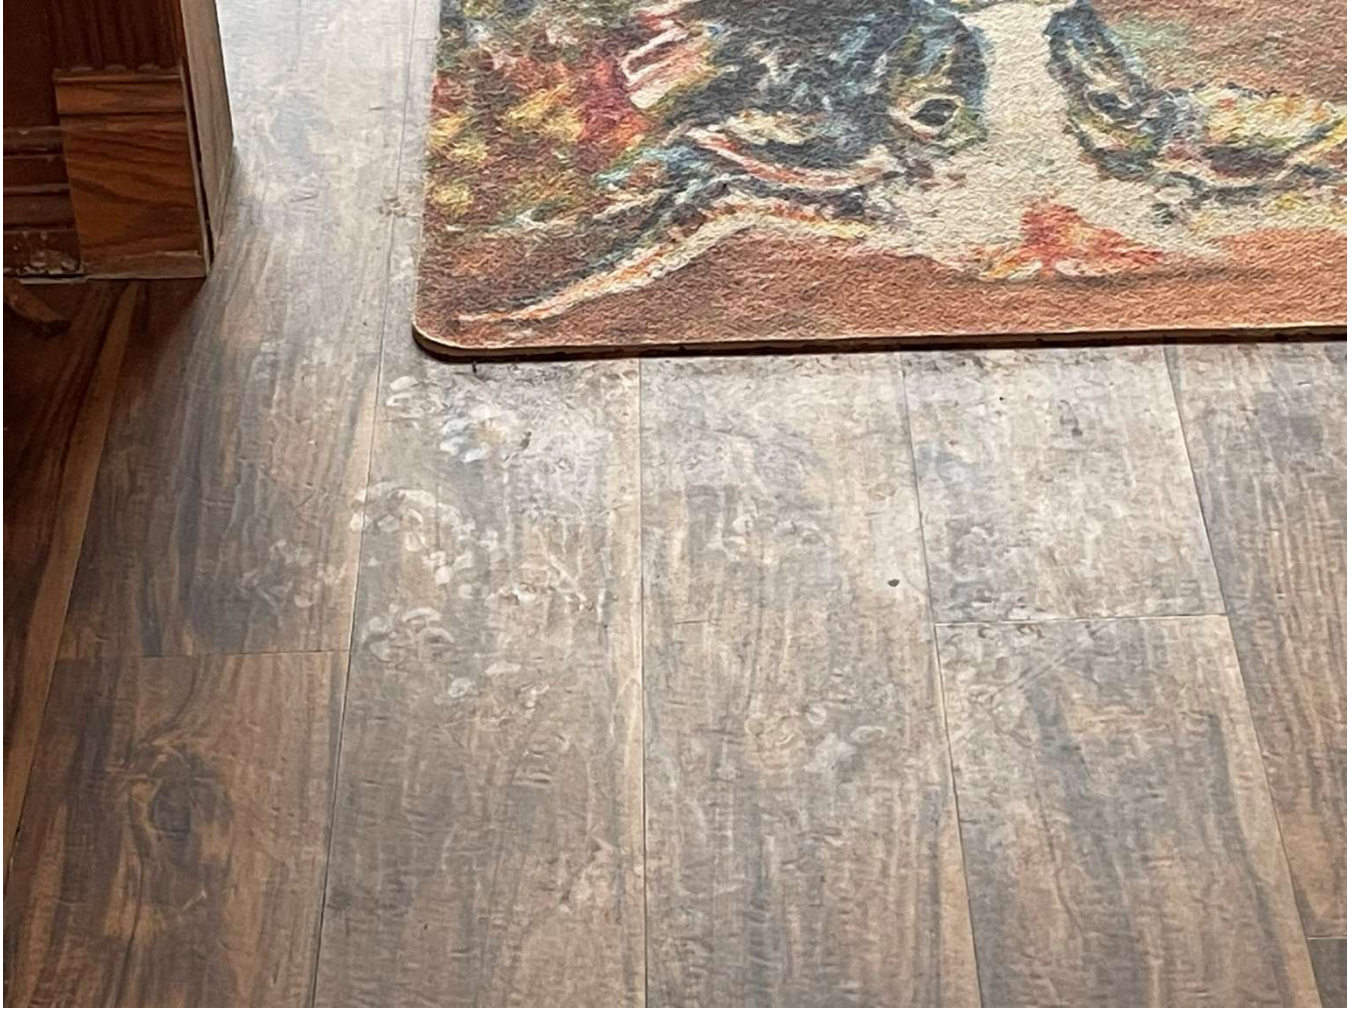
Paw Prints

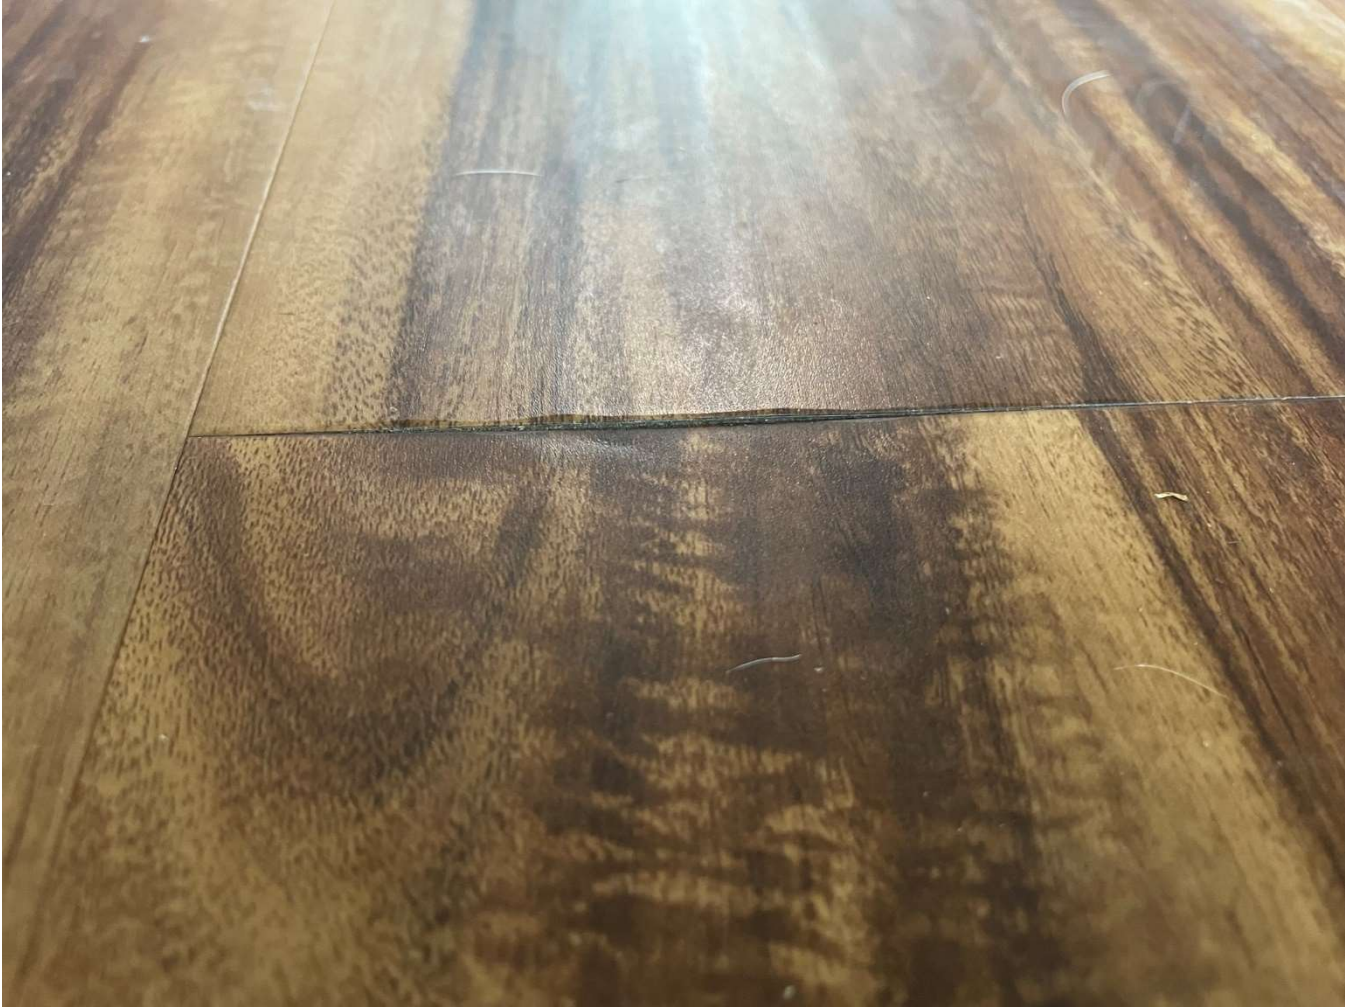
The customers secondary concerns of lifting and gapping end joints were most apparent in the living room. Several planks were separating from the adjacent board and could be pressed down independently demonstrating that the locking mechanism was not properly attached. Additionally, there were signs of damage in the form of peaking corners, and ramped end joints. There were also two boards that had small, raised spots consistent with debris trapped beneath the plank transferring through the plank to the surface. These issues were not widespread and appeared to be affecting about 12 boards in the living room.

The customer's secondary concerns with lifting end joints and damaged corners are a result of improper installation of the affected planks. The damaged corners occur when an unusual stress is applied to the corner, such as dropping the plank or impact to the corner during shipping. When this occurs, the corner will lift or break off from the plank. Corners damaged prior to or during installation must be culled and/ or used for cut planks at the edges or walls where the damage can be cut away. The ramping at the end joint is the result of a broken locking mechanism. This occurs when planks are forced into place or deflection occurs along the joint resulting in a break along the locking mechanism. The gapped, separating, and moving planks are the result of improperly joined locking mechanisms. If undamaged, it may be possible to re-join the locking mechanism and stabilize the planks. The damaged planks can be replaced through individual plank replacement or by carefully unclicking the room to the spot of the damaged board, replacing it, and then re-installing the other planks.

Disengaged end joint- deflection

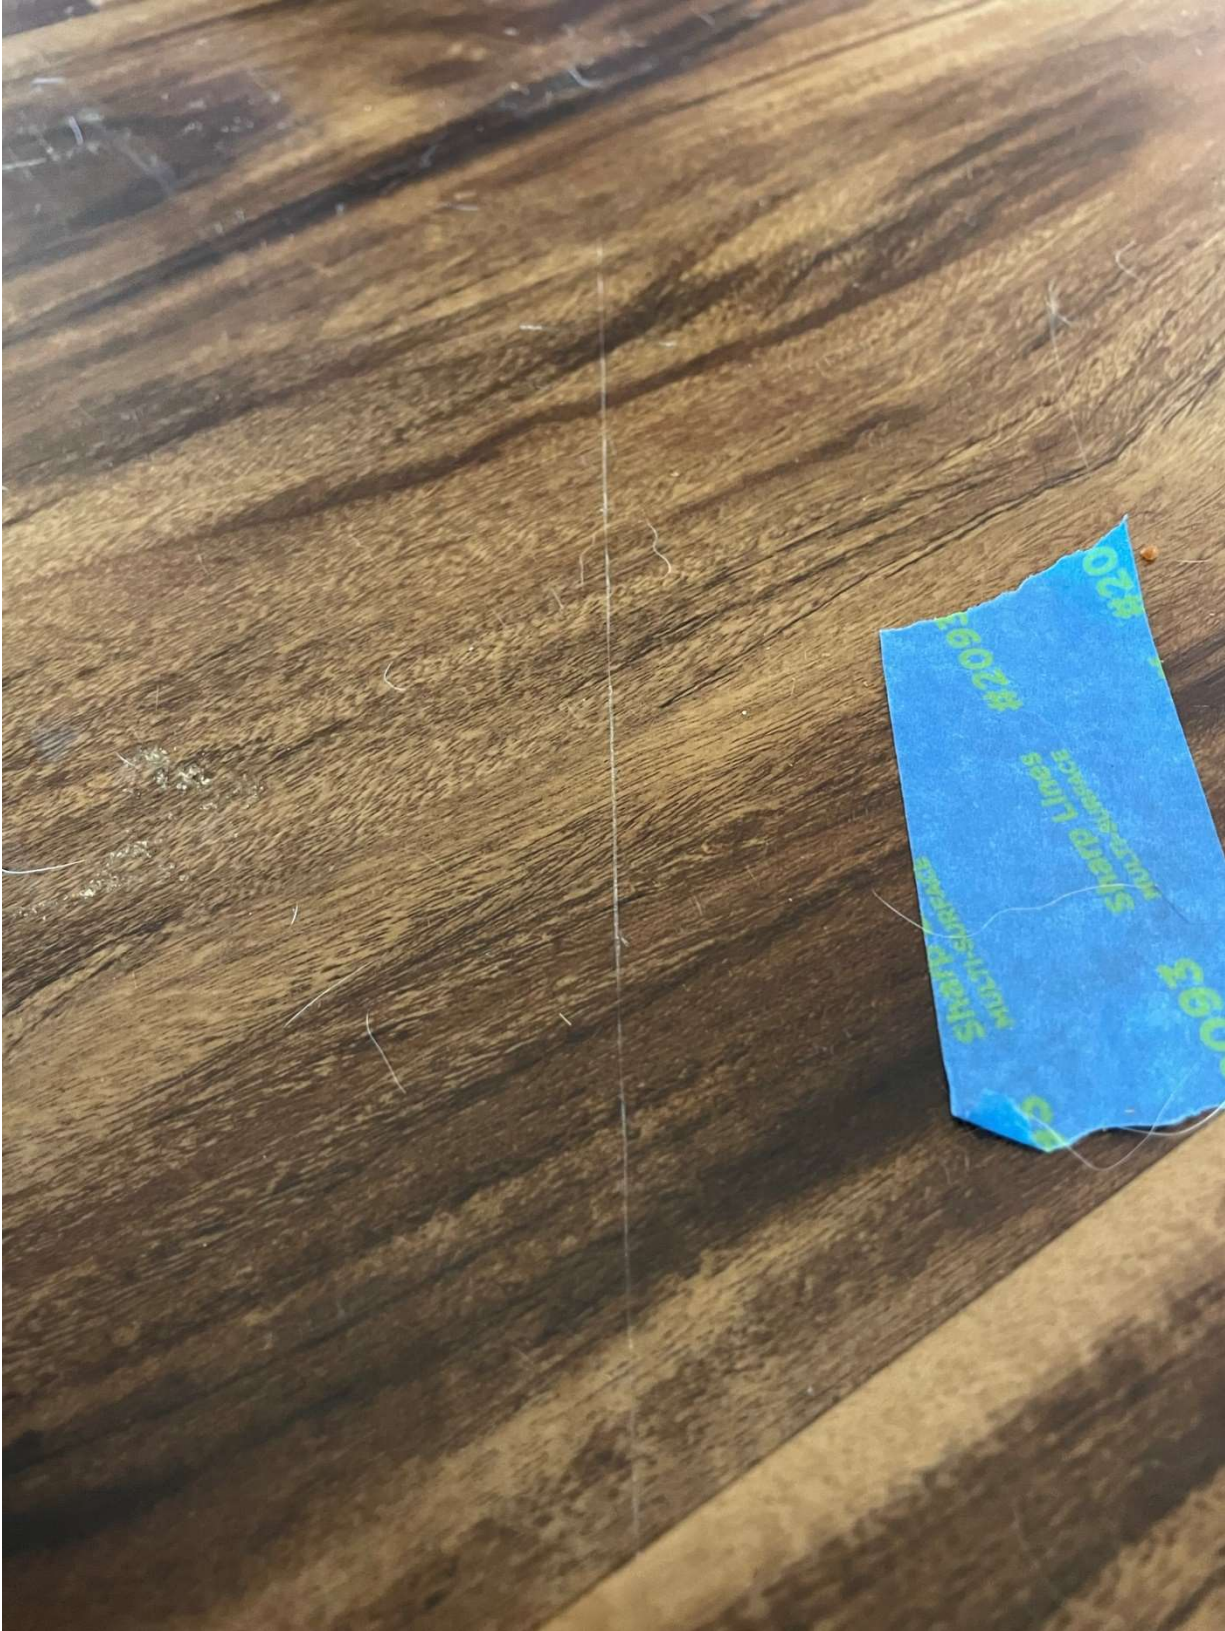
Scratch in wear layer

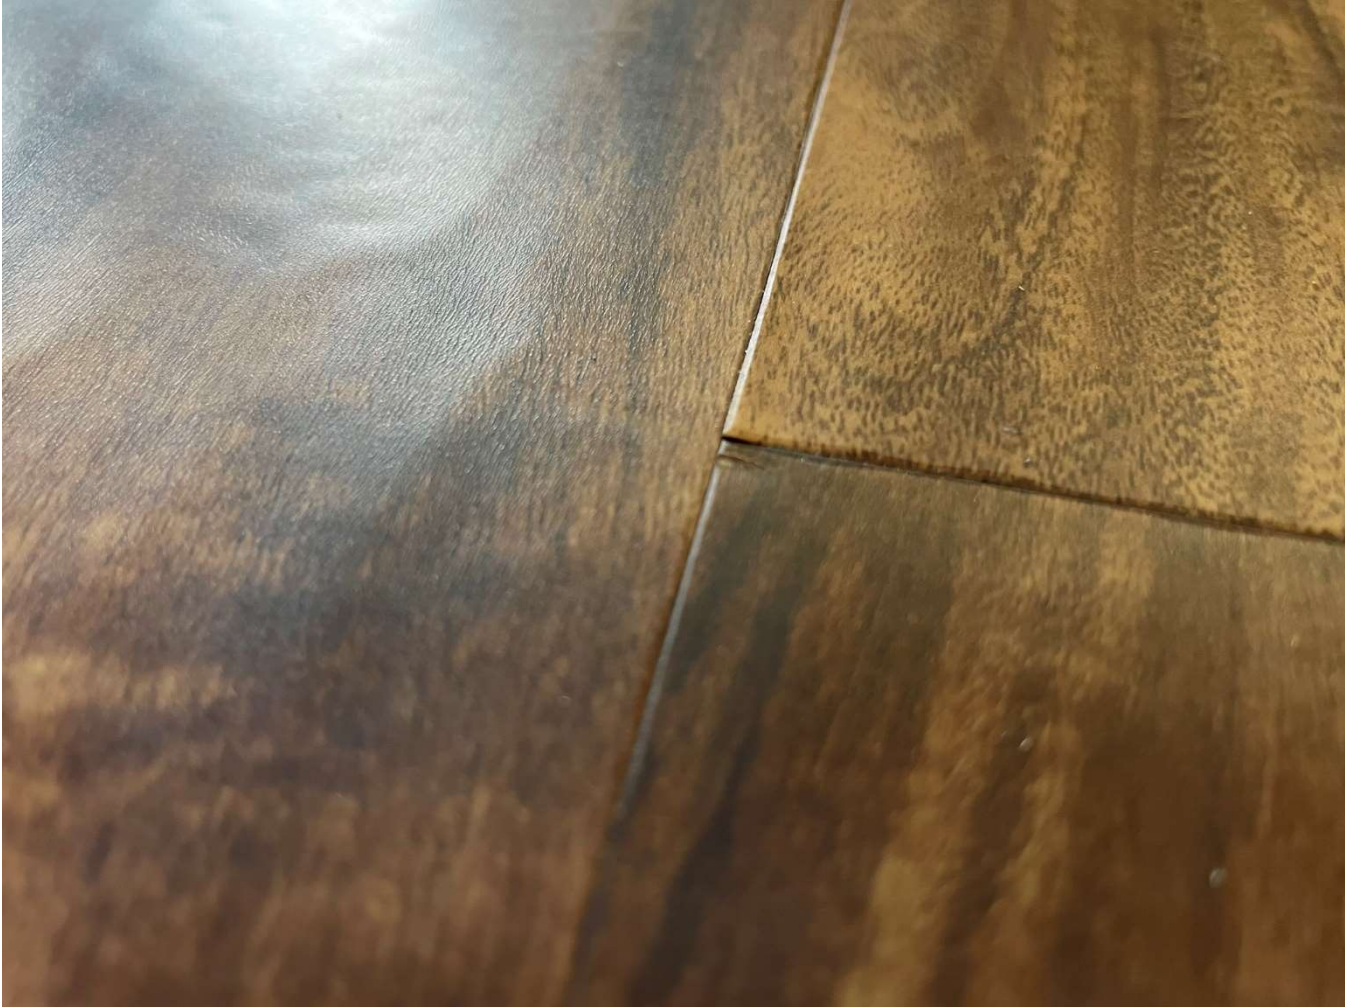
Damaged corner

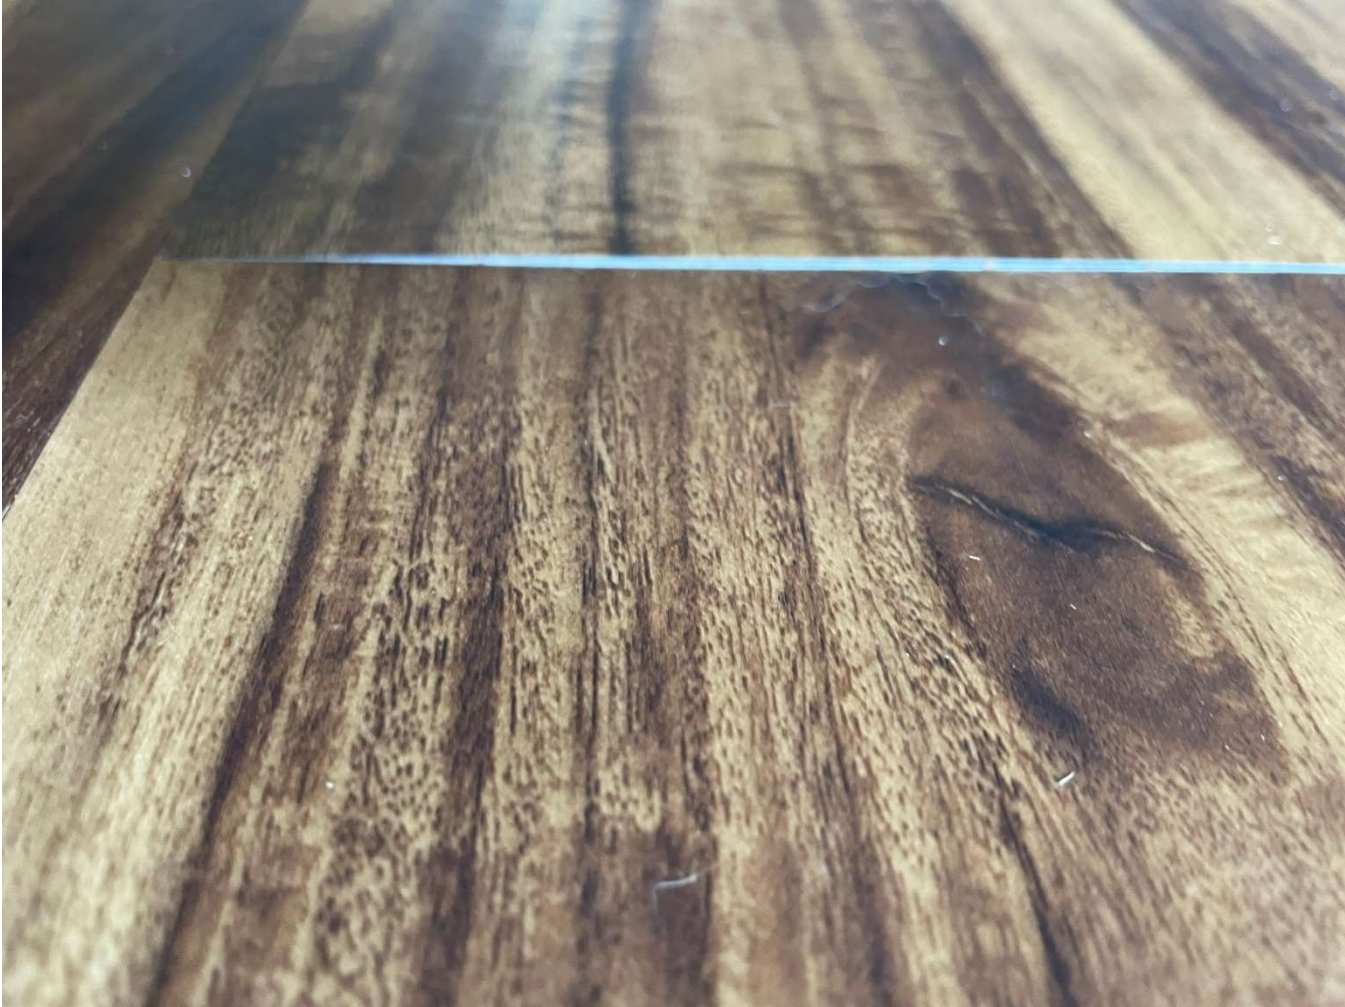
Disengaged end joint

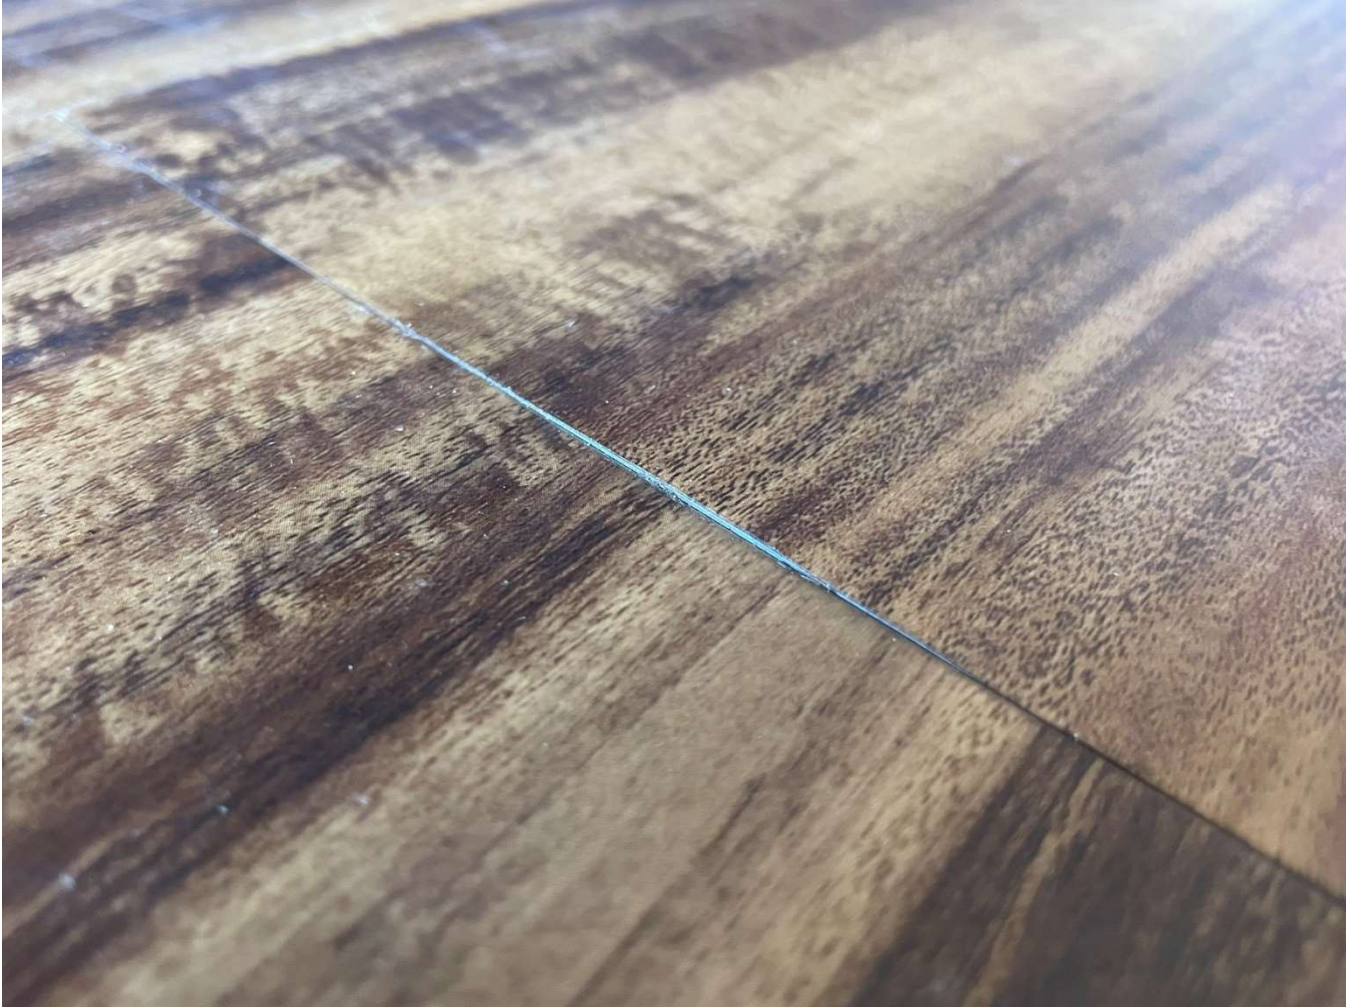
Disengaged end joint- deflection at joint

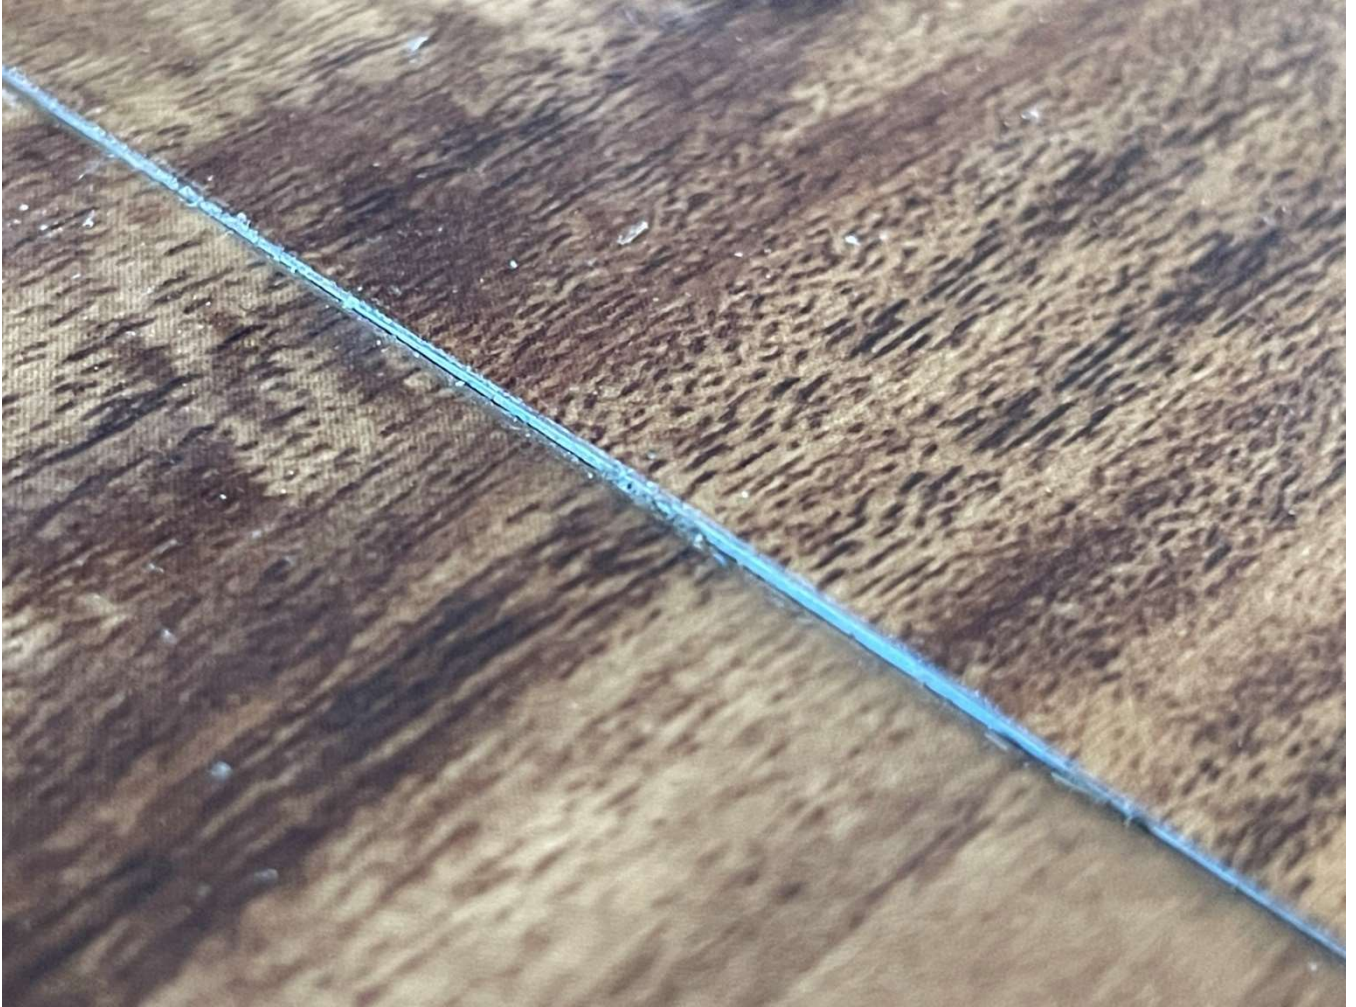
Close up of disengaged end joint
