August 2, 2022

You commissioned Flooring Warranty Services to inspect your floating resilient flooring for unusual marks, cleanability, and lifting/ separating end joints. The initial inspection was performed May, 9th 2022. Samples were collected and additional testing was performed at Professional Testing Laboratory in Dalton, GA. A follow up inspection and test cleaning was performed July 27th, 2022.

Problem Description:

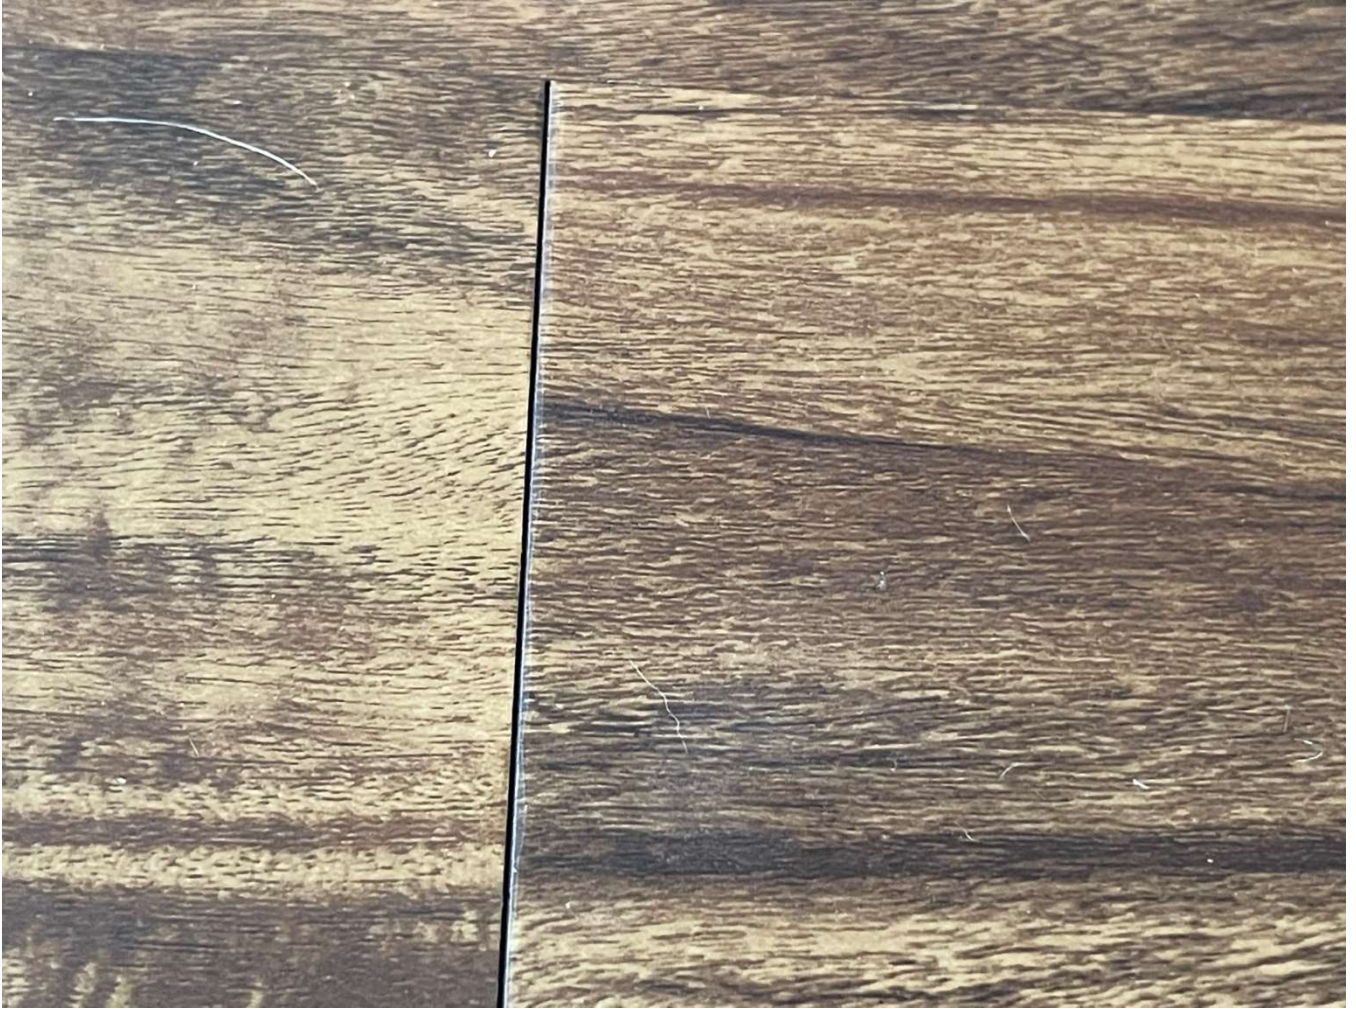
Gap at end joint

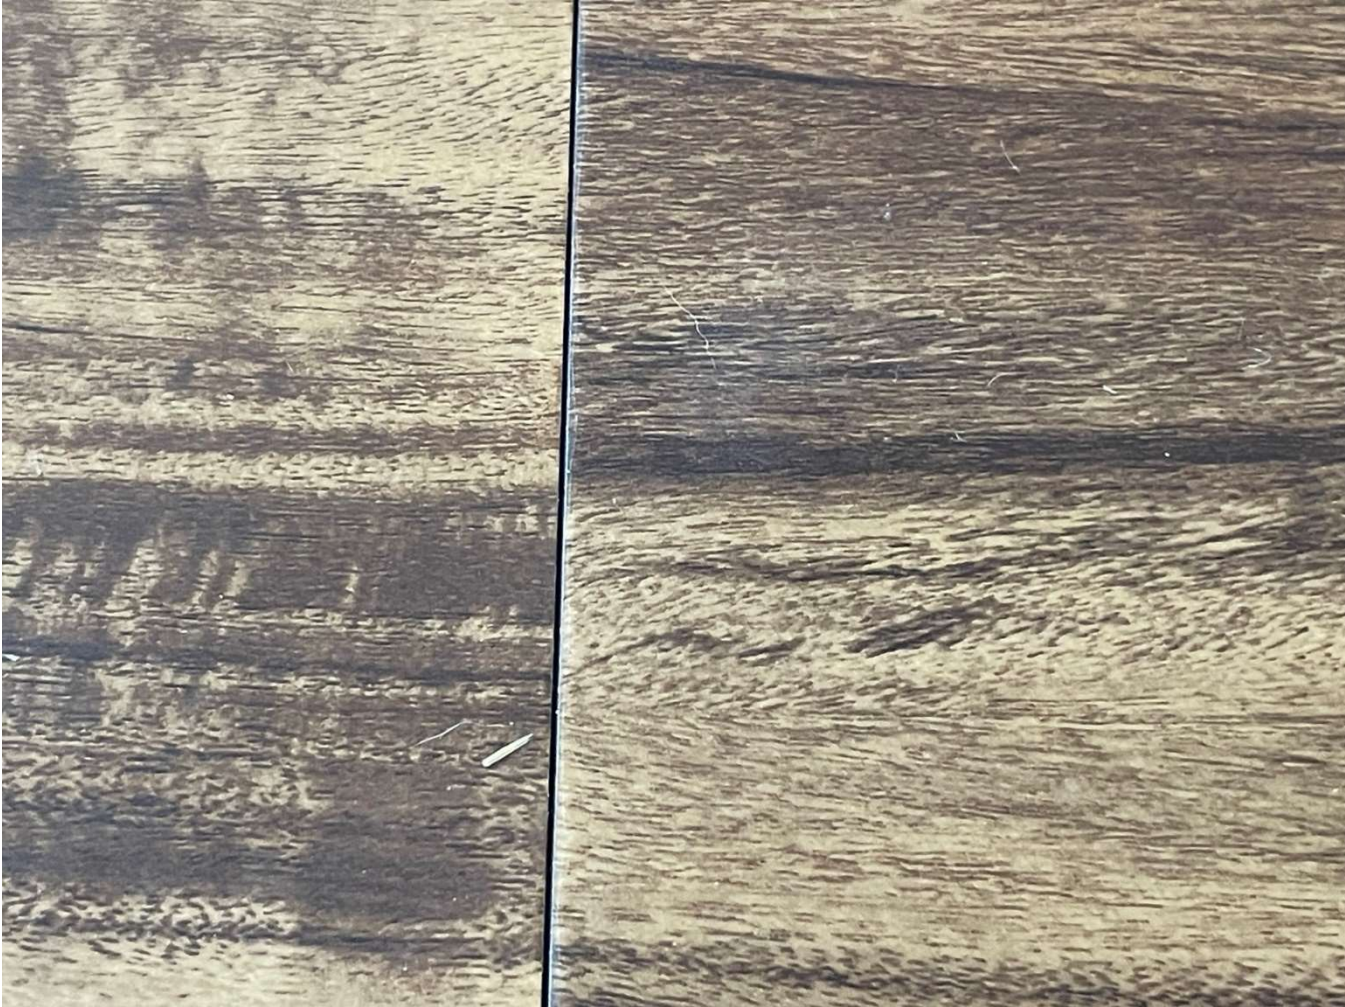
Gap at end joint

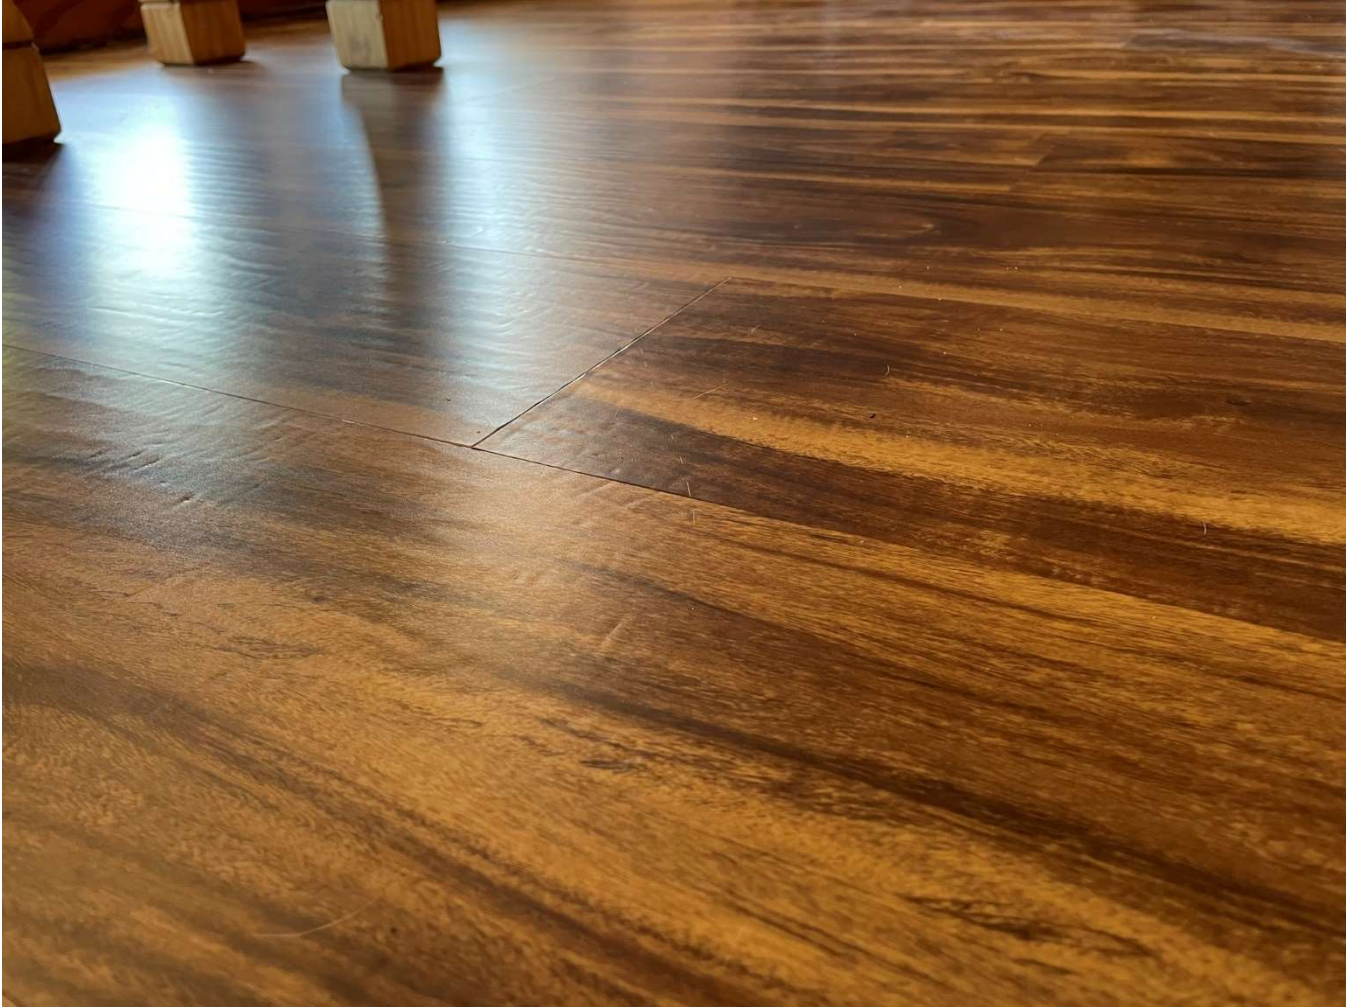
Ramp at end joint- broken locking mechanism

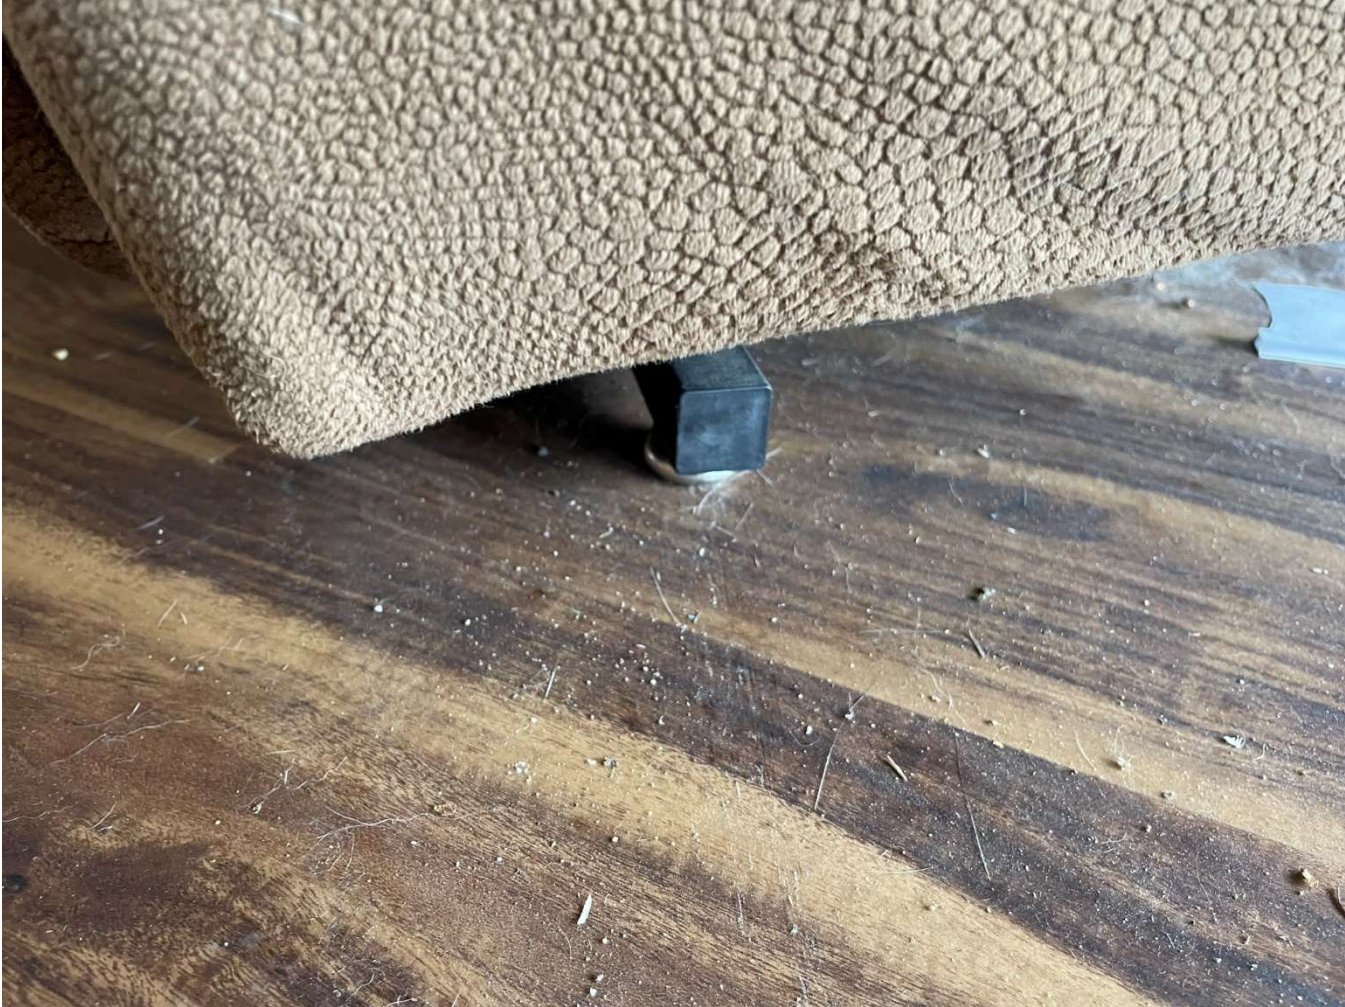
Metal furniture glides/ debris

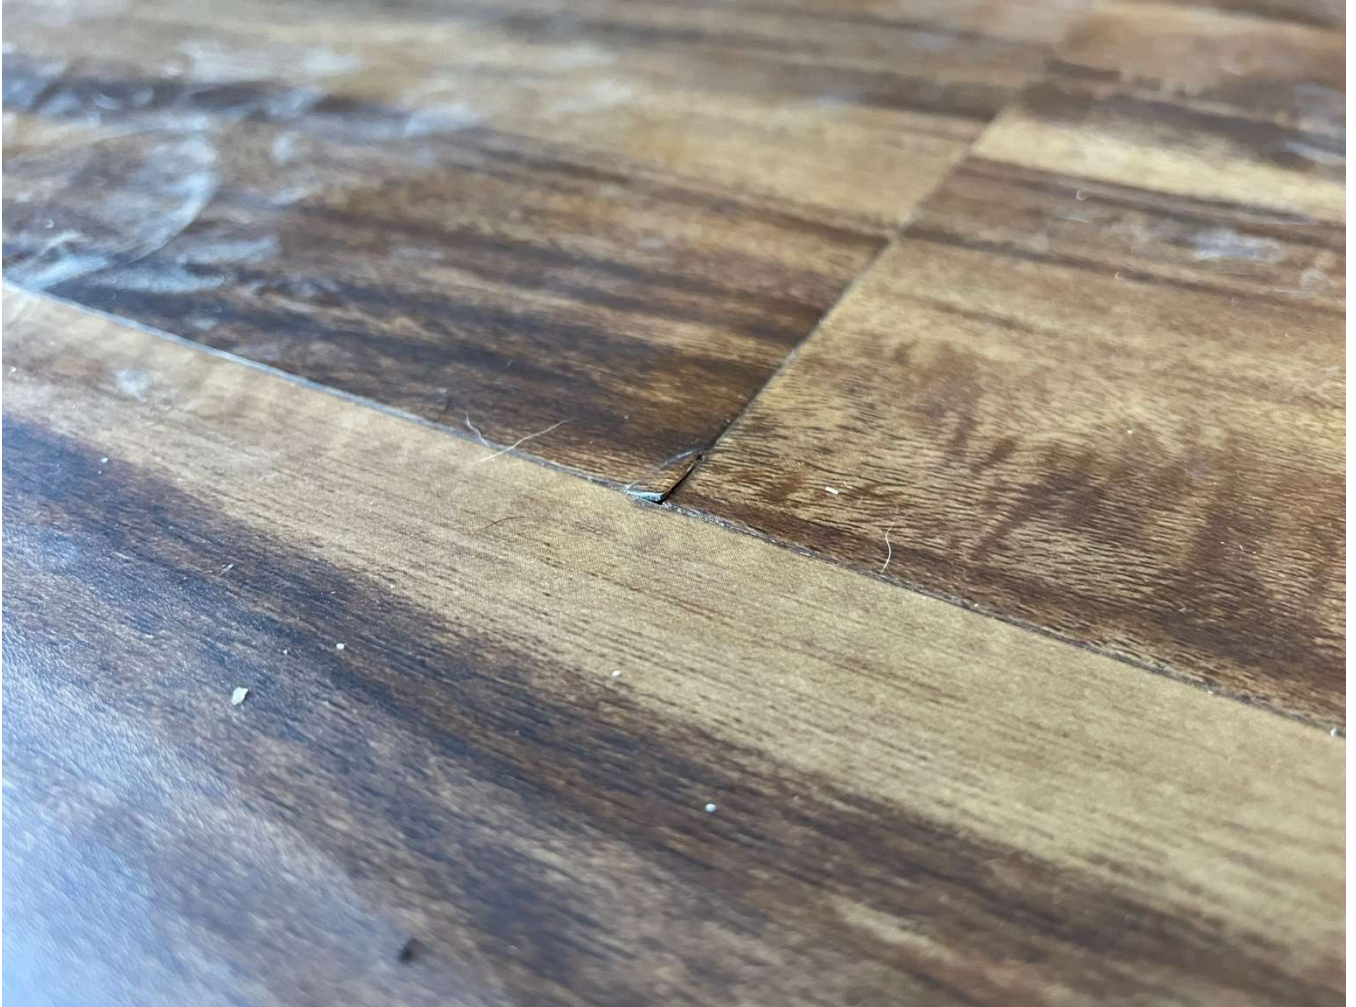
The customer's secondary concerns with lifting end joints and damaged corners are a result of improper installation of the affected planks. The damaged corners occur when an unusual stress is applied to the corner, such as dropping the plank or impact to the corner during shipping. When this occurs, the corner will lift or break off from the plank. Corners damaged prior to or during installation must be culled and/ or used for cut planks at the edges or walls where the damage can be cut away. The ramping at the end joint is the result of a broken locking mechanism. This occurs when planks are forced into place or deflection occurs along the joint resulting in a break along the locking mechanism. The gapped, separating, and moving planks are the result of improperly joined locking mechanisms. If undamaged, it may be possible to re-join the locking mechanism and stabilize the planks. The damaged planks can be replaced through individual plank replacement or by carefully unclicking the room to the spot of the damaged board, replacing it, and then re-installing the other planks.

Damaged corner

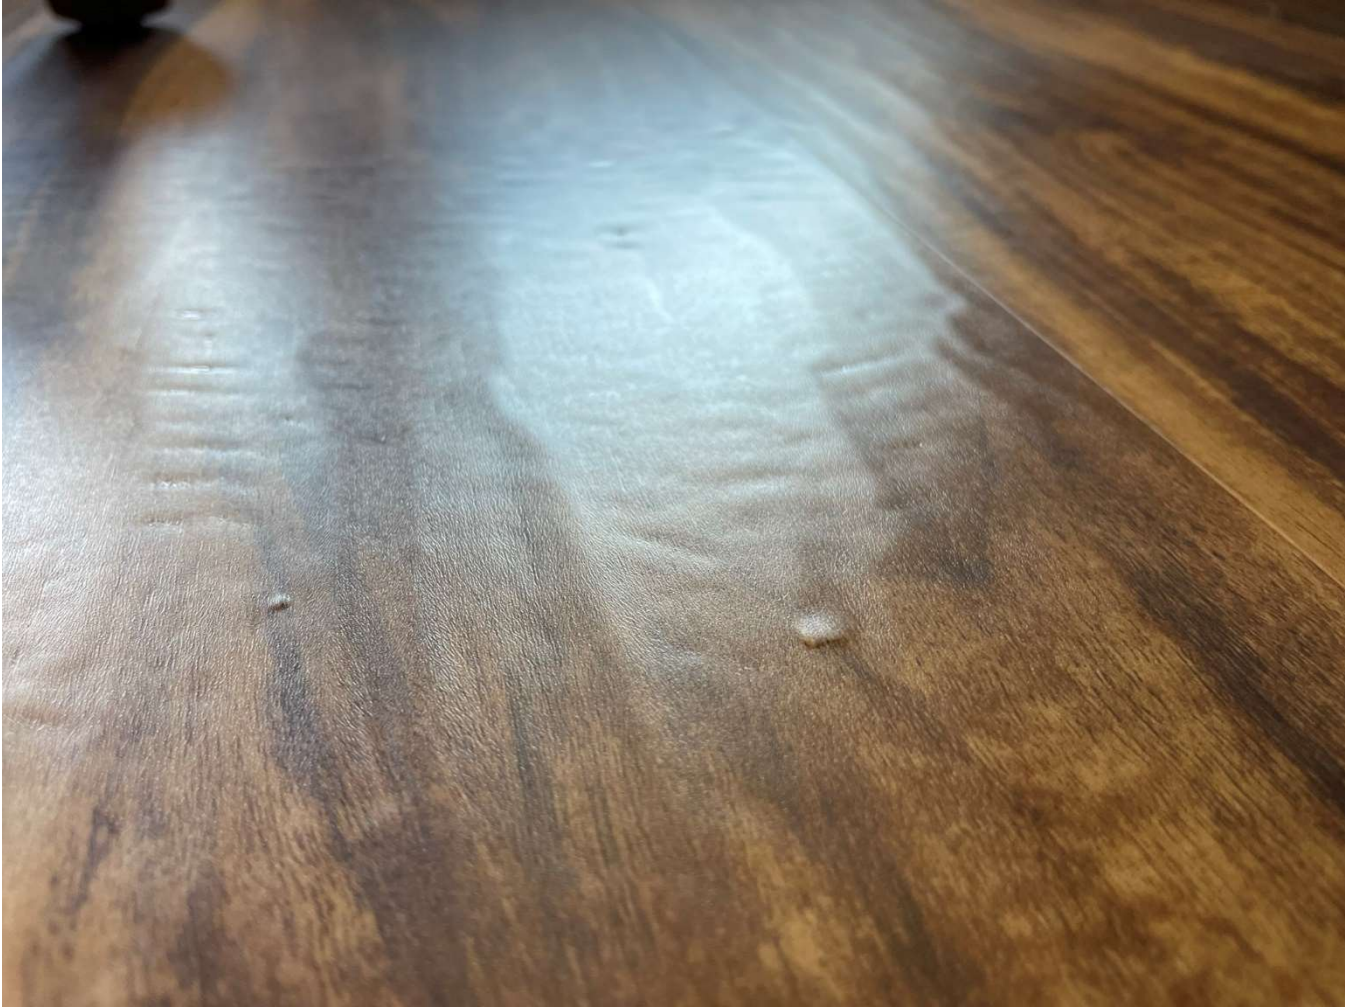
Telegraphing spots- possibly from debris trapped beneath flooring

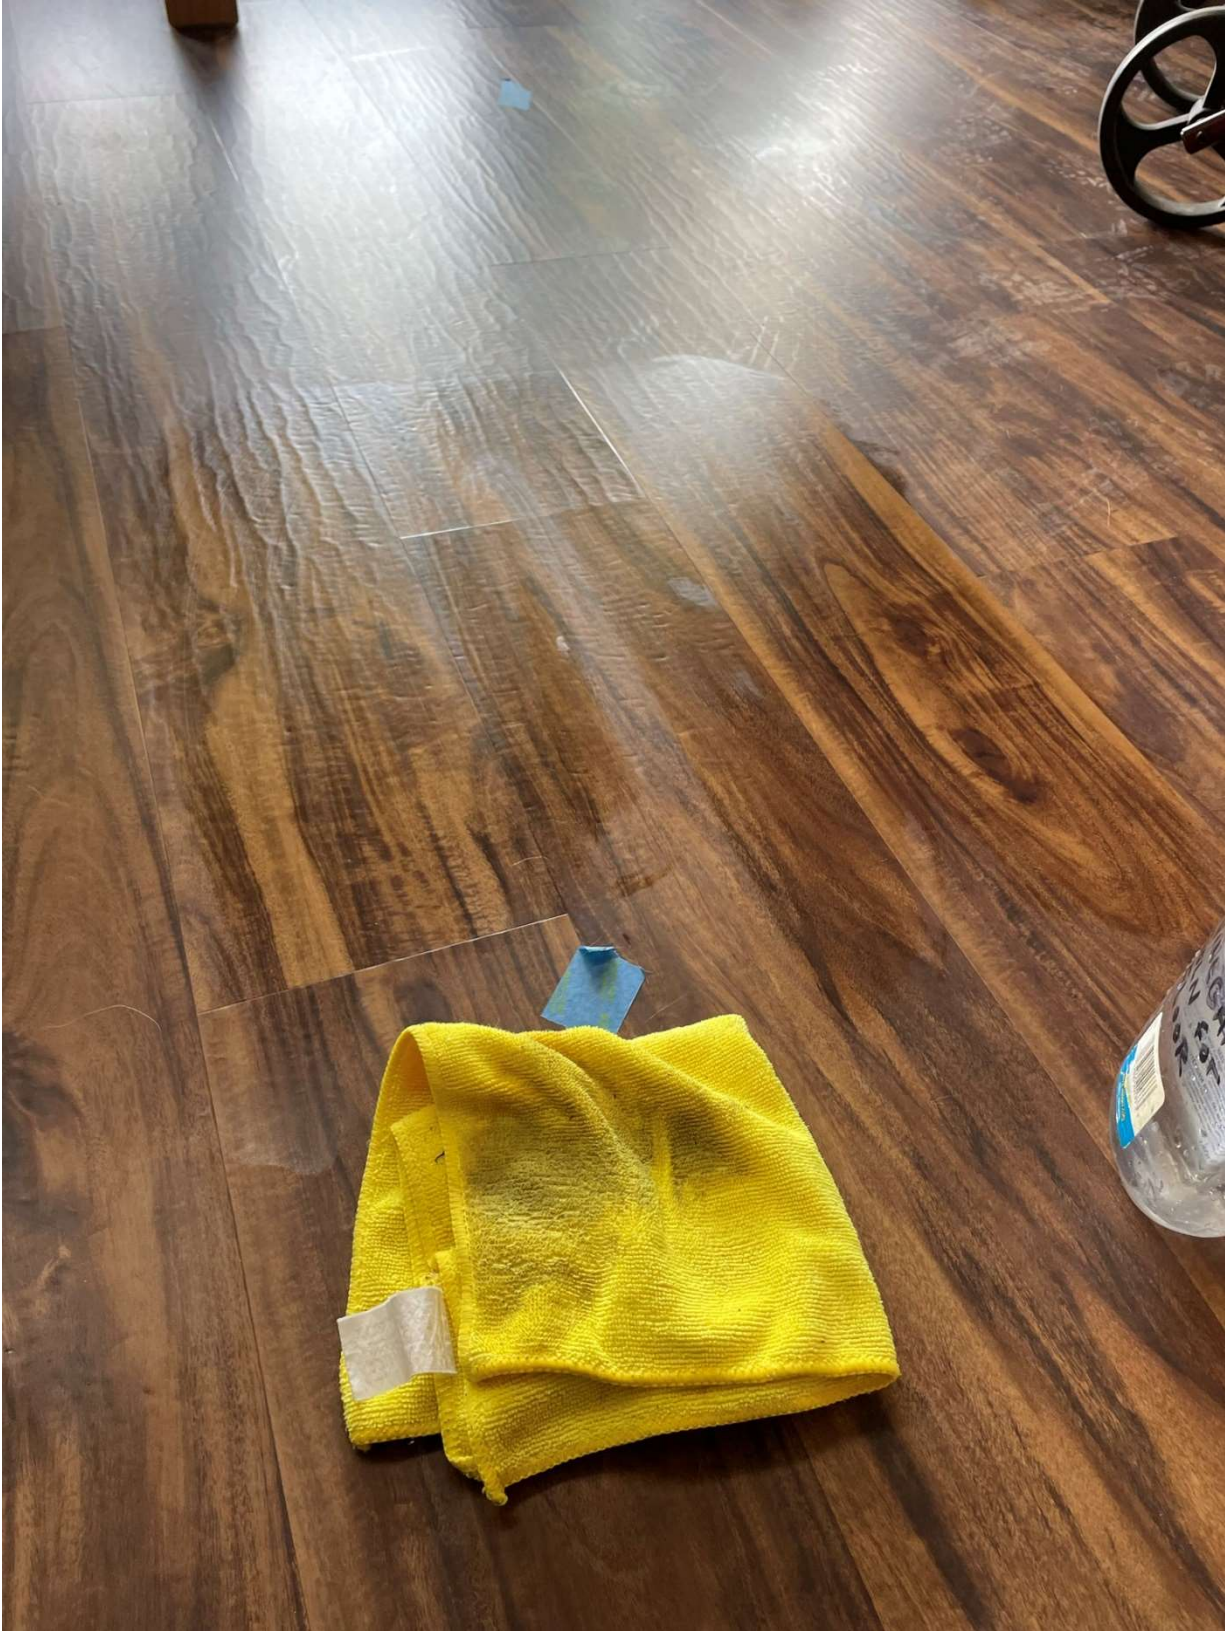
Test clean with customer's solution

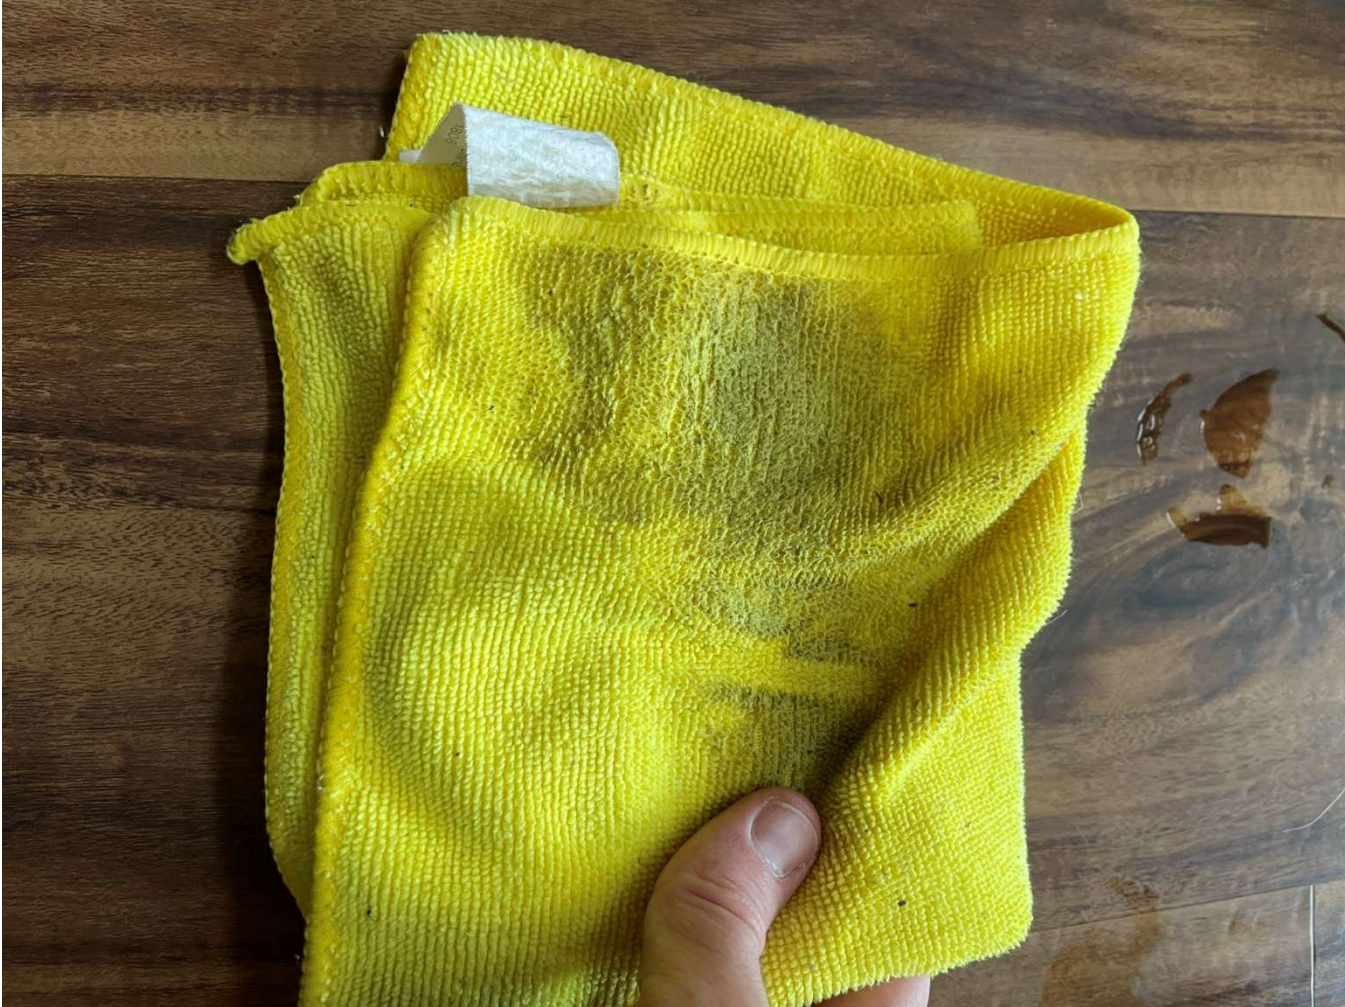
Soil transfer

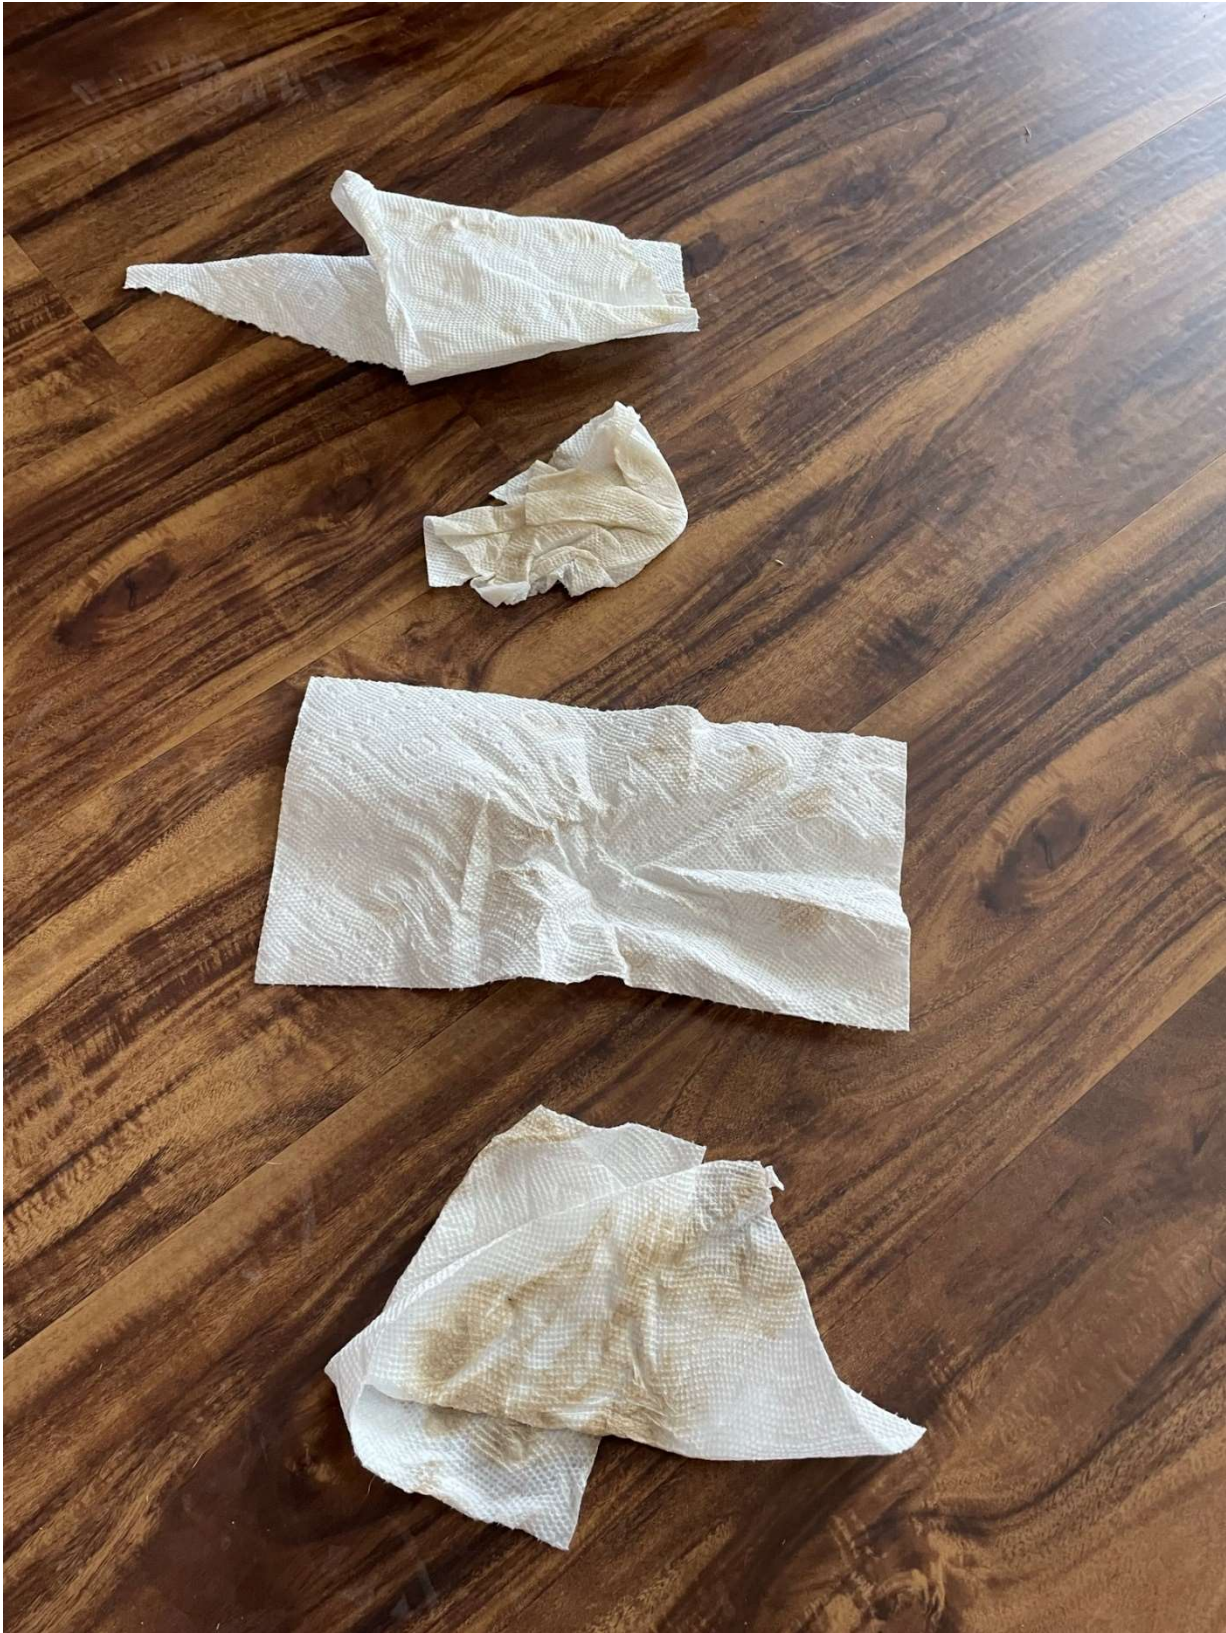
Soil transfer- various stages

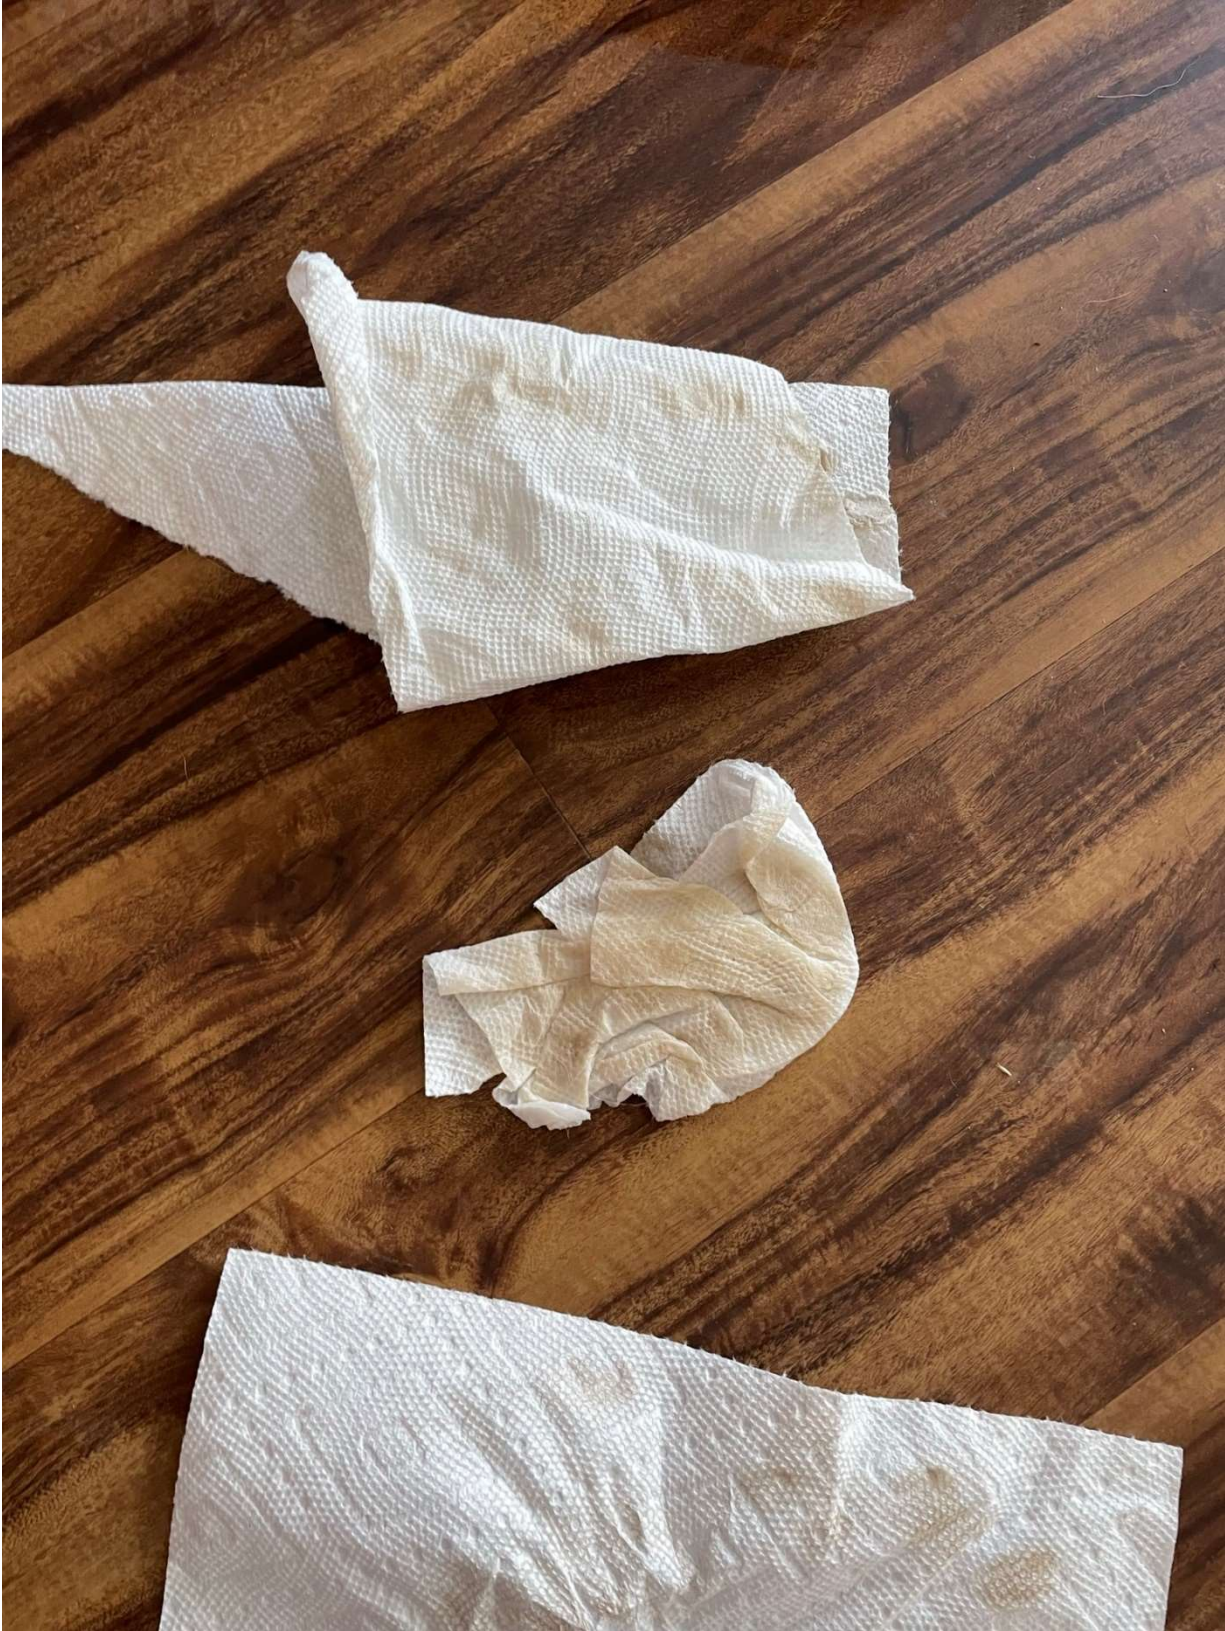
Soil transfer- various stages

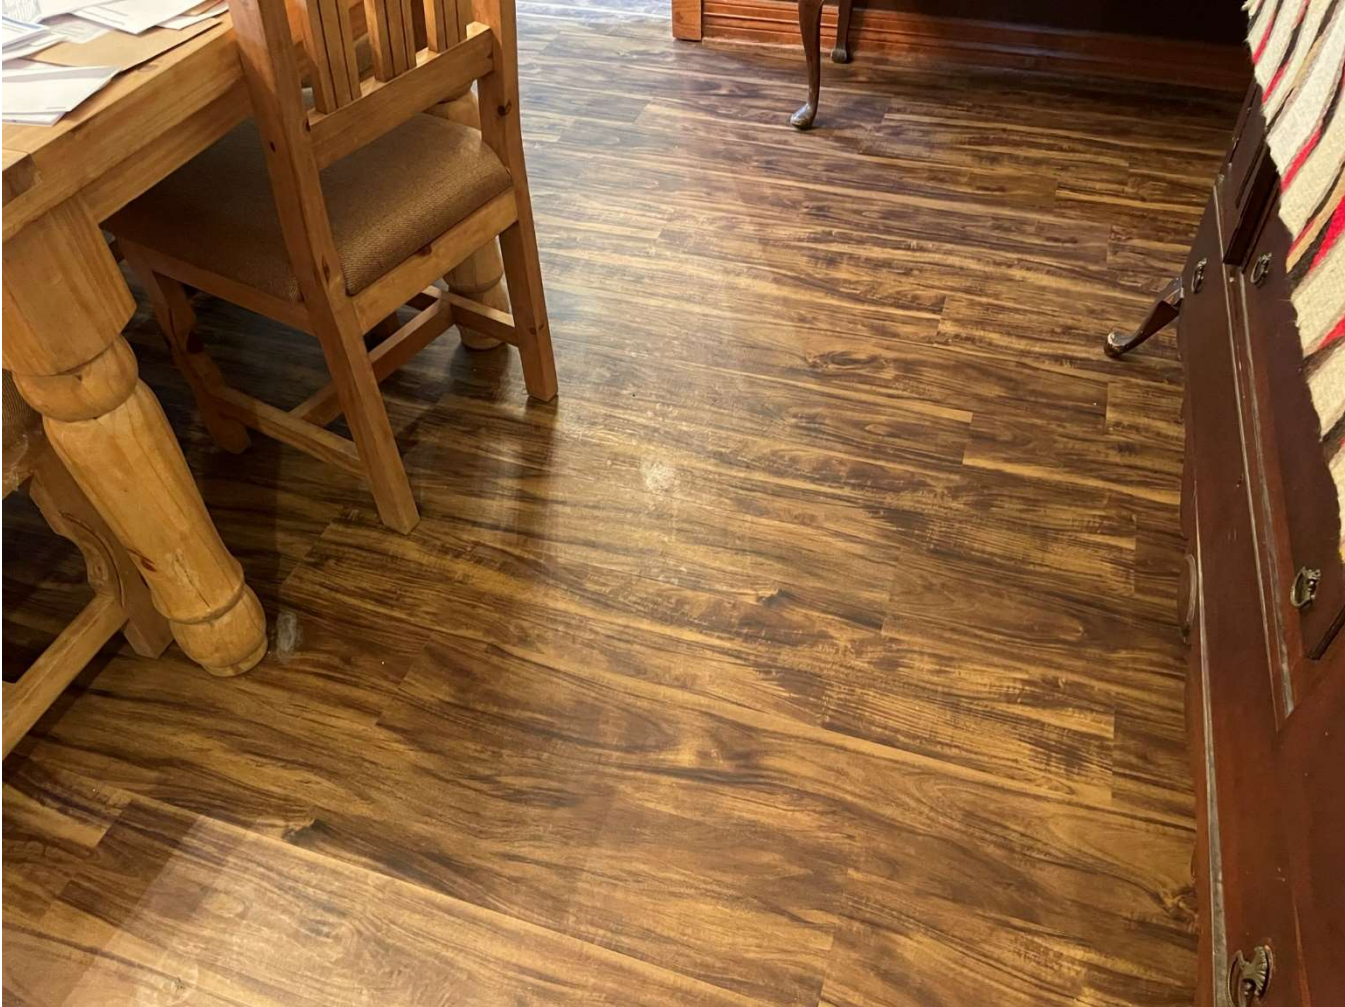
Prints/ scuff marks

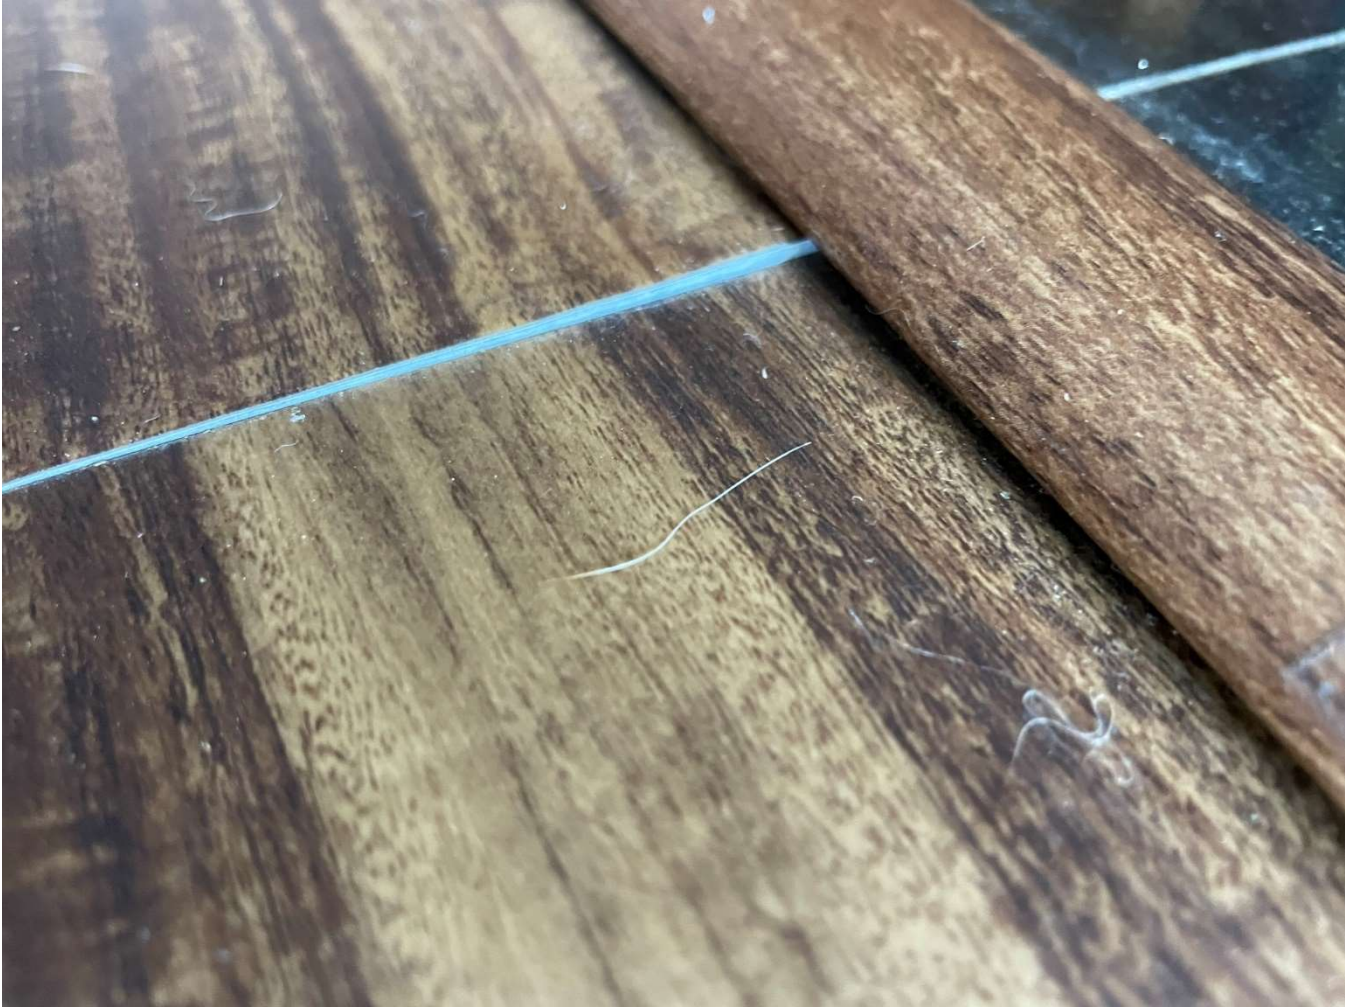
Disengaged end joint

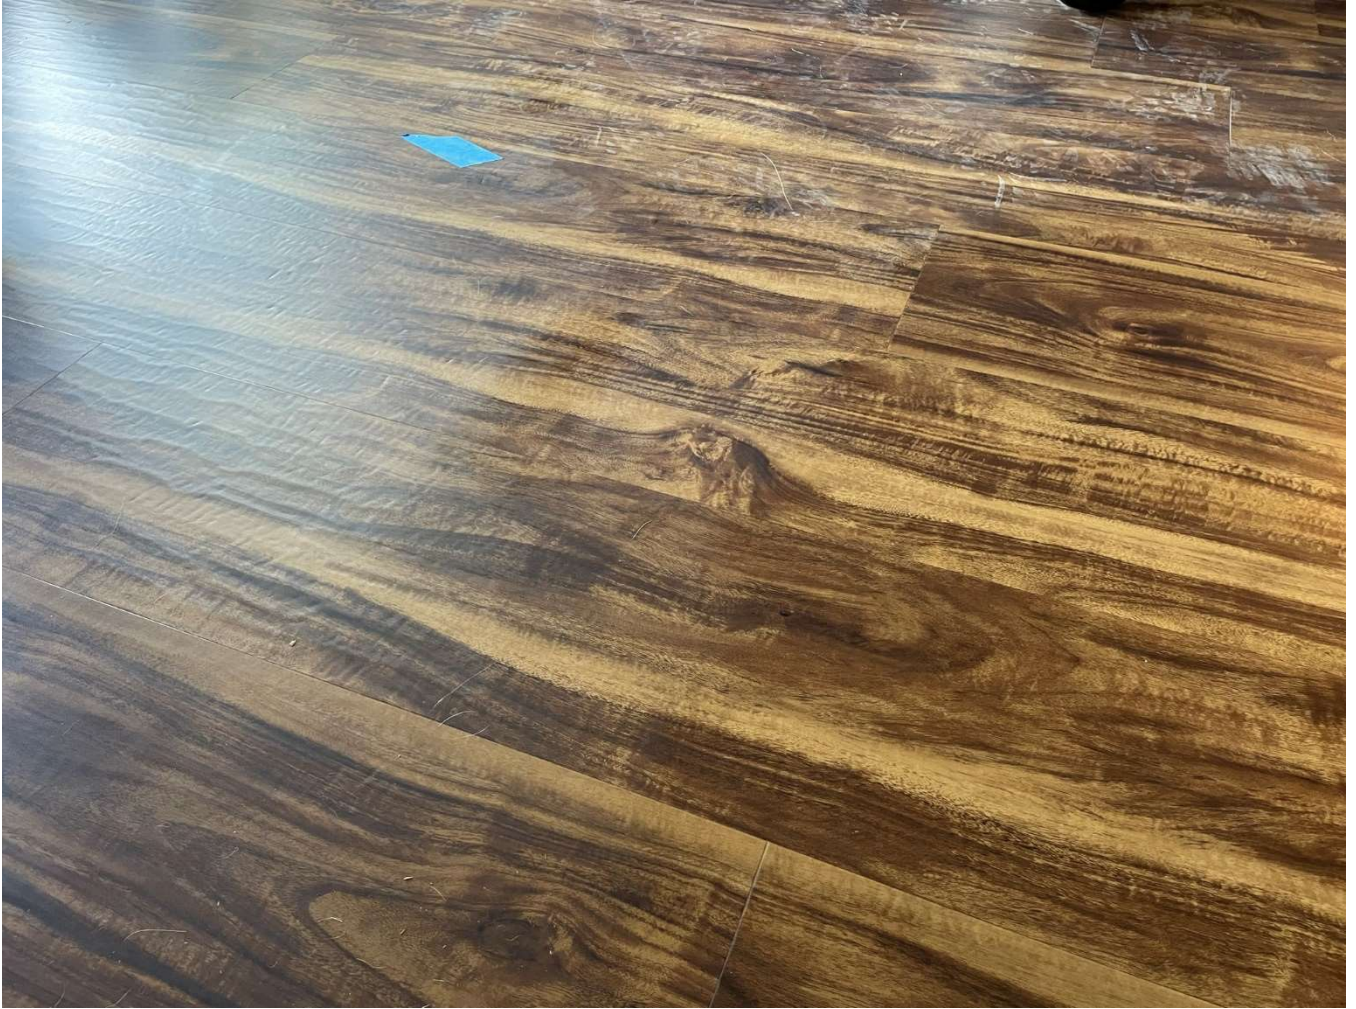
Larger cleaned area- haze still present

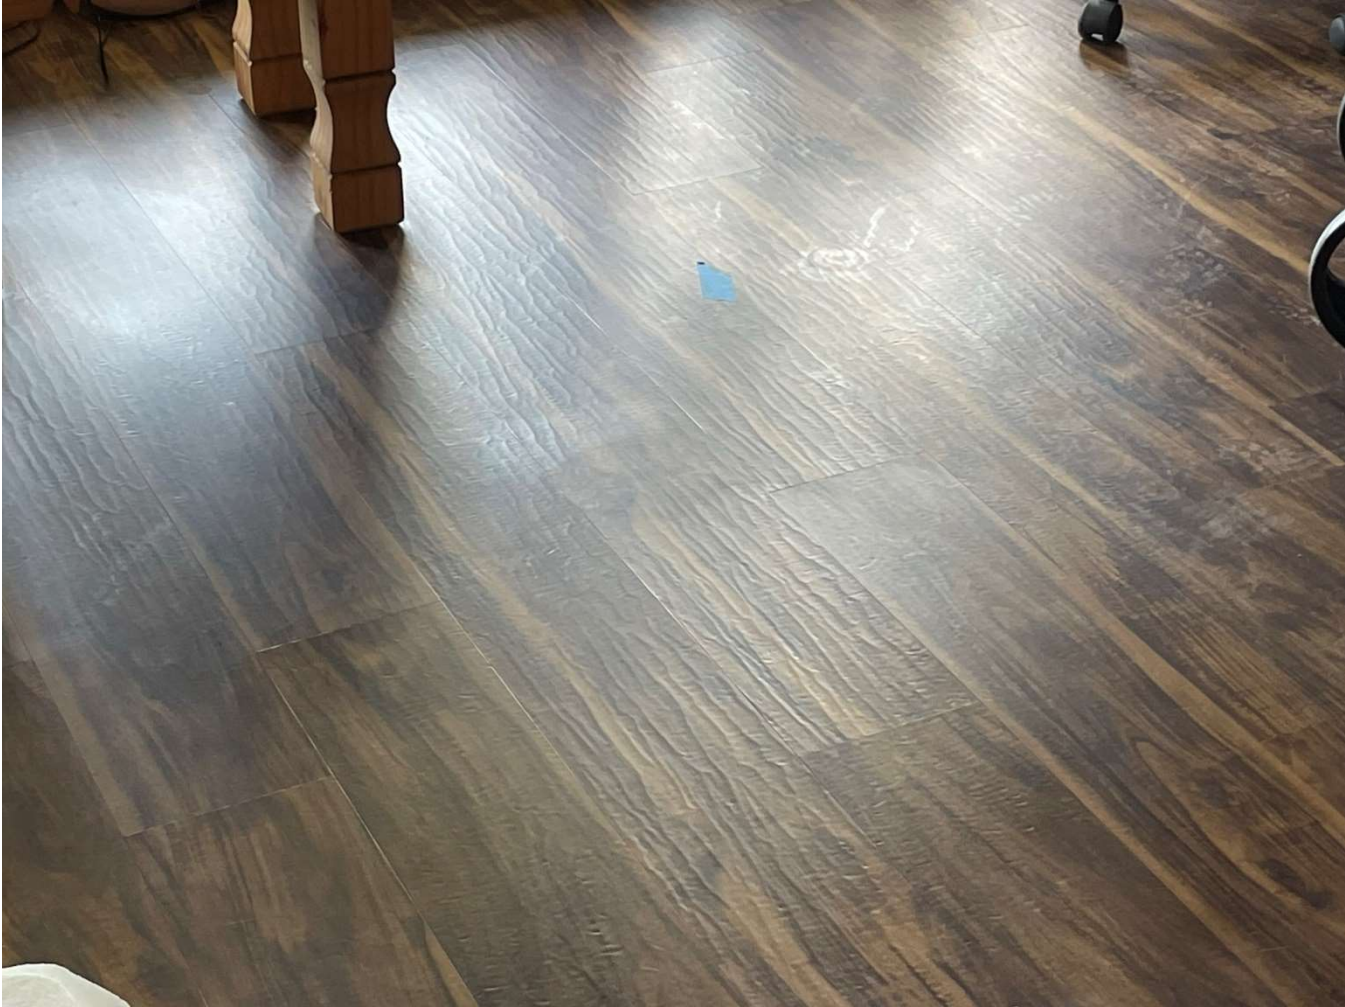
Prints/ Scuff marks

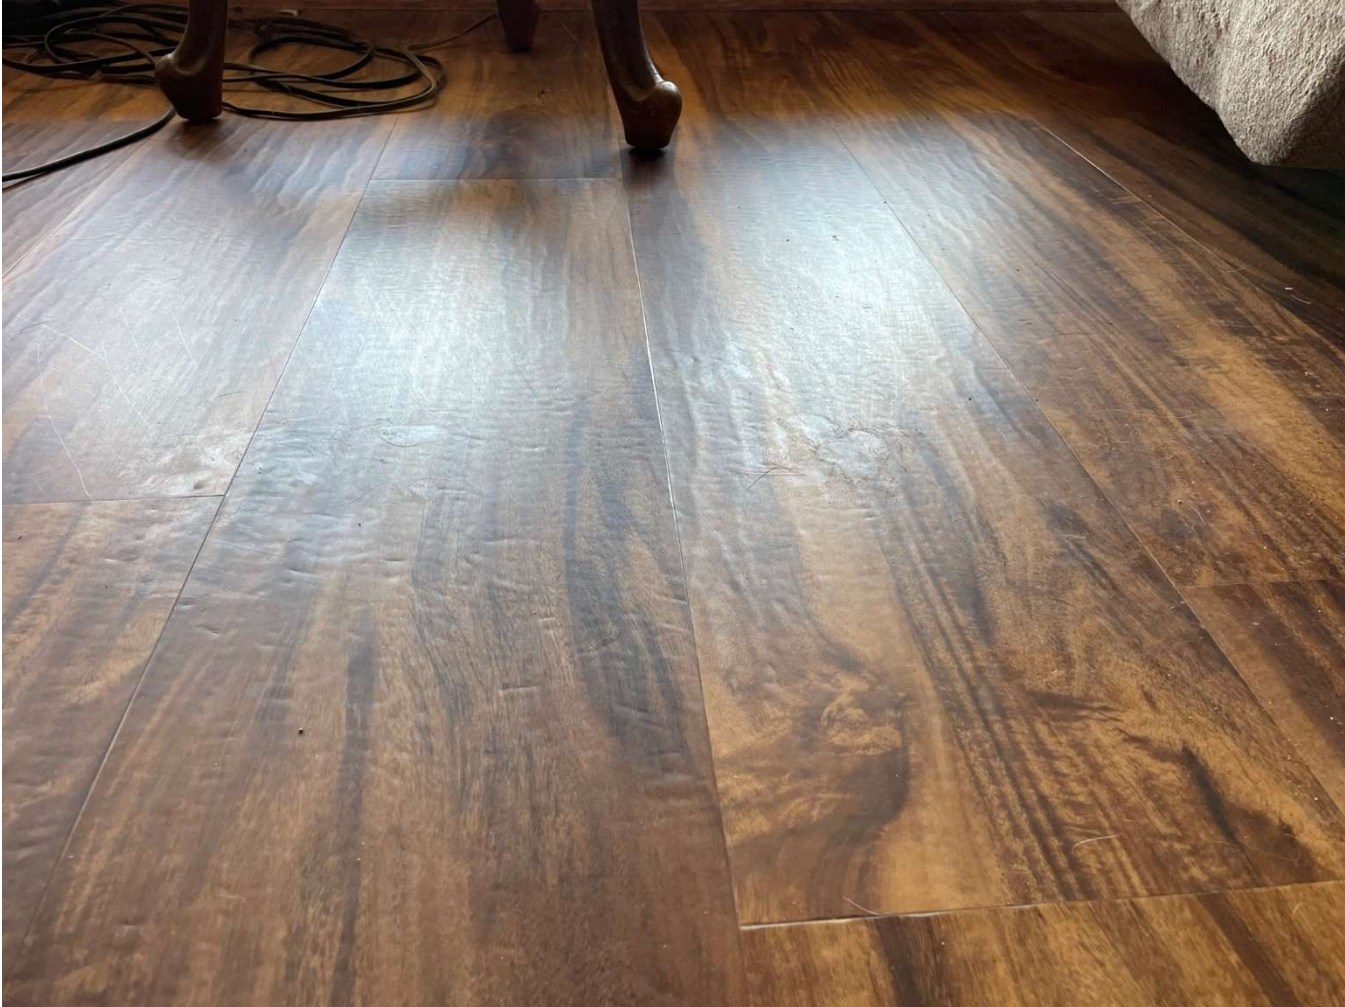
Scuff marks before cleaning
