August 2, 2022

You commissioned Flooring Warranty Services to inspect your floating resilient flooring for unusual marks, cleanability, and lifting/ separating end joints. The initial inspection was performed May, 9th 2022. Samples were collected and additional testing was performed at Professional Testing Laboratory in Dalton, GA. A follow up inspection and test cleaning was performed July 27th, 2022.

Problem Description:

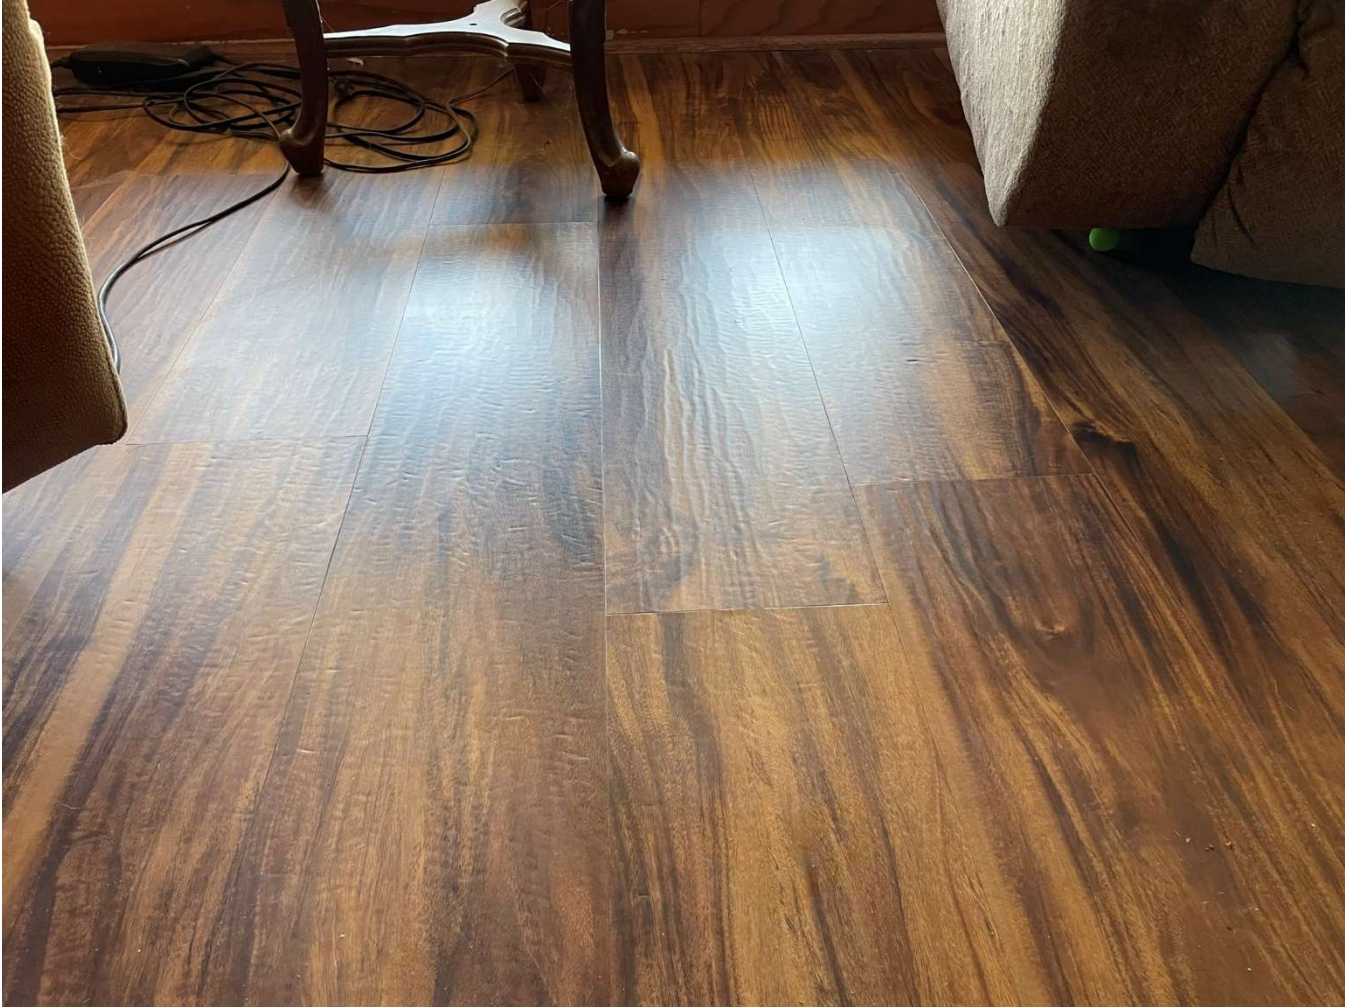
Scuff marks after cleaning

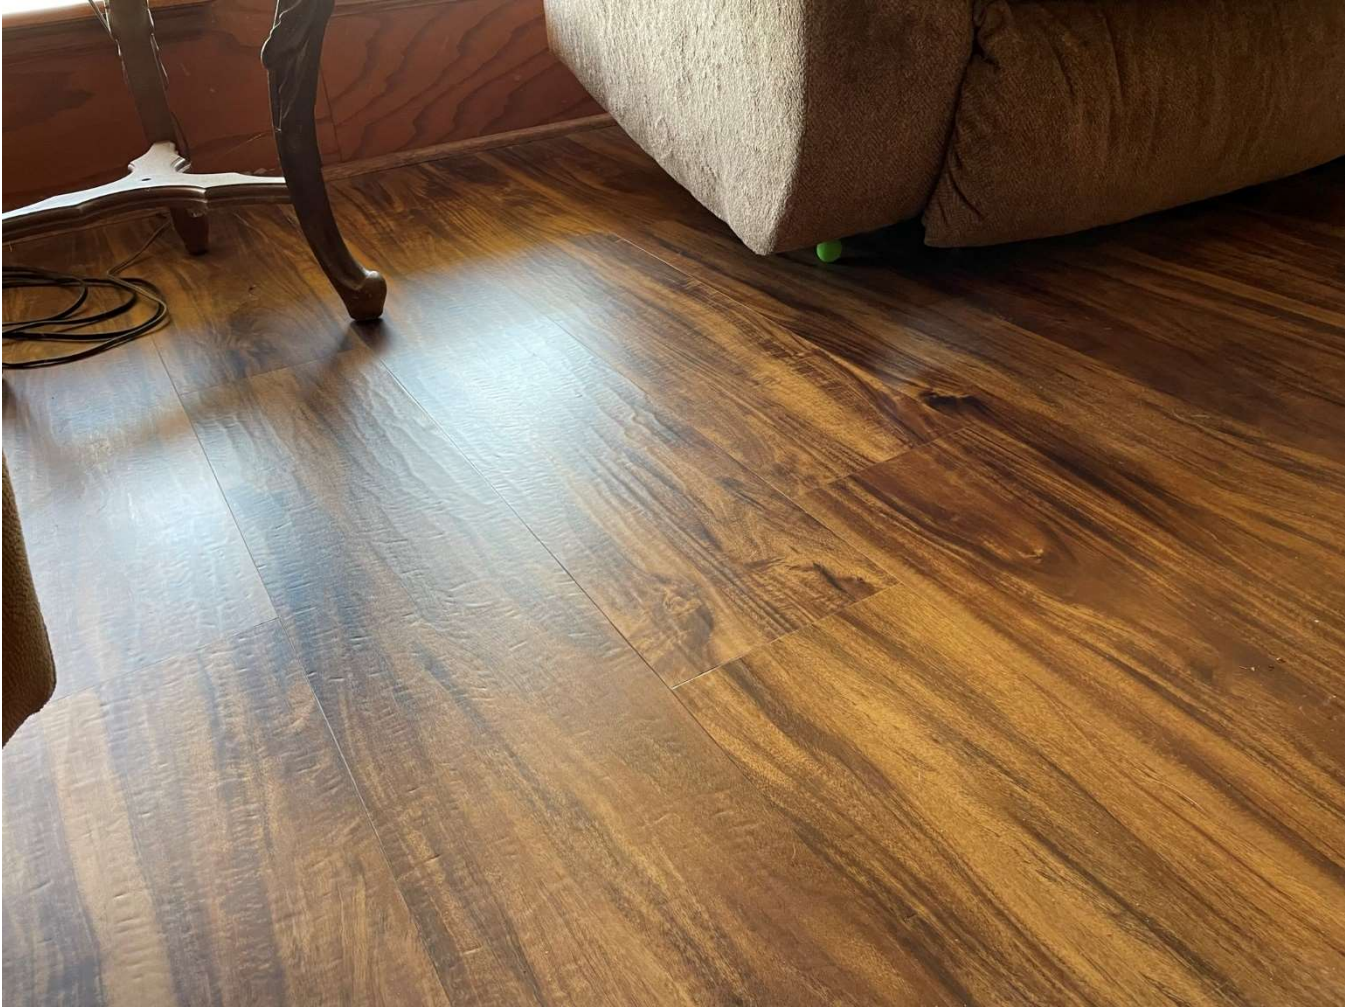
Scuff marks after cleaning

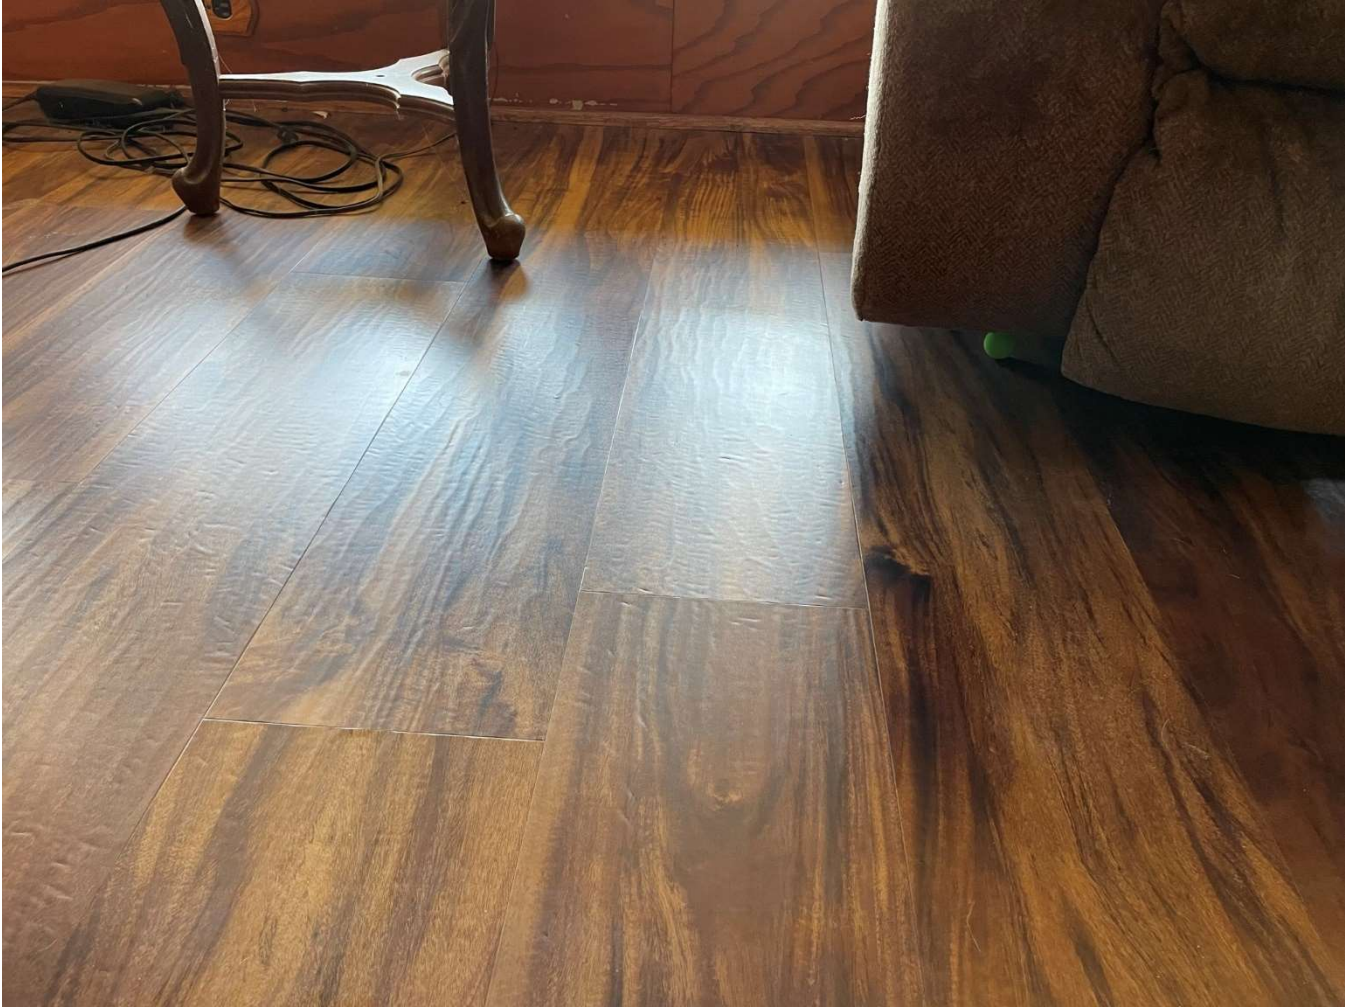
Scuff marks after cleaning

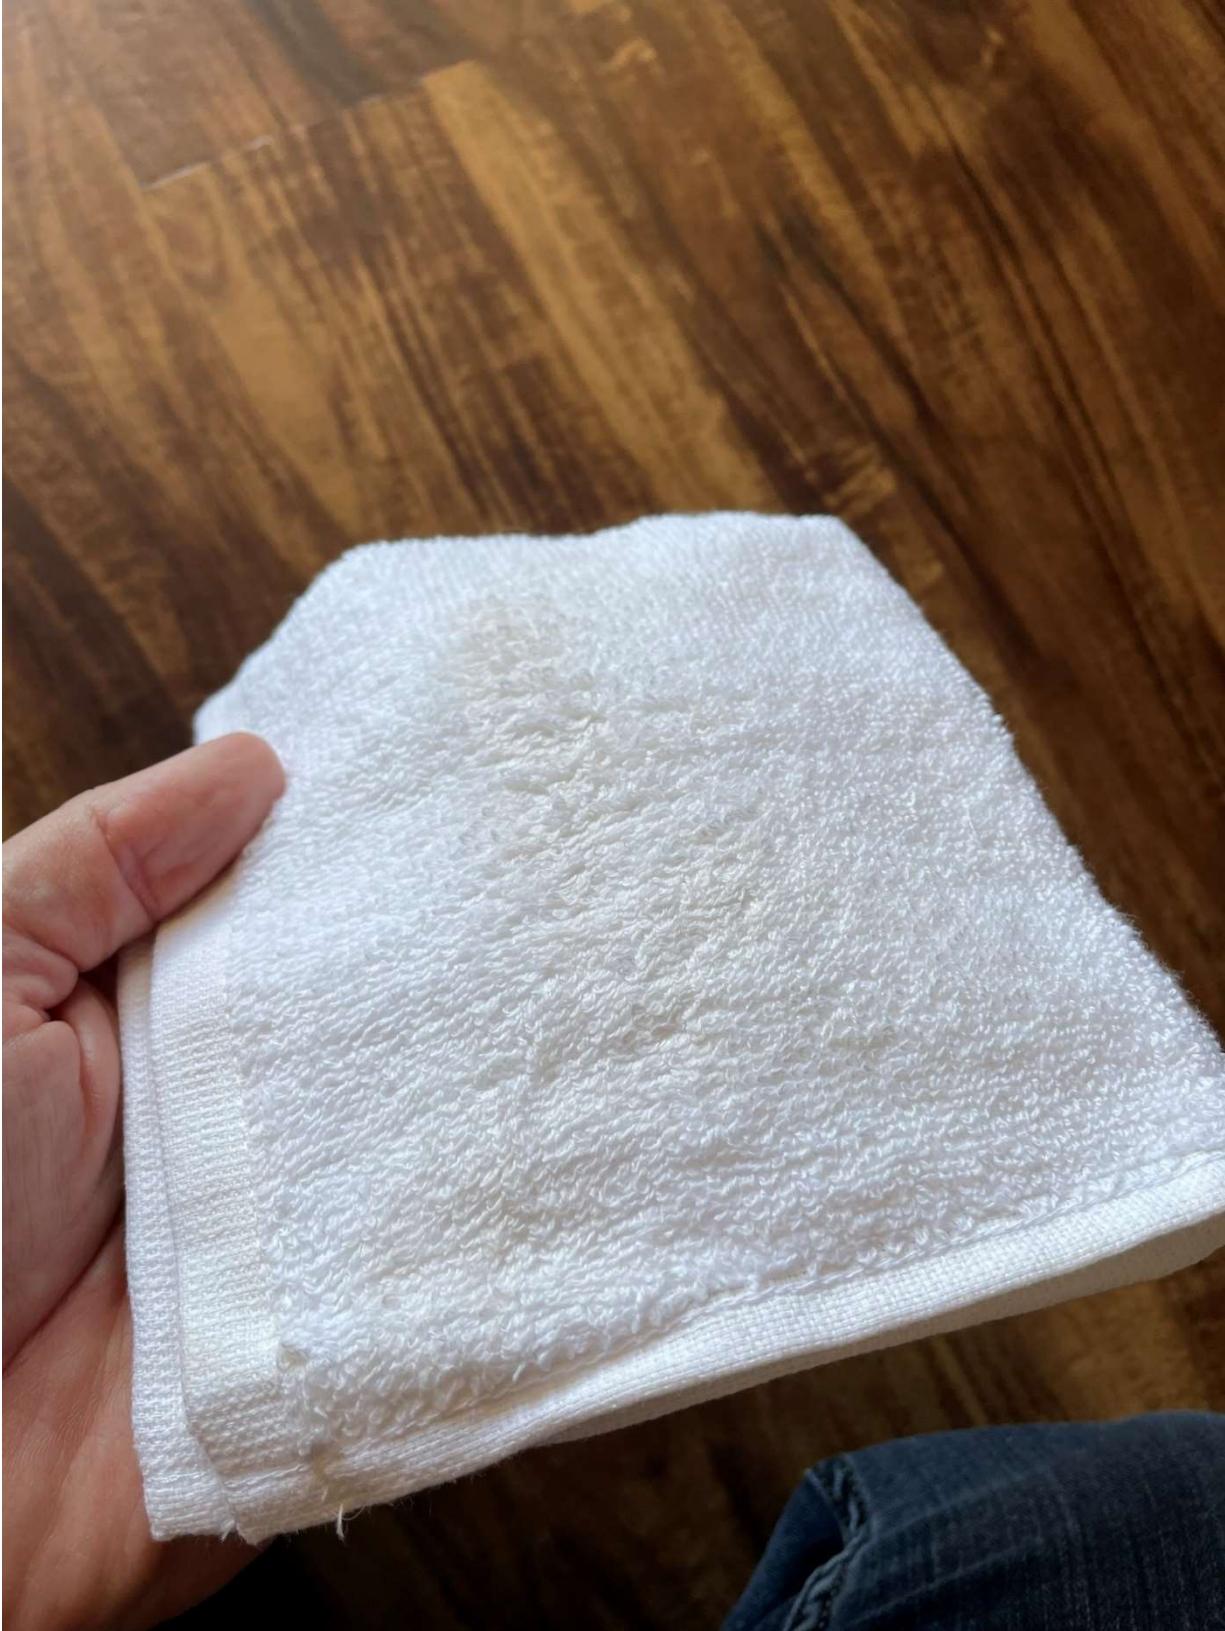
resulted in transfer of an orange-brown substance to the white cloth after multiple cleanings. After dry rubbing the cleaned area. The newly rubbed area had an even more glossy appearance than the surrounding area that was cleaned several times. Each time the area was rubbed it would become more glossy.

Orange-brown substance still transferring after several cleanings

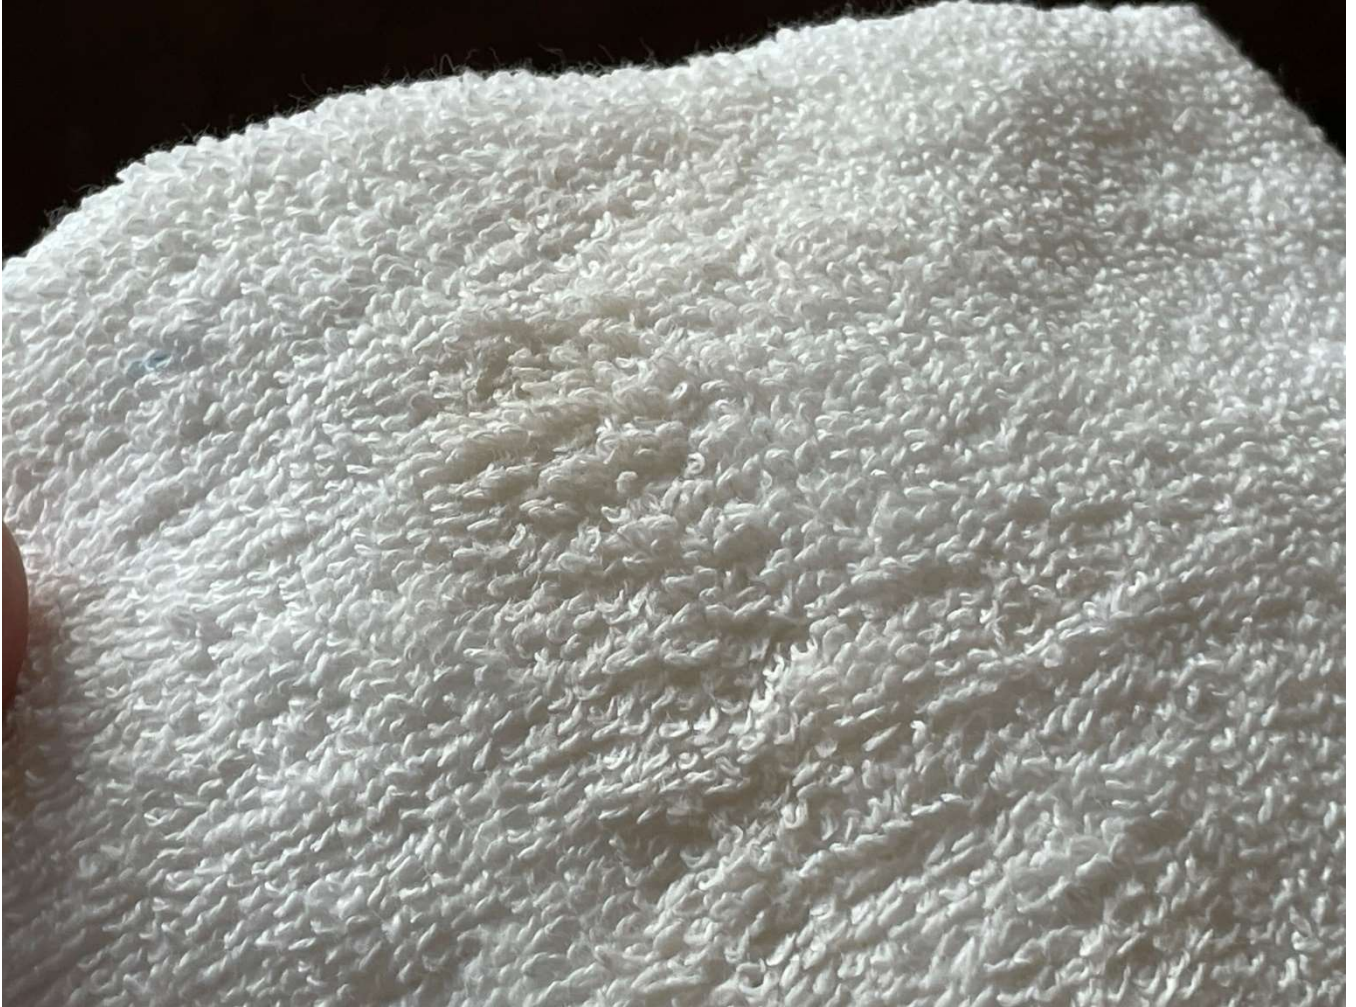
Orange-brown substance still transferring after several cleanings
