Inspection Report

Property Address:
9205 Sand Dune Cove
Parrish FL 34219

KMI Home Inspections, Inc.

Date: 12/4/2024	Time:	Report ID:
Property: 9205 Sand Dune Cove Parrish FL 34219	Customer: Chrissy Brahler	Real Estate Professional:

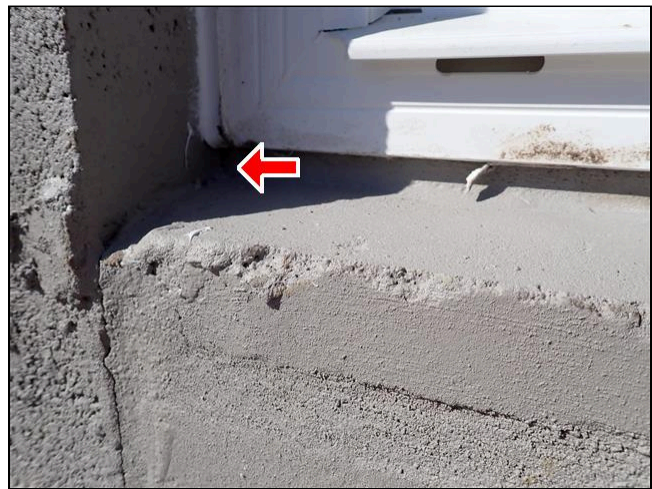
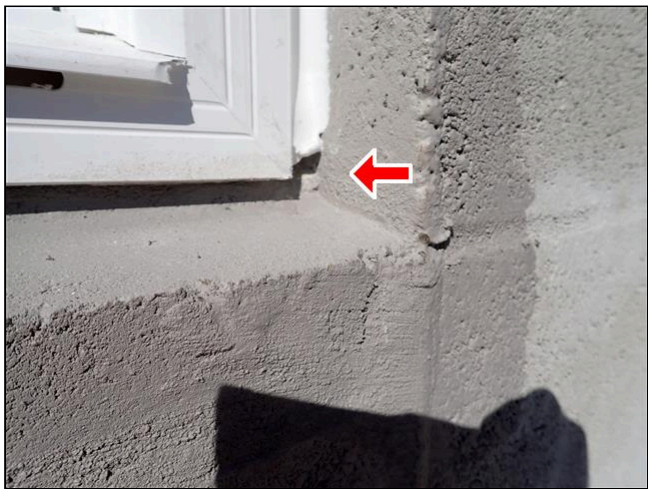
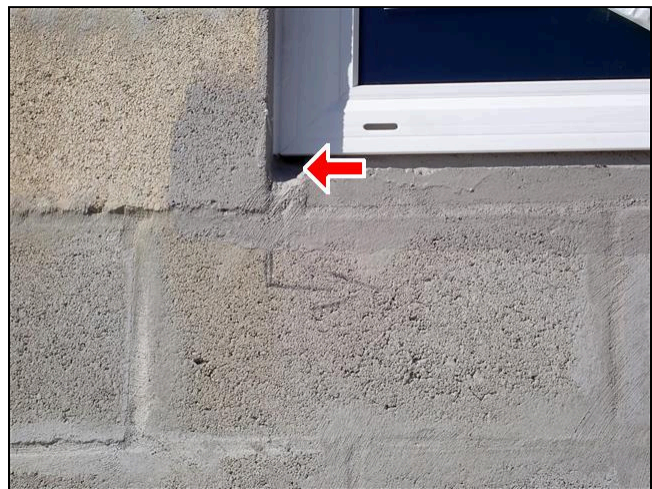
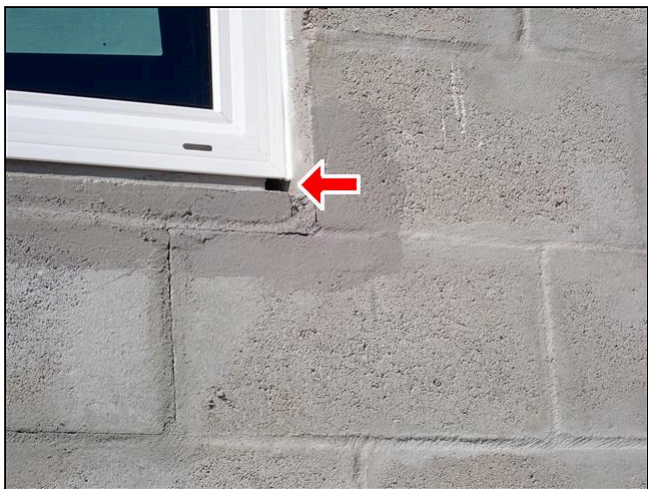
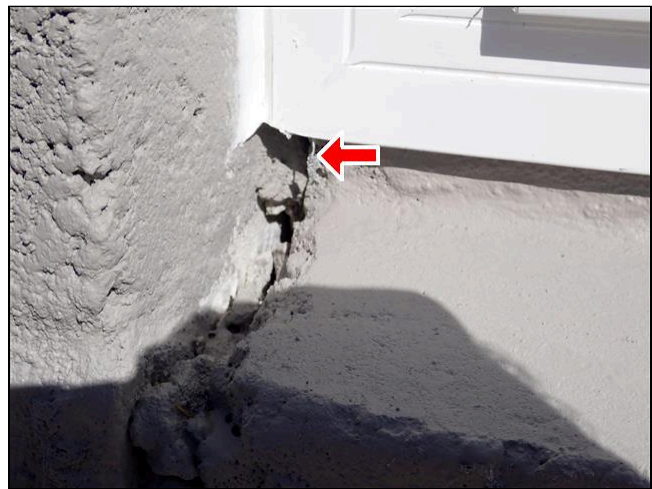
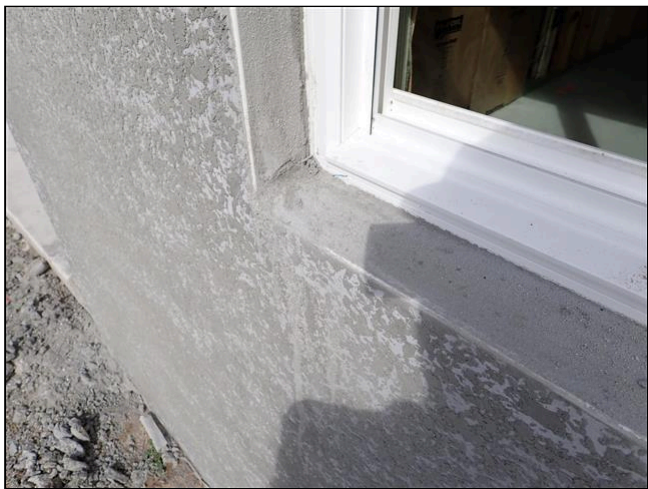
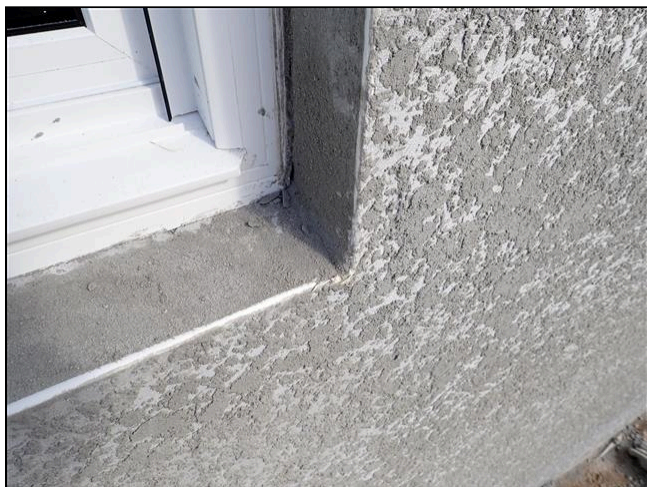
2.2 Caulking at exterior windows is missing at several locations at the lower corners around the perimeter of the home. Recommend installing caulk per manufacturers installation instructions.
UPDATED 12-17-24: Stucco coating filling the gaps.

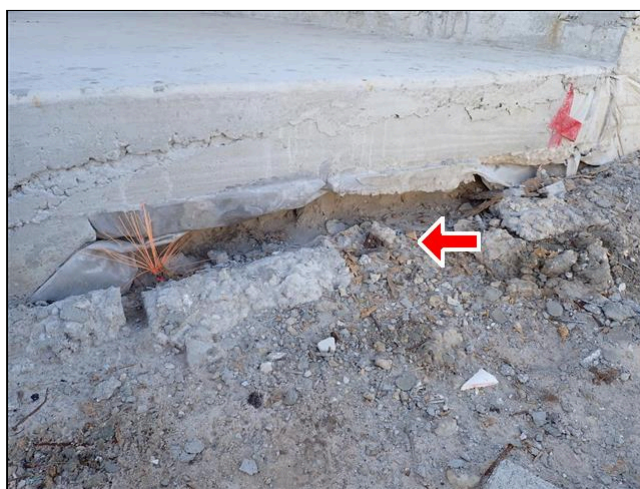
2.3 Item 1(Picture)

2.3 Front porch at the right side of the home has underpinned as a result of erosion. Recommend correct as needed.

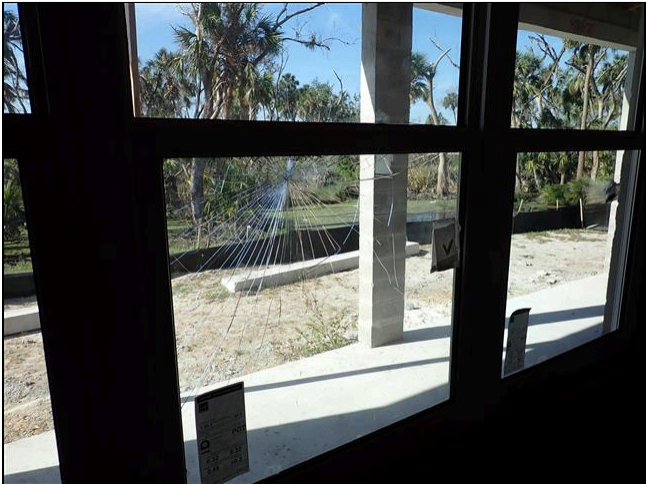
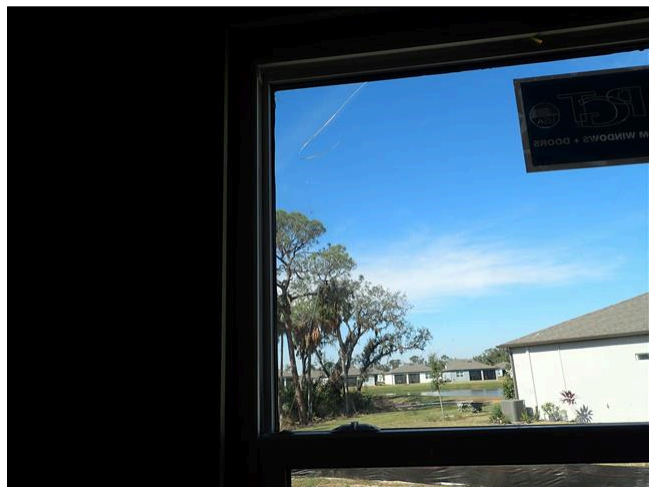
4.6 Three windows are broken at the rear of the home and the right side of the home. Recommend replace as needed.

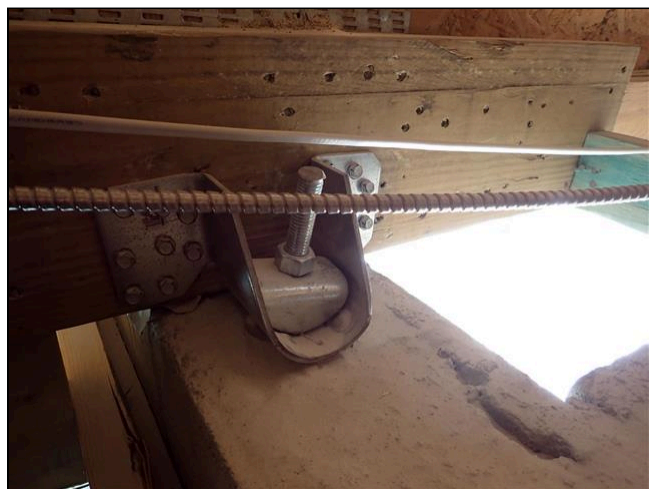
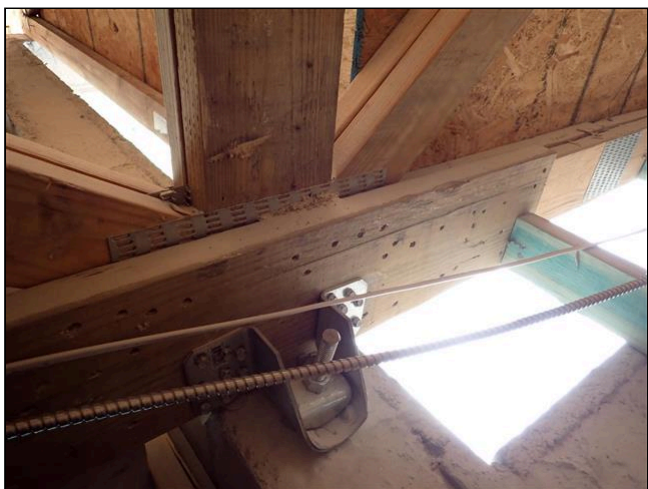
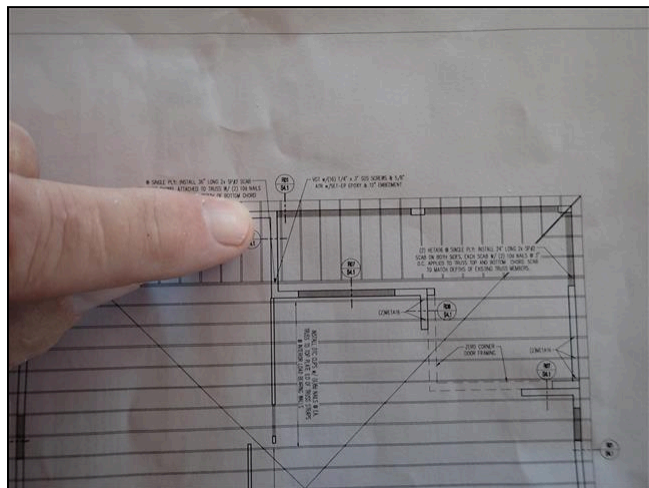
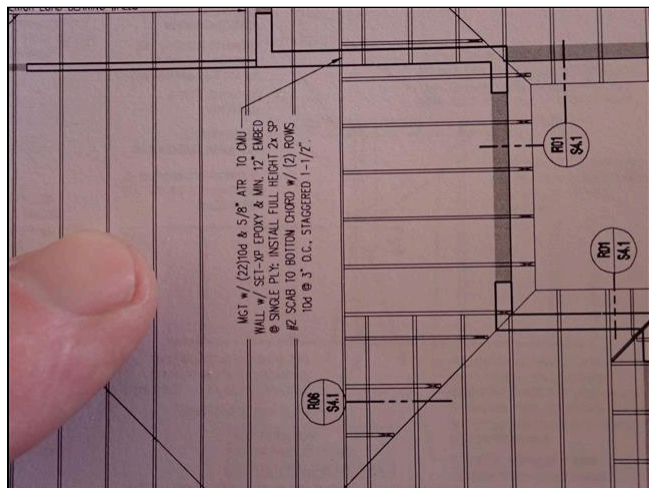
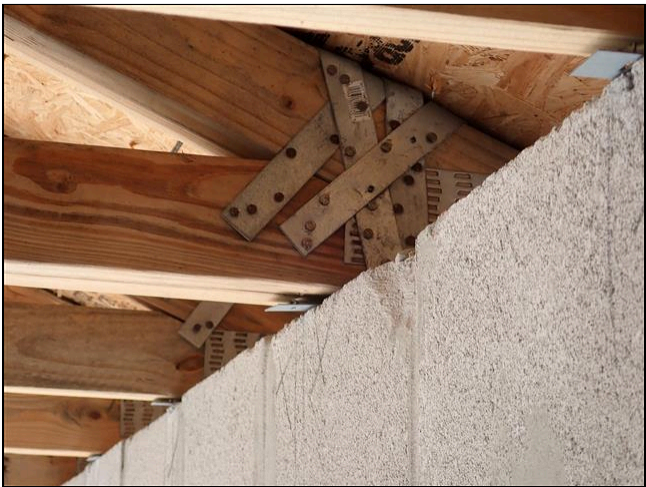
5.1 (1) Noted: Engineering letter specifies for former interior walls to have extensions installed after the retrofit however all interior wall framing has been replaced.

5.1 (2) Brackets installed per plans (for your information).

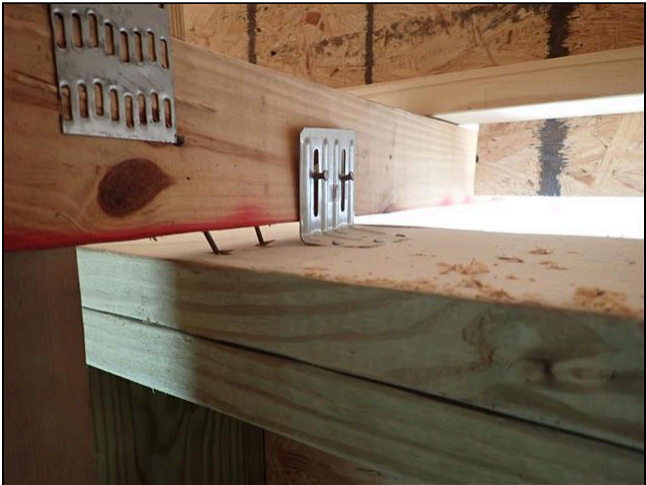
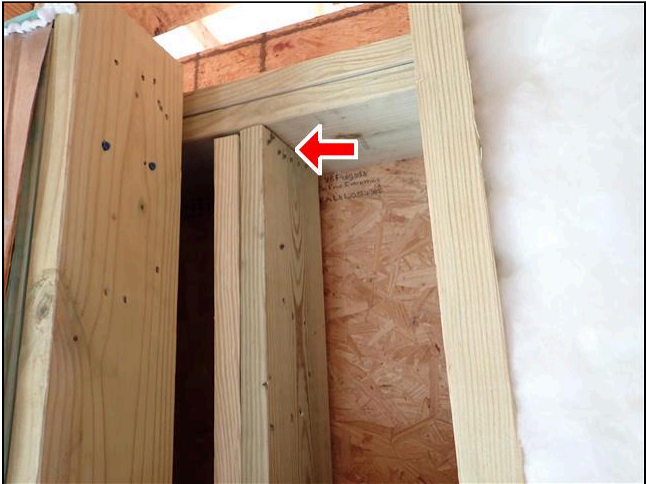
5.1 (3) Framing above the rear sliding glass door assembly has pulled loose or is not installed correctly. This condition can produce undue stress upon the rear sliding door assembly. Recommend correct as needed. UPDATED 12-17-24: Framing members sistered.

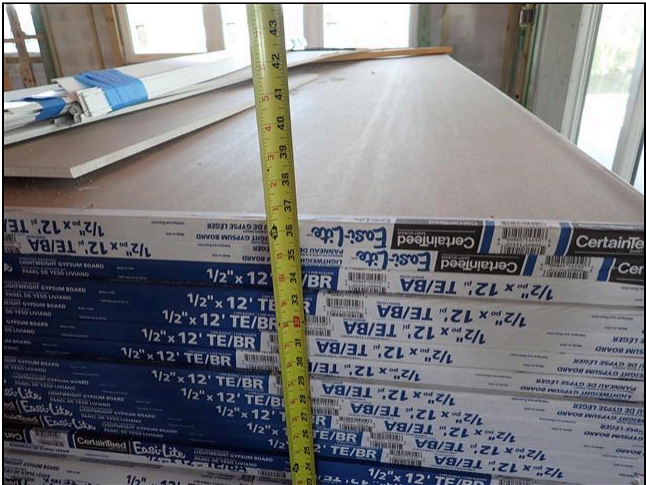
5.3 Item 1(Picture)

5.3 Excessively tall drywall stacks may put undue stress on the floor and floor system components. Recommend distributing the weight accordingly.

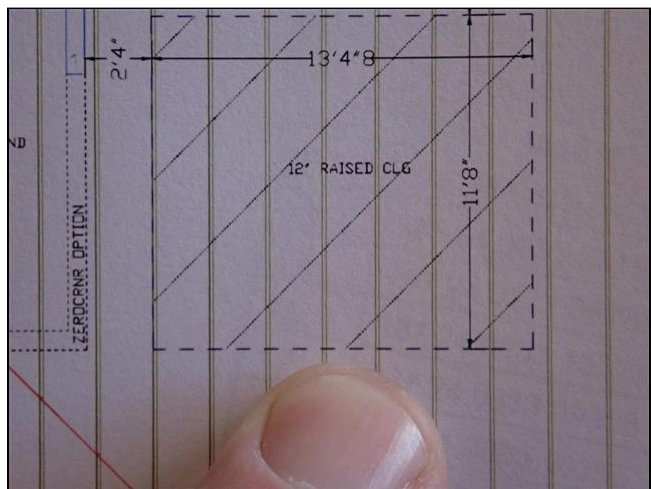
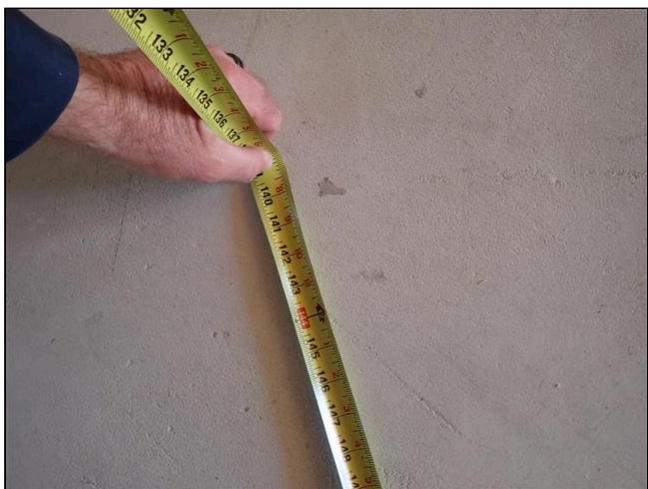
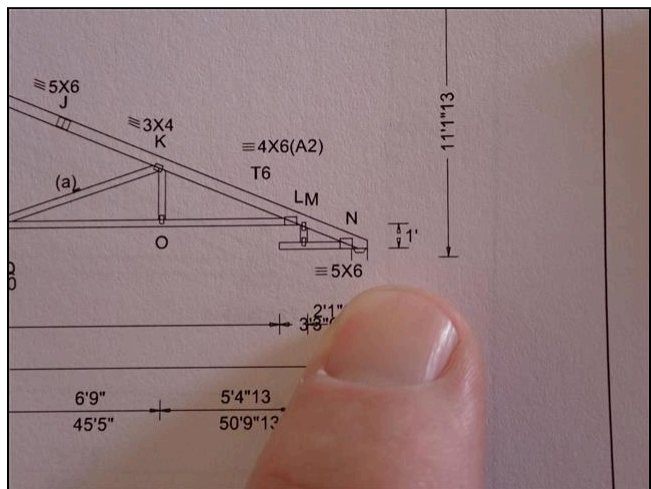
5.4 12' ceiling height in the TV room measures slightly lower as a result of the truss drawings and

block height (for your information).

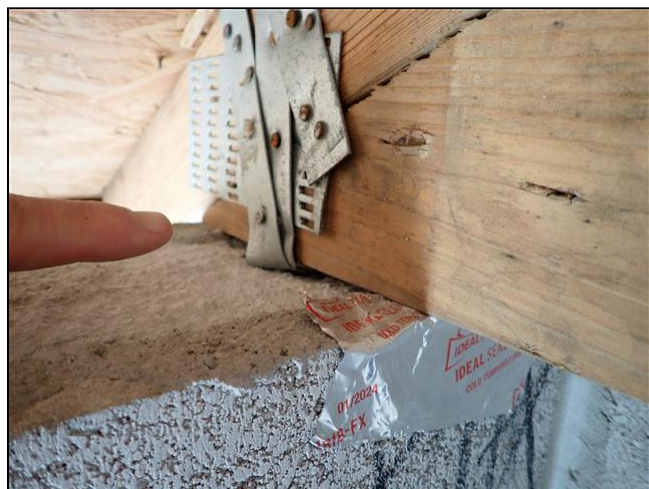
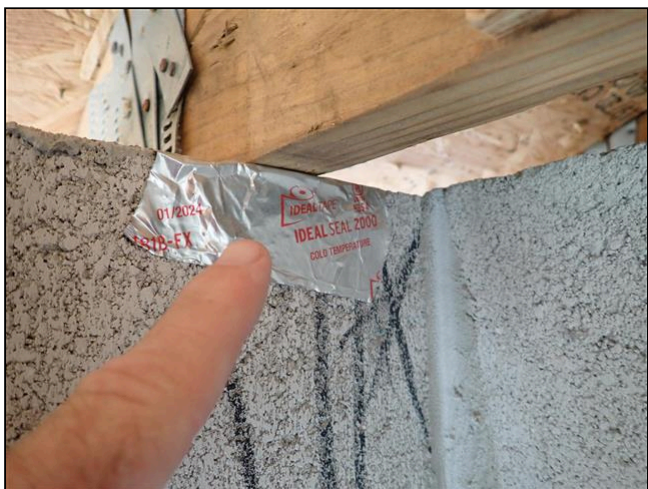
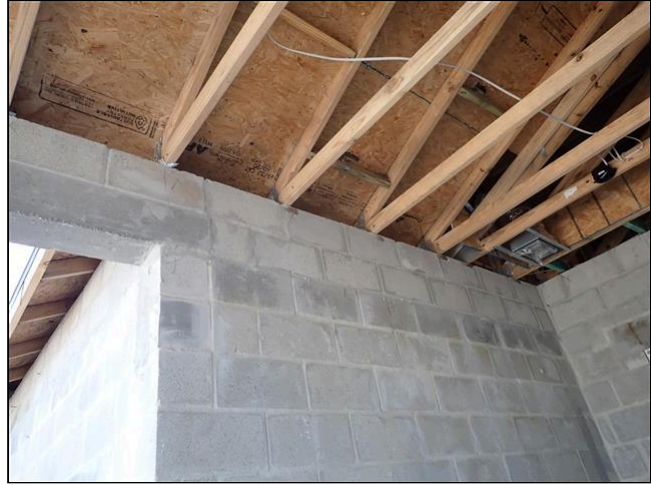
5.5 (1) Multiple trusses have missing bearing plates or are sitting on top of the truss straps around the perimeter of the home. Truss bearing plates act as a moisture barrier between the truss and the block. Trusses that sit on top of the truss straps are not effective. Recommend correct as needed. UPDATED 12-17-24: Garage Trusses visually confirmed that truss plates are present.

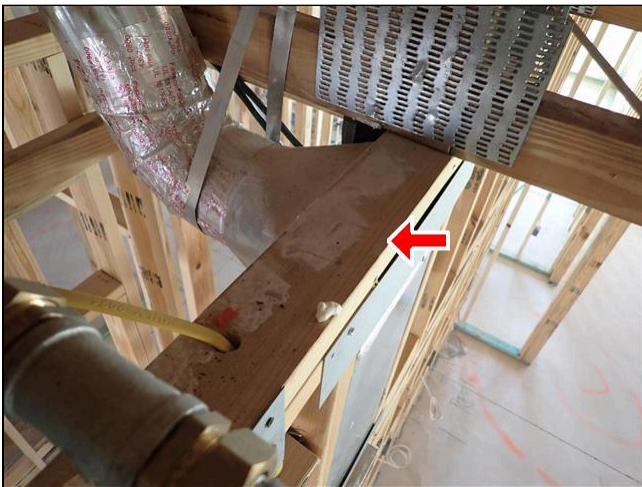
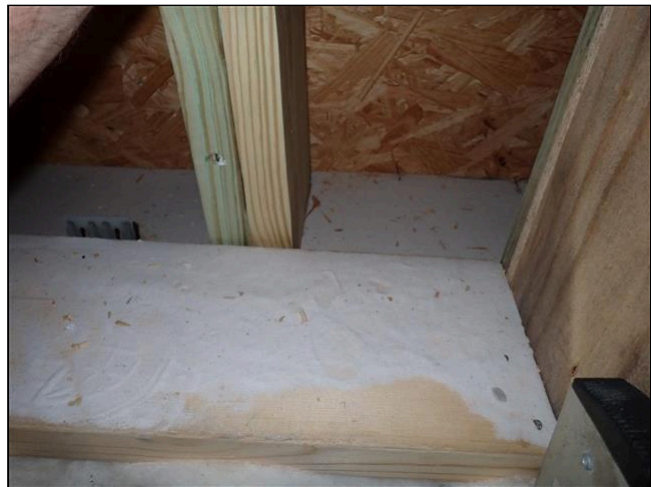
5.5 (2) Sand debris present on top of the interior wall framing suggest that a soda blast treatment may have occurred at the home. Recommend complete removal of all associated debris. UPDATED 12-17-24: Soda blast remnants still present.

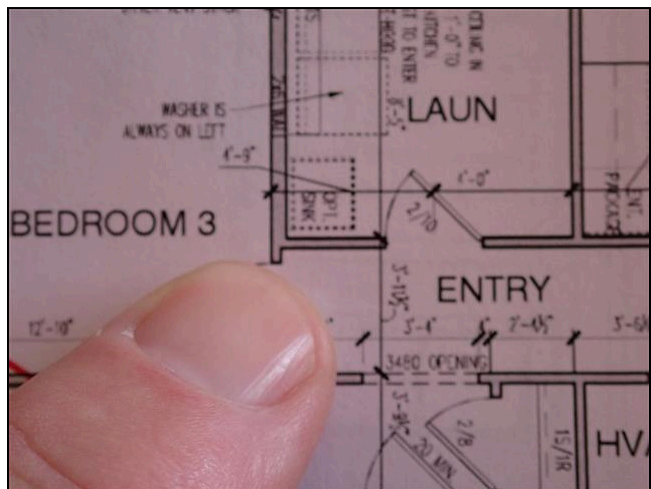
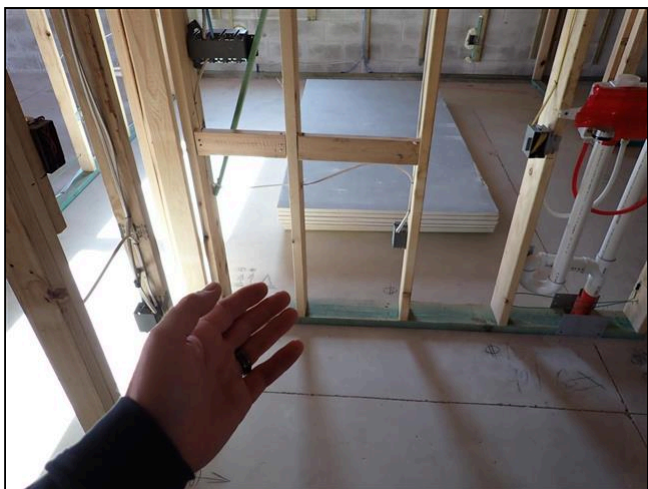
6.0 Optional laundry tub is currently not plumbed. Owner to verify if this option was selected.

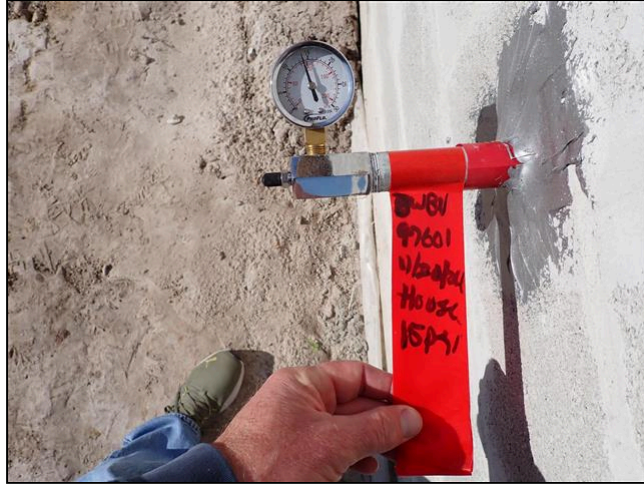
6.4 Item 1(Picture)

6.4 Gas lines under pressure test.

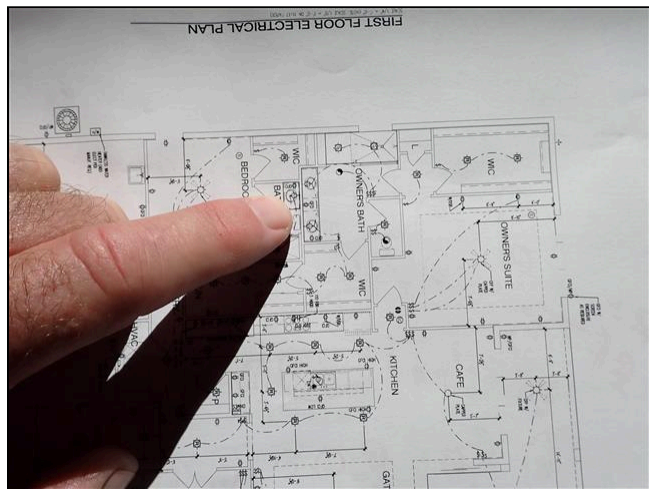
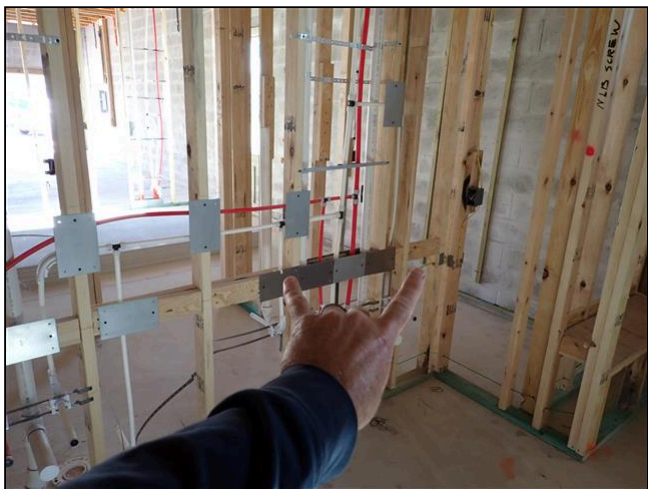
7.3 (1) Location of the outlets in the master bath area near the sinks does not match the drawings. Owner to determine if current locations are acceptable.

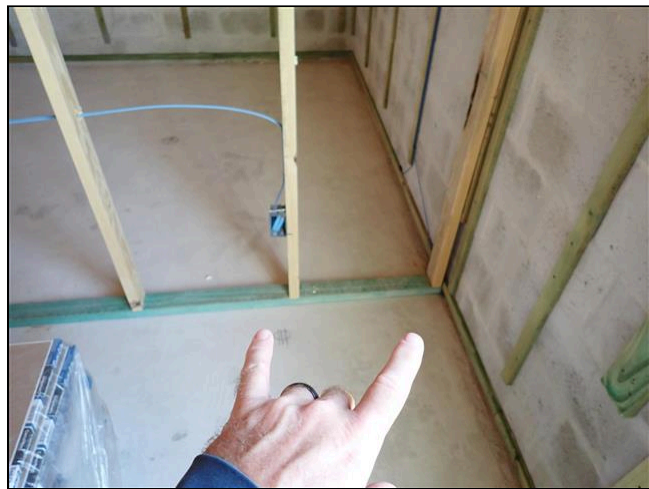
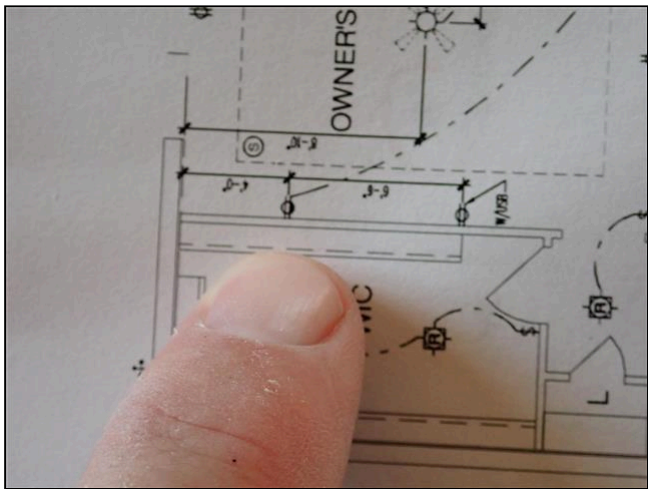
7.3 (2) Location of the outlet on the left wall of the master bedroom does not match the drawings. Owner to determine if current location is acceptable.

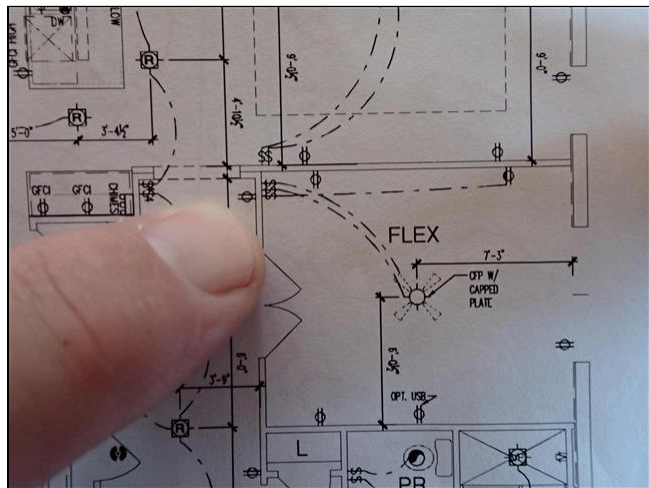
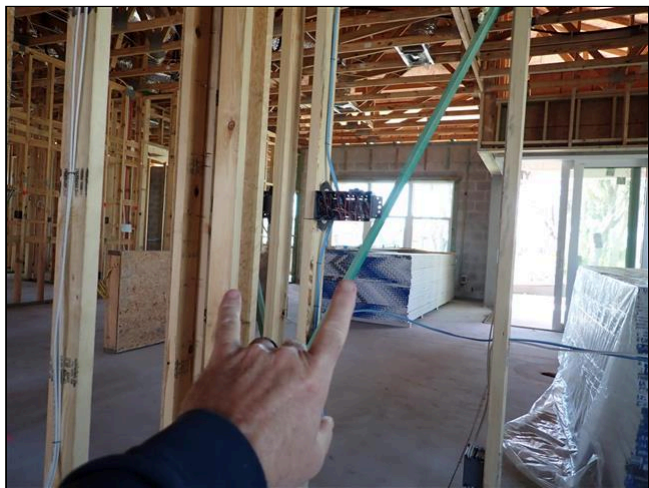
7.3 (3) Location of the switches at the flex room does not match the drawings. Owner to determine if current location is acceptable.

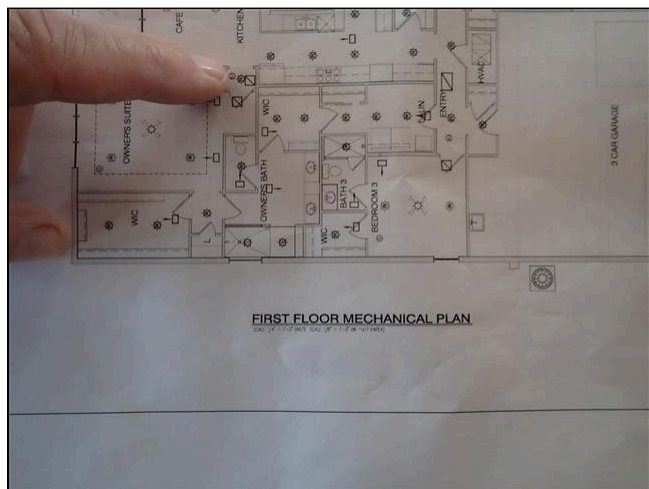
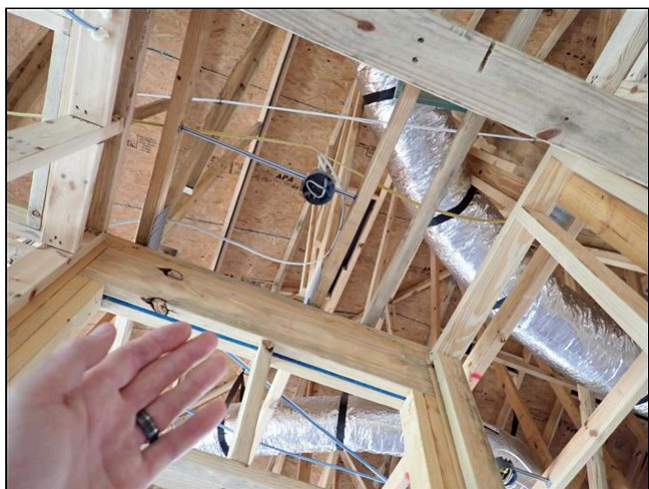
8.3 Return air duct is not present per the drawings outside of the master bedroom entry. Recommend

correct as needed.

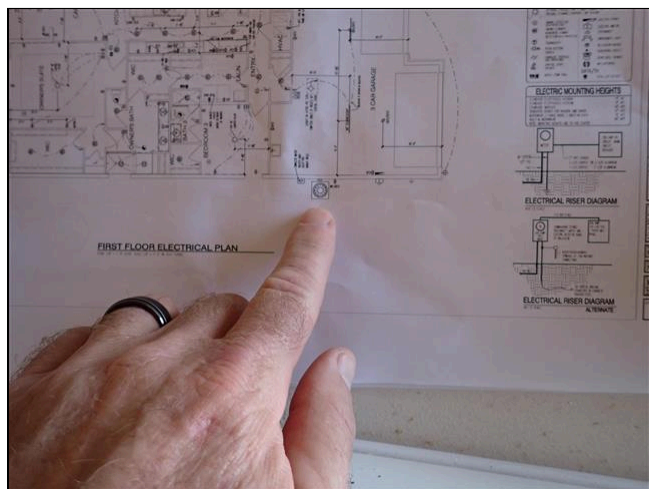
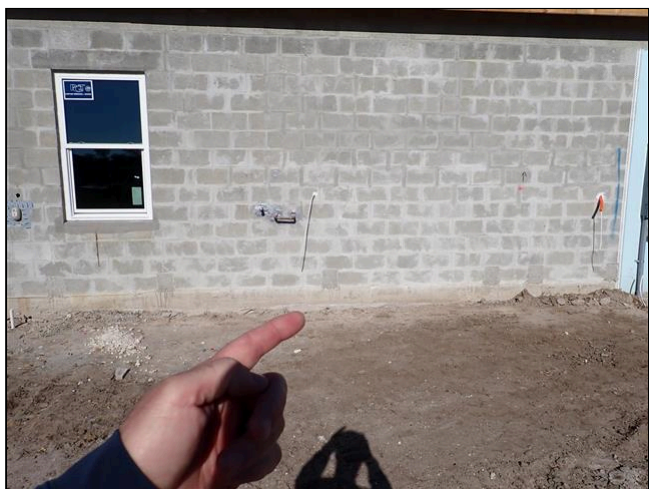
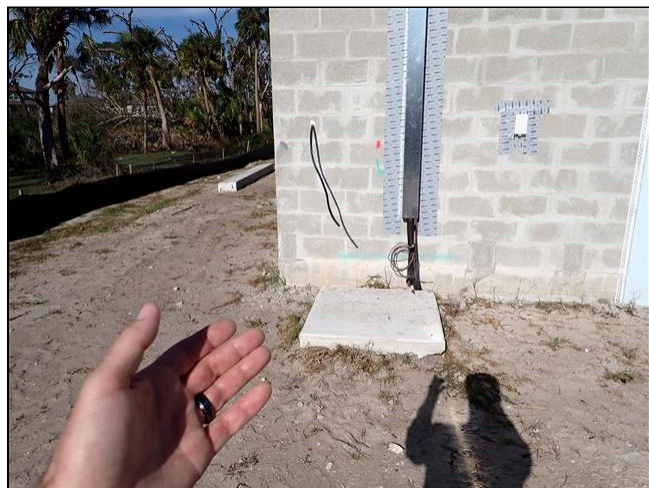
8.8 Condenser pad and related components are located at the left rear corner of the home. This is a discrepancy from the drawings that indicate the condenser should be located at the left side of the home closer to the front. Owner to determine if this location is acceptable.

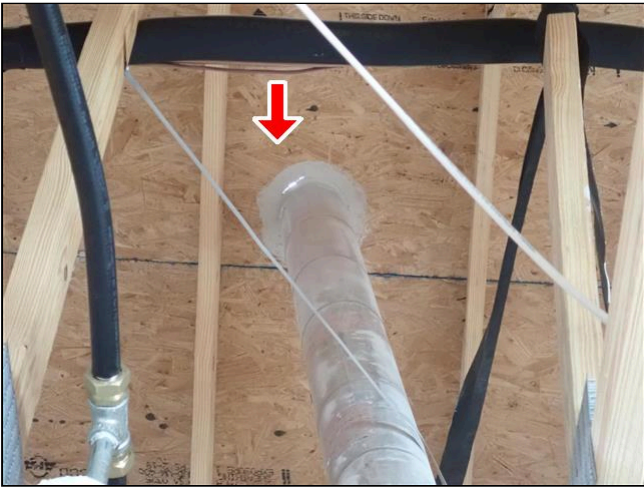
9.4 Item 1(Picture)

9.4 Vent pipe for the range hood fan appears to reveal light at the roof penetration. Recommend seal or repair as needed.

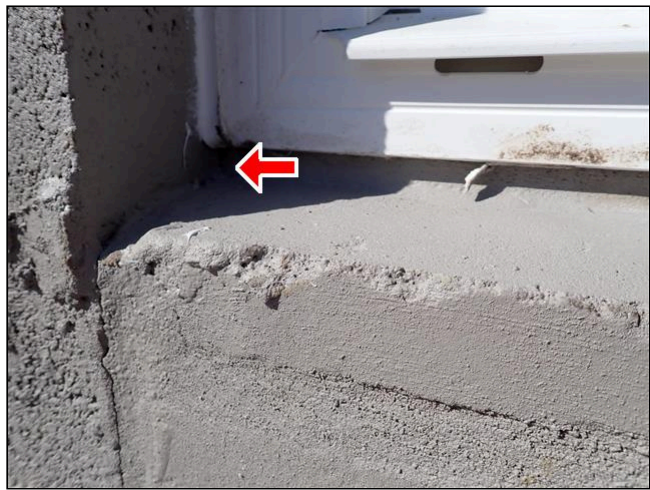
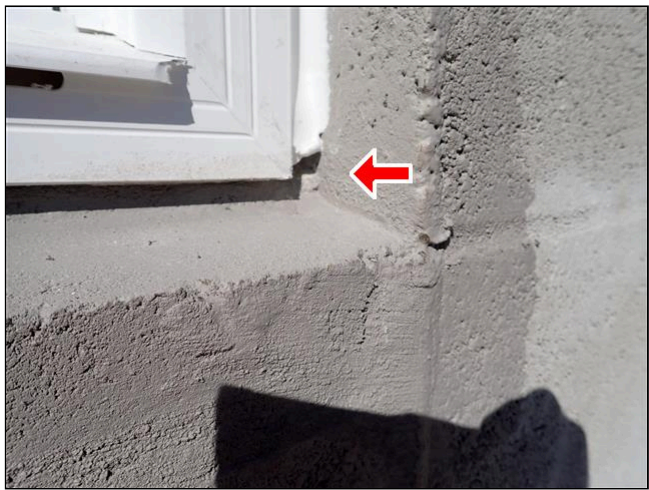
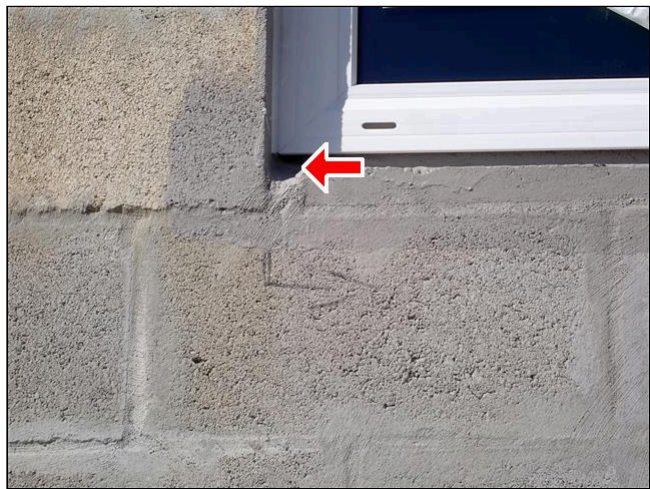
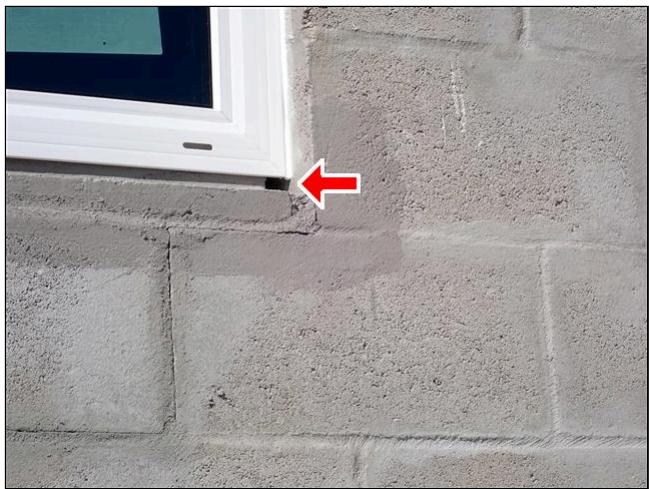
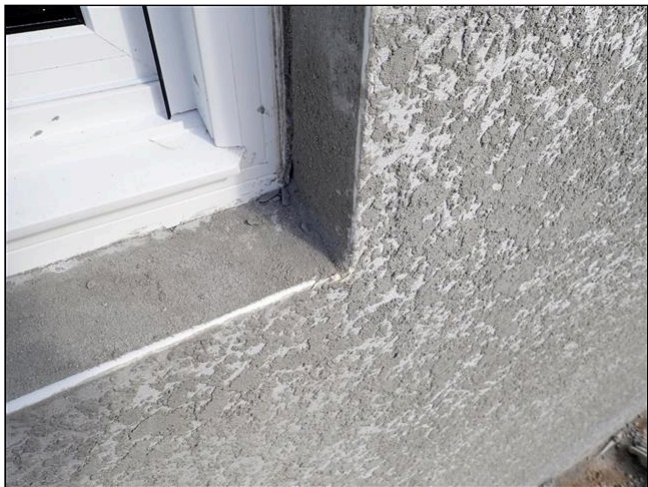
Caulking at exterior windows is missing at several locations at the lower corners around the perimeter of the home. Recommend installing caulk per manufacturers installation instructions. UPDATED 12-17-24: Stucco coating filling the gaps.

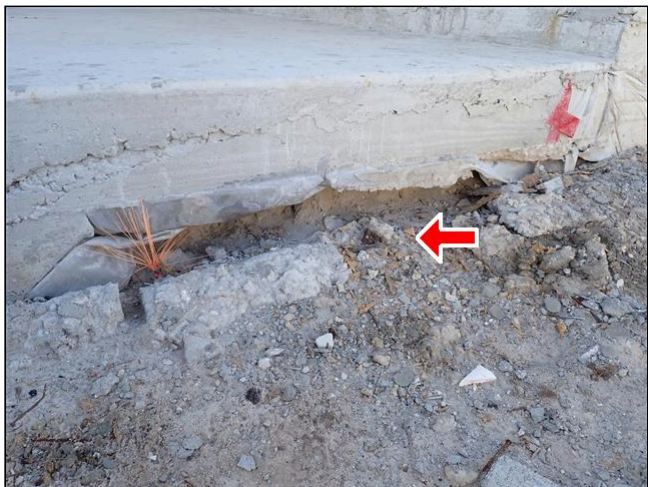
2.3 Item 1(Picture)

Front porch at the right side of the home has underpinned as a result of erosion. Recommend correct as needed.

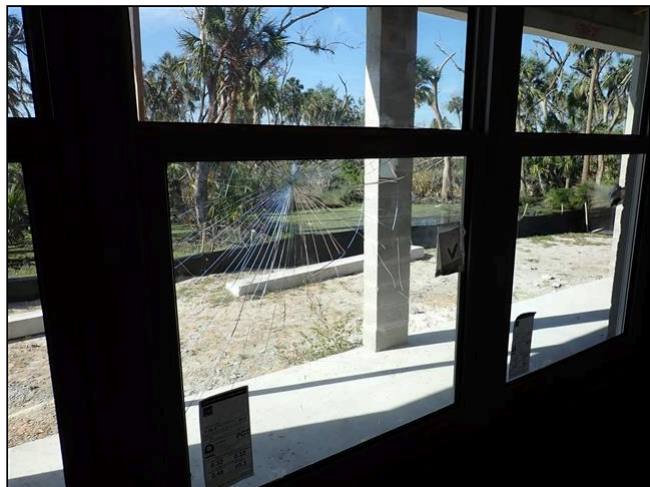
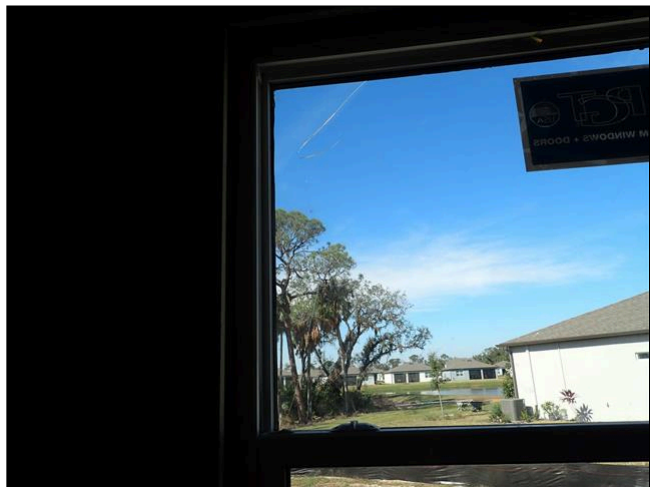
Three windows are broken at the rear of the home and the right side of the home. Recommend replace as needed.

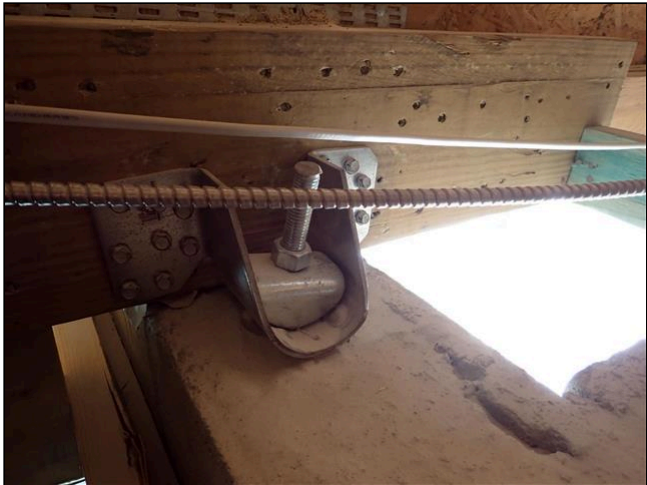
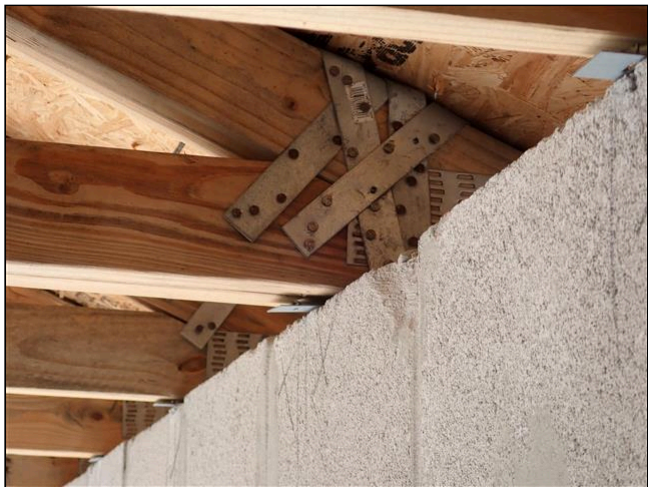
- (1) Noted: Engineering letter specifies for former interior walls to have extensions installed after the retrofit however all interior wall framing has been replaced.
- (2) Brackets installed per plans (for your information).

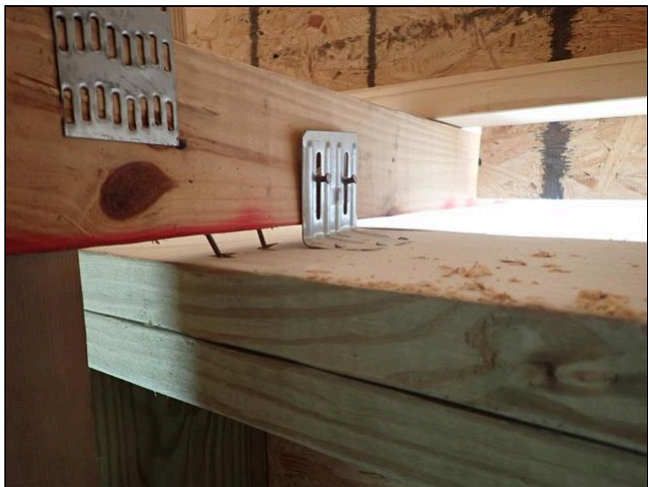
5.1 Item 10(Picture)

(3) Framing above the rear sliding glass door assembly has pulled loose or is not installed correctly. This condition can produce undue stress upon the rear sliding door assembly. Recommend correct as needed. UPDATED 12-17-24: Framing members sistered.

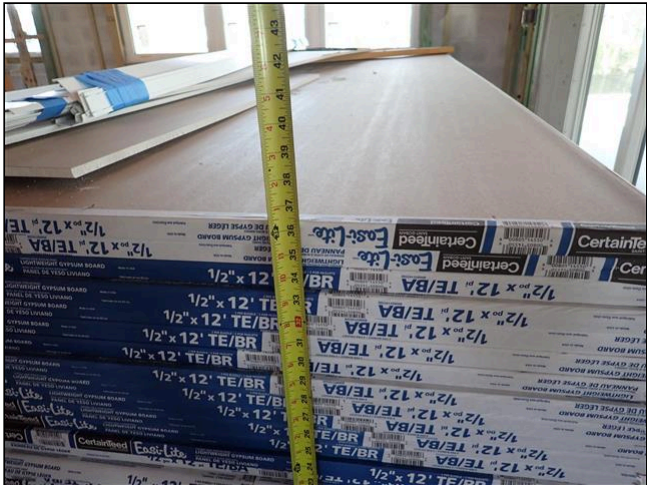
5.3 Item 1(Picture)

Excessively tall drywall stacks may put undue stress on the floor and floor system components. Recommend distributing the weight accordingly.

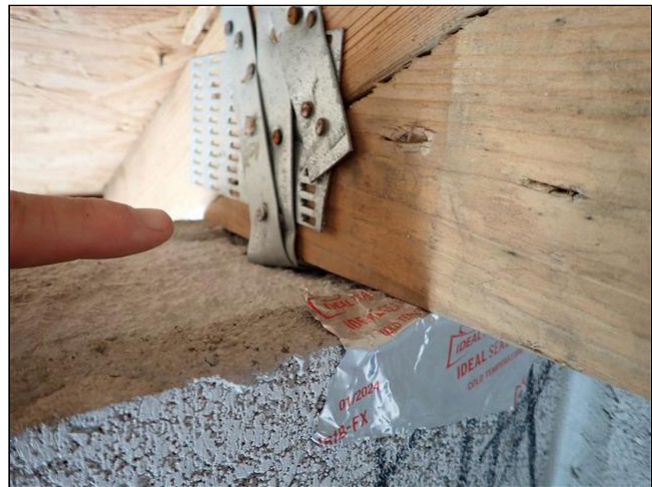
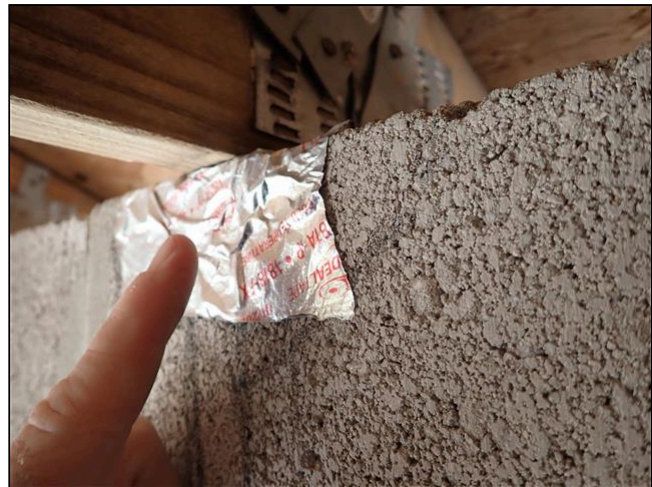
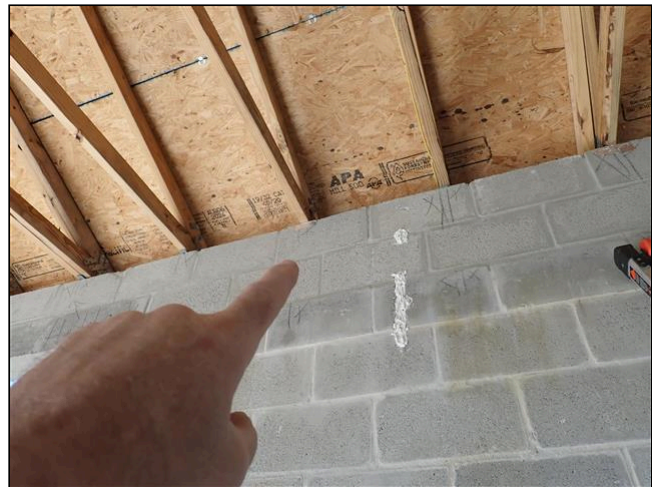
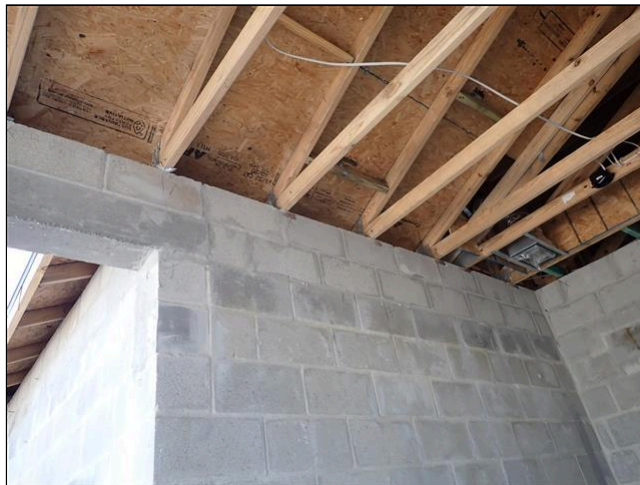
(1) Multiple trusses have missing bearing plates or are sitting on top of the truss straps around the perimeter of the home. Truss bearing plates act as a moisture barrier between the truss and the block. Trusses that sit on top of the truss straps are not effective. Recommend correct as needed. UPDATED 12-17-24: Garage Trusses visually confirmed that truss plates are present.

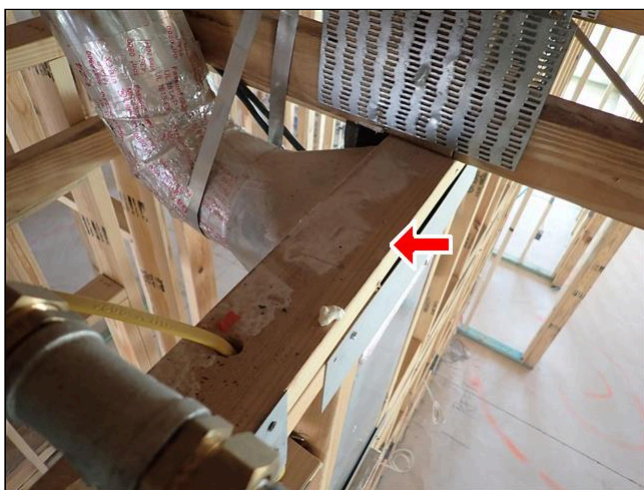
5.5 Item 27(Picture)

(2) Sand debris present on top of the interior wall framing suggest that a soda blast treatment may have occurred at the home. Recommend complete removal of all associated debris. UPDATED 12-17-24: Soda blast remnants still present.

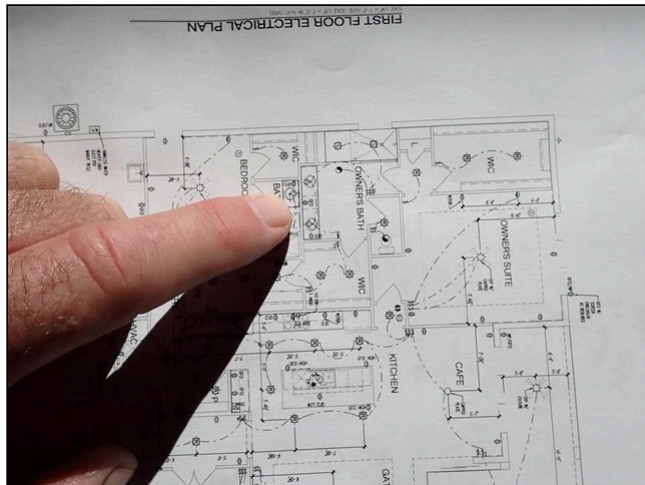
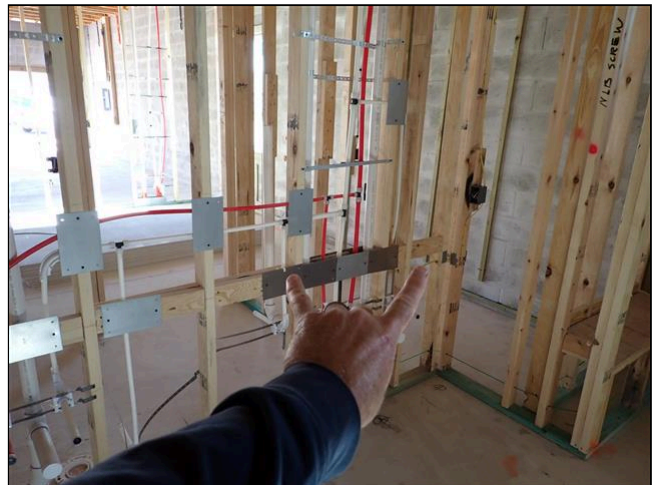
(1) Location of the outlets in the master bath area near the sinks does not match the drawings. Owner to determine if current locations are acceptable.

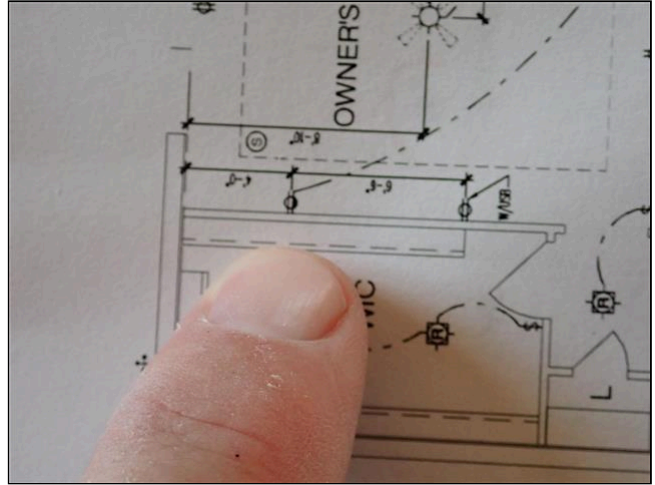
7.3 Item 4(Picture)

(2) Location of the outlet on the left wall of the master bedroom does not match the drawings. Owner to determine if current location is acceptable.

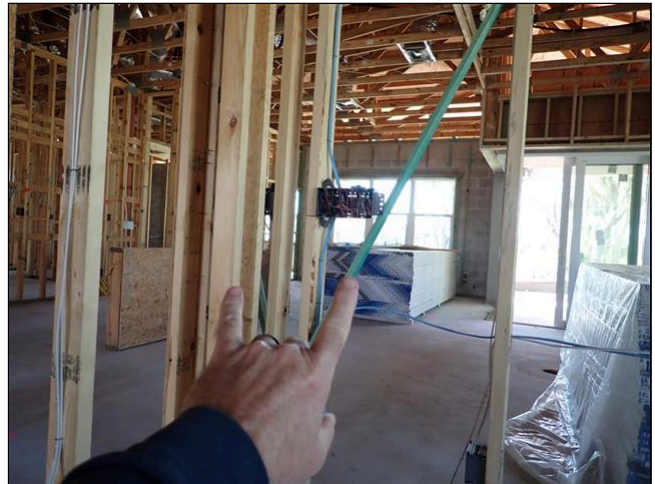
7.3 Item 6(Picture)

(3) Location of the switches at the flex room does not match the drawings. Owner to determine if current location is acceptable.

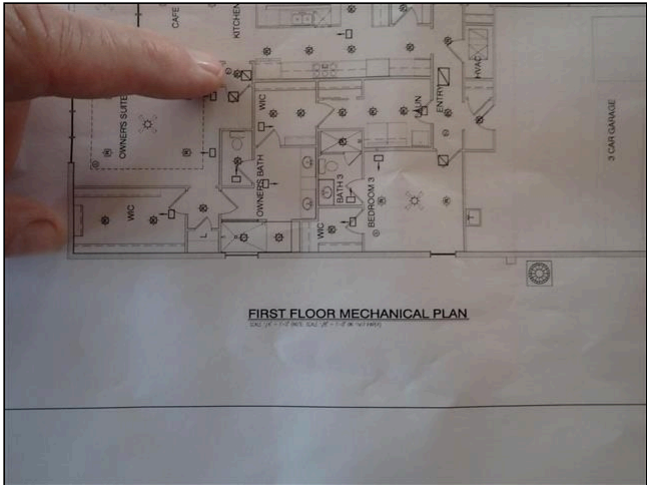
8.3 Item 1(Picture)

Return air duct is not present per the drawings outside of the master bedroom entry. Recommend correct as needed.

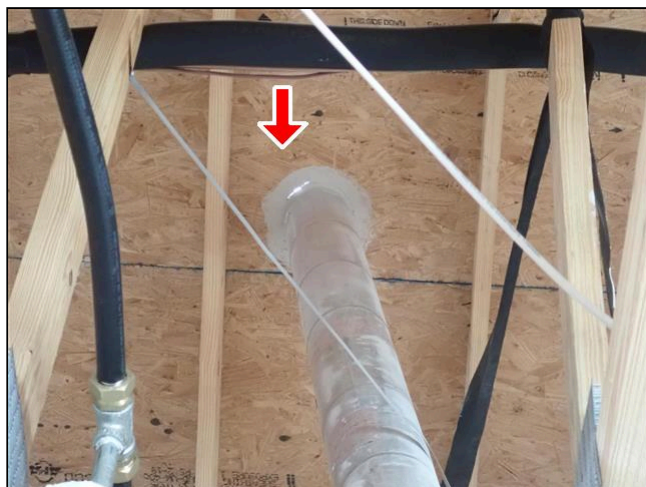
9.4 Item 1(Picture)

Vent pipe for the range hood fan appears to reveal light at the roof penetration. Recommend seal or repair as needed.
