## **Inspection Report**

**KMI Home Inspections, Inc.**

**Kapp A. McMullin, HI11423  
5932 Wildwood Ave.  
Sarasota, Florida 34231  
941-350-2927**

<b>Date:</b> 11/26/2021	<b>Time:</b>	<b>Report ID:</b>
<b>Property:</b>	<b>Customer:</b>	<b>Real Estate Professional:</b>

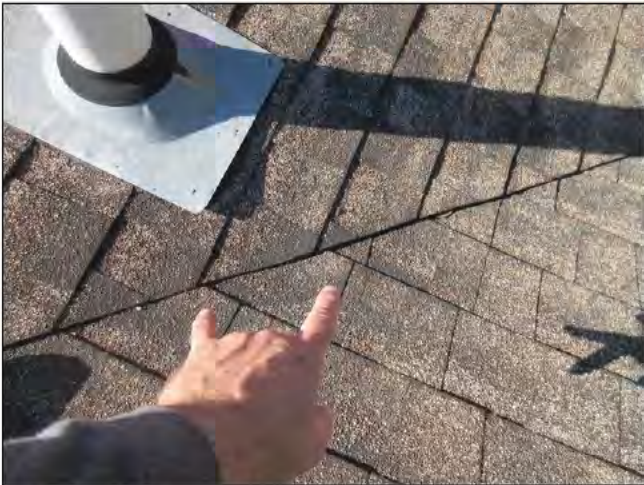
1.0 Item 1(Picture)

1.0 1732/1736- Roof covering has significant granular loss and has exceeded its useful life expectancy. Membrane roof covering above the garage unit and 8 Plex shows several areas that pond water. Tree limbs are in contact with the garage roof and the 8 Plex roof and should be trimmed. Recommend further review from a licensed roofing contractor and repair as needed.

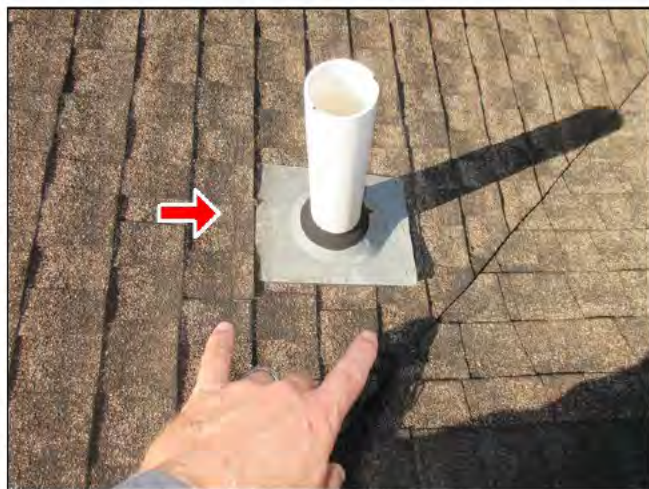
1.1 Item 1(Picture)

**1.1 1732/1736-** Several flashing boots are damaged or installed improperly. Repairs are needed. Bitumen flashing above the 8 Plex has pulled loose near the plumbing vent pipe. Recommend a licensed roofing contractor repair as needed.

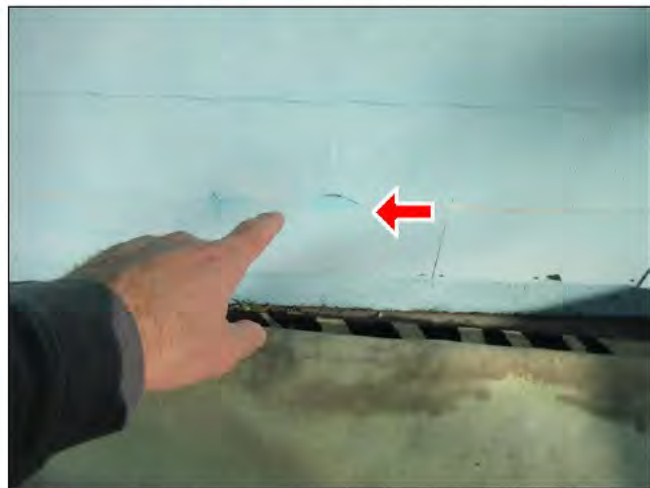
2.0 Item 1(Picture)

2.0 1732- Multiple slate tiles are damaged or cracked on the perimeter of the unit. Garage- Rear and side sheds are deteriorated at the door frame and/or siding and need repairs. 8 Plex- Masonry coating on the rear of the lower units has several hairline settlement cracks. Displacement was not observed (for your information). 8 Plex- Wood siding at the lower level is partially deteriorated in several areas. Recommend repair as needed.

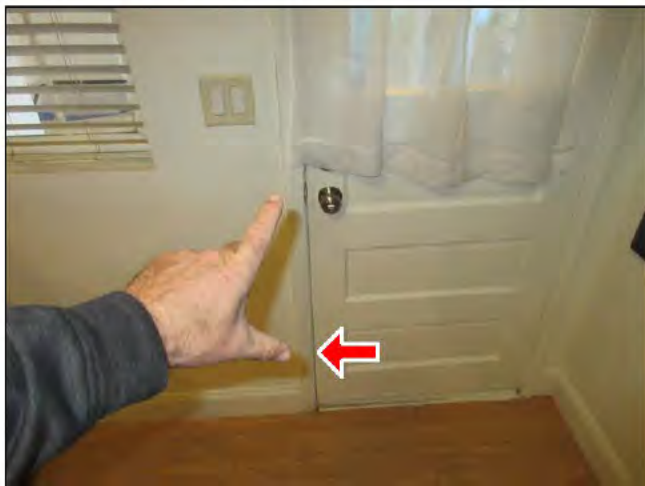
2.1 Item 1(Picture)

**2.1** 1732- Front and rear entry doors are missing weather stripping. 1736- Front and rear entry doors are missing weather stripping.

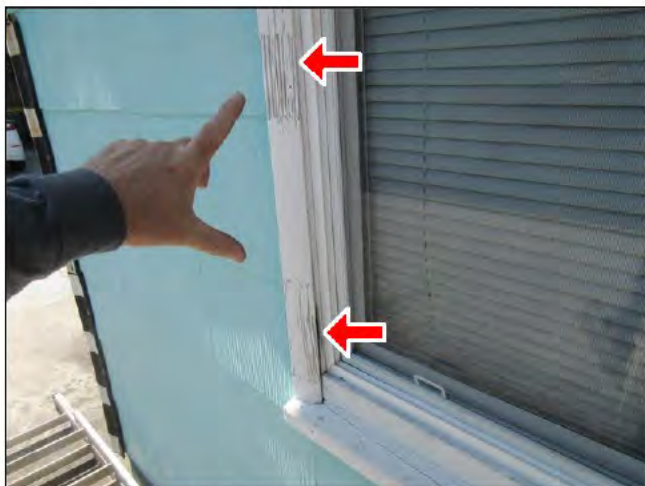
2.2 Item 1(Picture)

**2.2** Multiple window frames or trim around the units are peeling paint. Recommend seal, prep and paint as needed.

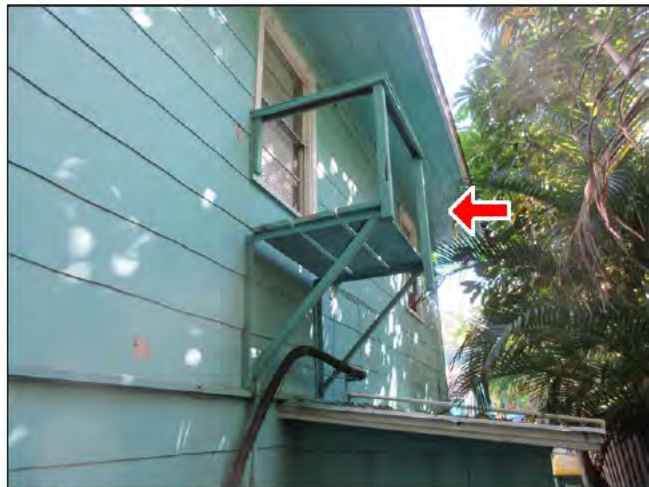
2.3 Item 1(Picture)

2.3 Garage- There is a platform at the rear side wall of the upper garage apartment near one of the windows. The purpose of this platform is unknown. Pickets on the handrail leading to the upper garage apartment are spaced too far apart for safety. Recommend 4" max spacing for safety. Support post below the right side stairs (facing front) of the 8 Plex is loose and needs securing. At least one support post for the metal awning on the back side of the 8 Plex is loose and needs securing at the top.

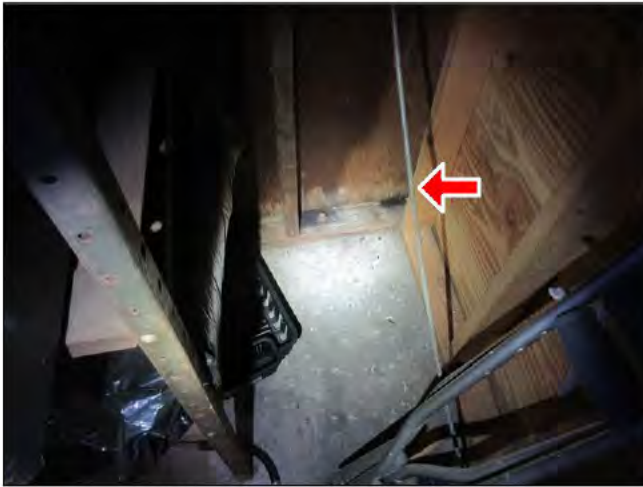
2.4 Item 1(Picture)

**2.4** Water stains are present on some of the lower components of the garage walls. Drainage may need to be corrected in these areas. Recommend monitoring during a heavy rain and correcting as needed. Concrete slopes towards the foundation vents on the left side of the Duplex. Water may enter the crawlspace during periods of heavy rain. Recommend monitoring and correcting as needed.

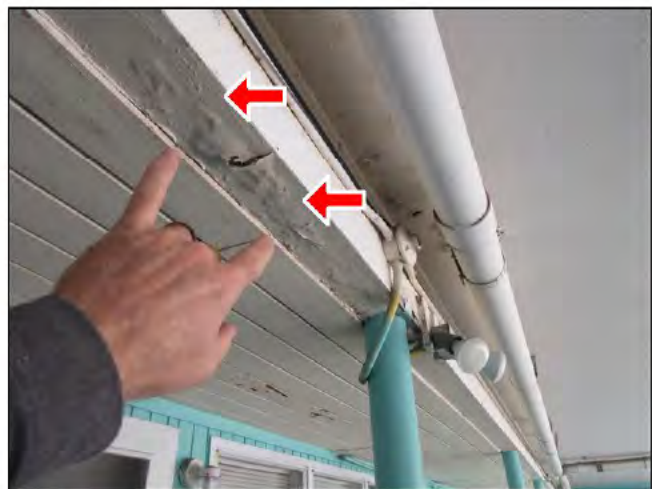
2.5 Item 1(Picture)

2.5 8 Plex- Ceiling and beams above the carport of the 8 Plex is damaged/deteriorated or missing or peeling paint at several areas. Repairs are needed. Former antenna mast is loose and needs securing or removal above the 8-Plex.

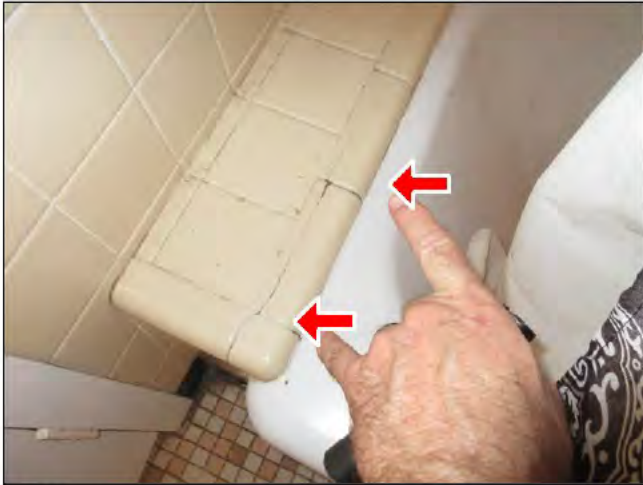
4.1 Item 1(Picture)

**4.1** Garage- Several tiles are loose or cracked at the shower surround. Repairs are needed. Unit 3- Several tiles are loose or cracked at the tile shower and wall surround. Repairs are needed. Unit 7- Several tiles are loose or cracked at the tile shower and wall surround. Repairs are needed.

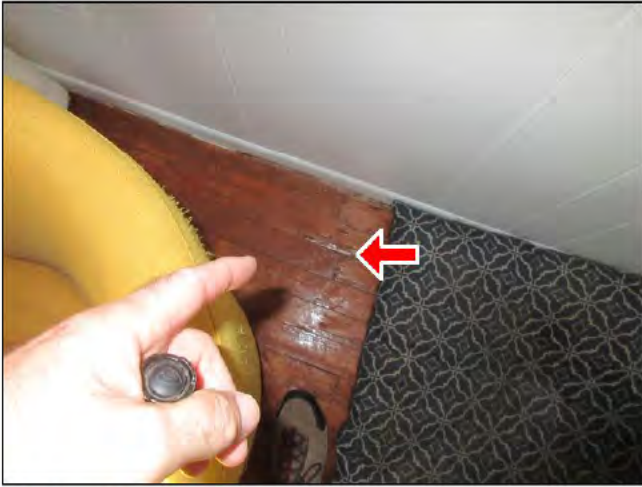
4.2 Item 1(Picture)

**4.2** Garage- Wood floor at the living room is damaged at several locations. Unit 3- Several damaged or chipped floor tiles are present in the kitchen/living room. Unit - Several damaged or chipped floor tiles are present in the bathroom. Recommend repair as needed.

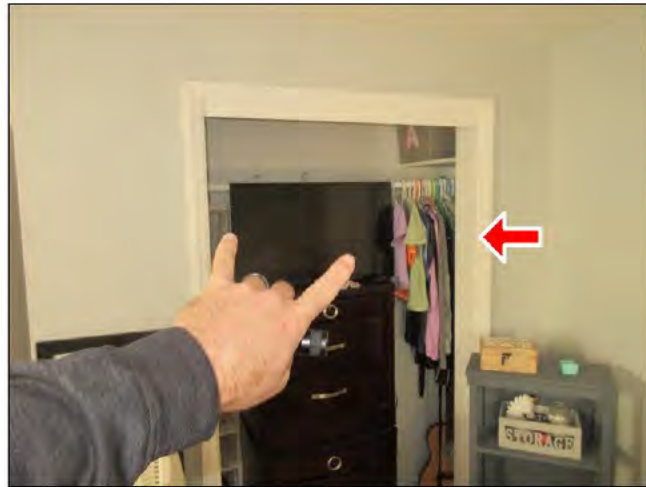
4.5 Item 1(Picture)

**4.5** 1732- Closet door is missing at the front guest bedroom.

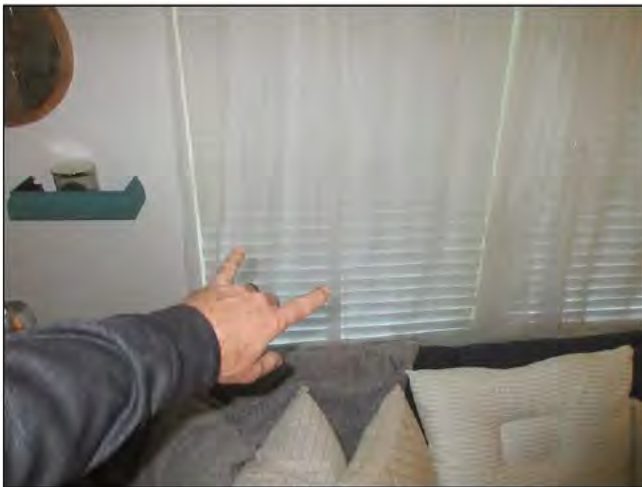
4.6 Item 1(Picture)

**4.6** 1732- Several windows difficult to operate or missing screens throughout the unit. 1736- One window at the front of the home is damaged at the glass pane. Garage- One window at the side of the home is damaged at the glass pane. Shower window crank unit is missing a screw and needs repair to operate properly. 8 Plex- Multiple windows are missing screens or are difficult to operate.

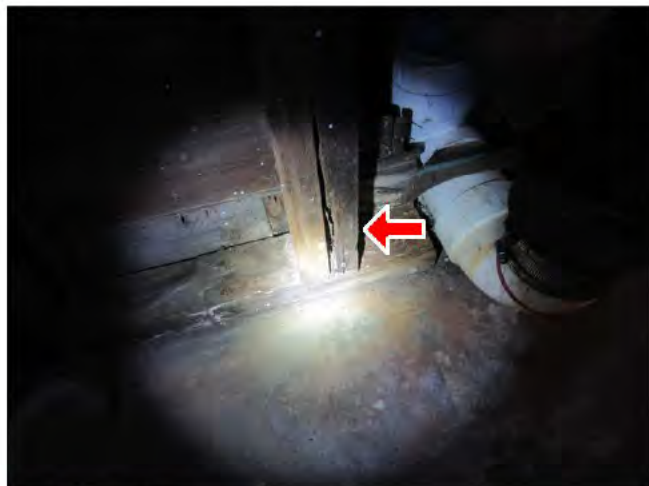
5.1 Item 1(Picture)

5.1 Garage- Several studs and bottom plates at the rear and side walls of the garage are deteriorated and need repairs. Water stains are present at several locations.

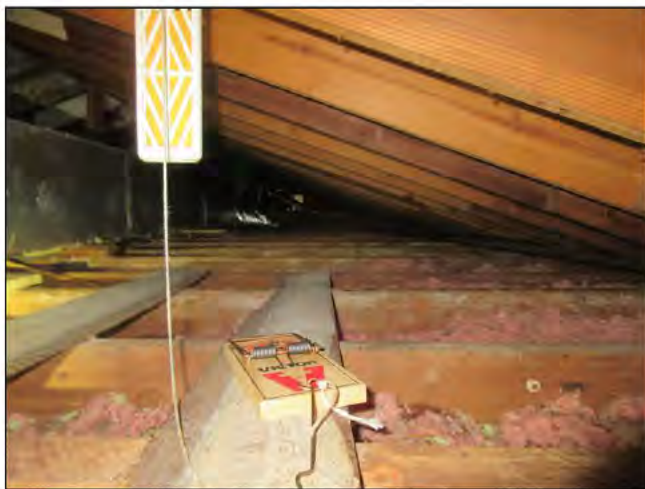
5.5 Item 1(Picture)

5.5 1732/1736- Firewall separation between the units is not present in the attic (for your information). Recommend install as needed. All Remaining Units- attic access was not present or accessible to view roof structure and components.

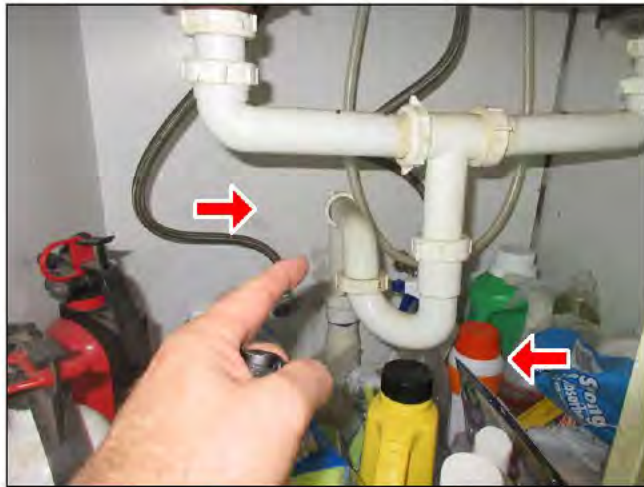
6.0 Item 1(Picture)

**6.0** Garage- Plumbing waste line below the kitchen sink has an s-trap that should be converted to a p-trap.

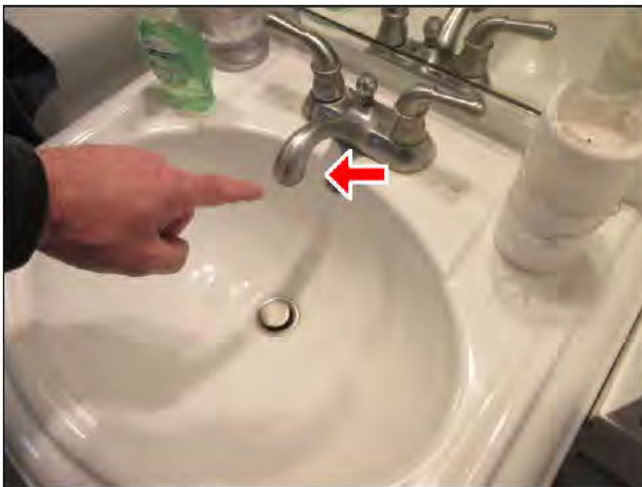
6.1 Item 1(Picture)

**6.1** 1732- Sink faucet is dripping at the guest bathroom. 1736- Toilet is loose at the floor at the hall bath. Repairs may include replacing the wax ring. We were unable to view this area from below to determine the condition of the flooring component below. Shower head is loose and needs securing. Tub drain is slow to drain. Garage- Tub drain is missing the stopper. 8 Plex- Hose bib knob at the rear of the building is damaged and needs replacing. Unit 3- Toilet is loose at the floor at the hall bath. Unit 3- Tub drain area is corroded and tub is missing the stop valve. Unit 2- Tub drain is slow to drain. Unit 8- Toilet is loose at the floor at the hall bath. Unit 7- Bathroom sink has several hairline cracks present.

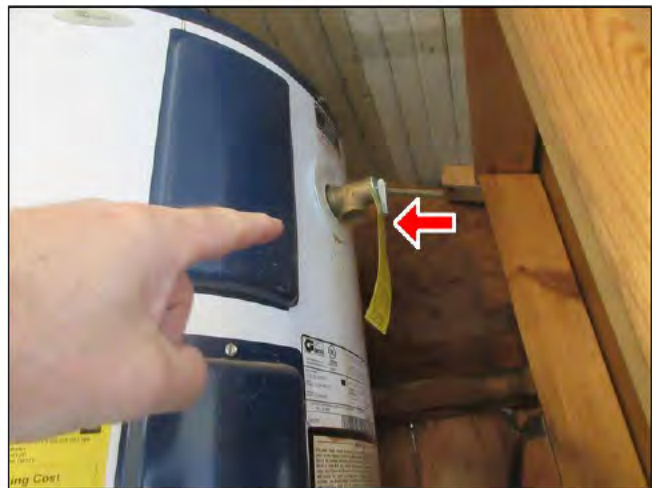
6.2 Item 1(Picture)

**6.2** 1732- Water Heater is missing a T & P Relief valve pipe. 1736- Water Heater is missing a T & P Relief valve pipe and has exposed romex wiring that should be encased. Garage- Water Heater has exposed romex wiring that should be encased. Unit 4- Water Heater is missing a T & P Relief valve pipe. Unit 3- Water Heater has an inappropriately sized T & P Relief valve pipe. T & P Pipes should be 3/4" diameter and not reduced to 1/2". Unit 2- Water Heater has an inappropriately sized T & P Relief

valve pipe. T & P Pipes should be 3/4" diameter and not reduced to 1/2". Unit 7- Water Heater is missing a T & P Relief valve pipe.

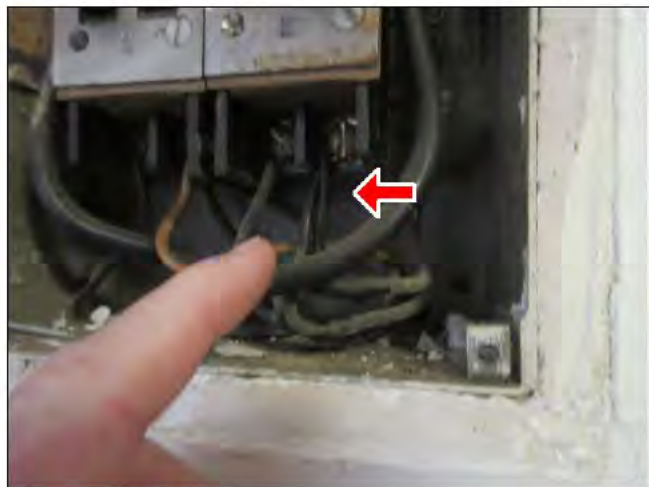
7.1 Item 1(Picture)

**7.1** 1732- Double tap present in the Federal Pacific sub-panel in the kitchen. Multiple issues are present at the Challenger meterbase panels at the right side of the home including: missing romex connectors, exposed wires, double wiring at circuits, burned or damaged breakers. Repairs are needed

and safety hazards are present within these panels. Many insurance companies have issues with Federal Pacific and Challenger electrical panels. We recommend you check with your insurance company regarding these panels. 1736- Square D distribution panel in the kitchen is missing a knock out cover. Garage- Main panel has missing romex connectors, improper panel cover screws and mixed ground and neutral wires that should be terminated on separate grounding and neutral bars. Panel cover has water stains on the front from a leaking valve above. Unit 3- Double taps are present in the sub-panel in the kitchen. Unit 7- Square D distribution panel in the kitchen is missing a knock out cover. Recommend further evaluation from a licensed electrical contractor and repair as needed.

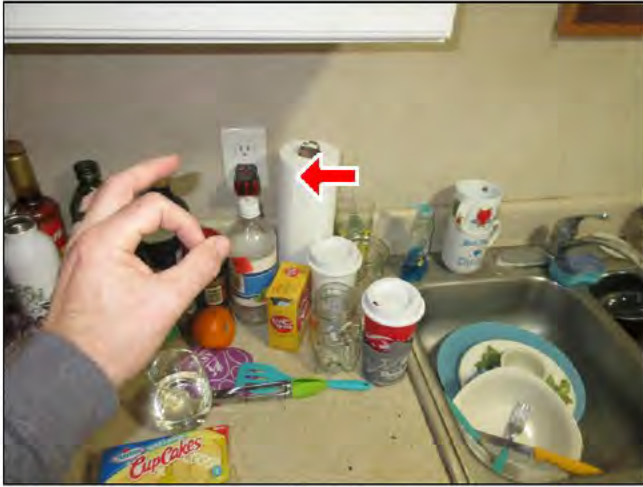
7.4 Item 1(Picture)

**7.4** Unit 4- Three prong outlet near the kitchen sink did not work when tested. Unit 5- Three prong outlet near the kitchen sink is showing an open ground. Recommend further evaluation from a licensed electrical contractor and repair as needed.

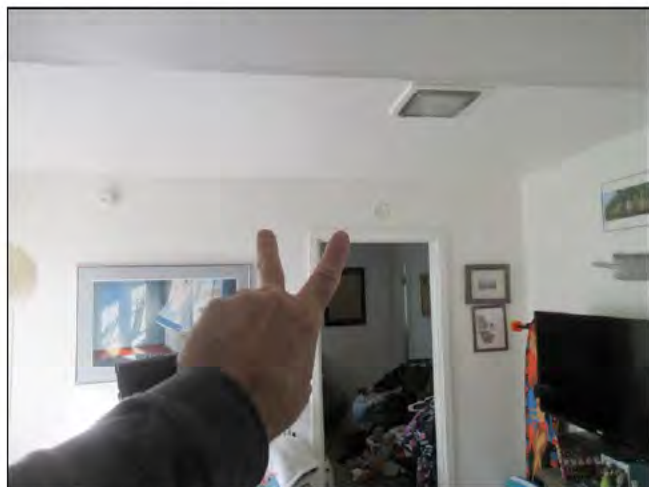
7.8 Item 1(Picture)

**7.8 Multiple Smoke detectors missing or not working throughout the units. Recommend safety upgrade to include smoke detectors in each room of every unit.**

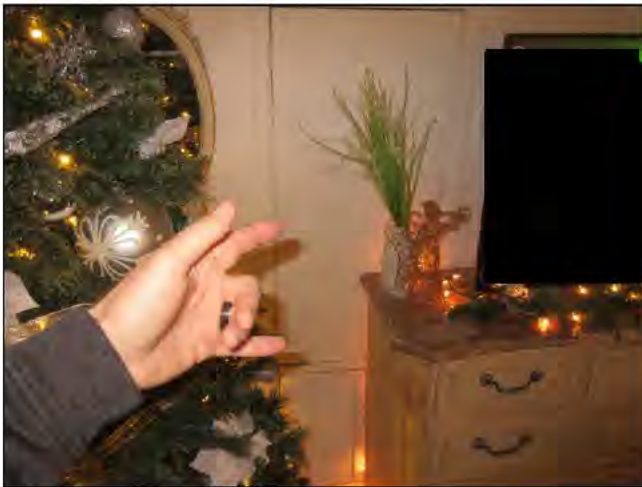
8.0 Item 1(Picture)

**8.0** 1732- The air handler closet is blocked with a large entertainment center. We were unable to observe this area. Garage- Wall mounted heater in the guest bath has a damaged or melted cover. This is considered unsafe and should be repaired or removed. 8 Plex- Older Wall Mounted Heating Elements were not inspected.

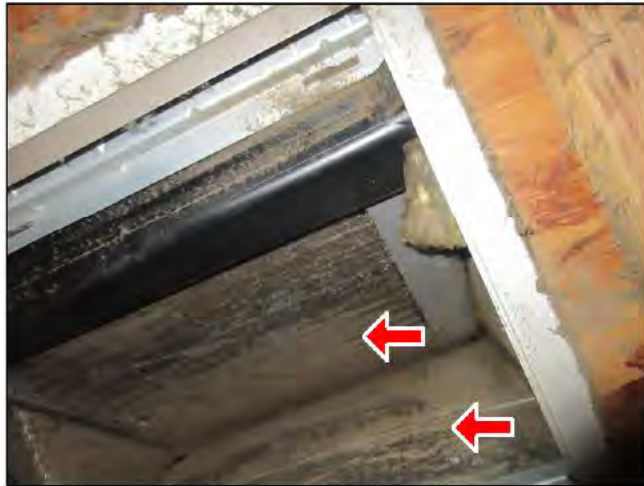
8.3 Item 1(Picture)

**8.3** Garage- A-coil at the air handler is dirty and needs cleaning and servicing. Recommend service from a licensed HVAC Contractor.

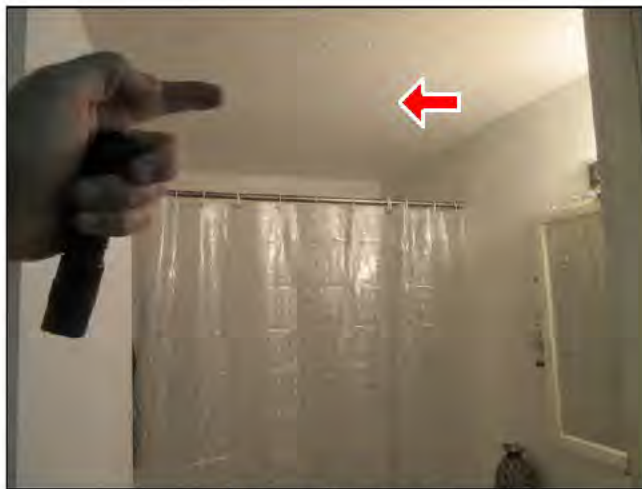
9.4 Item 1(Picture)

9.4 1736- Ventilation is not present at the hall bath. Recommend installing vent fan as needed.

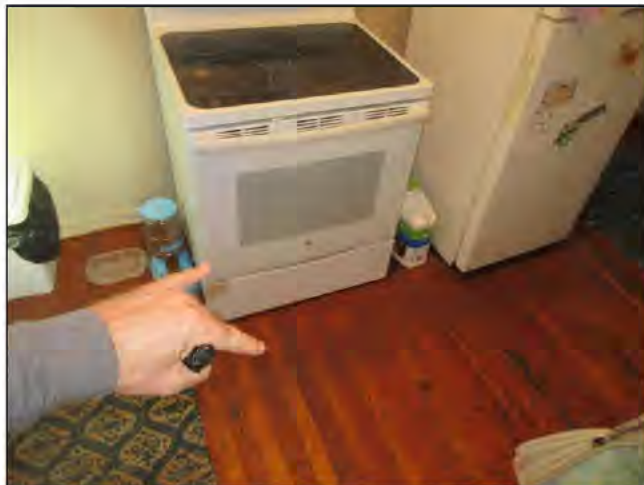
10.1 Item 1(Picture)

**10.1** Garage- The anti-tip bracket is missing at the range. The anti-tip bracket prevents the range from inadvertently tipping over. Recommend install as needed.

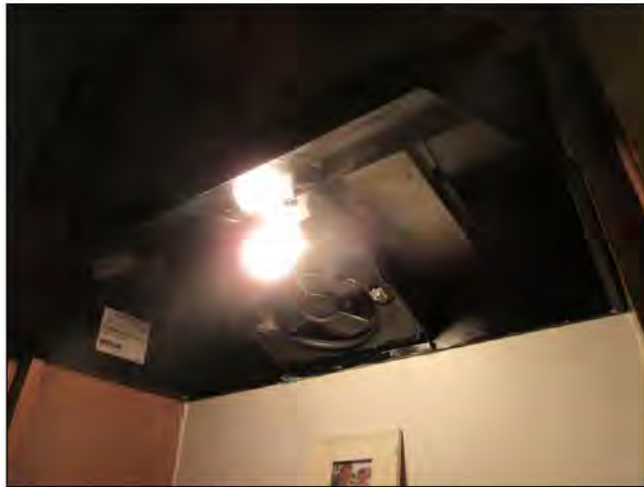
10.2 Item 1(Picture)

**10.2** 1732- Range hood is missing light covers and filters.

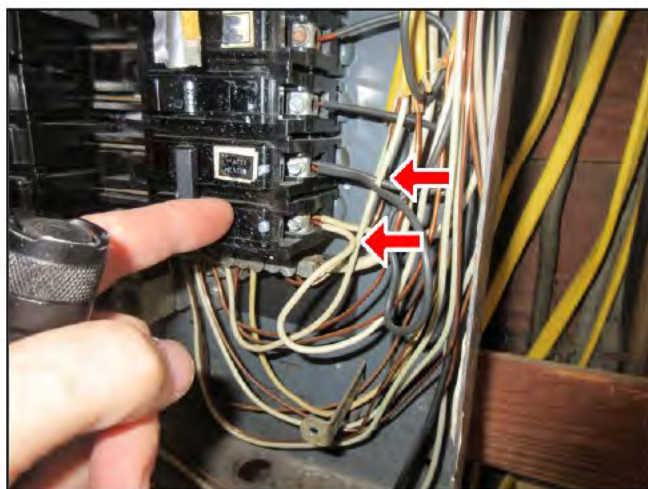
7.2 Item 1(Picture)

Garage- Several breakers have double wiring and/or over fused breakers. Recommend further evaluation from a licensed electrical contractor and repair as needed.
