Inspection Report

KMI Home Inspections, Inc.

Date: 8/1/2024	Time:	Report ID:
Property:	Customer:	Real Estate Professional:

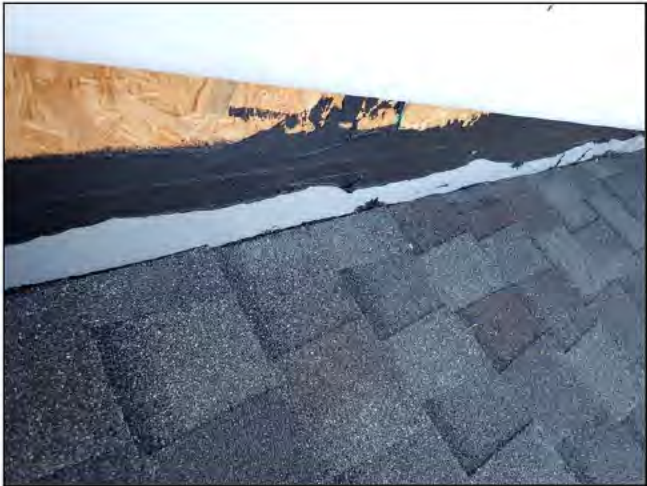
1.1 Item 1(Picture)

1.1 Flashing installed above the garage roof and sealed (for your information).

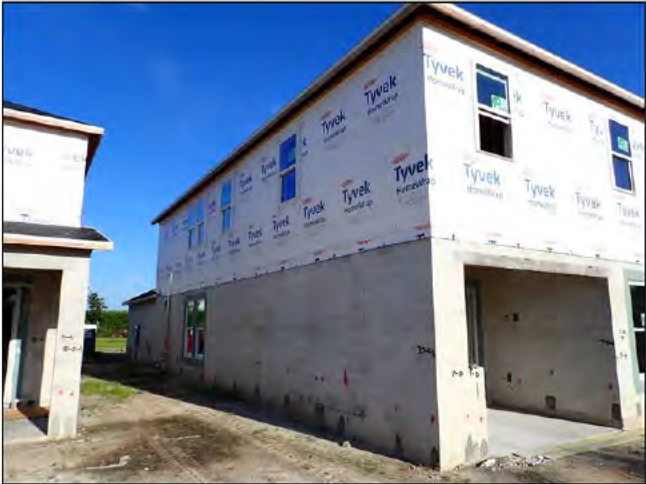
2.0 Item 3(Picture)

2.0 Exterior Views

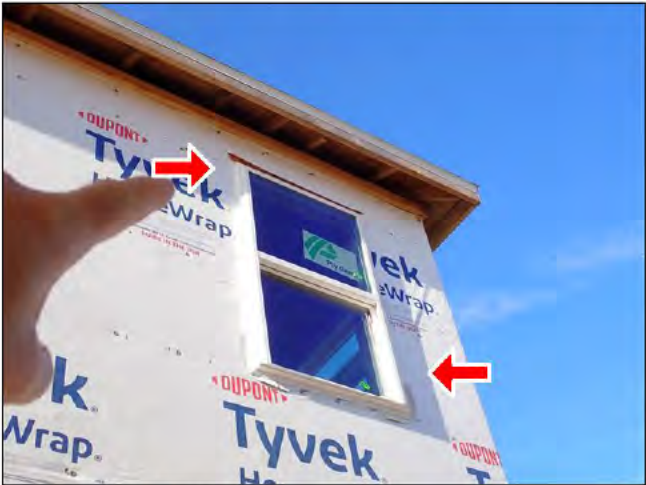
2.2 Item 1(Picture)

2.2 Upper front left corner windows do not have a complete installation. Recommend completing the installation and installing the proper flashing as needed.

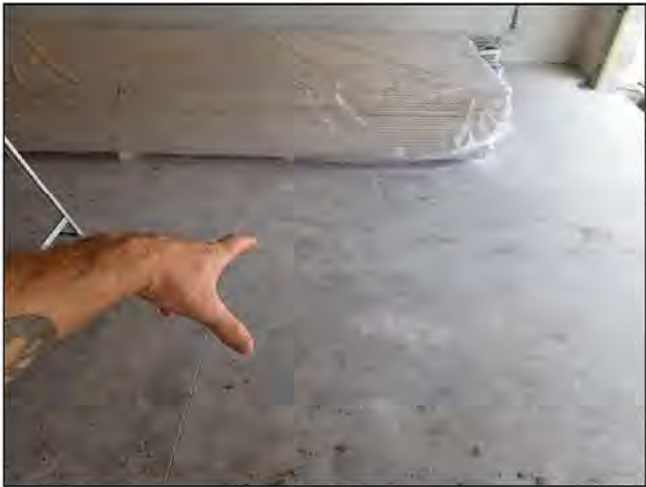
3.2 Item 1(Picture)

3.2 Hairline shrinkage/settlement cracks observed on the garage floor. Displacement was not observed (for your information).

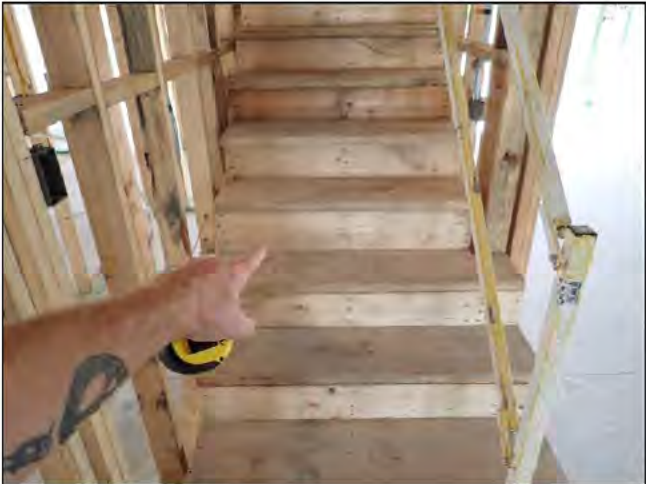
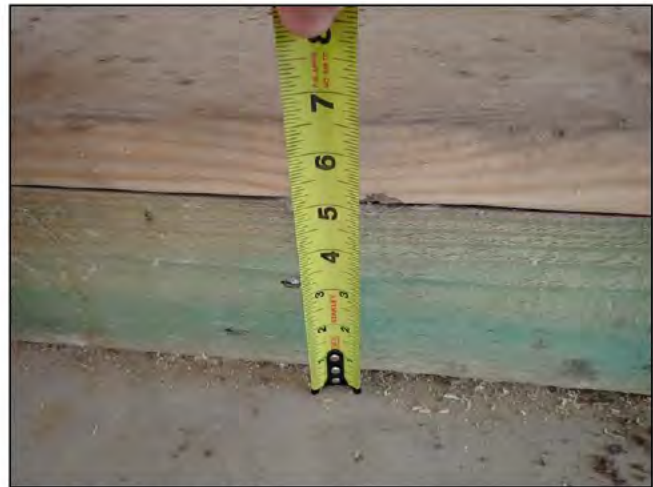
4.3 Several steps at the base of the stairs are not uniform in height and need correcting (2" variance). Recommend correct as needed.

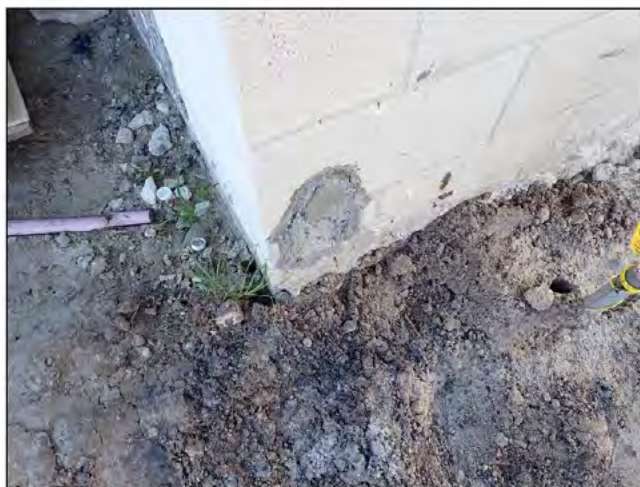
5.1 Item 1(Picture)

5.1 (1) Fill cells observed around the perimeter of the home as indicated on the drawings (for your information).

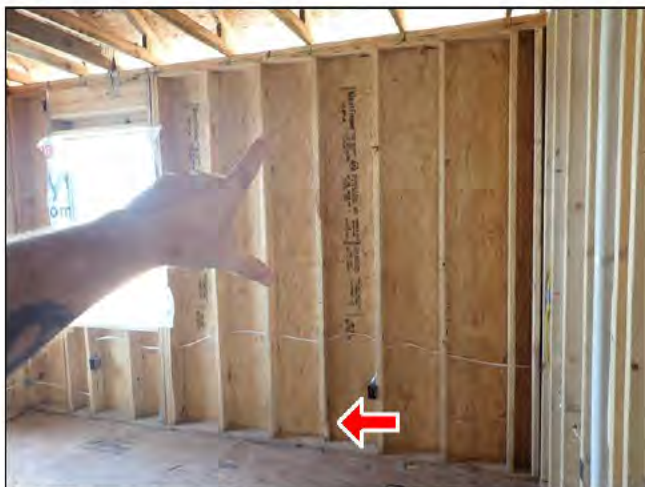
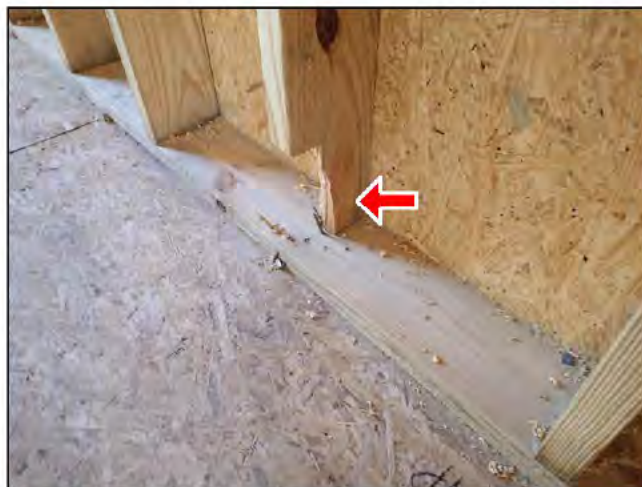
5.1 (2) One 2x6 wall stud is damaged at the base on the left side exterior wall of the upstairs front guest bedroom. Recommend replacing stud as needed.

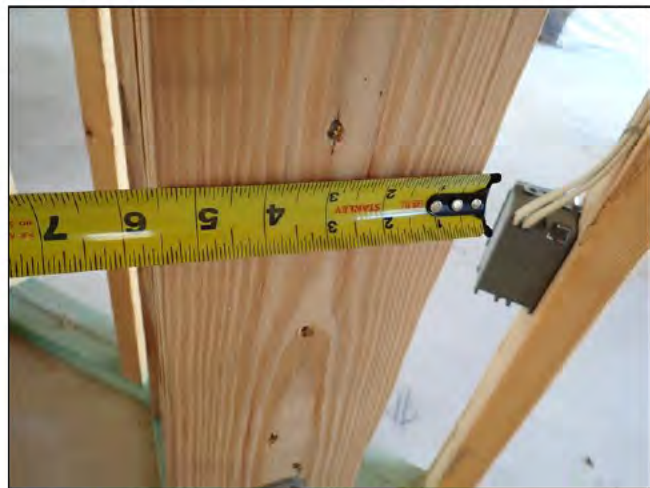
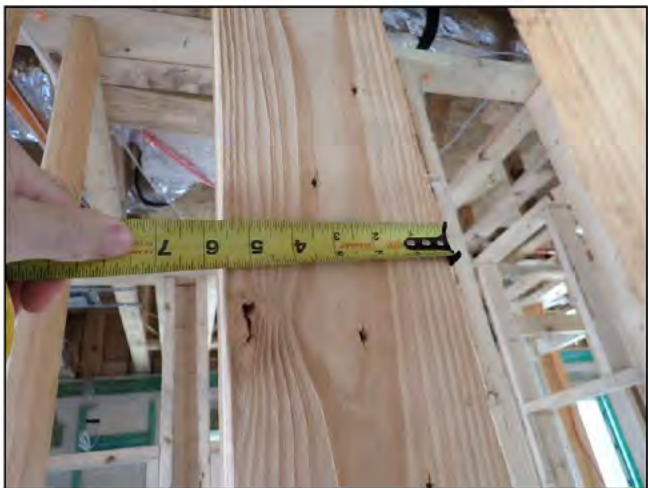
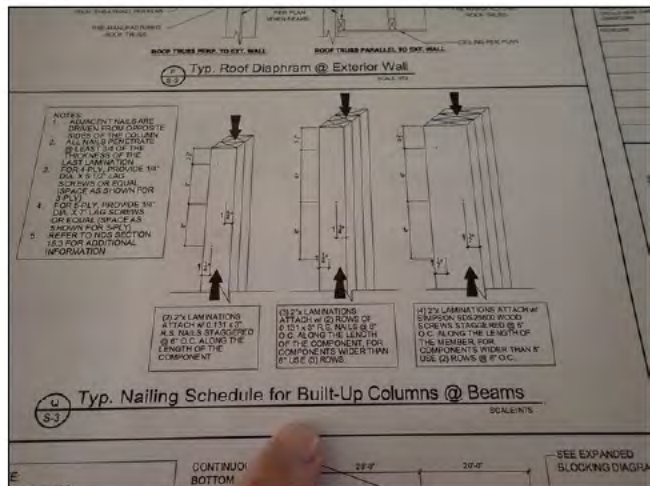
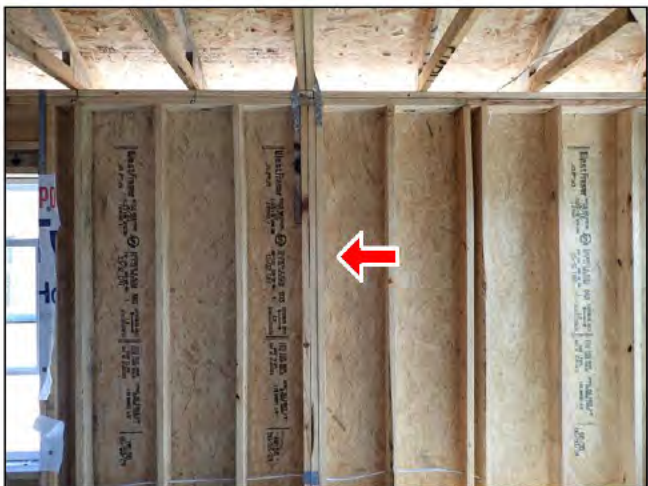
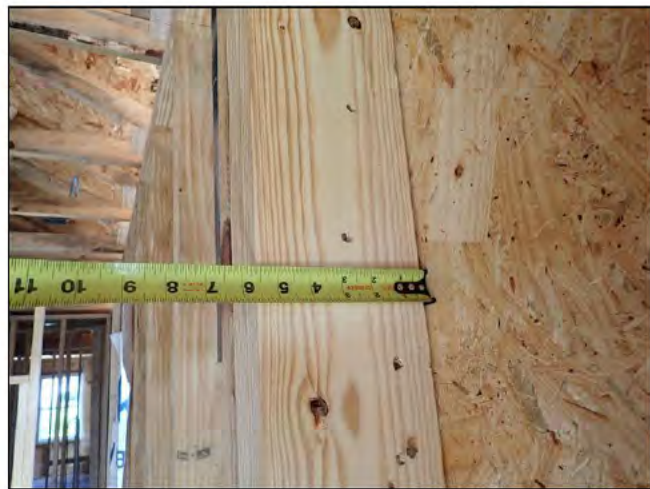
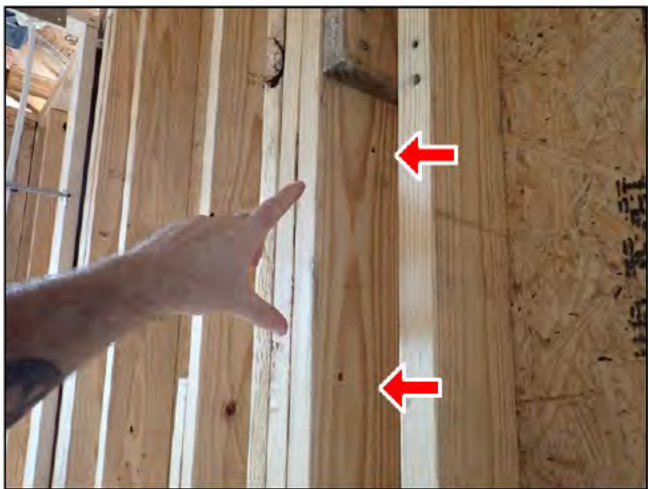
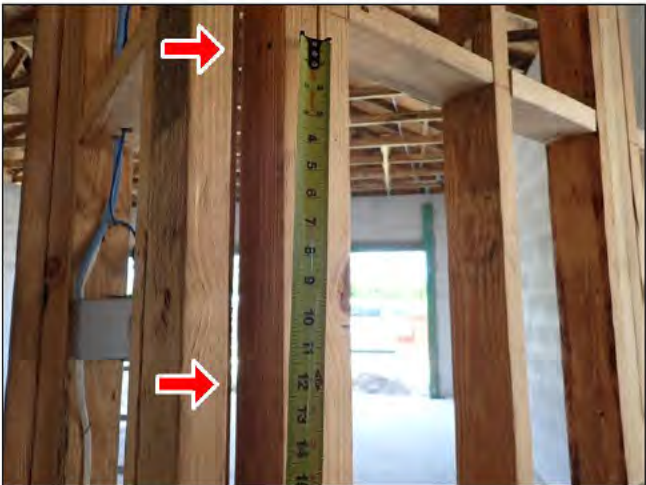
5.2 (1) Several built up columns on the lower level and upper level do not have the fasteners installed per the blue print specifications. Recommend correct as needed to comply with drawing specifications.

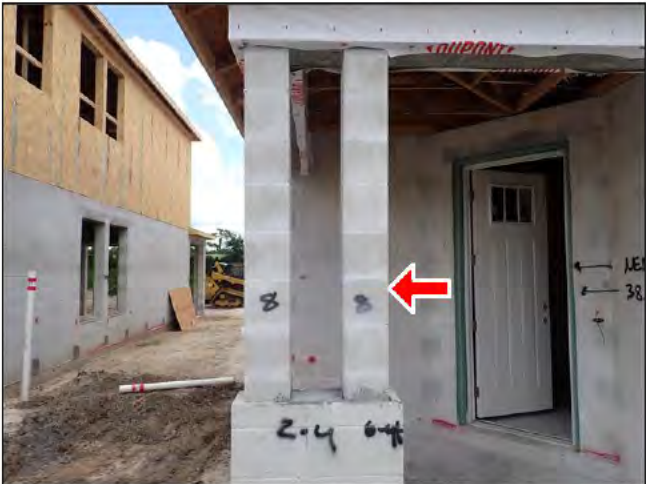
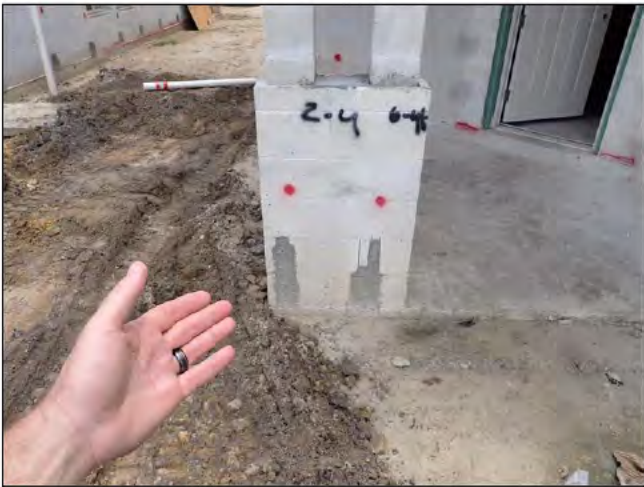
5.2 (2) We were unable to confirm the inside upper column is filled with grout per the drawing specifications. This column sounds hollow when struck unlike the outer column that sounds solid when struck. There appears to be separation or movement at the top of this column as well. Recommend confirm fill and correct movement as needed.

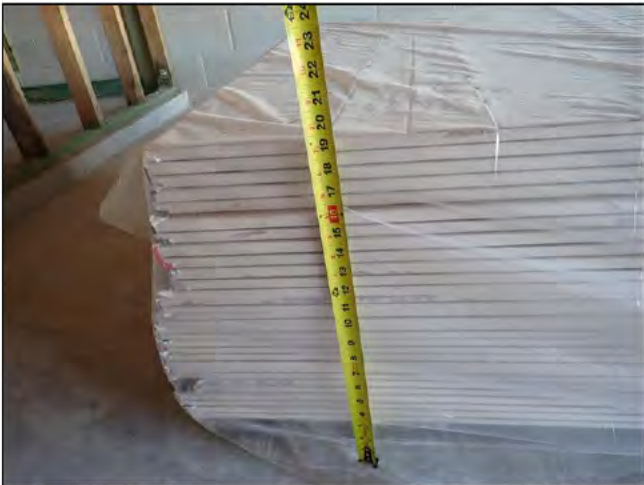
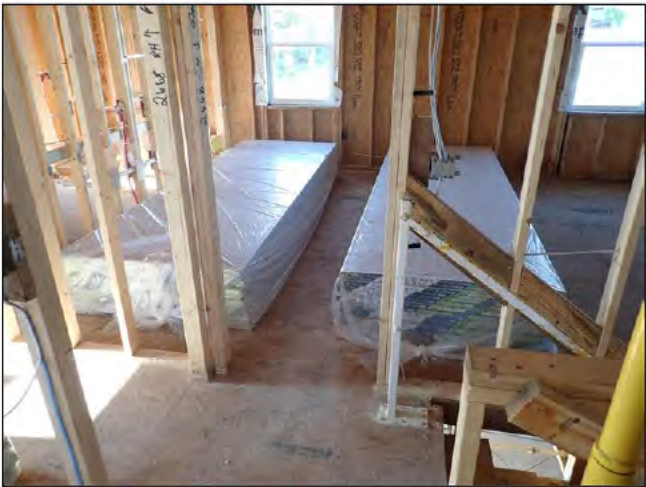
5.3 Excessively tall drywall stacks may put undue stress on the floor and floor system components. Recommend distributing the weight accordingly.

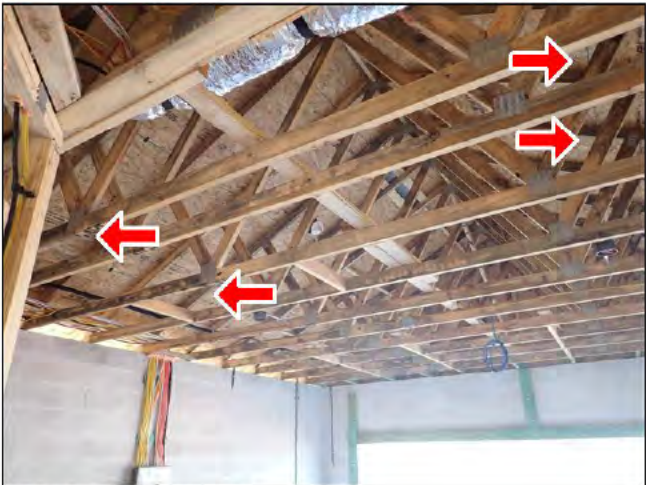
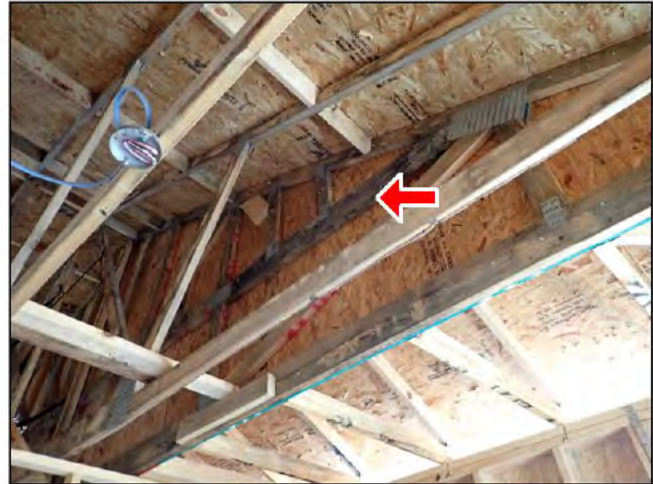
5.5 (1) Several roof framing, floor truss assemblies and studs have areas that are stained with an unknown substance. Recommend testing the substance from an environmental assessor as needed.

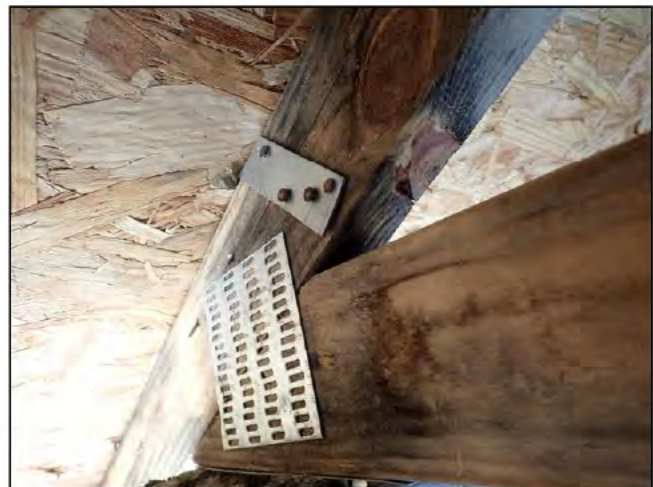
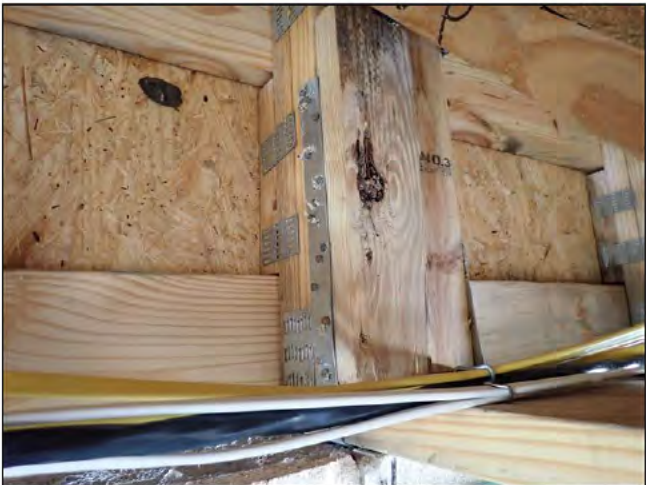
5.5 (3) Straps and Simpson SDWC connectors per drawings.

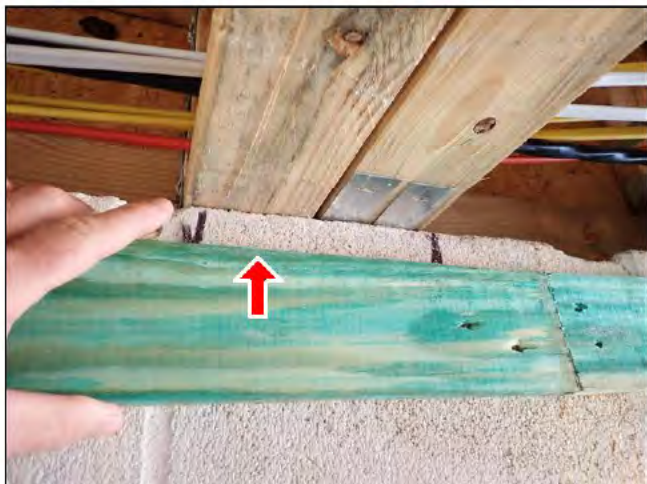
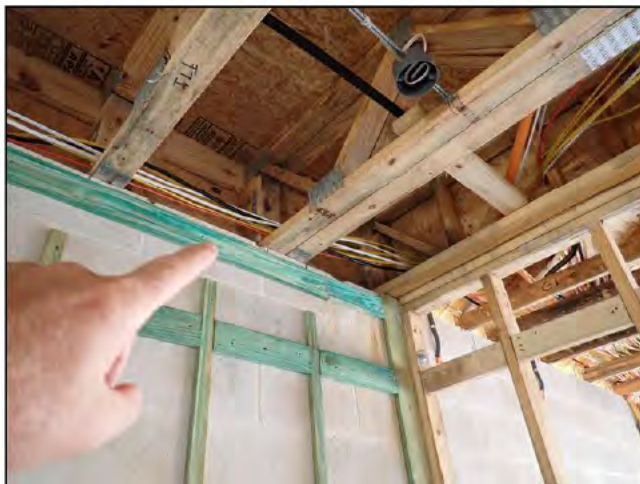
5.5 (4) Floor truss is missing a seat plate above the kitchen area. Recommend installing missing seat plate as needed.

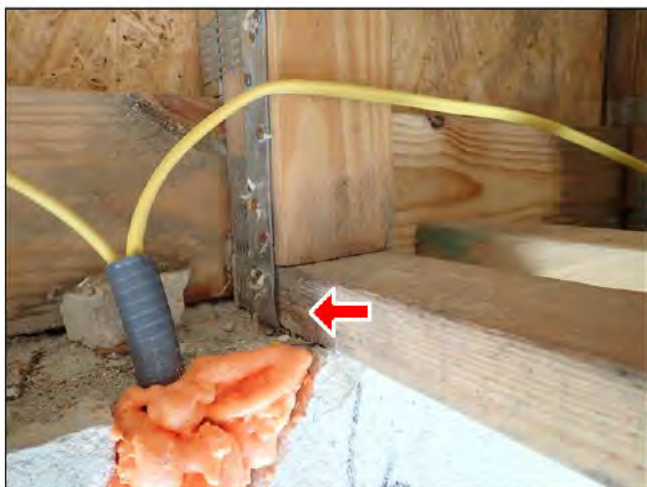
5.5 Item 21(Picture)

5.5 (5) Several floor trusses appear to be sitting on top of the metal straps along the right side of the home near the back patio and the kitchen area. Recommend correct strap alignment as needed.

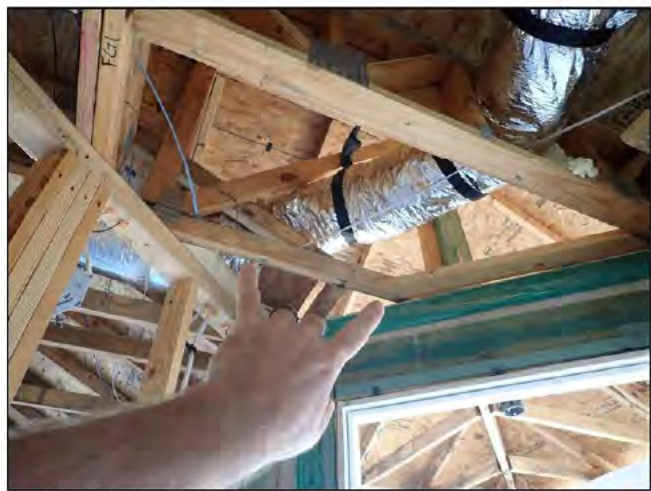
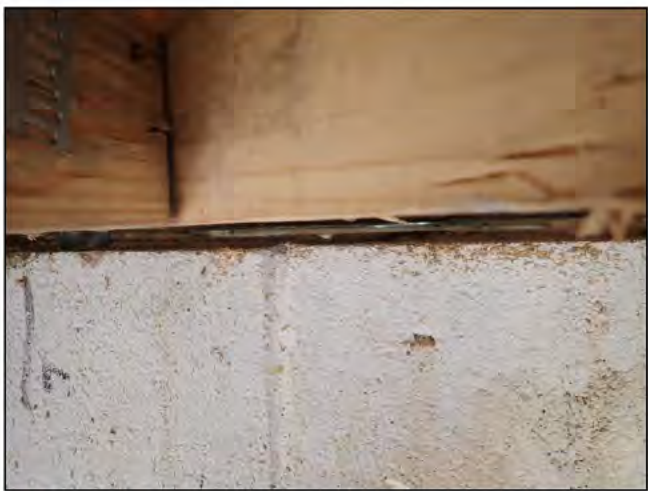
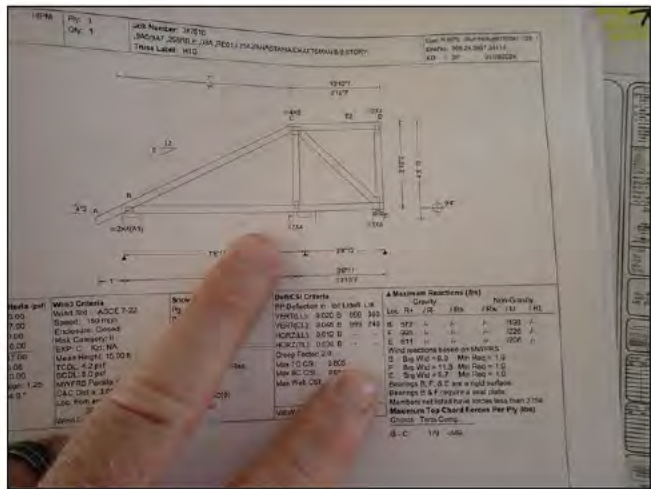
5.5 (6) Truss above the main entry door at the front of the home is designed to have multiple bearing points per the specifications. This truss however is elevated above its intended bearing point in the middle. Recommend correct as needed.

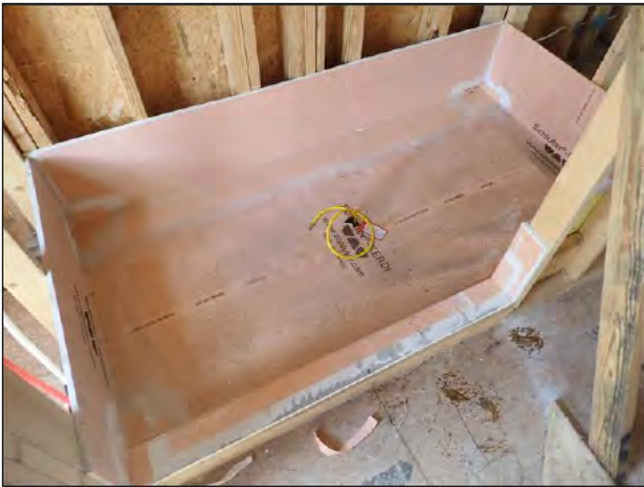
6.0 Item 1(Picture)

6.0 Shower pan is leaking at the upstairs rear bathroom. Recommend correct and re-test as needed.

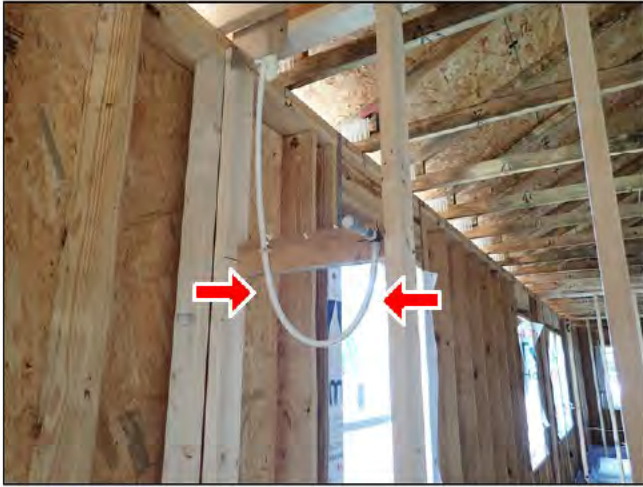
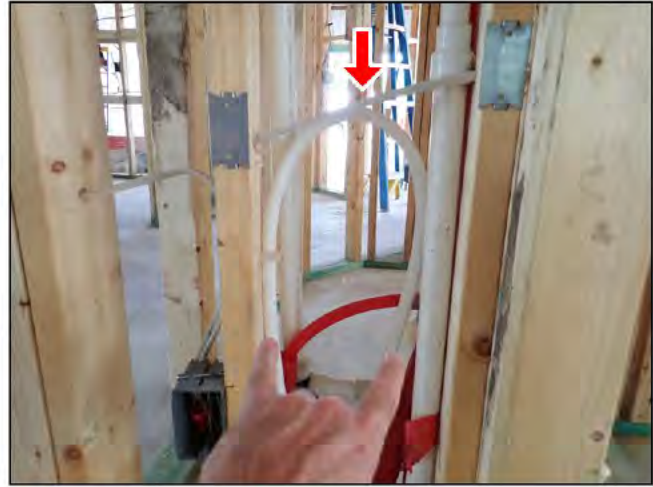
6.1 (2) Water line to the shower head at the rear upstairs bathroom and water line in the wall near the laundry room have excessive bends in the wall cavities. This can lead to stress being placed on these lines. Recommend correct as needed.

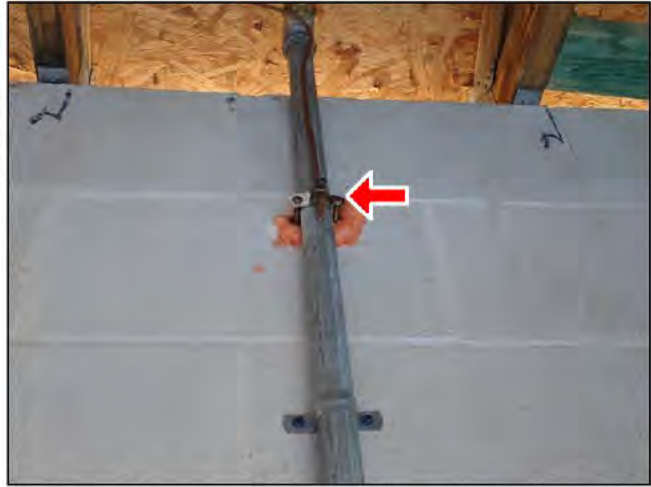
6.4 Item 2(Picture)

6.4 Gas pipe test under pressure. Bonding of the gas line present.

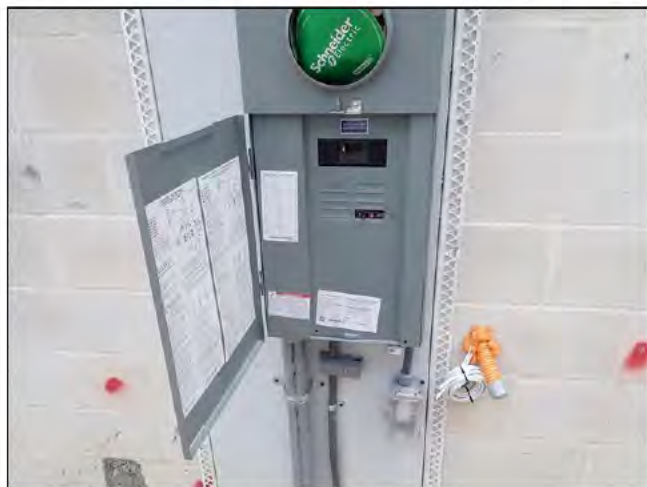
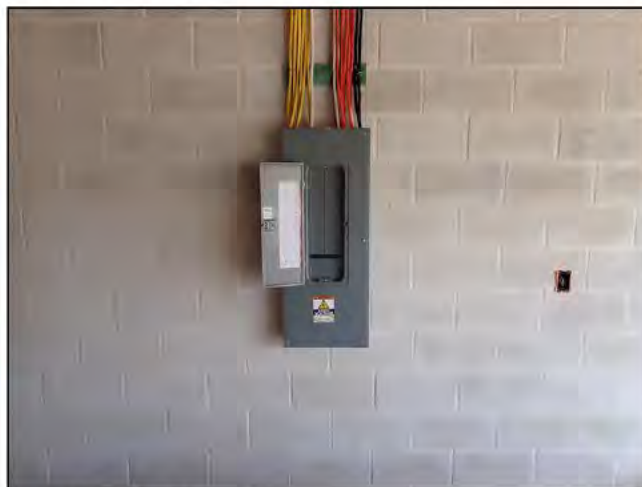
7.7 The main shut-off is located outside on the right side of the home near the meterbase. The main distribution panel is located in the garage (for your information).

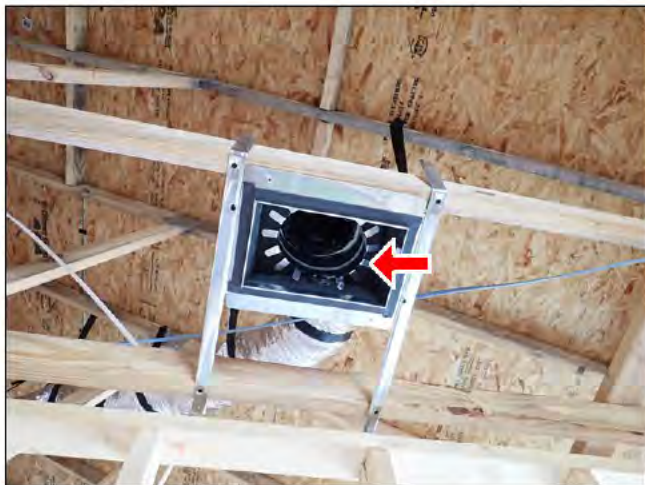
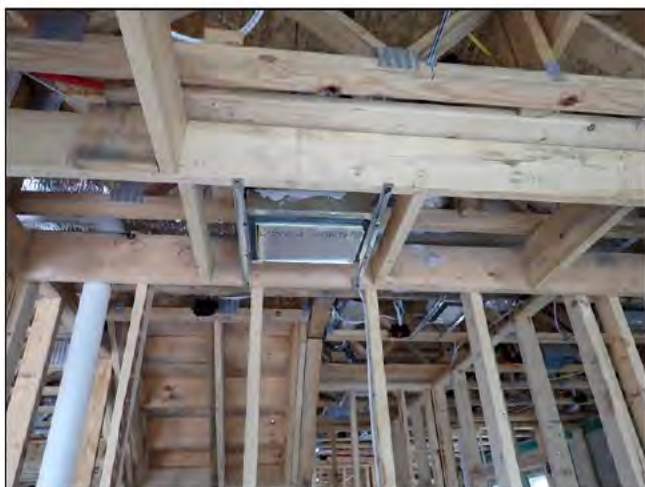
8.3 Several distribution boxes are missing covers to keep debris from entering the duct work during construction. Recommend installing missing covers as needed. Supply duct above the entry way to the master bedroom is kinked which may reduce air flow. Recommend correct as needed.

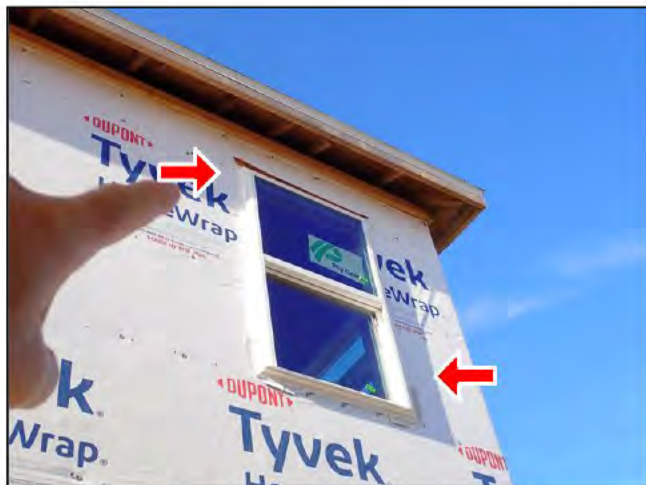
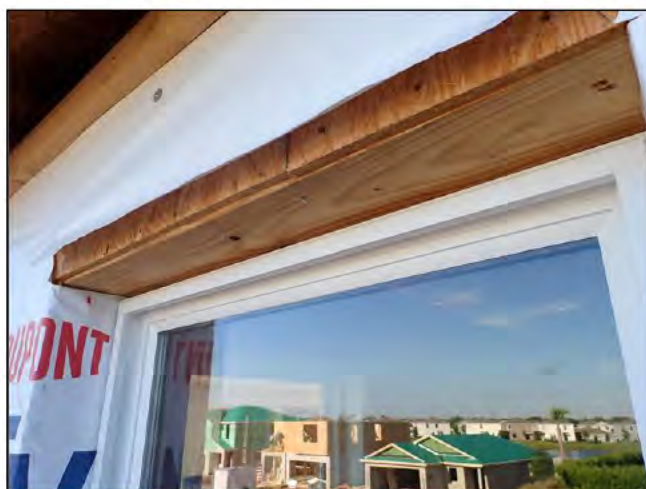
Upper front left corner windows do not have a complete installation. Recommend completing the installation and installing the proper flashing as needed.

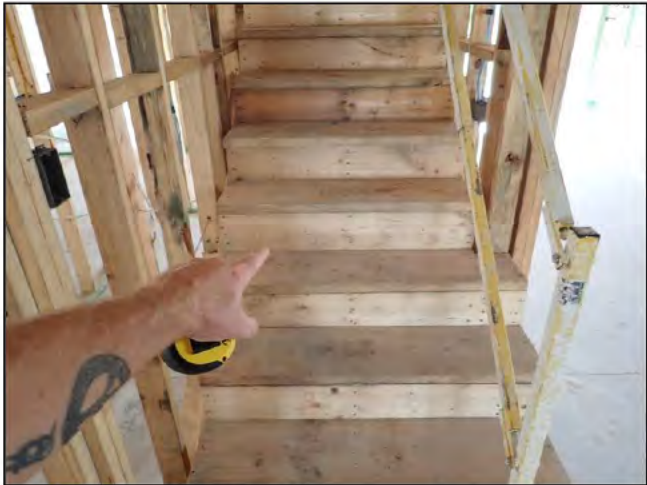
4.3 Item 1(Picture)

Several steps at the base of the stairs are not uniform in height and need correcting (2" variance). Recommend correct as needed.

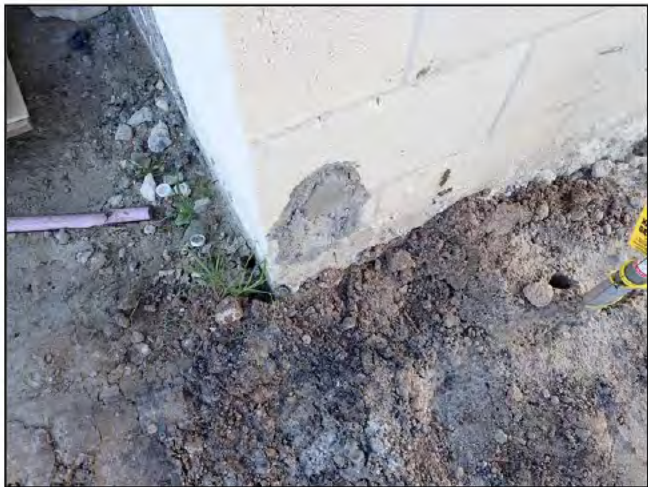
5.1 Item 1(Picture)

(1) Fill cells observed around the perimeter of the home as indicated on the drawings (for your information).

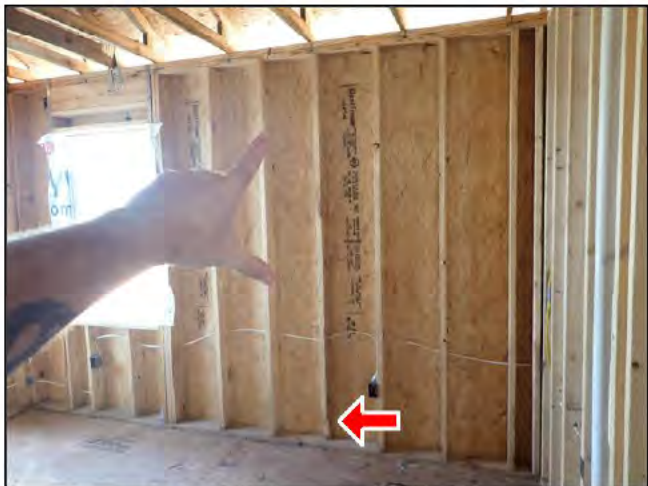
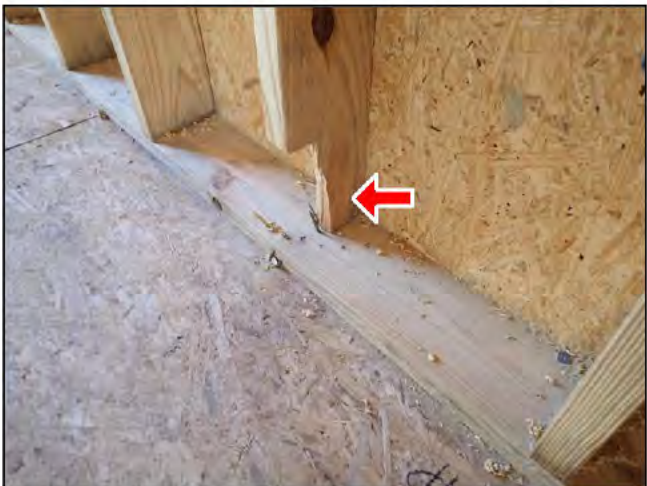
(2) One 2x6 wall stud is damaged at the base on the left side exterior wall of the upstairs front guest bedroom. Recommend replacing stud as needed.

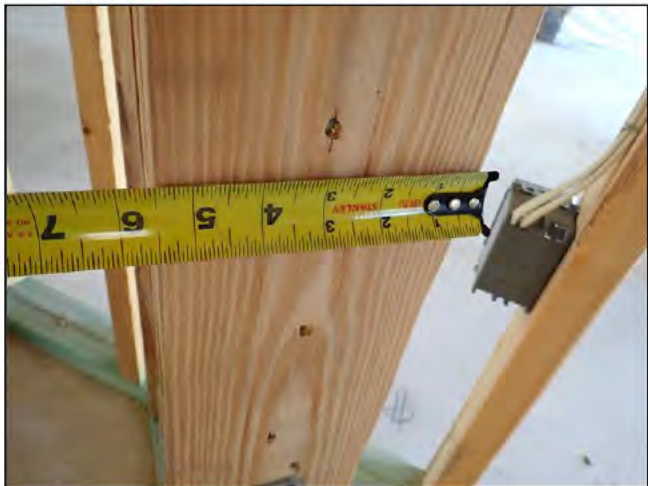
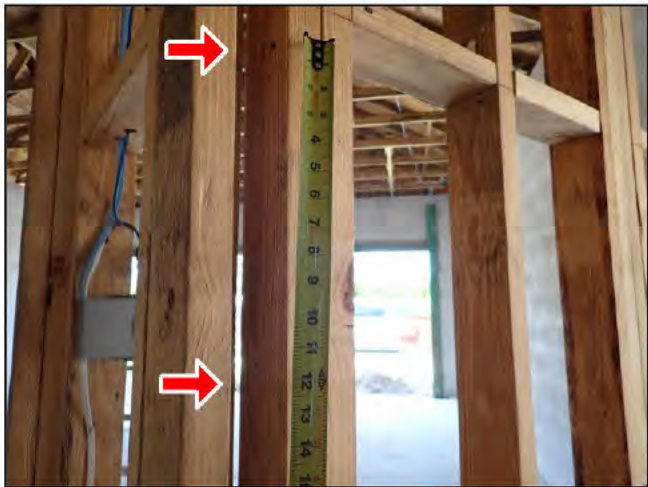
(1) Several built up columns on the lower level and upper level do not have the fasteners installed per the blue print specifications. Recommend correct as needed to comply with drawing specifications.

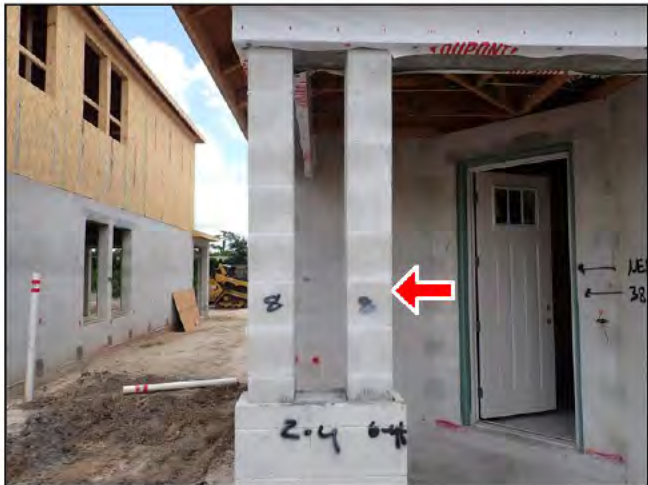
5.2 Item 10(Picture)

(2) We were unable to confirm the inside upper column is filled with grout per the drawing specifications. This column sounds hollow when struck unlike the outer column that sounds solid when struck. There appears to be separation or movement at the top of this column as well. Recommend confirm fill and correct movement as needed.

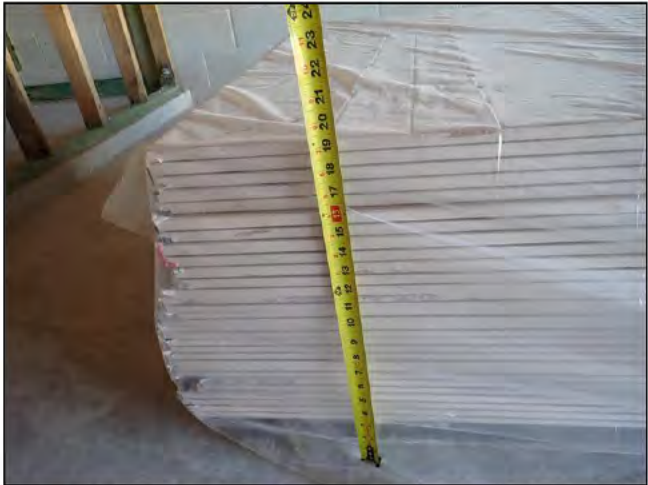
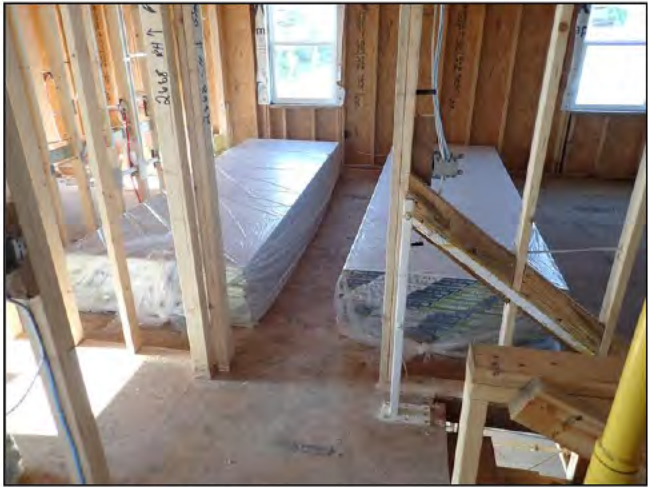
Excessively tall drywall stacks may put undue stress on the floor and floor system components. Recommend distributing the weight accordingly.

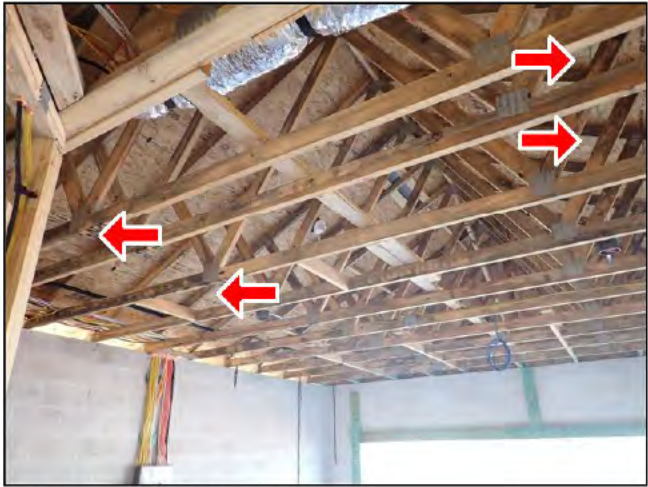
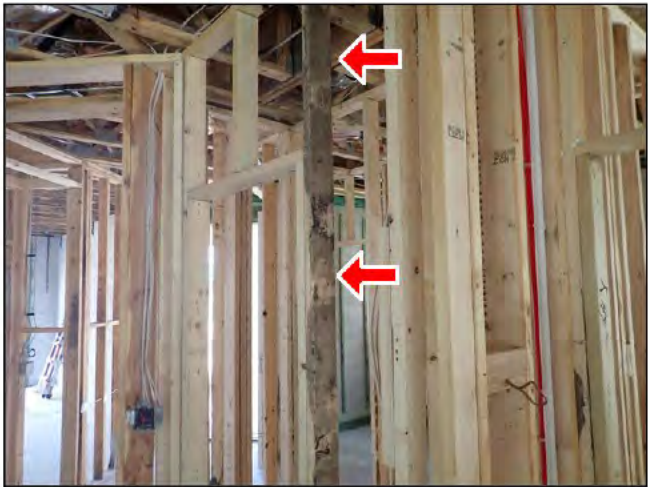
(1) Several roof framing, floor truss assemblies and studs have areas that are stained with an unknown substance. Recommend testing the substance from an environmental assessor as needed.

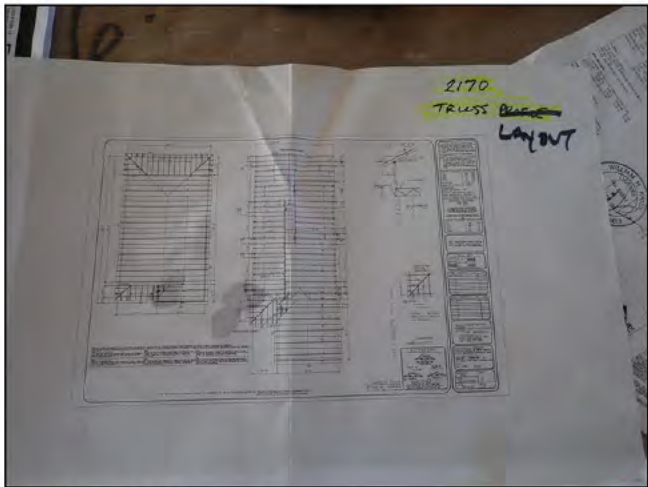
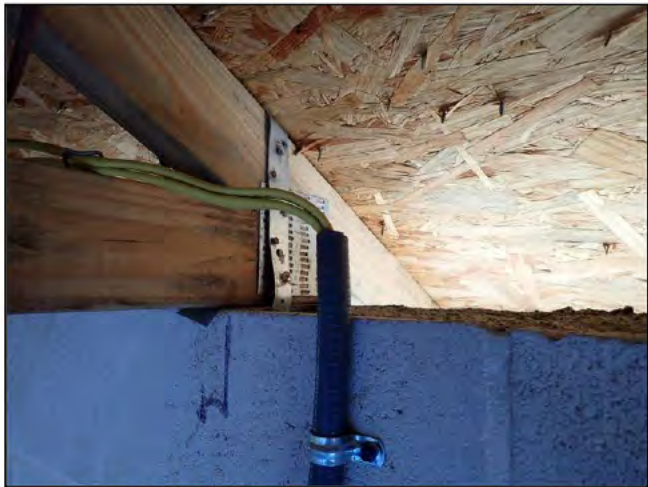
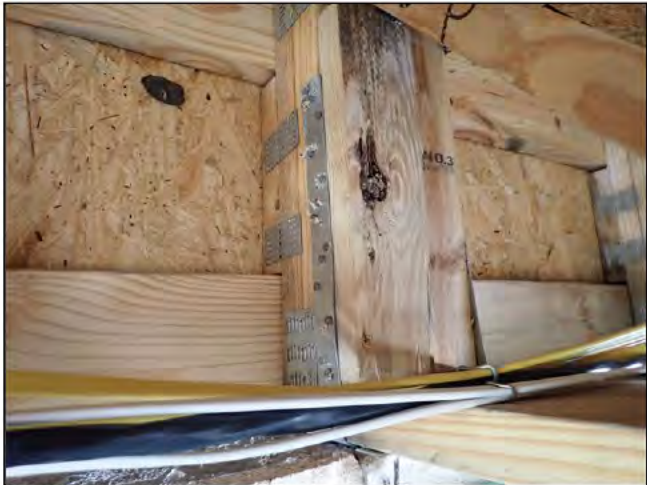
5.5 Item 11(Picture)
(3) Straps and Simpson SDWC connectors per drawings.

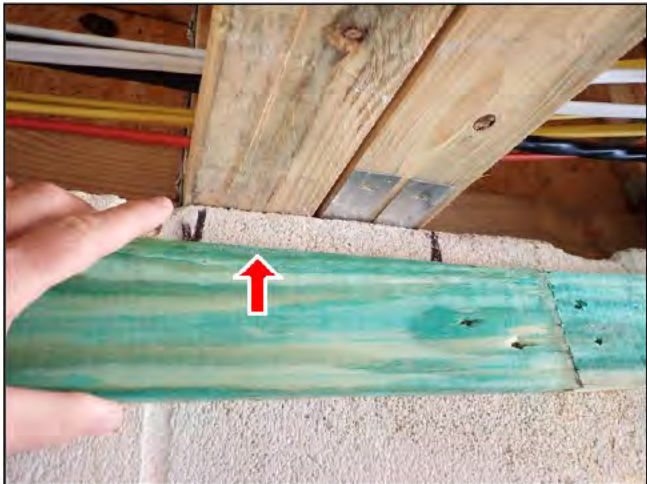
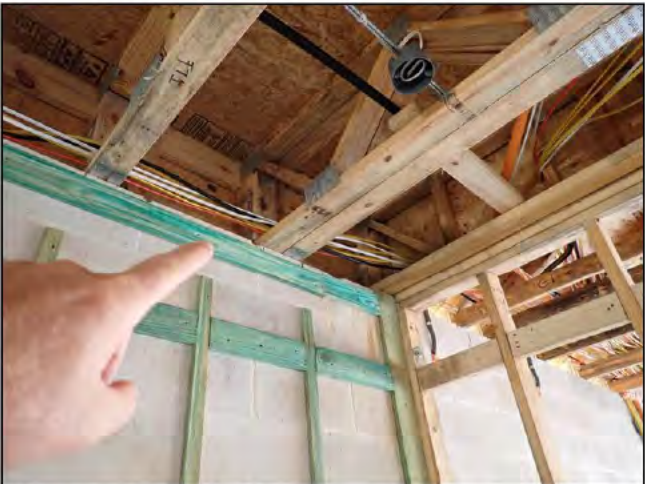
(4) Floor truss is missing a seat plate above the kitchen area. Recommend installing missing seat plate as needed.

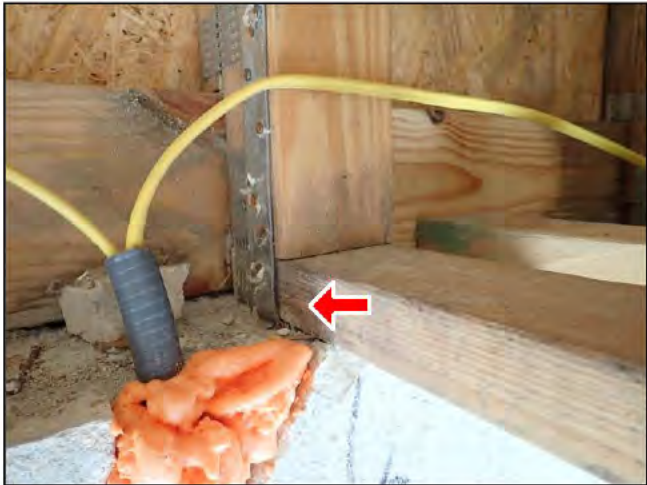
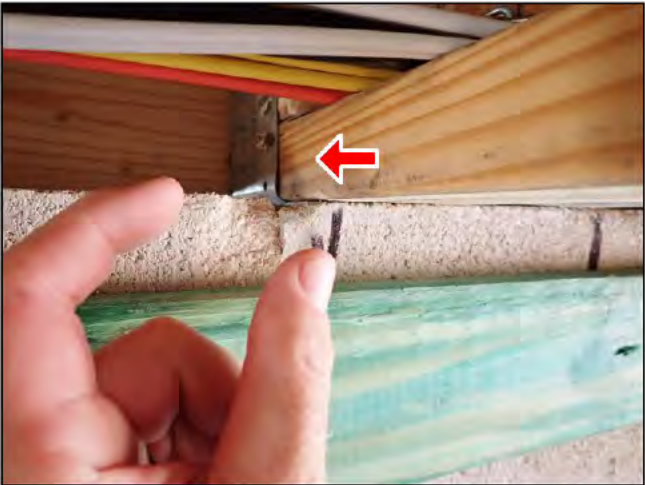
(5) Several floor trusses appear to be sitting on top of the metal straps along the right side of the home near the back patio and the kitchen area. Recommend correct strap alignment as needed.

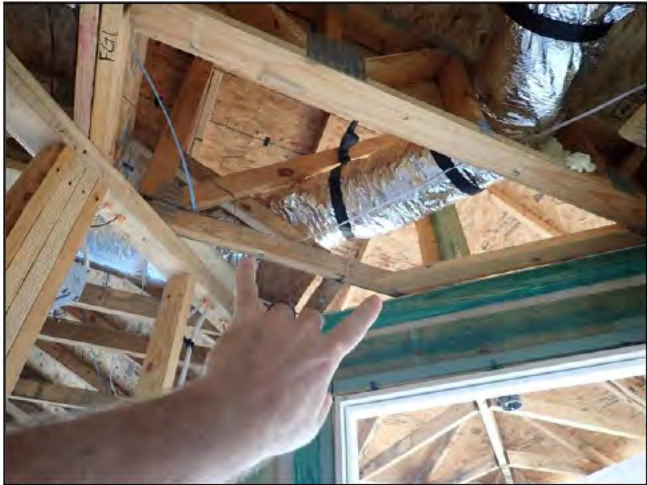
5.5 Item 23(Picture)

(6) Truss above the main entry door at the front of the home is designed to have multiple bearing points per the specifications. This truss however is elevated above its intended bearing point in the middle. Recommend correct as needed.

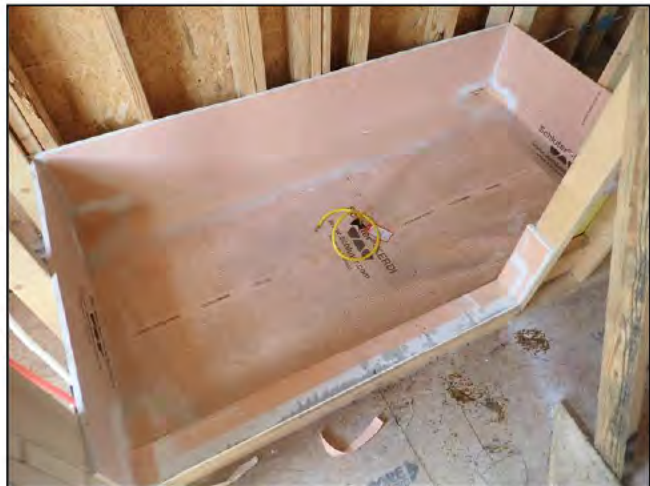
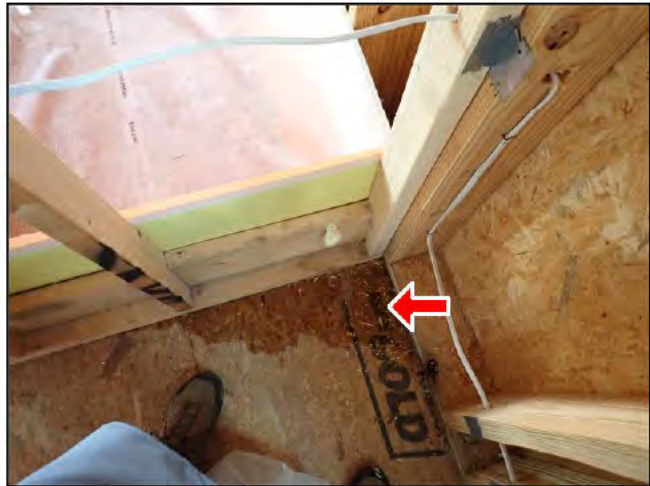
Shower pan is leaking at the upstairs rear bathroom. Recommend correct and re-test as needed.

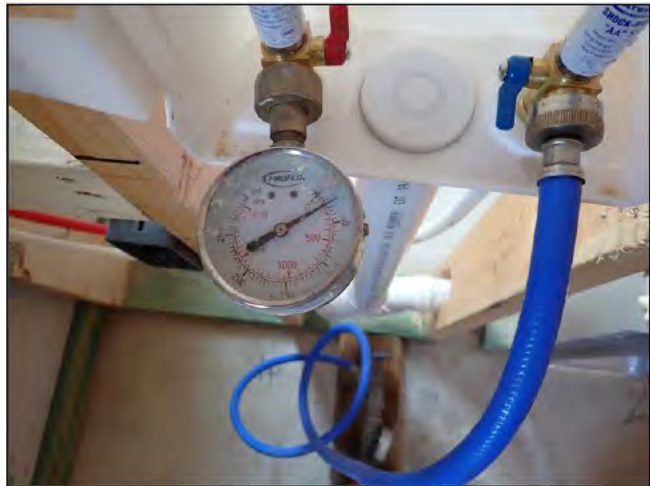
6.1 Item 1(Picture)

(1) Water supply lines under test pressure (for your information).

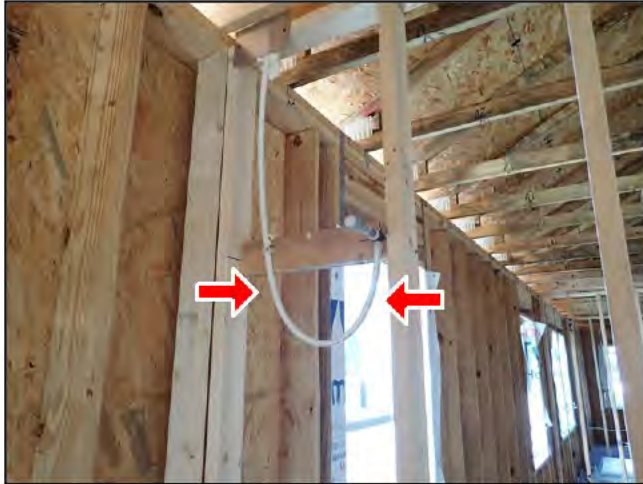
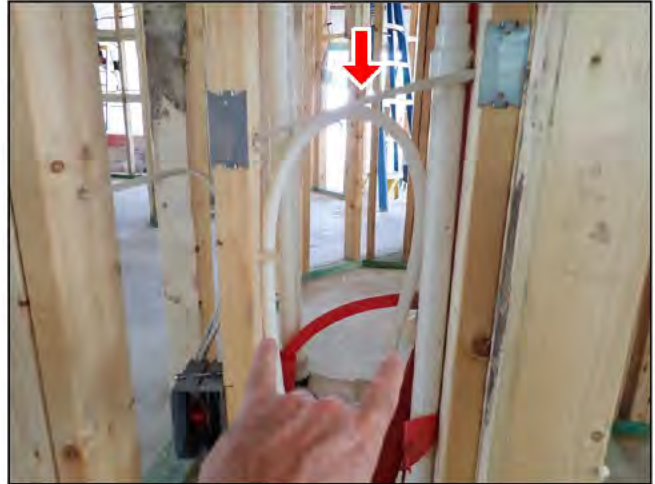
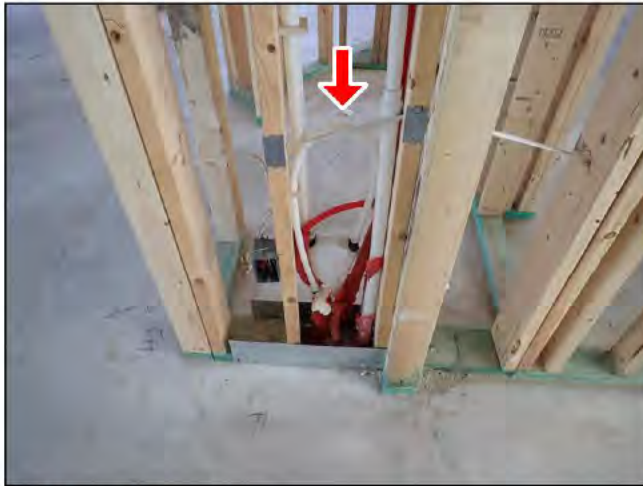
laundry room have excessive bends in the wall cavities. This can lead to stress being placed on these lines. Recommend correct as needed.

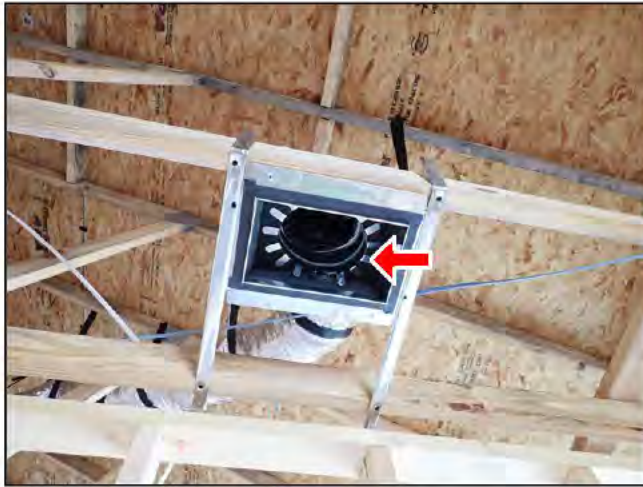
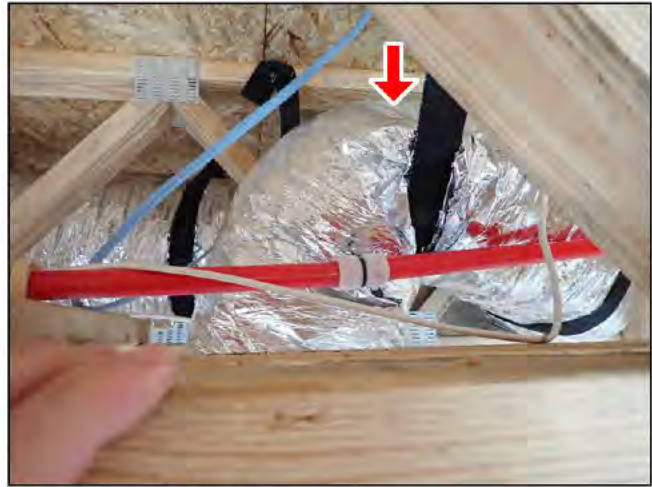
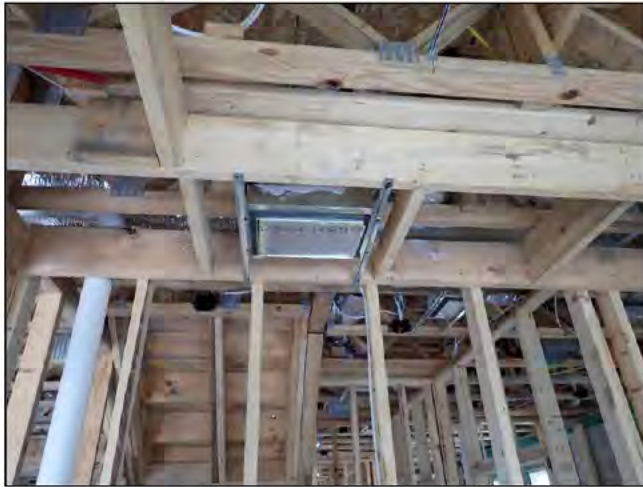
Several distribution boxes are missing covers to keep debris from entering the duct work during construction. Recommend installing missing covers as needed. Supply duct above the entry way to the master bedroom is kinked which may reduce air flow. Recommend correct as needed.
