Inspection Report

Property Address:
4663 Cedron Court
Sarasota FL 34240

KMI Home Inspections, Inc.

Date: 3/11/2025	Time:	Report ID:
Property: 4663 Cedron Court Sarasota FL 34240	Customer: Marci Whitford	Real Estate Professional: Debra Forkan Coldwell Banker

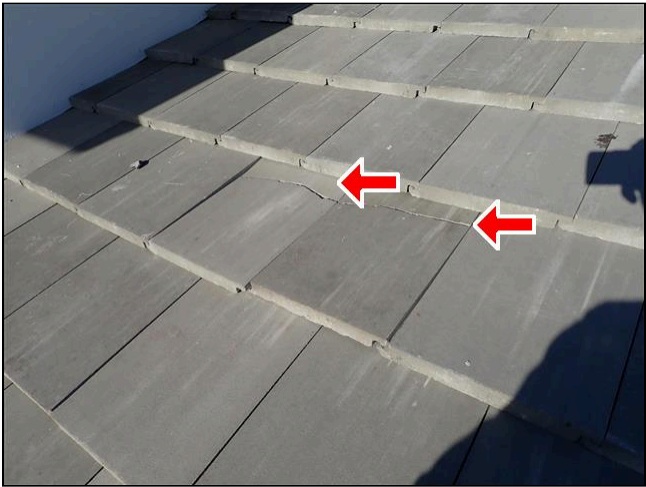
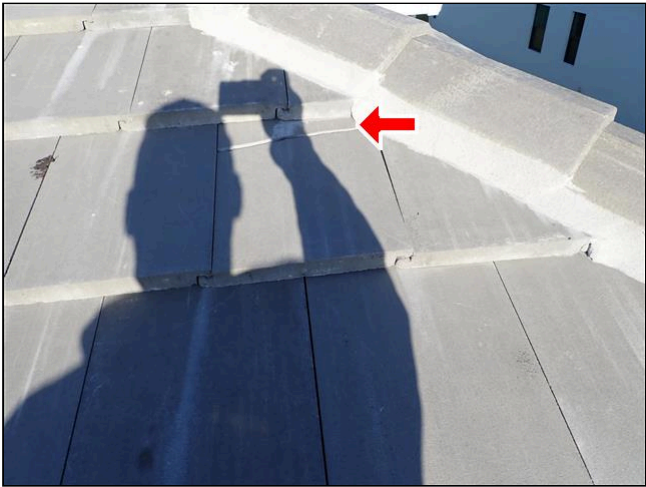
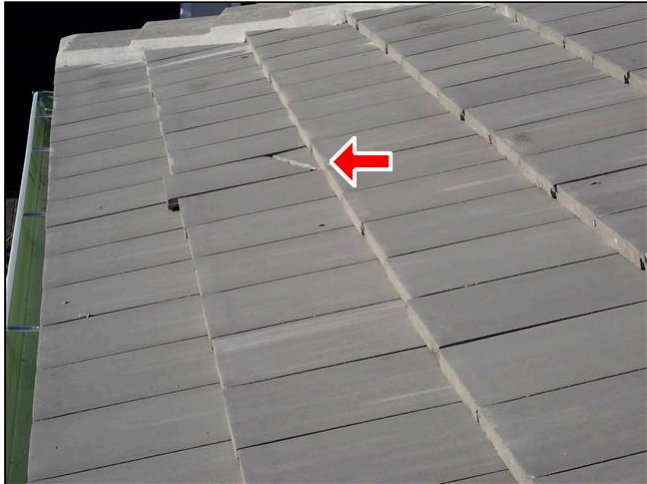
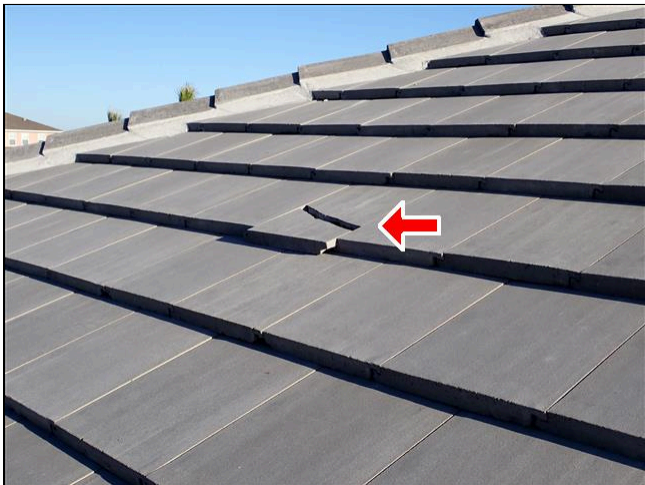
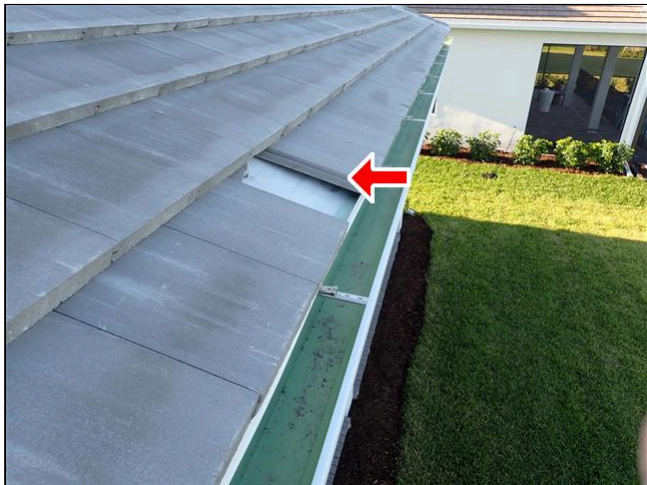
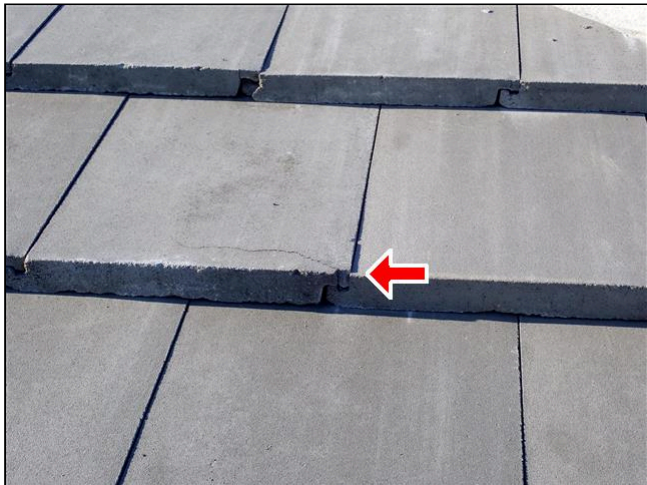
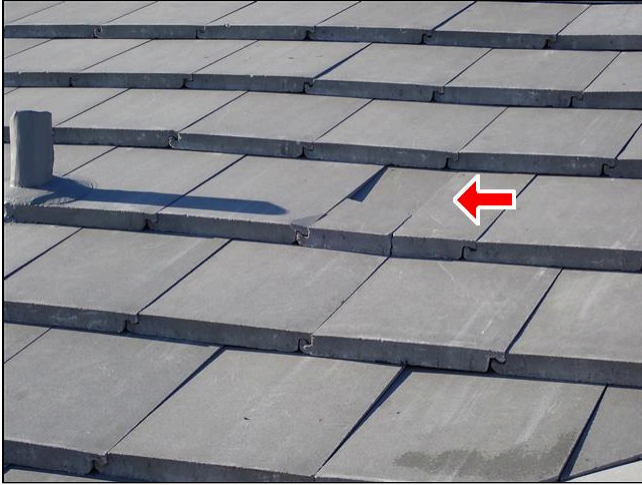
1.0 Several roofing tiles are cracked or chipped at various locations around the perimeter of the home. Recommend a licensed roofing contractor repair as needed.

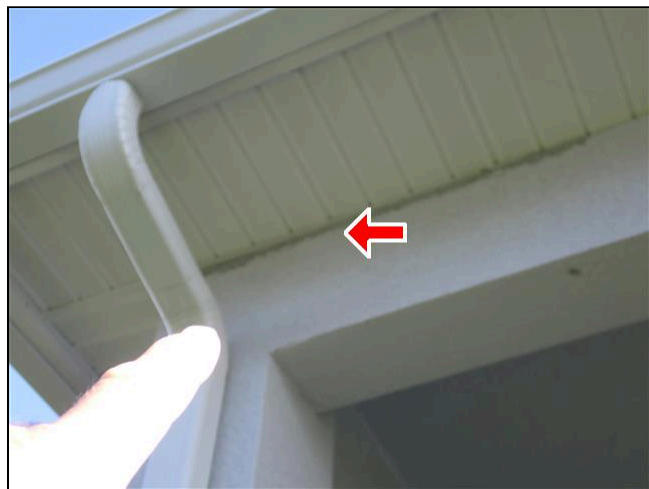
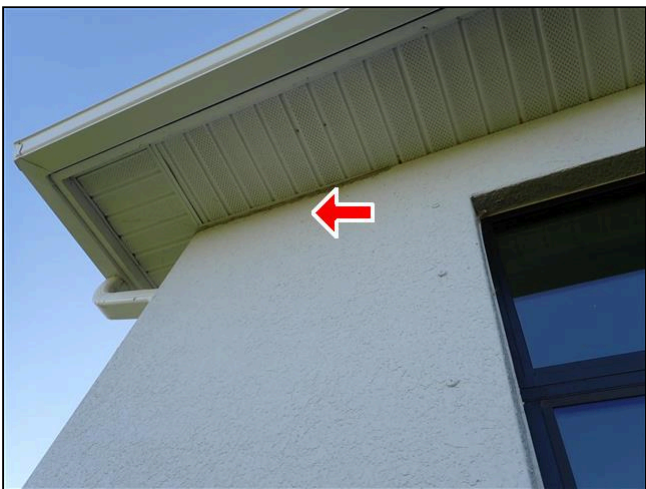
2.0 Paint is missing at the upper left and right rear corners of the home. Recommend prep and paint as needed.

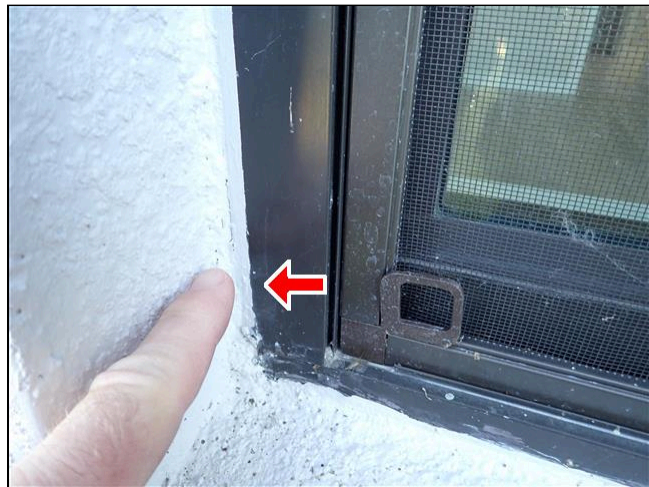
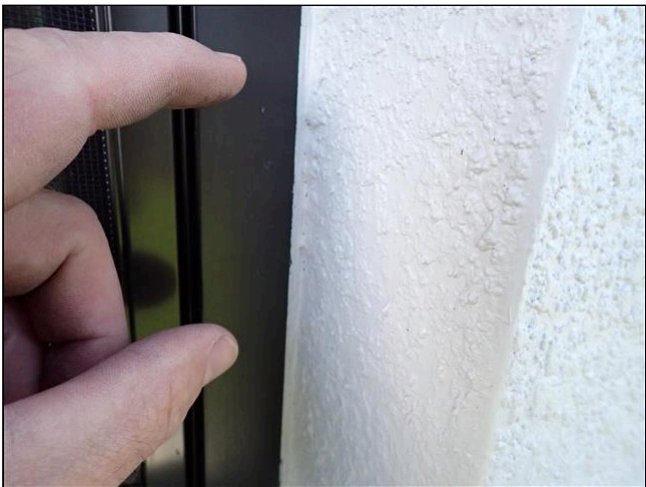
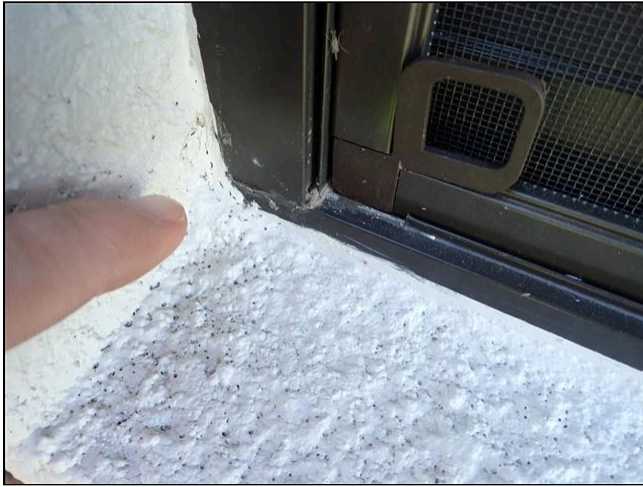
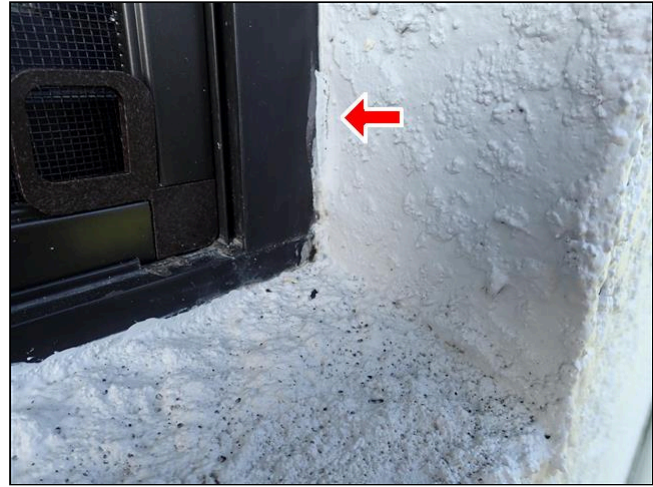
2.2 Several windows around the perimeter of the home have missing or checked caulk at the window frame and stucco joints. Recommend sealing as needed from a qualified contractor to prevent water intrusion at these locations.

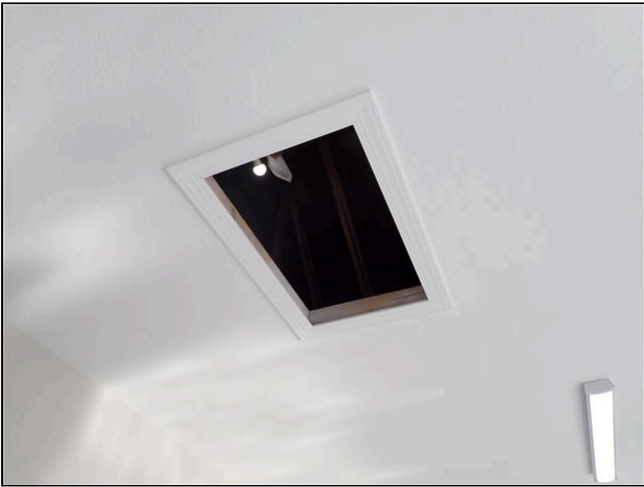
3.0 Item 1(Picture)

3.0 Attic access cover in the garage is missing. Recommend install cover as needed.

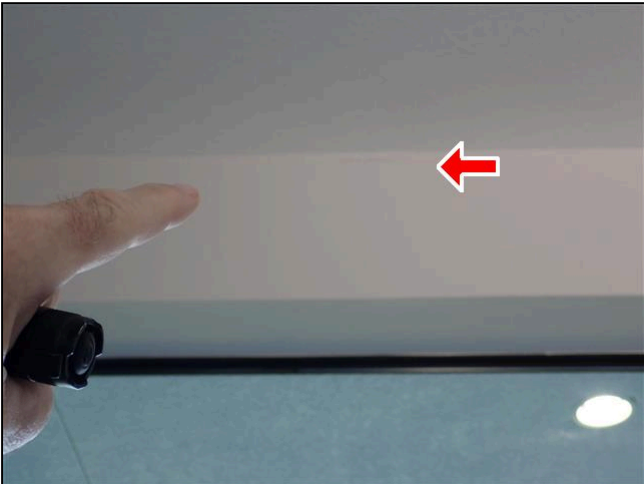
4.0 Item 1(Picture)

4.0 Drywall tape seam is visible at the rear wall of the living room. Recommend correct as needed from a qualified contractor.

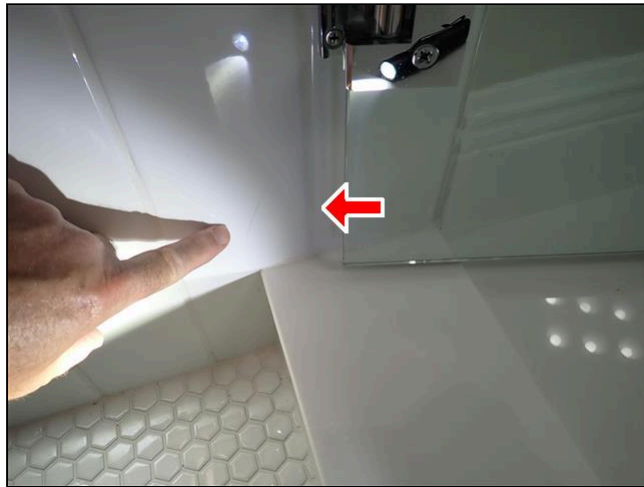
4.1 Item 1(Picture)

4.1 (1) One tile is cracked at the guest bathroom shower surround. Recommend repair as needed from a qualified tile contractor.

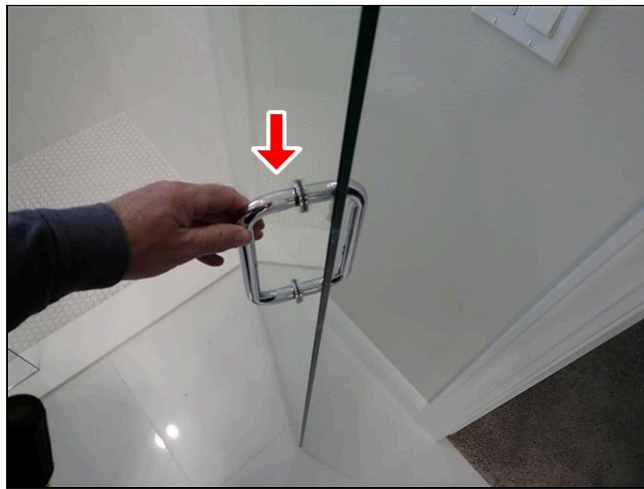
4.1 Item 2(Picture)

4.1 (2) Shower door handle is loose and needs securing at the guest bath shower. Recommend secure as needed.

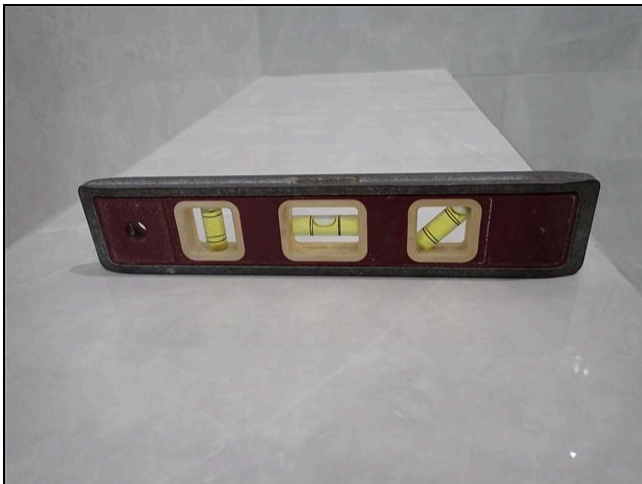
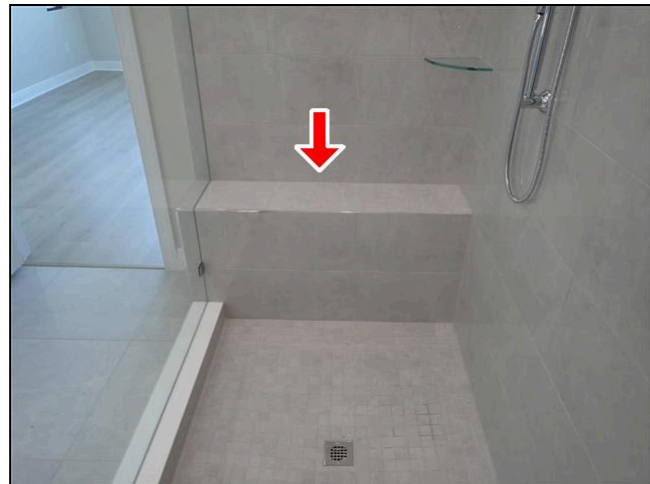
4.1 (3) Shower seat at the master bath shower is not properly pitched to shed water. Recommend repair as needed from a qualified tile contractor.

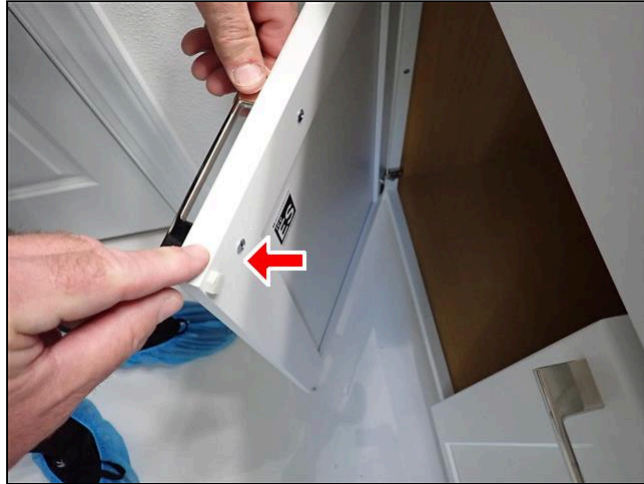
4.4 Item 1(Picture)

4.4 Cabinet door rail is cracked or damaged at the guest bath vanity. Recommend repair as needed.

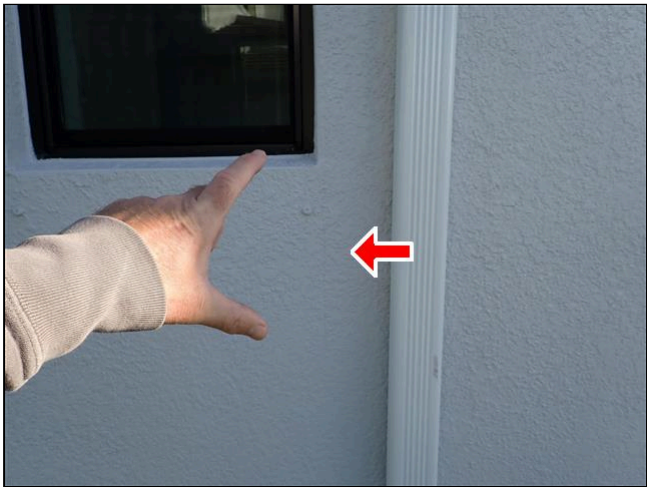
5.1 Item 1(Picture)

5.1 Several typical hairline settlement/shrinkage cracks observed at the left side of the home in the masonry coating. Displacement and excessive separation was not observed (for your information). Recommend seal or repair as needed.

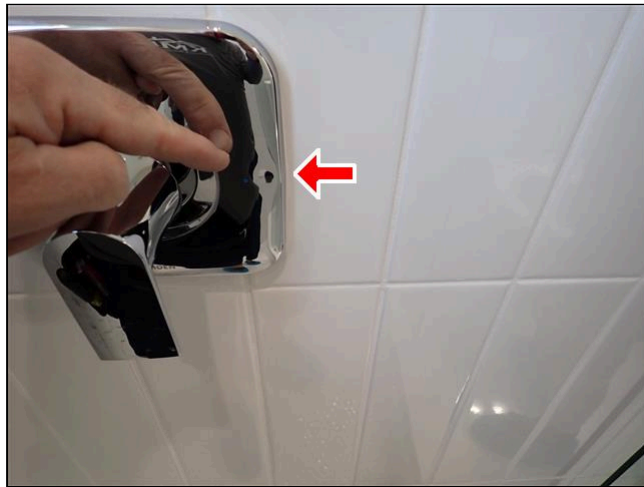
6.1 Item 1(Picture)

6.1 (1) Shower control trim ring is dented at the guest bath shower. Recommend replace trim ring as needed.

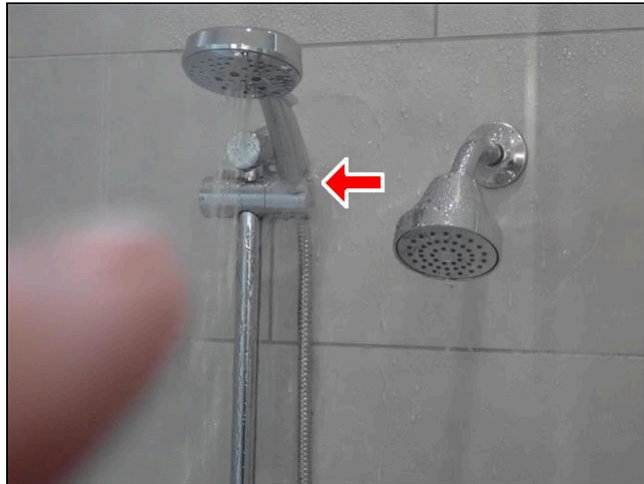
6.1 Item 2(Picture)

6.1 (2) Handheld shower head at the master bath shower leaks at the base when operated. Recommend repair as needed from a qualified contractor.

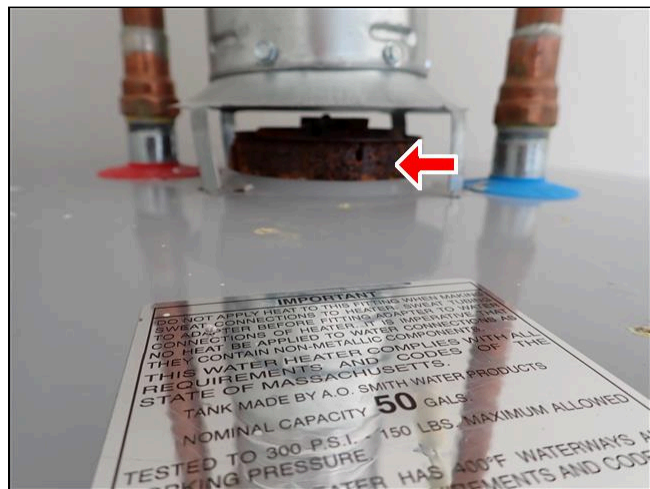
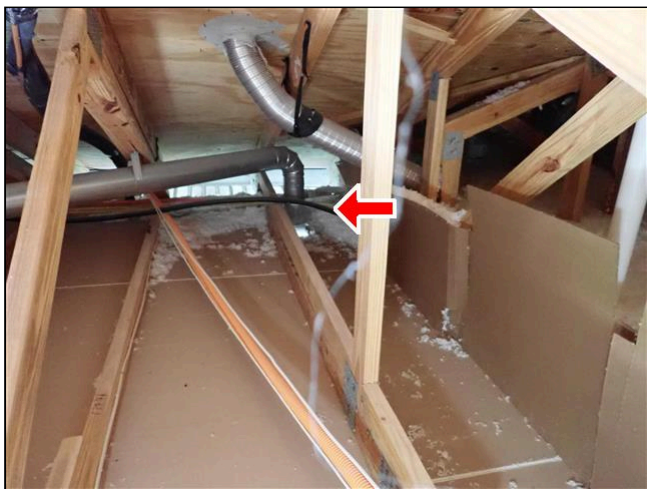
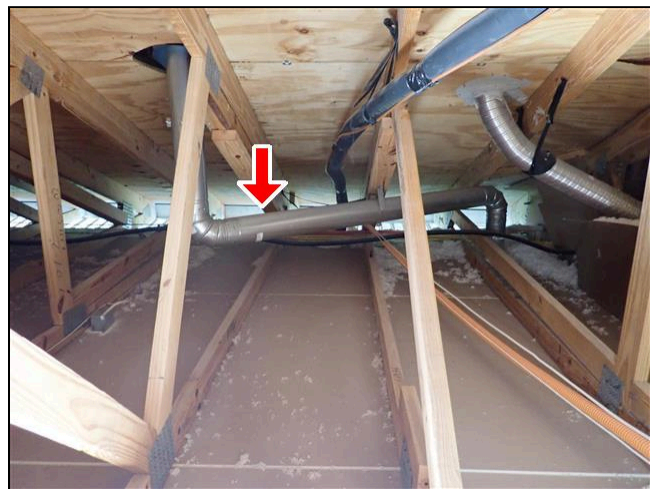
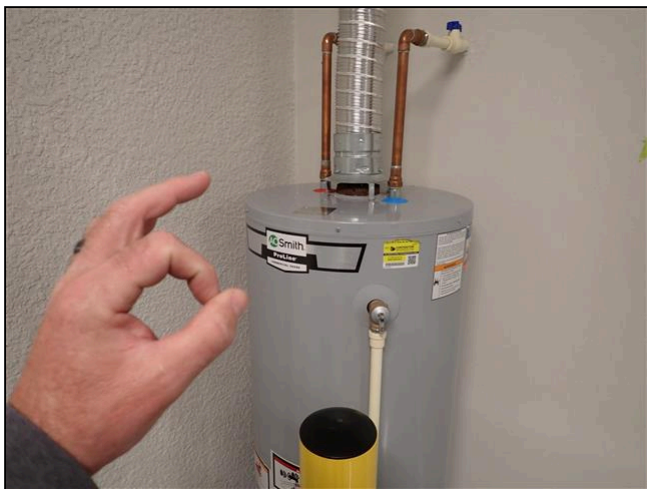
6.2 (1) The gas was not on during this inspection and did not allow for the testing of the hot water system. The flue collar at the top of the water heater is corroded and needs correcting. Recommend a licensed plumber correct as needed. The vent pipe for the water heater is pitched down and needs correcting and appears to be too close to combustible material in the attic. Recommend a licensed plumbing contractor correct as needed.

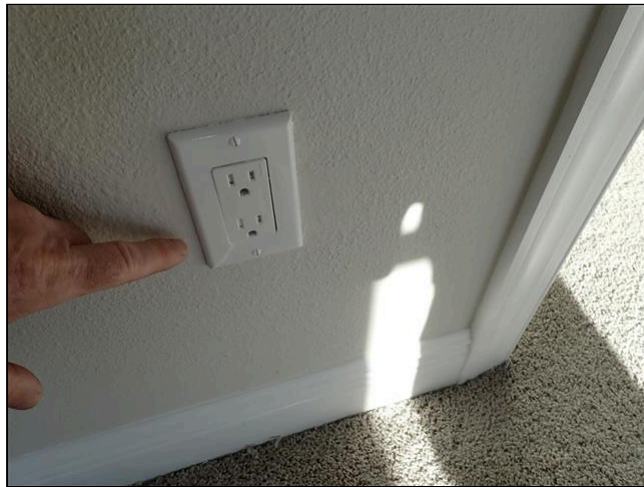
7.3 Item 1(Picture)

7.3 One outlet in the front guest bedroom has a damaged cover plate. Recommend replace cover plate as needed.

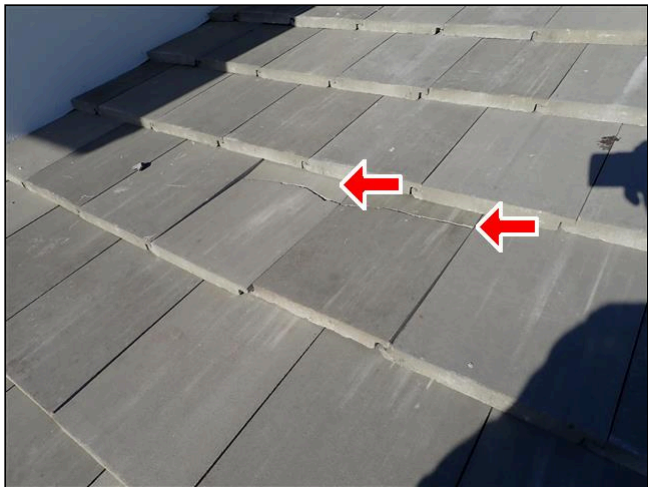
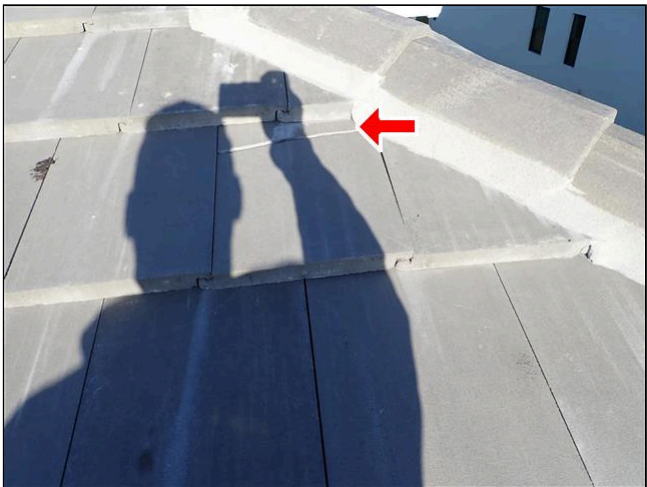
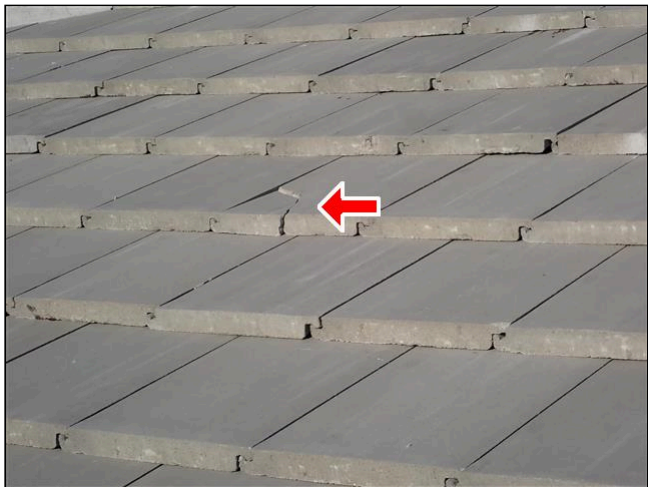
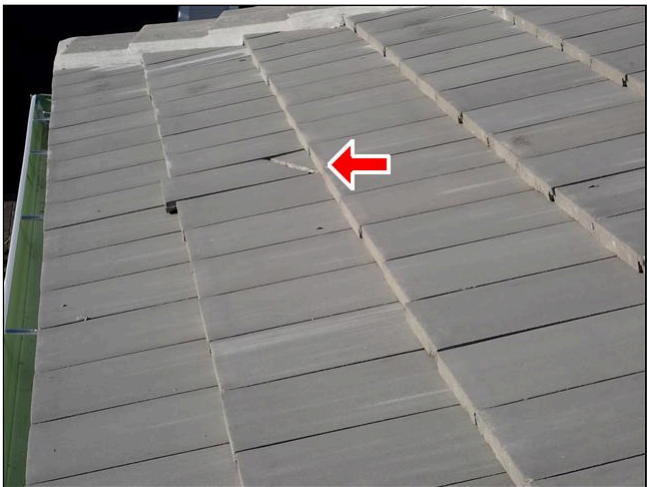
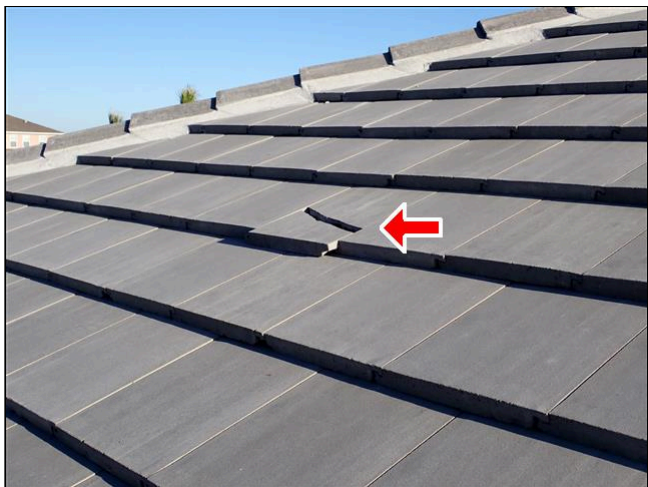
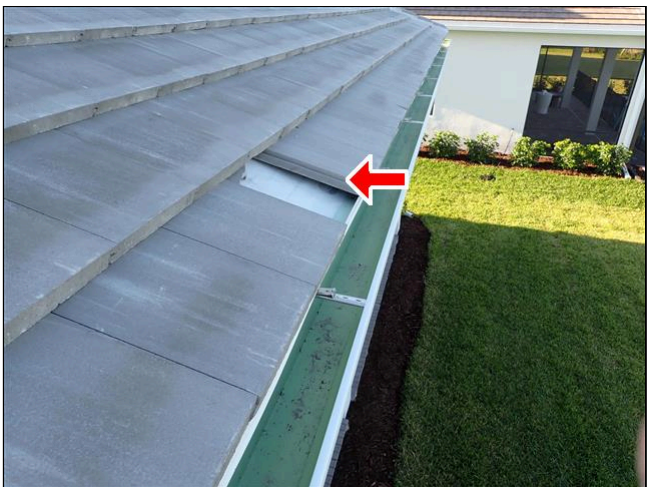
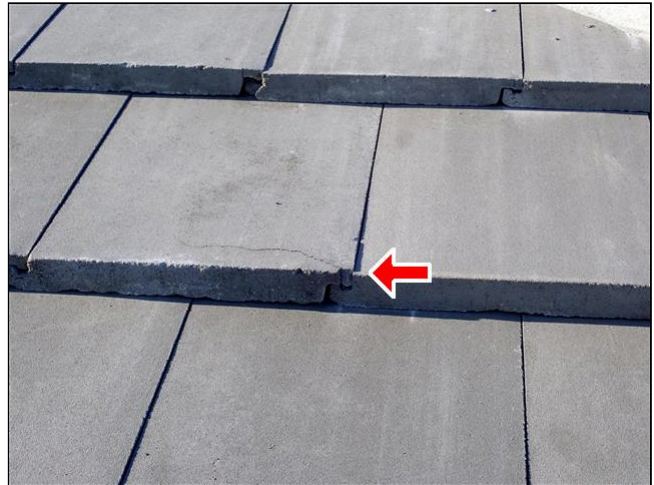
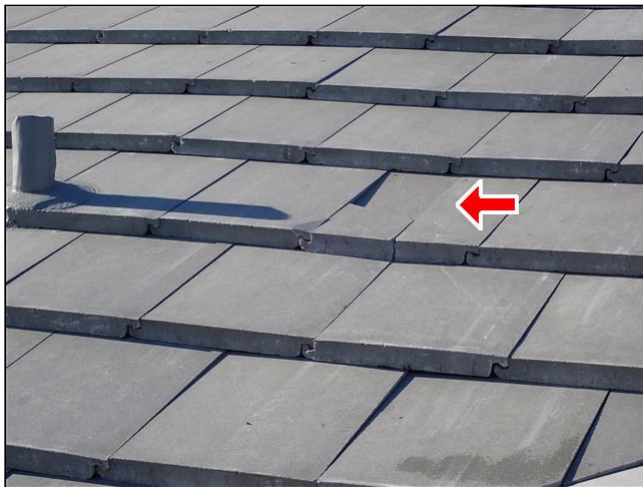
Several roofing tiles are cracked or chipped at various locations around the perimeter of the home. Recommend a licensed roofing contractor repair as needed.

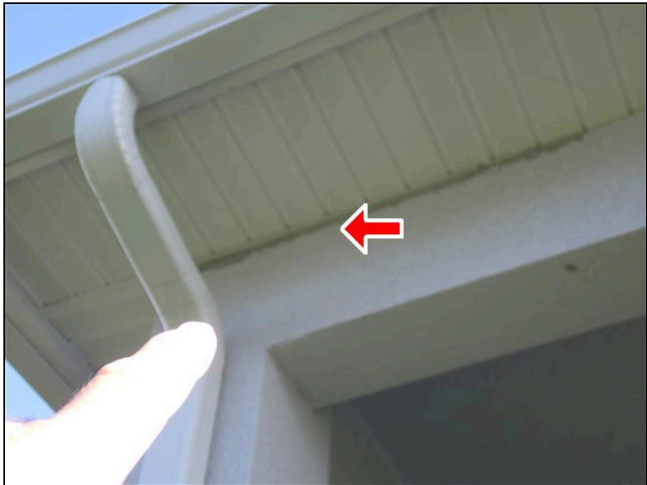
2.0 Item 1(Picture)

Paint is missing at the upper left and right rear corners of the home. Recommend prep and paint as needed.

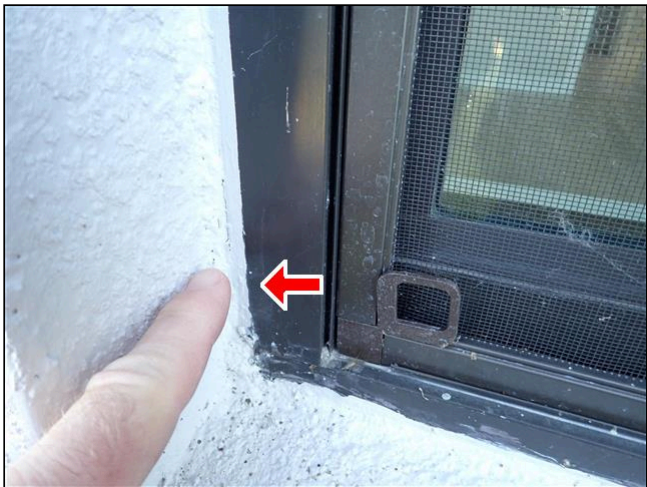
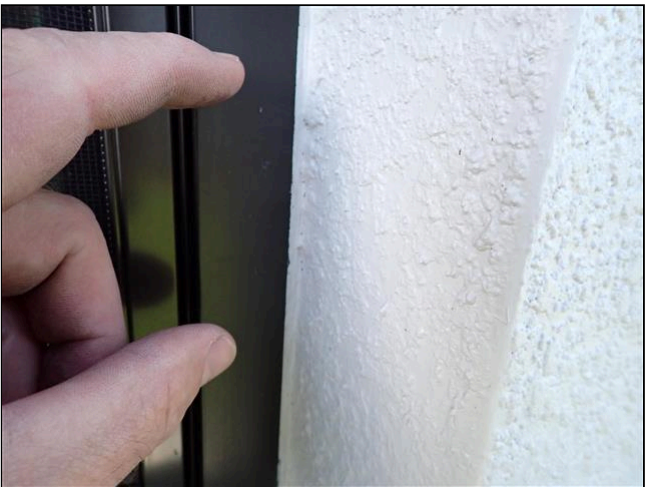
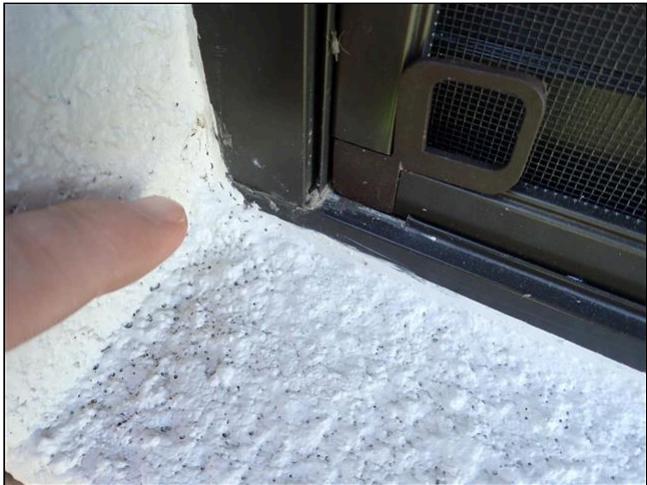
Several windows around the perimeter of the home have missing or checked caulk at the window frame and stucco joints. Recommend sealing as needed from a qualified contractor to prevent water intrusion at these locations.

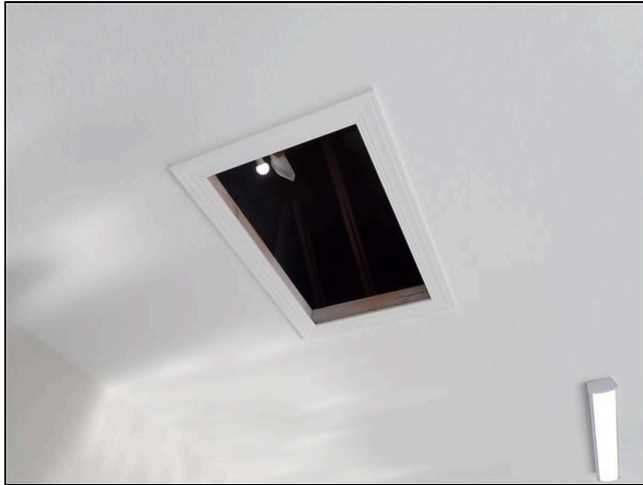
3.0 Item 1(Picture)

Attic access cover in the garage is missing. Recommend install cover as needed.

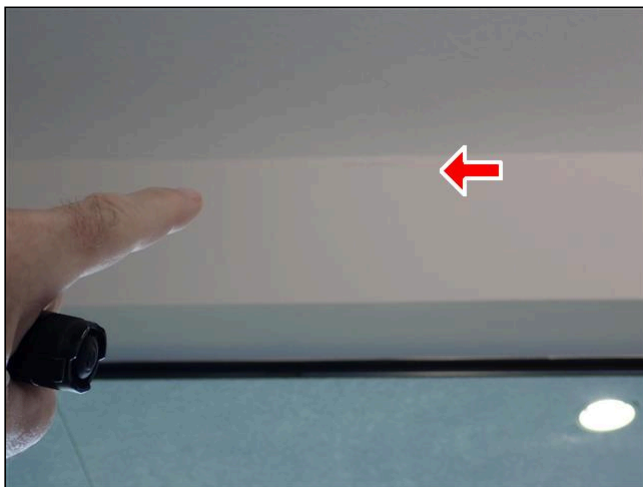
4.0 Item 1(Picture)

Drywall tape seam is visible at the rear wall of the living room. Recommend correct as needed from a qualified contractor.

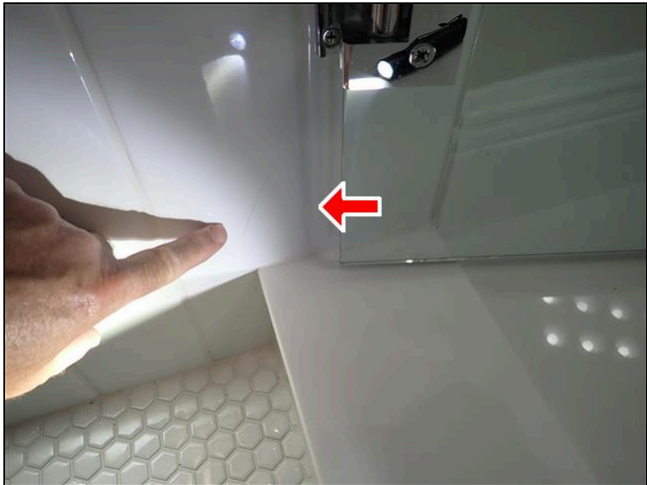
4.1 Item 1(Picture)

(1) One tile is cracked at the guest bathroom shower surround. Recommend repair as needed from a qualified tile contractor.

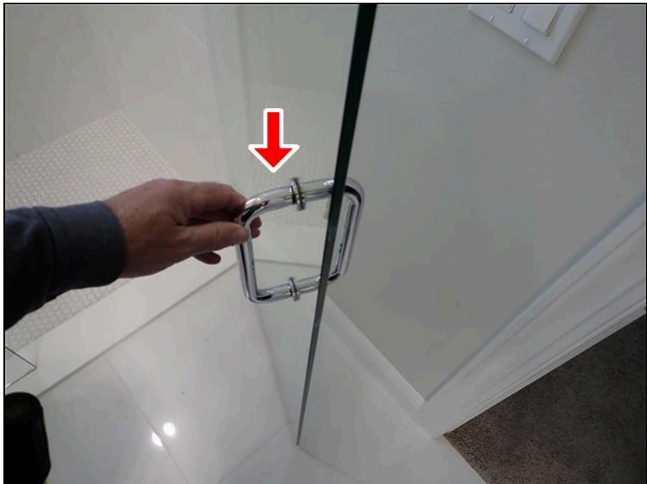
4.1 Item 2(Picture)

(2) Shower door handle is loose and needs securing at the guest bath shower. Recommend secure as needed.

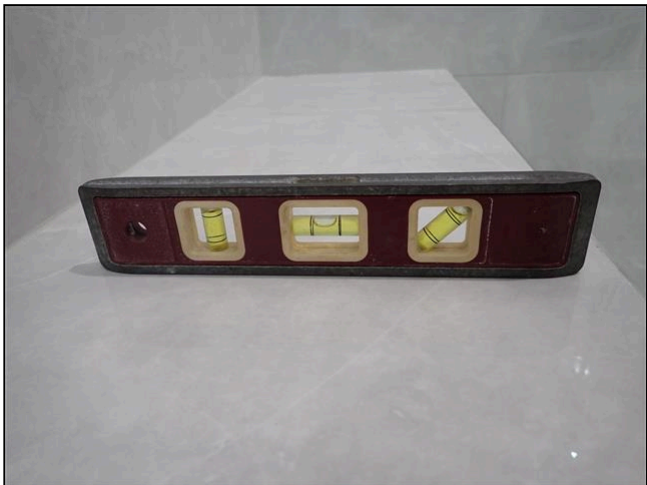
4.1 Item 3(Picture)

(3) Shower seat at the master bath shower is not properly pitched to shed water. Recommend repair as needed from a qualified tile contractor.

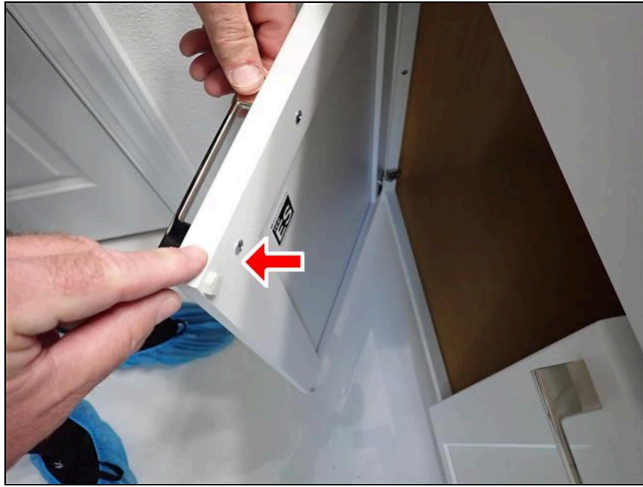
4.4 Item 1(Picture)

Cabinet door rail is cracked or damaged at the guest bath vanity. Recommend repair as needed.

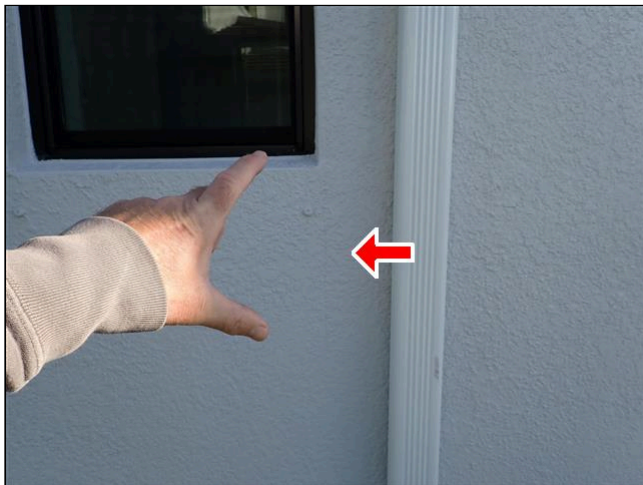
5.1 Item 1(Picture)

Several typical hairline settlement/shrinkage cracks observed at the left side of the home in the masonry coating. Displacement and excessive separation was not observed (for your information). Recommend seal or repair as needed.

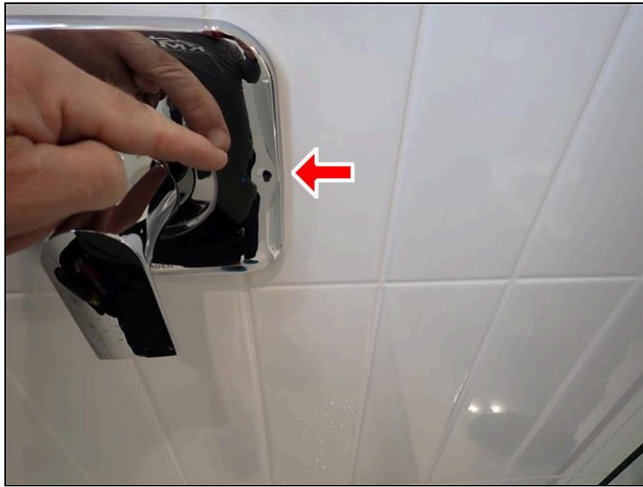
6.1 Item 1(Picture)

(1) Shower control trim ring is dented at the guest bath shower. Recommend replace trim ring as needed.

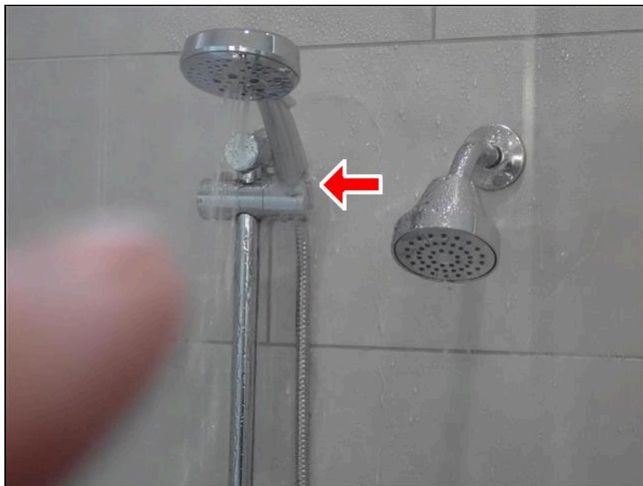
6.1 Item 2(Picture)

(2) Handheld shower head at the master bath shower leaks at the base when operated. Recommend repair as needed from a qualified contractor.

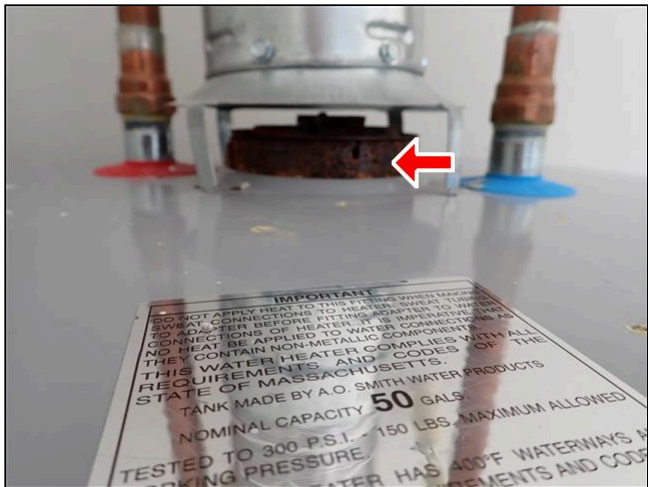
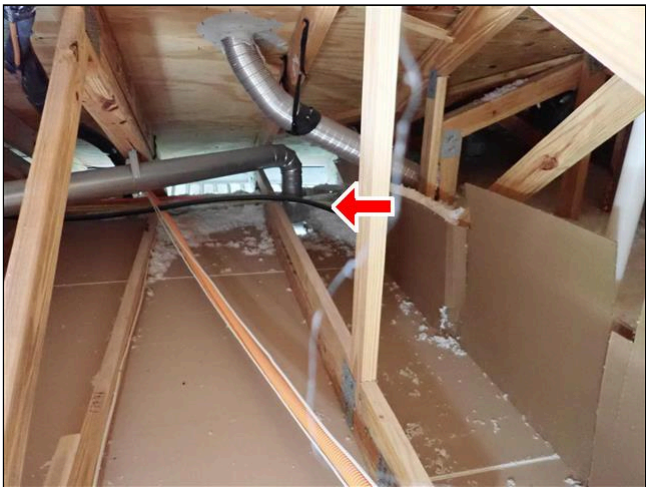
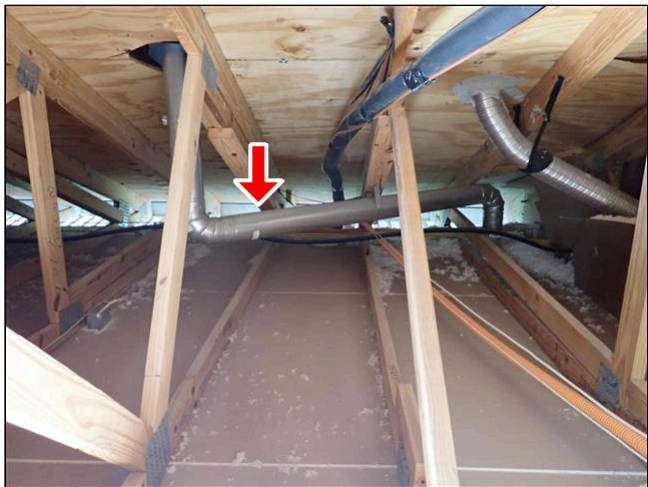
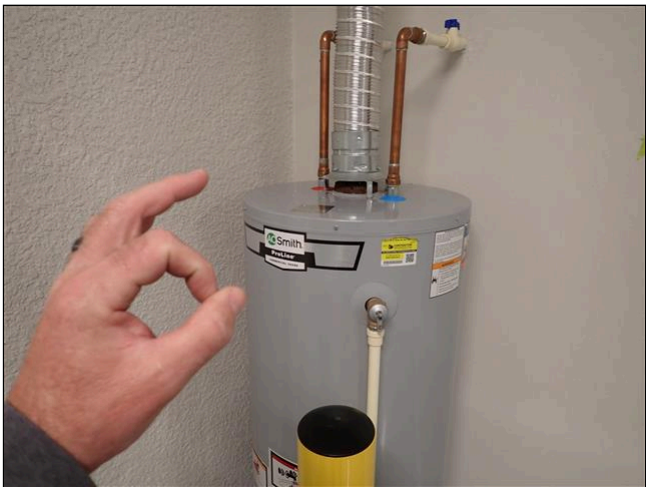
(1) The gas was not on during this inspection and did not allow for the testing of the hot water system. The flue collar at the top of the water heater is corroded and needs correcting. Recommend a licensed plumber correct as needed. The vent pipe for the water heater is pitched down and needs correcting and appears to be too close to combustible material in the attic. Recommend a licensed plumbing contractor correct as needed.

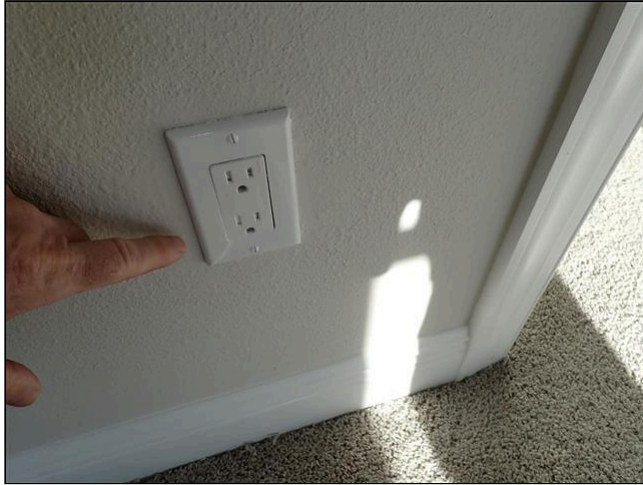
7.3 Item 1(Picture)

One outlet in the front guest bedroom has a damaged cover plate. Recommend replace cover plate as needed.
