Date: 8/1/2024	Time:	Report ID:
Property: 9216 Tequila Sunrise Drive Sarasota FL 34241	Customer: Layne Hazlip	Real Estate Professional:

In Attendance: Inspector Only	Type of building: Single Family (2 story)	Approximate age of building: New Construction
Temperature: Over 65 (F) = 18 (C)	Weather: Cloudy	Ground/Soil surface condition: Damp
Rain in last 3 days: Yes	Radon Test: No	Water Test: No
Home Occupied: No	Recently Painted Interior: No	Recently Painted Exterior: No
Excluded Items: Pre-Drywall Inspection Only	Sewer Camera Inspection: No

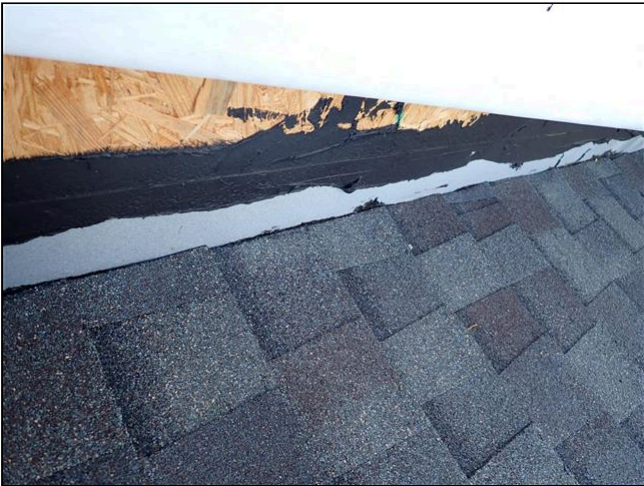
1.1 Item 1(Picture)

1.1 Flashing installed above the garage roof and sealed (for your information).

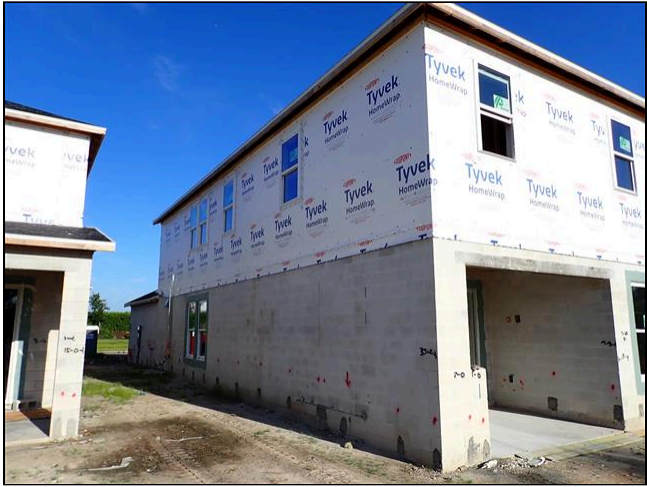
2.0 Item 3(Picture)

2.0 Exterior Views

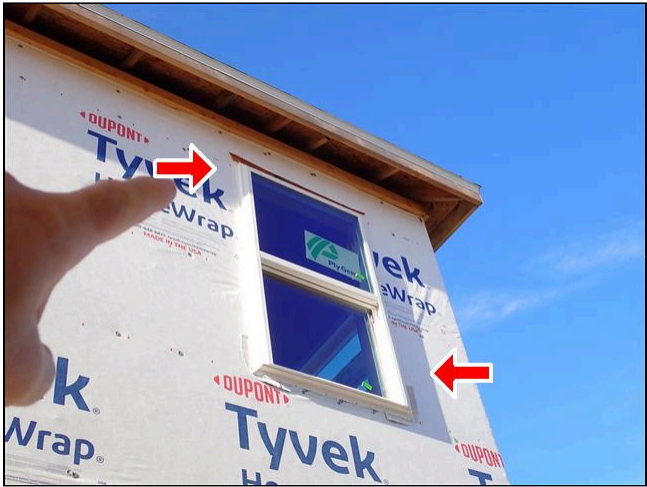
2.2 Item 1(Picture)

2.2 Upper front left corner windows do not have a complete installation. Recommend completing the installation and installing the proper flashing as needed.

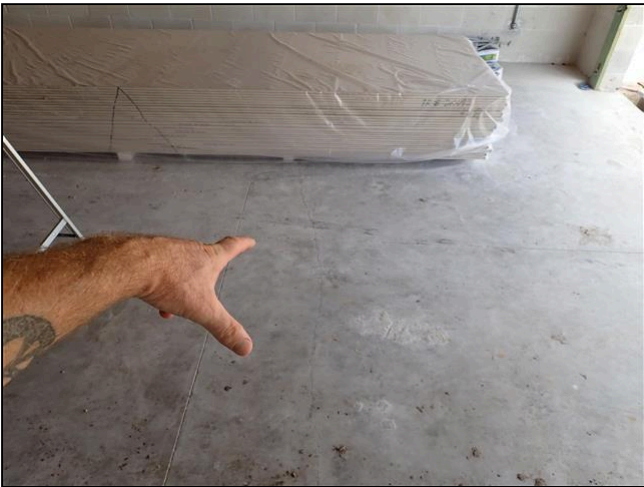
3.2 Item 1(Picture)

3.2 Hairline shrinkage/settlement cracks observed on the garage floor. Displacement was not observed (for your information).

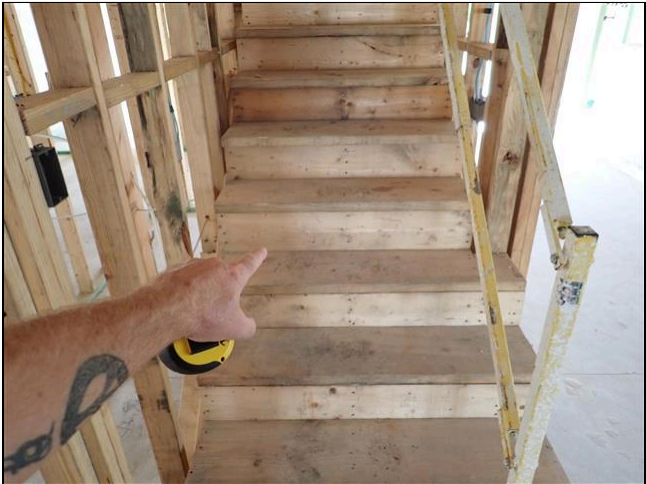
4.3 Item 1(Picture)

4.3 Several steps at the base of the stairs are not uniform in height and need correcting (2" variance). Recommend correct as needed.

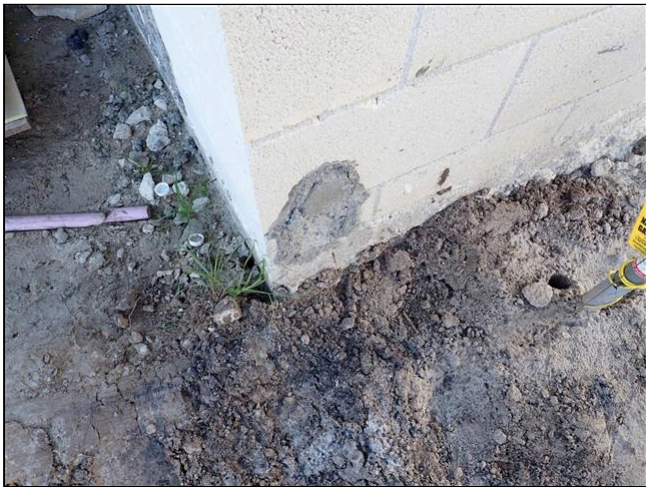
5.1 Item 1(Picture)

5.1 (1) Fill cells observed around the perimeter of the home as indicated on the drawings (for your information).

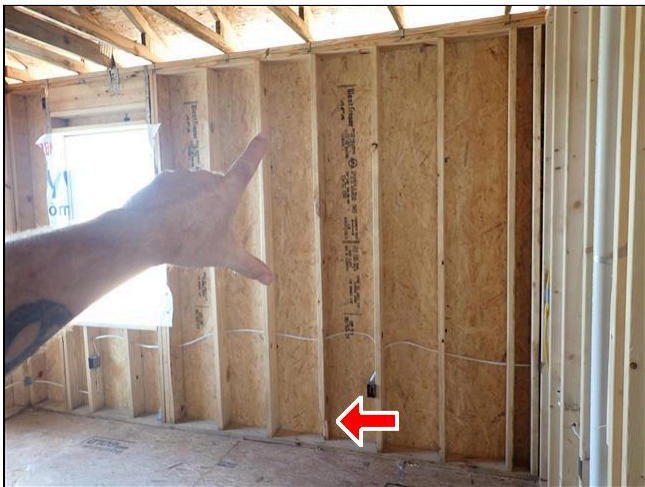
5.1 Item 2(Picture)

5.1 (2) One 2x6 wall stud is damaged at the base on the left side exterior wall of the upstairs front guest bedroom. Recommend replacing stud as needed.

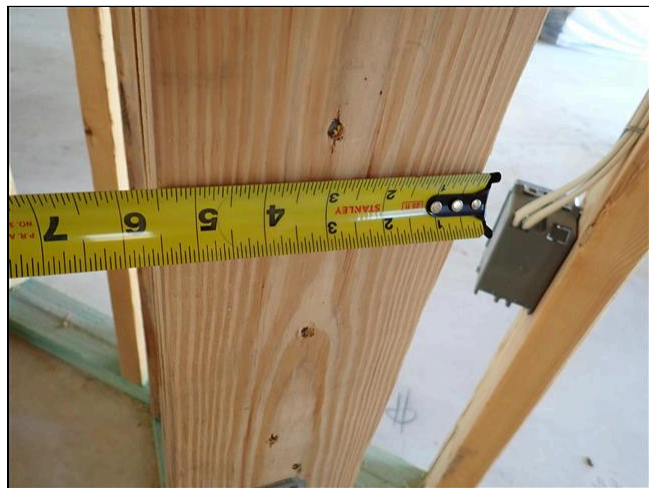
5.2 Item 1(Picture)

5.2 (1) Several built up columns on the lower level and upper level do not have the fasteners installed per the blue print specifications. Recommend correct as needed to comply with drawing specifications.

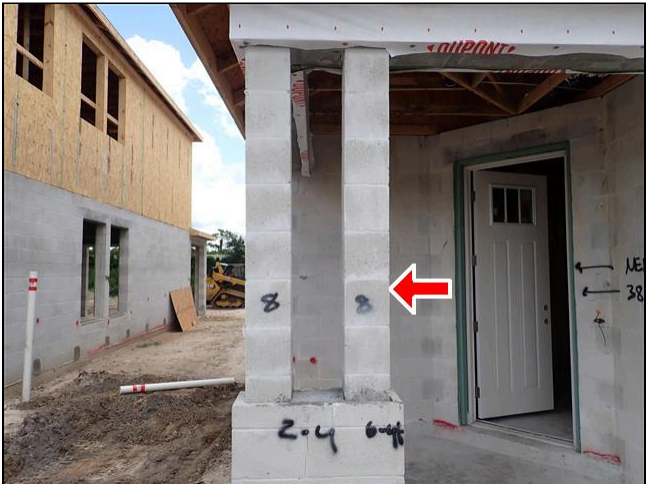
5.2 Item 10(Picture)

5.2 (2) We were unable to confirm the inside upper column is filled with grout per the drawing specifications. This column sounds hollow when struck unlike the outer column that sounds solid when struck. There appears to be separation or movement at the top of this column as well. Recommend confirm fill and correct movement as needed.

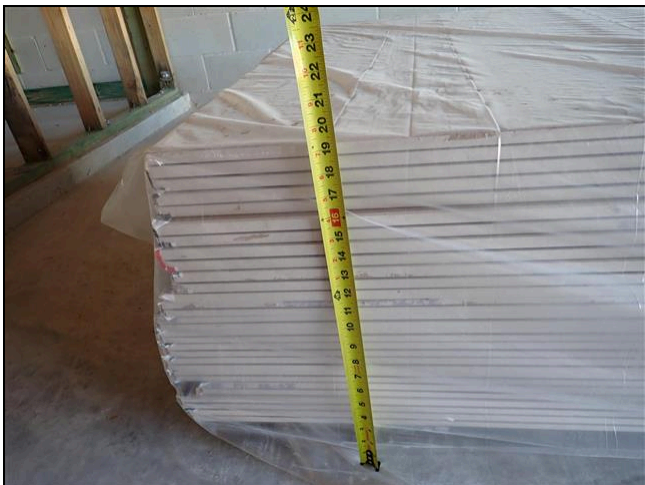
5.3 Item 1(Picture)

5.3 Excessively tall drywall stacks may put undue stress on the floor and floor system components. Recommend distributing the weight accordingly.

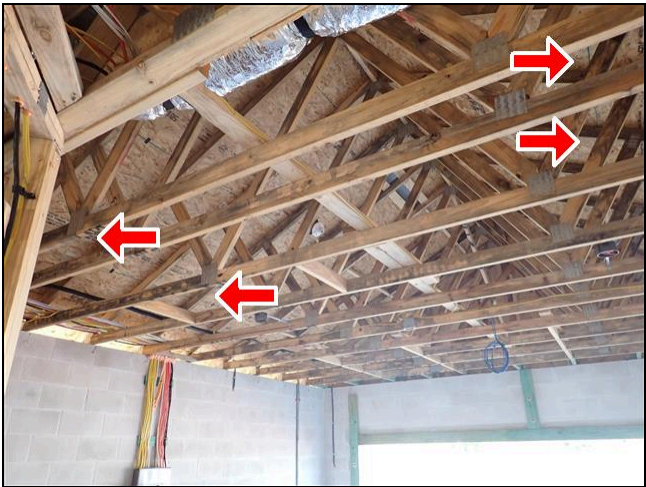
5.5 Item 1(Picture)

5.5 (1) Several roof framing, floor truss assemblies and studs have areas that are stained with an unknown substance. Recommend testing the substance from an environmental assessor as needed.

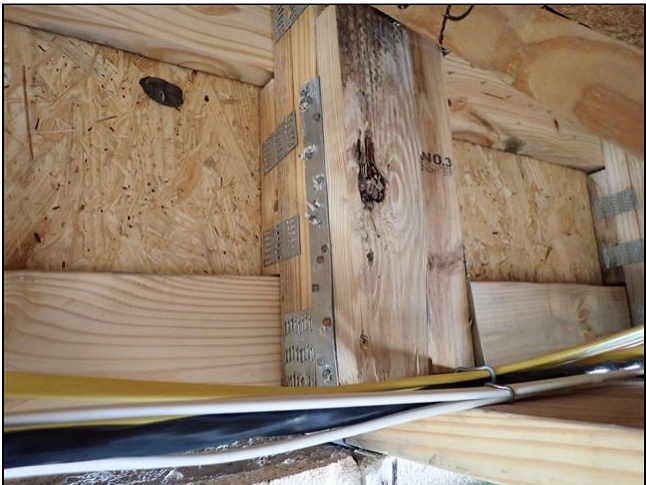
5.5 Item 18(Picture)

5.5 (3) Straps and Simpson SDWC connectors per drawings.

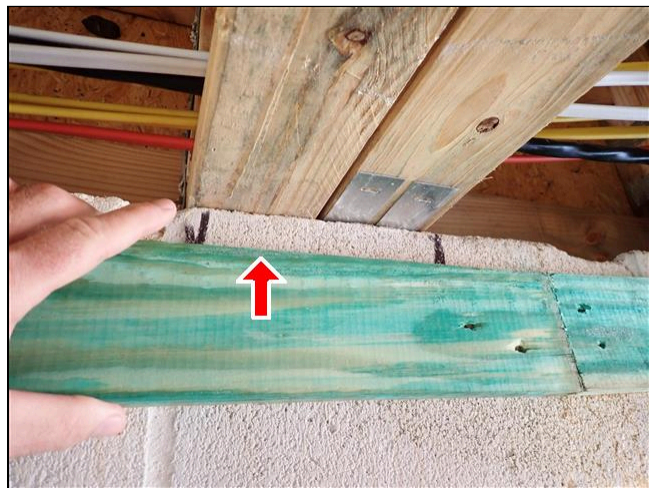
5.5 Item 19(Picture)

5.5 (4) Floor truss is missing a seat plate above the kitchen area. Recommend installing missing seat plate as needed.

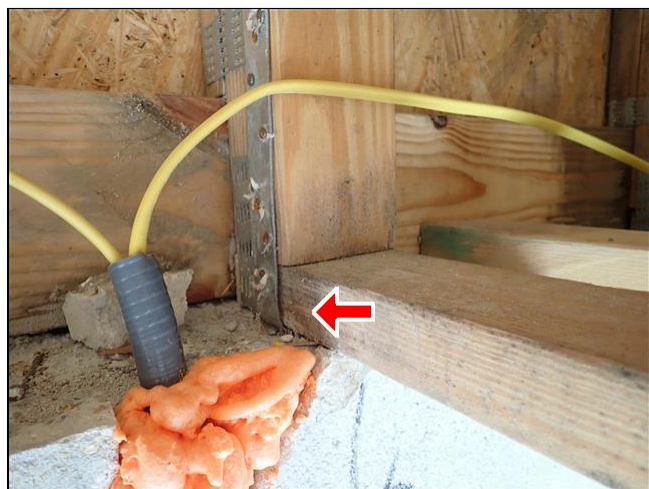
5.5 Item 21(Picture)

5.5 (5) Several floor trusses appear to be sitting on top of the metal straps along the right side of the home near the back patio and the kitchen area. Recommend correct strap alignment as needed.

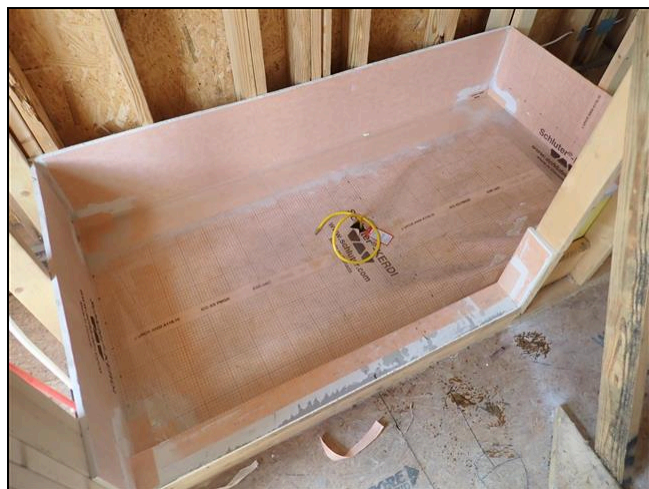
6.0 Item 1(Picture)

6.0 Shower pan is leaking at the upstairs rear bathroom. Recommend correct and re-test as needed.

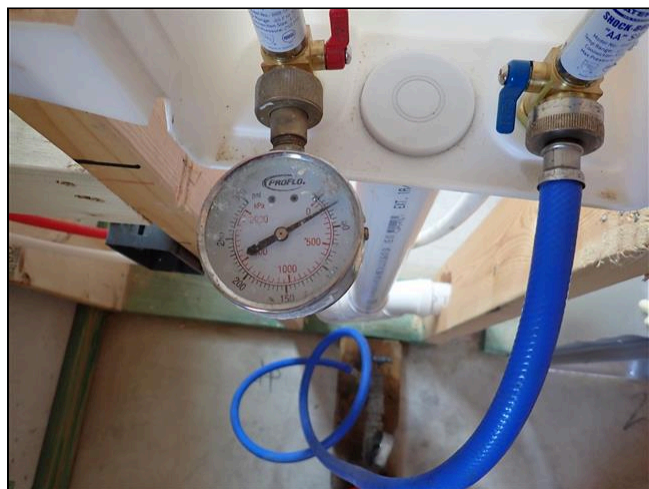
6.1 Item 1(Picture)

6.1 (1) Water supply lines under test pressure (for your information).

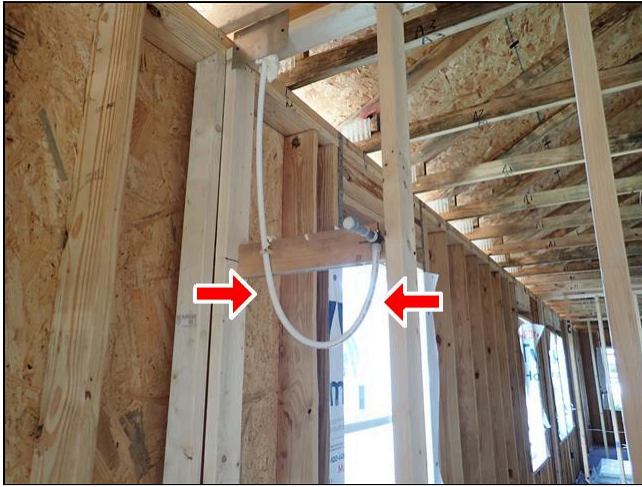
6.1 Item 3(Picture)

6.1 (2) Water line to the shower head at the rear upstairs bathroom and water line in the wall near the laundry room have excessive bends in the wall cavities. This can lead to stress being placed on these lines. Recommend correct as needed.

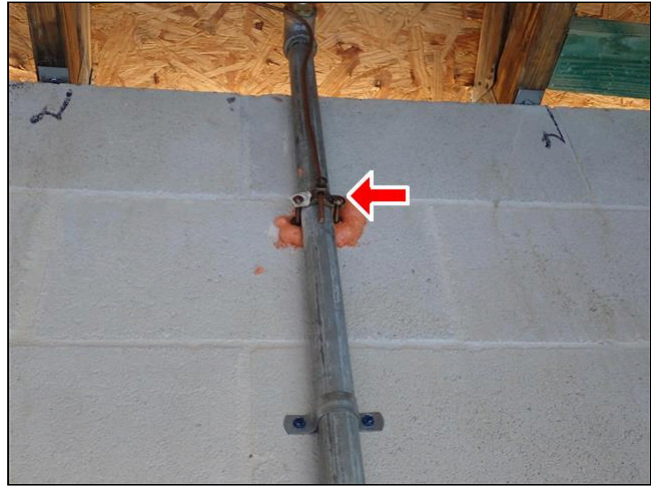
6.4 Item 2(Picture)

6.4 Gas pipe test under pressure. Bonding of the gas line present.

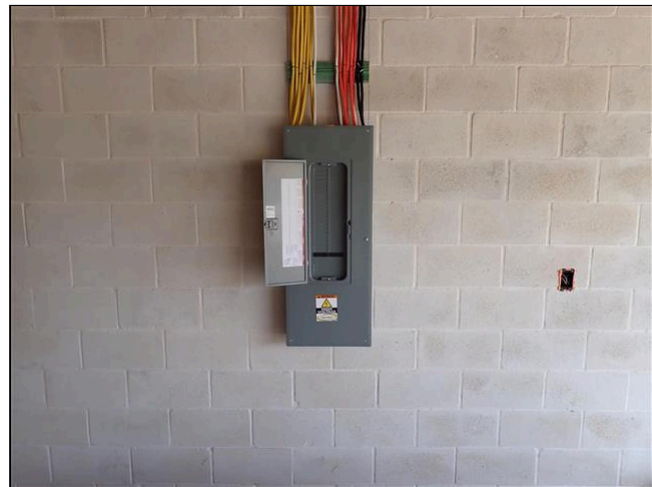
7.7 Item 2(Picture)

7.7 The main shut-off is located outside on the right side of the home near the meterbase. The main distribution panel is located in the garage (for your information).

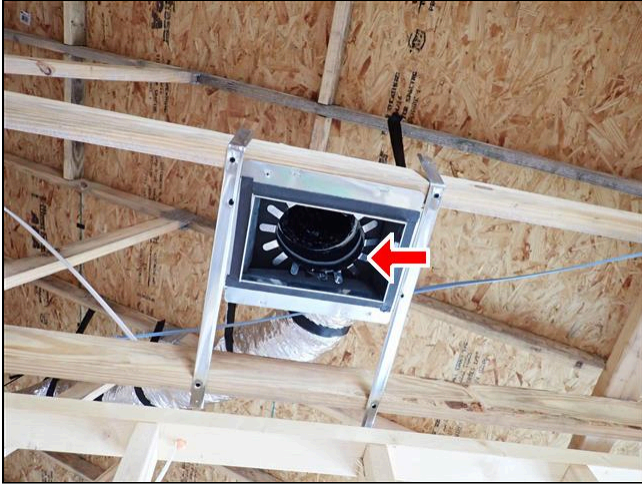
8.3 Item 1(Picture)

8.3 Several distribution boxes are missing covers to keep debris from entering the duct work during construction. Recommend installing missing covers as needed. Supply duct above the entry way to the master bedroom is kinked which may reduce air flow. Recommend correct as needed.

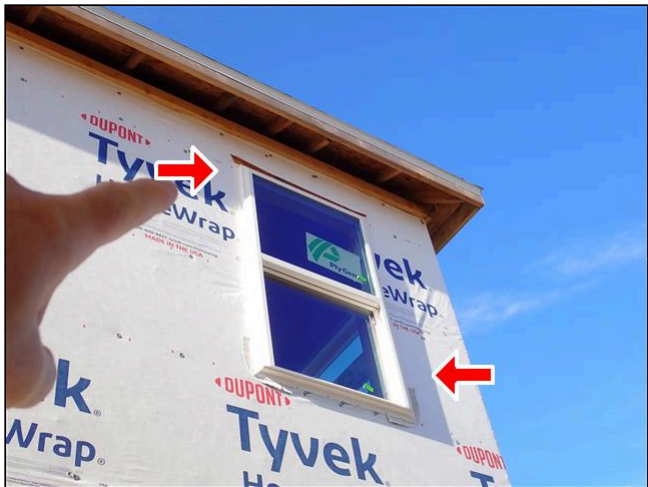
2.2 Item 1(Picture)

Upper front left corner windows do not have a complete installation. Recommend completing the installation and installing the proper flashing as needed.

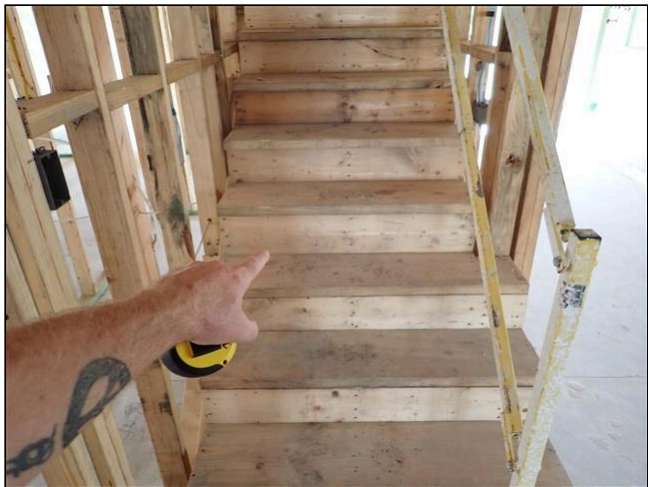
4.3 Item 1(Picture)

Several steps at the base of the stairs are not uniform in height and need correcting (2" variance). Recommend correct as needed.

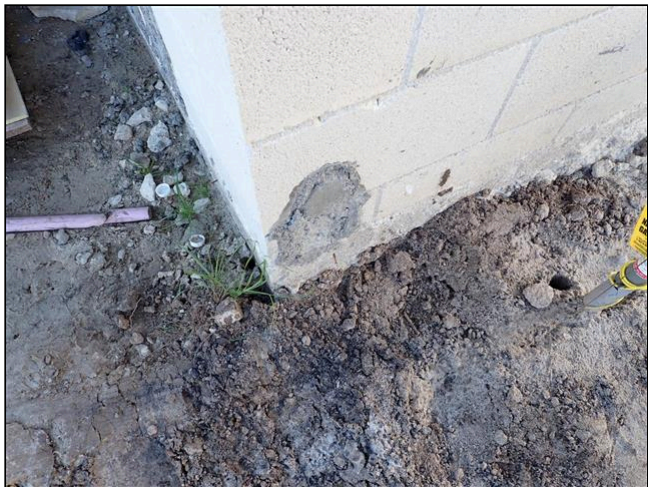
5.1 Item 1(Picture)

(1) Fill cells observed around the perimeter of the home as indicated on the drawings (for your information).

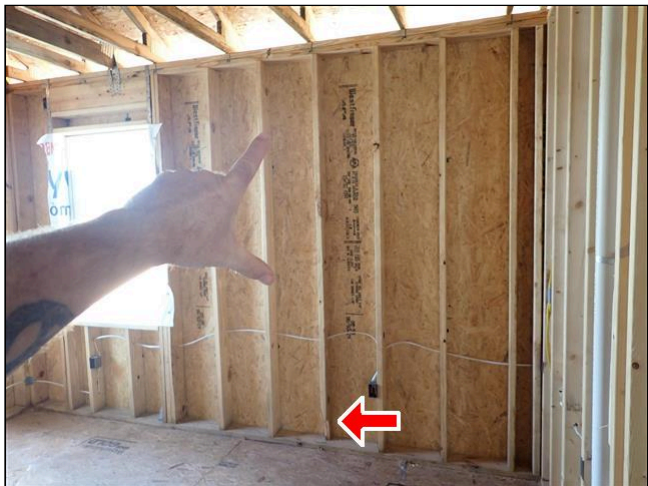
5.1 Item 2(Picture)

(2) One 2x6 wall stud is damaged at the base on the left side exterior wall of the upstairs front guest bedroom. Recommend replacing stud as needed.

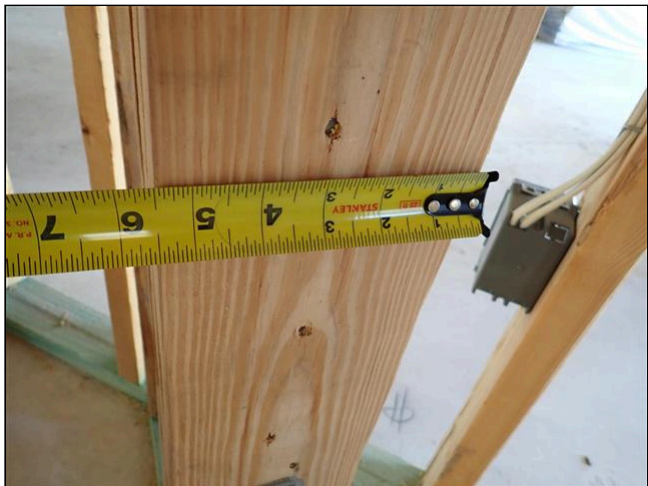
5.2 Item 1(Picture)

(1) Several built up columns on the lower level and upper level do not have the fasteners installed per the blue print specifications. Recommend correct as needed to comply with drawing specifications.

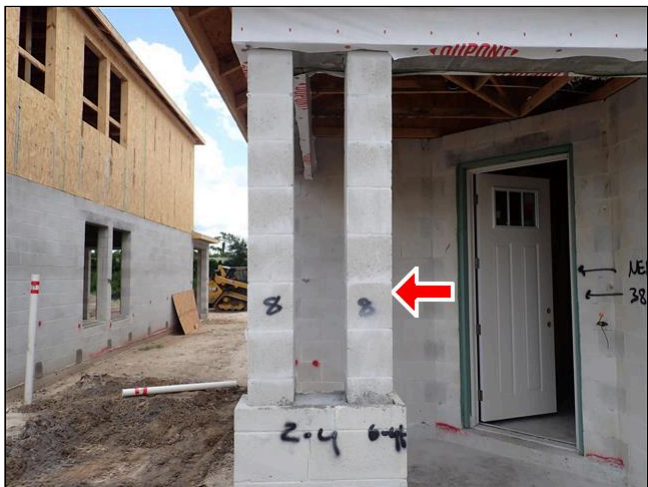
5.2 Item 10(Picture)

(2) We were unable to confirm the inside upper column is filled with grout per the drawing specifications. This column sounds hollow when struck unlike the outer column that sounds solid when struck. There appears to be separation or movement at the top of this column as well. Recommend confirm fill and correct movement as needed.

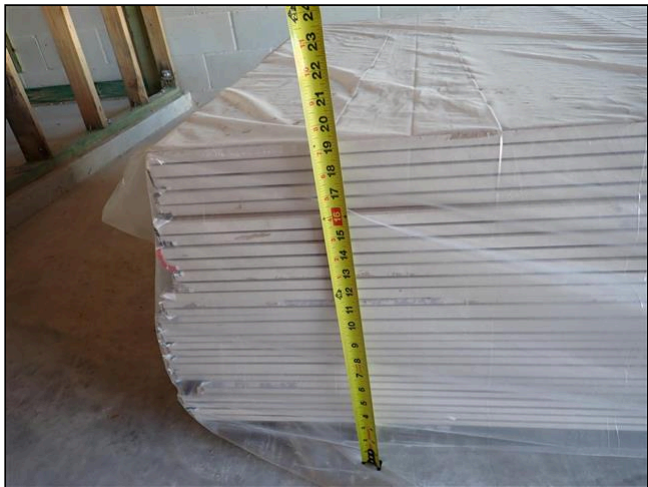
5.3 Item 1(Picture)

Excessively tall drywall stacks may put undue stress on the floor and floor system components. Recommend distributing the weight accordingly.

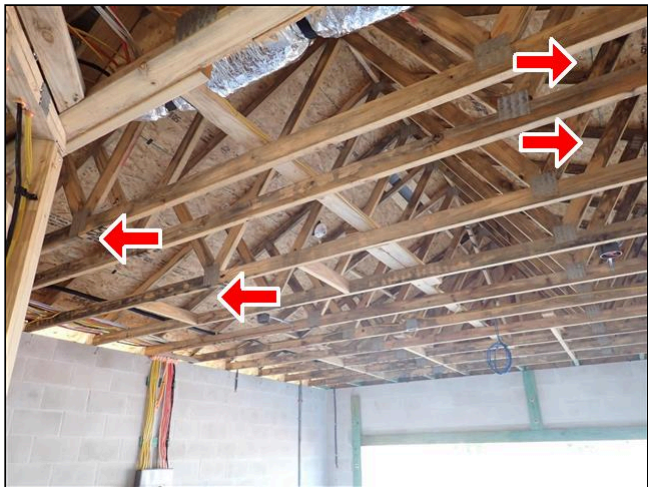
5.5 Item 1(Picture)

(1) Several roof framing, floor truss assemblies and studs have areas that are stained with an unknown substance. Recommend testing the substance from an environmental assessor as needed.

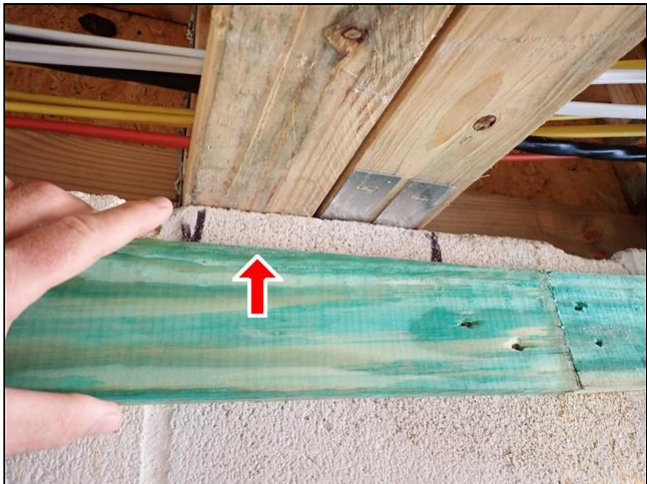
5.5 Item 19(Picture)

(4) Floor truss is missing a seat plate above the kitchen area. Recommend installing missing seat plate as needed.

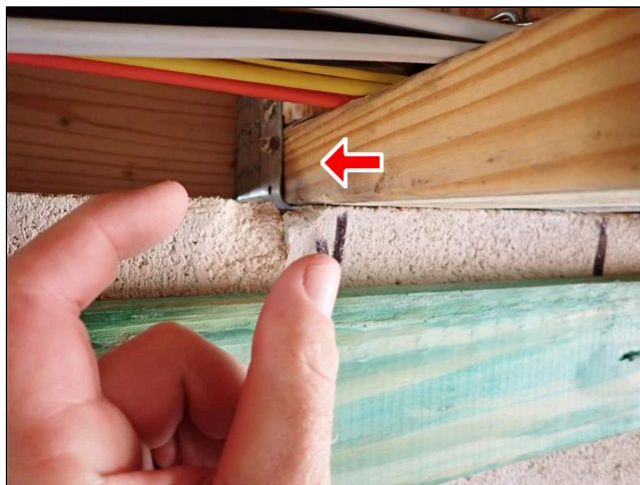
5.5 Item 22(Picture)

(5) Several floor trusses appear to be sitting on top of the metal straps along the right side of the home near the back patio and the kitchen area. Recommend correct strap alignment as needed.

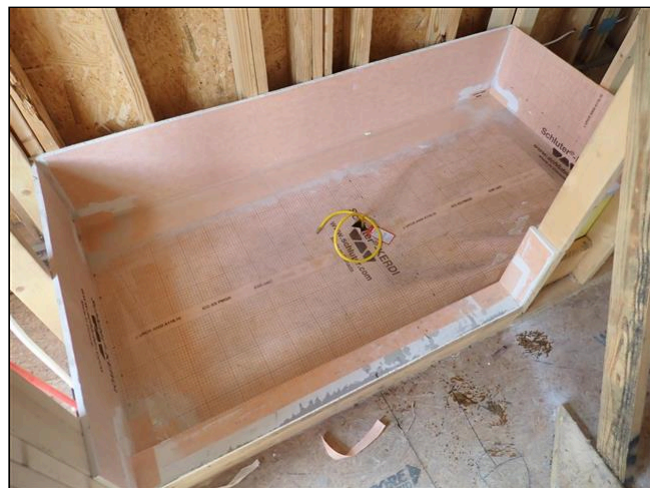
6.0 Item 1(Picture)

Shower pan is leaking at the upstairs rear bathroom. Recommend correct and re-test as needed.

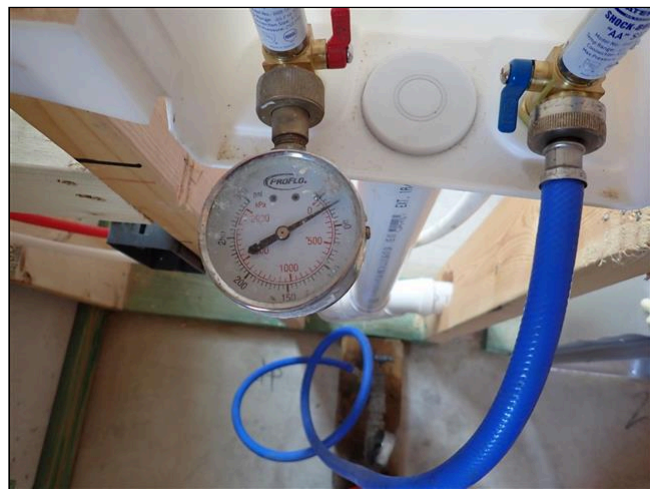
6.1 Item 1(Picture)

(1) Water supply lines under test pressure (for your information).

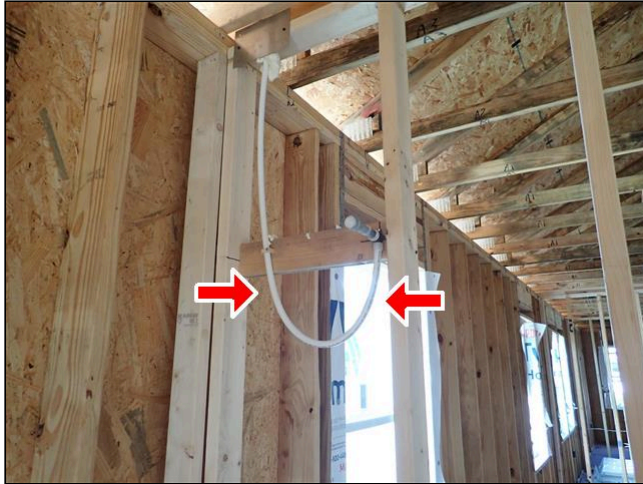
6.1 Item 3(Picture)

(2) Water line to the shower head at the rear upstairs bathroom and water line in the wall near the

laundry room have excessive bends in the wall cavities. This can lead to stress being placed on these lines. Recommend correct as needed.

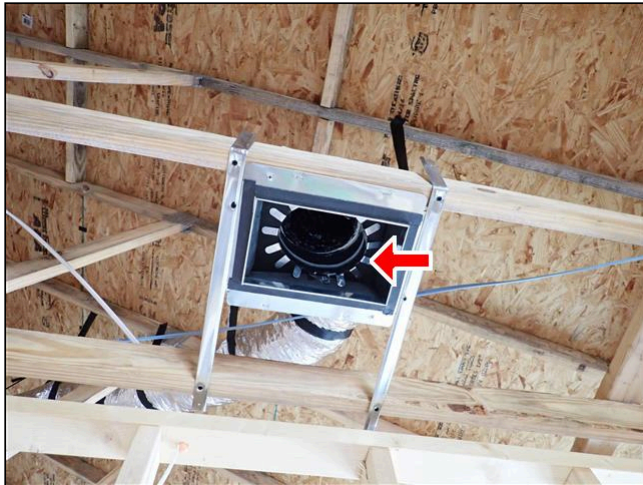
8.3 Item 1(Picture)

Several distribution boxes are missing covers to keep debris from entering the duct work during construction. Recommend installing missing covers as needed. Supply duct above the entry way to the master bedroom is kinked which may reduce air flow. Recommend correct as needed.
