Inspection Report

308 Ohio Place, 1730 Morrill St, 1732/1736 Morrill St.
Sarasota Florida 34236

KMI Home Inspections, Inc.

Date: 11/26/2021	Time:	Report ID:
Property: 308 Ohio Place, 1730 Morrill St, 1732/1736 Morrill St. Sarasota Florida 34236	Customer: George Chung Cho Chung	Real Estate Professional: Kimberly Colgate Private Wealth Realty, Inc.

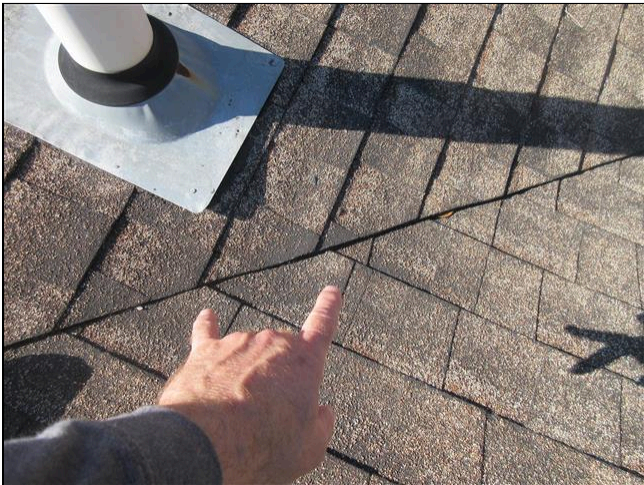
1.0 Item 1(Picture)

1.0 1732/1736- Roof covering has significant granular loss and has exceeded its useful life expectancy. Membrane roof covering above the garage unit and 8 Plex shows several areas that pond water. Tree limbs are in contact with the garage roof and the 8 Plex roof and should be trimmed. Recommend further review from a licensed roofing contractor and repair as needed.

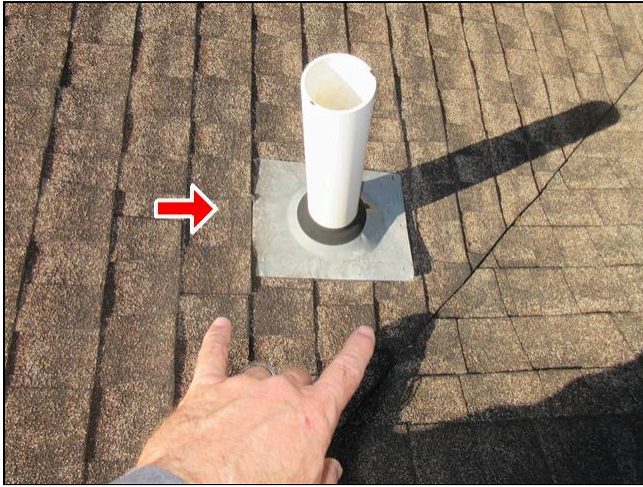
1.1 Item 1(Picture)

1.1 1732/1736- Several flashing boots are damaged or installed improperly. Repairs are needed. Bitumen flashing above the 8 Plex has pulled loose near the plumbing vent pipe. Recommend a licensed roofing contractor repair as needed.

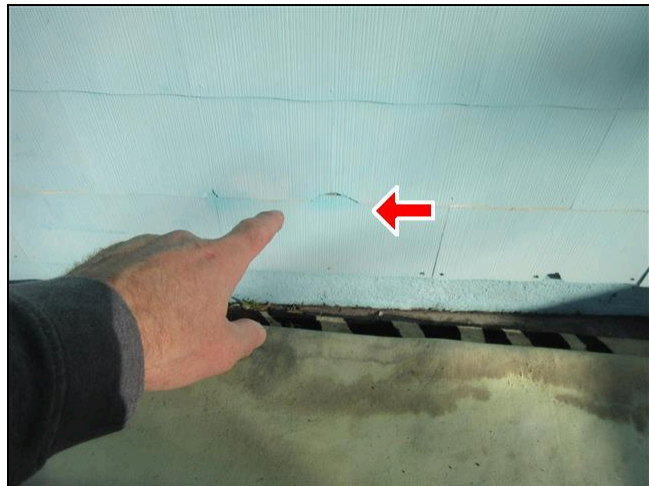
2.0 Item 1(Picture)

2.0 1732- Multiple slate tiles are damaged or cracked on the perimeter of the unit. Garage- Rear and side sheds are deteriorated at the door frame and/or siding and need repairs. 8 Plex- Masonry coating on the rear of the lower units has several hairline settlement cracks. Displacement was not observed (for your information). 8 Plex- Wood siding at the lower level is partially deteriorated in several areas. Recommend repair as needed.

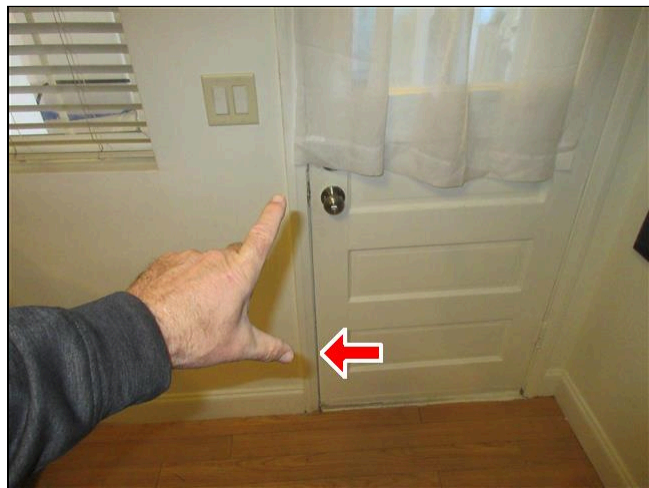
2.1 Item 1(Picture)

2.1 1732- Front and rear entry doors are missing weather stripping. 1736- Front and rear entry doors are missing weather stripping.

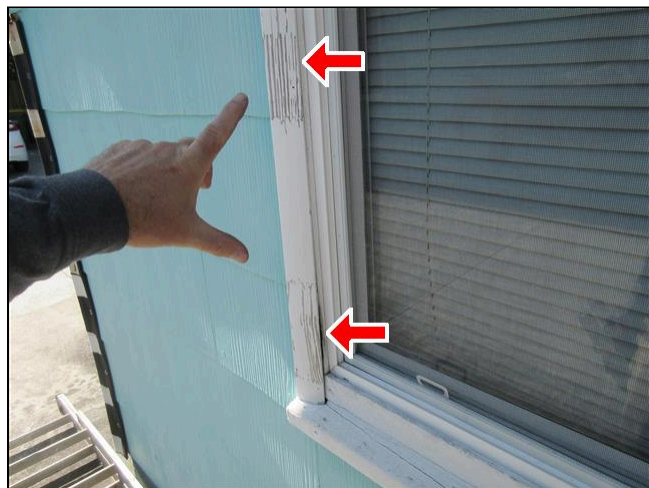
2.2 Item 1(Picture)

2.2 Multiple window frames or trim around the units are peeling paint. Recommend seal, prep and paint as needed.

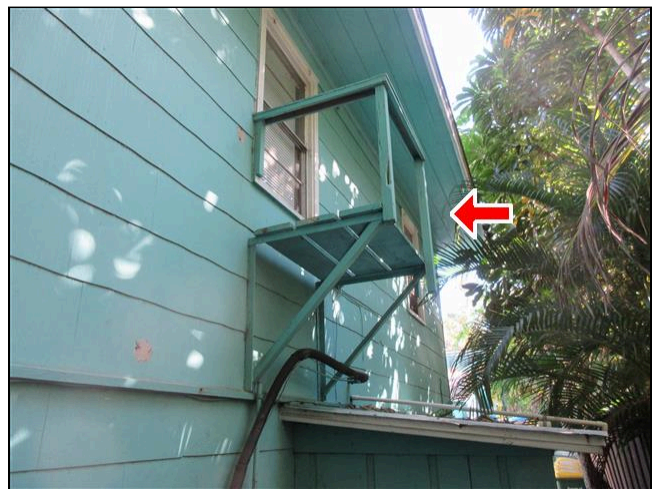
2.3 Item 1(Picture)

2.3 Garage- There is a platform at the rear side wall of the upper garage apartment near one of the windows. The purpose of this platform is unknown. Pickets on the handrail leading to the upper garage apartment are spaced too far apart for safety. Recommend 4" max spacing for safety. Support post below the right side stairs (facing front) of the 8 Plex is loose and needs securing. At least one support post for the metal awning on the back side of the 8 Plex is loose and needs securing at the top.

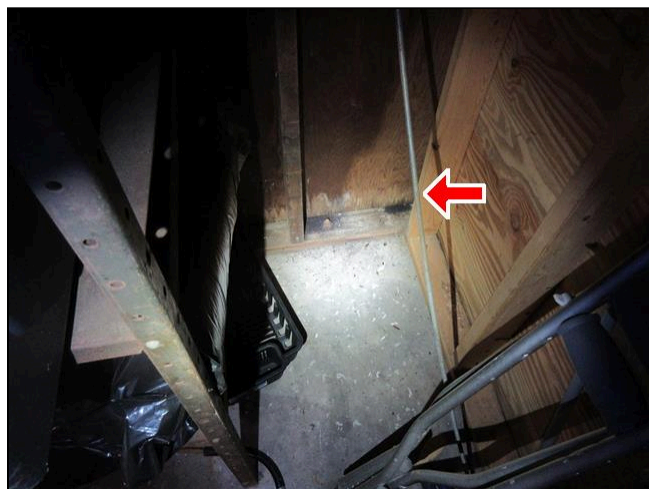
2.4 Item 1(Picture)

2.4 Water stains are present on some of the lower components of the garage walls. Drainage may need to be corrected in these areas. Recommend monitoring during a heavy rain and correcting as needed. Concrete slopes towards the foundation vents on the left side of the Duplex. Water may enter the crawlspace during periods of heavy rain. Recommend monitoring and correcting as needed.

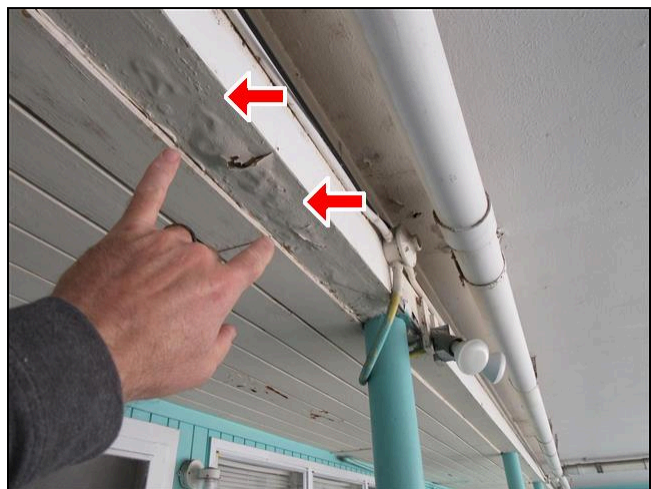
2.5 Item 1(Picture)

2.5 8 Plex- Ceiling and beams above the carport of the 8 Plex is damaged/deteriorated or missing or peeling paint at several areas. Repairs are needed. Former antenna mast is loose and needs securing or removal above the 8-Plex.

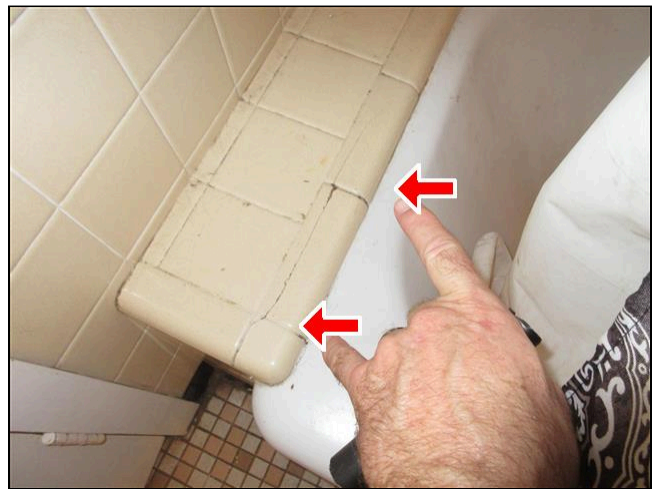
4.1 Item 1(Picture)

4.1 Garage- Several tiles are loose or cracked at the shower surround. Repairs are needed. Unit 3- Several tiles are loose or cracked at the tile shower and wall surround. Repairs are needed. Unit 7- Several tiles are loose or cracked at the tile shower and wall surround. Repairs are needed.

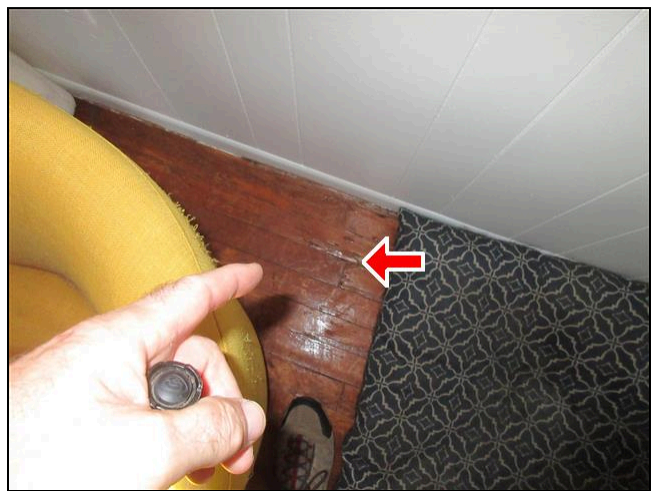
4.2 Item 1(Picture)

4.2 Garage- Wood floor at the living room is damaged at several locations. Unit 3- Several damaged or chipped floor tiles are present in the kitchen/living room. Unit - Several damaged or chipped floor tiles are present in the bathroom. Recommend repair as needed.

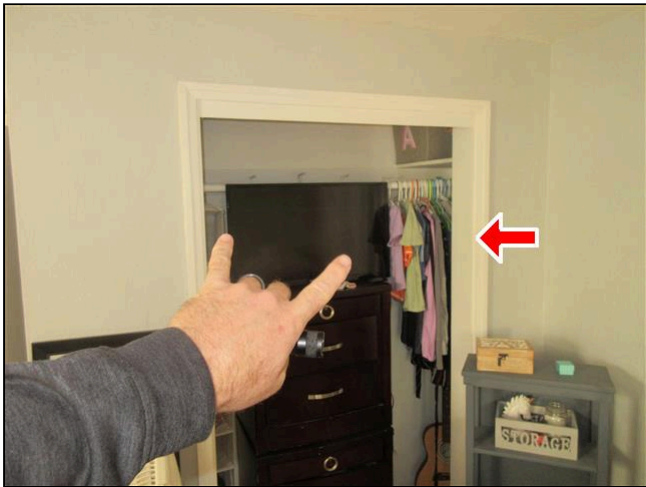
4.5 Item 1(Picture)

4.5 1732- Closet door is missing at the front guest bedroom.

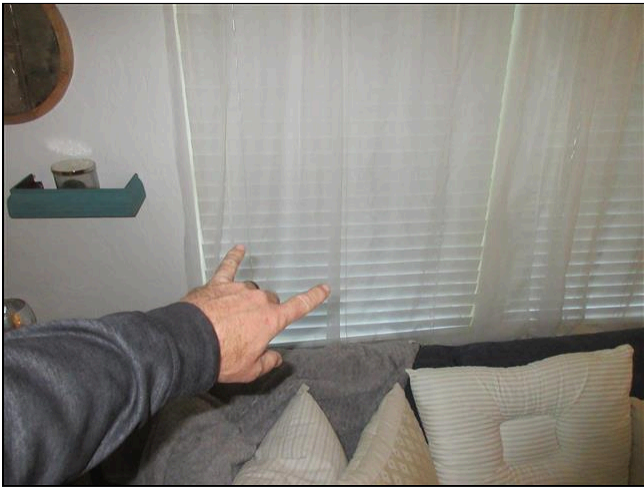
4.6 Item 1(Picture)

4.6 1732- Several windows difficult to operate or missing screens throughout the unit. 1736- One window at the front of the home is damaged at the glass pane. Garage- One window at the side of the home is damaged at the glass pane. Shower window crank unit is missing a screw and needs repair to operate properly. 8 Plex- Multiple windows are missing screens or are difficult to operate.

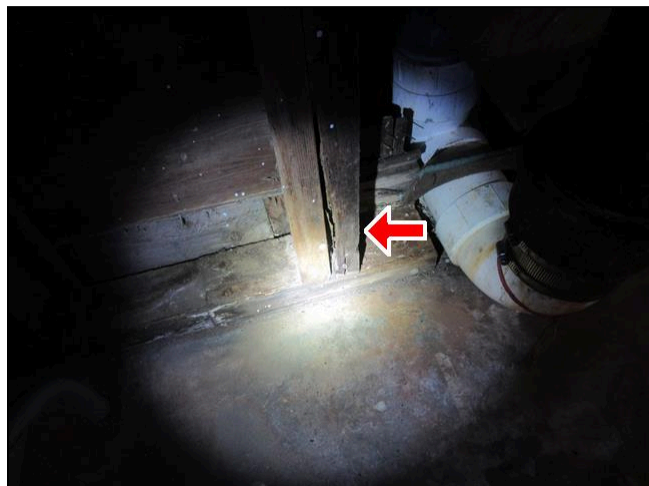
5.1 Item 1(Picture)

5.1 Garage- Several studs and bottom plates at the rear and side walls of the garage are deteriorated and need repairs. Water stains are present at several locations.

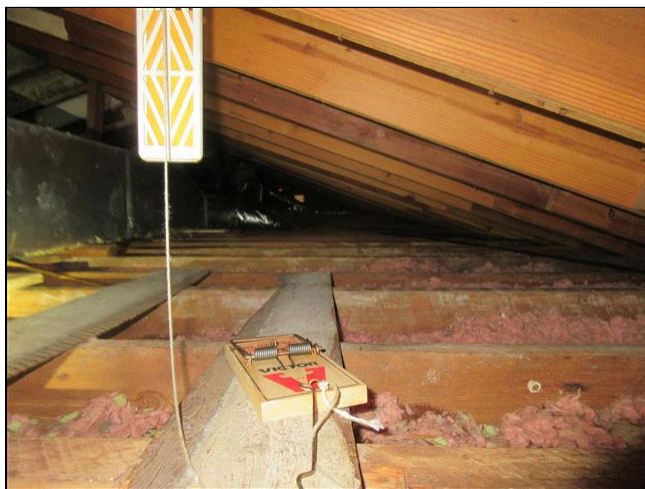
5.5 Item 1(Picture)

5.5 1732/1736- Firewall separation between the units is not present in the attic (for your information). Recommend install as needed. All Remaining Units- attic access was not present or accessible to view roof structure and components.

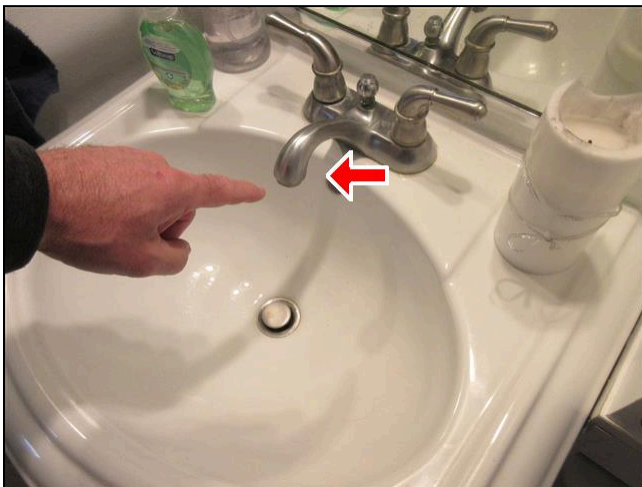
6.1 Item 1(Picture)

6.1 1732- Sink faucet is dripping at the guest bathroom. 1736- Toilet is loose at the floor at the hall bath. Repairs may include replacing the wax ring. We were unable to view this area from below to determine the condition of the flooring component below. Shower head is loose and needs securing. Tub drain is slow to drain. Garage- Tub drain is missing the stopper. 8 Plex- Hose bib knob at the rear of the building is damaged and needs replacing. Unit 3- Toilet is loose at the floor at the hall bath. Unit 3- Tub drain area is corroded and tub is missing the stop valve. Unit 2- Tub drain is slow to drain. Unit 8- Toilet is loose at the floor at the hall bath. Unit 7- Bathroom sink has several hairline cracks present.

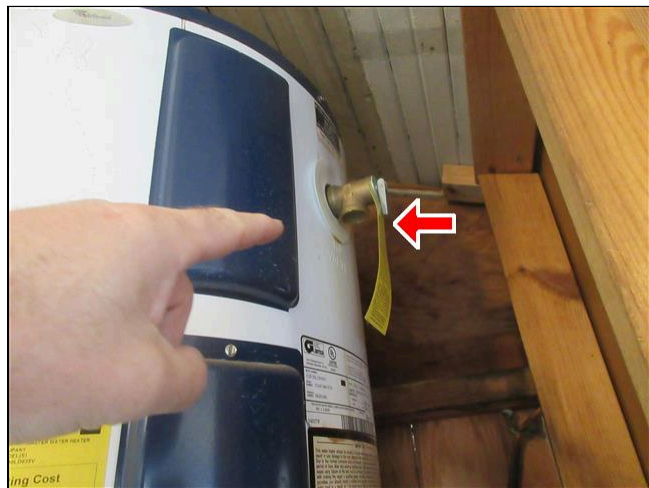
6.2 Item 1(Picture)

6.2 1732- Water Heater is missing a T & P Relief valve pipe. 1736- Water Heater is missing a T & P Relief valve pipe and has exposed romex wiring that should be encased. Garage- Water Heater has exposed romex wiring that should be encased. Unit 4- Water Heater is missing a T & P Relief valve pipe. Unit 3- Water Heater has an inappropriately sized T & P Relief valve pipe. T & P Pipes should be 3/4" diameter and not reduced to 1/2". Unit 2- Water Heater has an inappropriately sized T & P Relief

valve pipe. T & P Pipes should be 3/4" diameter and not reduced to 1/2". Unit 7- Water Heater is missing a T & P Relief valve pipe.

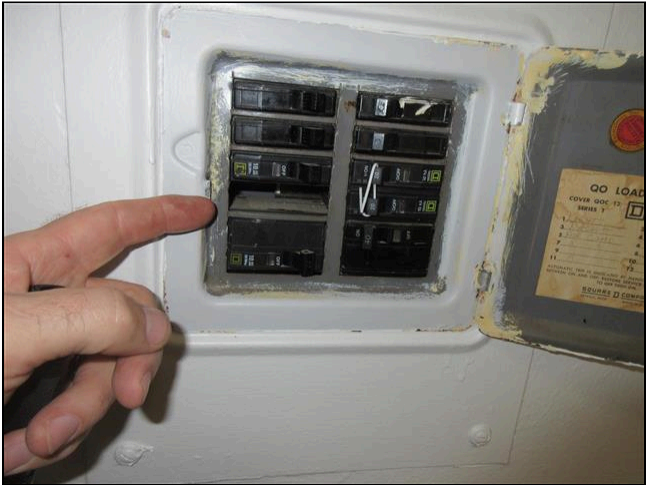
7.1 Item 15(Picture)

7.1 1732- Double tap present in the Federal Pacific sub-panel in the kitchen. Multiple issues are present at the Challenger meterbase panels at the right side of the home including: missing romex connectors, exposed wires, double wiring at circuits, burned or damaged breakers. Repairs are needed

and safety hazards are present within these panels. Many insurance companies have issues with Federal Pacific and Challenger electrical panels. We recommend you check with your insurance company regarding these panels. 1736- Square D distribution panel in the kitchen is missing a knock out cover. Garage- Main panel has missing romex connectors, improper panel cover screws and mixed ground and neutral wires that should be terminated on separate grounding and neutral bars. Panel cover has water stains on the front from a leaking valve above. Unit 3- Double taps are present in the sub-panel in the kitchen. Unit 7- Square D distribution panel in the kitchen is missing a knock out cover. Recommend further evaluation from a licensed electrical contractor and repair as needed.

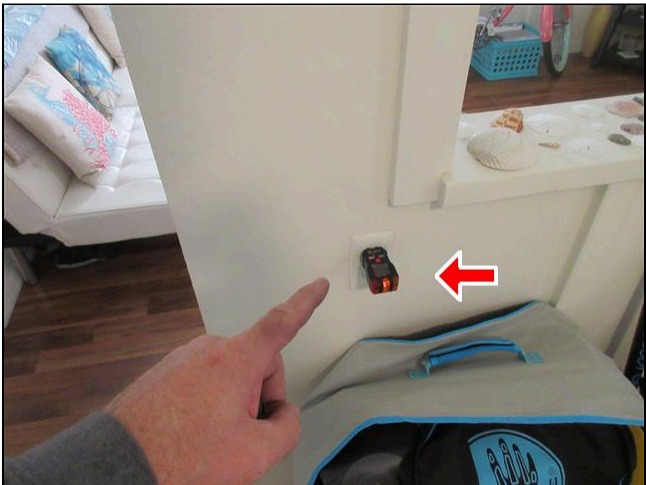
7.3 Item 9(Picture)

7.3 1732- Exposed romex wiring running along the floor near the rear entry door should be secured and encased in conduit. Several open slices are present in the water heater area. 1736- Three prong outlet at the rear of the home at the left side of the rear entry door is either not working properly or is ungrounded. Ceiling fan in the living room is missing a blade. Improperly wired attic light is present in the attic above the pull down stairs. Garage- Open splice observed above the electrical distribution panel. Rear storage area has an improperly wired and installed overhead light. Unit 8- At least one three prong outlet is wired incorrectly at the living room (hot/neutral reversed). Unit 5- At least one three prong outlet is wired incorrectly at the dining room (open ground). Recommend further evaluation from a licensed electrical contractor and repair as needed.

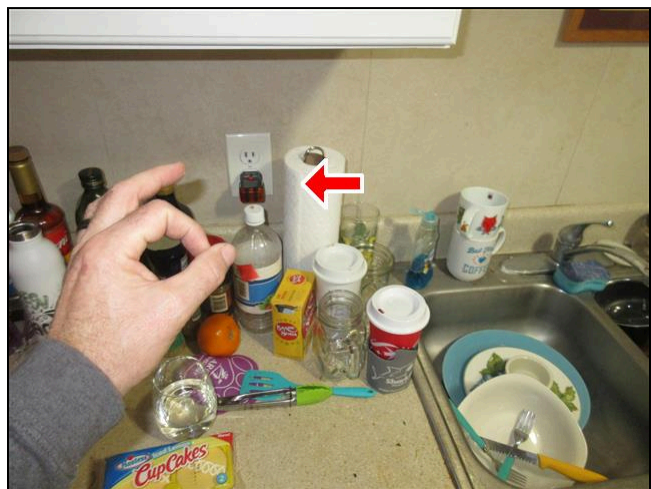
7.4 Item 1(Picture)

7.4 Unit 4- Three prong outlet near the kitchen sink did not work when tested. Unit 5- Three prong outlet near the kitchen sink is showing an open ground. Recommend further evaluation from a licensed electrical contractor and repair as needed.

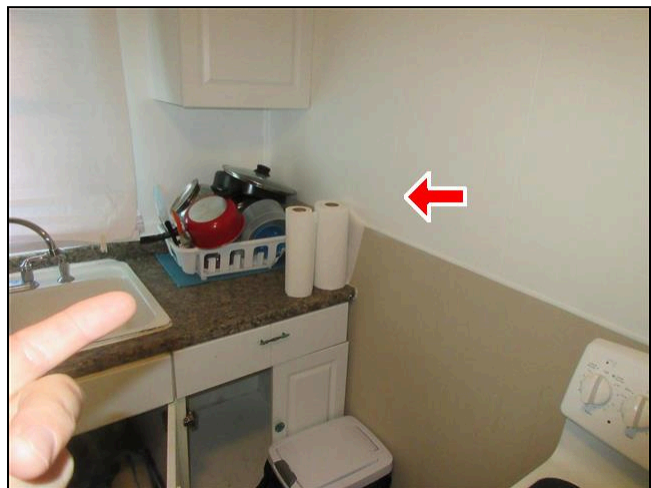
7.5 Item 1(Picture)

7.5 Few GFCI receptacles were present at the units. Recommend safety upgrade to GFCI receptacles at the exterior of units, garage, bathrooms, kitchens and any receptacle within 6' of a water source.

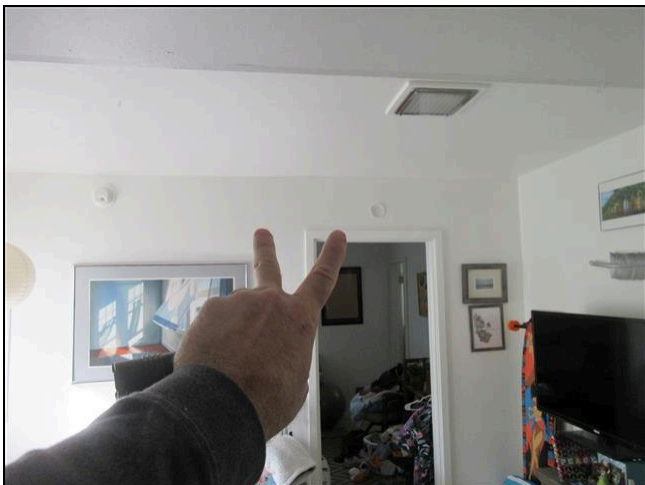
7.8 Item 1(Picture)

7.8 Multiple Smoke detectors missing or not working throughout the units. Recommend safety upgrade to include smoke detectors in each room of every unit.

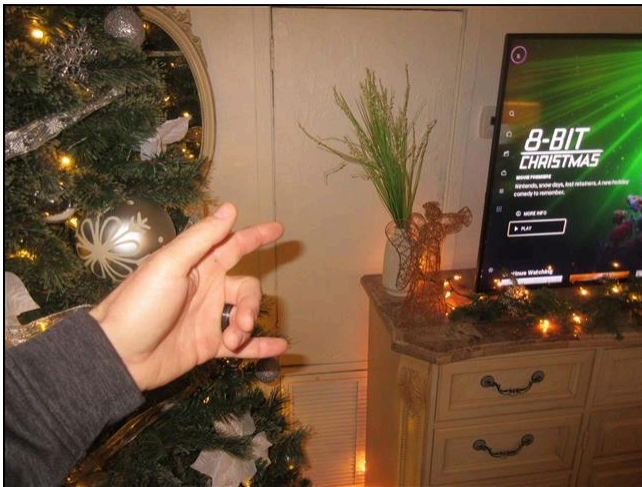
8.0 Item 1(Picture)

8.0 1732- The air handler closet is blocked with a large entertainment center. We were unable to observe this area. Garage- Wall mounted heater in the guest bath has a damaged or melted cover. This is considered unsafe and should be repaired or removed. 8 Plex- Older Wall Mounted Heating Elements were not inspected.

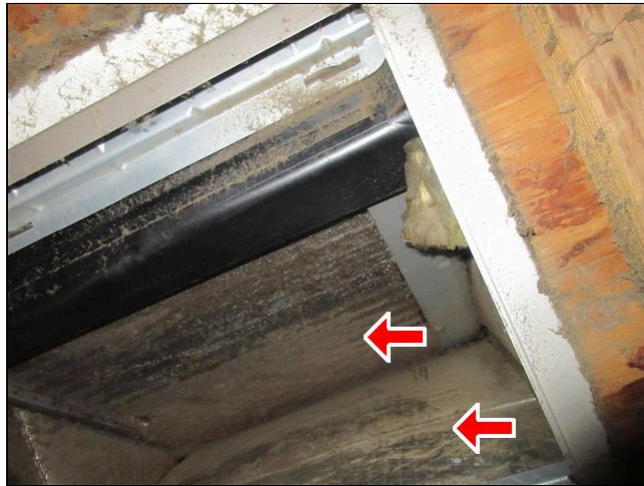
8.3 Item 1(Picture)

8.3 Garage- A-coil at the air handler is dirty and needs cleaning and servicing. Recommend service from a licensed HVAC Contractor.

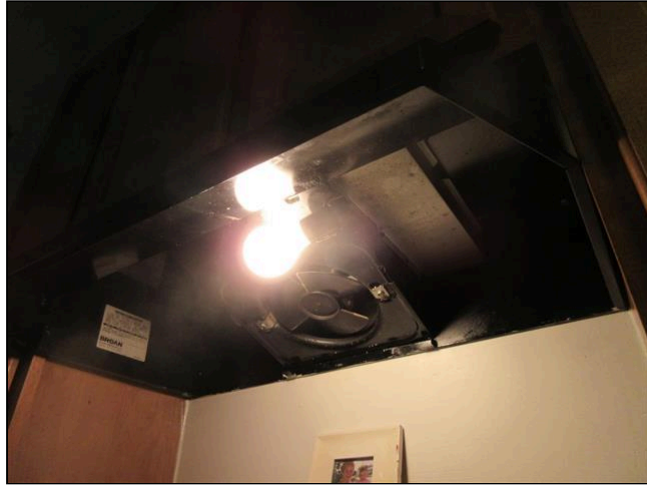
10.2 Item 1(Picture)

10.2 1732- Range hood is missing light covers and filters.

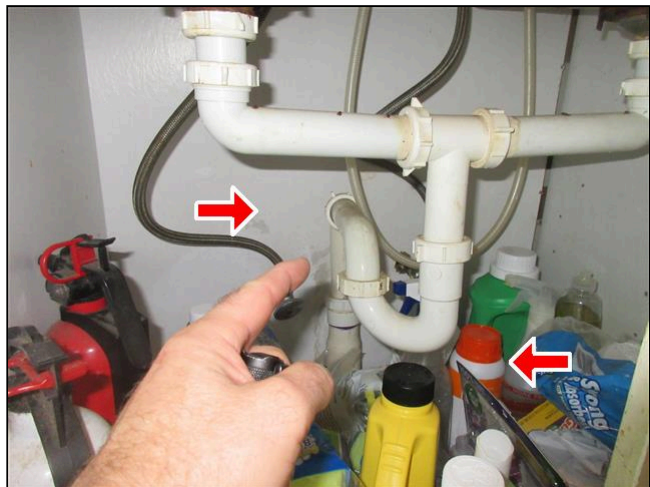
6.0 Item 1(Picture)

Garage- Plumbing waste line below the kitchen sink has an s-trap that should be converted to a p-trap.

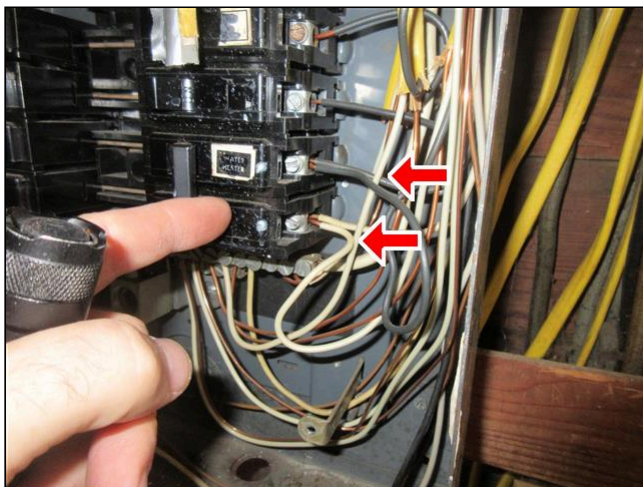
7.2 Item 1(Picture)

Garage- Several breakers have double wiring and/or over fused breakers. Recommend further evaluation from a licensed electrical contractor and repair as needed.

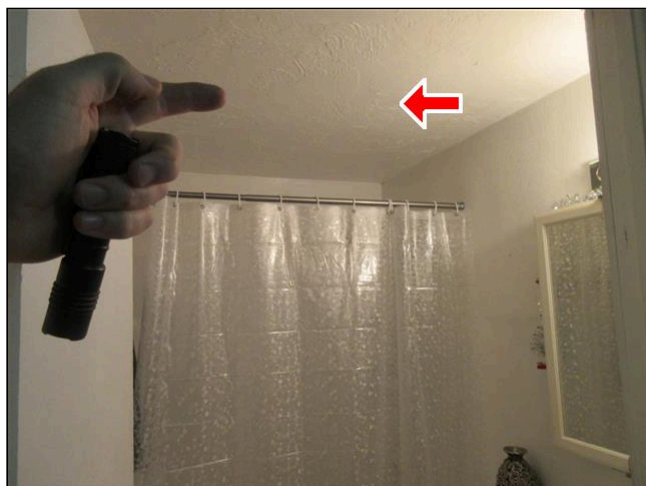
9.4 Item 1(Picture)

1736- Ventilation is not present at the hall bath. Recommend installing vent fan as needed.
