# **RV** Inspection Report

Ranger RV, LLC

Scott Mansito Cibolo. TX 78108

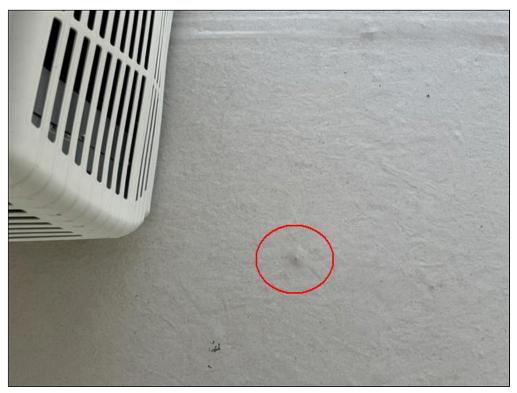
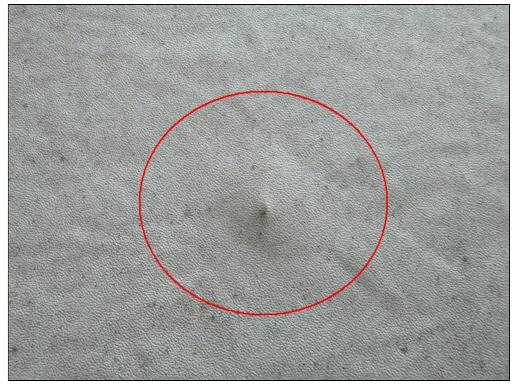
(3) There is an unidentifiable object sticking up under the roof membrane located on the curbside of the front AC unit. It is recommended that this be further evaluated by a qualified RV technician.

Object next to Front AC

Object Under Membrane

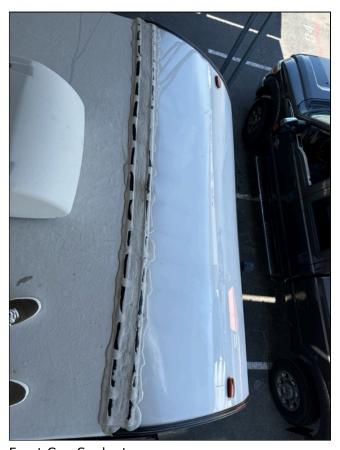
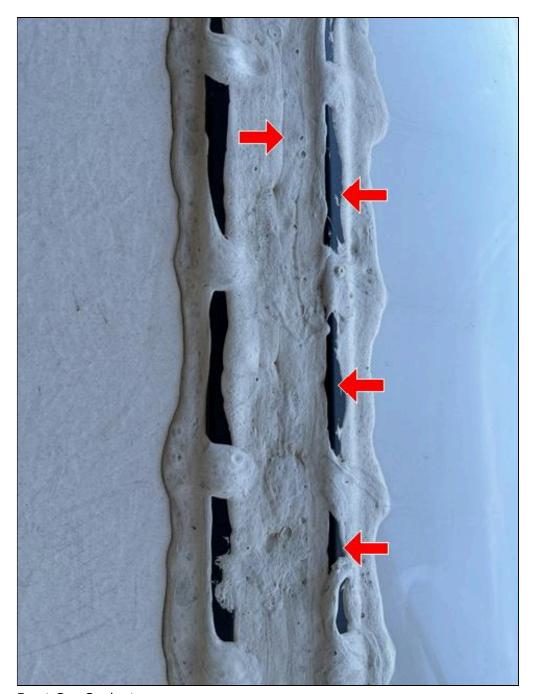
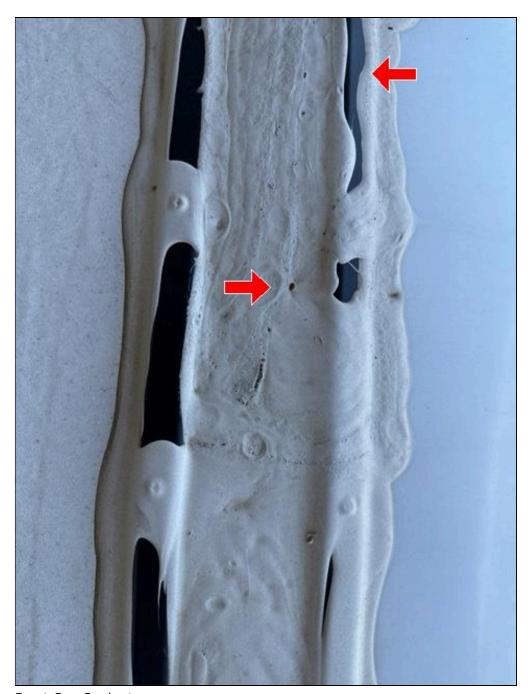
- (1) The front cap from side to side has multiple pin holes and cracks in the sealant. This could allow water intrusion. It is recommended that this be further evaluated by a qualified RV technician.
- (2) Front cap has a dent in the center front of the RV. The sealant has discoloration in this area and has a softer feel when pressing down on it. This area has multiple pin holes in the sealant. This could allow water intrusion. It is recommended that this be further evaluated by a qualified RV technician.

(1) The front cap from side to side has multiple pin holes and cracks in the sealant. This could allow water intrusion. It is recommended that this be further evaluated by a qualified RV technician.

Front Cap Sealant

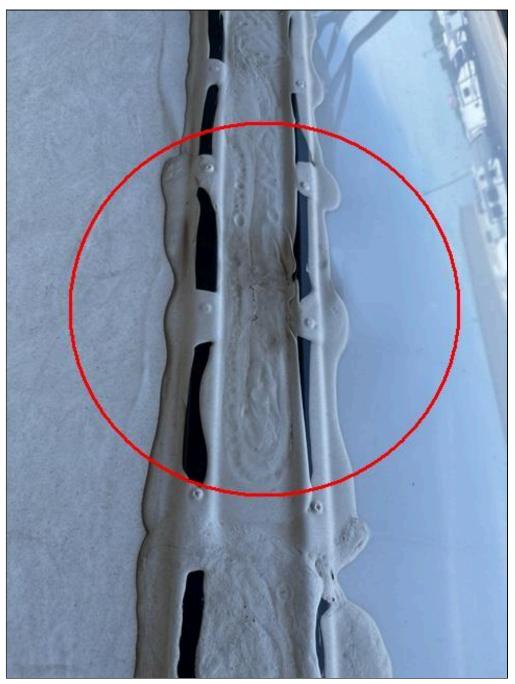
(2) Front cap has a dent in the center front of the RV. The sealant has discoloration in this area and has a softer feel when pressing down on it. This area has multiple pin holes in the sealant. This could allow water intrusion. It is recommended that this be further evaluated by a qualified RV technician.

Dent in Front Cap

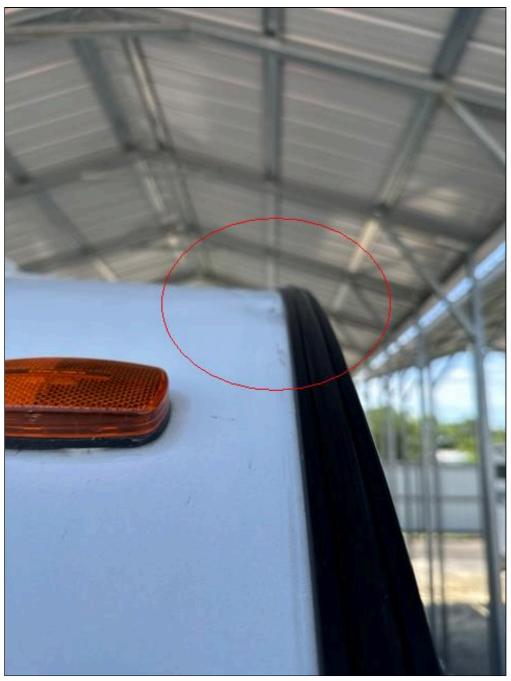
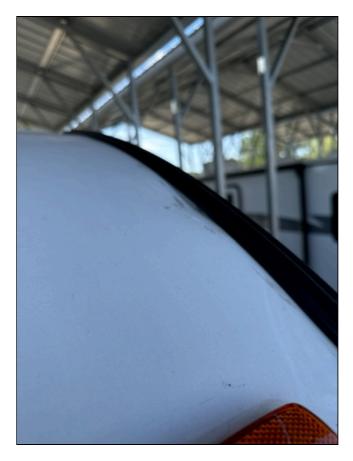
(2) Front cap has a dent on the top curve on the streetside. It is recommended that this be further evaluated by a qualified RV technician.

Front Cap Streetside

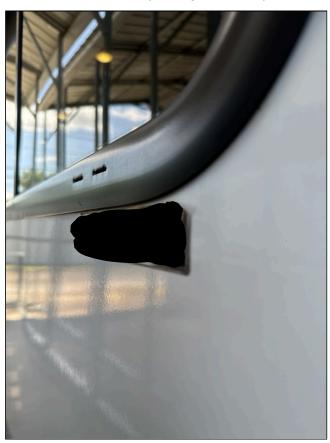
The '29VIEW' decal is pealing on the top on the decal located next to the entry door.

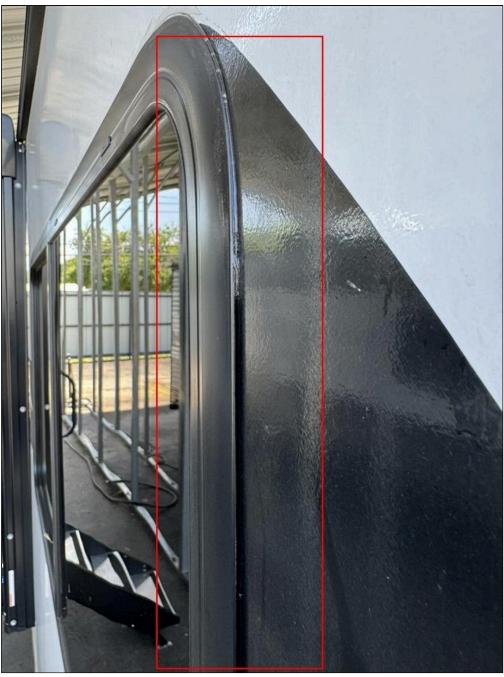
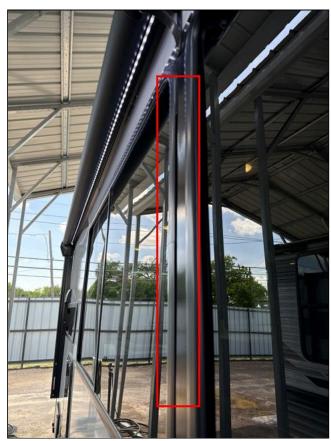
(1) All of the windows on the curbside sidewall have sealant on the top of the windows and going over the top edges. None of the windows have sealant going down the sides of the windows or on the bottom of the windows. This could allow water intrusion. It is recommended that this be further evaluated by a qualified RV technician.

Curbside Window

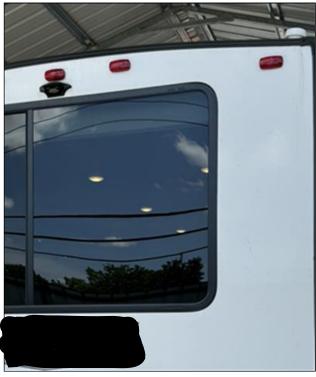
The rear window does not have sealant going down the sides of the window or on the bottom of the window. This could allow water intrusion. It is recommended that this be further evaluated by a qualified RV technician.

Rear Window

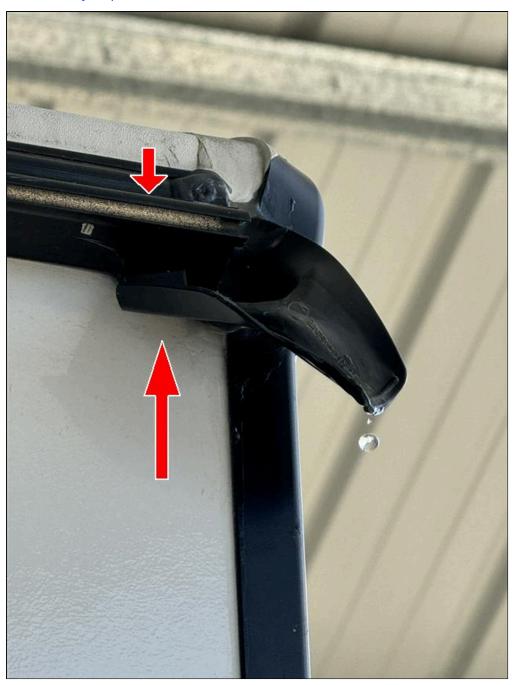
(2) The gutter downspout is broken on the streetside gutter. It is recommended that this be further evaluated by a qualified RV technician.

**Gutter Downspout**

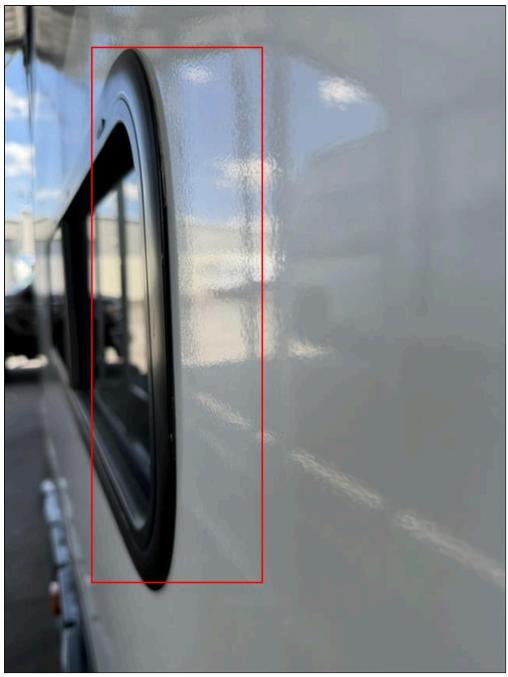
All of the windows on the streetside sidewall have sealant on the top of the windows and going over the top edges. None of the windows have sealant going down the sides of the windows or on the bottom of the windows. This could allow water intrusion. It is recommended that this be further evaluated by a qualified RV technician.

Streetside Window

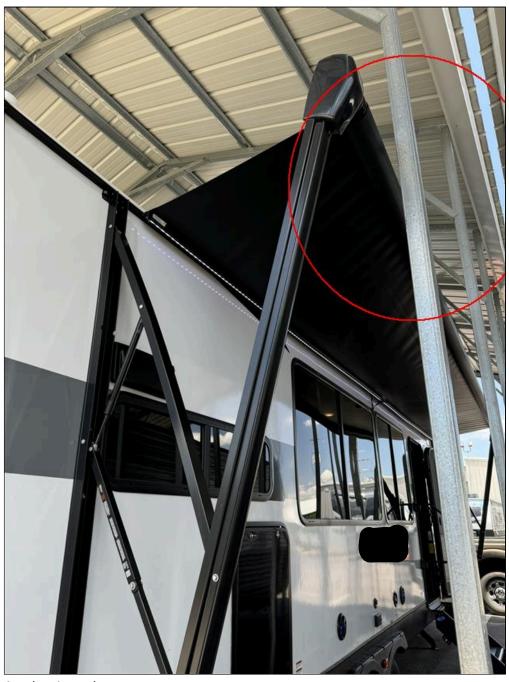
The awning fabric and total operation could not be evaluated because of the location of the awning and the building structure next to it. It is recommended that this be further evaluated by a qualified RV technician.

**Awning Location**

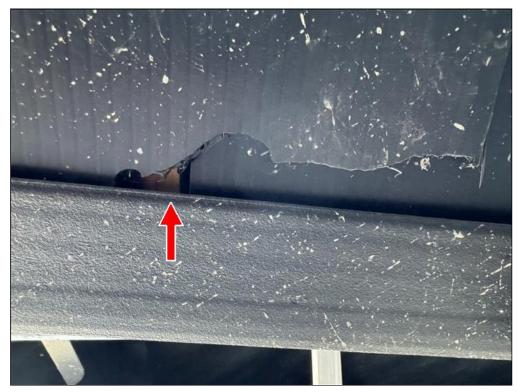
- (1) The underbelly is broken on the curbside located on the front panel with exposed wood. This could allow water intrusion. It is recommended that this be further evaluated by a qualified RV technician.

(1) The underbelly is broken on the curbside located on the front panel with exposed wood. This could allow water intrusion. It is recommended that this be further evaluated by a qualified RV technician.

**Underbelly Curbside Front**

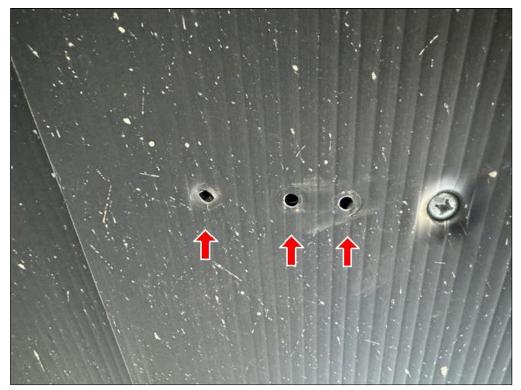
- (2) The underbelly has holes in it located on the streetside on the second panel. This could allow water intrusion. It is recommended that this be further evaluated by a qualified RV technician.

(2) The underbelly has holes in it located on the streetside on the second panel. This could allow water intrusion. It is recommended that this be further evaluated by a qualified RV technician.

Holes in Underbelly

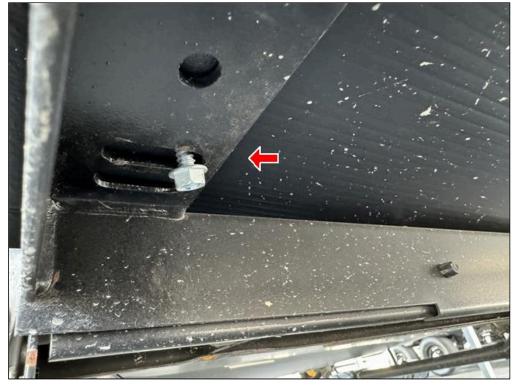
(3) There is a loose bolt on the mounting bracket for the front stabilizer on the curbside. It is recommended that this be further evaluated by a qualified RV technician.

Loose Nut

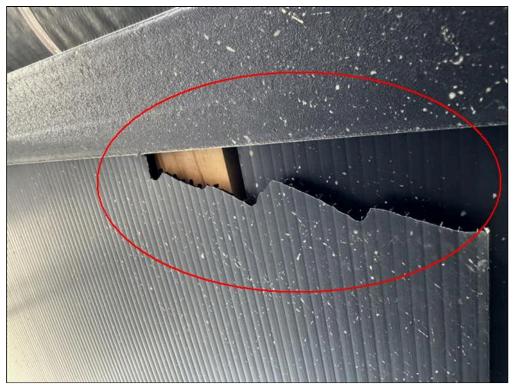
- (4) The underbelly is broken on the streetside on the front panel with exposed wood. This could allow water intrusion. It is recommended that this be further evaluated by a qualified RV technician.

(4) The underbelly is broken on the streetside on the front panel with exposed wood. This could allow water intrusion. It is recommended that this be further evaluated by a qualified RV technician.

Broken Underbelly Panel

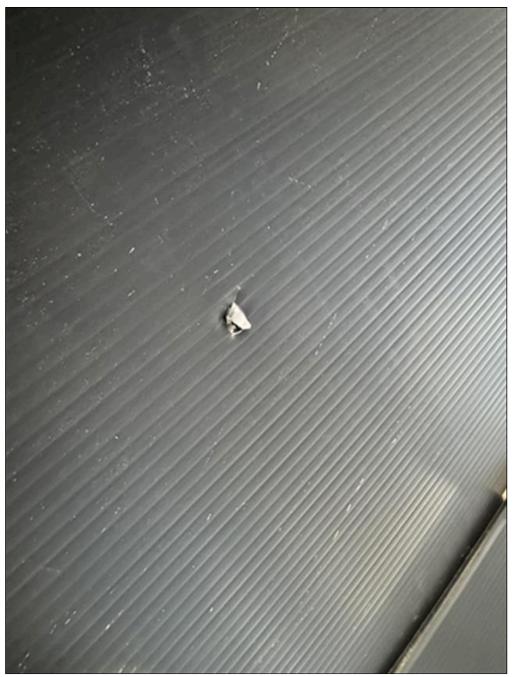
- (5) The underbelly has a puncture in it located on the middle on the third panel. This could allow water intrusion. It is recommended that this be further evaluated by a qualified RV technician.

(5) The underbelly has a puncture in it located on the middle on the third panel. This could allow water intrusion. It is recommended that this be further evaluated by a qualified RV technician.

Puncture in Underbelly

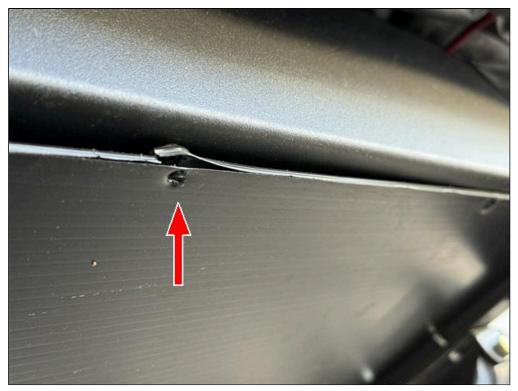
- (6) The underbelly is detached in several spots along the rear of the RV. This could allow water intrusion. It is recommended that this be further evaluated by a qualified RV technician.

(6) The underbelly is detached in several spots along the rear of the RV. This could allow water intrusion. It is recommended that this be further evaluated by a qualified RV technician.

**Detached Underbelly**

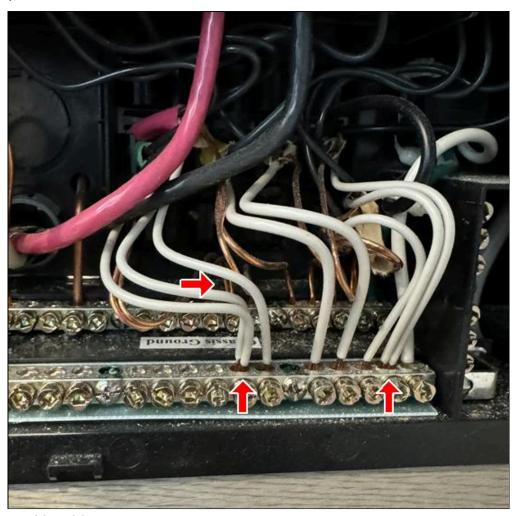
There are double wires connected on the bus bar. It is recommended that this be further evaluated by a qualified RV technician.

**Double Wiring**

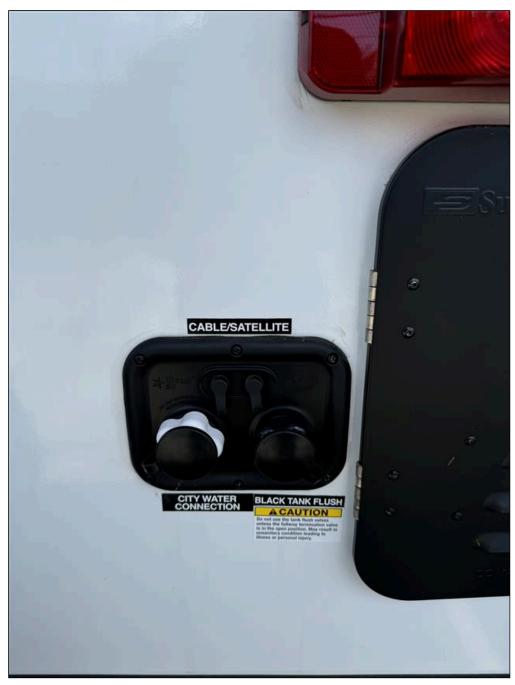
The city water connection could not be tested because the city water that was available was from a manual pump. The manual pump could not supply a constant flow of water to test the system. It is recommended that this be further evaluated by a qualified RV technician.

City Water Connection

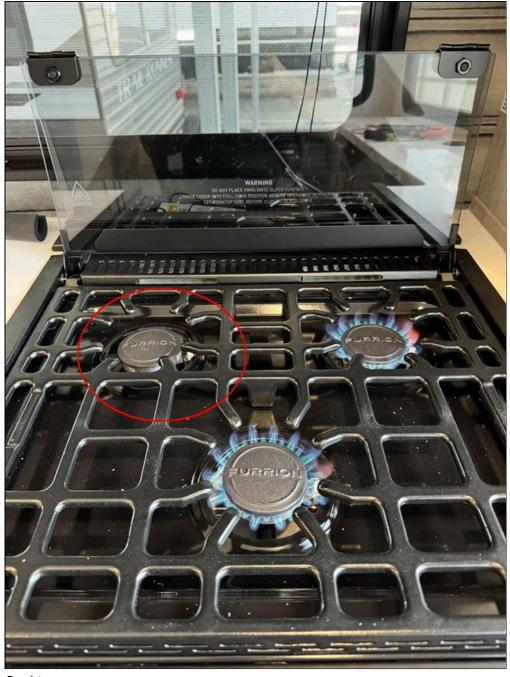
The back left burner on the cooktop would not ignite. This is a Life Safety Issue. It is recommended that this be further evaluated by a qualified RV technician prior to occupying the RV.

Cooktop

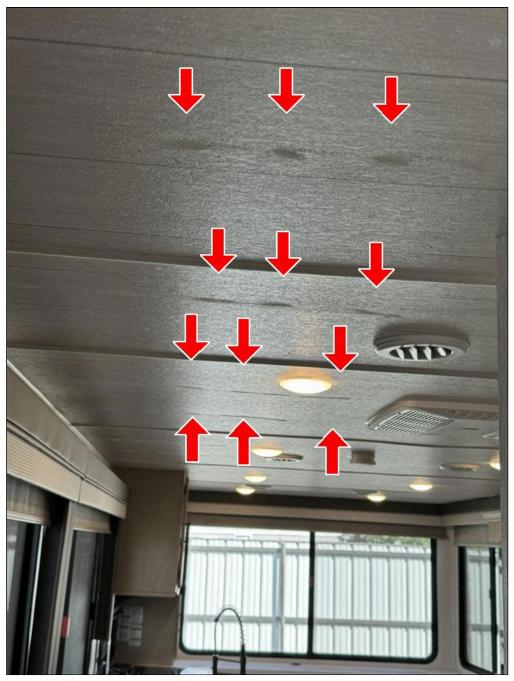
The ceiling has a tacky residue along almost every panel. It is recommended that this be further evaluated by a qualified RV technician.

Ceiling Panels

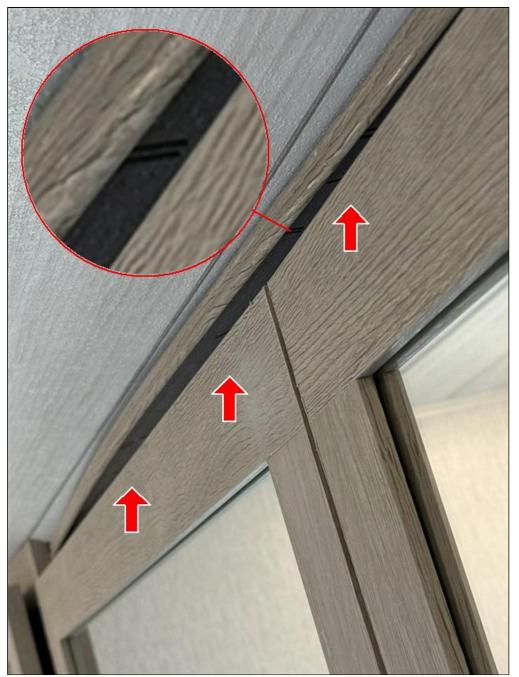
(1) The trim above the cabinets above the bed is separated from the wall with exposed staples showing. It is recommended that this be further evaluated by a qualified RV technician.

Trim Above the Bed

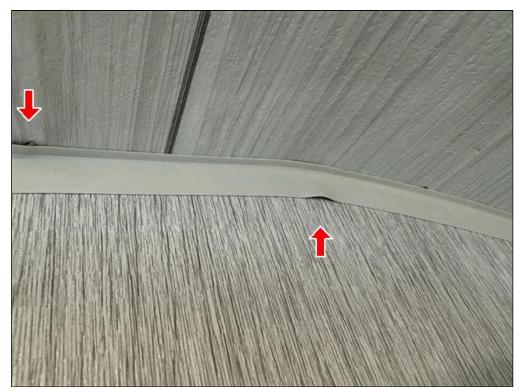
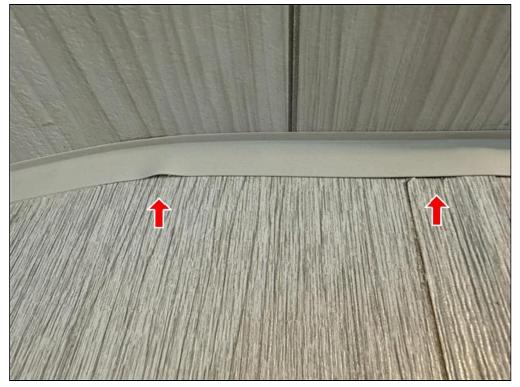
(2) There are multiple place in the bedroom ceiling trim that is separating from the wall. It is recommended that this be further evaluated by a qualified RV technician.

Streetside Bedroom Ceiling Trim

Curbside Bedroom Ceiling

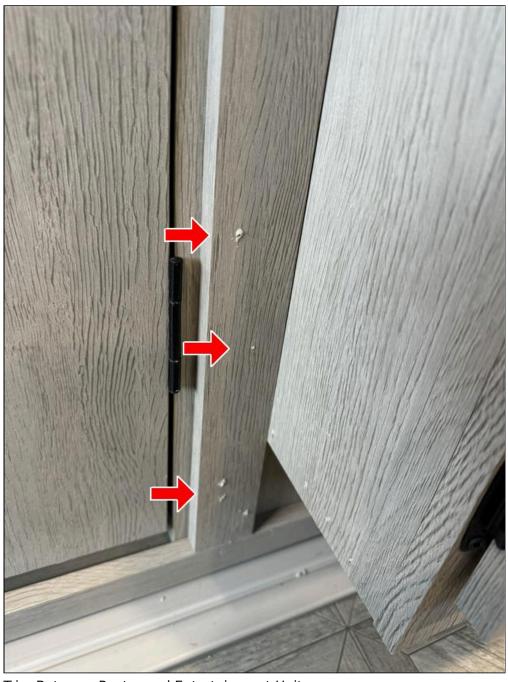
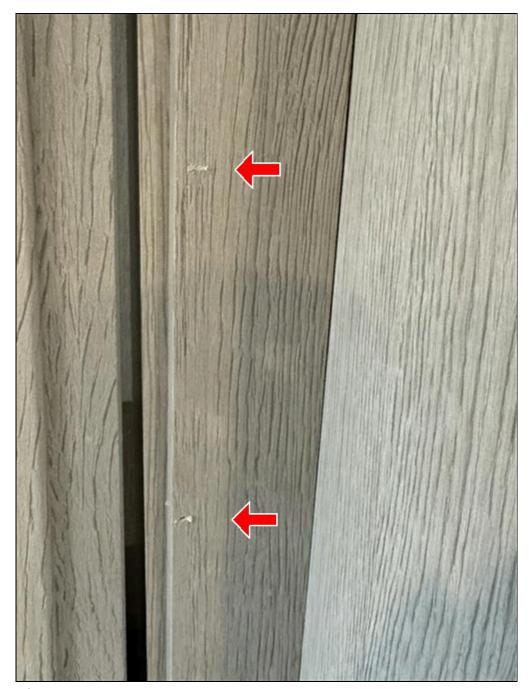
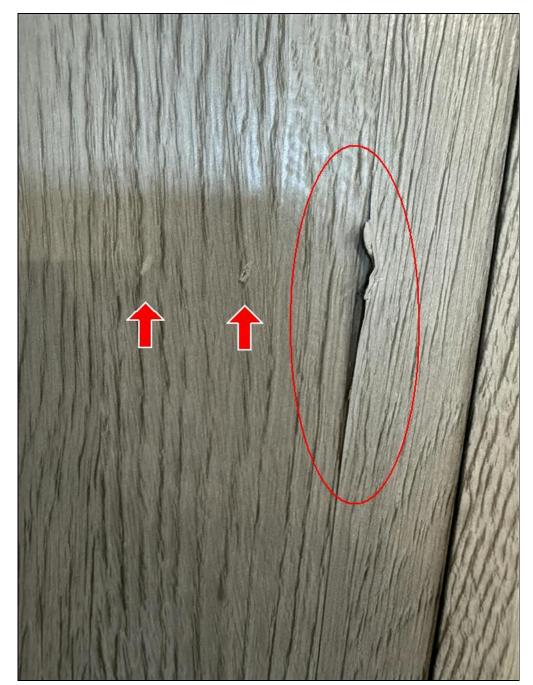
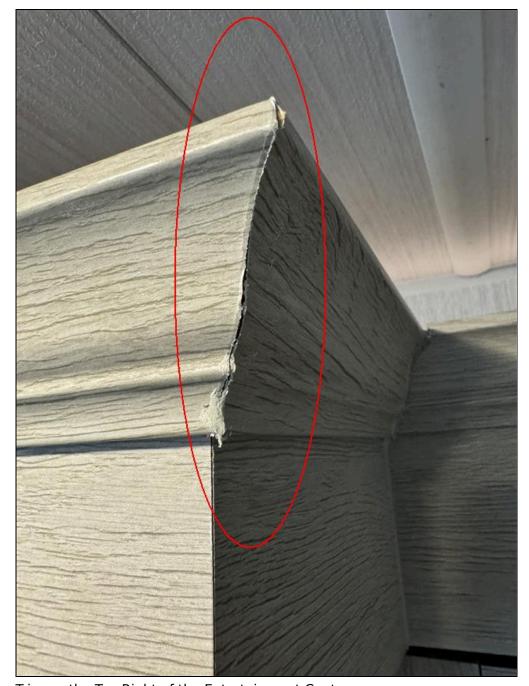
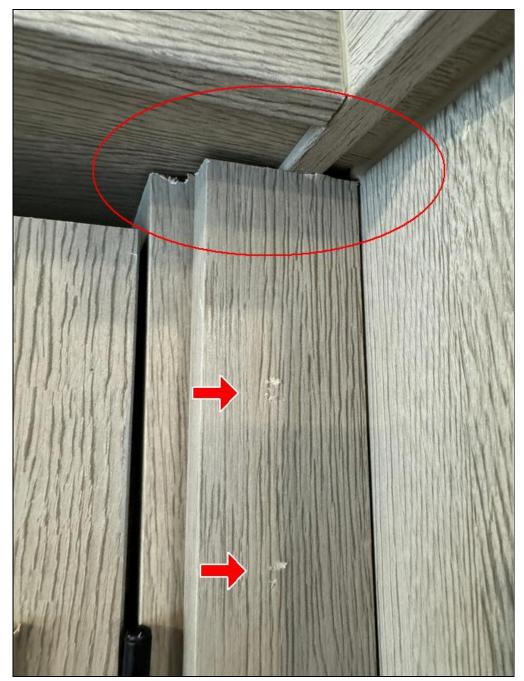
There are multiple locations through the RV that have scuff marks, separation or not aligned, pealing or damage trim. It is recommended that this be further evaluated by a qualified RV technician.

Trim Between Pantry and Entertainment Unit

Trim Next to Pantry

Trim on Left Side of Entertainment Center

Trim on the Top Right of the Entertainment Center

Trim by the Bedroom Door

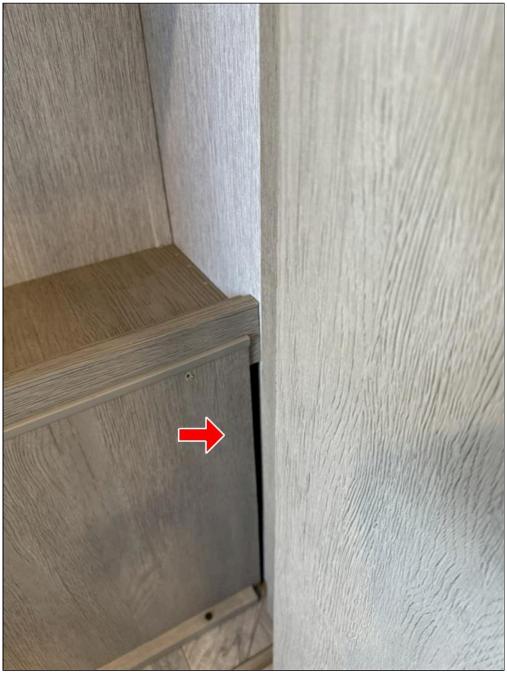
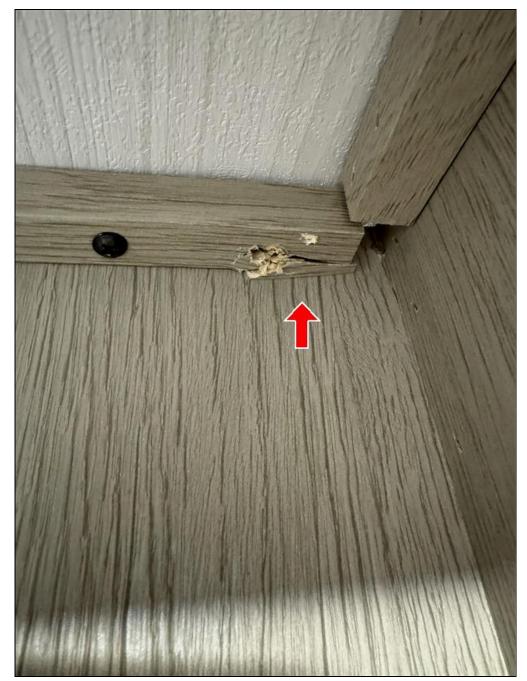
Some of the cabinets / pantry trim does not align correctly. It is recommended that this be further evaluated by a qualified RV technician.

Pantry

Bathroom Cabinet

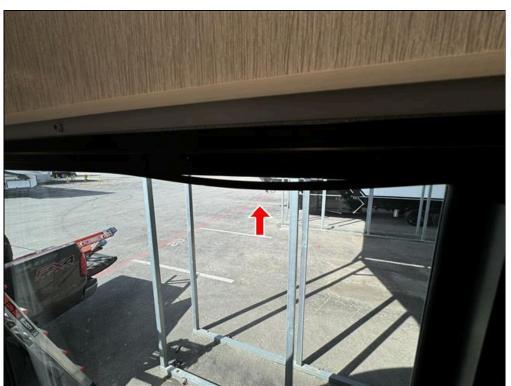
The bedroom curbside window inner seal / trim is separating from the seal. It is recommended that this be further evaluated by a qualified RV technician.

Curbside Bedroom Window
