Inside-Out Home Inspectors

Home Inspection Report

Toronto, ONTARIO

Inspected on Wed, Nov 25 2020 at 1:00 PM

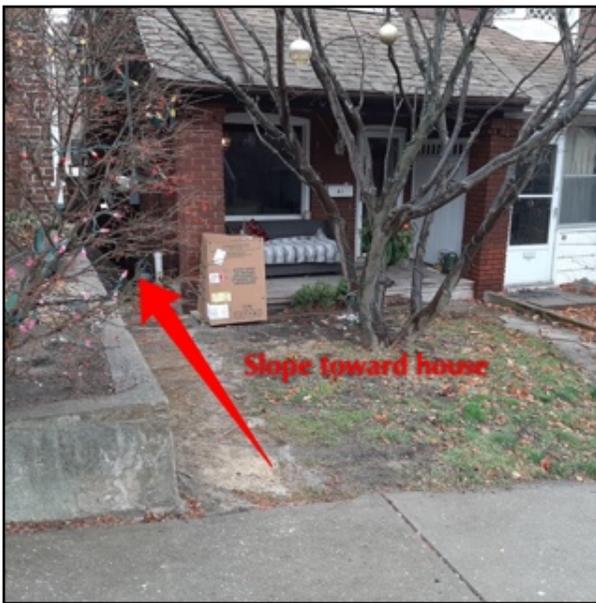
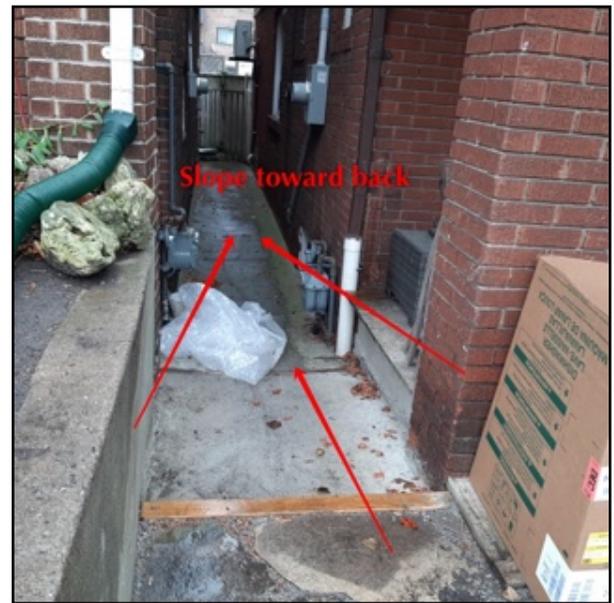
2) Comment 5: During the inspection of the flagstone walkway at the front west side of the house, it was determined that the slope was back towards the building. No water was observed at the time of this inspection. This condition can cause water, snow and ice to flow toward the house. It is recommended that the walkway grading slope toward the street. Correcting this condition will ensure for adequate runoff and would reduce the possibility of water infiltration into the foundation at the front of the house.

During the inspection of the flagstone walkway at the front west side of the house, it was determined that the slope was back towards the building. No water was observed at the time of this inspection. This condition can cause water, snow and ice to flow toward the house. It is recommended that the walkway grading slope toward the street. Correcting this condition will ensure for adequate runoff and would reduce the possibility of water infiltration into the foundation at the front of the house.

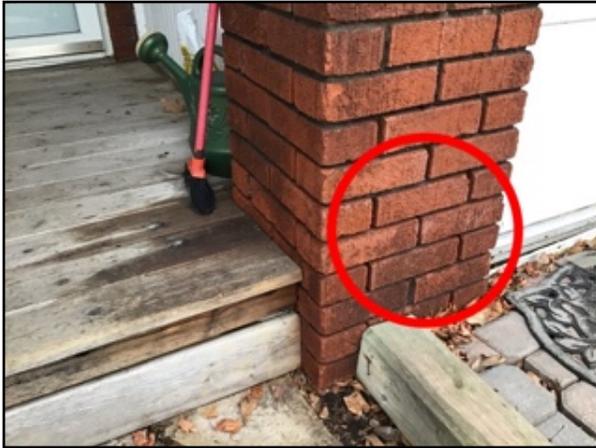
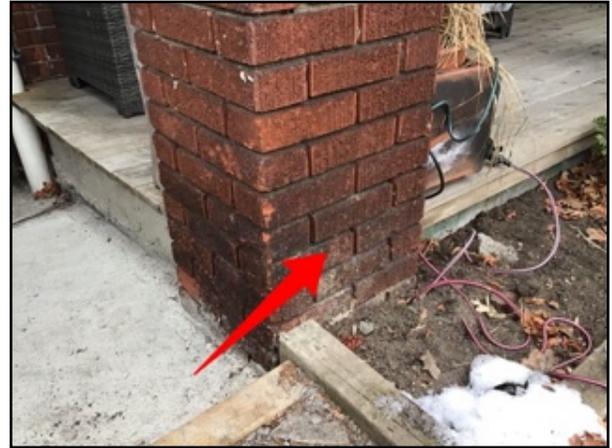
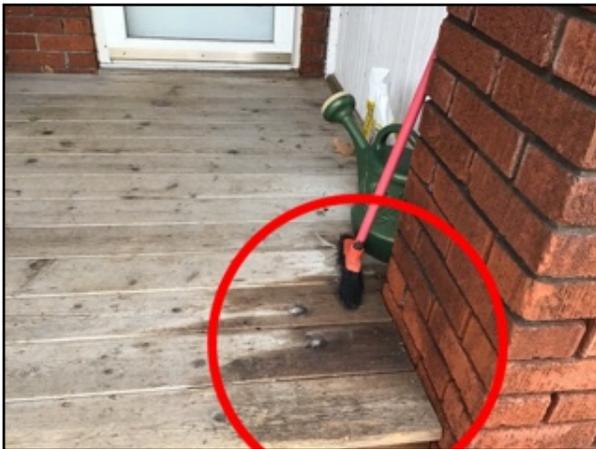
3) Comment 6: The brick columns on the front porch were observed to be in need of repair. No standing or running water was observed during inspection. Correction of this defect by repairing the tuck pointing in the lower area of the columns would correct this condition. Further investigation of the source of moisture is recommended.

The brick columns on the front porch were observed to be in need of repair. No standing or running water was observed during inspection. Correction of this defect by repairing the tuck pointing in the lower area of the columns would correct this condition. Further investigation of the source of moisture is recommended.

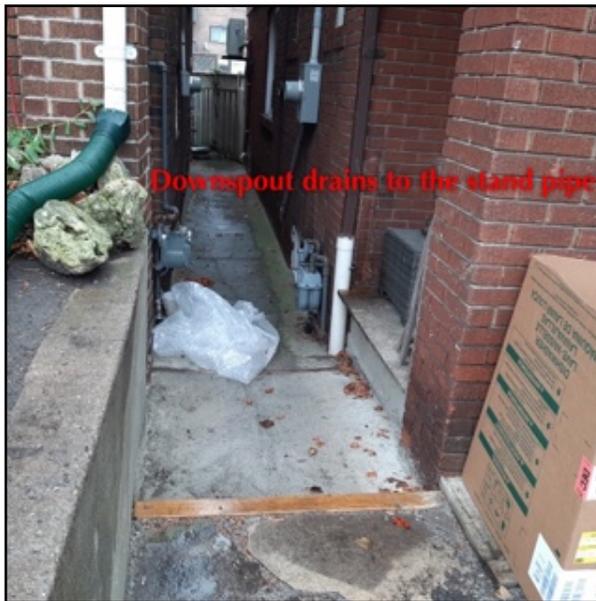
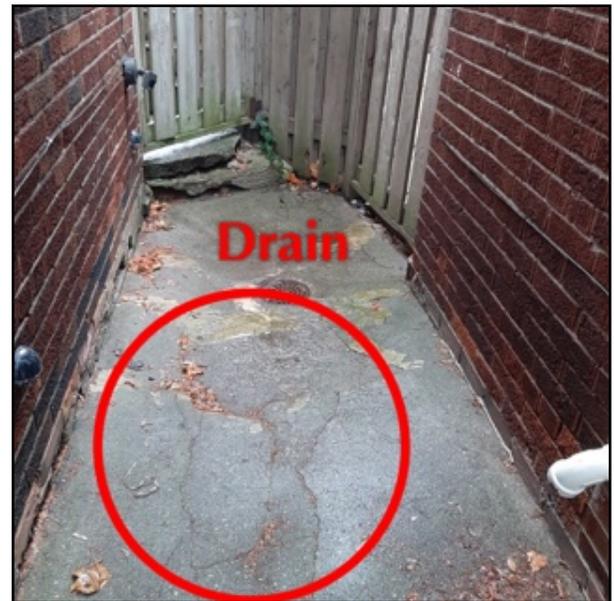
4) Comment 7: The walkway at the north side of the building shared with the home to the north, showed signs of cracking and settling. This defect can cause moisture intrusion into the foundation. Water backup in the area due to the drain clogging from leaves and debris can create an unsafe condition such as ice formation in winter. Correction of this condition with the installation of a French drain would be recommended. Creating a larger drainage surface would provide better flow of rain water and snowmelt ensuring correct operation of the system.

The walkway at the north side of the building shared with the home to the north, showed signs of cracking and settling. This defect can cause moisture intrusion into the foundation. Water backup in the area due to the drain clogging from leaves and debris can create an unsafe condition such as ice formation in winter. Correction of this condition with the installation of a French drain would be recommended. Creating a larger drainage surface would provide better flow of rain water and snowmelt ensuring correct operation of the system.

A French drain with patio pavers provides good drainage and a more stable surface for the sidewalk.

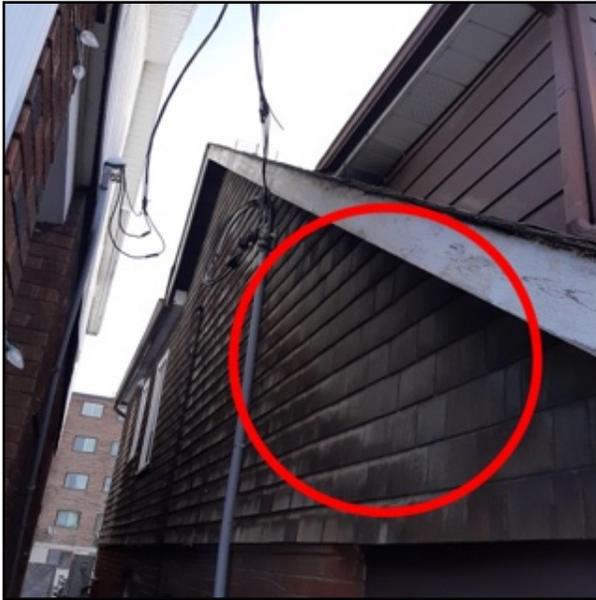
Figure 10-1

5) Comment 10: The front of the house has aluminum siding with no defects observed. The back (east facing second story wall) aluminum siding paint covering appeared weathered with no signs of any missing pieces or cracks. This is a minor defect. The north side of the home has wood shingles that are showing some weathering and are in need of maintenance. This minor defect requires correction. Paint or stain and repair of loose or damaged shingles is required.

The front of the house has aluminum siding with no defects observed. The back (east facing second story wall) aluminum siding paint covering appeared weathered with no signs of any missing pieces or cracks. This is a minor defect. The north side of the home has wood shingles that are showing some weathering and are in need of maintenance. This minor defect requires correction. Paint or stain and repair of loose or damaged shingles is required.

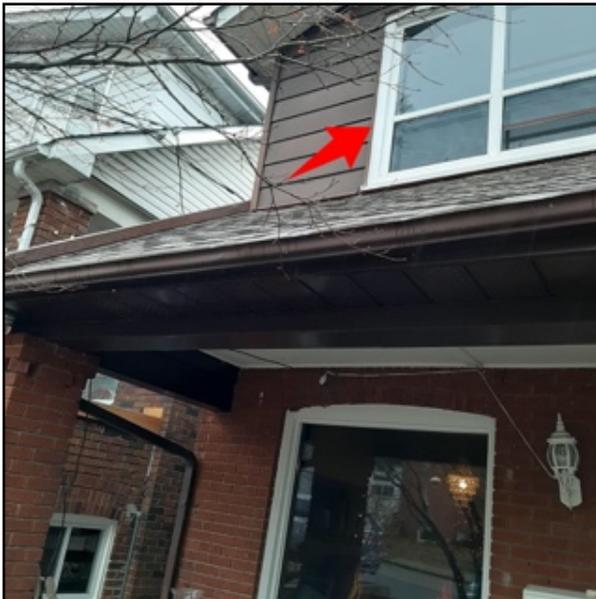
Figure 11-1

6) Comment 11: The exterior of the windows was found not to have any current defects. As described in the "interior" section of this report, a recommendation to replace the single hung aluminum windows with a more efficient window system was noted. Modern high-efficiency windows, trim and caulking provide superior performance by reducing heat loss, maintaining cooling during summer months and reducing air and moisture penetration into the home. It is recommended that an energy audit be performed by a licensed provider.

The exterior of the windows was found not to have any current defects. As described in the "interior" section of this report, a recommendation to replace the single hung aluminum windows with a more efficient window system was noted. Modern high-efficiency windows, trim and caulking provide superior performance by reducing heat loss, maintaining cooling during summer months and reducing air and moisture penetration into the home. It is recommended that an energy audit be performed by a licensed provider.

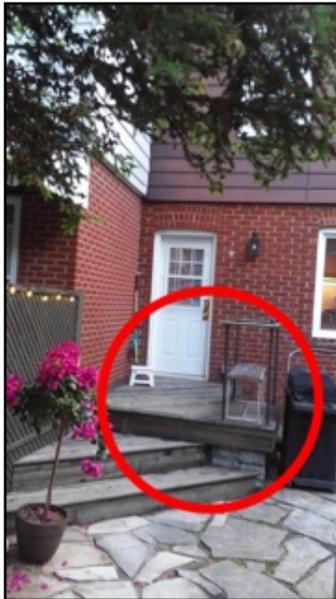
Figure 12-1

7) Comment 12: A guard rail and railing on the rear deck and patio were not installed. This is an unsafe condition. Missing these components is a significant risk for injury in day-to-day use due to falls. Installation of the components noted will ensure proper function of the system.

A guard rail and railing on the rear deck and patio were not installed. This is an unsafe condition. Missing these components is a significant risk for injury in day-to-day use due to falls. Installation of the components noted will ensure proper function of the system.

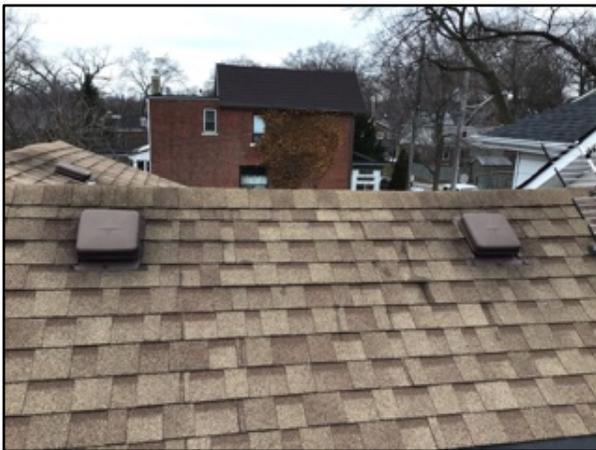
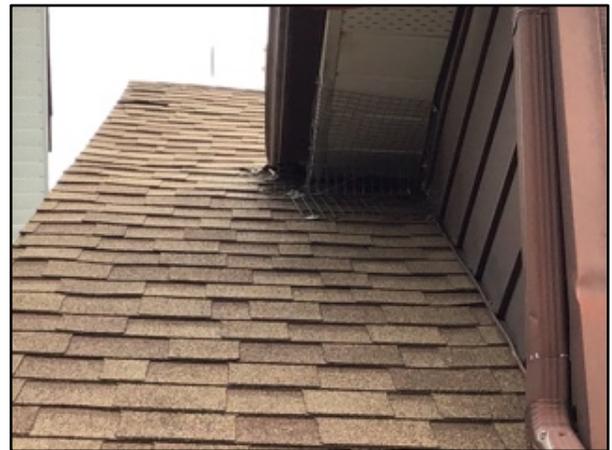
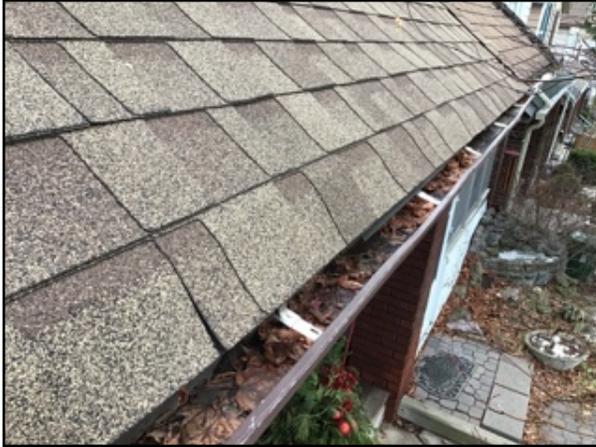
The front west facing gable roofing was observed to be functioning normally. Previous shingles were completely removed and a new single layer was applied. The average lifespan of a three tab shingle roof is 20 to 25 years. As the majority of the building faces west, sun damage may advance the rate of wear.

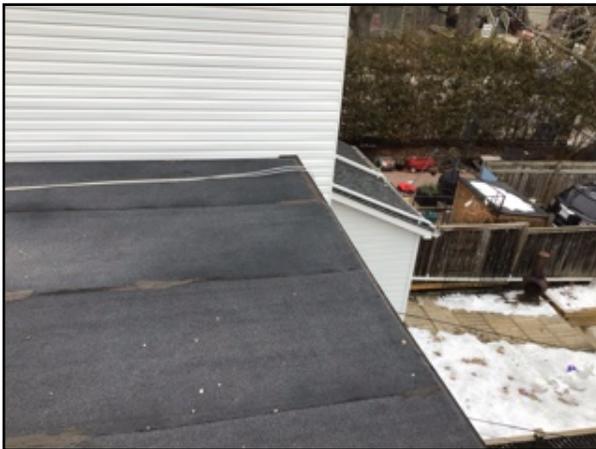
Figure 14-1

The flat portion of the roof was inspected. It is composed of a modified bitumen roofing material, which appeared to be correctly installed and in good repair. The life expectancy of a flat roof is up to 20 years.

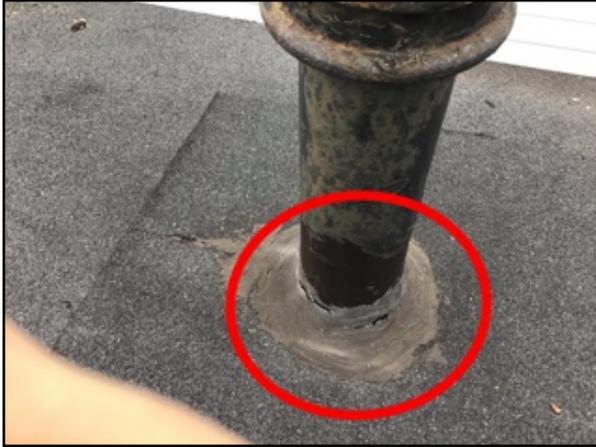
Figure 15-1

8) Comment 15: The plumbing vent boot was observed to have loose and cracked caulking. This seal is required to prevent water leakage through the roof and into the building. Installation of additional flashing, caulking or boot is recommended.

The plumbing vent boot was observed to have loose and cracked caulking. This seal is required to prevent water leakage through the roof and into the building. Installation of additional flashing, caulking or boot is recommended.

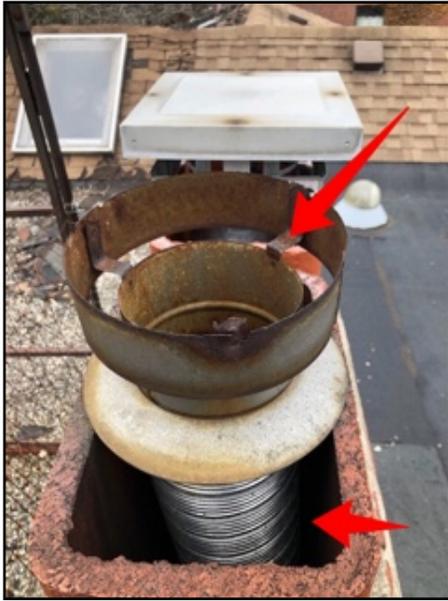
Figure 16-1

9) Comment 16: The chimney cap and the metal seal surrounding the chimney liner are missing. This defect will cause rain to enter the chimney. The area is also not protected from pest intrusion. Installation of an aluminum cap and cover over the chimney flue with high temperature silicone connections to the aluminum vent liner is recommended.

The chimney cap and the metal seal surrounding the chimney liner are missing. This defect will cause rain to enter the chimney. The area is also not protected from pest intrusion. Installation of an aluminum cap and cover over the chimney flue with high temperature silicone connections to the aluminum vent liner is recommended.

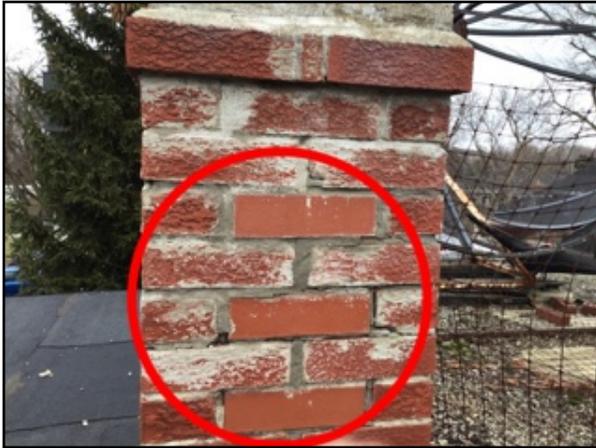
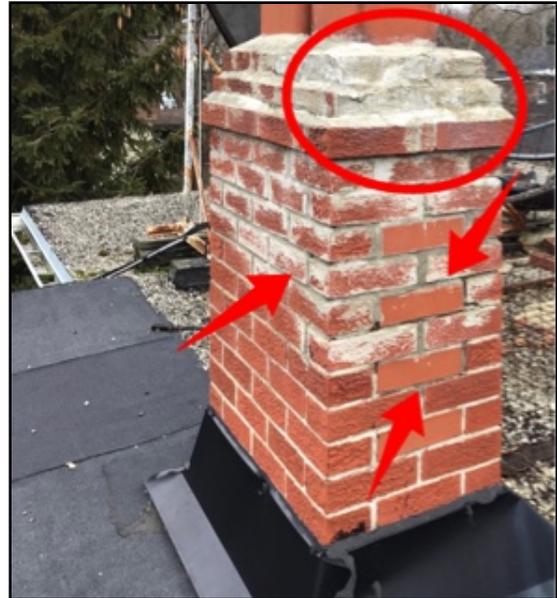
10) Comment 18: Loose brick and substandard tuck pointing on the chimney was observed. Loose bricks and insufficient chimney tuck pointing can cause leaks and moisture penetration into the building through the chimney stack. It's recommended that a professional mason assess the chimney for structural soundness and make the required repairs.

Loose brick and substandard tuck pointing on the chimney was observed. Loose bricks and insufficient chimney tuck pointing can cause leaks and moisture penetration into the building through the chimney stack. It's recommended that a professional mason assess the chimney for structural soundness and make the required repairs.

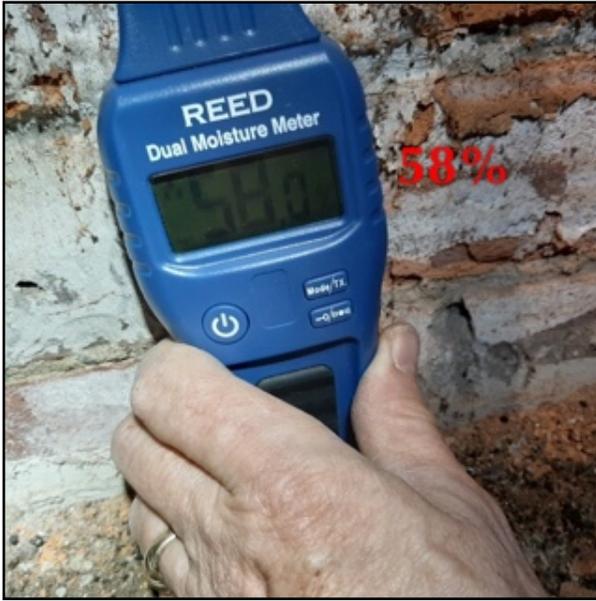
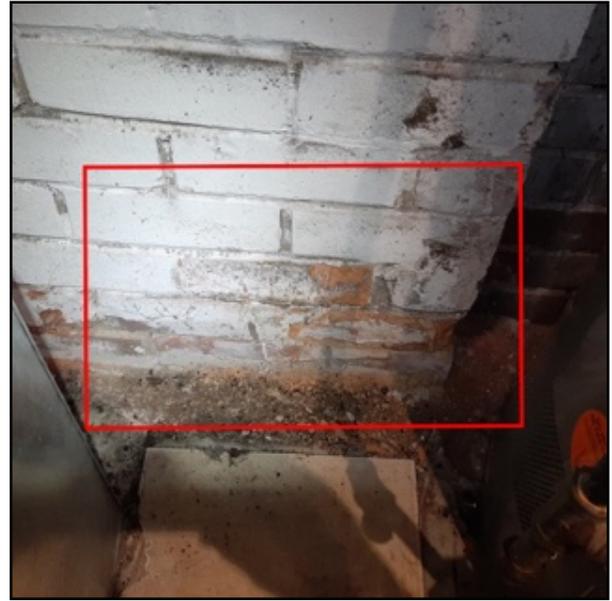
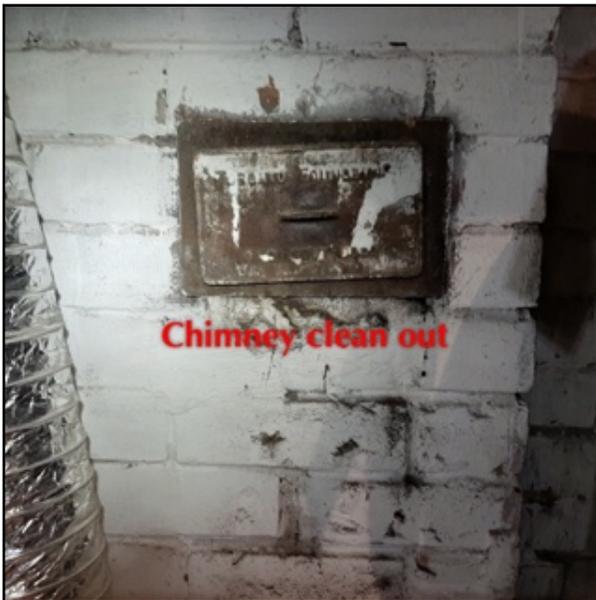
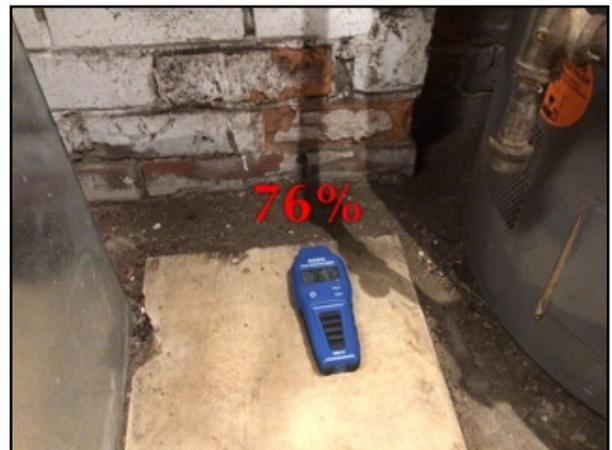
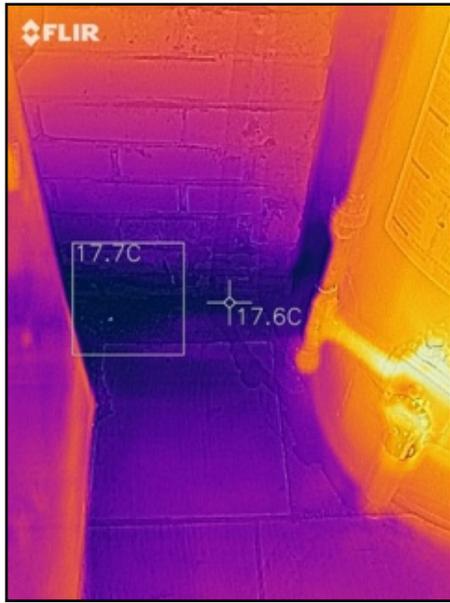
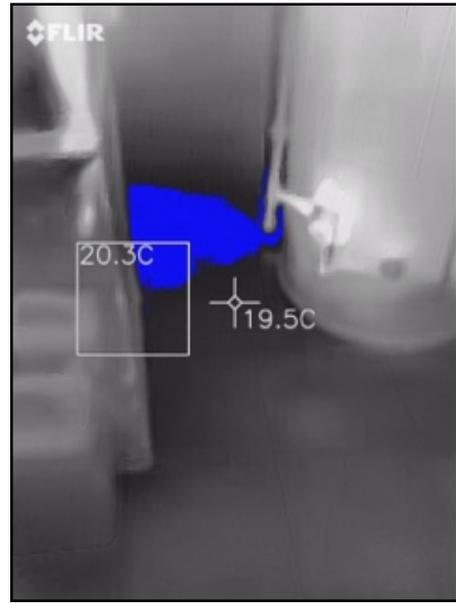
11) Comment 19: Moisture and efflorescence of the chimney brick base was observed. A moisture reading of 58% was recorded at the base of the chimney near the basement floor. Thermographic imaging showed a change in temperature at the same location identified via moisture meter. A high moisture reading is anything above 20% where a normal reading is +/- 1.5 %. This defect may be related to the missing chimney cap or insufficient tuck pointing.

Moisture and efflorescence of the chimney brick base was observed. A moisture reading of 58% was recorded at the base of the chimney near the basement floor. Thermographic imaging showed a change in temperature at the same location identified via moisture meter. A high moisture reading is anything above 20% where a normal reading is +/- 1.5 %. This defect may be related to the missing chimney cap or insufficient tuck pointing.

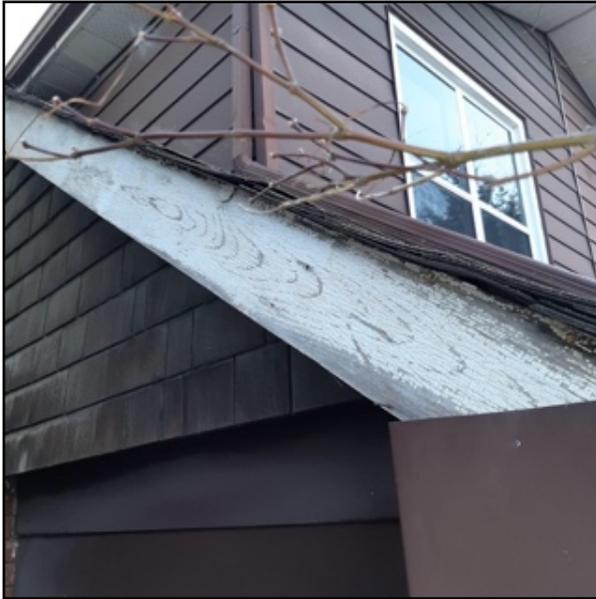
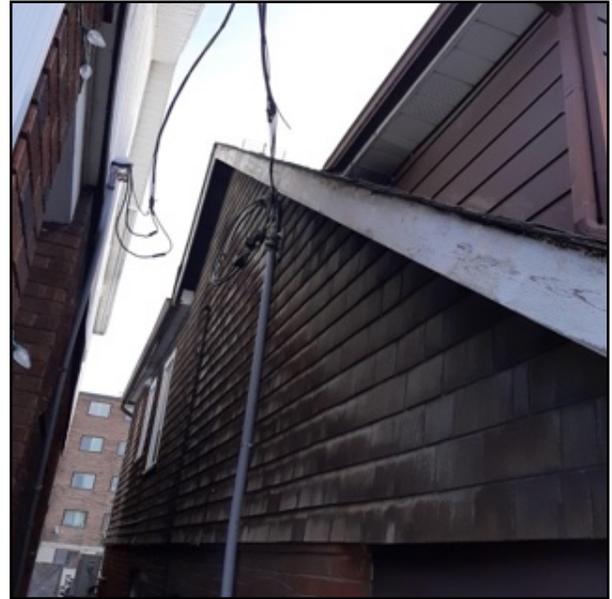
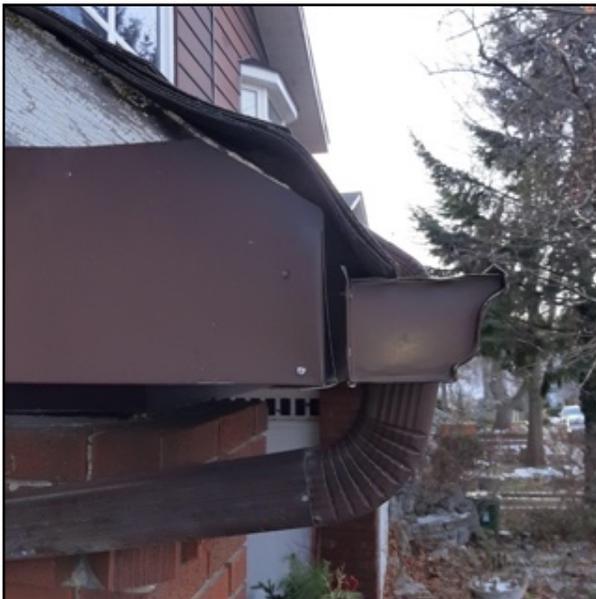
12) Comment 20: Peeling paint on the north gable was observed. This minor defect could allow moisture and insect damage to occur. Priming and painting the exposed wood is required. This area should be covered with aluminum to provide a long term solution.

Peeling paint on the north gable was observed. This minor defect could allow moisture and insect damage to occur. Priming and painting the exposed wood is required. This area should be covered with aluminum to provide a long term solution.

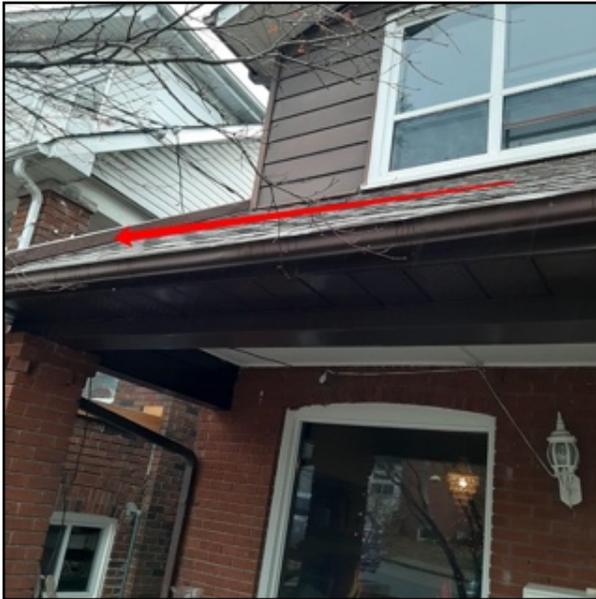
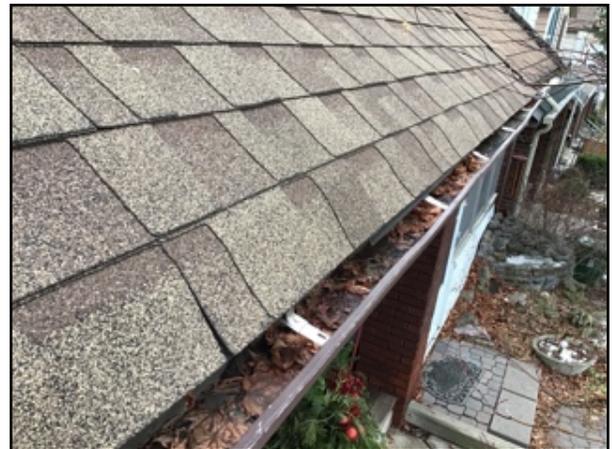
13) Comment 21: The front gutter was incorrectly sloped away from downspout. This condition would allow water to pool and debris to collect. The gutter should slope toward the downspout to allow water to drain.

The front gutter was incorrectly sloped away from downspout. This condition would allow water to pool and debris to collect. The gutter should slope toward the downspout to allow water to drain.

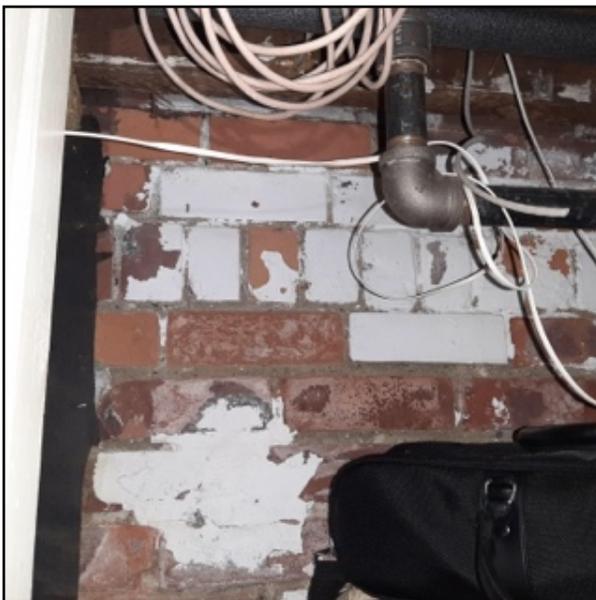
Figure 22-1

14) Comment 22: Investigation of the foundation walls was limited to an area of the west wall near the water metre. The area was defect free. This small area did not provide enough access to make accurate observations on the integrity of the entire foundation.

Investigation of the foundation walls was limited to an area of the west wall near the water metre. The area was defect free. This small area did not provide enough access to make accurate observations on the integrity of the entire foundation.

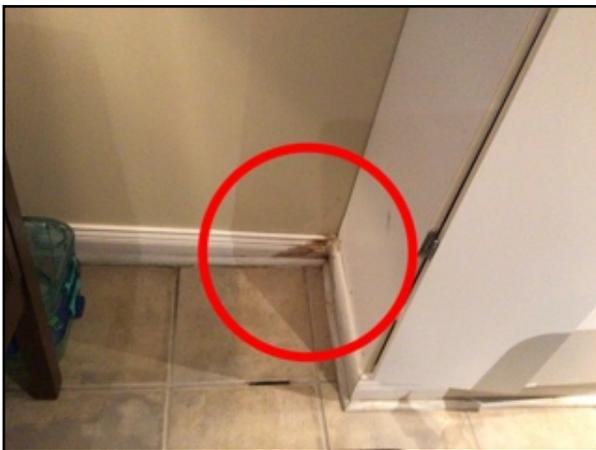
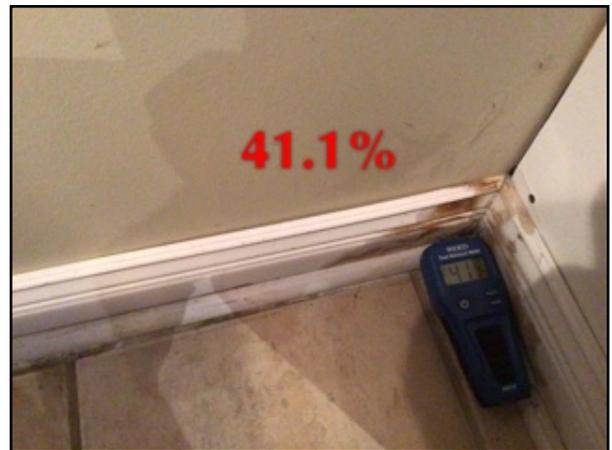
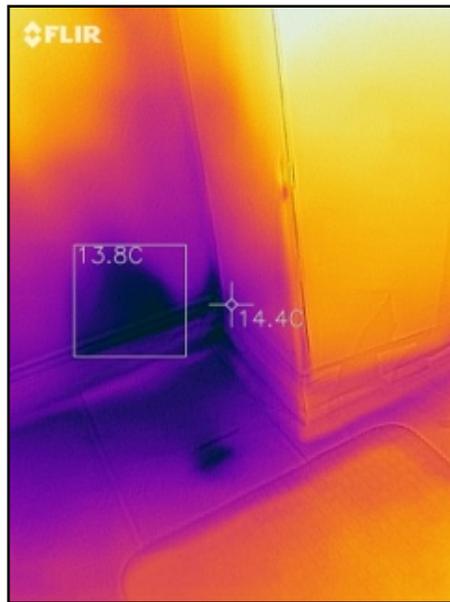
15) Comment 23: Evidence of moisture on the trim in the back of the basement beside the laundry was observed. A moisture reading 41.1% was observed at the baseboard. Thermographic imaging shows activity behind the drywall, however no satining on the drywall was observed. This area is directly in front of the soil down pipe and below the exterior sidewalk grouting connection at the wall. Mold and mildew development can be a major safety concern. Repair of the seal on the plumbing stack at the roof may remove this as a source of moisture. Further investigation of the seal between the house and the sidewalk to the north is recommend.

Evidence of moisture on the trim in the back of the basement beside the laundry was observed. A moisture reading 41.1% was observed at the baseboard. Thermographic imaging shows activity behind the drywall, however no satining on the drywall was observed. This area is directly in front of the soil down pipe and below the exterior sidewalk grouting connection at the wall. Mold and mildew development can be a major safety concern. Repair of the seal on the plumbing stack at the roof may remove this as a source of moisture. Further investigation of the seal between the house and the sidewalk to the north is recommend.

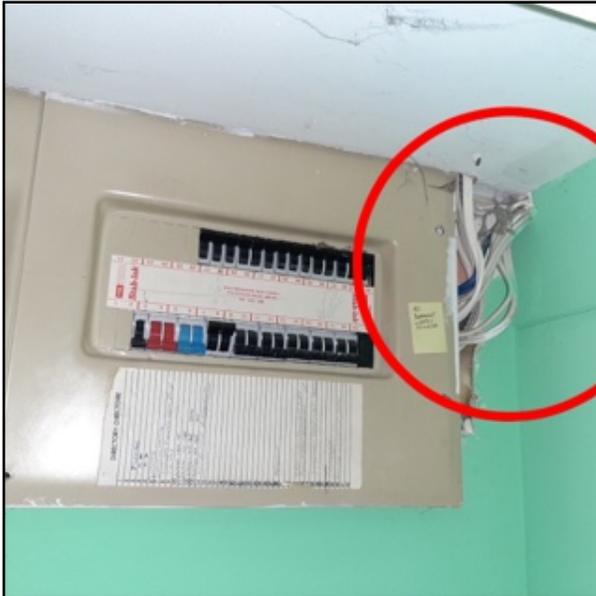
Figure 26-1

18) Comment 26: The exposed wires to the right of the service panel are a minor defect and a potential hazard for electrical shock. It is recommended that a closure over this area be installed to prevent possible electrical shock.

The exposed wires to the right of the service panel are a minor defect and a potential hazard for electrical shock. It is recommended that a closure over this area be installed to prevent possible electrical shock.

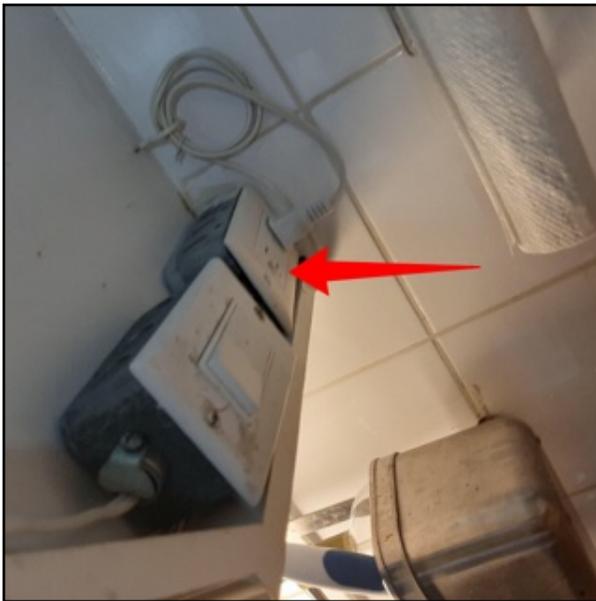
Figure 28-1

19) Comment 28: GFCI protected outlets were present in bathrooms but not in the kitchen. This is a major defect. GFCI's should be installed where water is within 5 feet of the outlet. A licensed electrician should assess this and any other outlets in the house for safety and repair to return them to a safe state of operation.

GFCI protected outlets were present in bathrooms but not in the kitchen. This is a major defect. GFCI's should be installed where water is within 5 feet of the outlet. A licensed electrician should assess this and any other outlets in the house for safety and repair to return them to a safe state of operation.

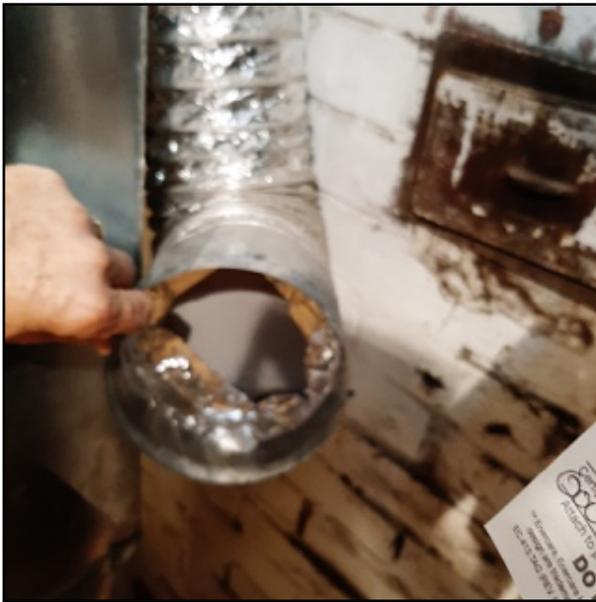
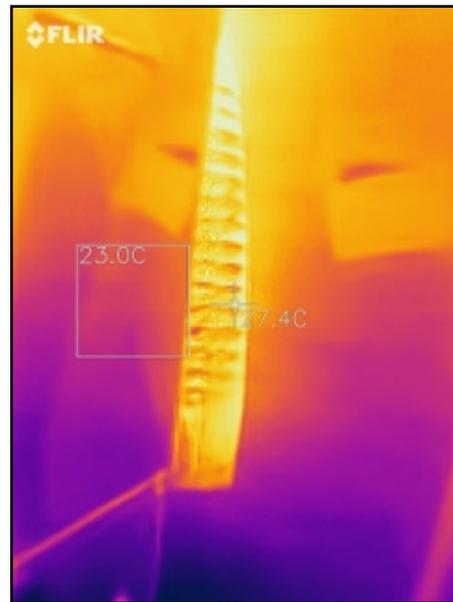
20) Comment 33: During the inspection of the furnace, an unused exhaust vent from the furnace to the chimney was identified. It is not needed as the furnace is vented directly outside versus up the chimney. Correction of this condition is required. Thermographic imaging showed heated air present in the duct. Piping removal and installation of a covering plate is recommend. This service should be provided b a licensed furnace repair technician.

During the inspection of the furnace, an unused exhaust vent from the furnace to the chimney was identified. It is not needed as the furnace is vented directly outside versus up the chimney. Correction of this condition is required. Thermographic imaging showed heated air present in the duct. Piping removal and installation of a covering plate is recommend. This service should be provided b a licensed furnace repair technician.

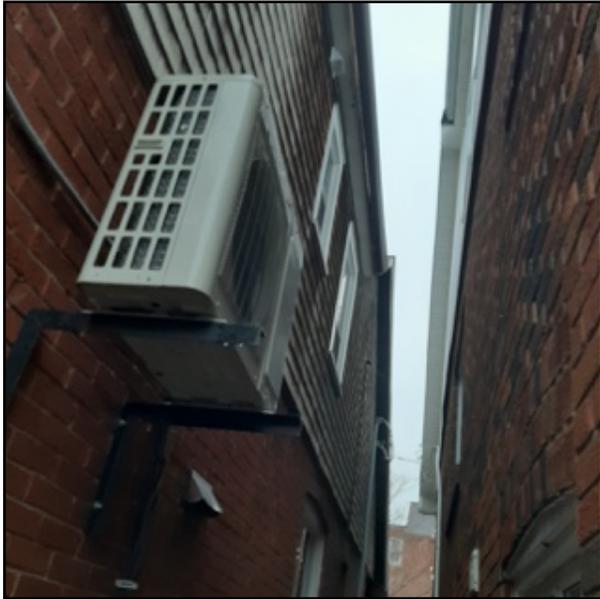
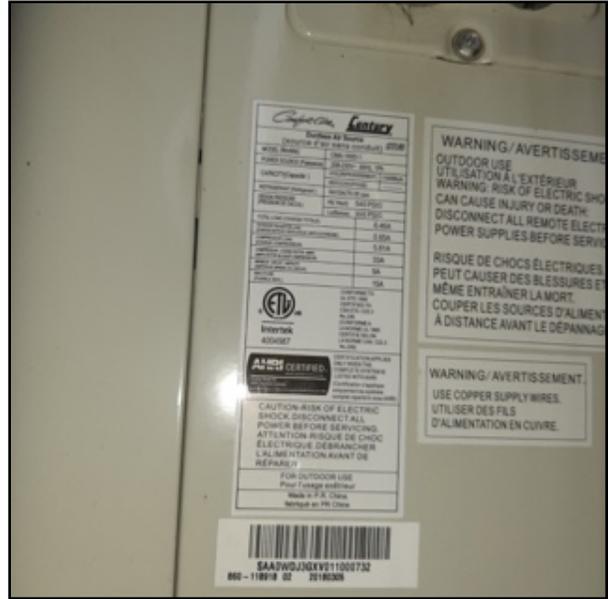
21) Comment 34: Portions of the cooling were not inspected as the condenser unit was mounted on the wall on the north side of the house. Outdoor temperature was below 16°C therefore air-conditioning system was not tested. Operation below this temperature can cause damage to the unit.

Portions of the cooling were not inspected as the condenser unit was mounted on the wall on the north side of the house. Outdoor temperature was below 16°C therefore air-conditioning system was not tested. Operation below this temperature can cause damage to the unit.

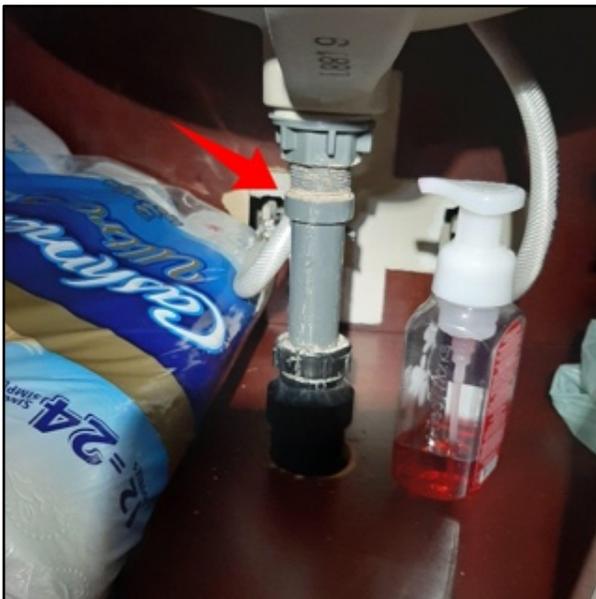
Figure 38-1

22) Comment 38: A minor defect in the vanity tailpipe was discovered. There was evidence of mineral deposits around the tailpipe seal and connection to the P trap. This is a result of water leakage through the tailpipe connection. It is recommended that the seals or tailpipe be repaired or replaced to avoid further damage to the interior of the sink base and possible mold development.

A minor defect in the vanity tailpipe was discovered. There was evidence of mineral deposits around the tailpipe seal and connection to the P trap. This is a result of water leakage through the tailpipe connection. It is recommended that the seals or tailpipe be repaired or replaced to avoid further damage to the interior of the sink base and possible mold development.

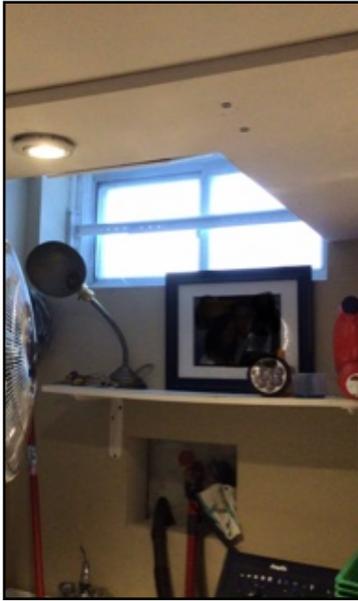
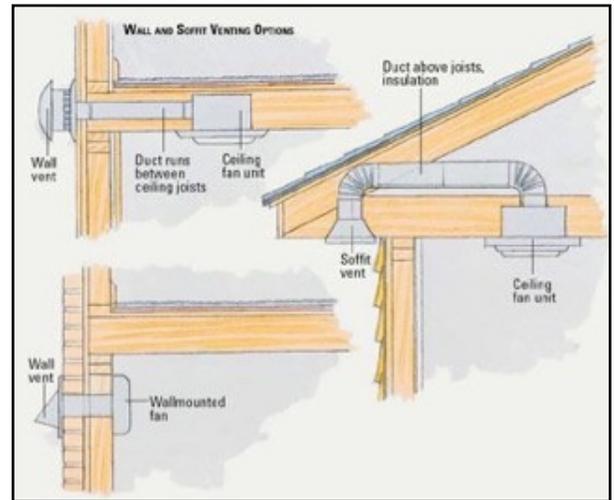
23) Comment 40: The laundry room contained a toilet, vanity and laundry sink. This area measures approximately 10' x 12' or 120 square feet. The existing window was small and difficult to open. It was determined that the ventilation in the bathroom/laundry room area was not adequate. Moist air from the washer, dryer and bathroom fixtures require adequate ventilation to reduce risk of moisture build up. It is estimated that for every square foot of floor space, 1 CFM (cubic feet per minute) of ventilation required. Therefore this area would require the installation of a ventilation system of 120 CFM capacity at minimum, vented to the exterior.

The laundry room contained a toilet, vanity and laundry sink. This area measures approximately 10' x 12' or 120 square feet. The existing window was small and difficult to open. It was determined that the ventilation in the bathroom/laundry room area was not adequate. Moist air from the washer, dryer and bathroom fixtures require adequate ventilation to reduce risk of moisture build up. It is estimated that for every square foot of floor space, 1 CFM (cubic feet per minute) of ventilation required. Therefore this area would require the installation of a ventilation system of 120 CFM capacity at minimum, vented to the exterior.

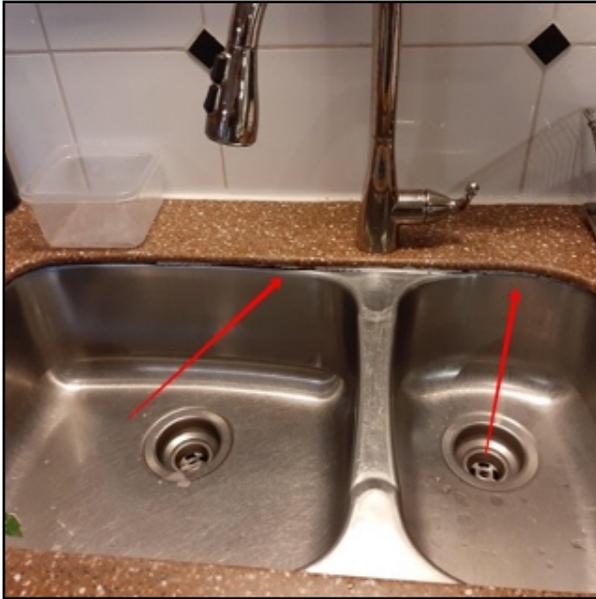
Figure 41-1

24) Comment 41: A minor defect was observed at the connection of the counter top and under-counter sink. Infiltration of water from underneath the sink and counter connection can cause damage to the cabinet below. The caulking between the sink and the countertop needs to be repaired and replaced.

A minor defect was observed at the connection of the counter top and under-counter sink. Infiltration of water from underneath the sink and counter connection can cause damage to the cabinet below. The caulking between the sink and the countertop needs to be repaired and replaced.

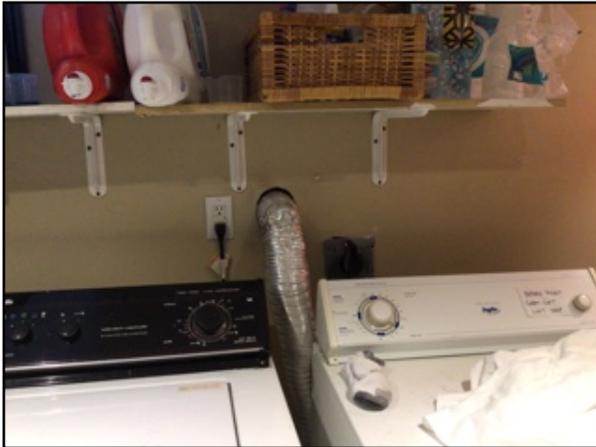
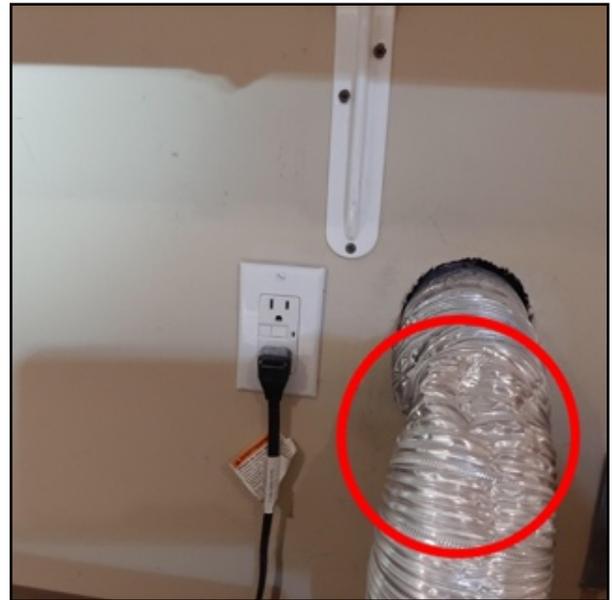
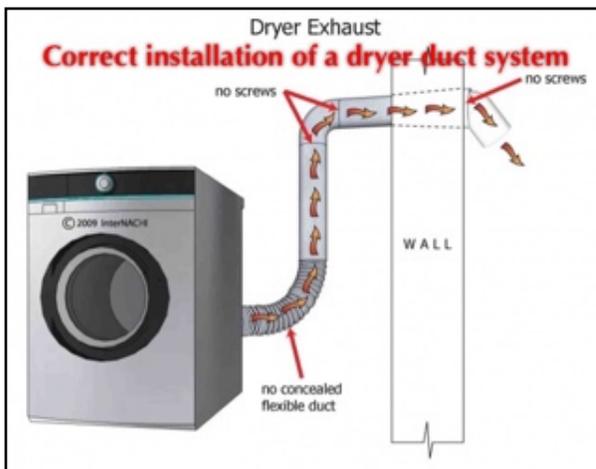
25) Comment 44: Dryer vent should have a solid 90° angle to go through the house exterior. The buildup of lint from poor flow of the dryer exhaust is a fire hazard. Installation of a solid pipe system is required to ensure safe and correct function of this system.

Dryer vent should have a solid 90° angle to go through the house exterior. The buildup of lint from poor flow of the dryer exhaust is a fire hazard. Installation of a solid pipe system is required to ensure safe and correct function of this system.

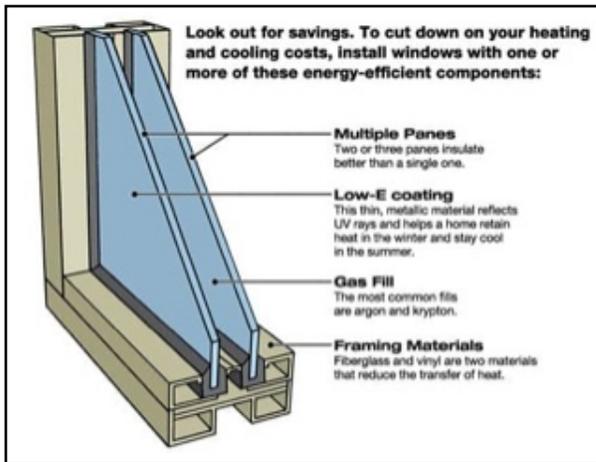
Figure 47-1

27) Comment 47: The windows on the first and second floors are made up of aluminum double glass units. No apparent leaking of air was observed at the time however they are not efficient. This installation appears to be near the end of the estimated life expectancy. Further evaluation by an energy consultant is required.

The windows on the first and second floors are made up of aluminum double glass units. No apparent leaking of air was observed at the time however they are not efficient. This installation appears to be near the end of the estimated life expectancy. Further evaluation by an energy consultant is required.
