## Management Asbestos Survey

Melvich Village Hall  
118 Portskerra Road  
Melvich  
Thurso  
KW14 7YL

Scope of Works -	Carry out Management Survey of Village Hall.
Survey Description	Management Survey
Client Contact -	Trudy Perry (Melvich Village Hall Association)
Job Number -	HAS1681

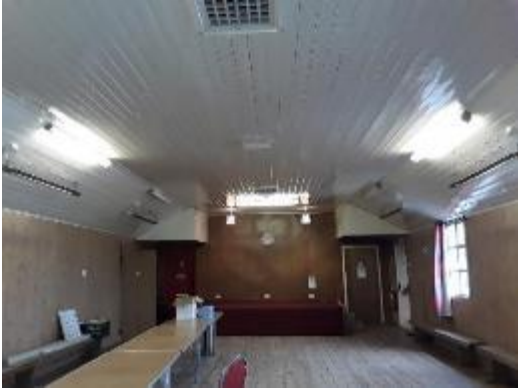
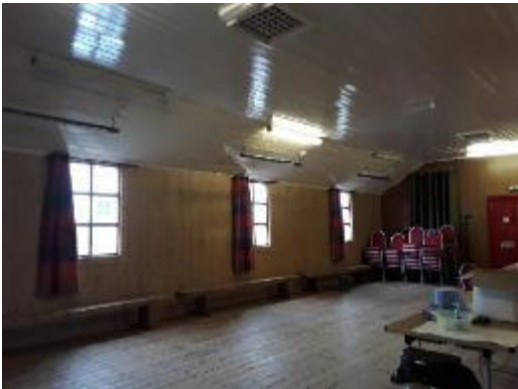
Item	Level	Location/Room Number	Survey Type	Sample Reference	Quantity		
1	Ground	Main Hall	Management

<b>Material Description</b>			<b>Material Risk</b>		
		Additional Information Paint finish to ceiling. Timber & UPVC doors. Timber windows. UPVC sheets to timber cladded walls. Modern electrical distribution board to wall.			Product Type	Damage	Treatment
<b>Score</b>

<b>Material Risk</b>					
		<b>Accessibility</b>					
<b>Recommendations</b>			<b>Asbestos Type</b>				
			No Asbestos Detected				
<b>Ceiling</b>		<b>Wall</b>		<b>Flooring</b>		<b>Other</b>	
Timber cladding		Timber cladding		Timber			
Job Survey Date		16/10/2020		Surveyor Name(s)	James Anderson		
Bulk Certificate Number		TVS/20/4516		UKAS Laboratory	TVS Analysis Ltd		
Note: Recommendations are based on the Material Assessment scores only and are the opinion of the surveyor at the time of inspection. Please note a Priority Assessment is required to provide a Total Risk Assessment Score. This must be completed by or on behalf of the duty holder.				Priority Assessment (Customer to complete)

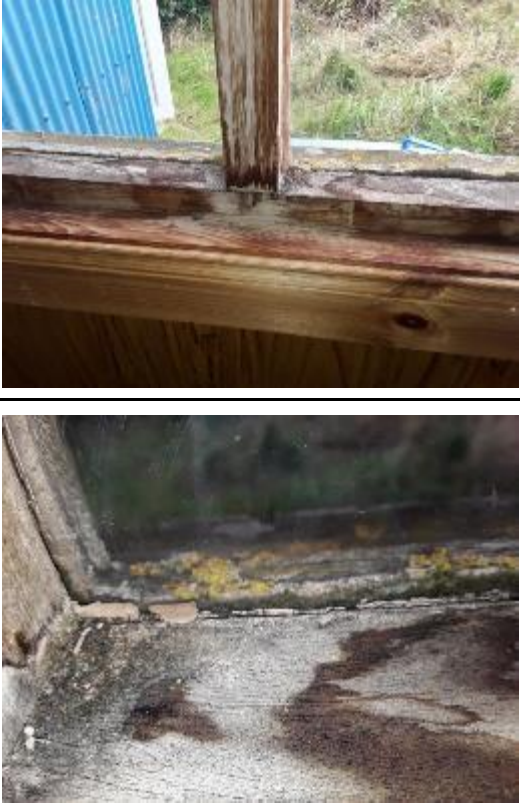
Item	Level	Location/Room Number	Survey Type	Sample Reference	Quantity			
2	Ground	Main Hall	Management	S001	x5

Material Description			Material Risk			
		Putty to window glass - sample sent for analysis, result of analysis was N.A.D.I.S.			Product Type	Damage	Treatment	Asbestos Type
		Additional Information						
					Score			
					Material Risk			
					Accessibility			
		Recommendations			Asbestos Type			
					No Asbestos Detected			
		Ceiling		Wall		Flooring		Other
		N/A		N/A		N/A		
Job Survey Date		16/10/2020		Surveyor Name(s)	James Anderson			
Bulk Certificate Number		TVS/20/4516		UKAS Laboratory	TVS Analysis Ltd			
Note: Recommendations are based on the Material Assessment scores only and are the opinion of the surveyor at the time of inspection. Please note a Priority Assessment is required to provide a Total Risk Assessment Score. This must be completed by or on behalf of the duty holder.				Priority Assessment (Customer to complete)

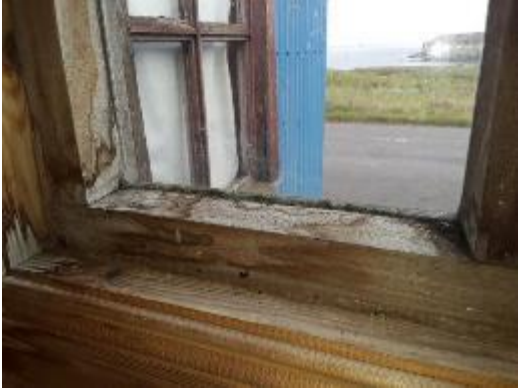
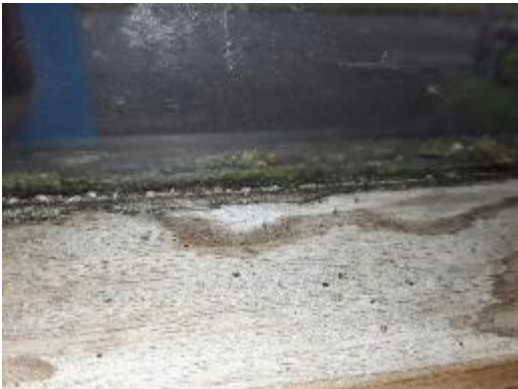
Item	Level	Location/Room Number	Survey Type	Sample Reference	Quantity	
4	Ground	Entrance	Management	As S001	x1

<b>Material Description</b>			<b>Material Risk</b>	
		Putty to window glass - same as product identified in item 2, no asbestos detected.			Product Type	Damage

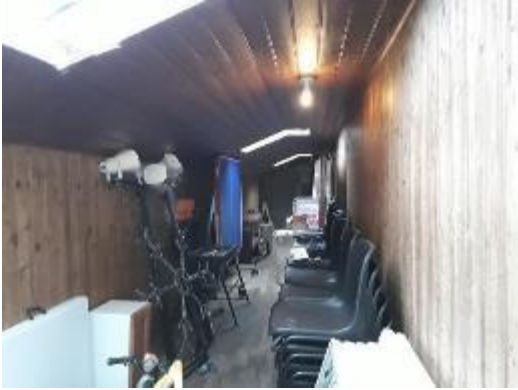
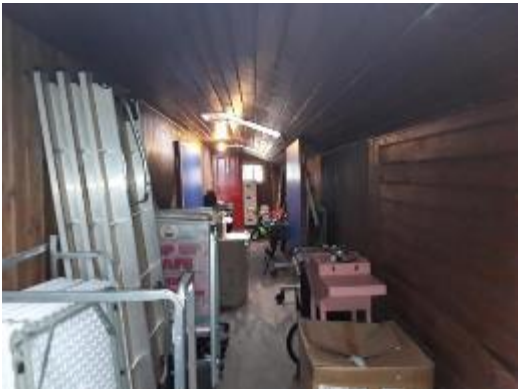
Item	Level	Location/Room Number	Survey Type	Sample Reference	Quantity		
5	Ground	Store	Management

Additional Information				
			Timber doors & windows.				
					Score		
					Material Risk		
					Accessibility		
			Recommendations		Asbestos Type		
					No Asbestos Detected		
Ceiling		Wall		Flooring		Other	
Timber cladding		Timber cladding		Timber			
Job Survey Date		16/10/2020		Surveyor Name(s)		James Anderson	
Bulk Certificate Number		TVS/20/4516		UKAS Laboratory		TVS Analysis Ltd	
Note: Recommendations are based on the Material Assessment scores only and are the opinion of the surveyor at the time of inspection. Please note a Priority Assessment is required to provide a Total Risk Assessment Score. This must be completed by or on behalf of the duty holder.				Priority Assessment (Customer to complete)			
Location	Score	Accessibility	Score	Extent/Amount	Score

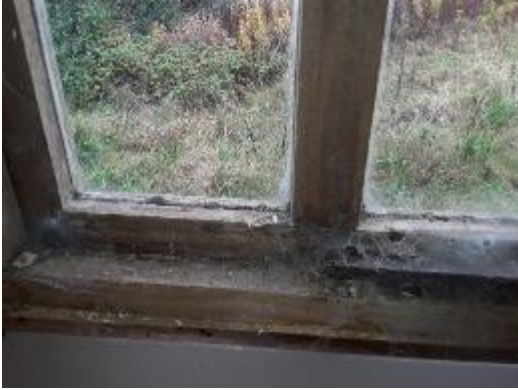
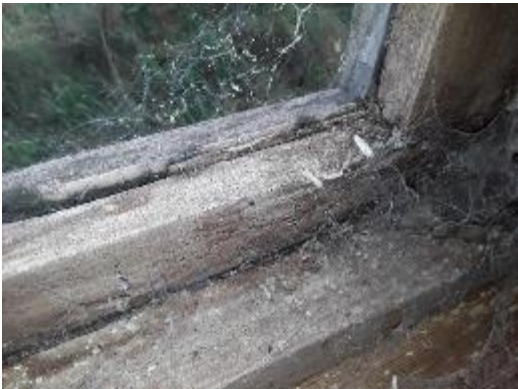
Item	Level	Location/Room Number	Survey Type	Sample Reference	Quantity	
6	Ground	Store	Management	As S001	x1

<b>Material Description</b>			<b>Material Risk</b>	
		Putty to window glass - same as product identified in item 2, no asbestos detected.			Product Type	Damage

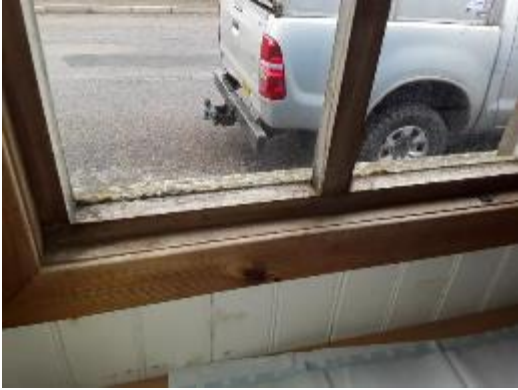
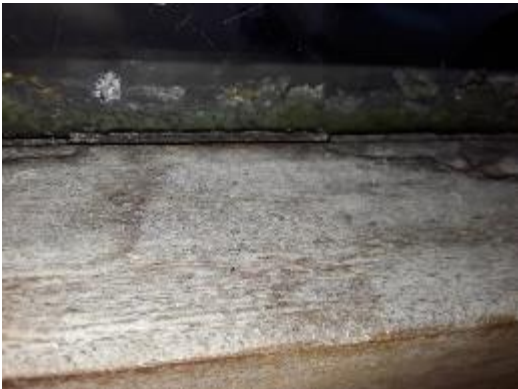
Item	Level	Location/Room Number	Survey Type	Sample Reference	Quantity		
8	Ground	Kitchen	Management	As S001	x2

Material Description			Material Risk		
		Putty to window glass - same as product identified in item 2, no asbestos detected.			Product Type	Damage	Treatment

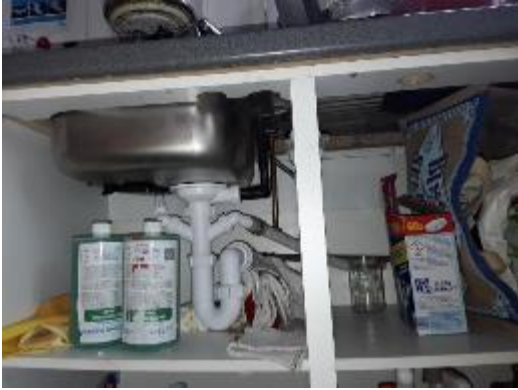
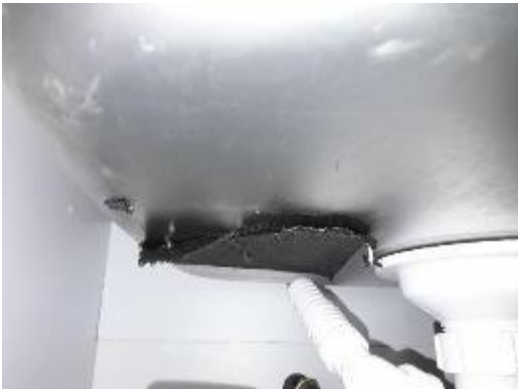
Item	Level	Location/Room Number	Survey Type	Sample Reference	Quantity		
9	Ground	Kitchen	Management	S002	x2

Material Description		Material Risk			
		Pad to sink & draining board - sample sent for analysis, result of analysis was N.A.D.I.S.		Product Type	Damage	Treatment	Asbestos Type

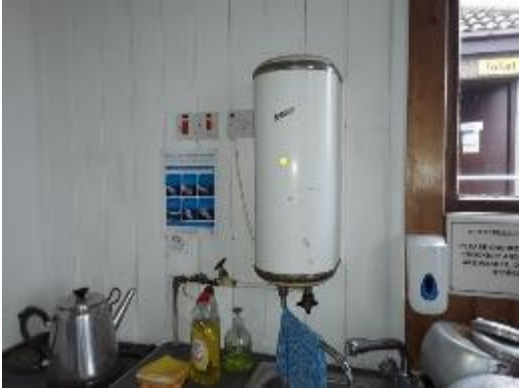
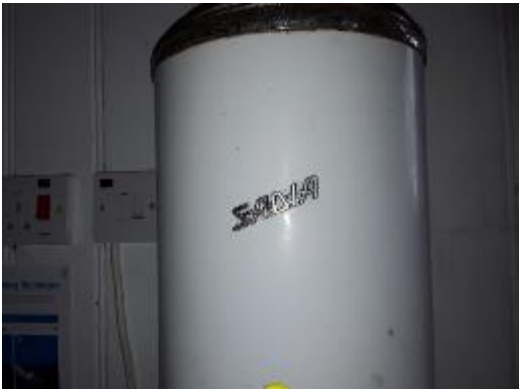
Item	Level	Location/Room Number	Survey Type	Sample Reference	Quantity		
10	Ground	Kitchen	Management		x1

Material Description		Material Risk			
		Sadia water heater - No access to live services, item is Presumed to contain ACM's.		Product Type	Damage	Treatment	Asbestos Type
		Additional Information					
				Score			
				Material Risk			
				Accessibility			
				Recommendations		Asbestos Type	
				As per CAR 2012, regular inspection is required.		Presumed	
		Ceiling		Wall		Flooring	
N/A		N/A		N/A			
Job Survey Date		16/10/2020		Surveyor Name(s)		James Anderson	
Bulk Certificate Number		TVS/20/4516		UKAS Laboratory		TVS Analysis Ltd	
Note: Recommendations are based on the Material Assessment scores only and are the opinion of the surveyor at the time of inspection. Please note a Priority Assessment is required to provide a Total Risk Assessment Score. This must be completed by or on behalf of the duty holder.				Priority Assessment (Customer to complete)

Melvich Village Hall								
Item	Sample No	Floor/Level	Room/Location	Material description	Product Type	Asbestos Type	Recommendation	Condition
10		Ground	Kitchen	Sadia water heater		<b>Presumed</b>	<b>As per CAR 2012, regular inspection is required.</b>

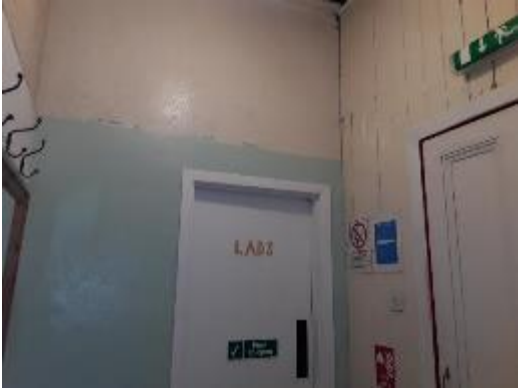
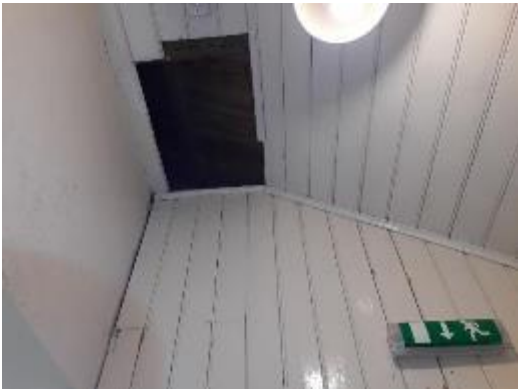
Item	Level	Location/Room Number	Survey Type	Sample Reference	Quantity		
11	Ground	Corridor	Management

<b>Material Description</b>		<b>Material Risk</b>			
				Product Type	Damage	Treatment	Asbestos Type
		<b>Additional Information</b>					
		Paint finish to ceiling & walls. Plastered brick & timber cladding walls. Timber door. Loft hatch within room.					
				<b>Score</b>			
				<b>Material Risk</b>			
				<b>Accessibility</b>			
				<b>Asbestos Type</b>			
				No Asbestos Detected			
		<b>Ceiling</b>		<b>Wall</b>		<b>Flooring</b>	
Timber cladding		Plastered brick		Timber			
<b>Job Survey Date</b>		16/10/2020		<b>Surveyor Name(s)</b>		James Anderson	
<b>Bulk Certificate Number</b>		TVS/20/4516		<b>UKAS Laboratory</b>		TVS Analysis Ltd	
Note: Recommendations are based on the Material Assessment scores only and are the opinion of the surveyor at the time of inspection. Please note a Priority Assessment is required to provide a Total Risk Assessment Score. This must be completed by or on behalf of the duty holder.				Priority Assessment (Customer to complete)

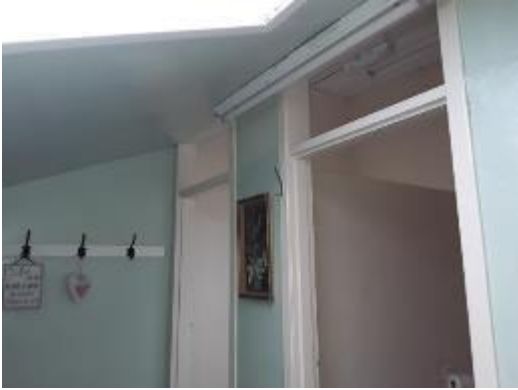
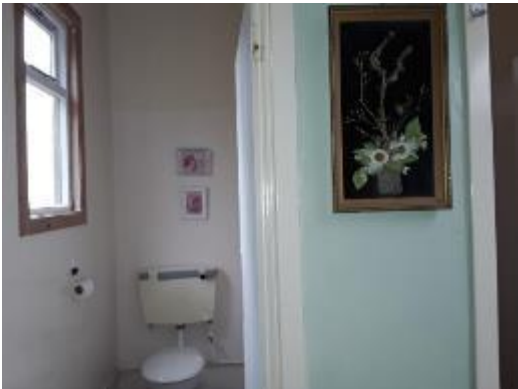
Item	Level	Location/Room Number	Survey Type	Sample Reference	Quantity		
12	Ground	Ladies W.C.	Management

<b>Material Description</b>			<b>Material Risk</b>		
		<b>Additional Information</b> Paint finish to ceiling & walls. Timber cladding & plasterboard ceilings. Timber doors. Plastic & ceramic sanitary goods. Metal & plastic service pipes. Plastic skylight to timber frame.			Product Type	Damage	Treatment
					<b>Score</b>

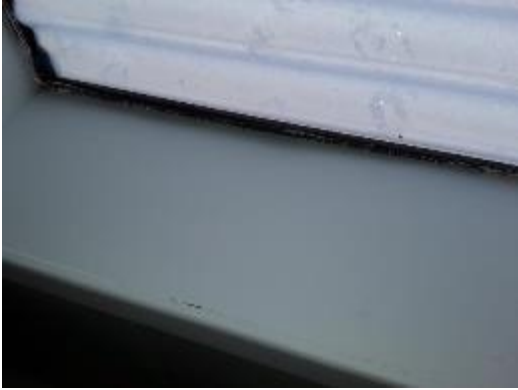
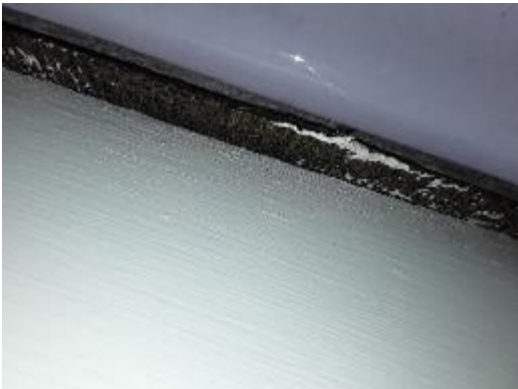
Item	Level	Location/Room Number	Survey Type	Sample Reference	Quantity		
13	Ground	Ladies W.C.	Management	S003	x1

Material Description		Material Risk			
		Felt to edge of skylight - sample sent for analysis, result of analysis was N.A.D.I.S.		Product Type	Damage	Treatment	Asbestos Type

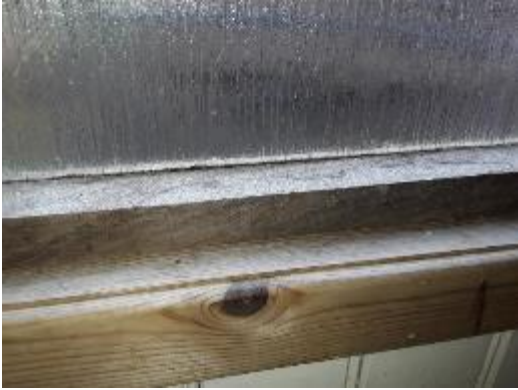
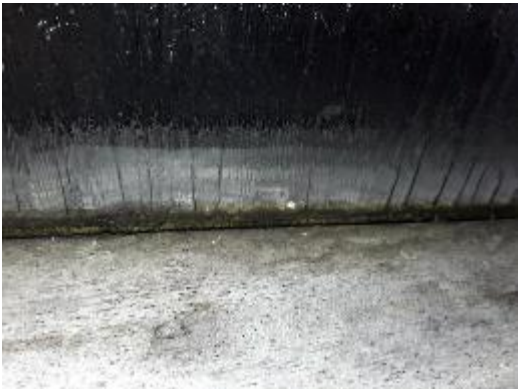
Item	Level	Location/Room Number	Survey Type	Sample Reference	Quantity		
15	Ground	Gents W.C.	Management	As S001	x1

Material Description			Material Risk		
		Putty to window glass - same as product identified in item 2, no asbestos detected.			Product Type	Damage	Treatment

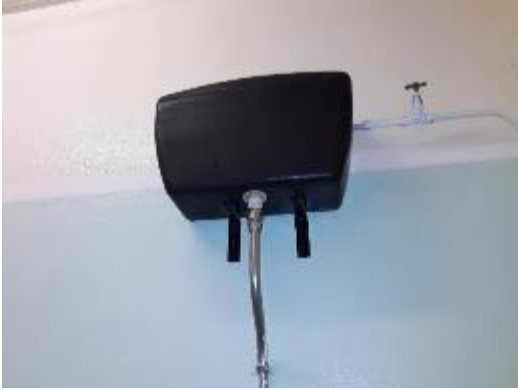
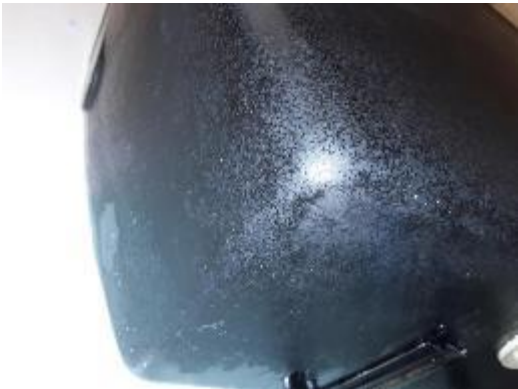
Item	Level	Location/Room Number	Survey Type	Sample Reference	Quantity		
16	Ground	Gents W.C.	Management	S004	x1

<b>Material Description</b>			<b>Material Risk</b>		
		Cistern above urinal - sample sent for analysis, result of analysis was N.A.D.I.S.			Product Type	Damage	Treatment

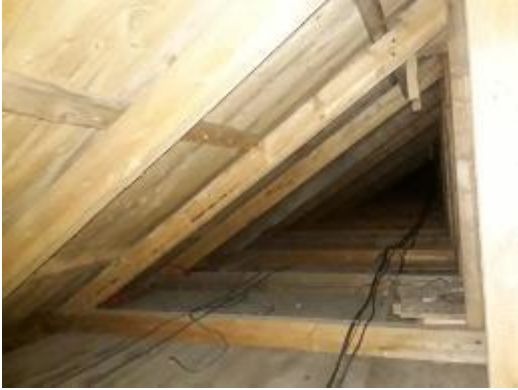
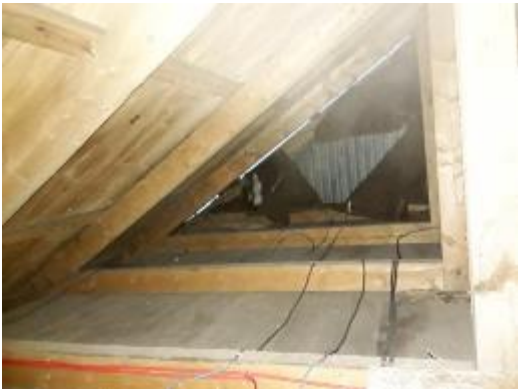
Item	Level	Location/Room Number	Survey Type	Sample Reference	Quantity		
17	Ground	Loft	Management

Material Description			Material Risk		
		Additional Information Timber roof trusses & inner lining to roof. Metal flue pipe.			Product Type	Damage	Treatment
Score

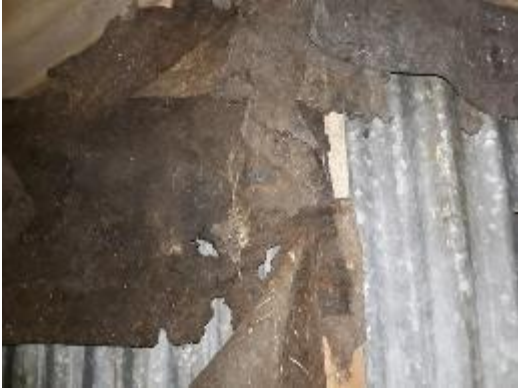
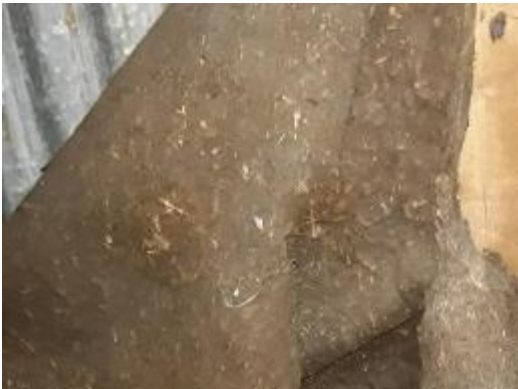
Item	Level	Location/Room Number	Survey Type	Sample Reference	Quantity			
18	Ground	Loft	Management	S005	12 m <sup>2</sup>

Material Description			Material Risk			
		Felt to gable end walls - sample sent for analysis, result of analysis was N.A.D.I.S.			Product Type	Damage	Treatment	Asbestos Type

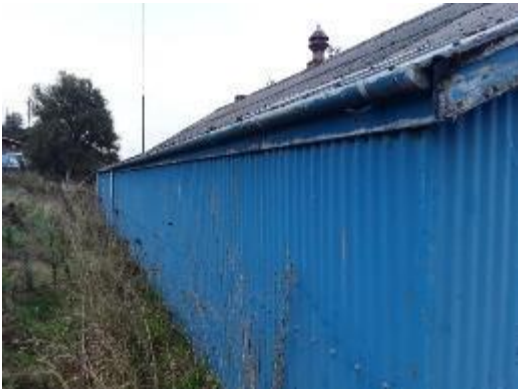
Item	Level	Location/Room Number	Survey Type	Sample Reference	Quantity		
19	External	General	Management				
 		Material Description			Material Risk		
		Profiled cement sheets to roof. Plastic rainwater goods. Timber soffits and fascia. Timber windows. UPVC doors.			Product Type	Damage	Treatment
Additional Information					Score

Recommendations			Asbestos Type		
					See Item 21		
Ceiling		Wall		Flooring		Other	
N/A		Profiled metal sheeting		N/A			
Job Survey Date		16/10/2020		Surveyor Name(s)		James Anderson	
Bulk Certificate Number		TVS/20/4516		UKAS Laboratory		TVS Analysis Ltd	
Note: Recommendations are based on the Material Assessment scores only and are the opinion of the surveyor at the time of inspection. Please note a Priority Assessment is required to provide a Total Risk Assessment Score. This must be completed by or on behalf of the duty holder.				Priority Assessment (Customer to complete)

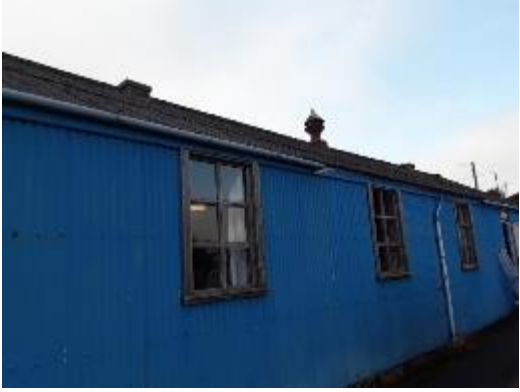
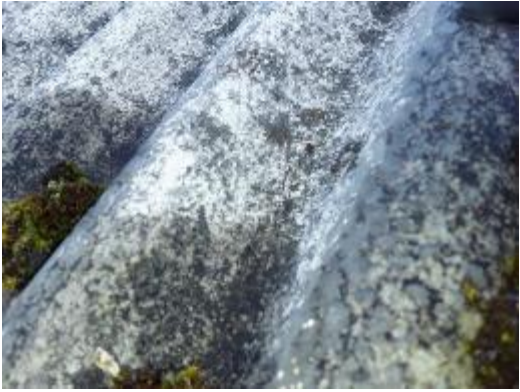
Item	Level	Location/Room Number	Survey Type	Sample Reference	Quantity			
21	External	Roof	Management	S007	450 m <sup>2</sup>

Melvich Village Hall								
Item	Sample No	Floor/Level	Room/Location	Material description	Product Type	Asbestos Type	Recommendation	Condition
21	S007	External	Village Hall Roof	Profiled sheets	Cement sheet	<b>Chrysotile</b>	<b>Removal of asbestos containing materials is recommended.</b>	Medium damage

Material Description			Material Risk			
		<p>Profiled sheets to roof - sample sent for analysis, product identified as being an ACM.</p>			Product Type	Damage	Treatment	Asbestos Type
		Additional Information			1	2	1	1
		Total of 150 x 3m x 1m sheets to roof.						
					Score			
					5			
					Material Risk			
					Low			
					Accessibility			
					Medium			
			Recommendations			Asbestos Type		
			Removal of asbestos containing materials is recommended.			Chrysotile		
Ceiling		Wall		Flooring		Other		
N/A		N/A		N/A				
Job Survey Date		16/10/2020		Surveyor Name(s)		James Anderson		
Bulk Certificate Number		TVS/20/4516		UKAS Laboratory		TVS Analysis Ltd		
Note: Recommendations are based on the Material Assessment scores only and are the opinion of the surveyor at the time of inspection. Please note a Priority Assessment is required to provide a Total Risk Assessment Score. This must be completed by or on behalf of the duty holder.				Priority Assessment (Customer to complete)
