**MELVICH VILLAGE HALL
118 PORTSKERRA ROAD
MELVICH
SUTHERLAND
KW14 7YL**

STRUCTURAL CONDITION REPORT

4R203013-01 A

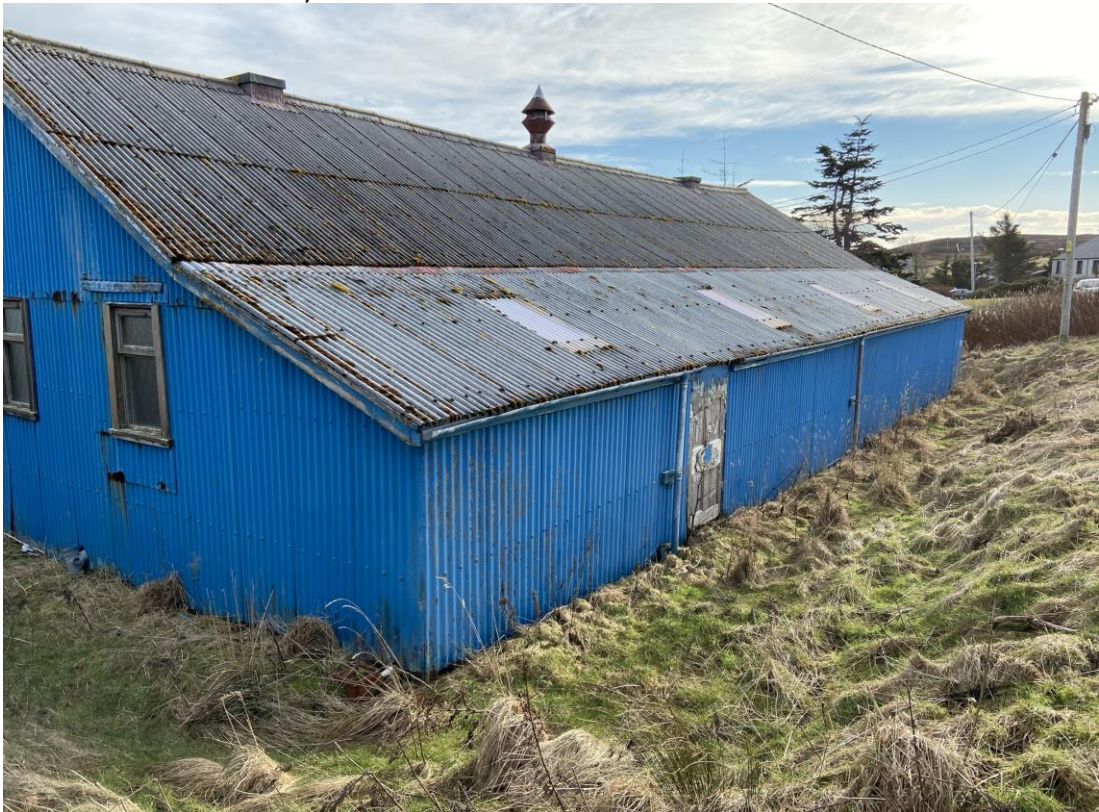
The condition of the floor within the western lean-to section is poor. It is evident that the floor cavity has become invaded by soils from the adjacent raised ground and this has caused extensive dampness and rot to the floor timbers.

Photo 2: North Gable & Ground West of 'Lean-to' Elevation

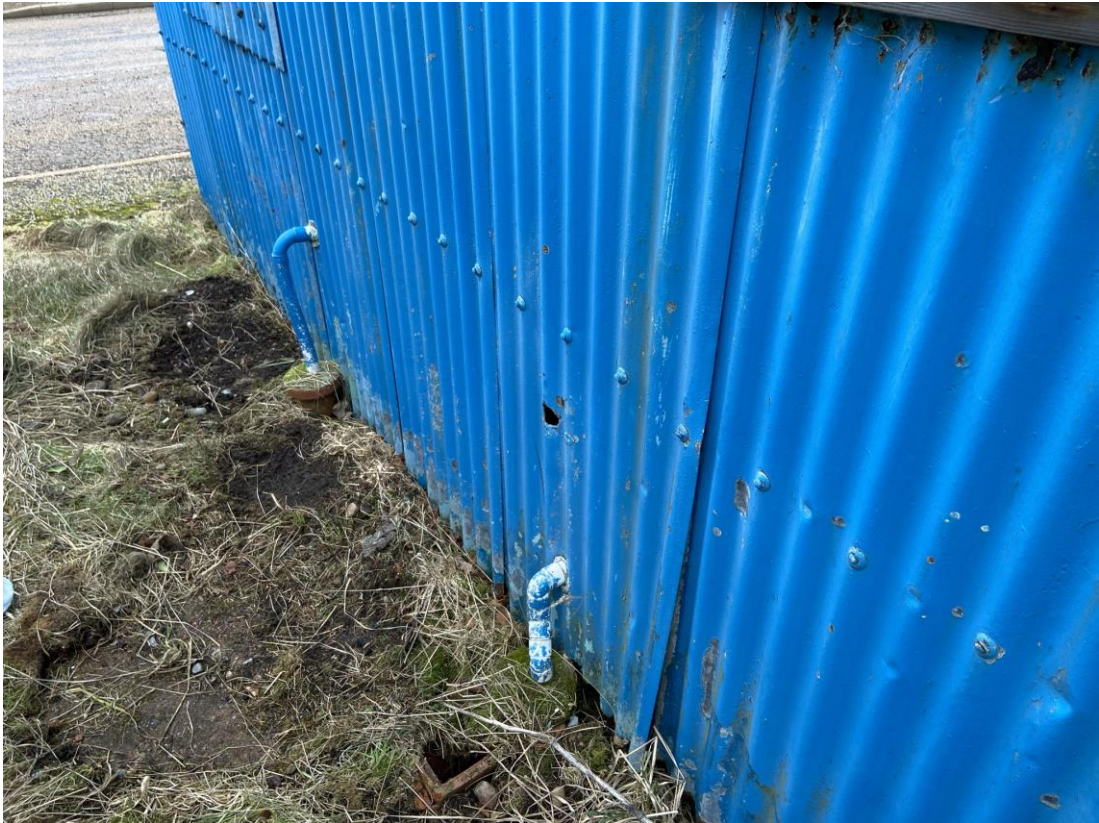
The condition of the profiled wall cladding panels is poor. The galvanising protection system has broken down extensively and the cladding is holed in places, due to severe corrosion.

Photo 3: North Gable Cladding

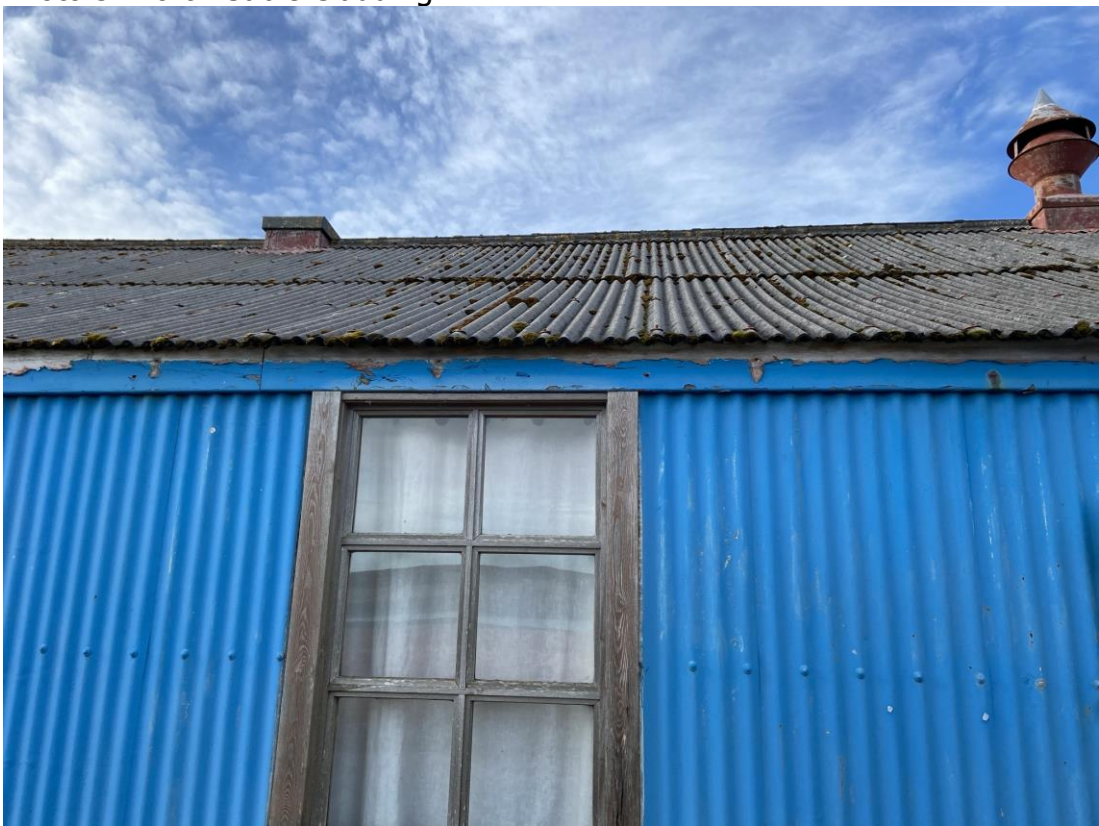
The condition of the profiled roof cladding panels and associated flashings is poor. The roof cladding is sagging in places and it does not provide a waterproof enclosure. This is evidenced by a notable water leak above the main hall.

Photo 4: Roof Cladding

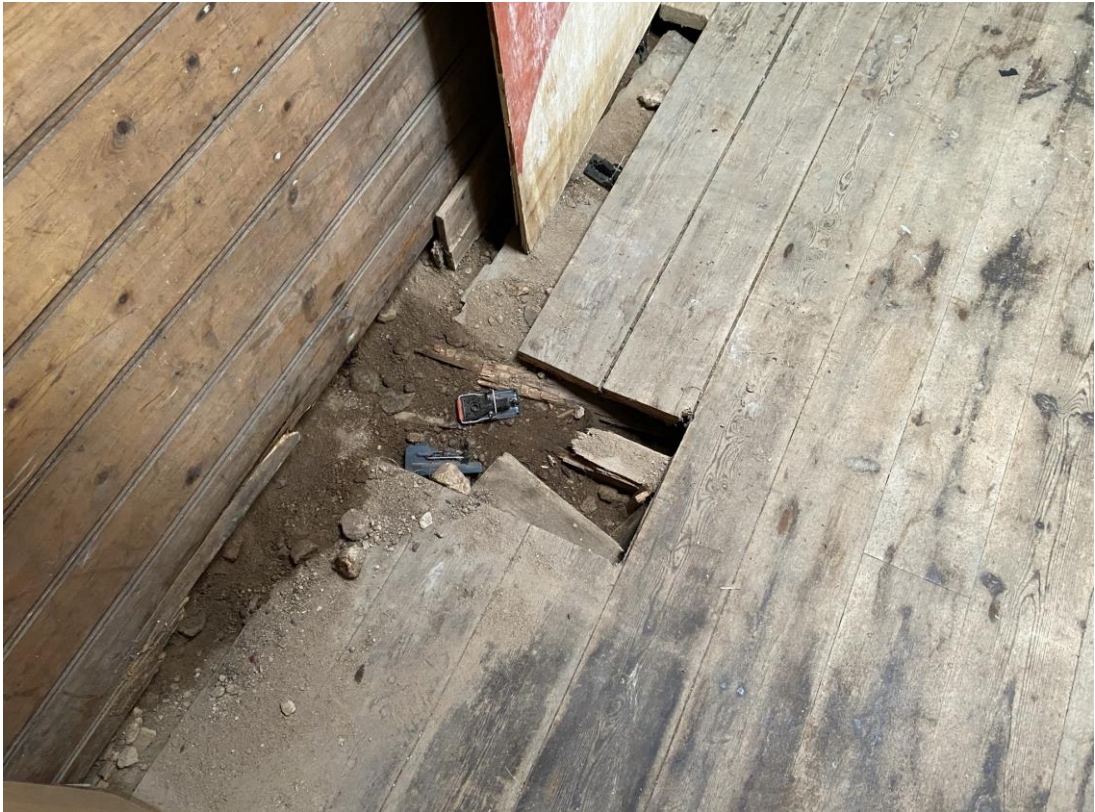
Photo 7: Rotted Floor, West 'Lean-to' Section

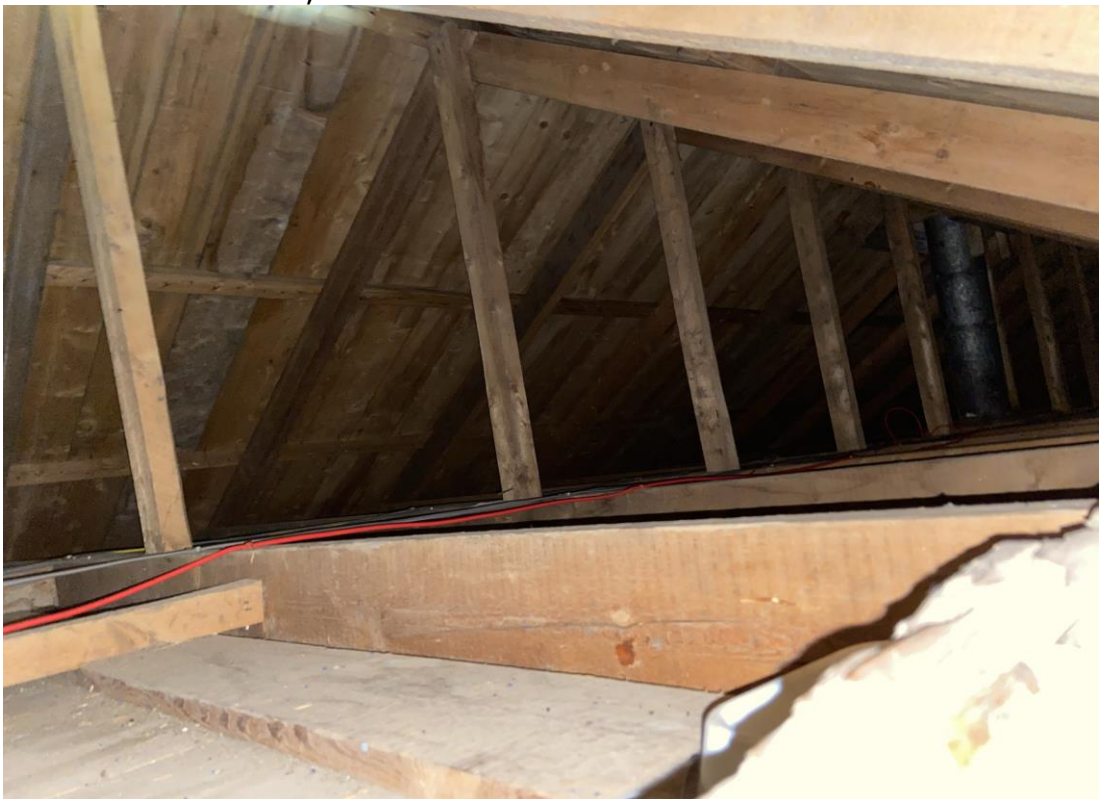
Where inspection was possible via an opening in the ceiling adjacent to the toilets, the timber roof truss members and sarking boards appear to be in good condition. However, the sagging roof panels at other locations above the main hall suggest there is some structural distress and/or undesirable deformations to the roof structure, which could not be seen from the ceiling hatch. There is also a significant possibility of roof timber damage where roof leakages are present.

Photo 8: Roof Trusses
