The Highland Council

New Community Hall, Melvich

Ground Investigation Report

CLIENT: The Highland Council
PROJECT TITLE: New Community Hall, Melvich
REPORT TITLE: Ground Investigation Report
PROJECT REFERENCE: 149169
DOCUMENT NUMBER: DOC 01

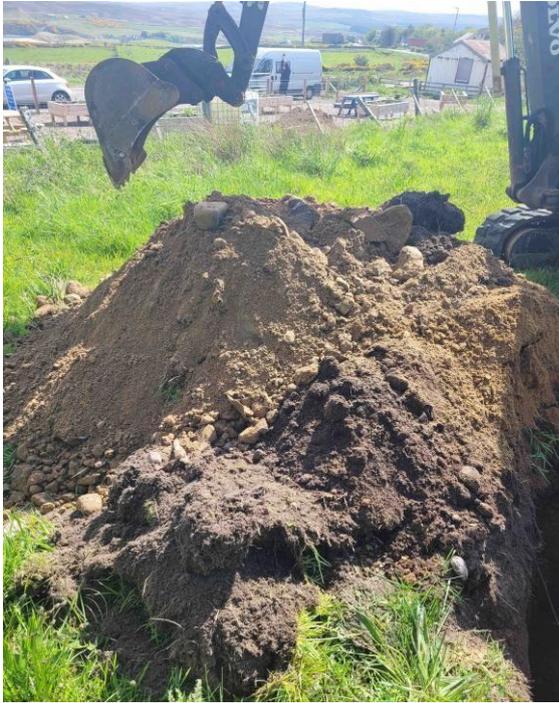
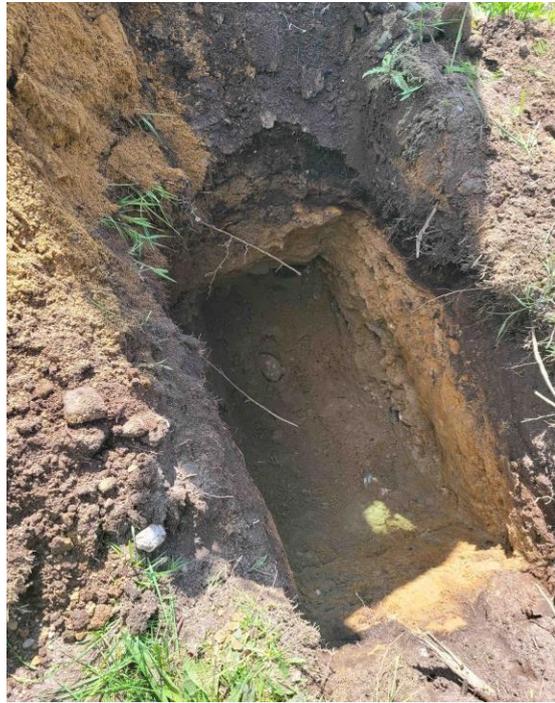
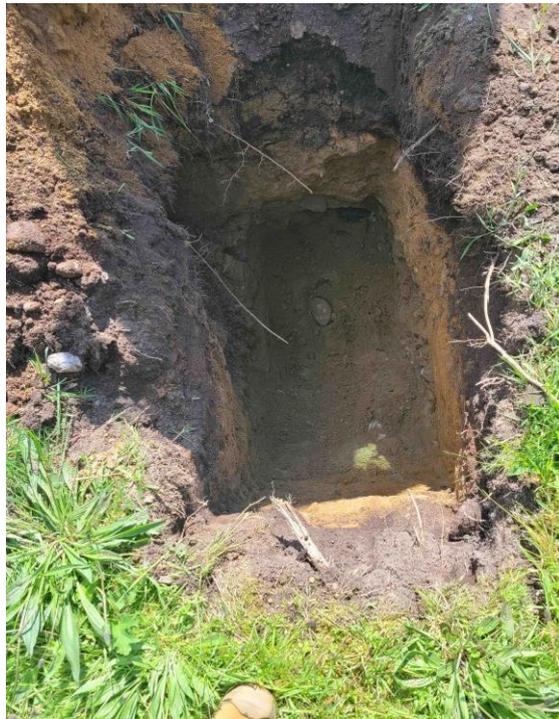
Trial Pit No: **TP1**

0.5	0.50	SAND/Silt. Boulders & Large Stone

1.0			
1.5			
1.70		Pit Terminated Due To Hard Digging.	
2.0			
2.5			
3.0

Remarks & groundwater observations	Dimensions	Logged by	Figure no/ status
Pit sides stable No Groundwater encountered No evidence of gas or other contamination	0.6m x 1.5m	C.Carter	0

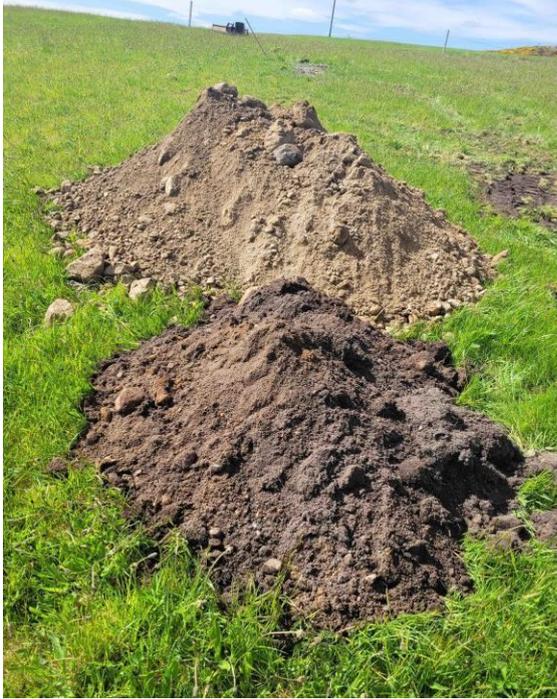
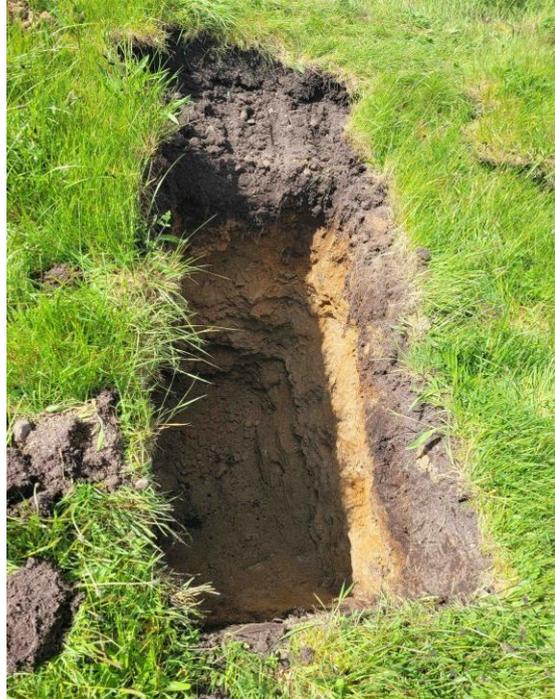
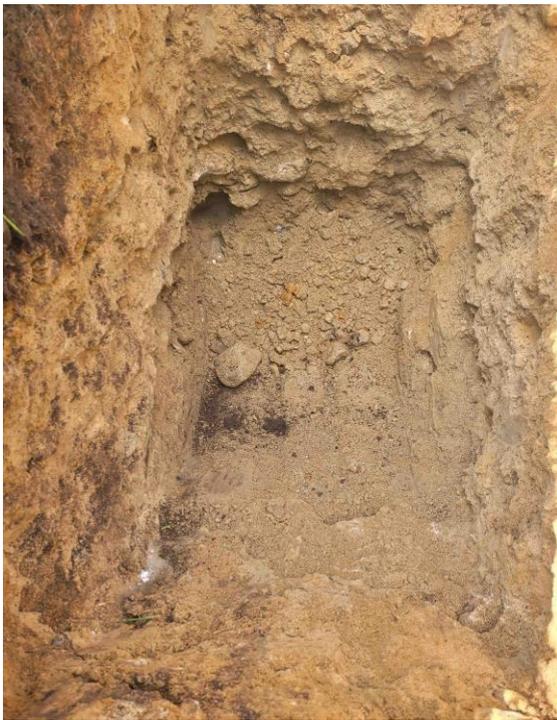
Trial Pit No: **TP2**

0.40		SAND/Silt. Boulders & Large Stone

0.5			
1.0		Pit Terminated Due To Hard Digging.	
1.5			
1.70			
2.0			
2.5			
3.0

Remarks & groundwater observations	Dimensions	Logged by	Figure no/ status
Pit sides stable No Groundwater encountered No evidence of gas or other contamination	0.6m x 1.5m	C.Carter	0

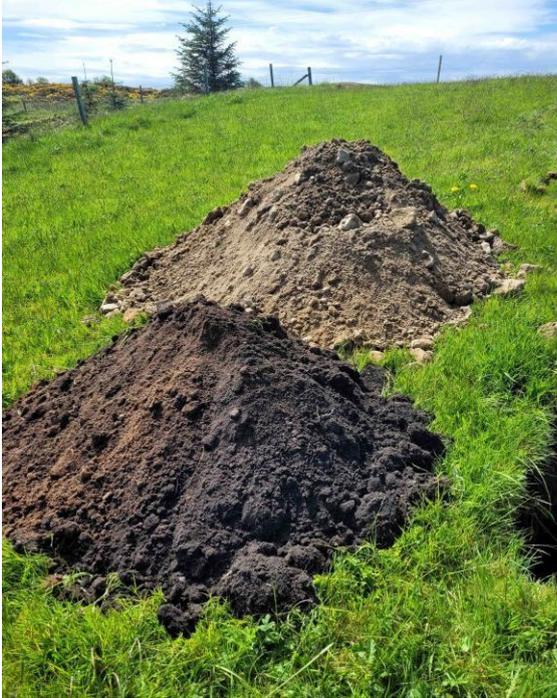
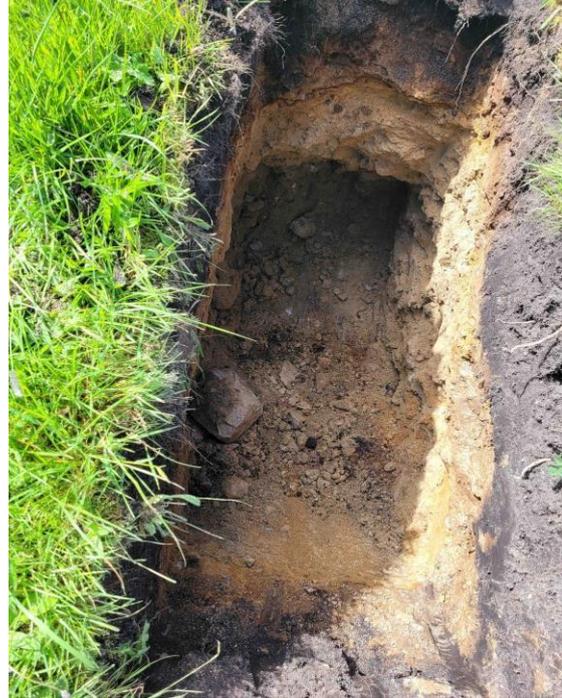
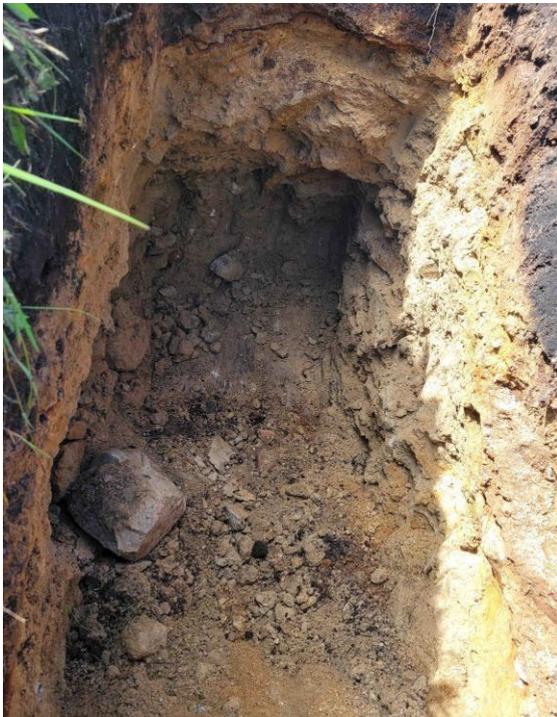
Trial Pit No: **TP3**

0.40	0.40	SAND/Silt. Boulders & Large Stone

0.50	0.50		
1.00	1.00	Pit Terminated Due To Hard Digging.	
1.50	1.50		
2.00	2.00		
2.50	2.50		
3.00	3.00

Remarks & groundwater observations	Dimensions	Logged by	Figure no/ status
Pit sides stable No Groundwater encountered No evidence of gas or other contamination	0.6m x 1.5m	C.Carter	0

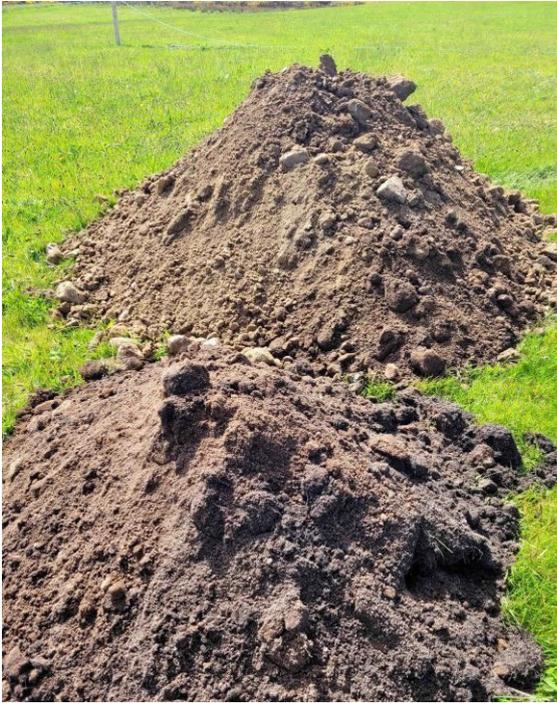
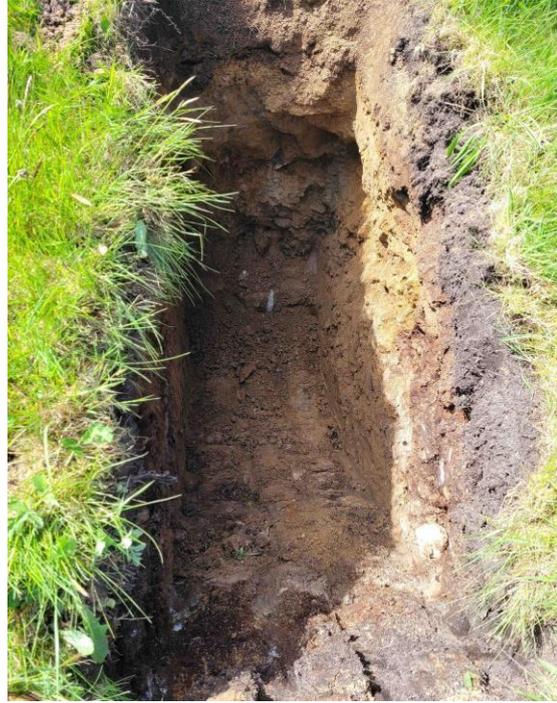
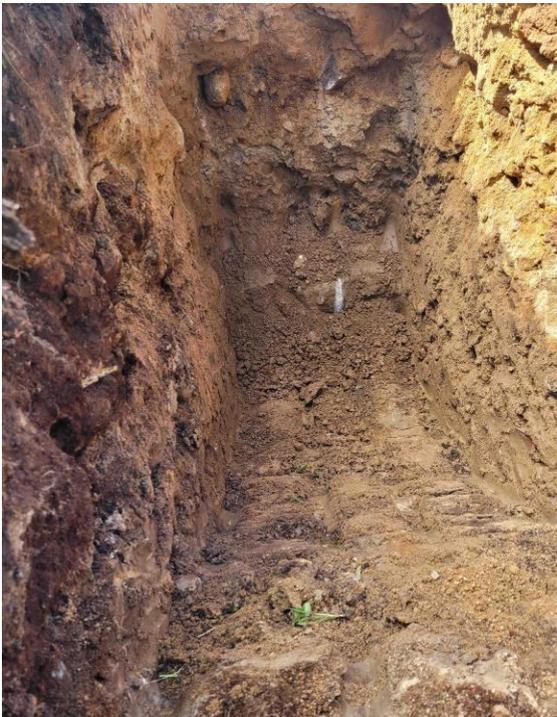
FAIRHURST	TRIAL PIT LOG	Trial Pit No: TP4
------------------	----------------------	--------------------------

Samples & tests	Water depth	Level (mOD)	Depth (mbgl)	Description of strata	Legend
				0.50	TOPSOIL	
				1.60	SAND/Silt. Boulders & Large Stone	
					Pit Terminated Due To Hard Digging.

Remarks & groundwater observations Pit sides stable No Groundwater encountered No evidence of gas or other contamination	Dimensions 0.6m x 1.5m	Logged by C.Carter	Figure no/ status 0
--	----------------------------------	------------------------------	-------------------------------

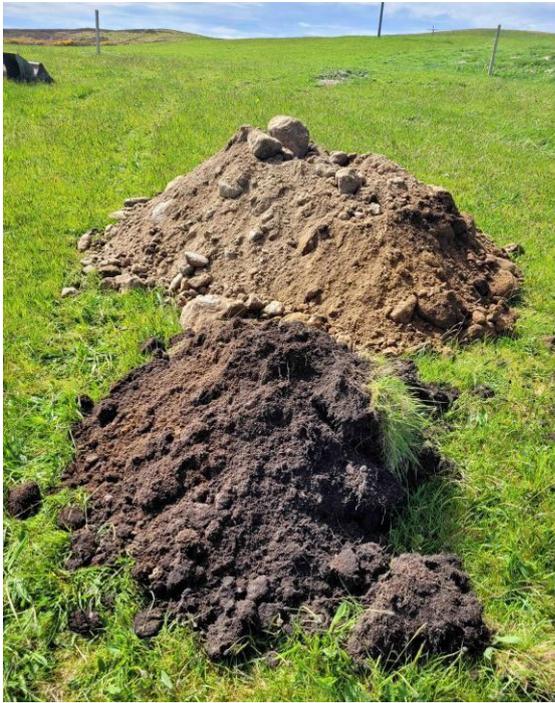
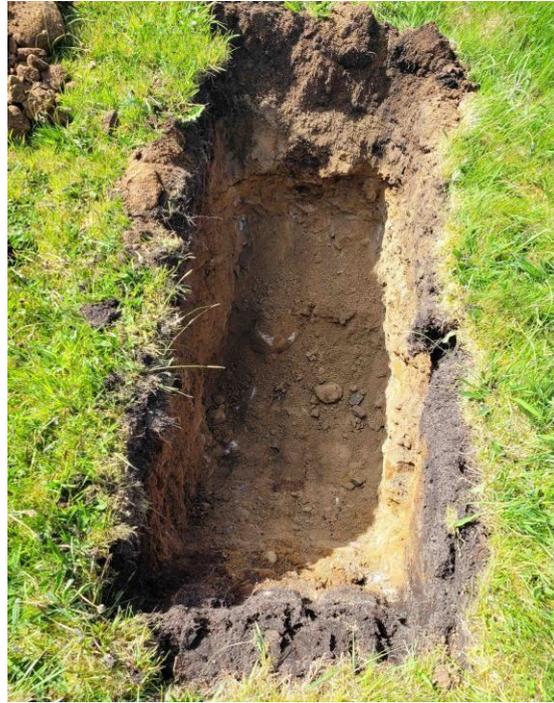
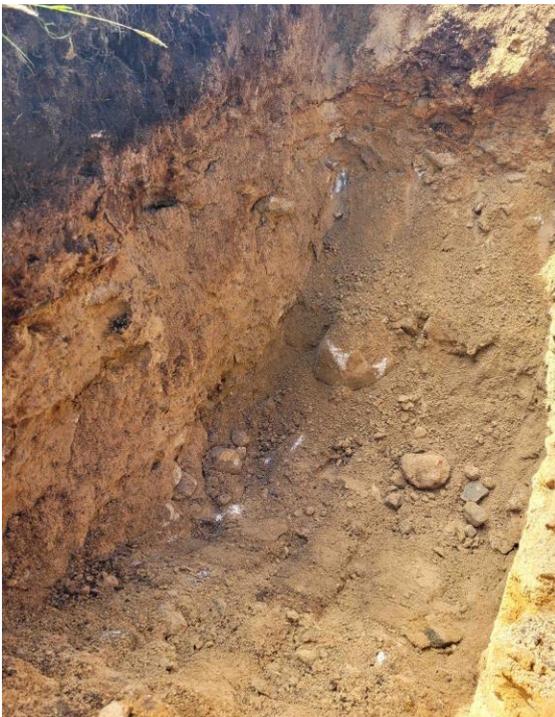
Trial Pit No: **TP5**

0.5		SAND/Silt. Boulders & Large Stone

1.0		Pit Terminated Due To Hard Digging.	
1.20			
1.5			
2.0			
2.5			
3.0

Remarks & groundwater observations	Dimensions	Logged by	Figure no/ status
Pit sides stable No Groundwater encountered No evidence of gas or other contamination	0.6m x 1.5m	C.Carter	0

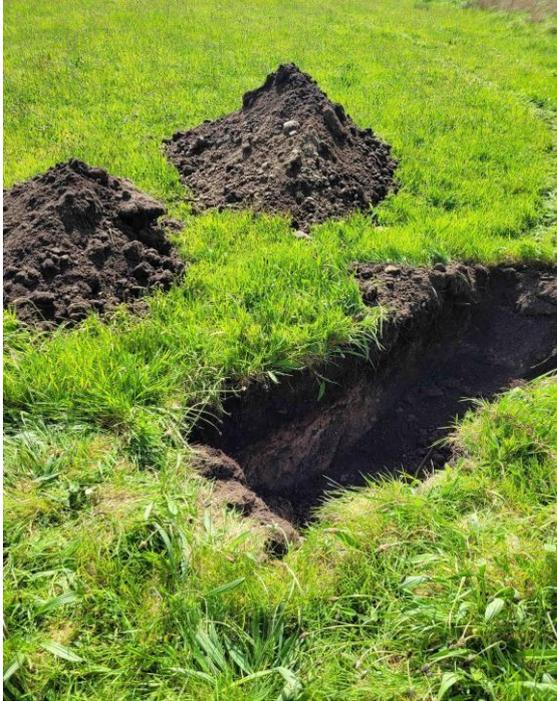
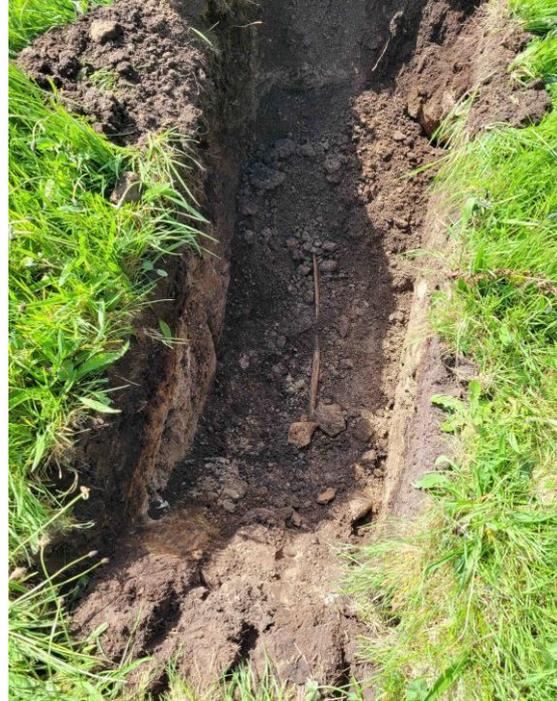
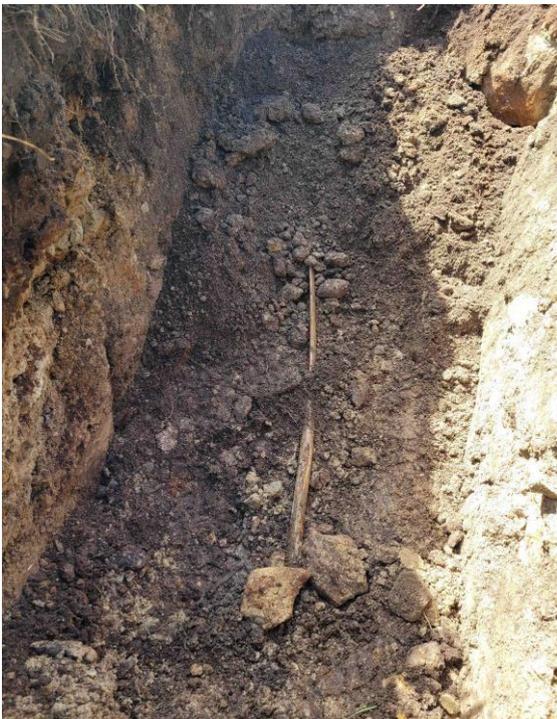
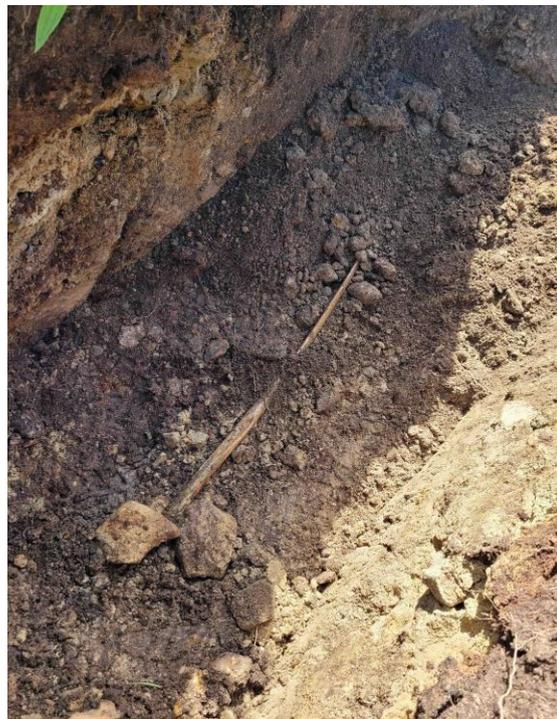
Trial Pit No: **TP6**

During the investigation, Trial Pit 6 proved an obstructive water pipe (assumed), 0.70mbgl. The remaining exploratory works did not identify any anthropogenic obstructions which affected the progress of ground investigation positions.

0.5			
	0.70	Pit Terminated Due To Old Water Pipe.	
1.0			
1.5			
2.0			
2.5			
3.0

Remarks & groundwater observations	Dimensions	Logged by	Figure no/ status
Pit sides stable No Groundwater encountered No evidence of gas or other contamination	0.6m x 1.5m	C.Carter	0

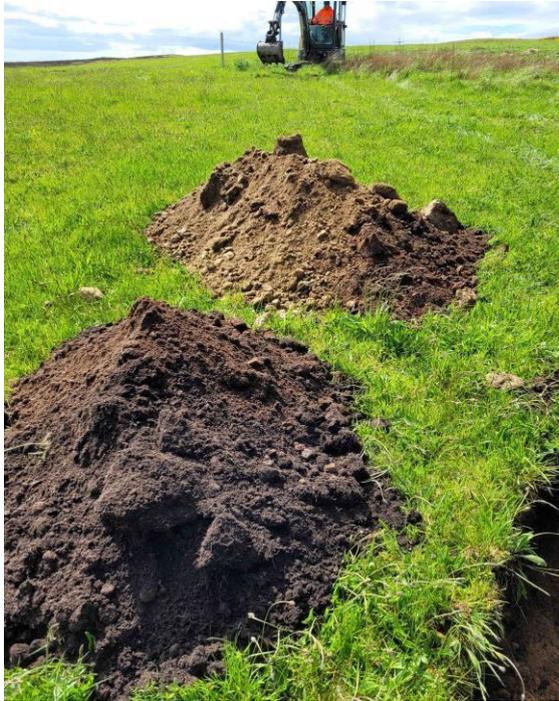
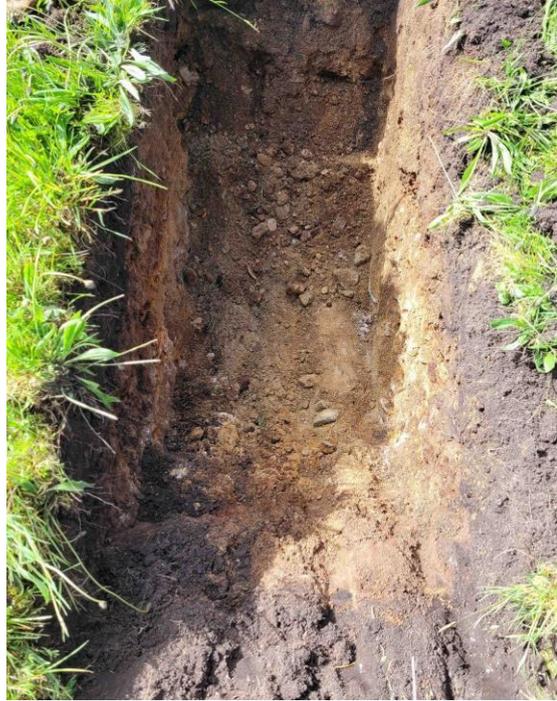
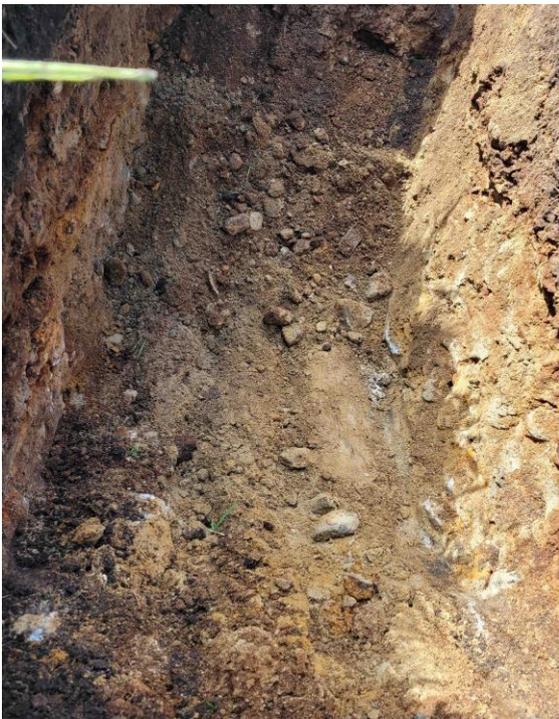
Trial Pit No: **TP7**

0.5	0.90	SAND/Silt. Boulders & Large Stone

1.0		Pit Terminated Due To Hard Digging.	
1.5			
2.0			
2.5			
3.0

Remarks & groundwater observations	Dimensions	Logged by	Figure no/ status
Pit sides stable No Groundwater encountered No evidence of gas or other contamination	0.6m x 1.5m	C.Carter	0

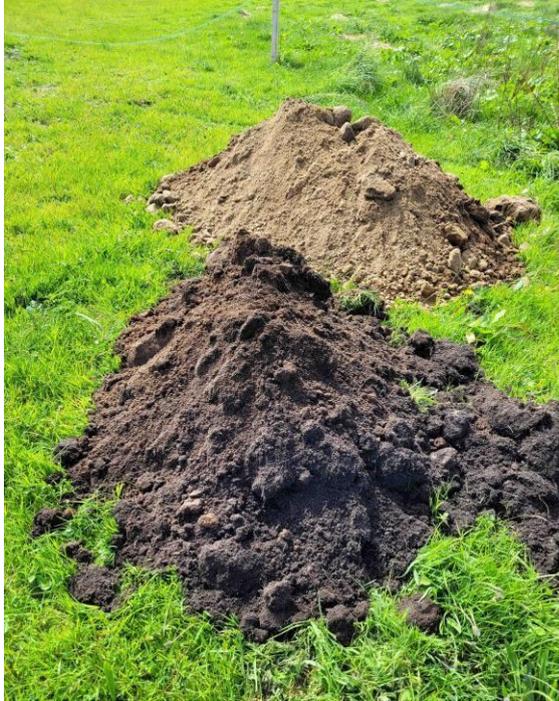
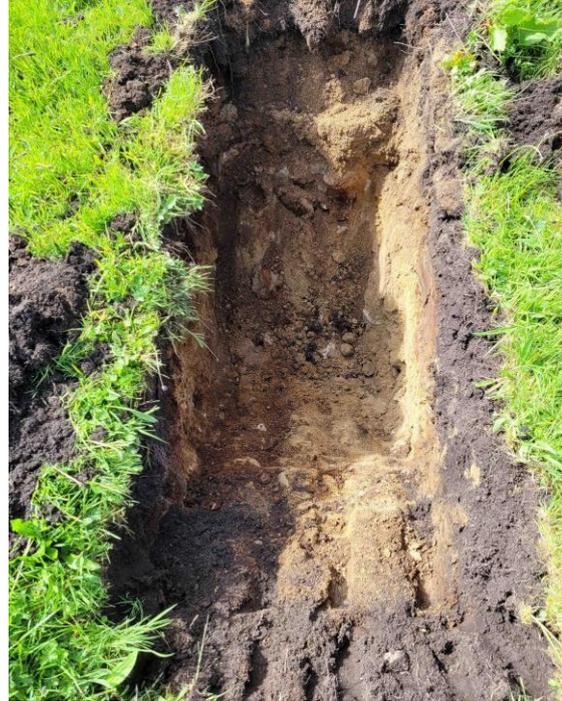
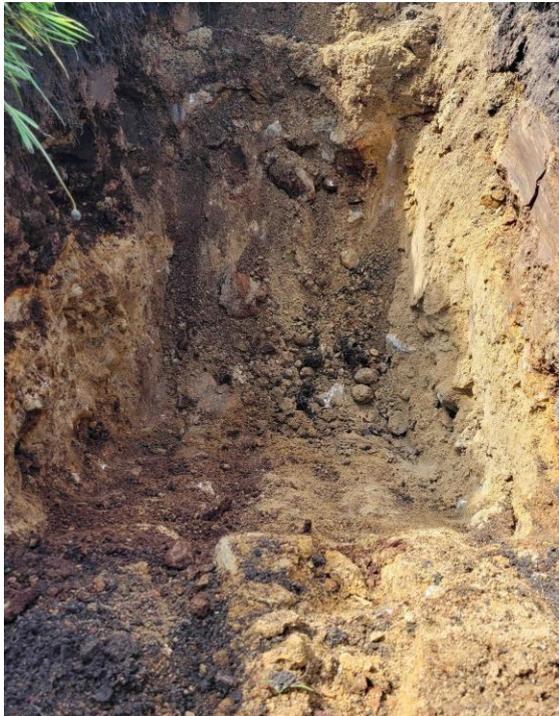
Trial Pit No: **TP8**

0.30	SAND/Silt. Boulders & Large Stone

0.5		
	1.00	Pit Terminated Due To Hard Digging.	
	1.5		
	2.0		
	2.5		
	3.0

Remarks & groundwater observations	Dimensions	Logged by	Figure no/ status
Pit sides stable No Groundwater encountered No evidence of gas or other contamination	0.6m x 1.5m	C.Carter	0

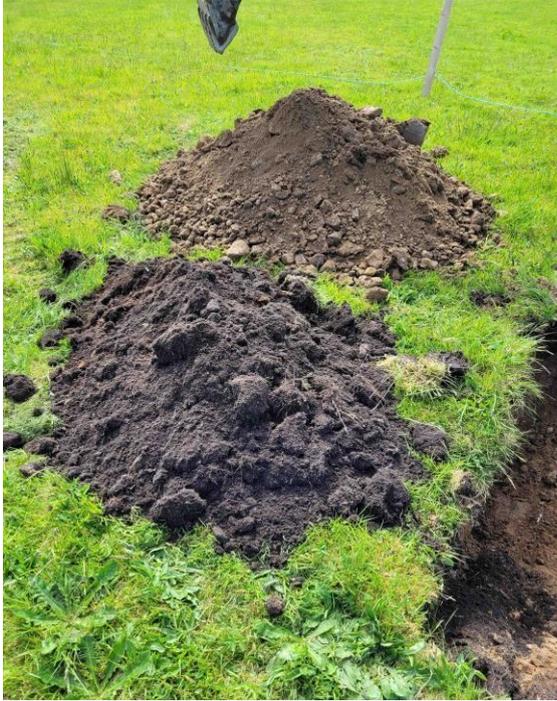
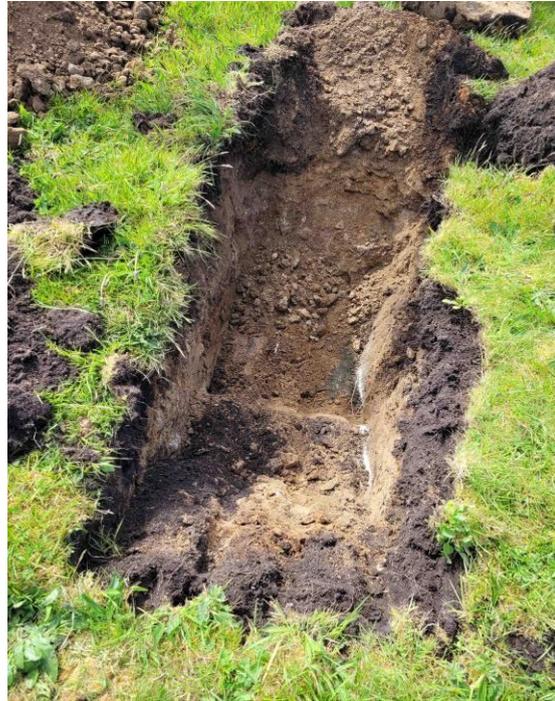
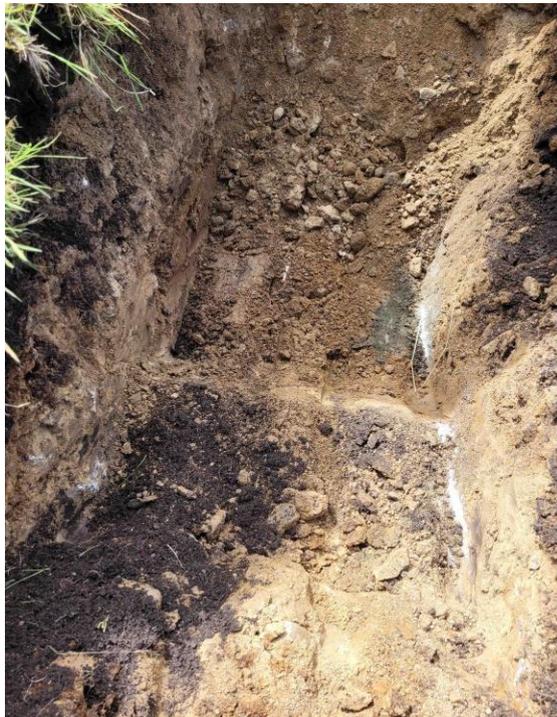
FAIRHURST	TRIAL PIT LOG	Trial Pit No: TP9
------------------	----------------------	--------------------------

Samples & tests	Water depth	Level (mOD)	Depth (mbgl)	Description of strata	Legend
				0.30	TOPSOIL	
				0.5	SAND/Silt. Boulders & Large Stone	
				0.80	Pit Terminated Due To Hard Digging.	
				1.0		
				1.5		
				2.0		
				2.5		
				3.0

Remarks & groundwater observations Pit sides stable No Groundwater encountered No evidence of gas or other contamination	Dimensions 0.6m x 1.5m	Logged by C.Carter	Figure no/ status 0
--	----------------------------------	------------------------------	-------------------------------
