Confidential Inspection Report

Inspected on 1/28/2012 @ 11:00 A.M.

Record Home Inspections

Inspection Date: Saturday, January 28th, 2012 at 11:00 A.M.

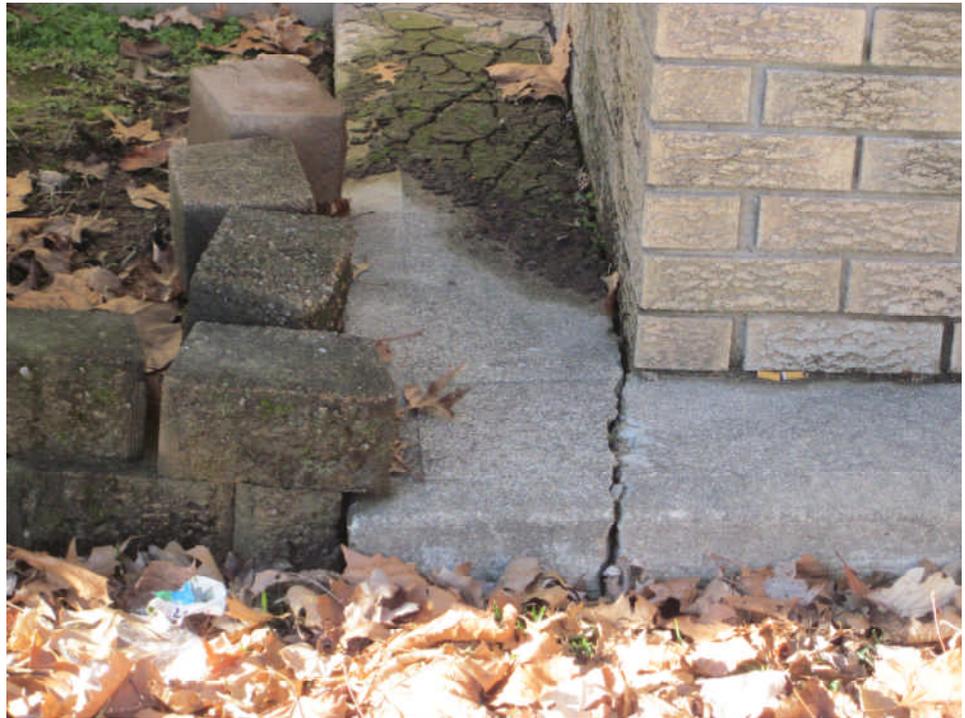
Entryway Stoop:

Action Necessary - The entryway stoop needs repair or replacement due to deterioration or settlement.

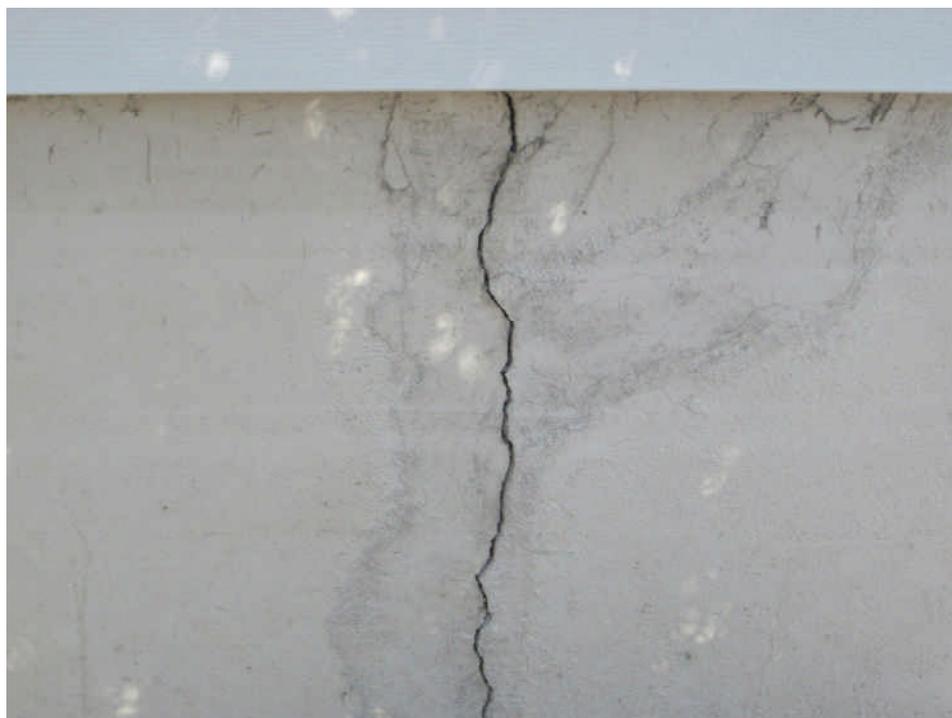
Description:

Yes - Cracking in the vertical foundation walls was noted from the exterior.

Vertical cracks were noted in the left side exterior wall. Repairs have been made in the past. This home has been flooded in the past.

Action Necessary - Cracks of 1/4" and wider warrants further investigation and analysis by a professional structural engineer and/or a licensed qualified foundation contractor to determine the cause and course of action.

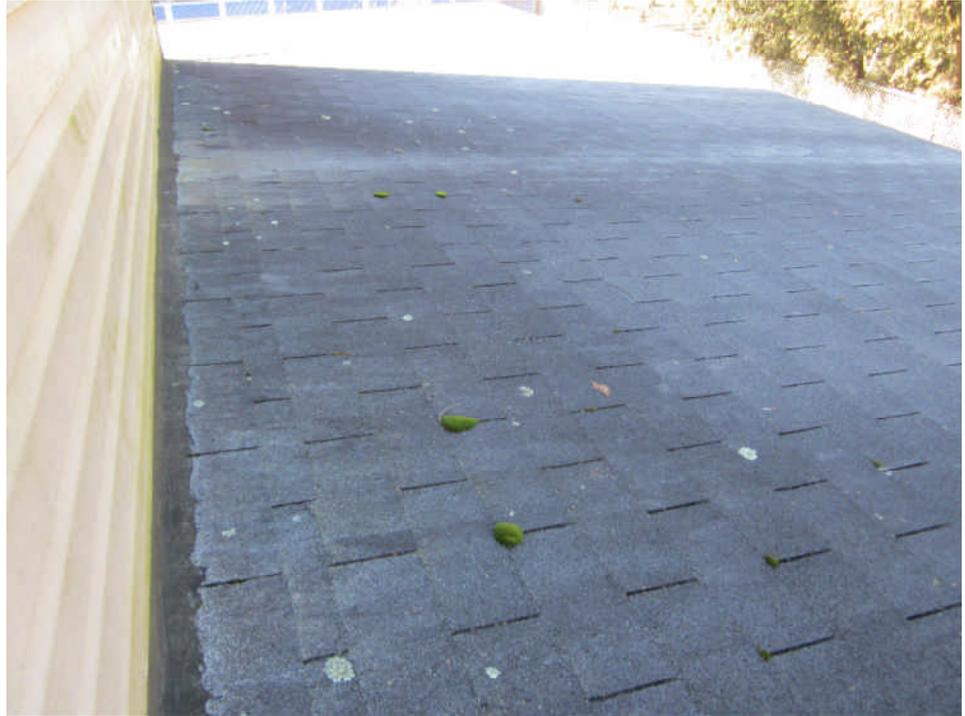
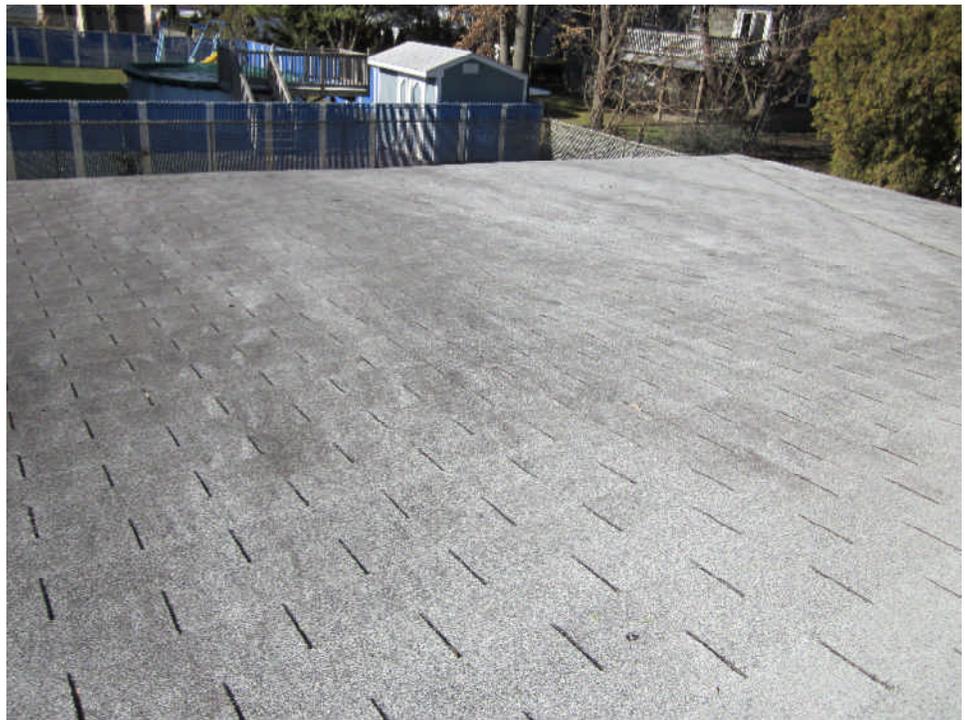
Condition of Roof
Covering
Material:

Attention Needed - The roof covering material shows signs of deterioration or damage that needs attention to prevent further deterioration or leakage. Moss build up is noted on the right side roof and lose of granulars is noted on the rear lower area roof.

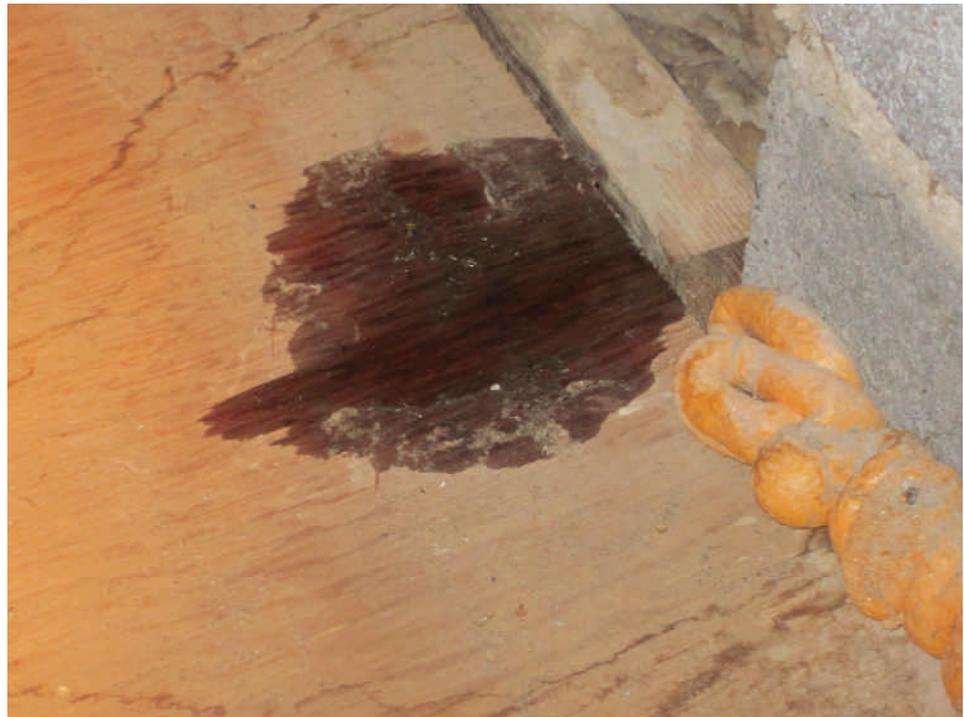
Evidence of Leaks on Interior of Attic:

Action Necessary - There is evidence of a current leak noted on the underside of the roof decking or rafters.

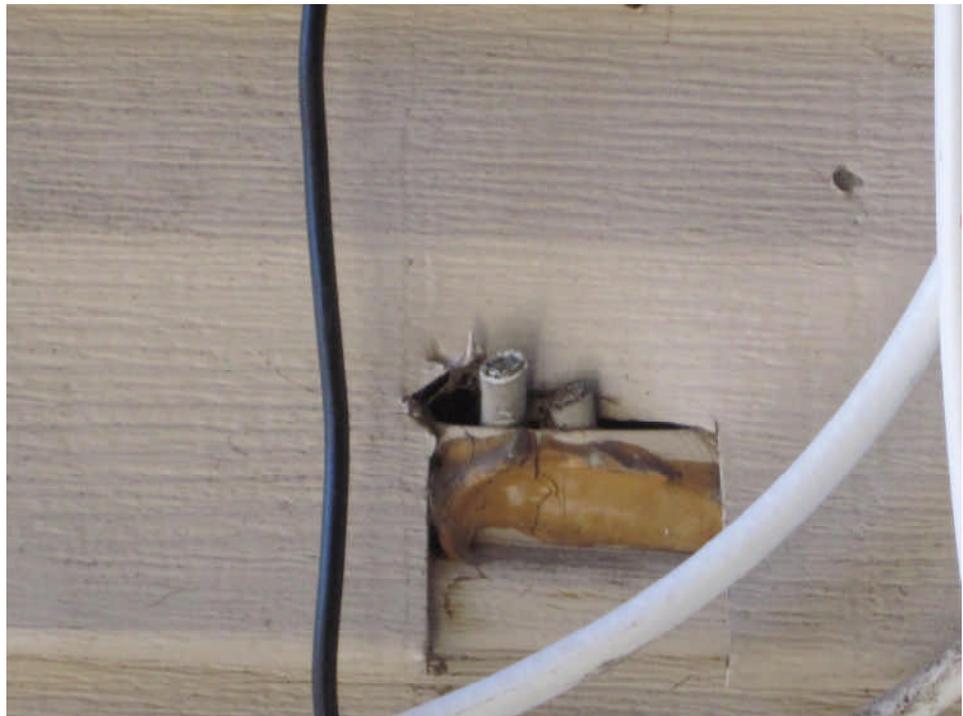
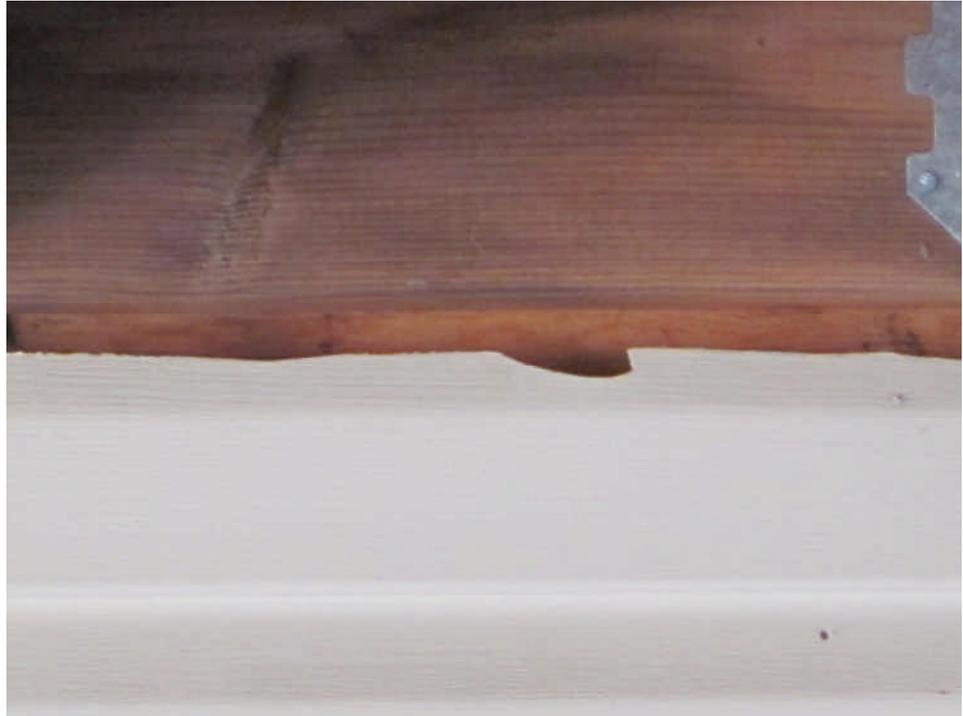
Siding Condition:

Attention Needed - The exterior siding material or finish is in a condition that requires minor repair to prevent further deterioration.

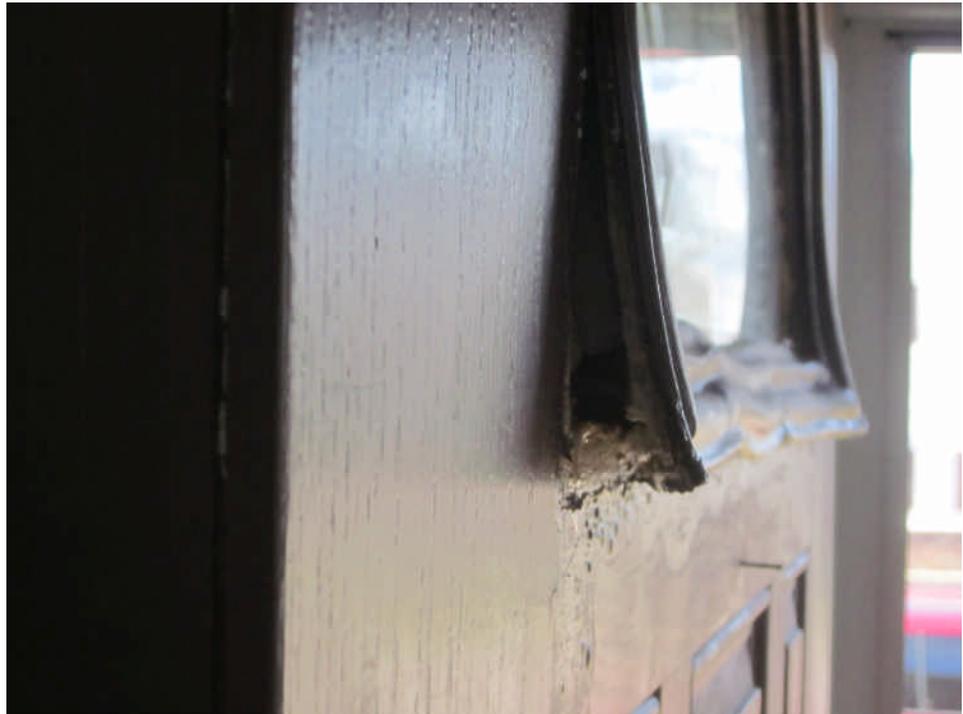
**Outside Entry
Doors:**

Action Necessary - The outside entry door is in need of repair or replacement.

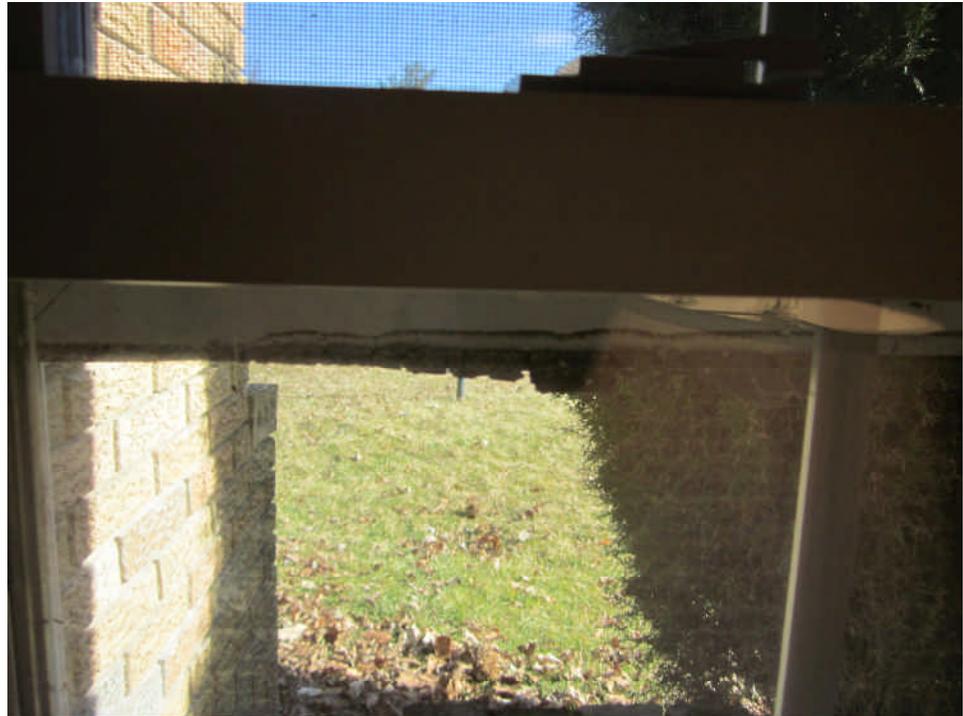
Window Condition:

Insulation Seal - One or more insulated glass windows have lost their vacuum seal. As a result of losing this seal, condensation between the two panes creates a clouded or streaked appearance. The window still performs the task of keeping the weather out, but it has lost much efficiency.

The windows are very tight and tough to open; further investigation is needed to determine the cause of this. Is it possible that the wood frames have swelled due to flooding issues?

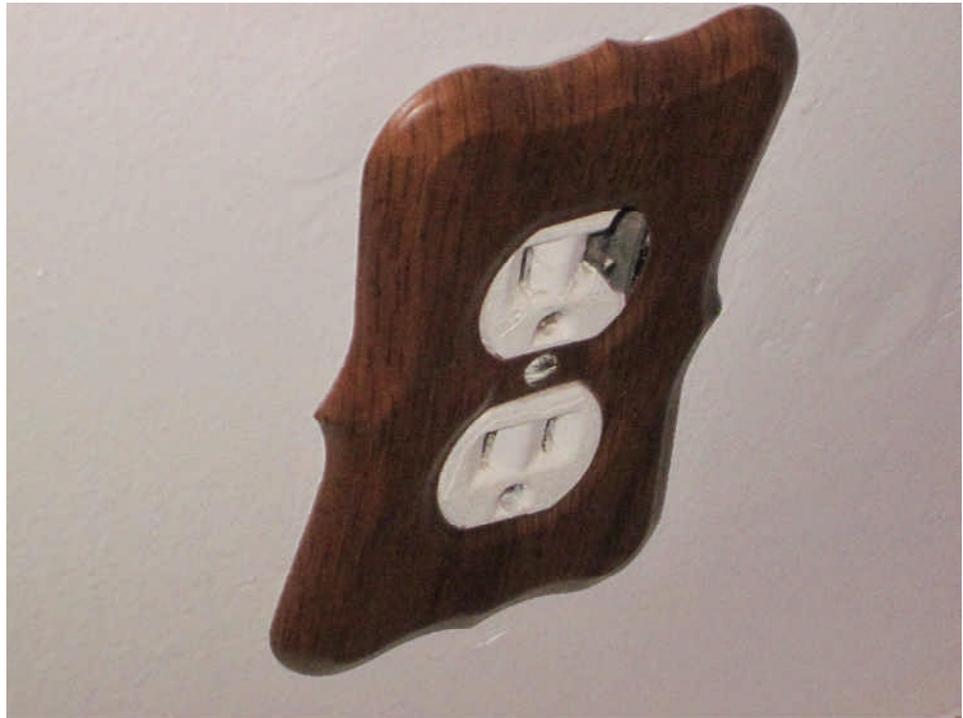
Living Room:

Action Necessary - At least one outlet tested in this room needs to be replaced.

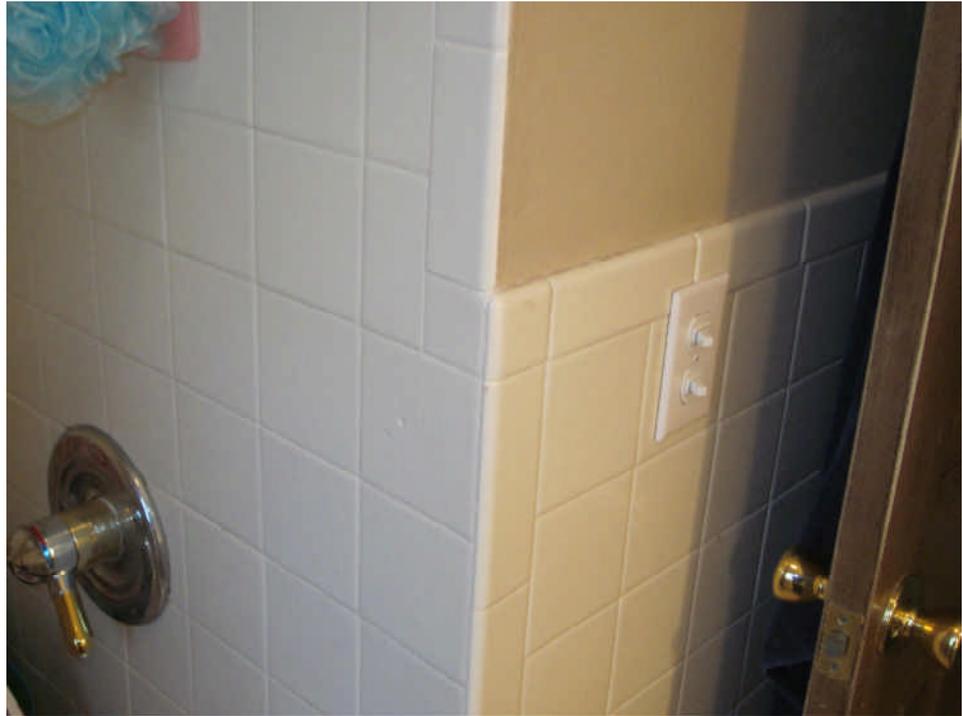
Light Switch:
Master Bathroom:

For safety reasons, it should not be located within reach while in the tub/shower.

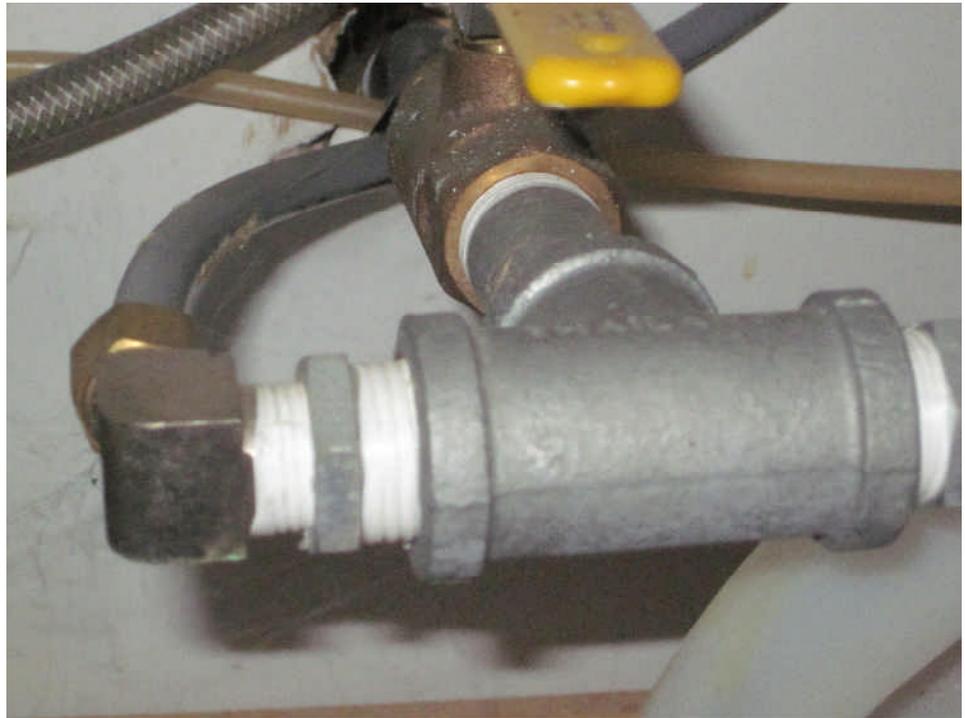
There are dis-similar metals being used in the second floor kitchen.

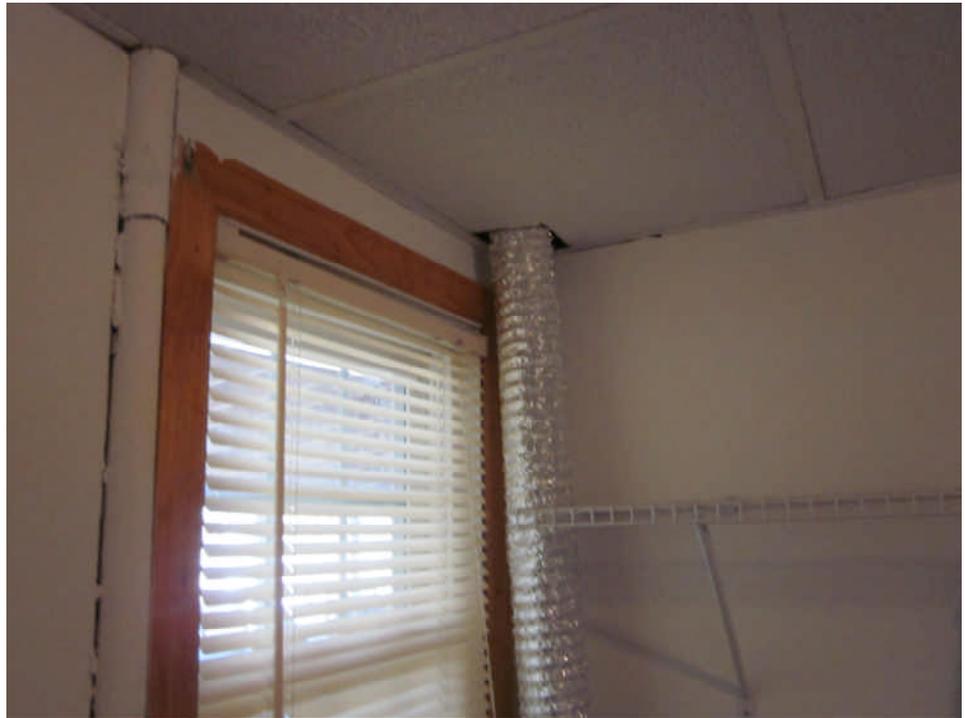
Windows:

The windows are very tight and tough to open; further investigation is needed to determine the cause of this. Is it possible that the wood frames have swelled due to flooding issues?
Air leakage is also noted around this window.

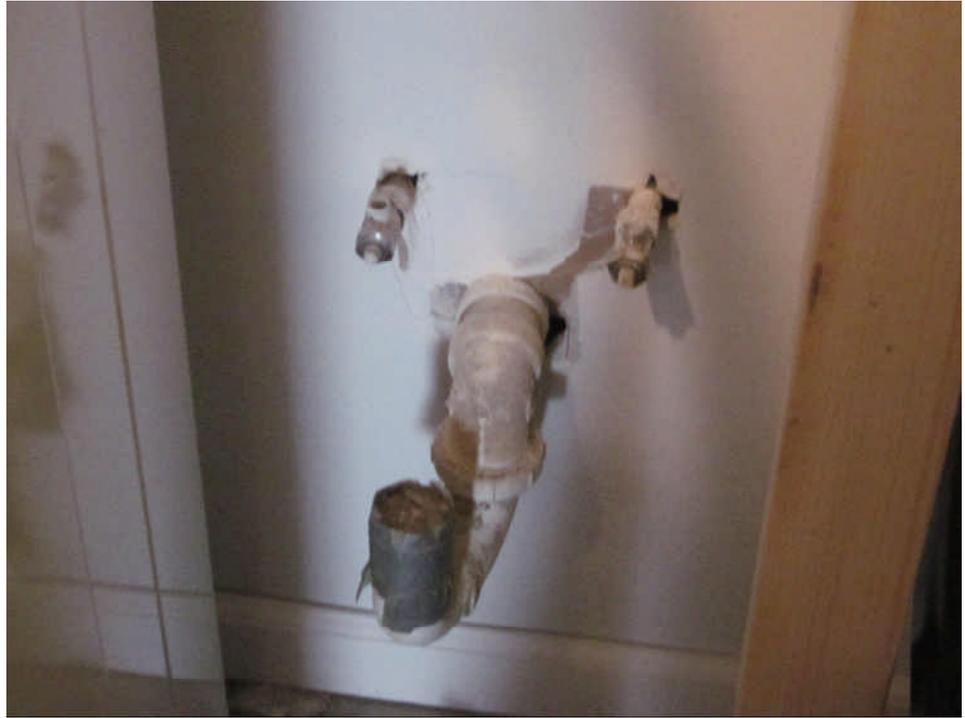
Laundry Basin:

Disconnected.

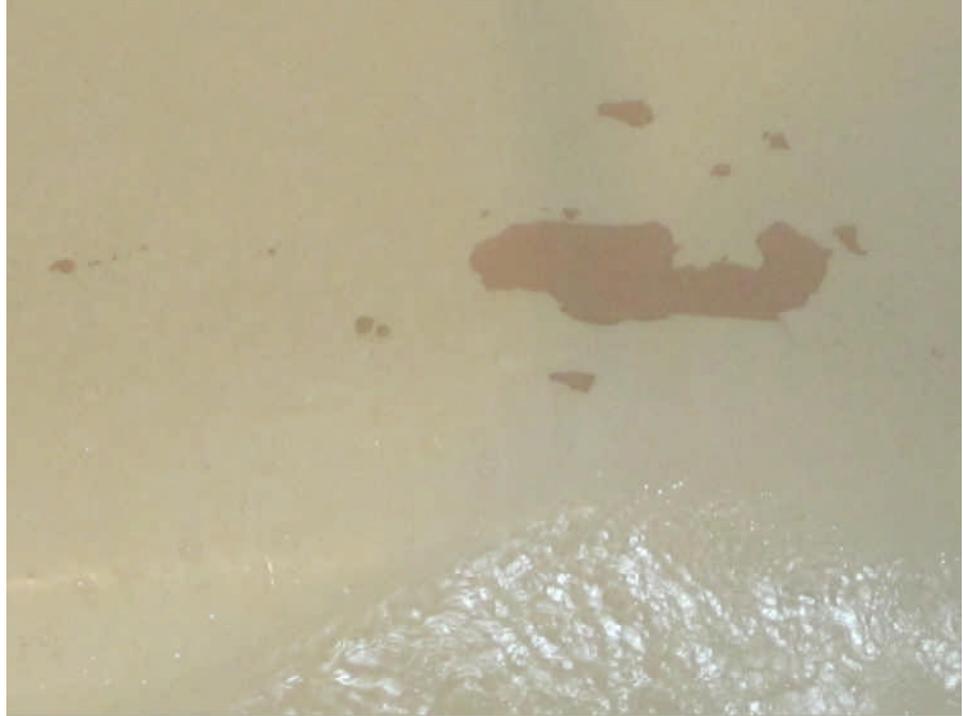
The steel tub needs re-touching.

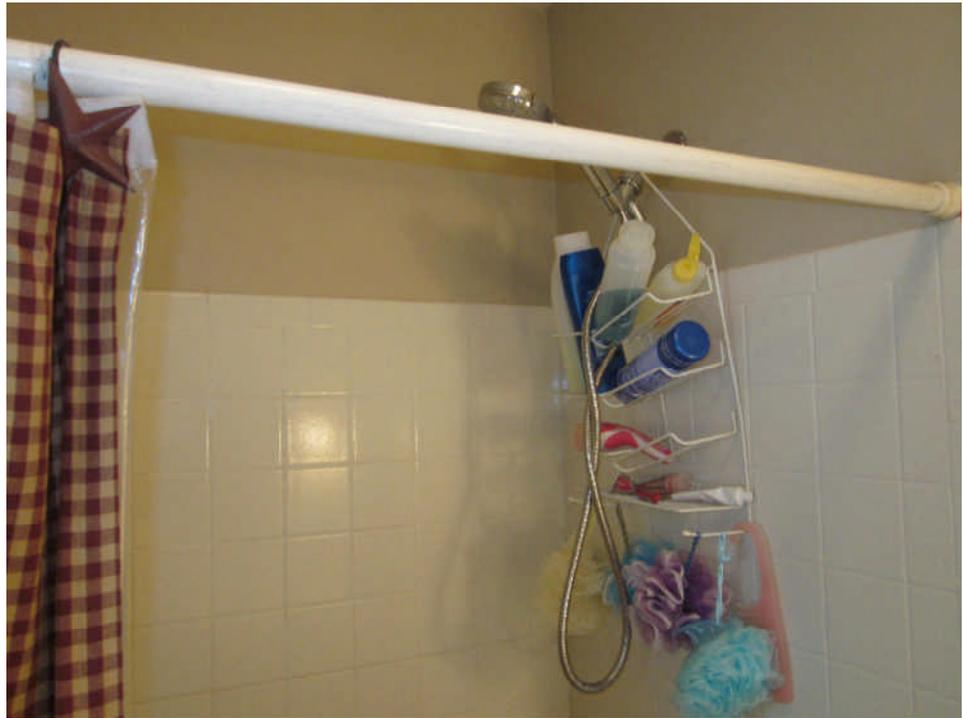
**Glass Tub/
Shower Door:**

There are no doors on the tub or shower. This is the most efficient way to prevent moisture damage caused by water getting out of the tub/shower. Consideration should be given to installing them.

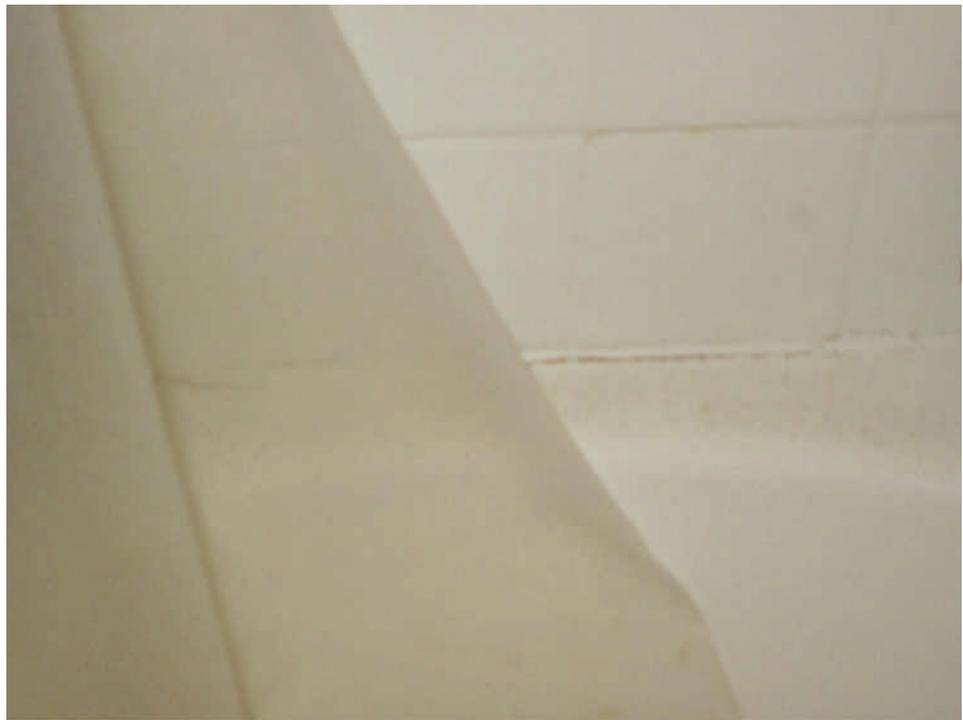
**Caulking/Water
Contact Areas:**

Attention Needed - The caulking in the water contact areas appears to need attention. Damage may result if not corrected.

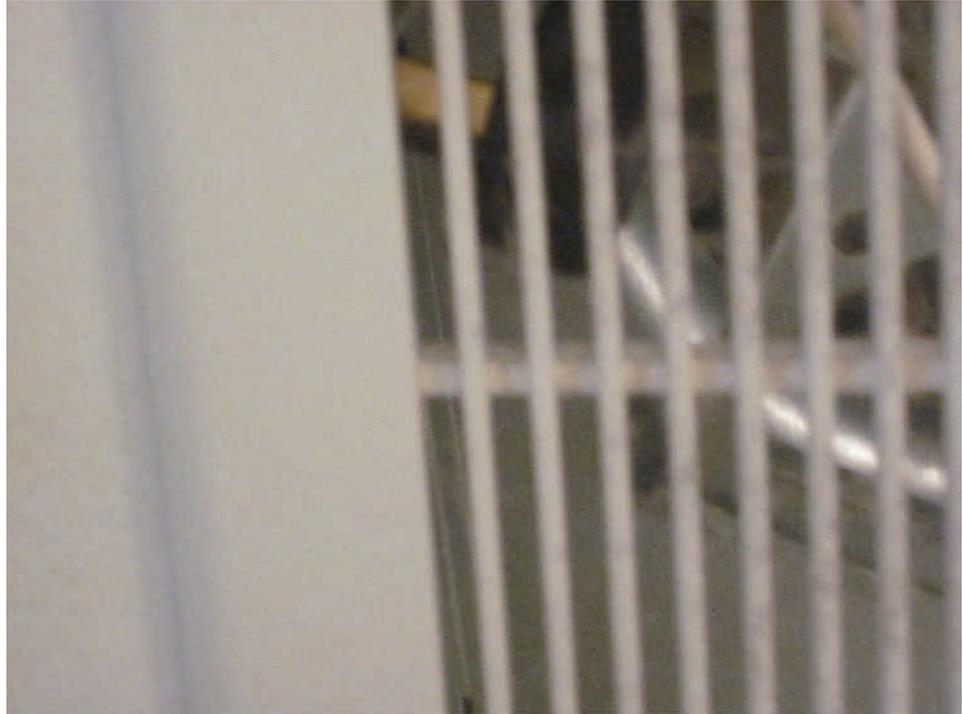
The electric to the fan is disconnected- The ventilation fan vents into the attic space. This introduces moisture into the attic that must be removed from the attic. It would be better to vent the bathroom to the outside rather than the attic.

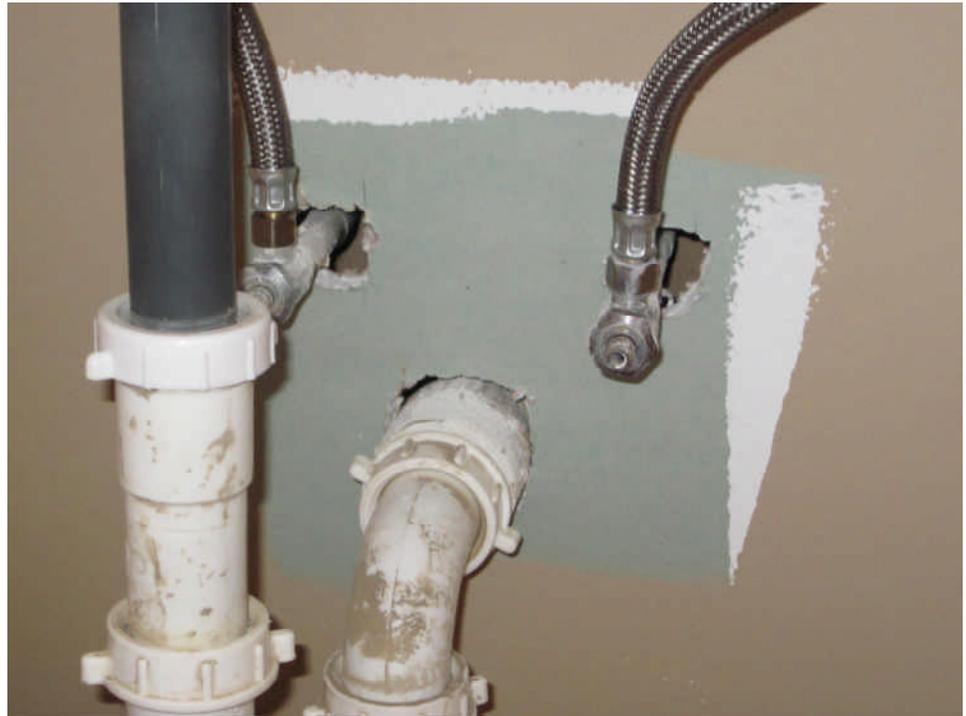
**Faucet and
Supply Lines:**

There are no shutoffs installed for both hot and cold water pipes under the basin.

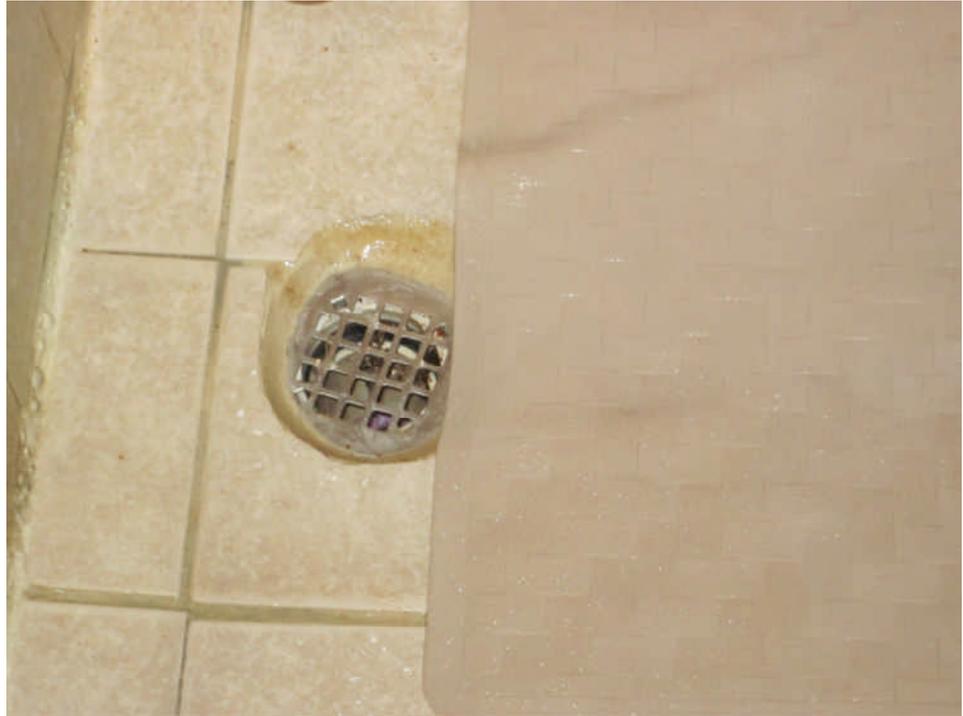
**Tub/Shower
Drain:**

The drain is not installed properly. You can cut yourself or trip.

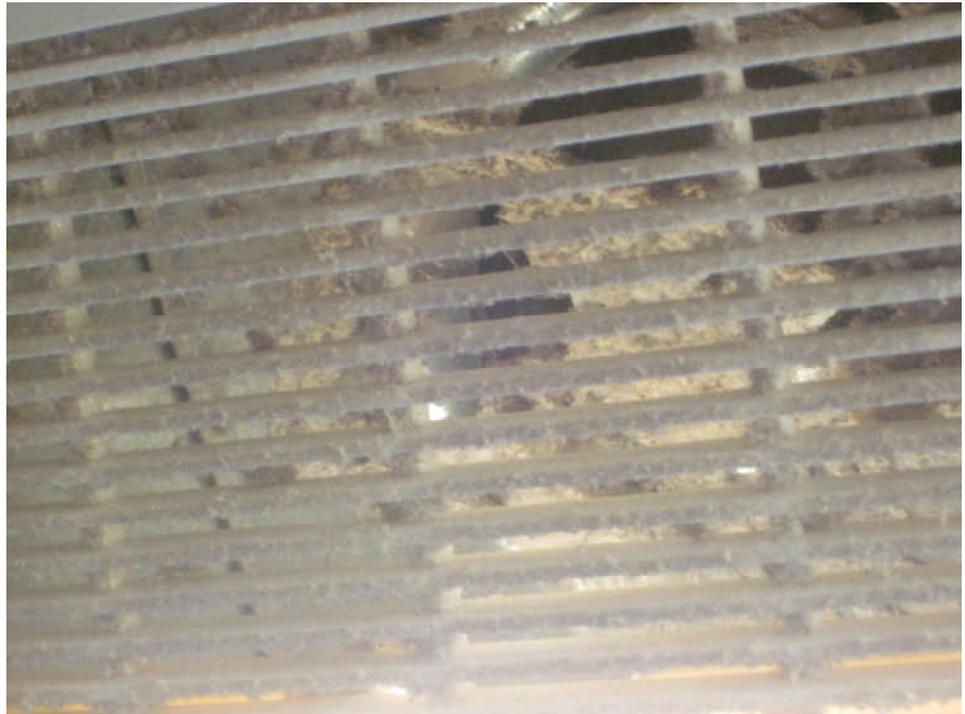
Ventilation Fans:

Attention Needed - There is an exhaust fan installed in this bathroom, but it does not appear to be removing air at a satisfactory rate. Cleaning or repair is indicated.

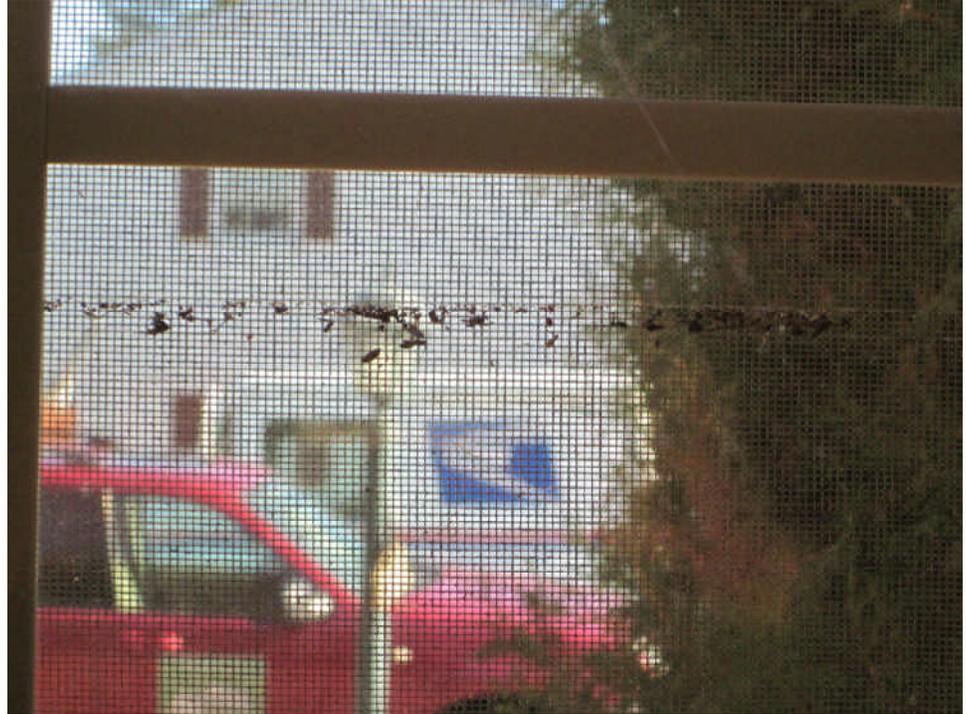
The windows are very tight and tough to open; further investigation is needed to determine the cause of this. Is it possible that the wood frames have swelled due to flooding issues?
Water or dirt/mud lines are visible at a height of about 5'-6' all around the windows and screens from previous flooding.

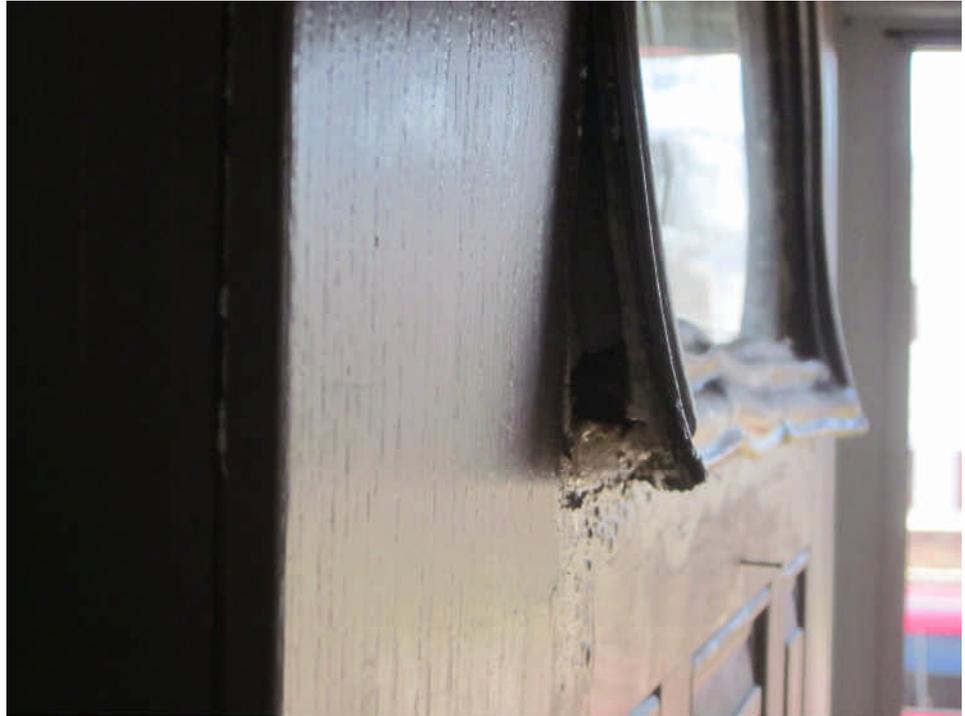
Front Entry Door:

Action Necessary - The main entry door needs repair or replacement.

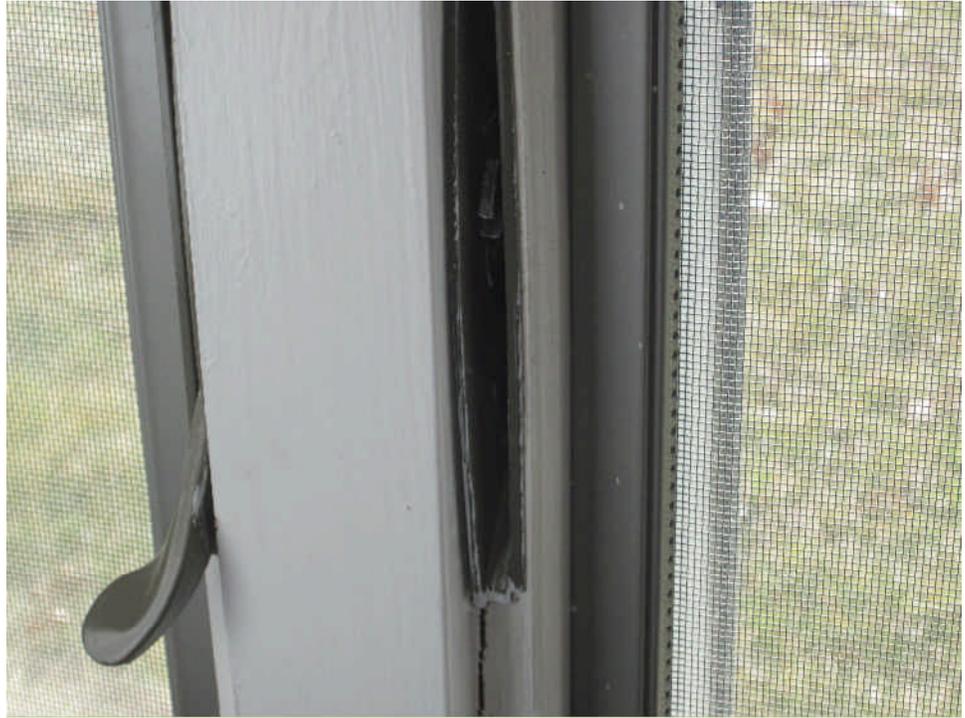
Windows:

Crank out type. One of the windows has a broken lock. Some screens are also missing.
