Report: ATO19002

Fatigue Testing of Bare and TDZ Specimens

Submitted To:
Zvi Ben-Zvi
Atomic Alloys
Houston, TX - USA

December 6, 2019

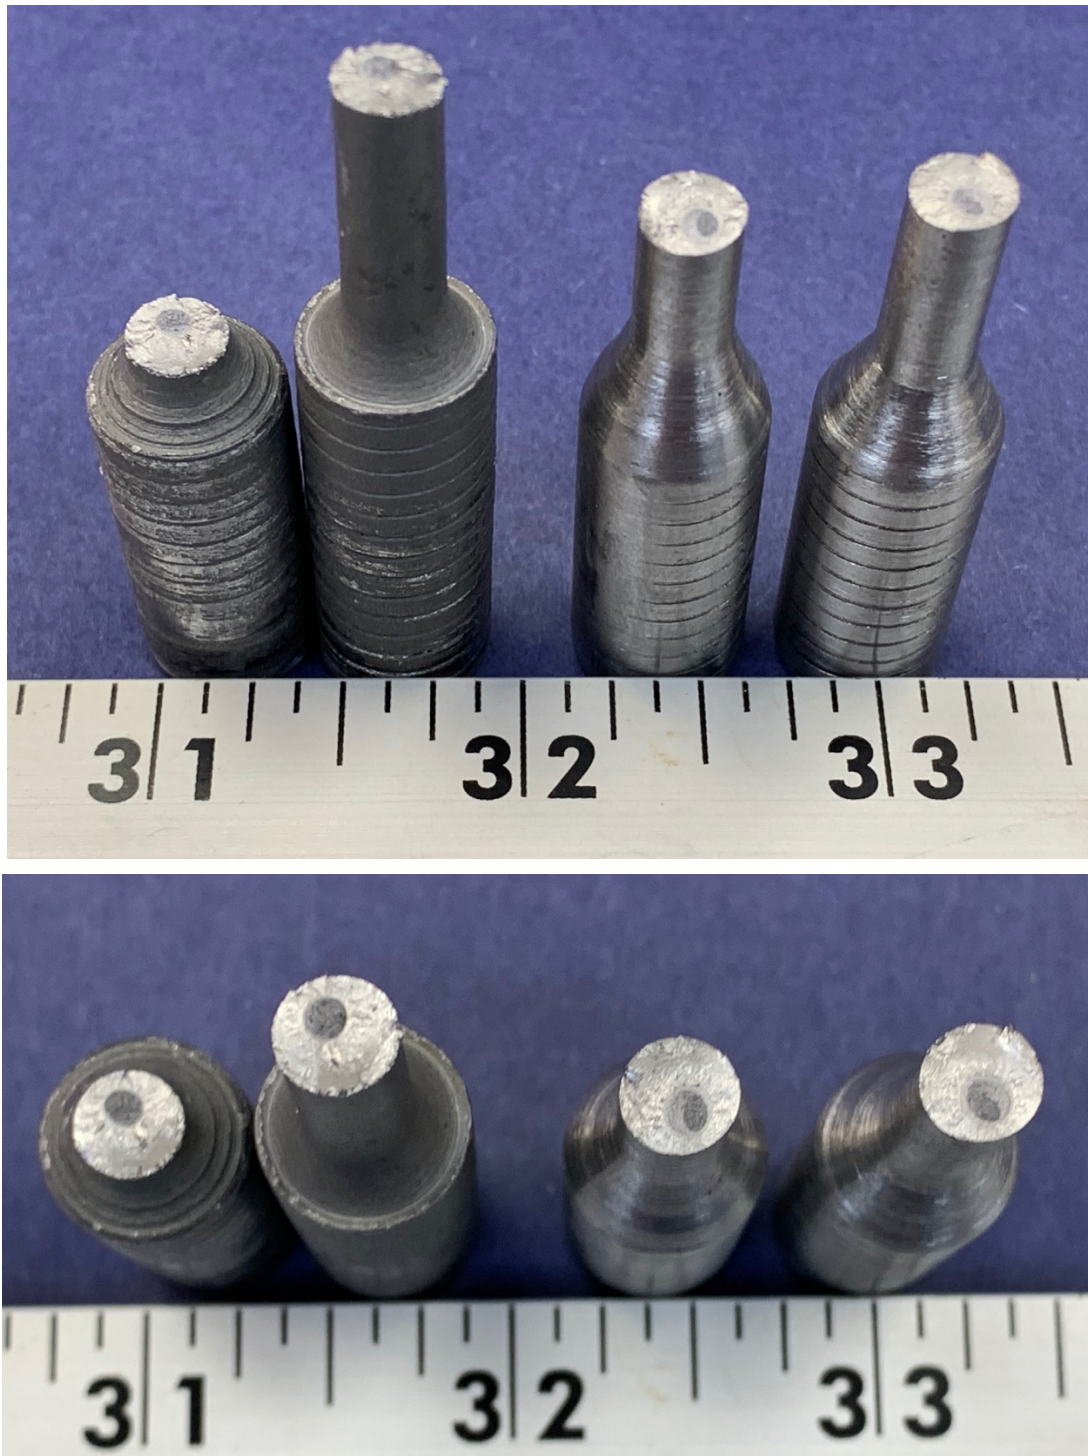
- Both specimens broke after 23,000 cycles of fatigue testing (the measurement system tracks by thousands of cycles).
- The fracture surfaces of both specimens are identical.
- Based on these initial results, it does not appear that there is a substantial effect of TDZ coating on fatigue strength.

Figure 2: Photograph of the (left) TDZ and (right) bare bolt fatigue testing specimen after fracturing to observe the crack propagation. The dark gray area is the final fracture surface that occurred during the crack opening process.
