# Alamo Cenotaph

## Investigation & Restoration

**Texas Historical Commission Update**  
**SAL Permit #HS 1120**

July 26, 2024

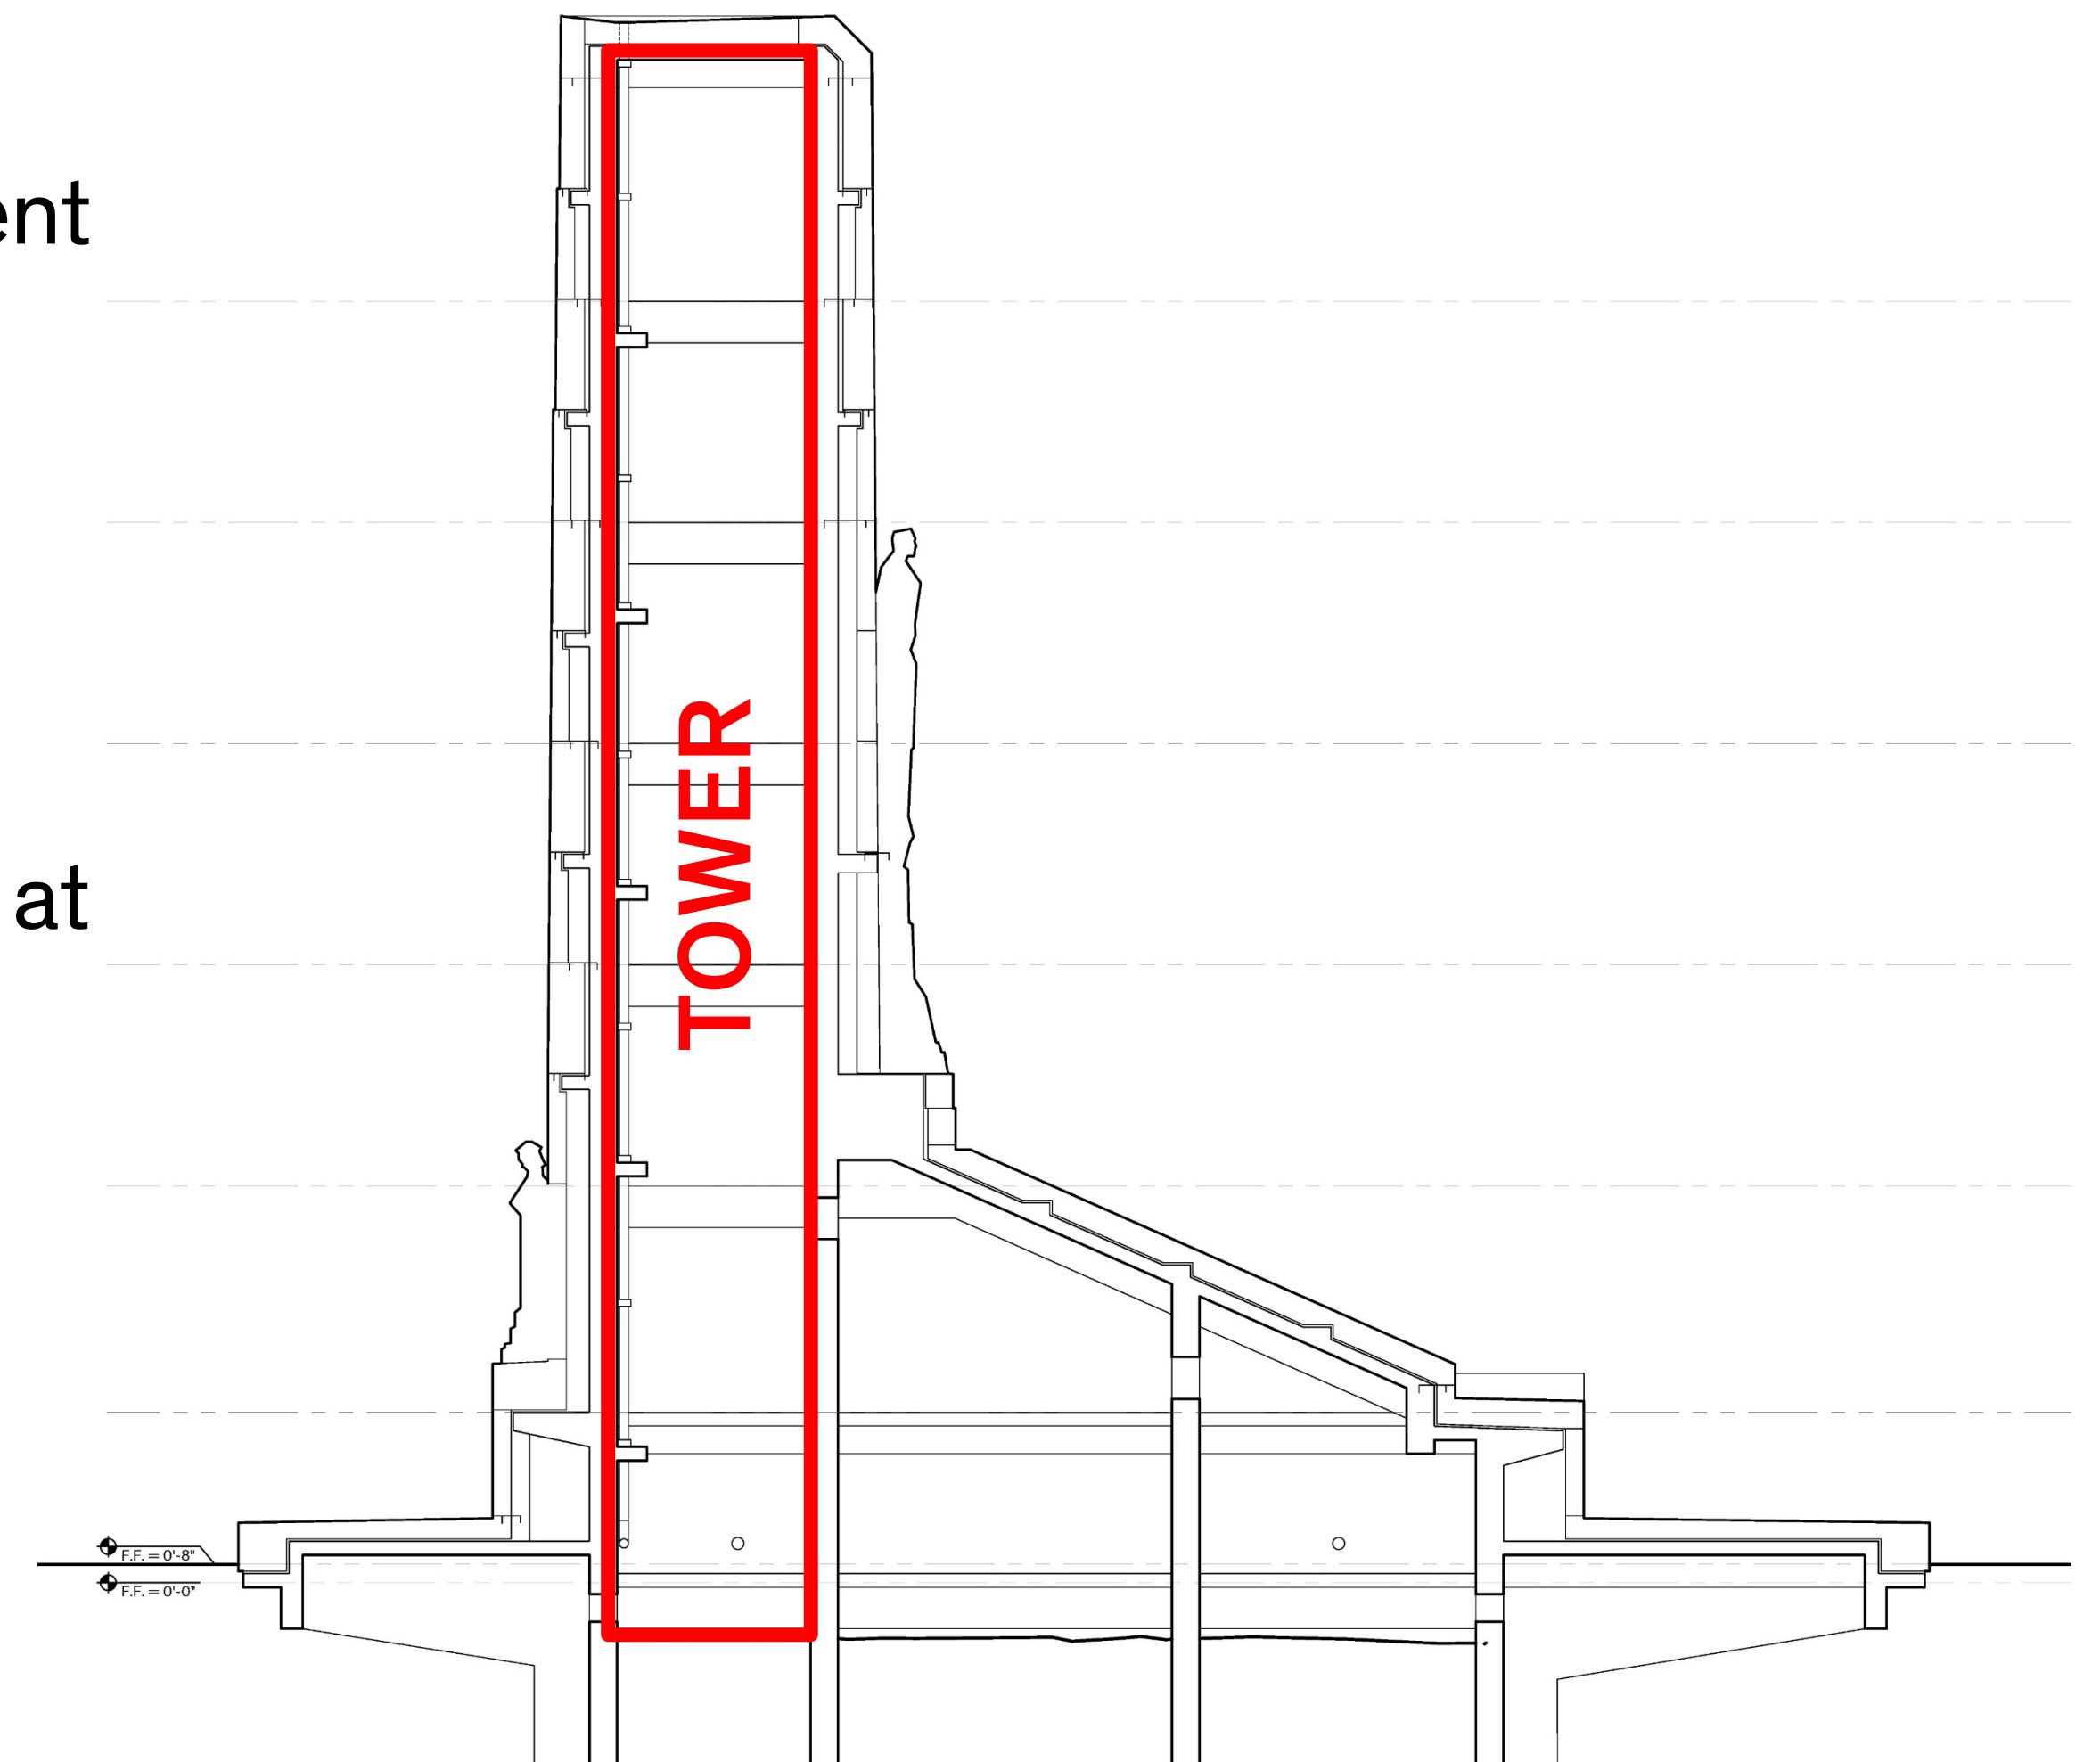
- Low concrete cover depth, exposed reinforcement
- Concrete carbonation
  - Concrete pH = 5 (12 is typical)
  - Carbonation depth of 1.5" from both sides at south wall
- Interior atmospheric conditions
  - Visible water infiltration
  - Insufficient air flow

*Initial investigation area*

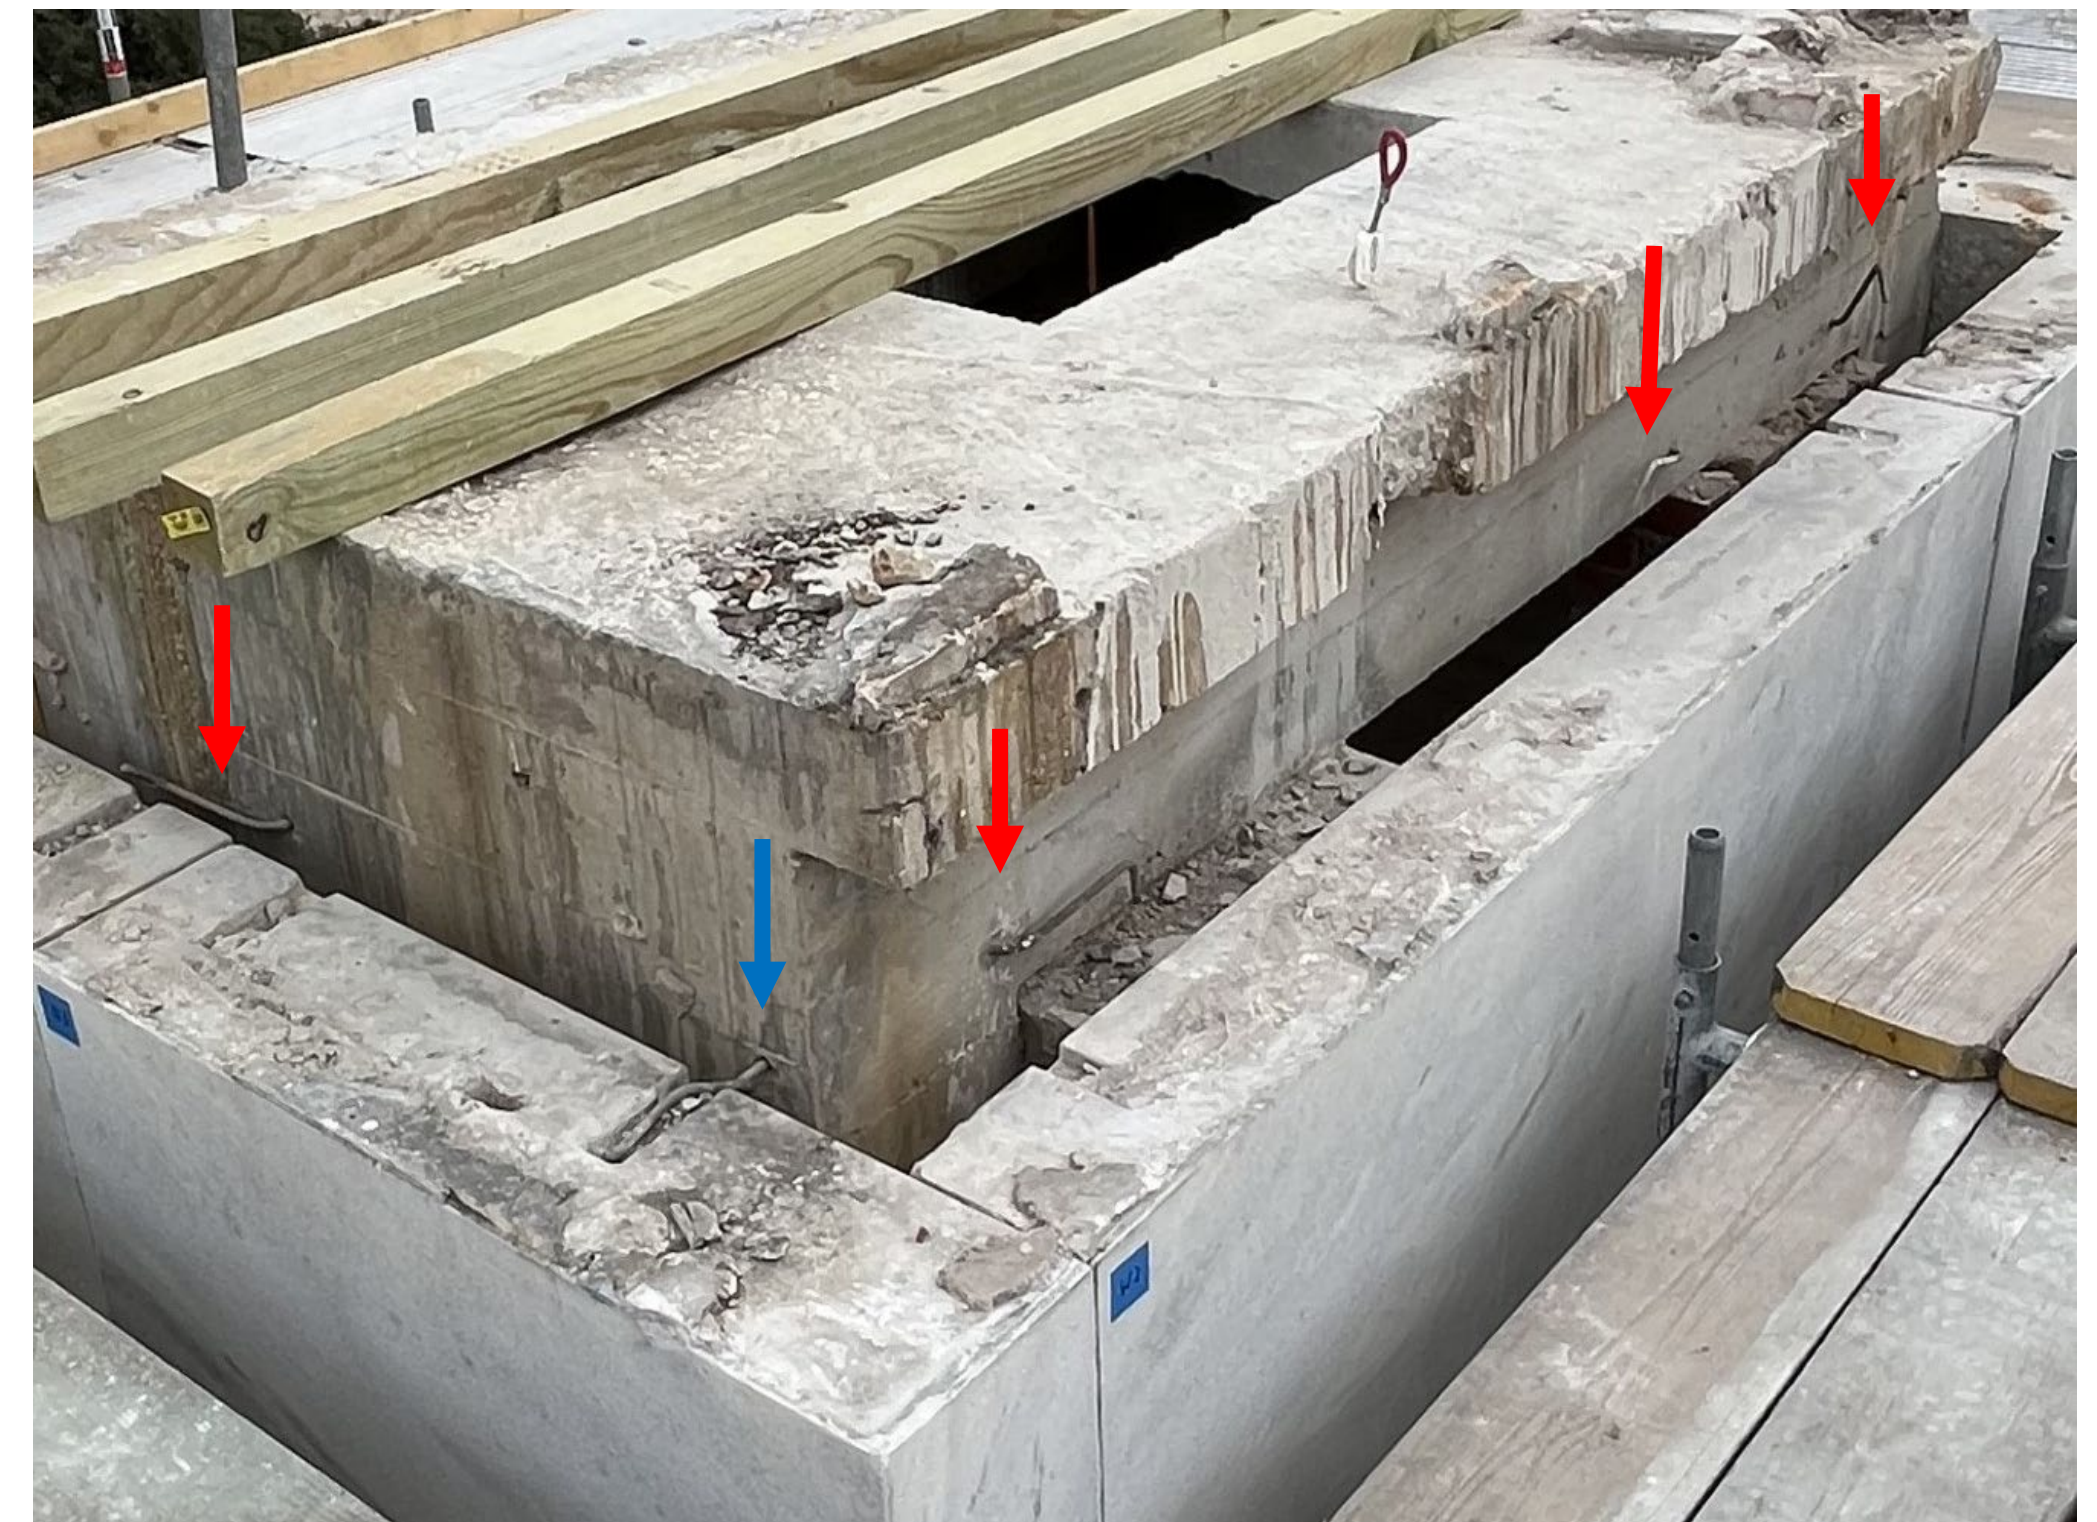
- Stone anchors
  - Missing and improperly attached stone anchors
- Exterior marble condition
  - Displacement
  - Spalling, cracking, joint damage
  - Soiling

*Stone anchors*

- Environmental control measures
  - Increase interior ventilation
  - Long-term monitoring
- Restoration of marble
  - Complete cleaning
  - Complete marble restoration
  - Reinstall marble with correct anchoring
  - Existing aluminum anchors can be cut and left embedded in concrete as required

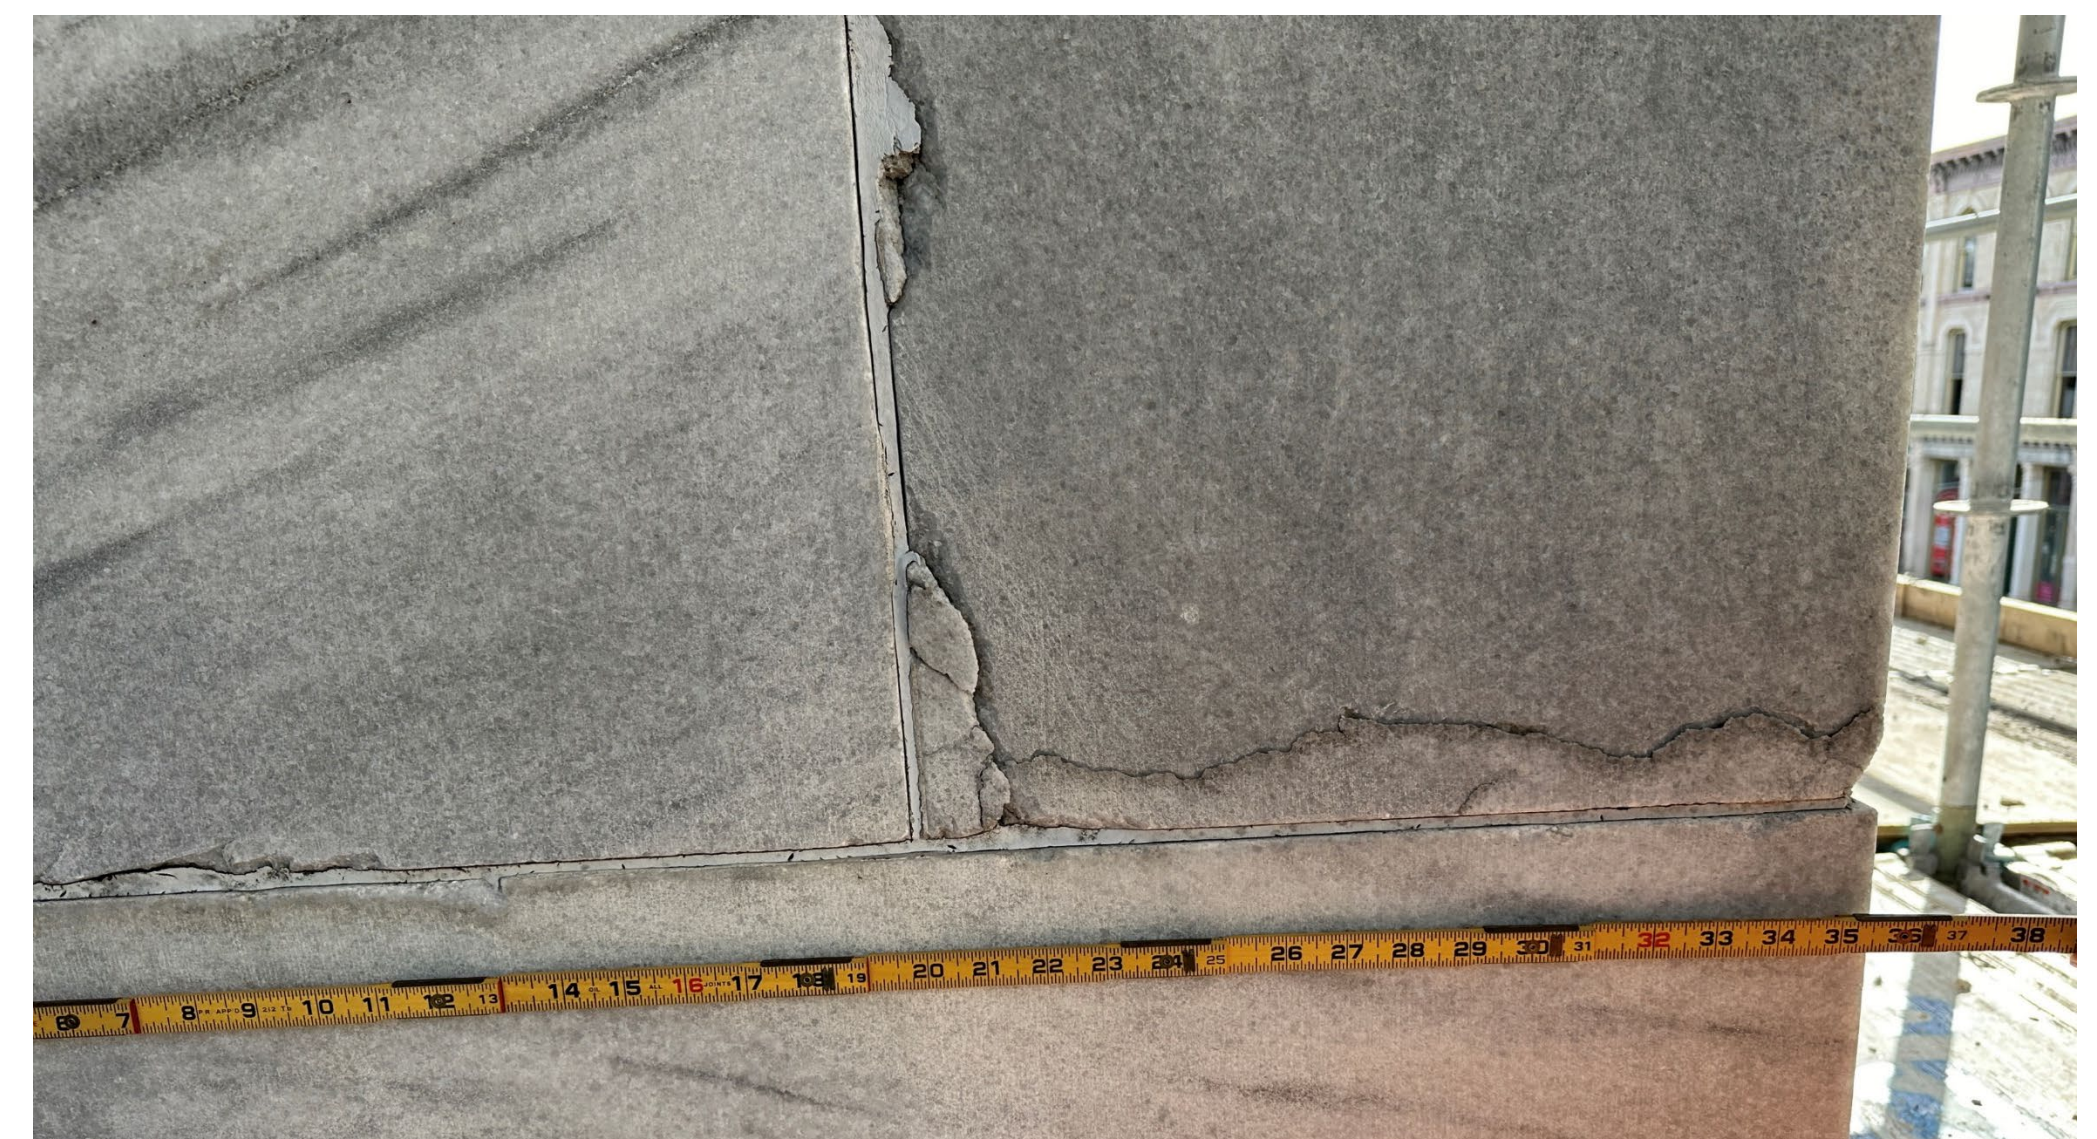
*Marble damage at joints*

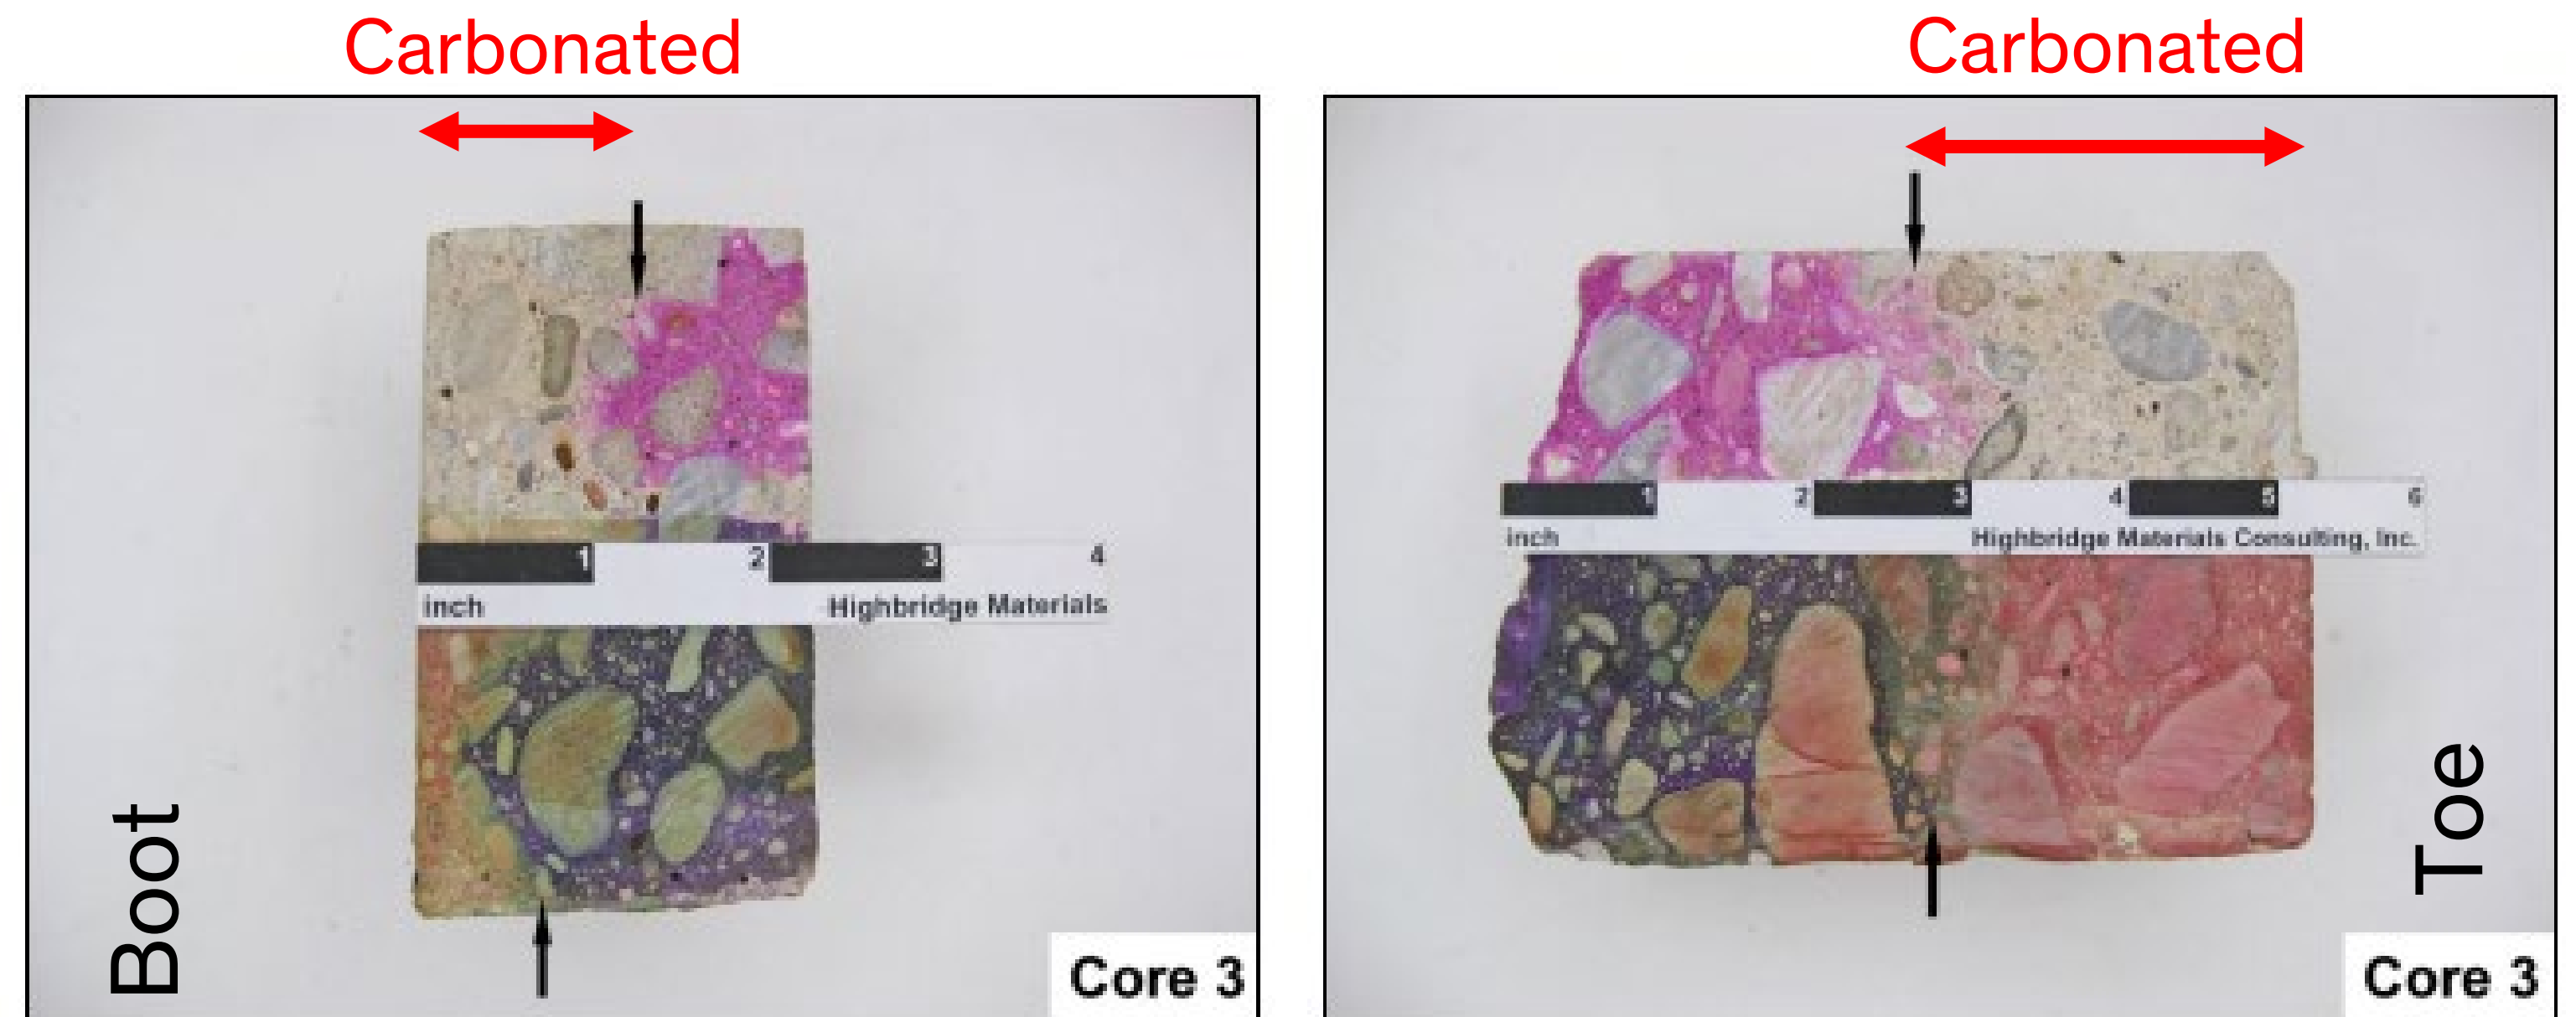
- Depth of carbonation ranges from 1" – 2.5"
- Concrete pH = 8-10 (12 is typical)
- Concrete below grade has negligible carbonation

*Above grade concrete core at south boot wall*

- Removal and replacement of brick infill
- Realkalization treatment of carbonated concrete
  - All beams require realkalization
  - North and south walls to be considered for realkalization
  - Realkalization area will depend on how much marble cladding is removed
  - Expose 1 foot of concrete structure below grade for treatment
- Apply protective anti-carbonation coating to all accessible concrete surfaces

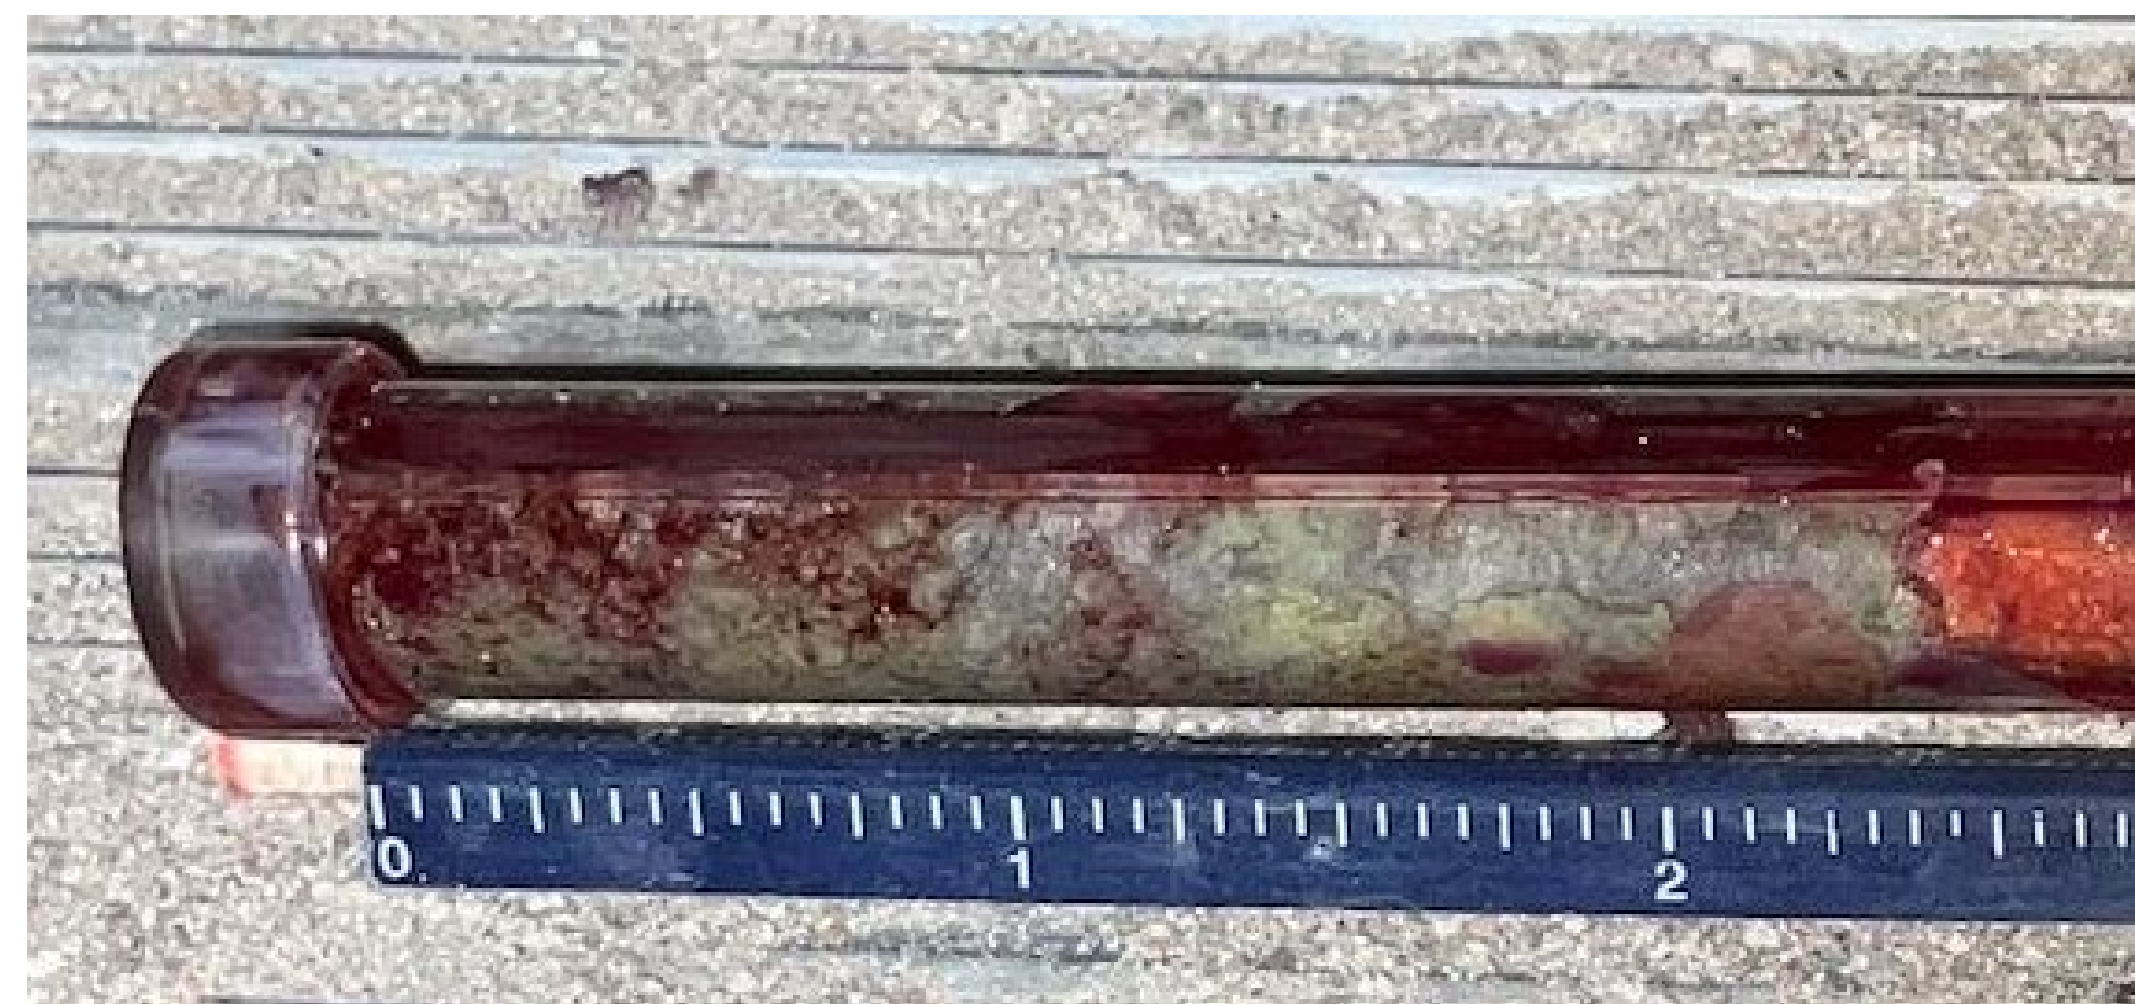
*On-site carbonation testing*

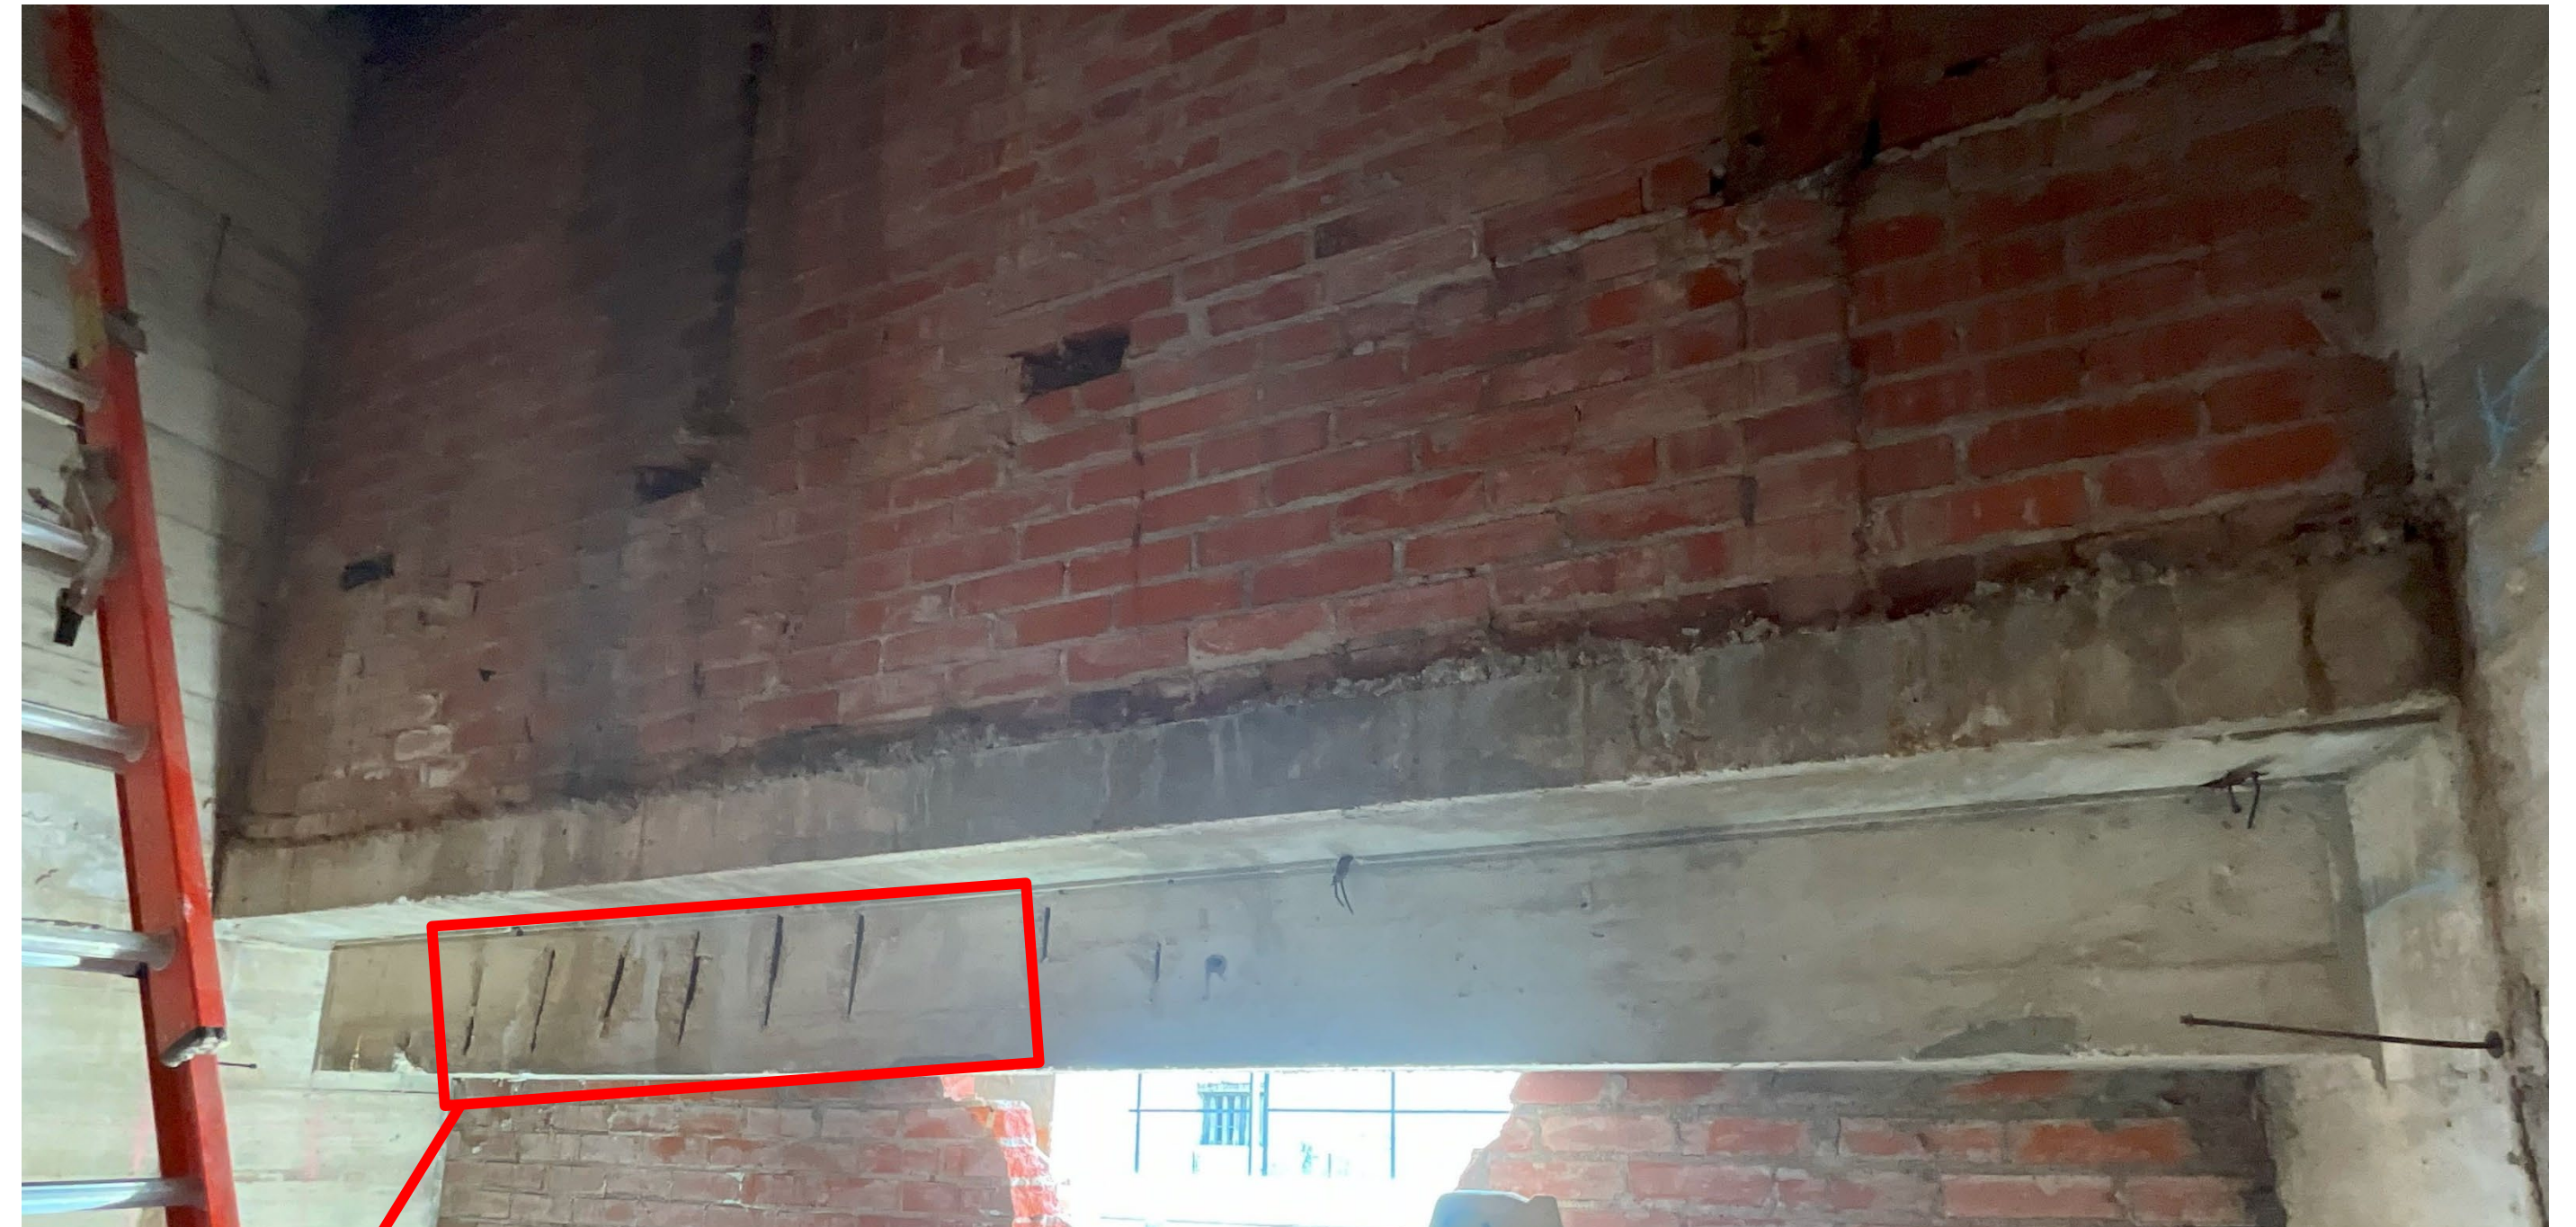
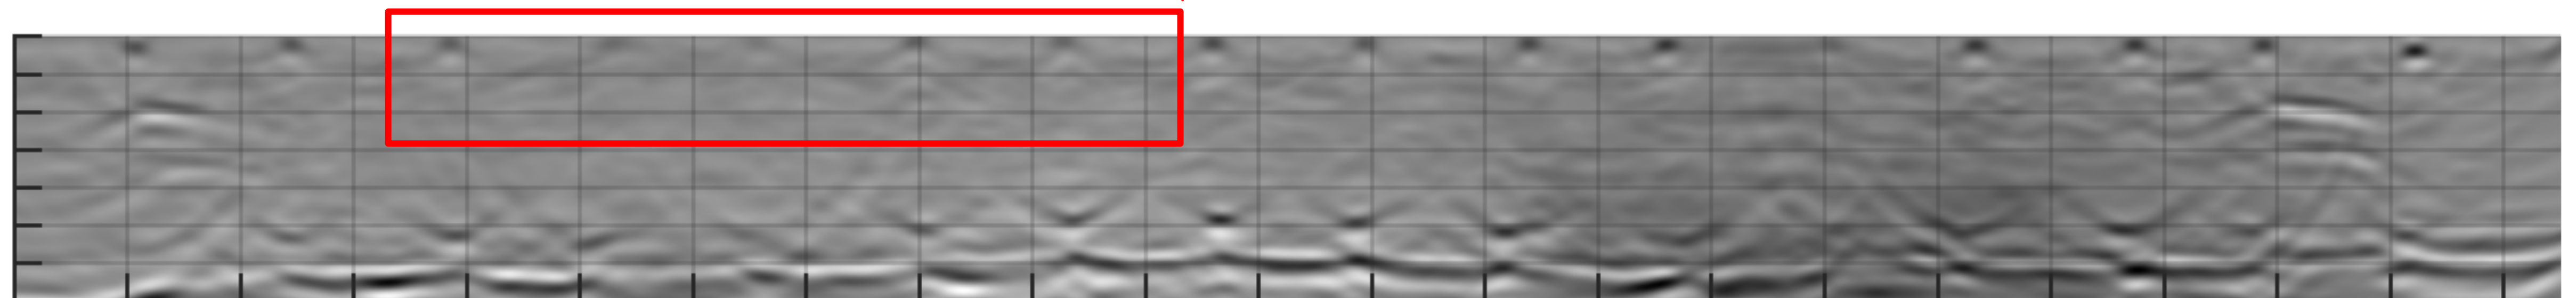
- Cover thickness varies between and within elevations
- North wall has thickest cover
- East beam has lowest cover
- Cover thickness is less than the depth of carbonation in many areas

*Ground penetrating radar scan*

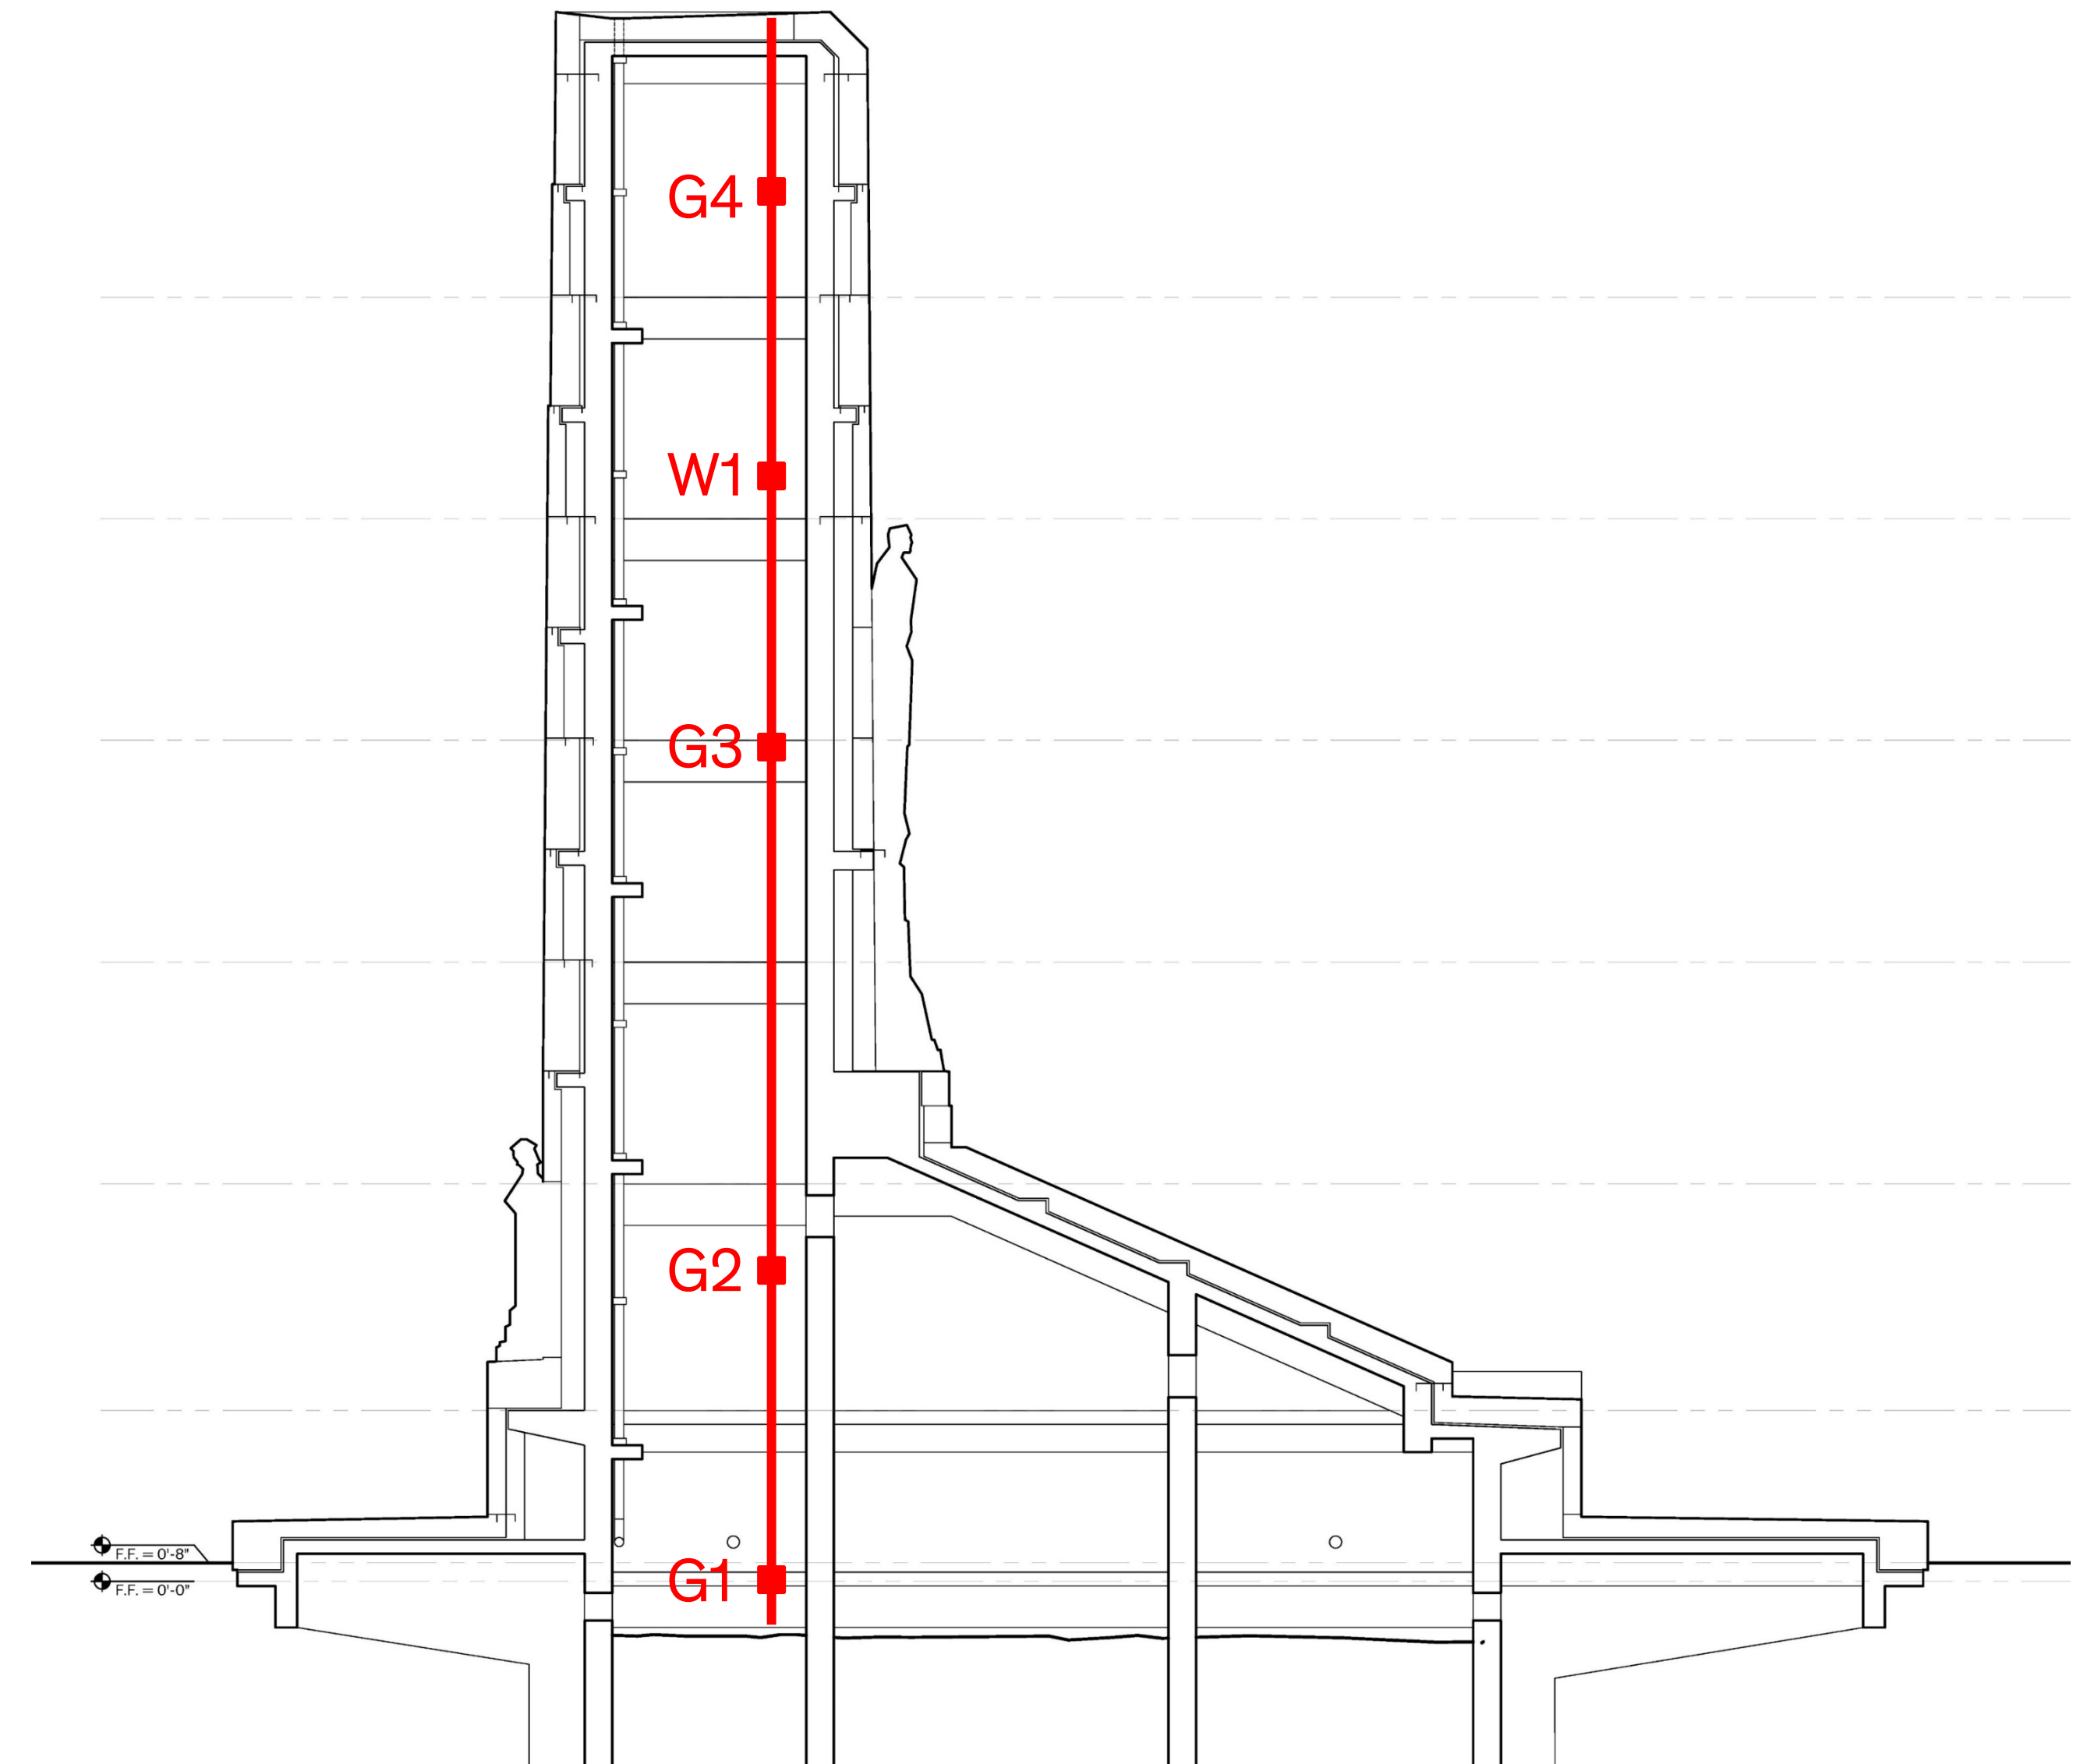
- Temperature and RH fluctuates daily (more fluctuation on top and bottom of tower)
- Higher average temperature at top of tower
- Higher relative humidity at bottom of tower
- Interior CO<sub>2</sub> level higher than average exterior level

*Approximate sensor locations*
