# Alamo Cenotaph

## Investigation & Restoration

**Texas Historical Commission Update**  
**SAL Permit #HS 1120**

July 26, 2024

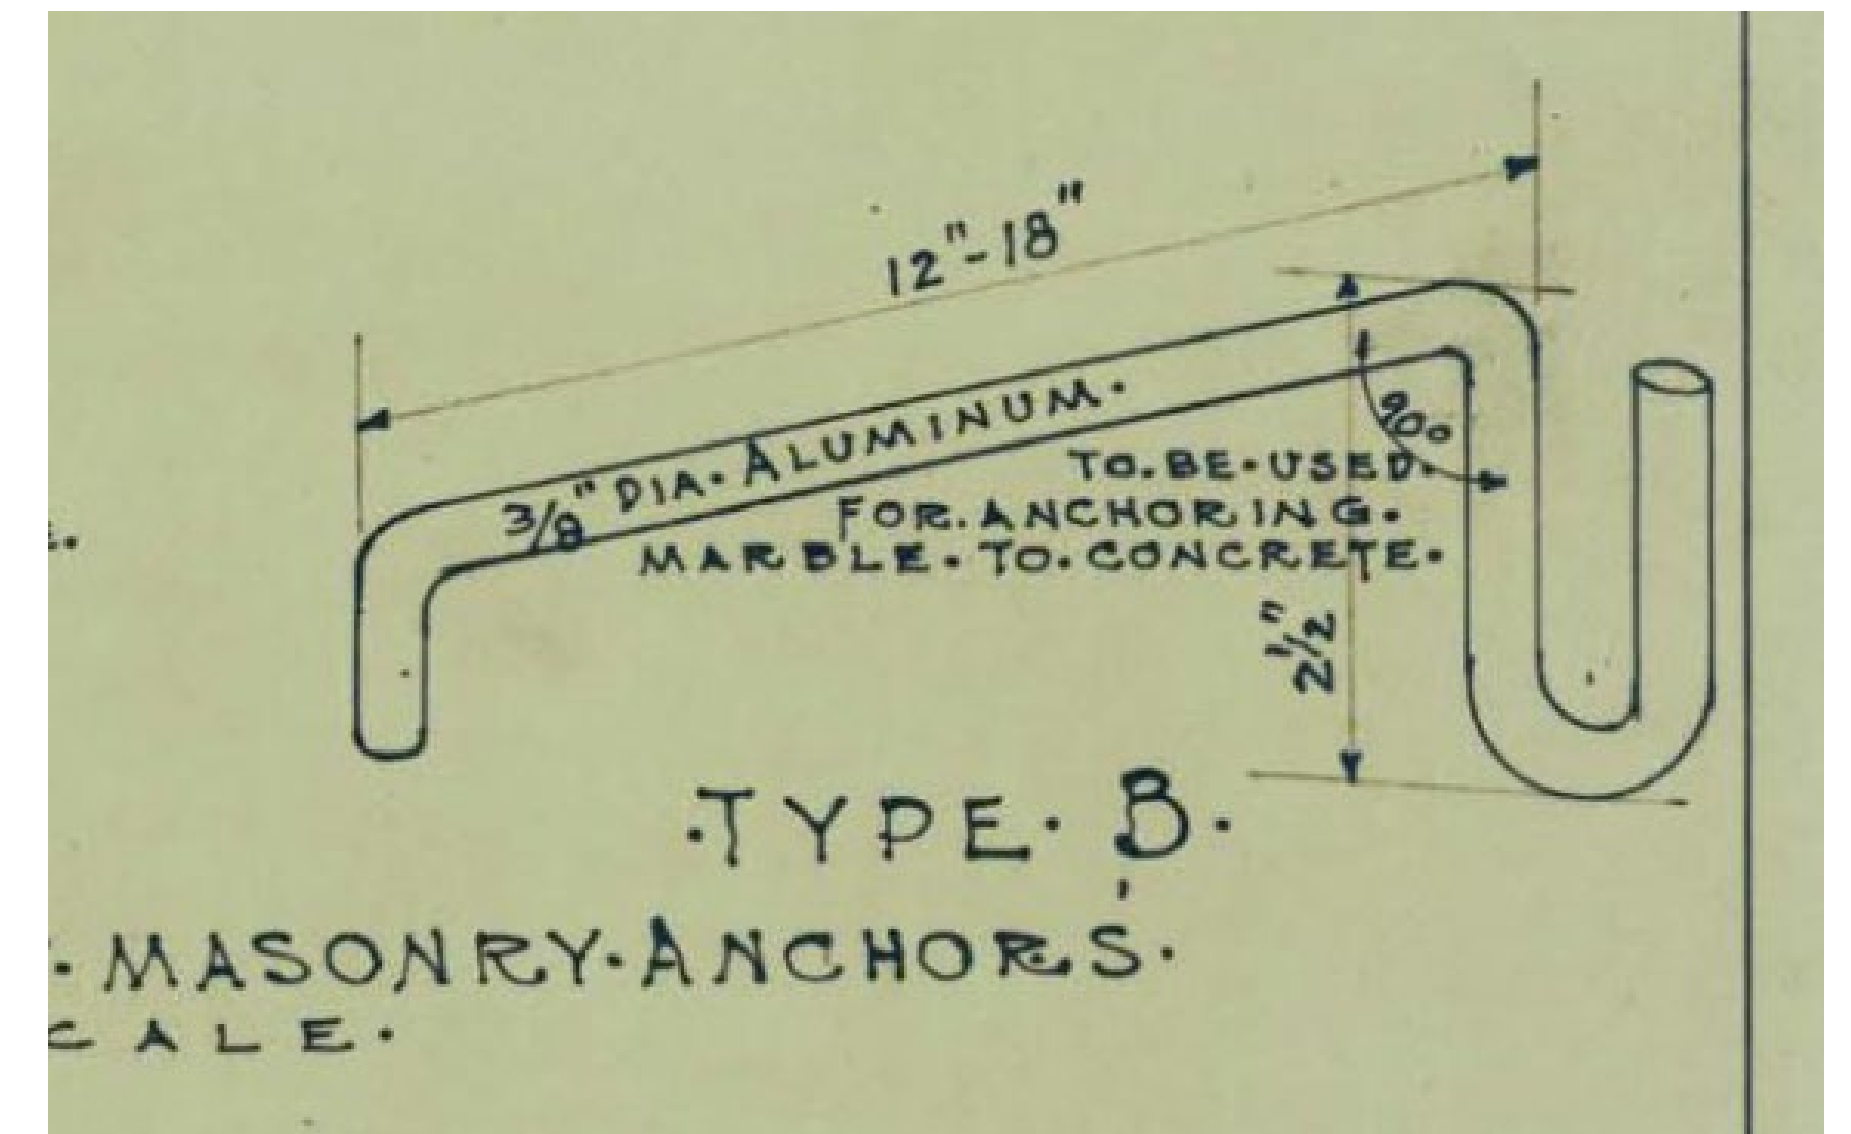
- Aluminum stone anchors
  - 95% aluminum
  - 4% copper
  - .5% iron
  - .5% magnesium
  - Alloy is safe to remain embedded in concrete
- Brick and mortar: sulfate contamination
  - In bricks: 0.3% - 0.7%
  - In mortar (20% Portland Cement): 0.8% -1.4%

*Historic anchor drawing*

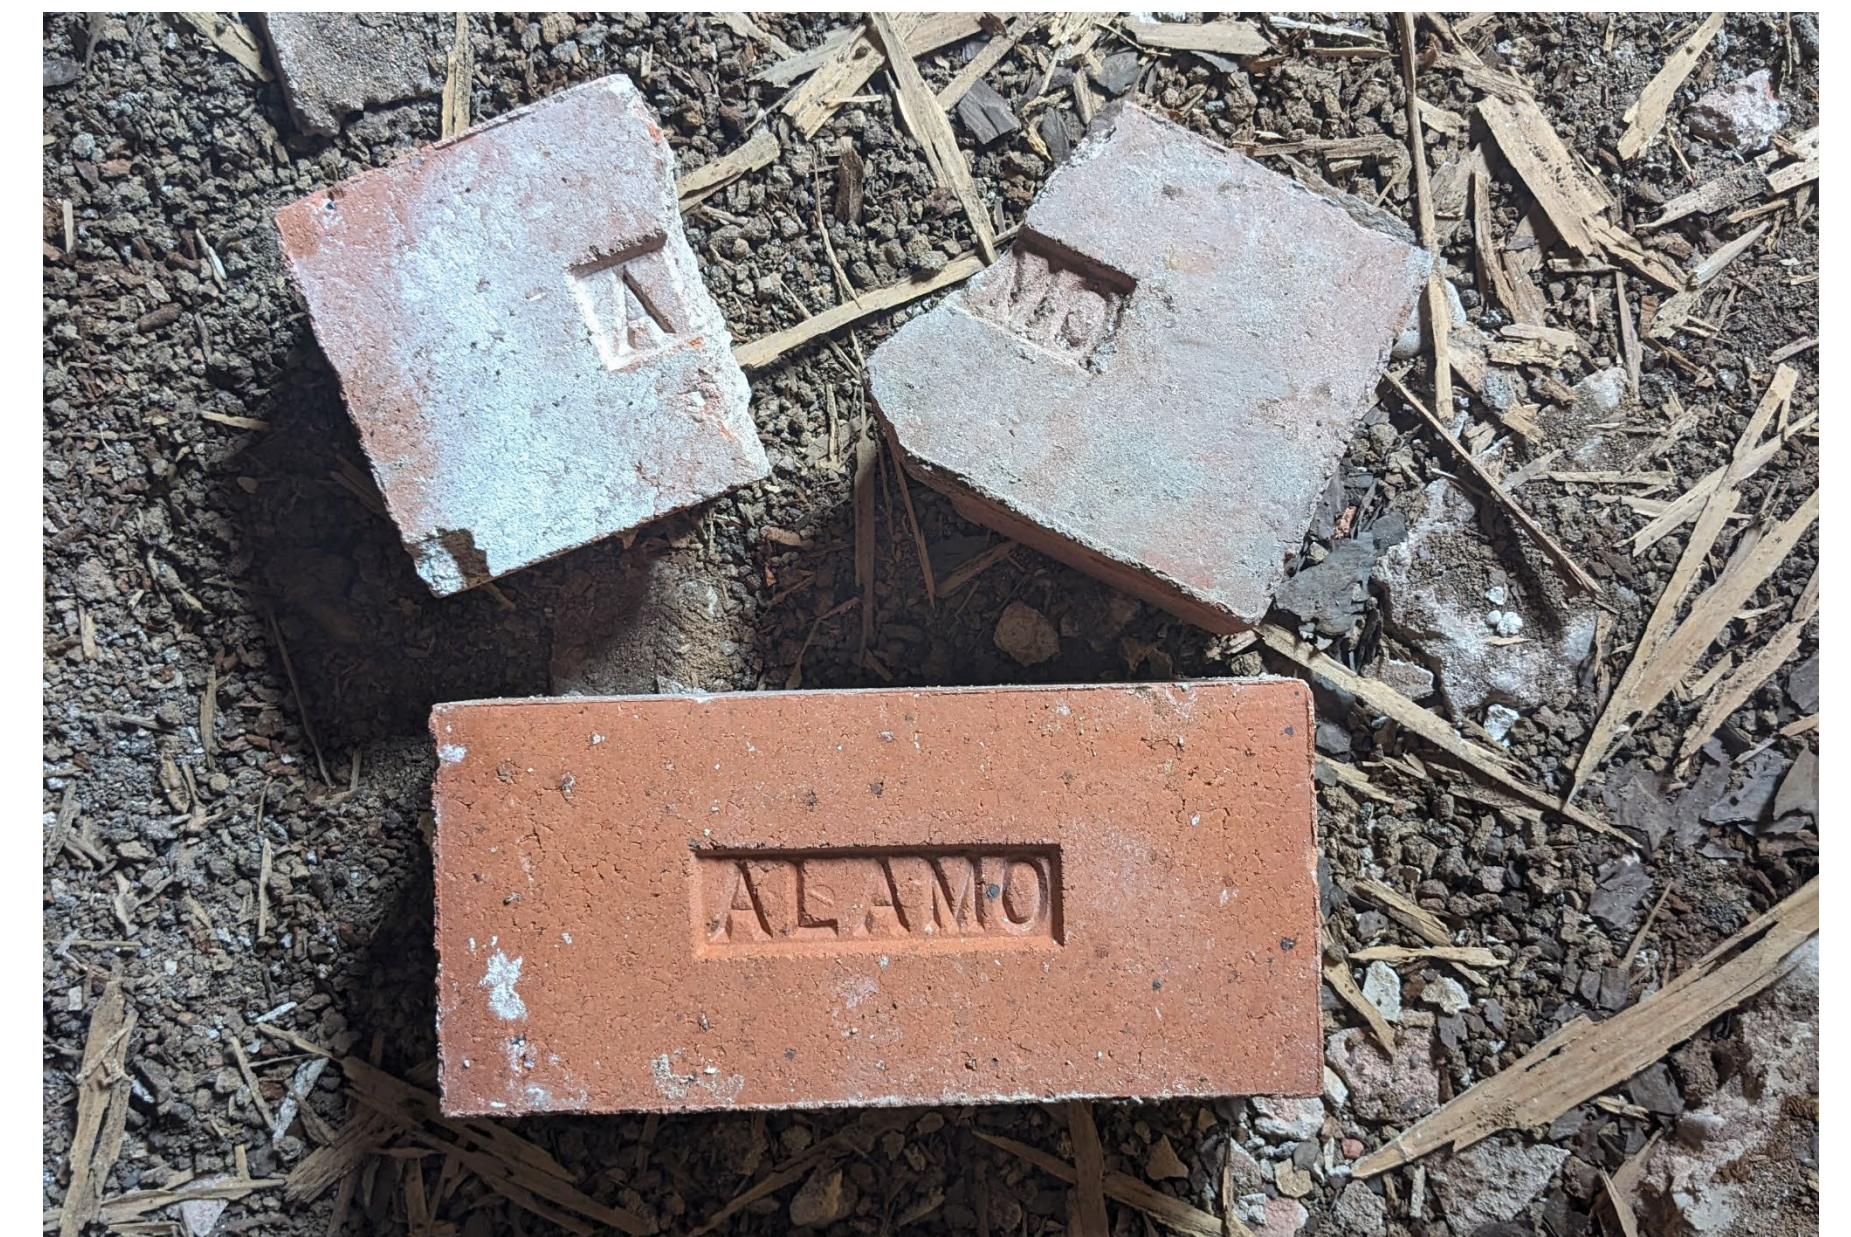
*Bricks from Cenotaph interior*

- Removal and replacement of brick infill
- Realkalization treatment of carbonated concrete
  - All beams require realkalization
  - North and south walls to be considered for realkalization
  - Realkalization area will depend on how much marble cladding is removed
  - Expose 1 foot of concrete structure below grade for treatment
- Apply protective anti-carbonation coating to all accessible concrete surfaces

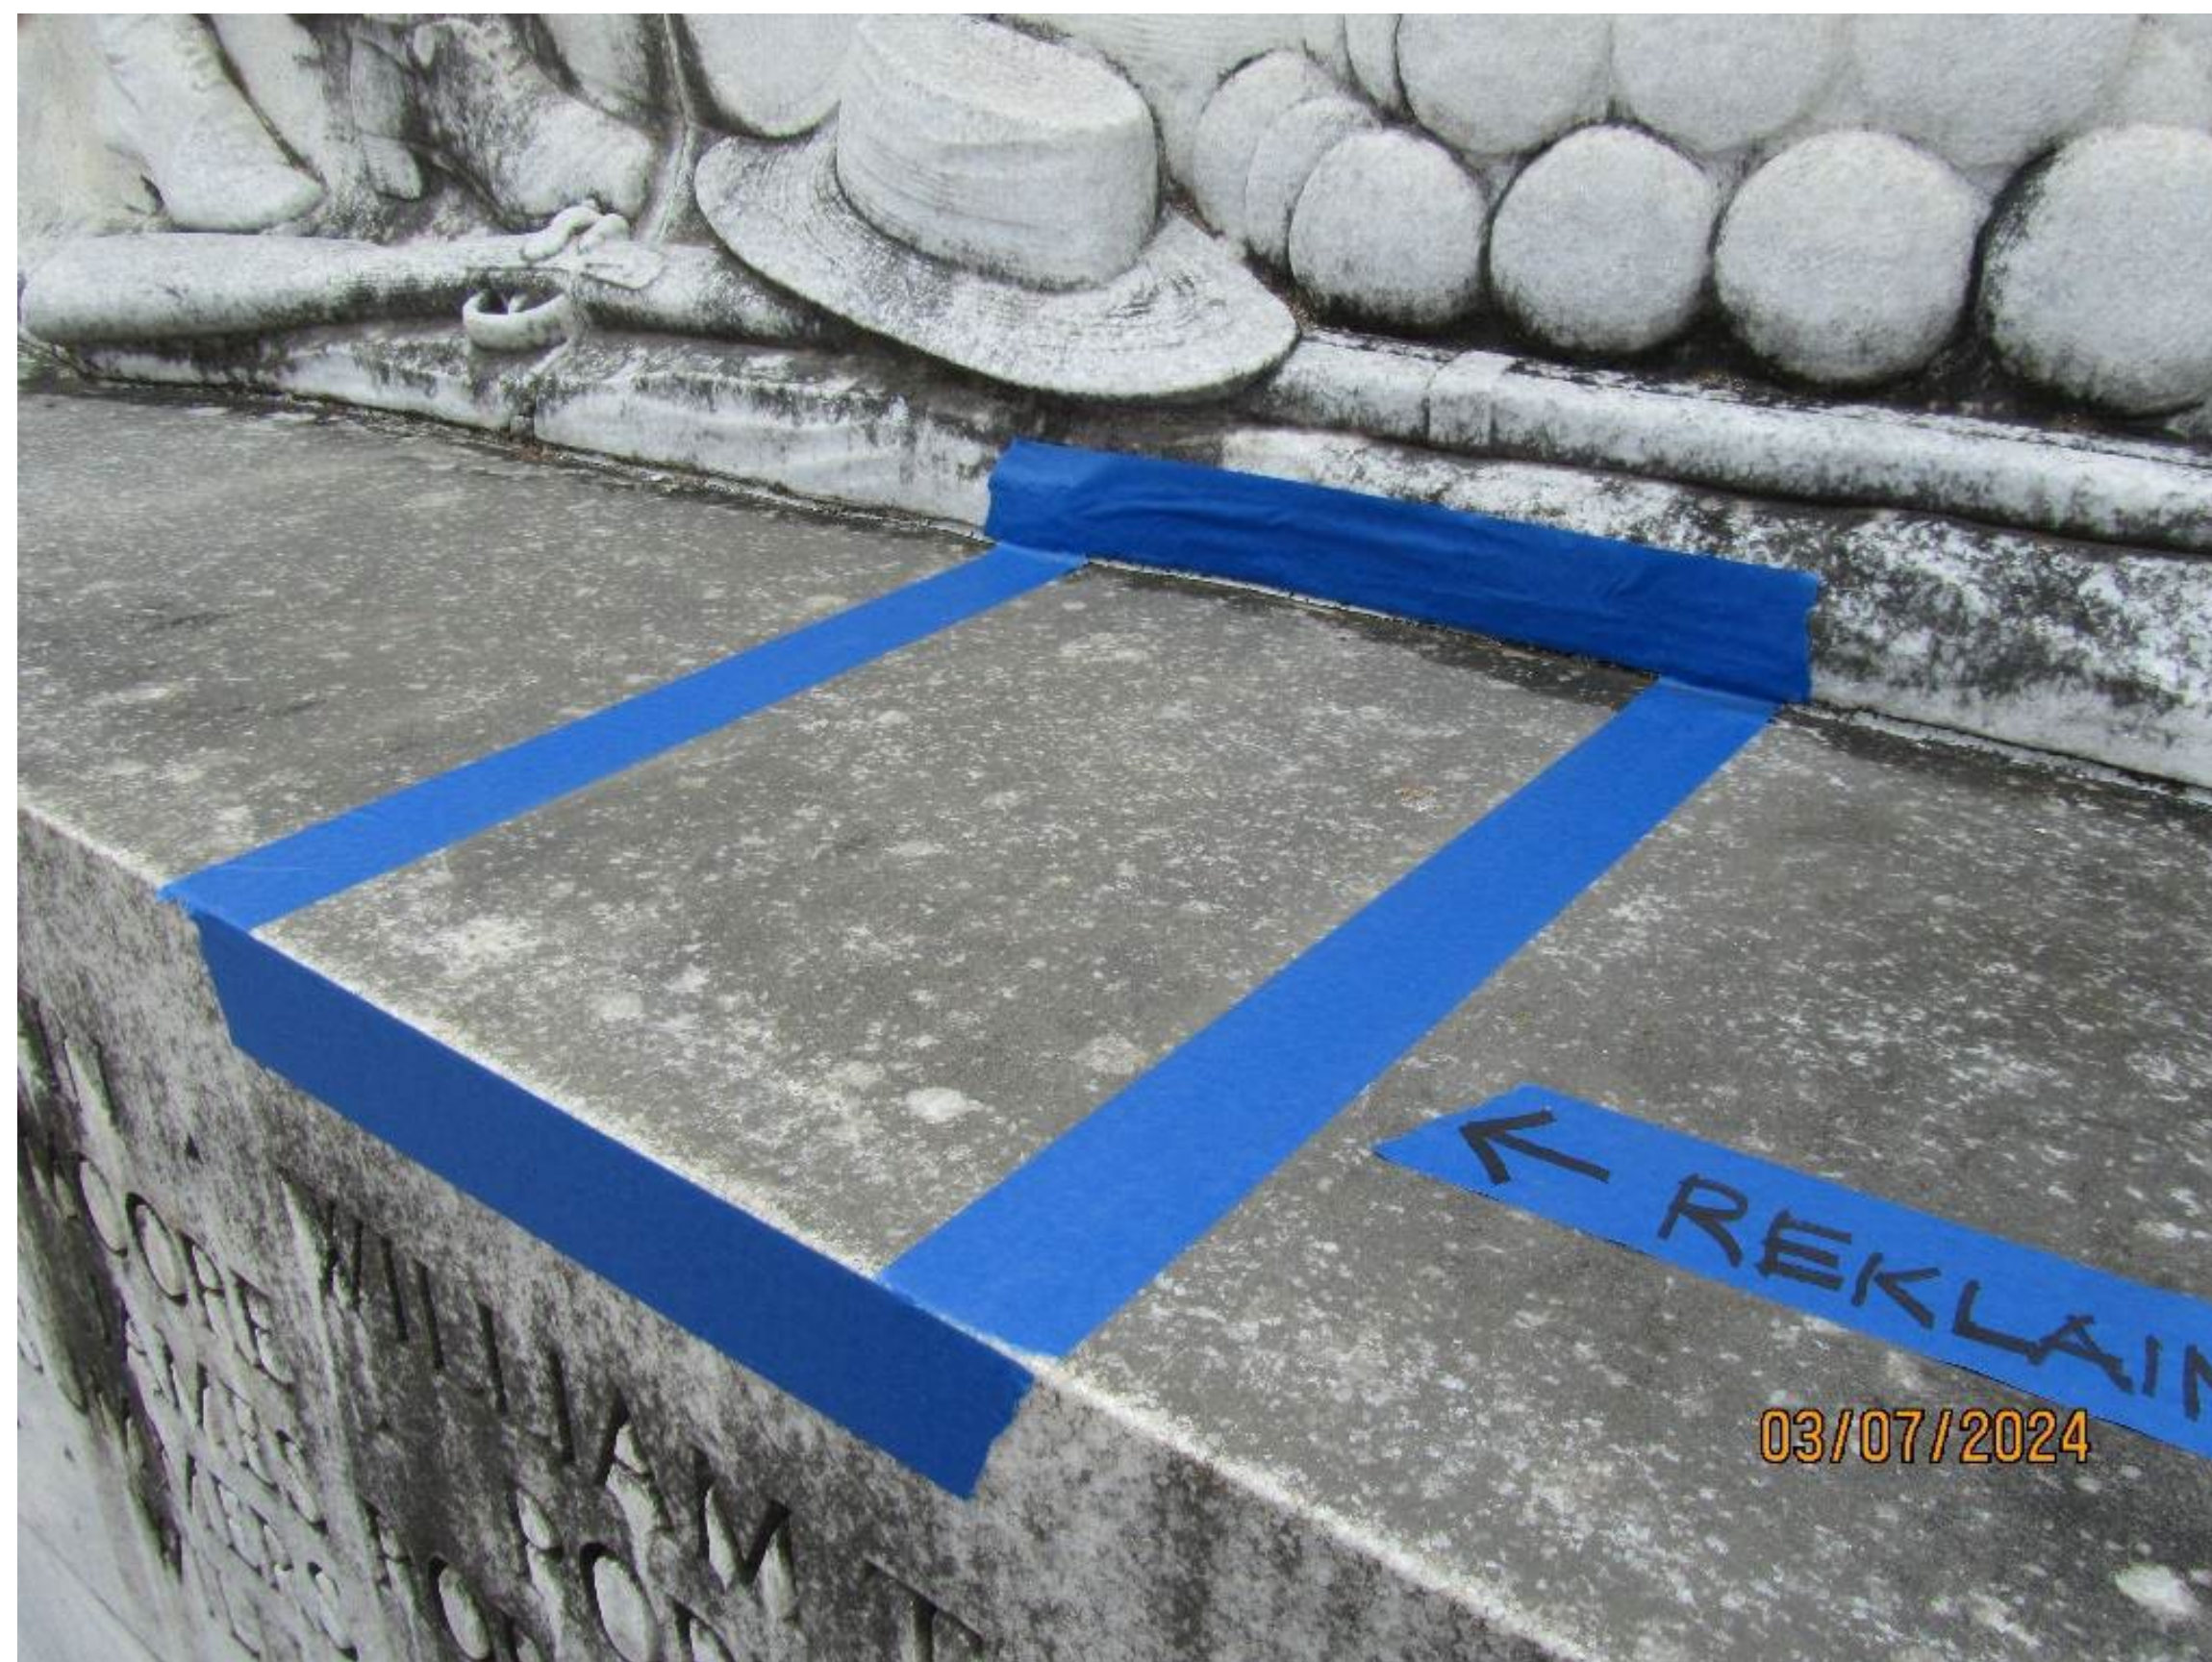
*Before chemical cleaning*

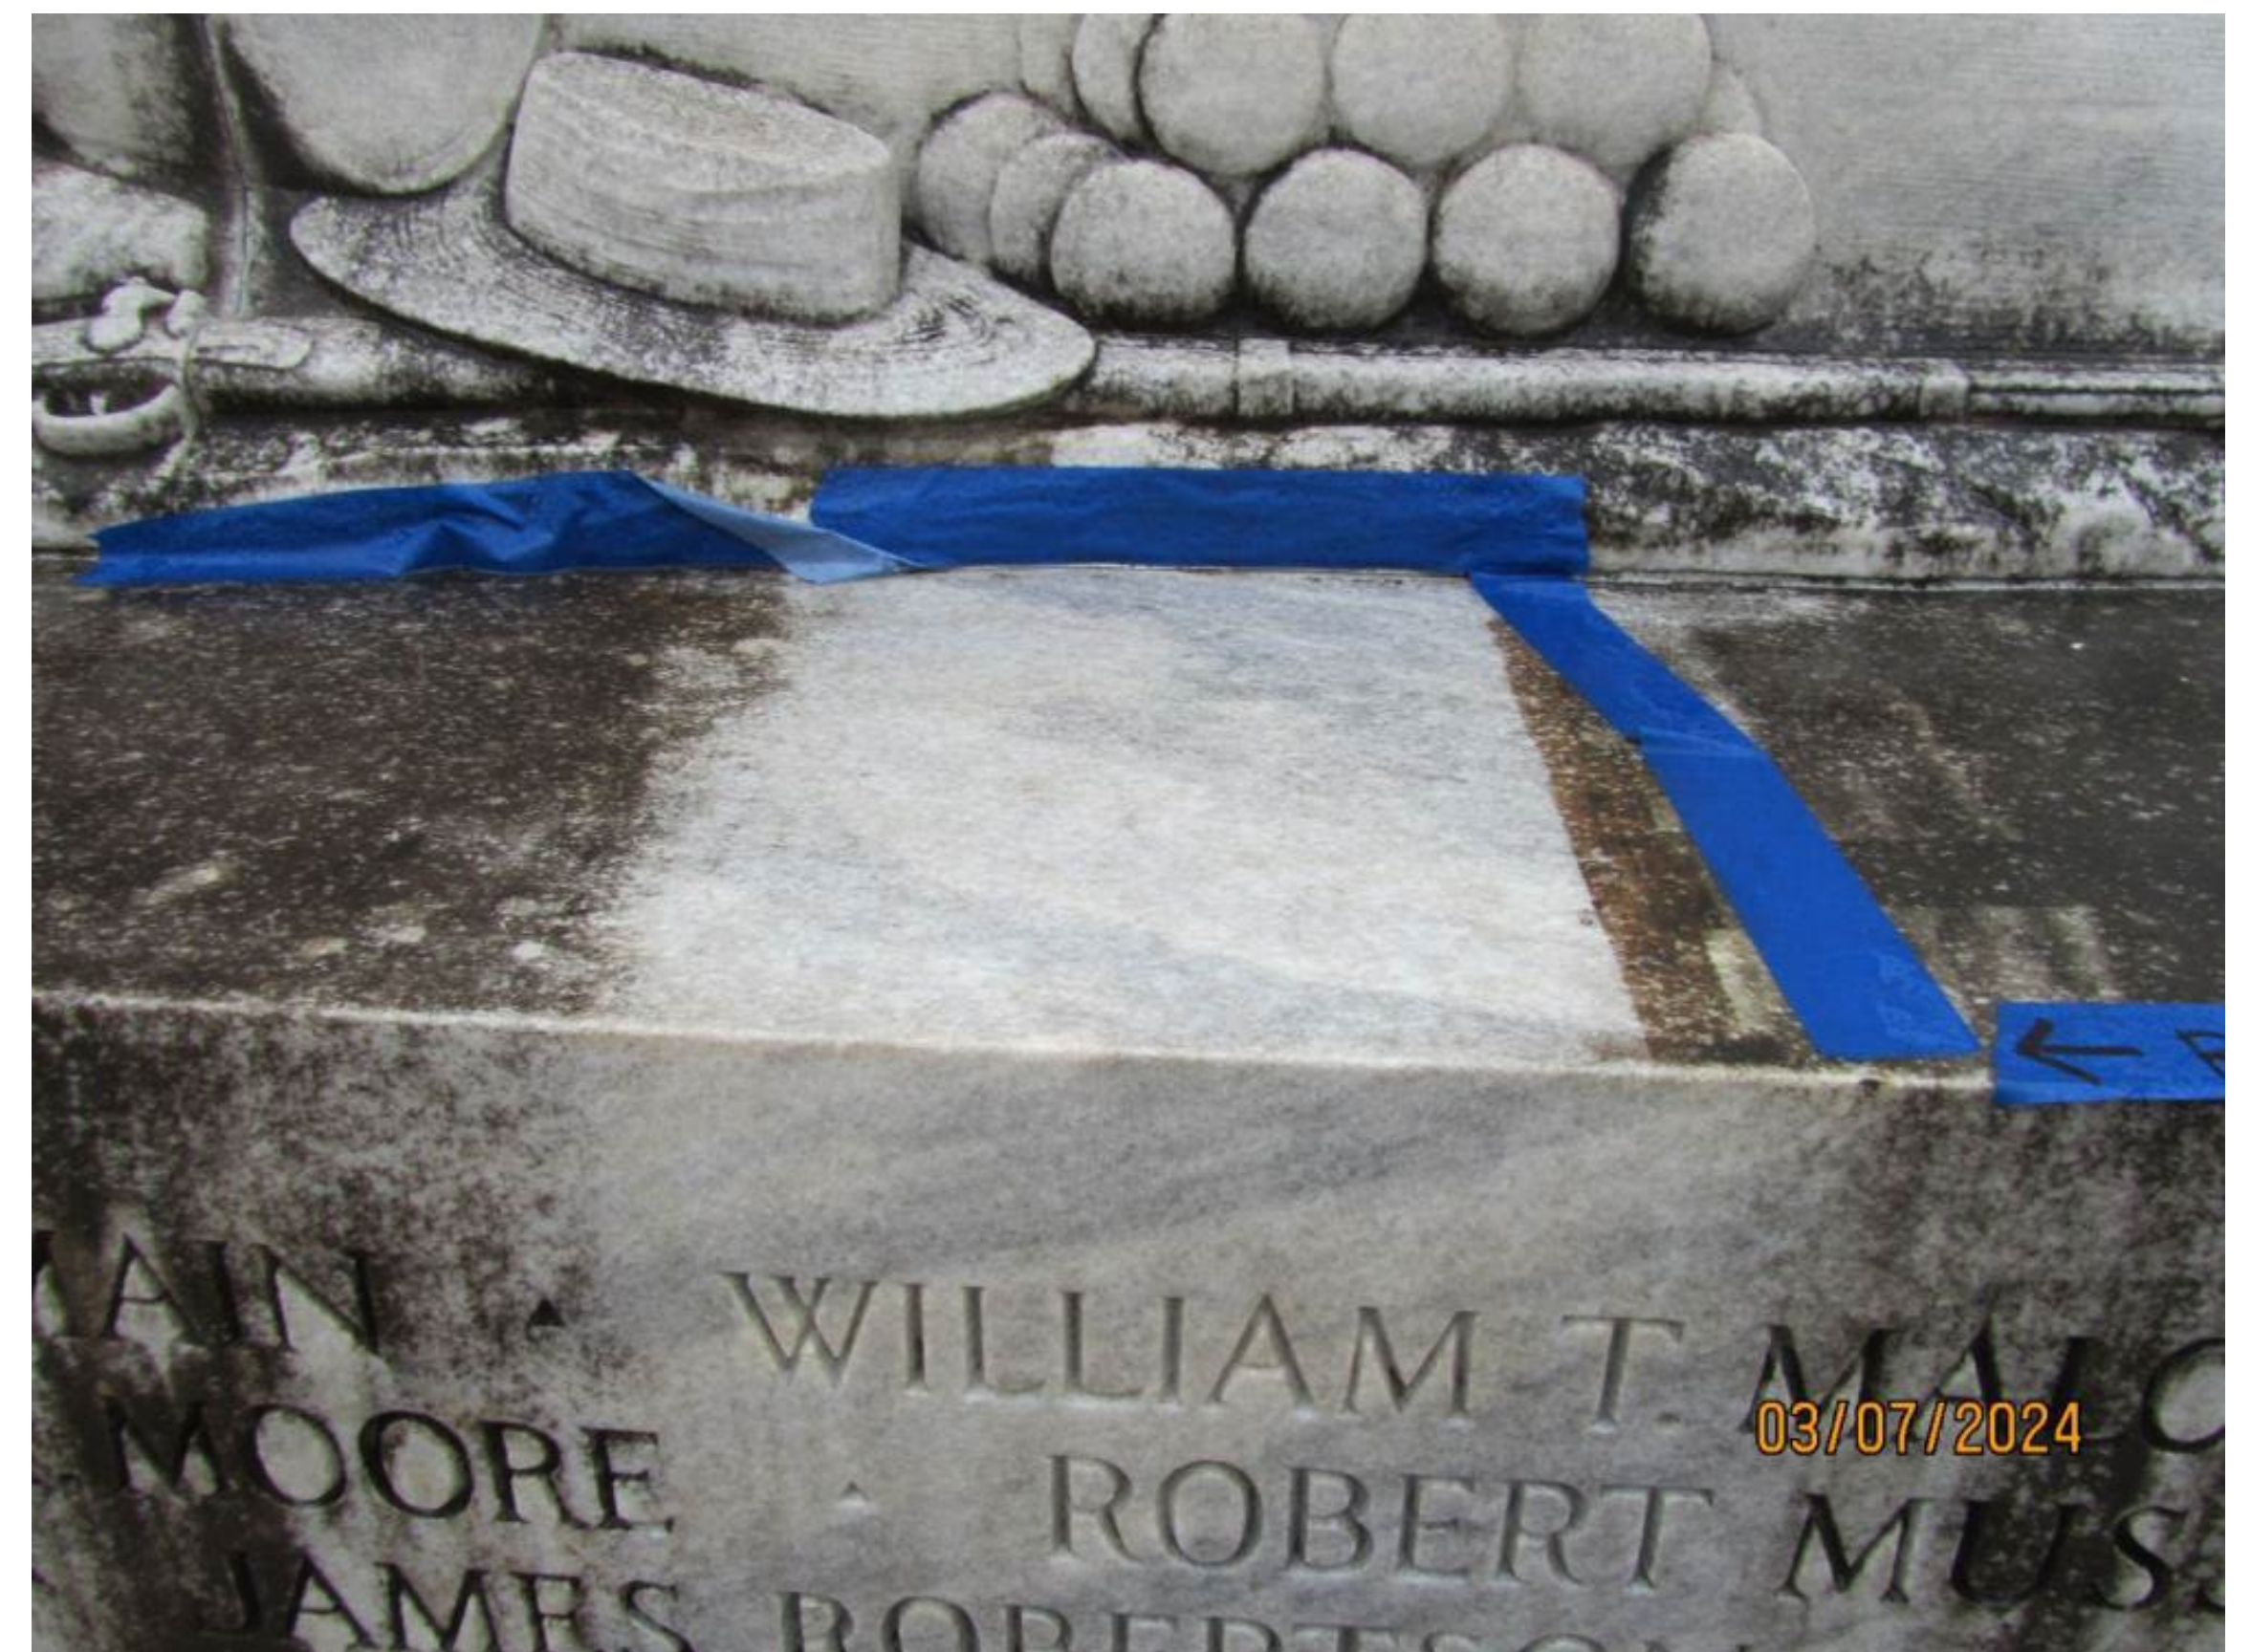
*After chemical cleaning*

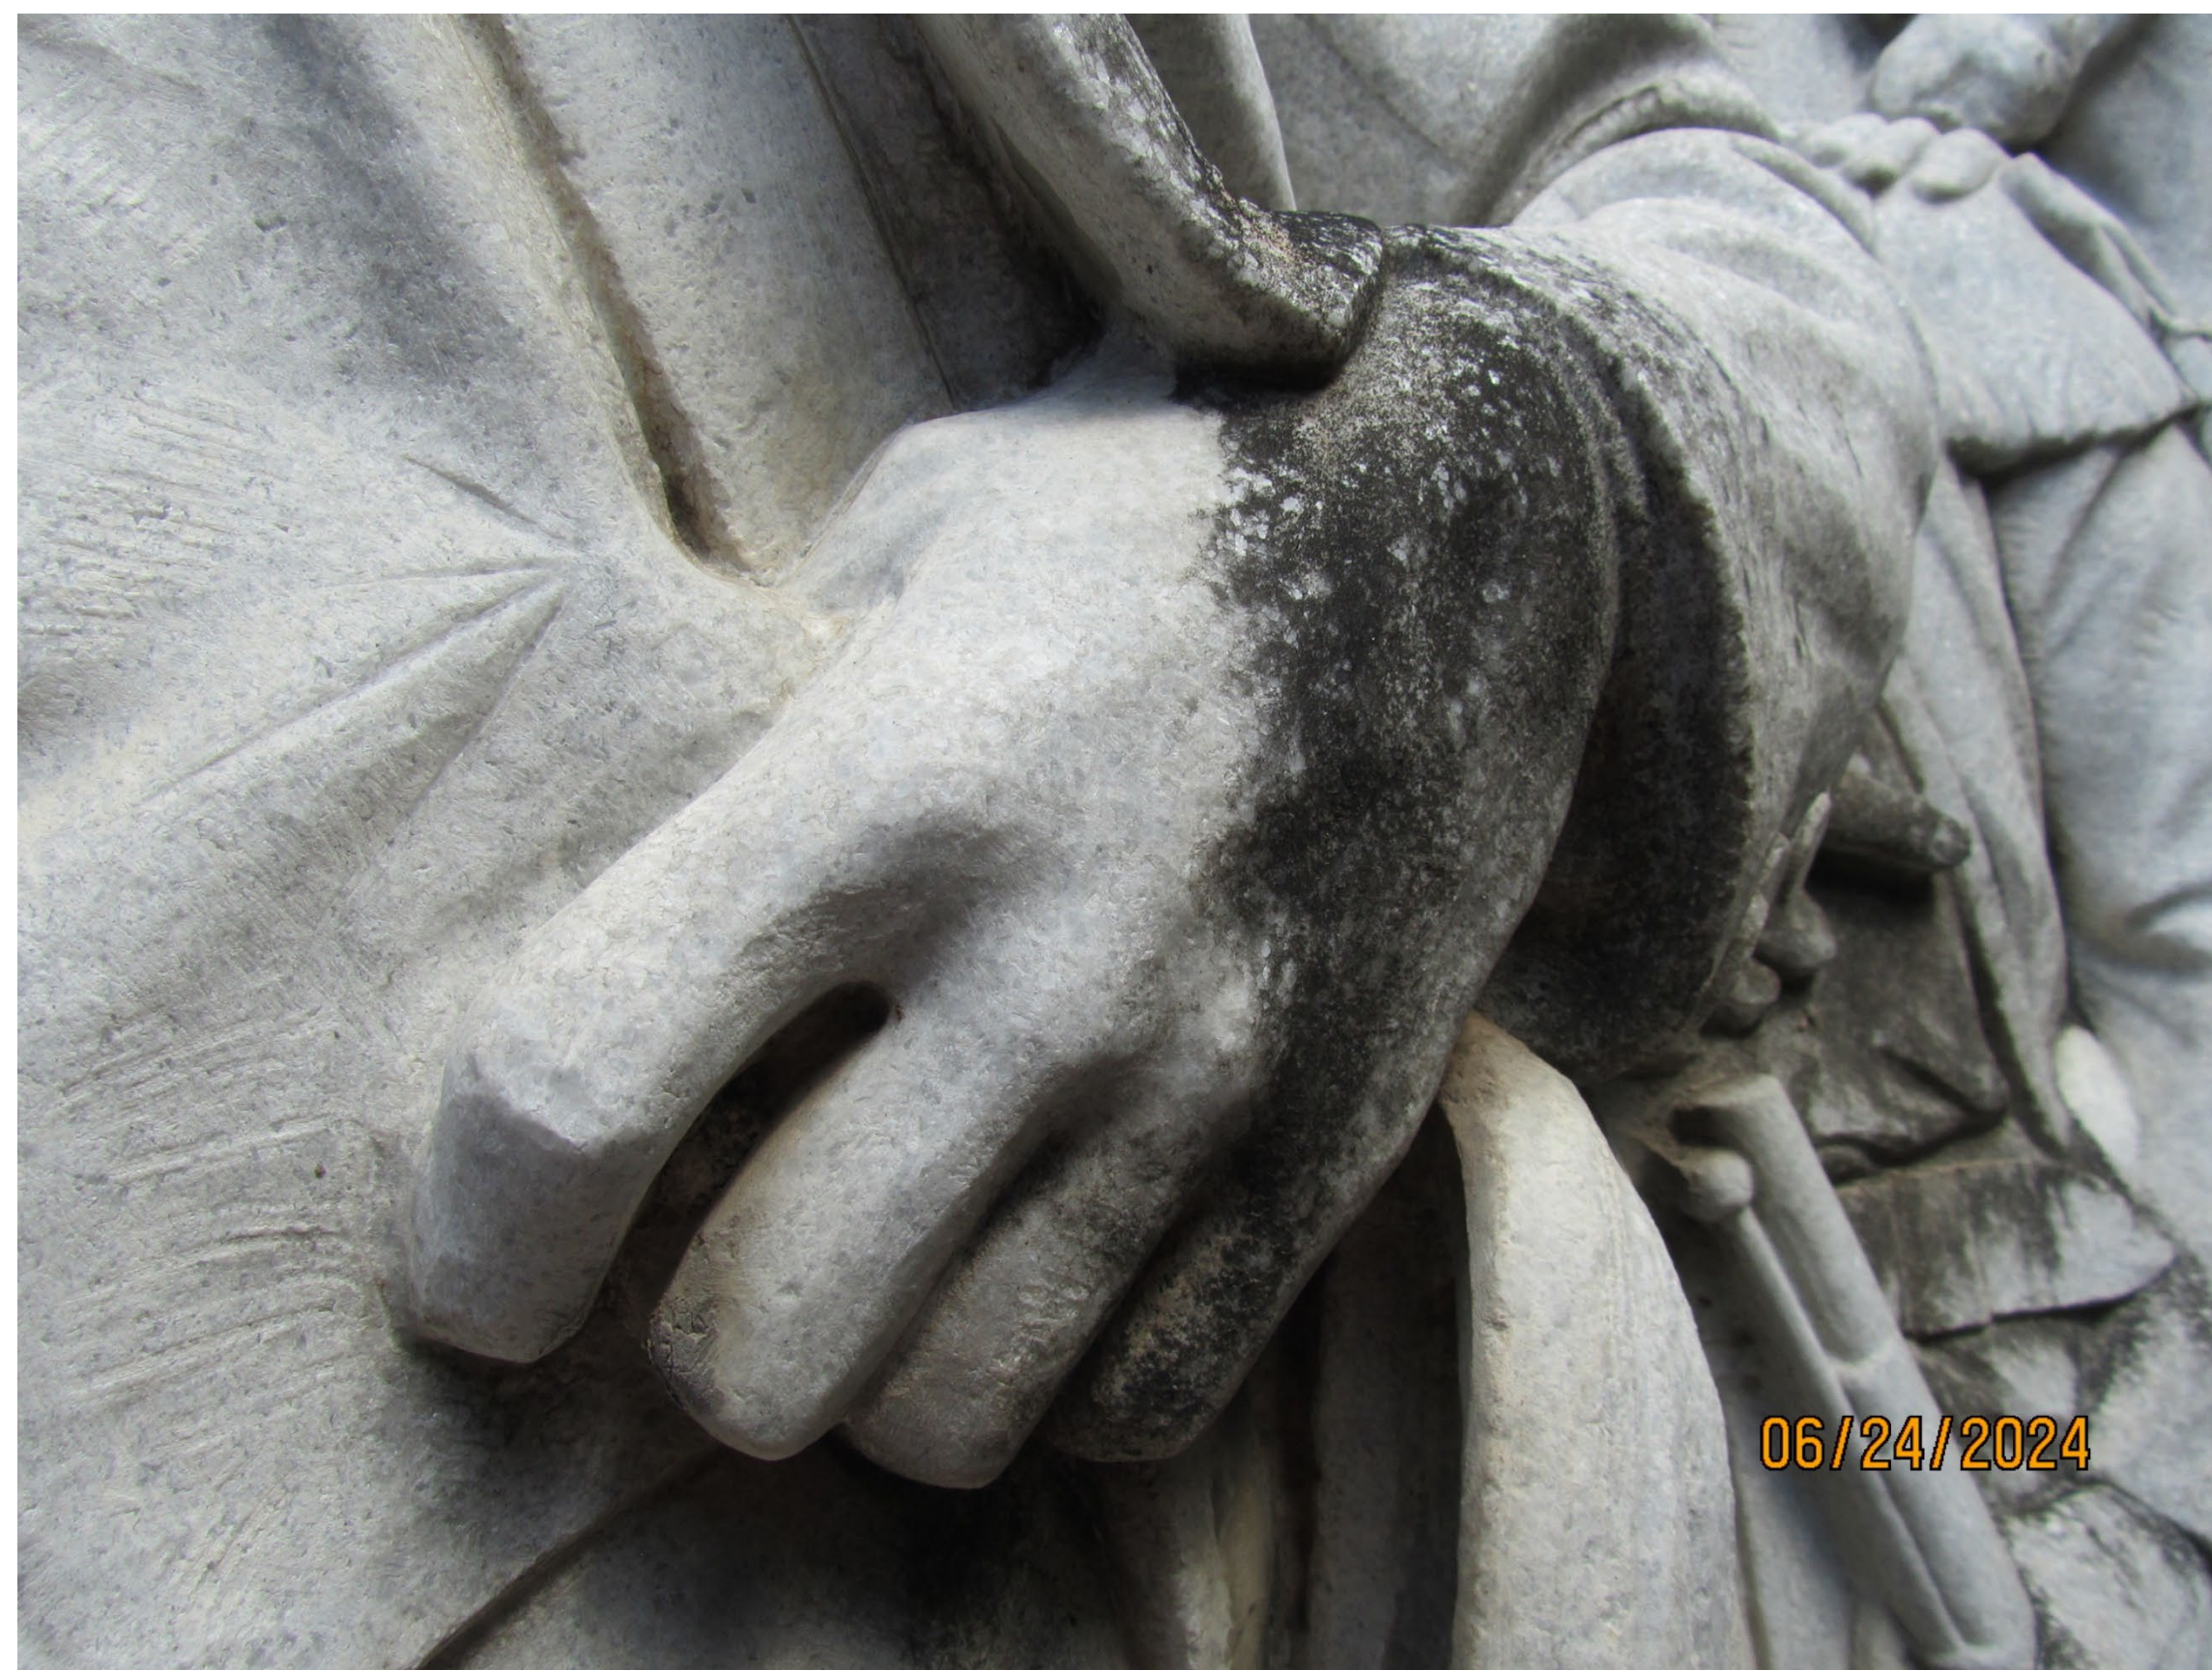
*Before laser cleaning*

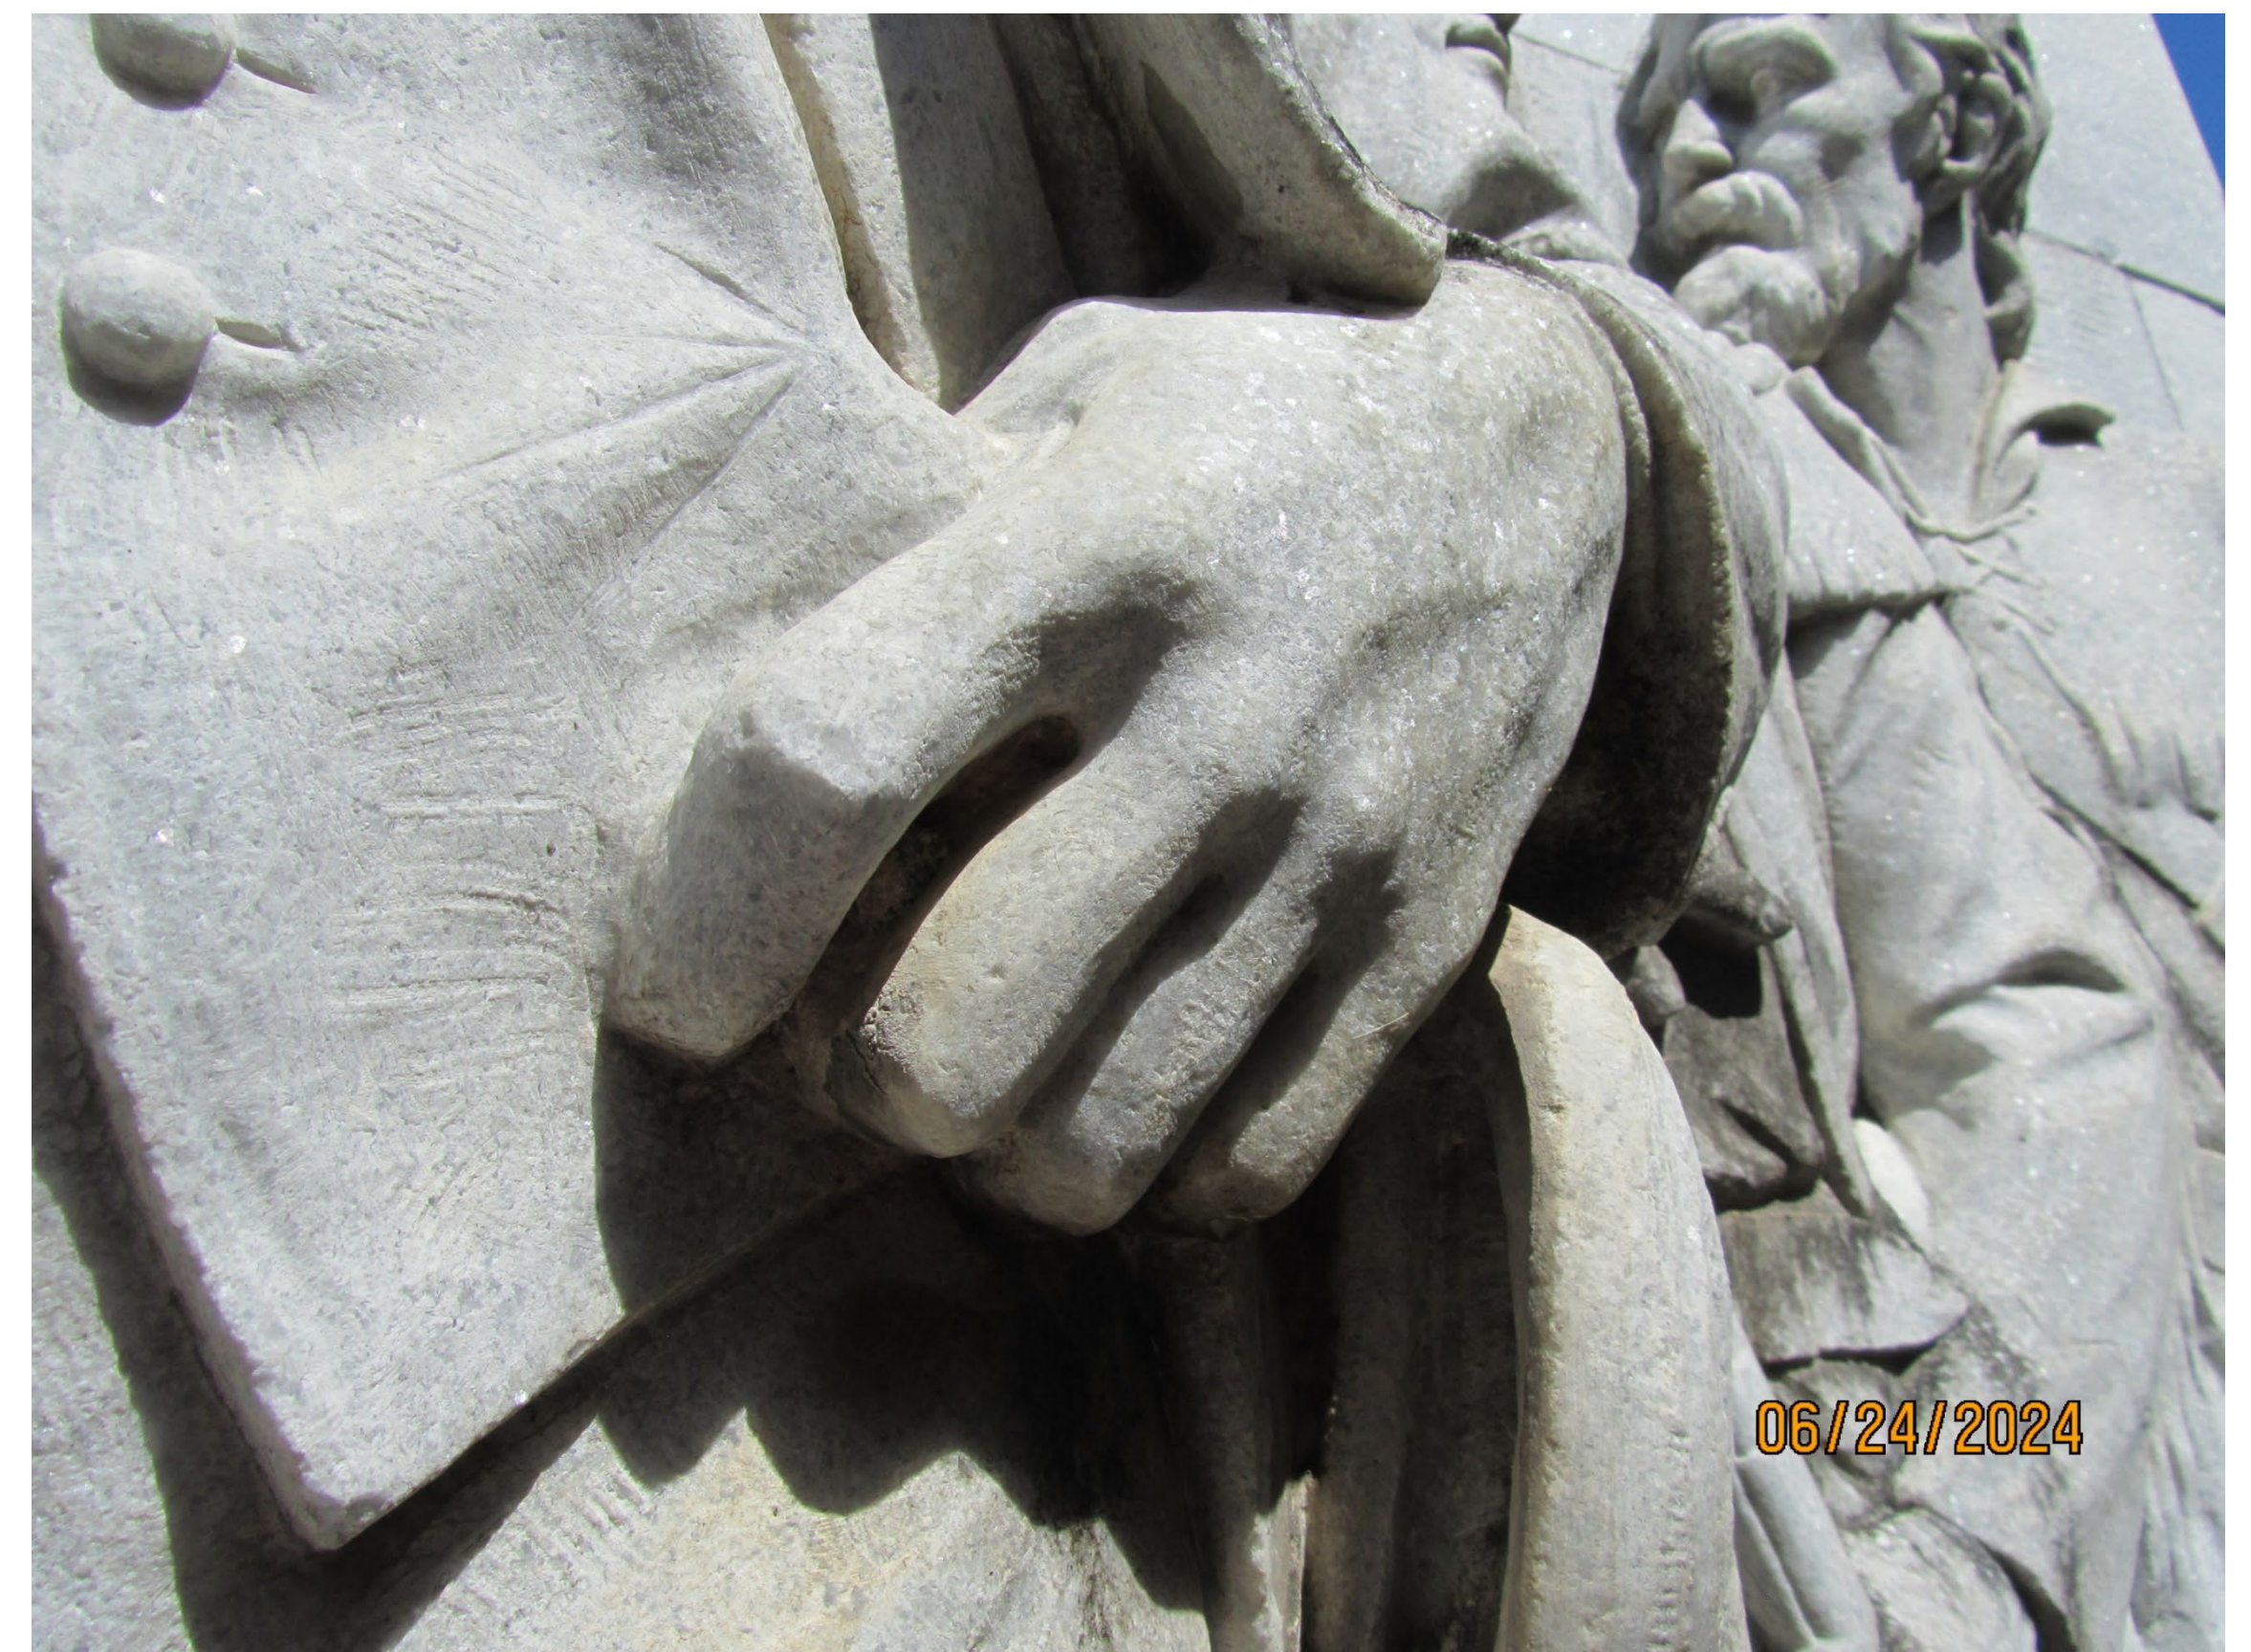
*After laser cleaning*
