**Tri-State Home Inspections
Bedford/Goffstown NH
Inspector: Joseph M. Griffin
NH License # 00005**

**Smith, Margaret
555 Oak Lane
Oaksville, NH**

Inspected 12/14/19 8:30 AM Client present at inspection, Weather heavy rain, cold

Inspection Summary

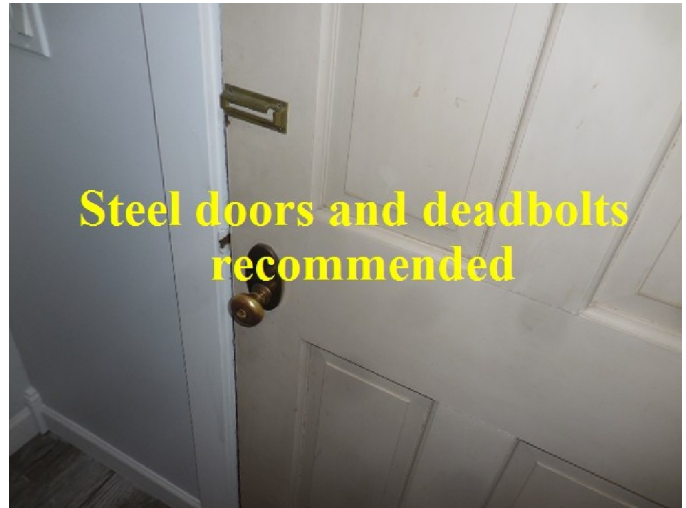
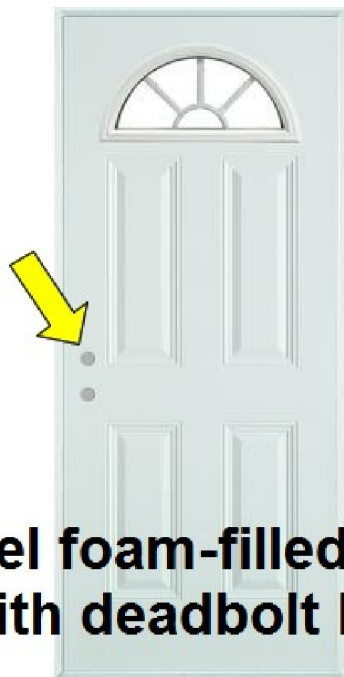
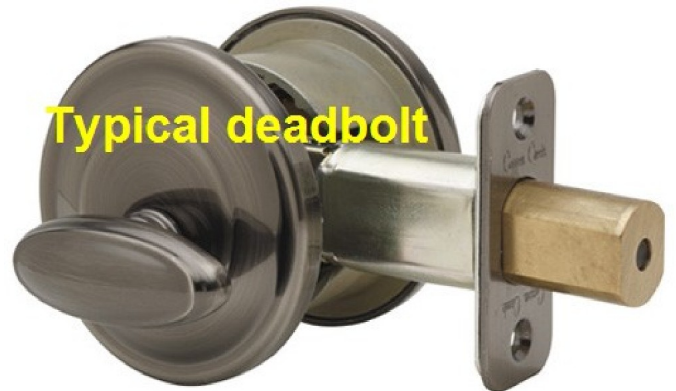
Entry Doors

Steel doors recommended at all entry points.
Deadbolts recommended at all exterior doors for safety reasons. See photo-repairs needed

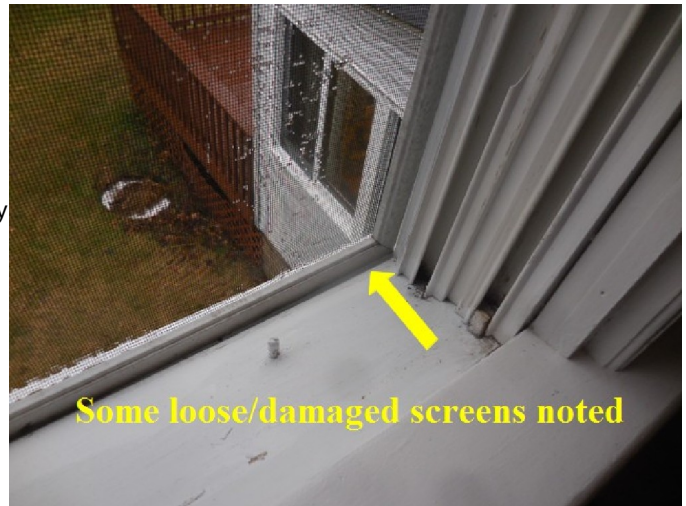
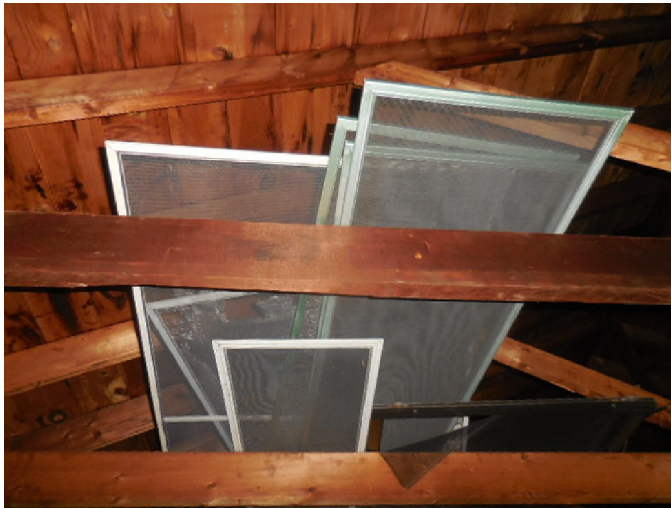
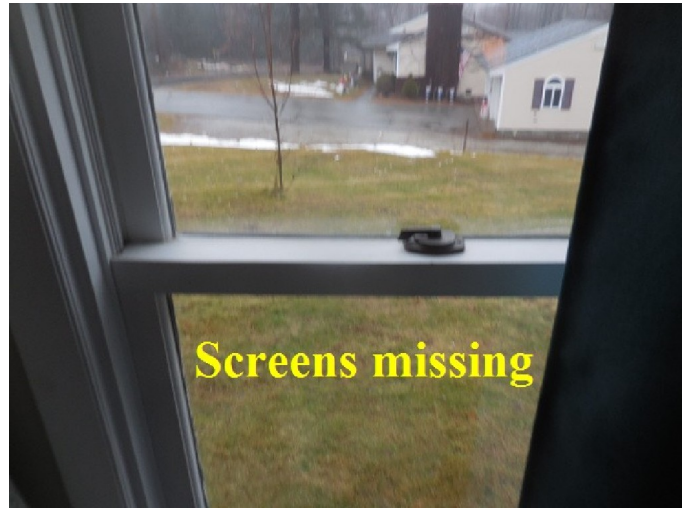
Windows Storm\Screen

All screens should be checked for proper fit and security at move-in.
Some missing screens were noted.
All screens should be checked for proper fit and security at move-in.
Recommend current homeowner install all screens BEFORE CLOSING to ensure fit and availability.
The newer windows have screens which are easily dislodged by children.
Recommend keeping children's beds away from windows.
Open windows from the top if they have full screens.

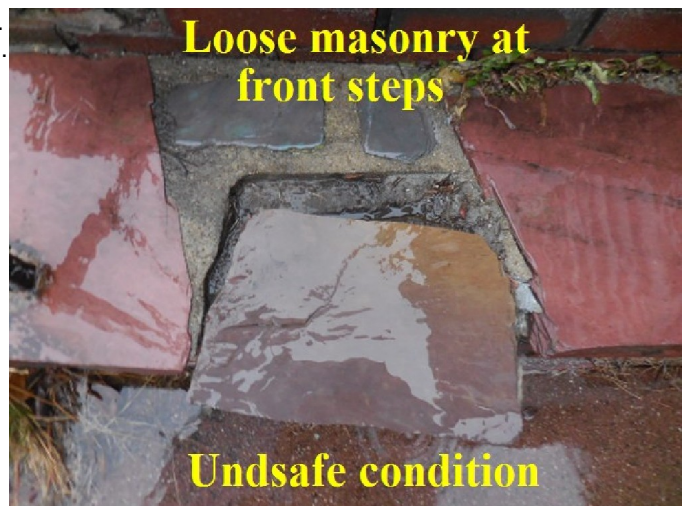
Steps

Loose and missing mortar joints were noted should be repaired.
Uneven areas present a tripping hazard and should be repaired.
See photo-repairs needed
Some cracks and loose and missing mortar joints were noted in brick steps.

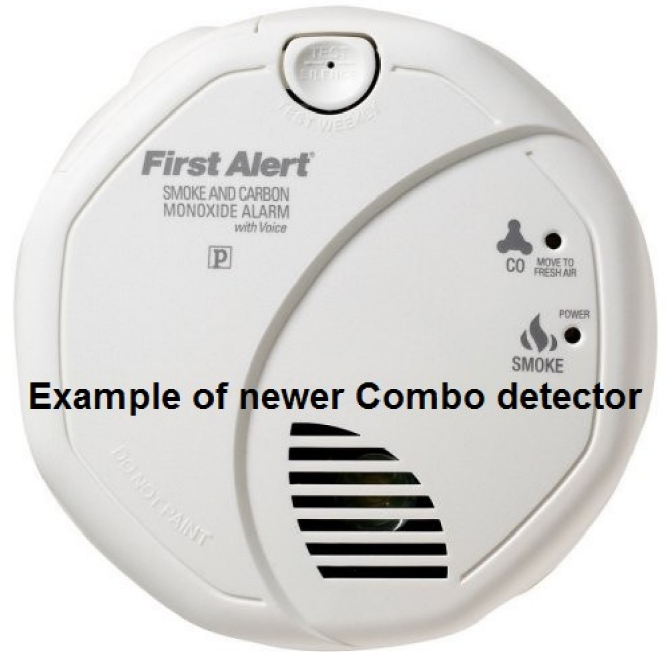
Smoke Detectors

Smoke detectors should be checked on the day home is occupied.
Older and few (by today's standards) smoke detectors noted. (See photo)
50/50 detectors are available now at most home centers.
Strongly suggest adding all new smoke detectors at move-in (Photo-electric type) in common hallways, inside and outside of sleeping areas, and at least one on every level of the home.
Hardwired detectors with battery backup if possible. If not, a dual 9v battery type is recommended.
Strongly suggest adding carbon monoxide detectors, one on each level, especially inside/outside sleeping areas.
Just having one in the basement may not protect you as it will be hard to hear through closed doors.
New technology is available today in a combo detector. (See example photo)
These detectors can detect high Carbon Monoxide levels in addition to Smoke detection.
They are recommended to be hard wired with a 9v battery backup for safety.

If battery powered only, make sure the detectors can ALL communicate wirelessly.
It is recommended to buy all the detectors together, and from the same manufacturer.

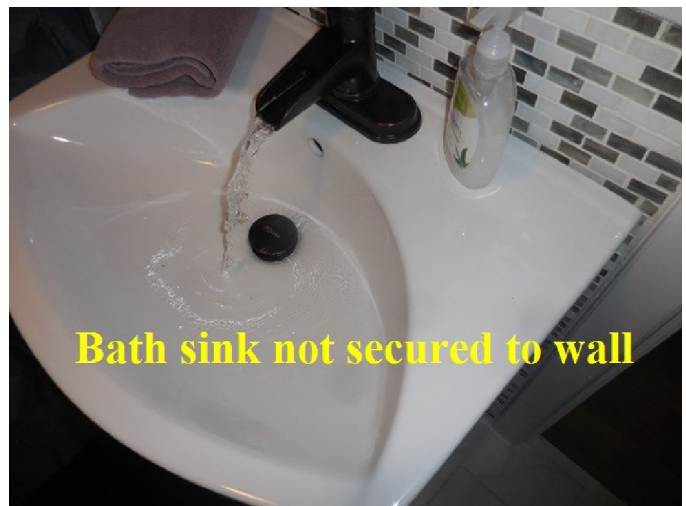
Bath sink

Sink and base not secured to wall. Falling hazard. See photo-repairs needed

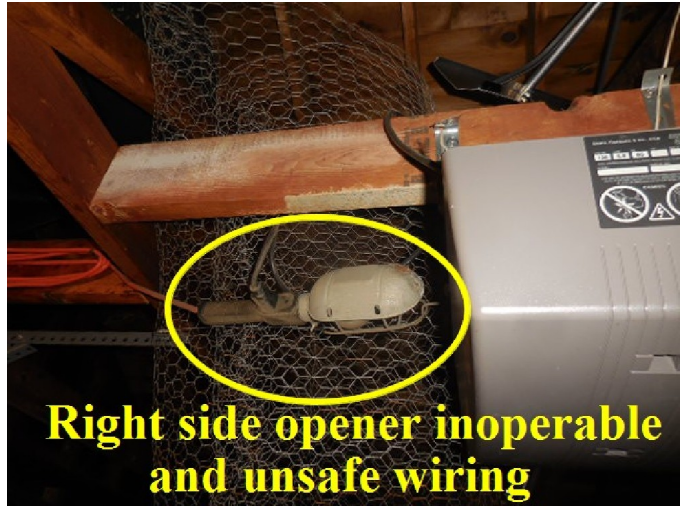
Auto Garage Door Lift Controls

One opener inoperable. All wiring to openers is unsafe/inferior. See photo-repairs needed

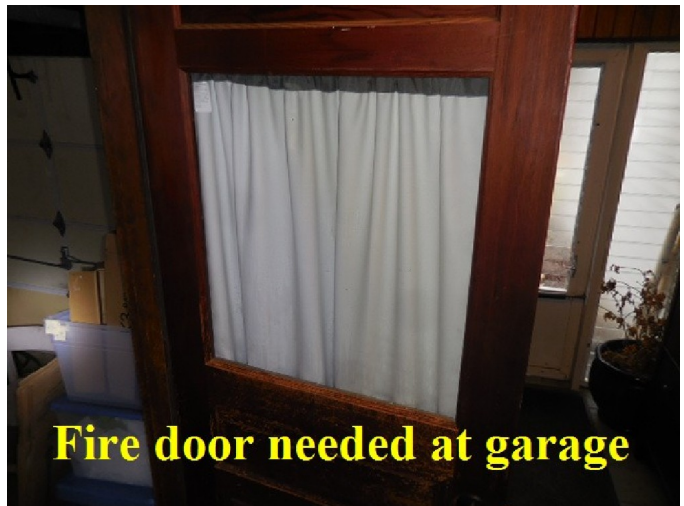
Garage Doors

The door between house and garage should be replaced with a fire rated door. See photo-repairs needed

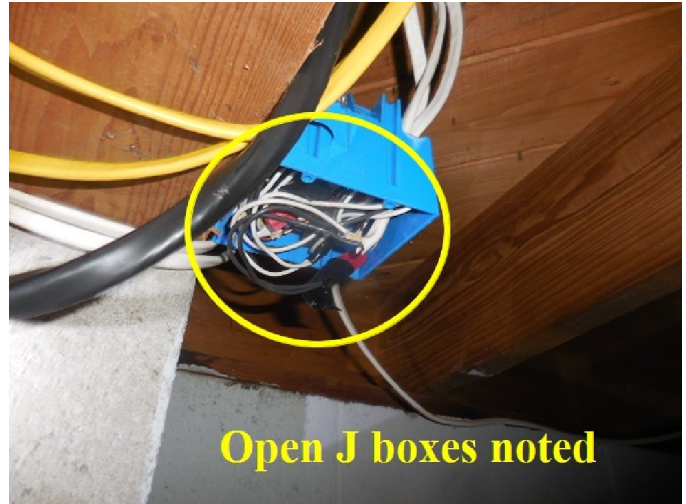
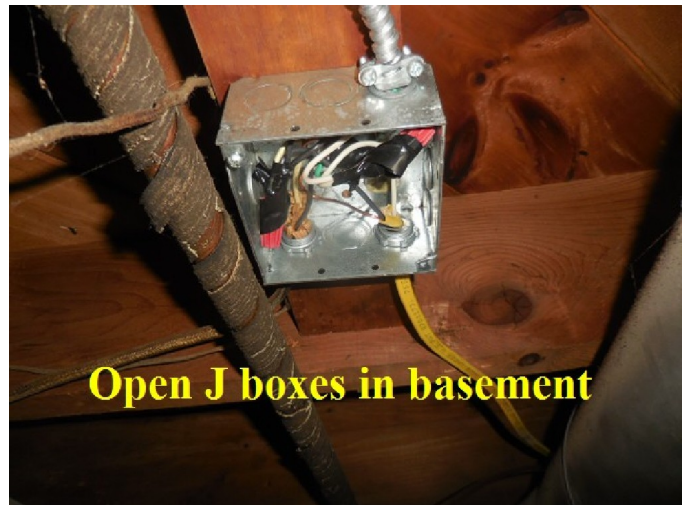
Visible wiring

Unsafe wiring noted overhead. See photo-repairs needed

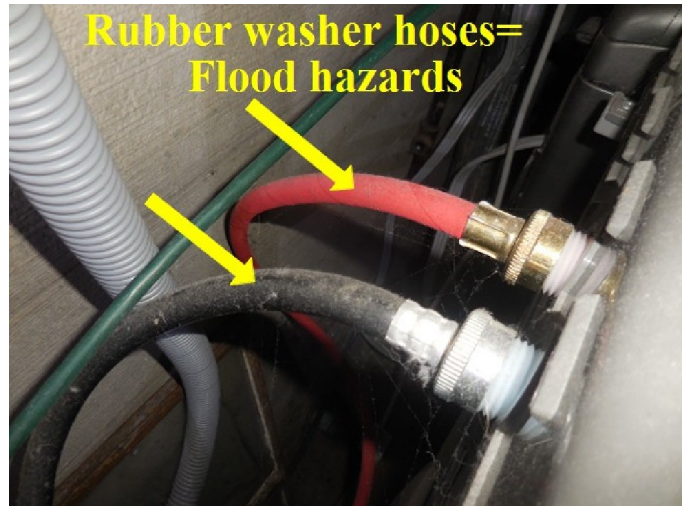
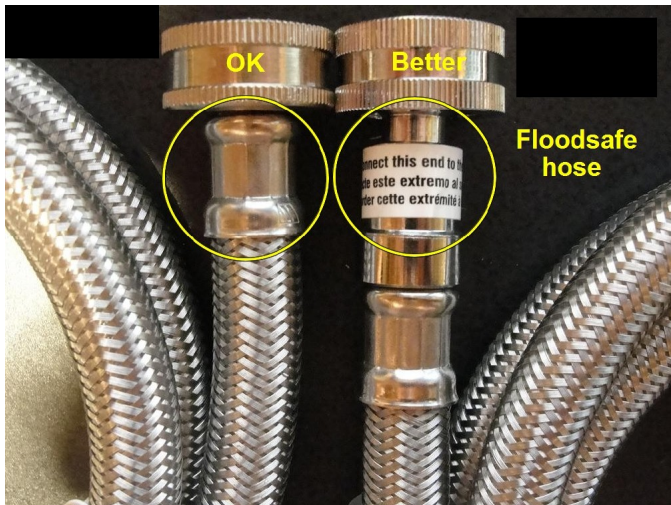
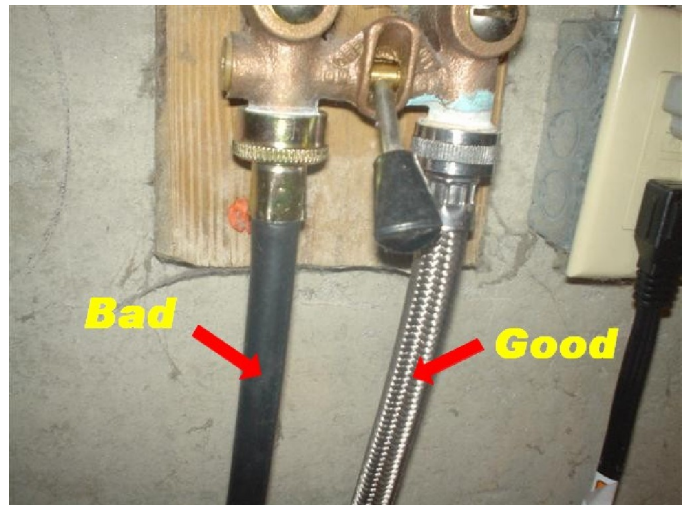
LAUNDRY

Recommend installing "Flood-Proof" stainless steel hoses to replace rubber hoses. See photo-repairs needed.

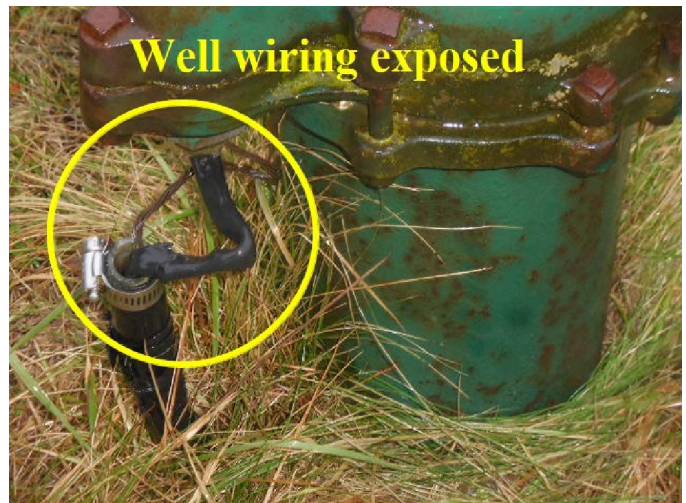
Well head/casing

Exposed wires not encased in conduit are susceptible to shorting or being contacted by weed whackers, mowers, etc. See photo-repairs needed

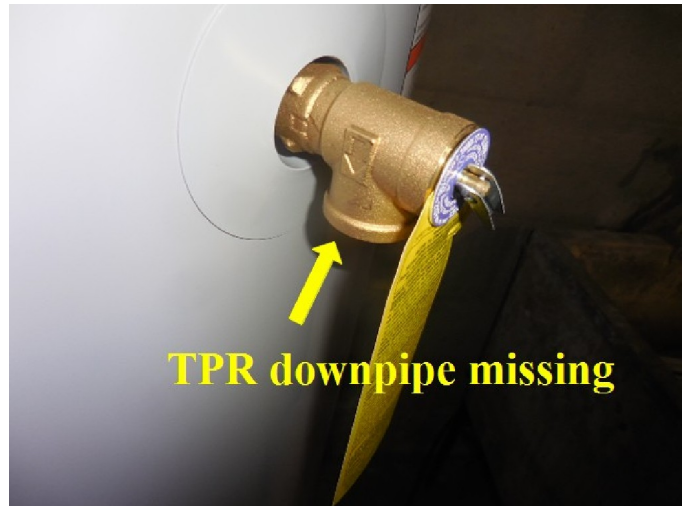
Temp. Pressure Relief Valve and Pipe

Temp and pressure valve extension should be extended to within 6" of floor.

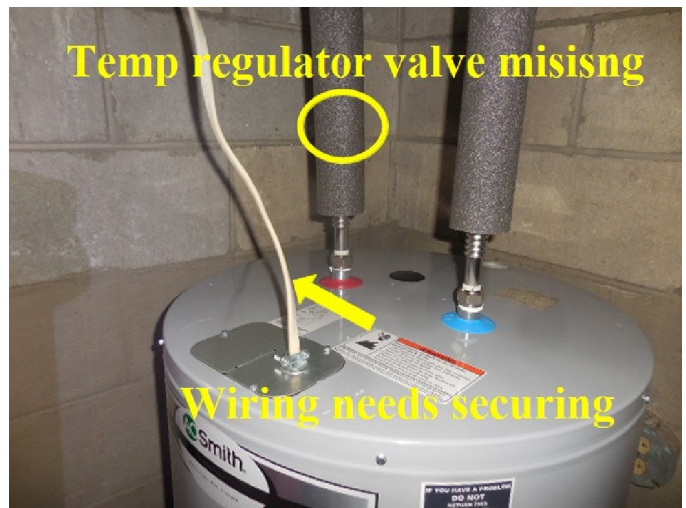
Wiring

Improper and unsafe wiring at water heater. See photo-repairs needed
Temp regulator valve also missing.

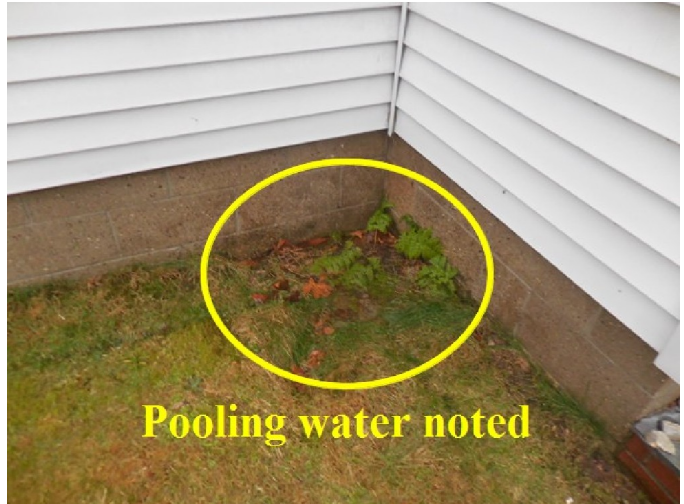
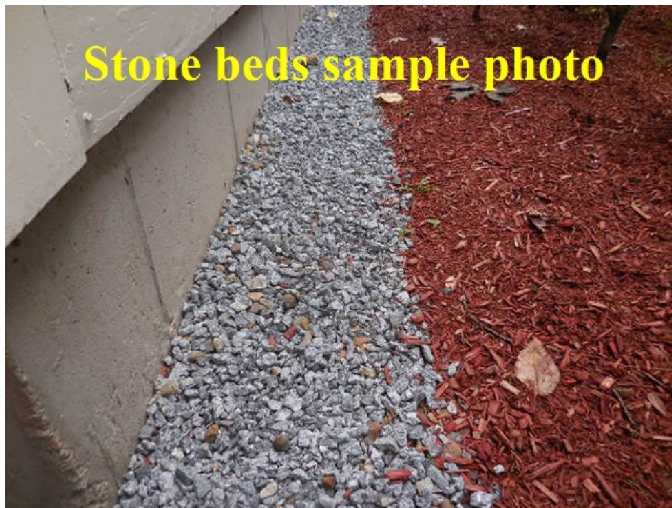
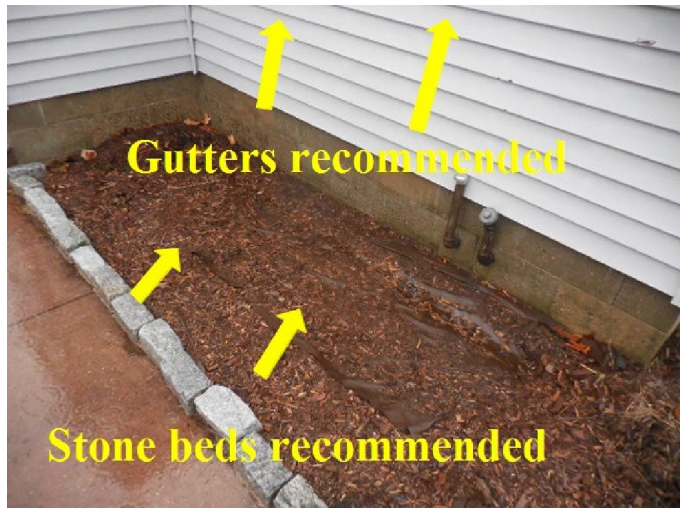
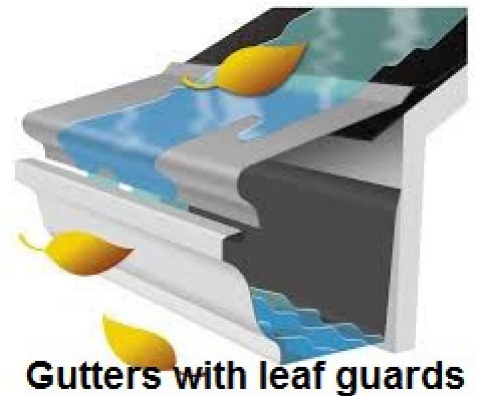
GUTTER SYSTEM

Gutters are strongly recommended. Stainless steel type are best, with gutter guards/leaf covers. Missing gutters and downspouts allow uncontrolled roof water to fall to the foundation. See photo
Downspout extensions are necessary to encourage positive flow away from the foundation.
Gutter guards are recommended to reduce debris accumulation in the gutters. See example photos.
Stone beds abutting foundation and extending past the splash line are also recommended to reduce splashup. See example photo.

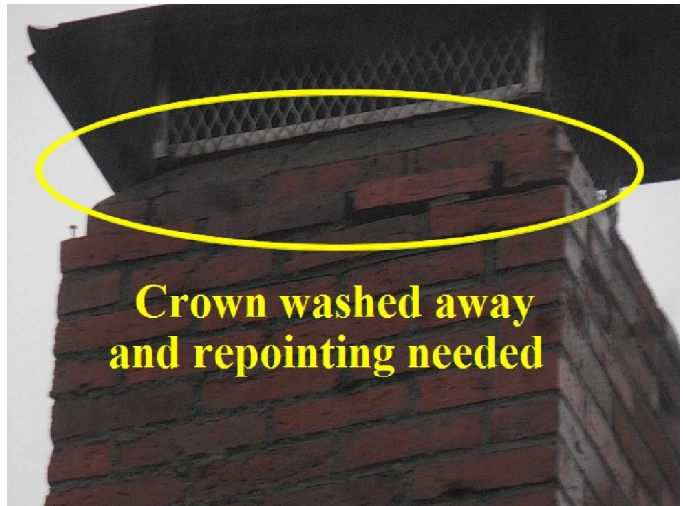
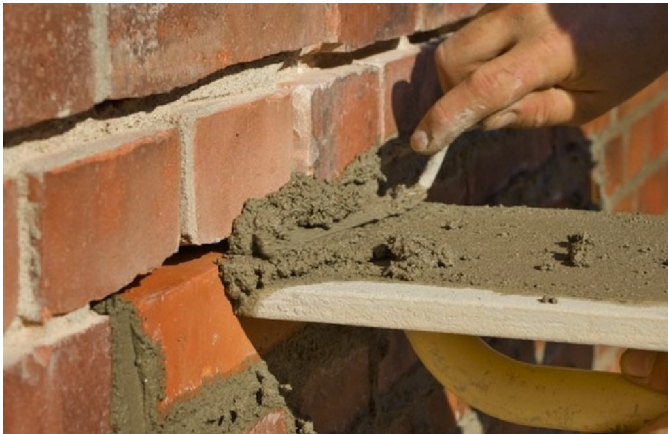
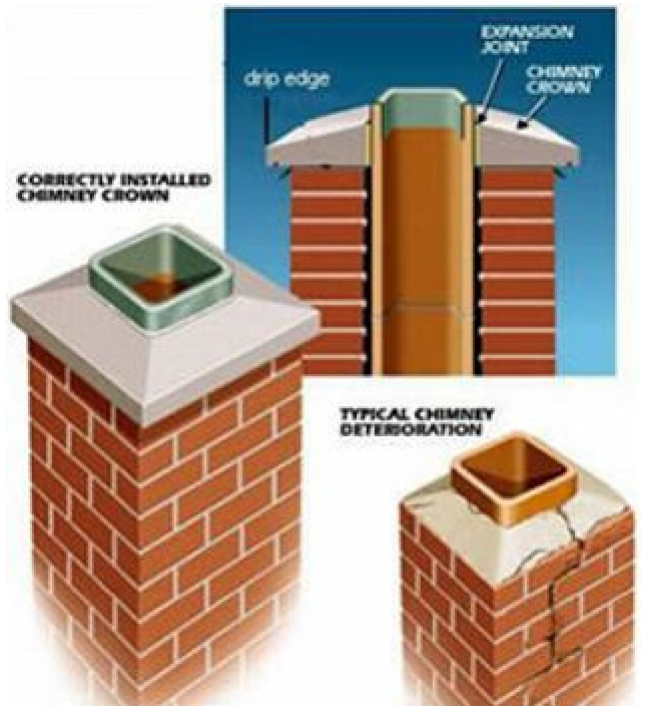
Chimney Top

The chimney wash/cap/crown should be replaced for better weather protection of the chimney. See photo-repairs needed. Cracked or disintegrating chimney caps/crowns are a common cause of roof leaks. See example photo of proper crowning. Some loose mortar noted at top courses. See photo-repairs needed.

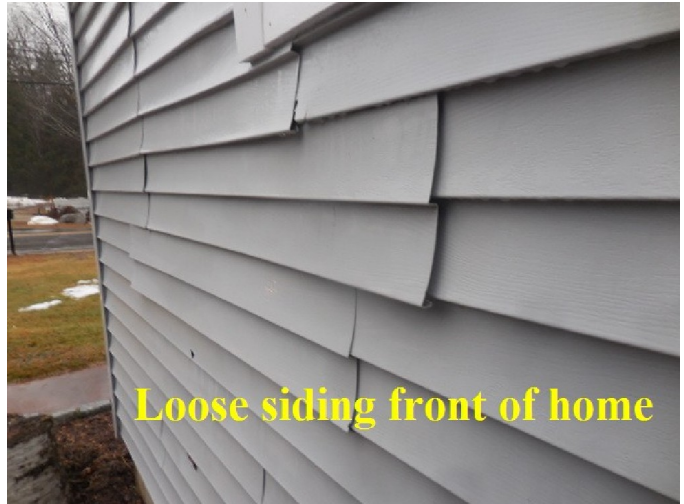
Some siding damage was noted. See photo-repairs needed

Loose siding front of home

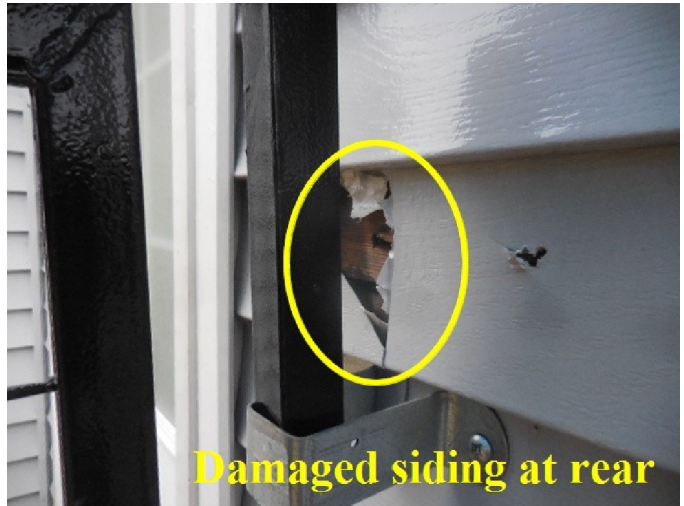
Damaged siding at rear

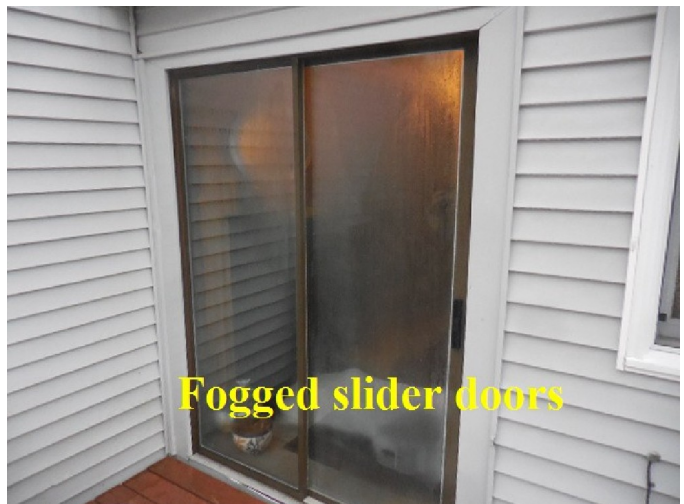
Door/front/rear/side

Fogged glass noted at both panels. See photo-repairs needed

Fogged slider doors

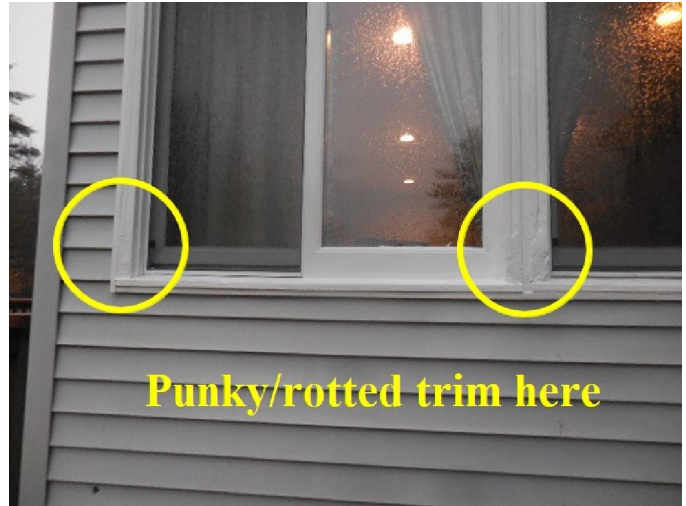
Window trim

Some window trim lines are soft/rotted. Composite trim is a better option in areas that receive water from roof runoff. See photo-repairs needed

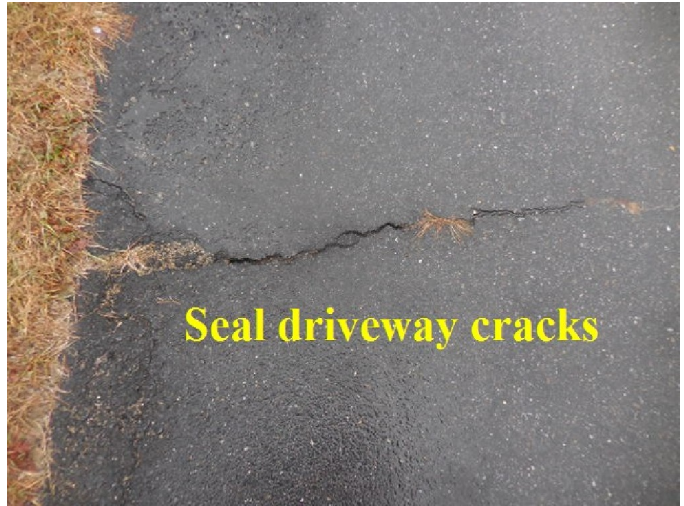
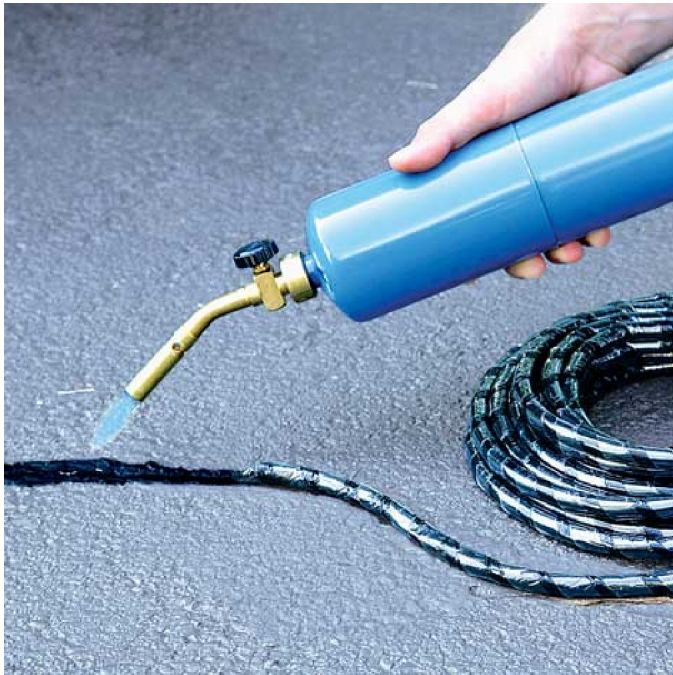
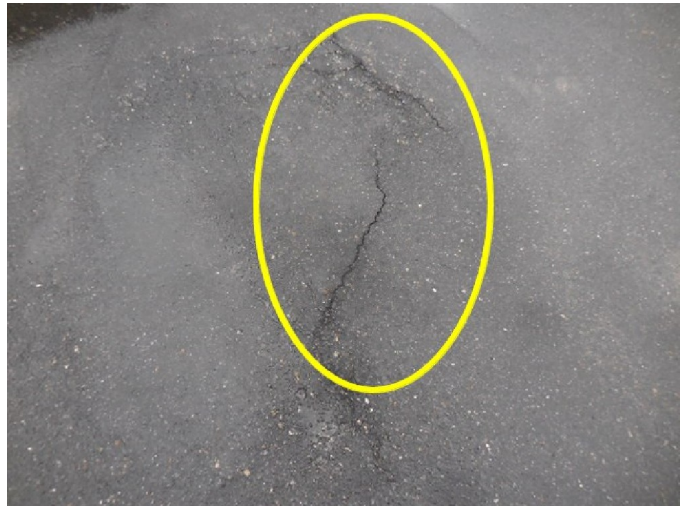
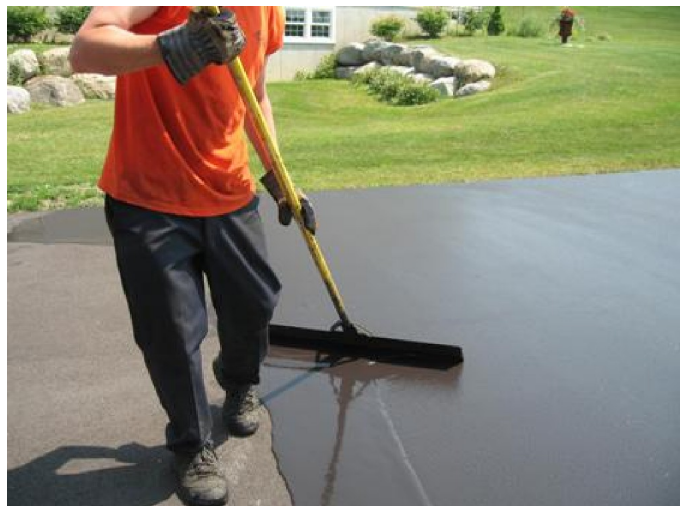
Driveway

Some cracks noted. Recommend filling cracks and sealing driveway to prevent damage from freeze-thaw cycles. See example photo.

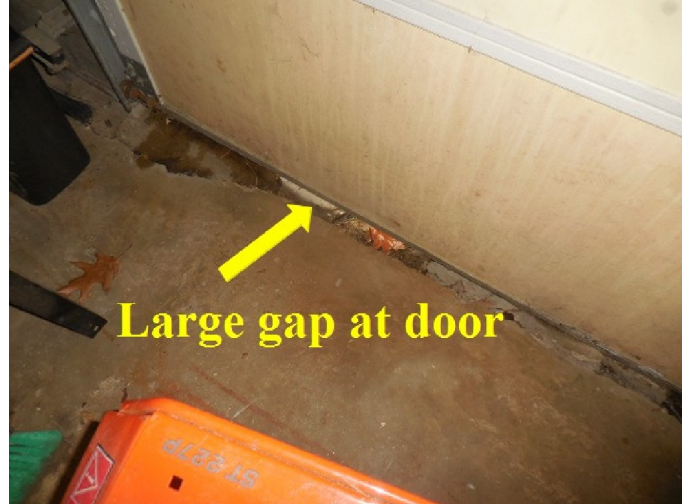
Trim around doors

Door does not seal to floor. Gaps noted. See photo-repairs needed

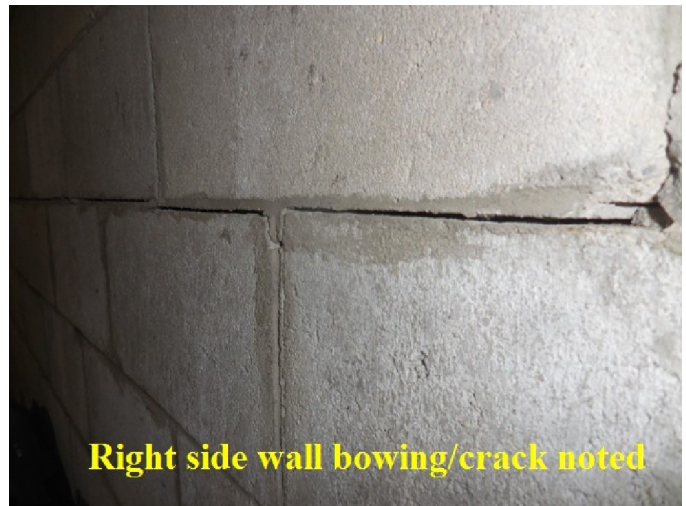
Basement Foundation Walls

There were some horizontal cracks and bowing and the entire structural condition should be evaluated by a structural contractor or engineer and all needed repairs should be made. See photo-repairs needed

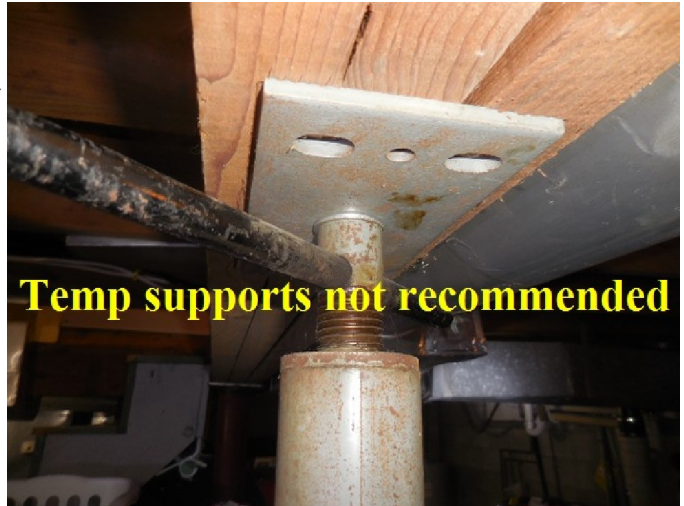
Basement Structural Columns

Temporary hollow jackscrew type support columns noted. See photo-repairs needed.

These types of jackscrew supports are meant for TEMPORARY support only, and not meant to carry the full bearing loads long-term. Steel-cement filled lally columns are recommended. See example photo.

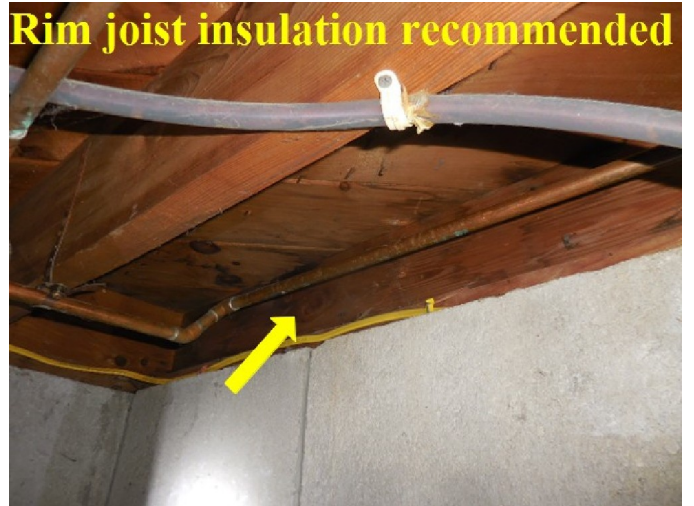
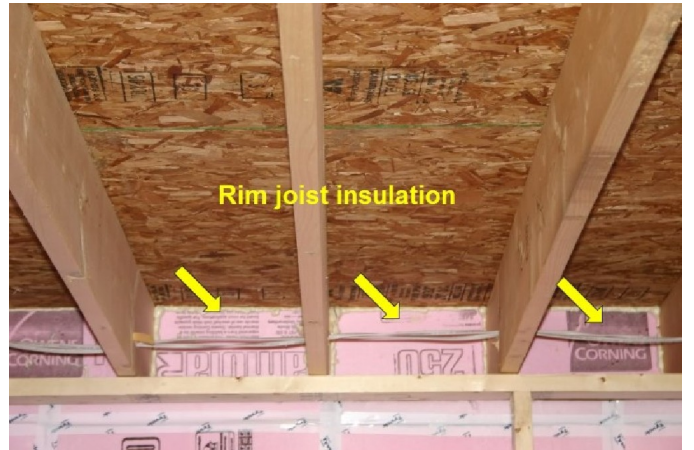
Basement Insulation

Other =
Rim joist insulation recommended. See photo-repairs needed

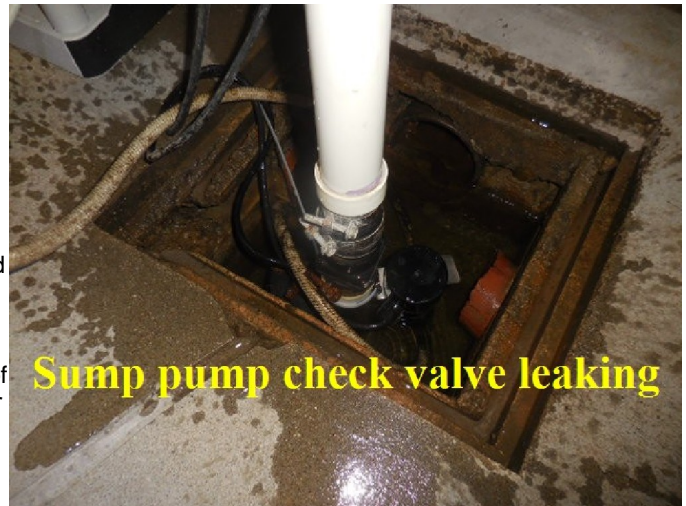
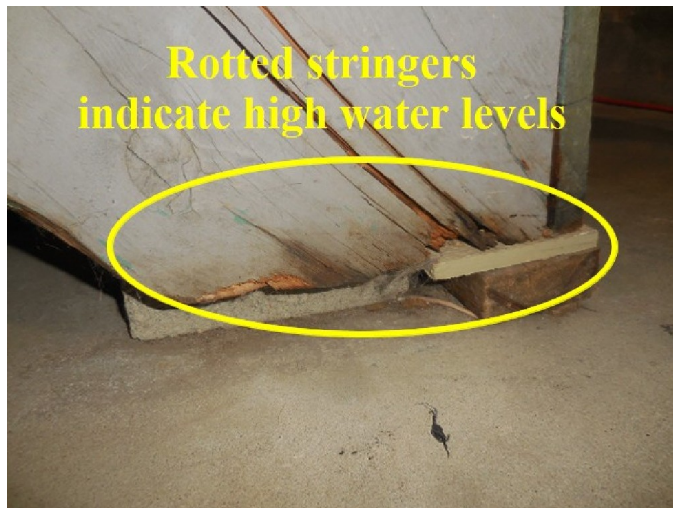
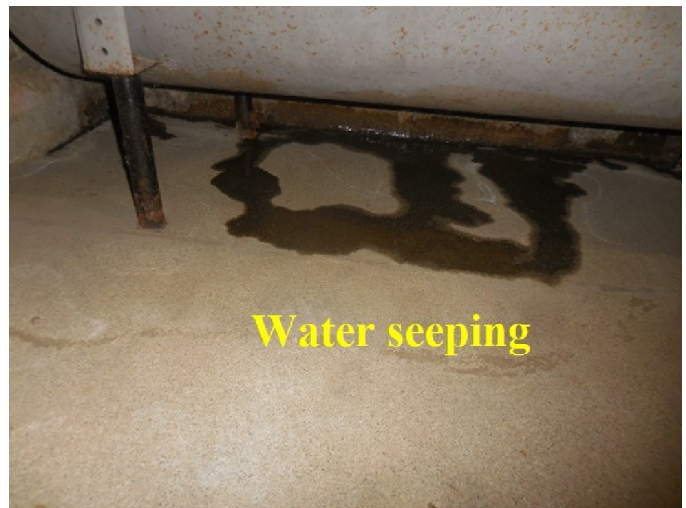
Basement Drainage

There is evidence of water entering basement and it appears to be an ongoing problem.

There was water standing on the floor at time of inspection and drainage should be improved.

Some water penetration was noted.

There was standing water in the sump pump pit. (Note: The presence of water promotes mold, fungus, dampness and bacteria.)

When the sump float was lifted pump check valve leaked profusely. The pump should be repaired or replaced. See photo-repairs needed

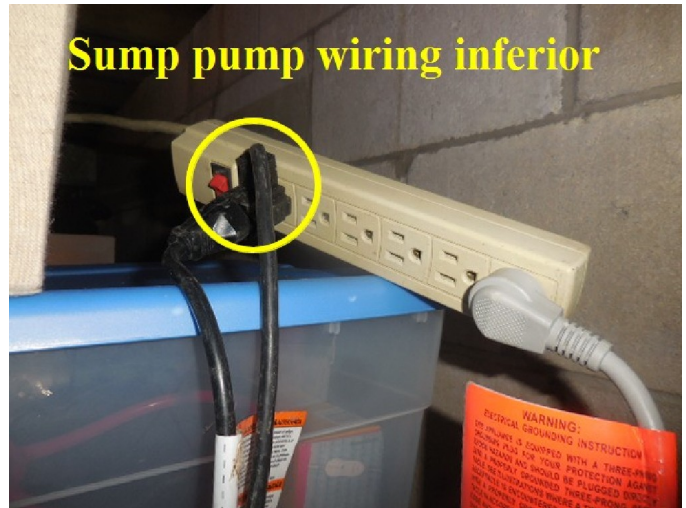
Sump wiring

The sump pump should be wired independent directly to the panel. See photo-repairs needed

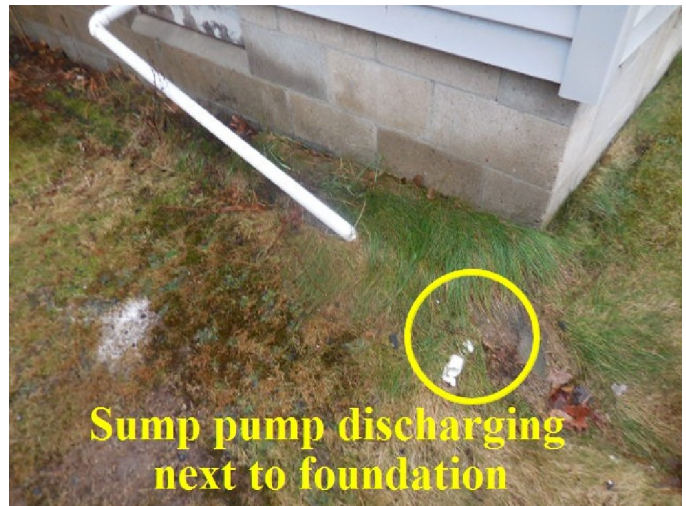
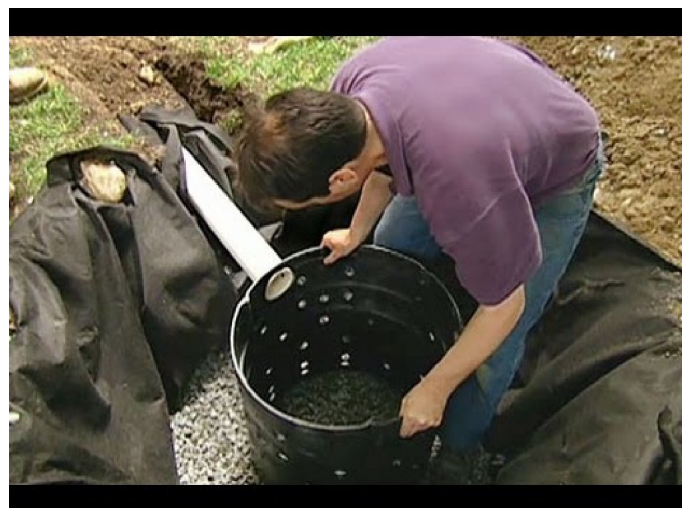
Sump pump installation

Sump pumps should discharge into a small dry well below grade, well away from the foundation walls. See photo-repairs needed

As they are piped now, the water would return back under the slab and overwork the pumps. See example of small drywell.

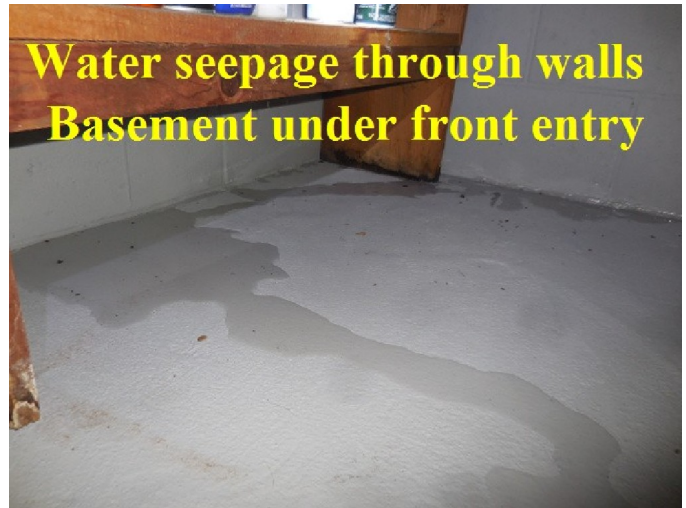
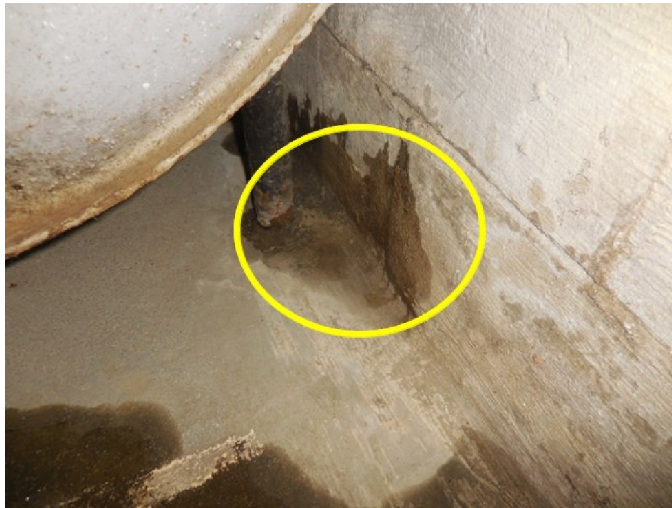
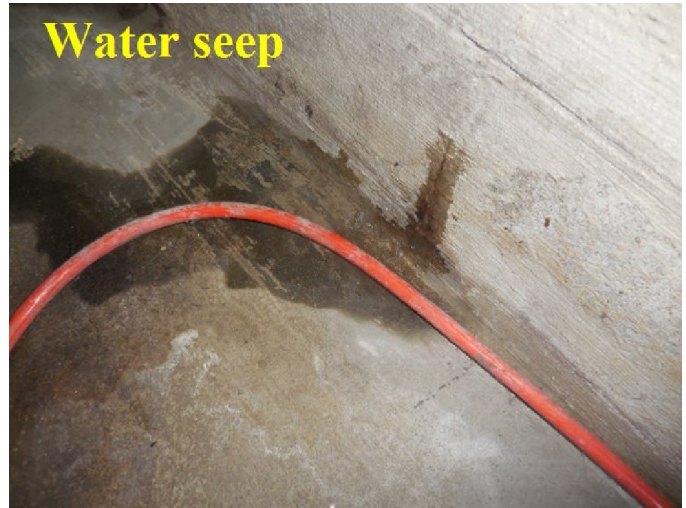
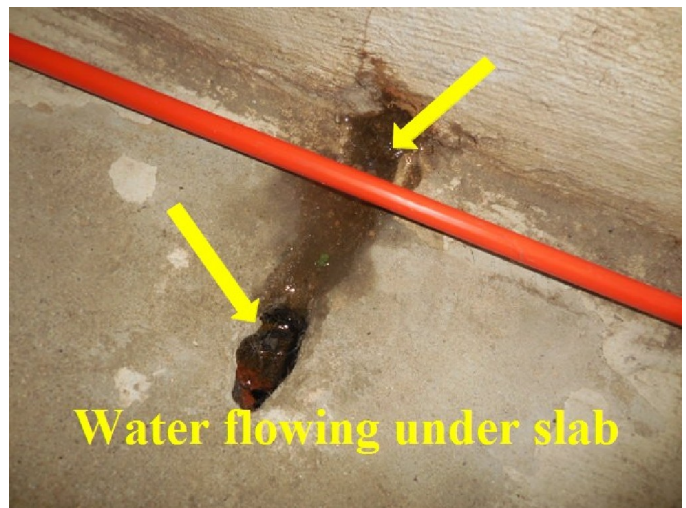
Wet areas/Standing water

Several areas of water intrusion noted, mostly due to lack of gutters and proper drainage techniques. See photo-repairs needed

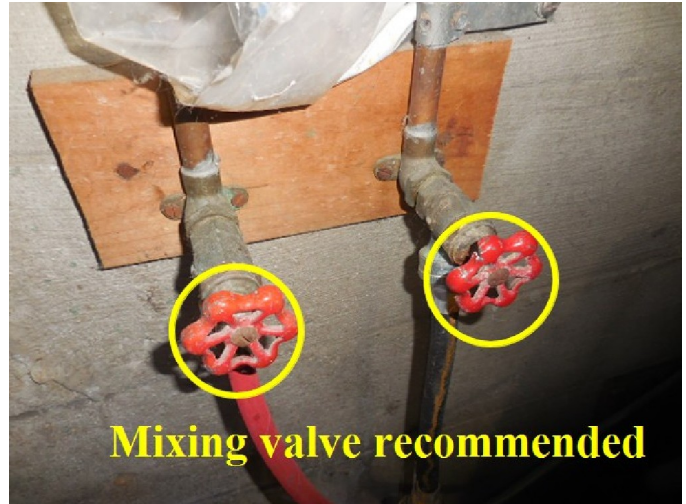
Laundry Water Faucets

Other =
Damaged/broken valve noted. See photo-repairs needed
Mixing valve recommended. See example photo

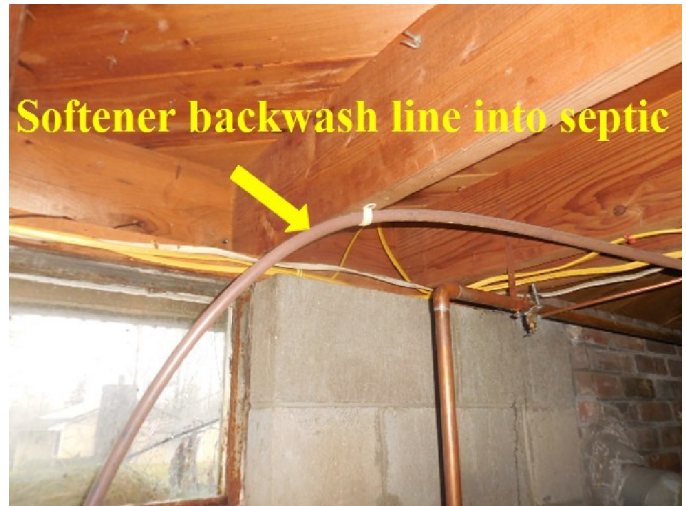
Water softener

The water softener backflush line should not empty into the septic system as it can cause scale buildup and tank degradation.
It is recommended to drain the line to the exterior if possible.
See photo-repairs needed

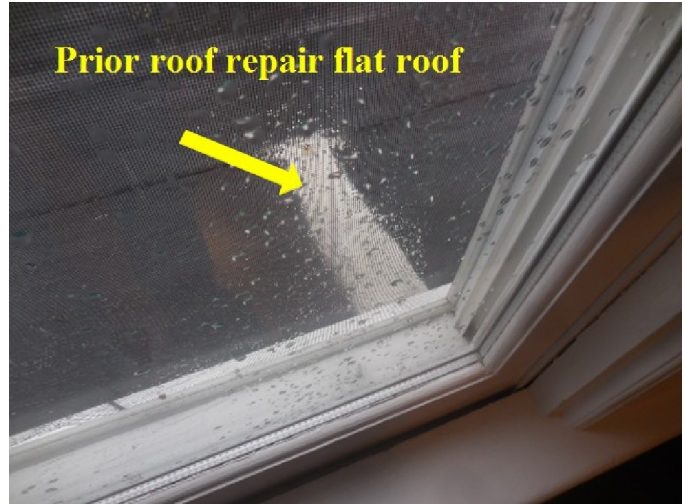
Roof Style

Some prior repairs noted to flat rolled roofing. Informational photo only- No repairs needed

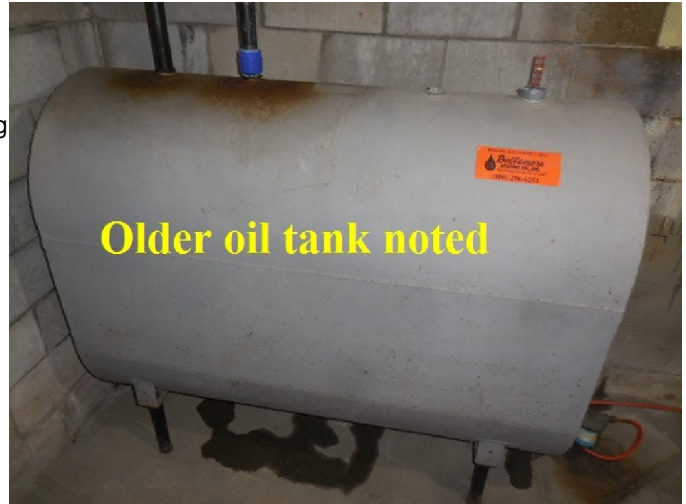
Forced Air System Energy Source

275 Gallon oil tank noted. NO ACTIVE leaks noted AT THIS TIME.

Note: Older tanks have recently come under scrutiny by the EPA. Informational photo only- No repairs needed
Your oil company may want to inspect the tank before delivering oil, they may choose to NOT FILL YOUR TANK, based on their company inspection guidelines or AGE parameters for oil tanks.
Be advised.
