XYZ ENERGY ANNUAL REPORT

ELECTRICAL SUB-STATION – TORONTO PLANT

IR-THERMOGRAPHY INSPECTION ANNUAL REPORT

The annual Thermography scan PM for XYZ Toronto Plant Electrical Sub-station was completed on June 26th, 2020. Below is the summary of the report findings:

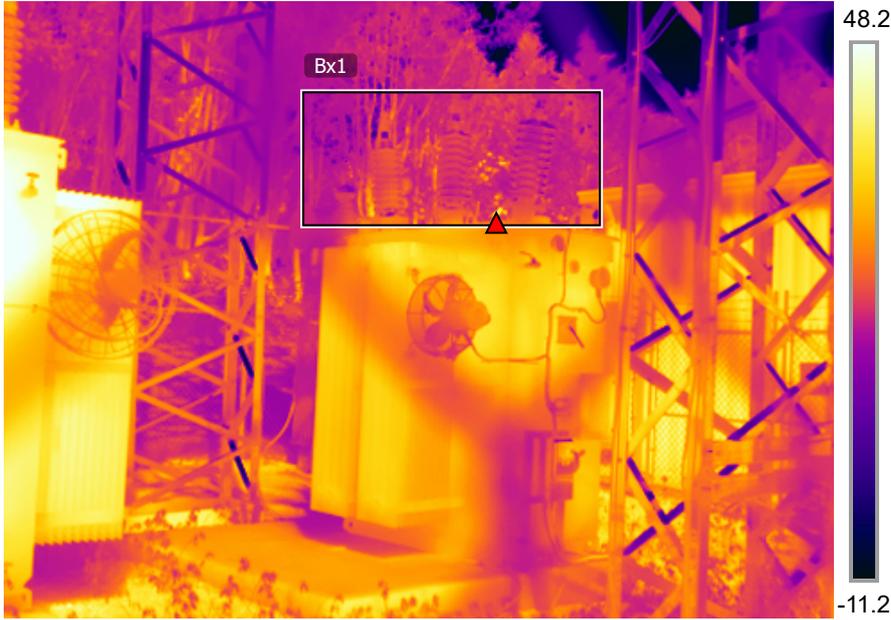
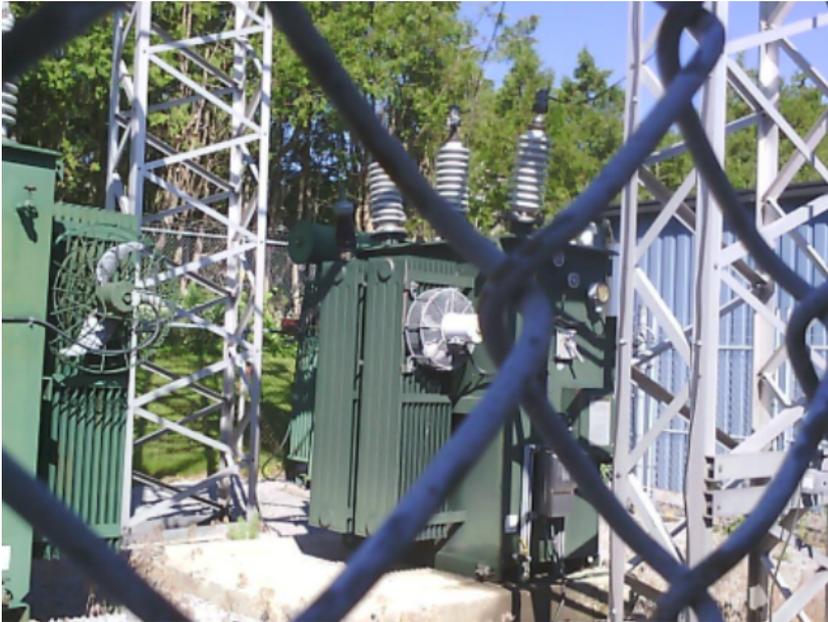
Unit #2

Bx1	Max	45.3 °C
-----	-----	---------

Normal

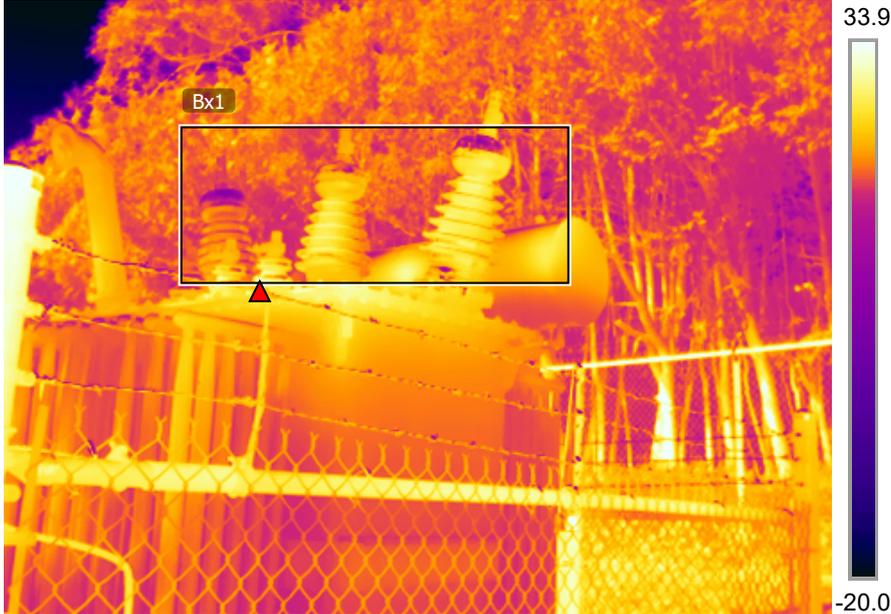
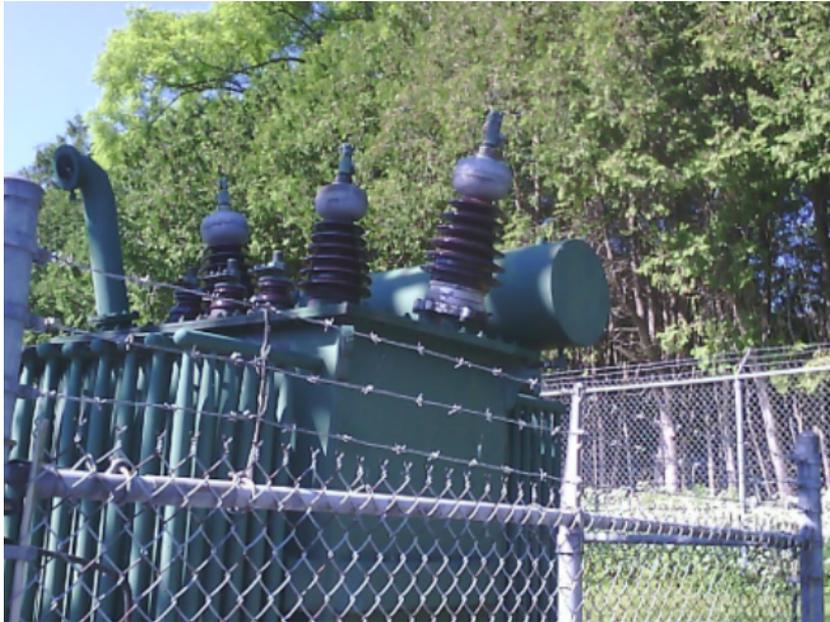
Unit #3

Bx1	Max	32.6 °C
-----	-----	---------

Normal

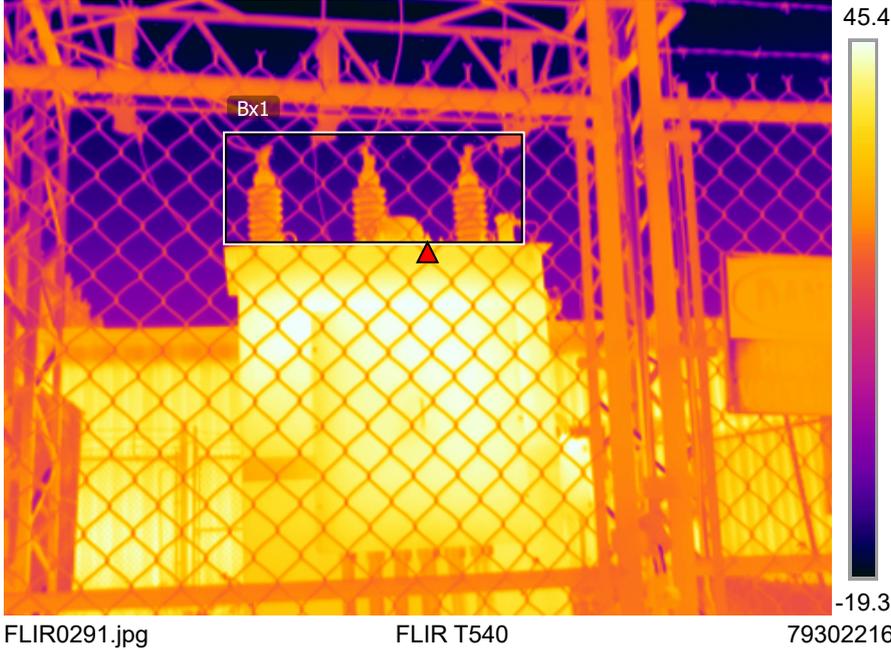
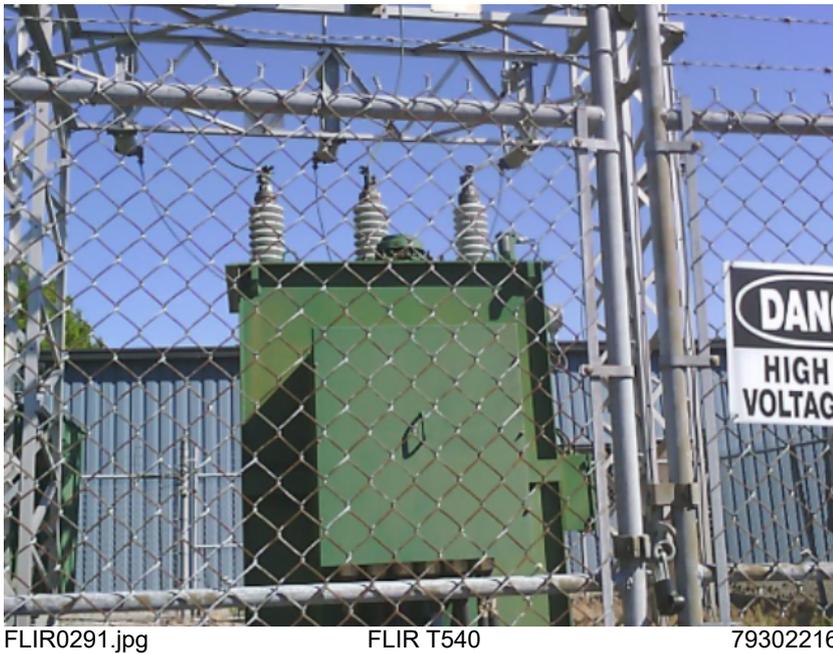
SubStation -XYZ Plant	Unit #1
-----------------------	---------

Bx1	Max	38.4 °C
-----	-----	---------

Normal

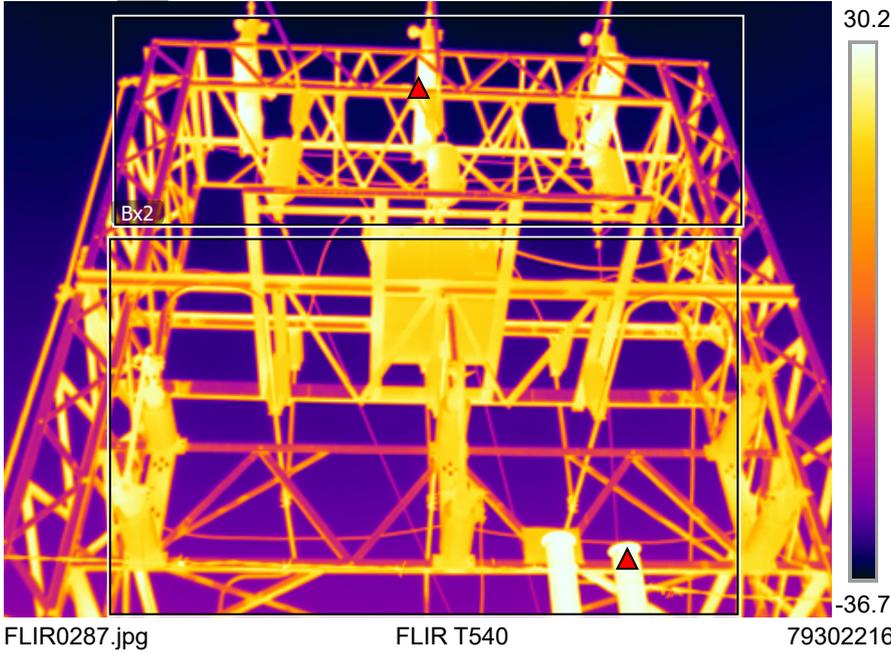
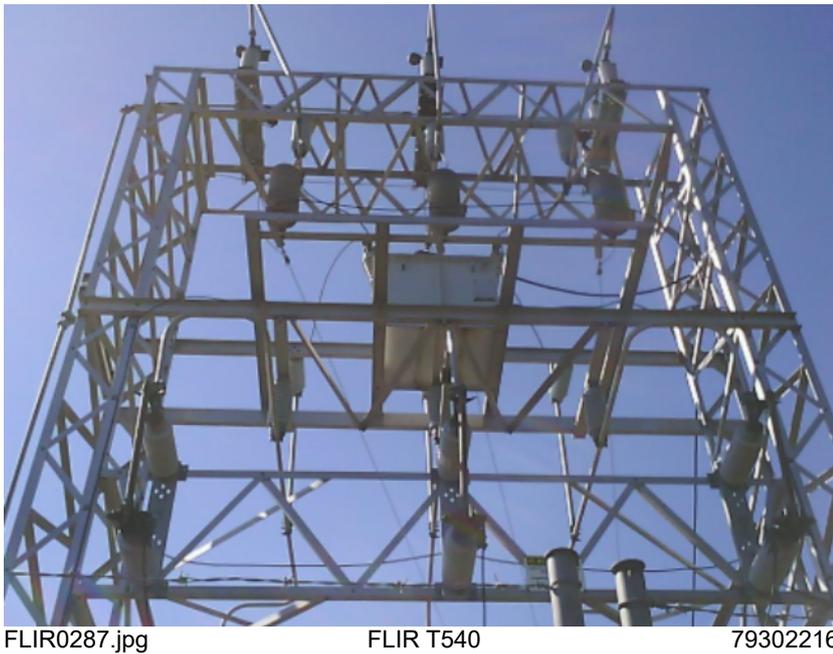
Tower #1

Bx1	Max	33.6 °C
Bx2	Max	32.2 °C

Normal

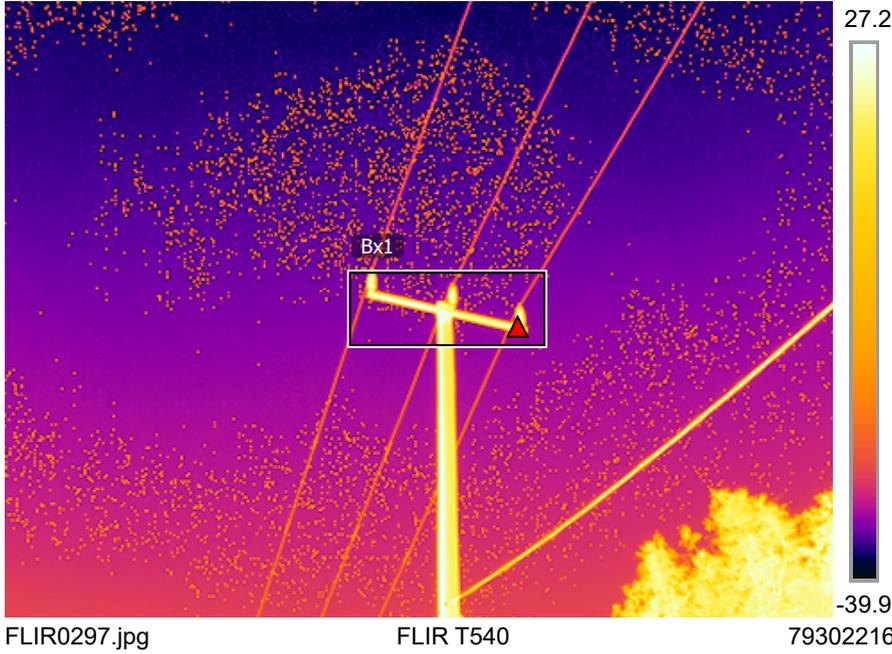
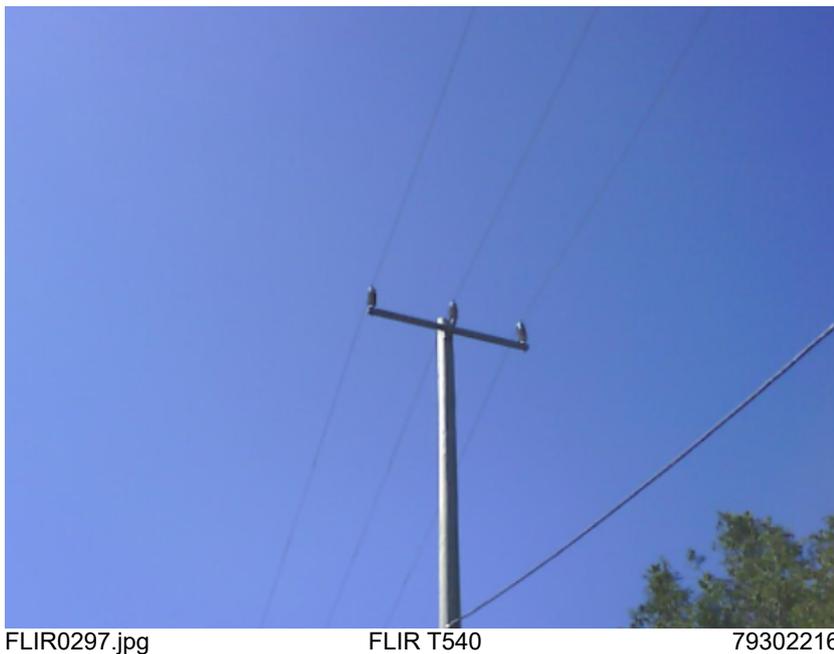
SubStation - XYZ Plant	Tower #2
------------------------	----------

Bx1	Max	29.6 °C
-----	-----	---------

Normal
