Building Inspection Report

123 STREET NAME CITY NAME, STATE NAME

Inspection Date:
10-11-12

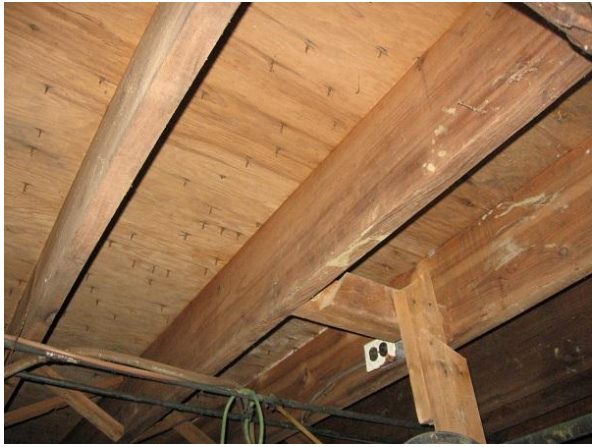
Photo #1

- **Monitor:** Exposed floor framing did appear generally functional, with the noted exceptions.
 - **Monitor:** The floor structure shows common sagging and movement. This is usually the result of the age and framing design of the building. There was not evidence of need for immediate, costly repair.
 - **Repair:** Visible pest or termite activity and/or damage were observed. See photo #1. Repairs and/or treatment by qualified contractors are needed.
-

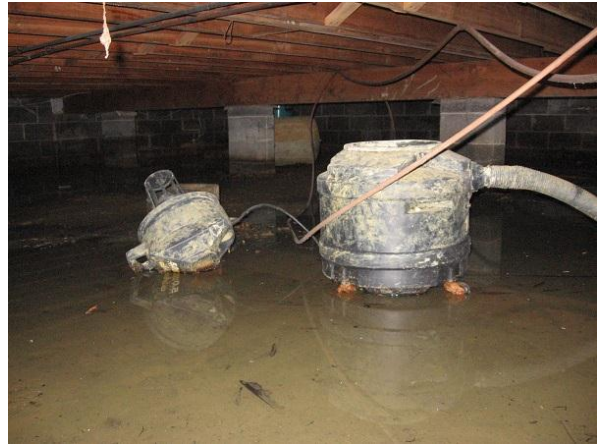
Photo #2

- **Repair:** Standing water was observed in the crawl space. See photos #2 and #9. Wet crawl spaces risk building damage from rot and insects and can cause interior mold or mildew. Roof and lot drainage repairs or improvements should be addressed as a first step to controlling water in the crawl space (see "Exterior"). Adding 1 or more sump pumps is necessary. This condition should then be monitored to determine if additional, potentially costly measures are necessary.

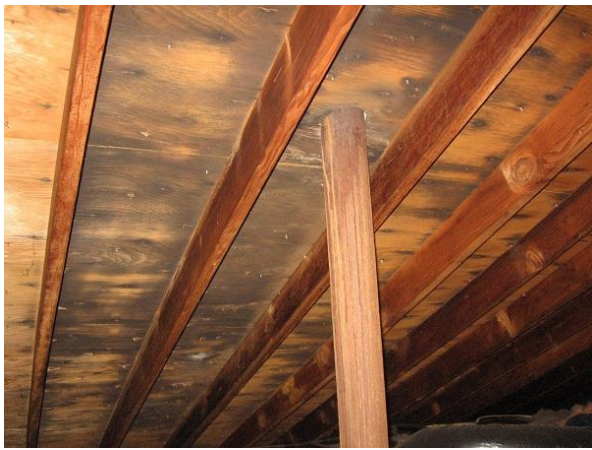
Photo #3

- **Repair:** Mildew or mold was found in various locations of the crawl and attic. See photo #3. This is usually due to improper ventilation. One (1) square foot of free vent area should be provided for every five hundred (500) square feet of crawl space. Proper ventilation helps control humidity and reduces the risk of rot. Crawl spaces can be vented to the building interior or exterior, depending on crawl space configuration. See also Ventilation pages.

- **Monitor:** 16" on-center rafter framing was noted.
- **Monitor, Repair:** Evidence of condensation was observed on the underside of the roof sheathing. See photo #3. This can weaken the sheathing and ultimately necessitate replacement. Improved roof and attic ventilation (see Insulation and Ventilation) can reduce condensation. During re-roofing, the sheathing should be investigated to determine if replacement is needed.
- **Repair:** Some evidence of roof leaks was observed at the attic stacks, etc. Please refer to the Roofing section of the report for recommendations.

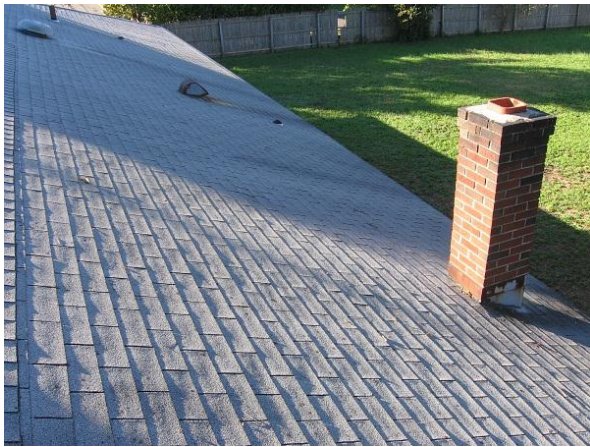
Photo #4

- **Repair:** The masonry chimney needs re-pointing (replacing the mortar between the bricks) to avoid water damage.
- **Repair:** The cap of the masonry chimney was cracked or damaged and should be replaced. See photo #4. The chimney flue should be checked for damage. Damaged flues can be unsafe.
- **Repair:** A rain cap and vermin screen should be installed on the masonry chimney and the chimney flue should be checked for damage. See photo #4. Damaged flues can be unsafe.
- **Monitor:** The chimney is no longer in service. It could be removed down to a level below the roof line.

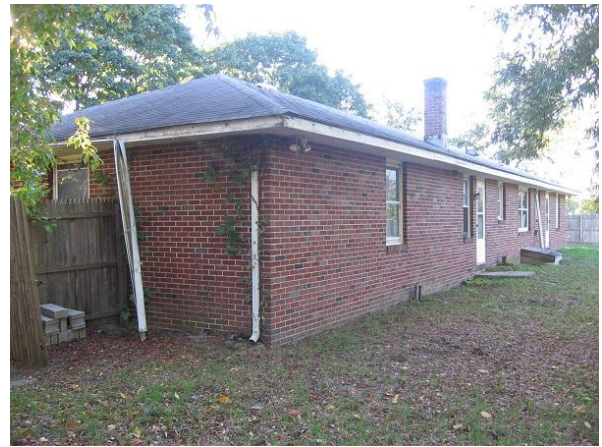
Photo #5

- **Repair:** The gutters require cleaning to avoid spilling roof runoff around the building – a potential source of water entry or water damage.
 - **Repair:** Damaged or missing gutters at most areas should be repaired or replaced as necessary to avoid spilling roof runoff around the building – a potential source of water entry or water damage. See photo #5.
 - **Repair:** Loose or damaged downspouts at all areas should be repaired promptly.
 - **Repair:** Missing elbows of the downspouts at most areas will need replacement.
 - **Repair:** It is recommended that gutters and downspouts be installed where missing to avoid spilling roof runoff around the building – a potential source of water entry or water damage. See also photos below.
-

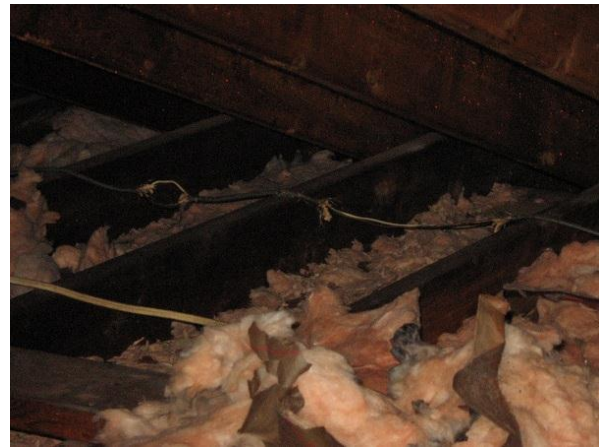
- **Repair:** Abandoned wiring throughout the attic should be replaced or appropriately terminated. See photo #6.
- **Repair:** Damaged wiring throughout the attic should be replaced or appropriately repaired. See photo #7.
- **Repair:** Wiring exposed on interior finishes at the garage should be relocated or protected by a rigid conduit.
- **Repair:** Improper electrical connections should be repaired. All electrical connections should be made inside junction boxes fitted with cover plates.
- **Repair:** All junction boxes in the attic should be fitted with cover plates, in order to protect the wire connections.
- **Repair:** The installation of the distribution wiring in the attic is non-standard. It is suspected that the installation was performed by an amateur, rather than a licensed electrician.

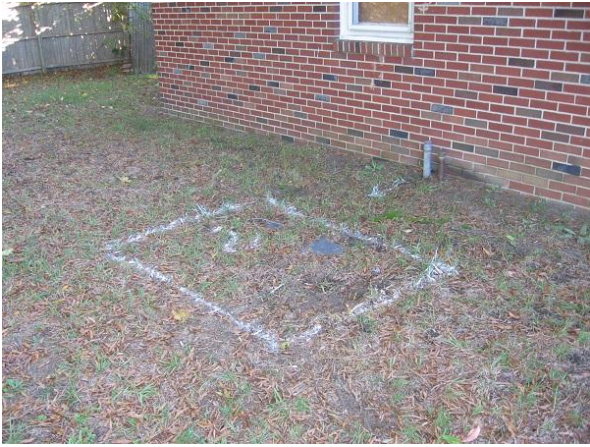
Photo #8

- **Repair:** Damaged attic ducting will need repairs.
 - **Major Concern, Repair:** It is suspected that an underground oil storage tank exists on the property at the rear yard. See photo #8. If the tank has leaked ***you could face a costly environmental cleanup*** task since the US EPA has indicated that leaky residential oil tanks are an environmental hazard for which Federal spill cleanup regulations could apply. Buried tanks which have not leaked can be opened, cleaned, and filled in-place or they can be removed entirely. ***Before purchasing the property you should have the tank or soil tested to assure that no leaks have occurred.*** If the tank is to continue in use it may be possible to purchase tank leak cleanup insurance, possibly through your oil company. Tank replacement with a newer (fiberglass) leak-resistant type or tank relocation indoors will also involve a significant expense.
