Building Inspection Report

123 STREET NAME CITY NAME, STATE NAME

Inspection Date:
10-11-12

Prepared By:
REGIONAL HOME INSPECTION SERVICES OF NEW JERSEY
P.O. BOX 1664
MEDFORD, NJ 08055

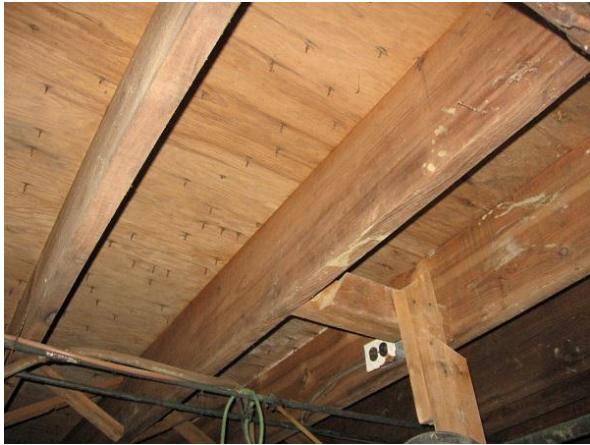
Photo #1

- **Monitor:** Exposed floor framing did appear generally functional, with the noted exceptions.
 - **Monitor:** The floor structure shows common sagging and movement. This is usually the result of the age and framing design of the building. There was not evidence of need for immediate, costly repair.
 - **Repair:** Visible pest or termite activity and/or damage were observed. See photo #1. Repairs and/or treatment by qualified contractors are needed.
-

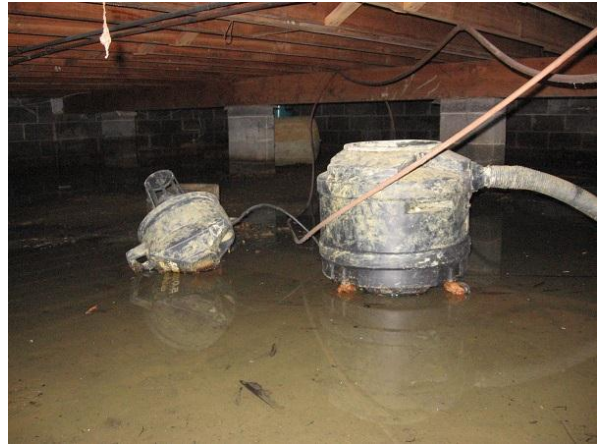
Photo #2

- **Repair:** Standing water was observed in the crawl space. See photos #2 and #9. Wet crawl spaces risk building damage from rot and insects and can cause interior mold or mildew. Roof and lot drainage repairs or improvements should be addressed as a first step to controlling water in the crawl space (see “Exterior”). Adding 1 or more sump pumps is necessary. This condition should then be monitored to determine if additional, potentially costly measures are necessary.

- **Repair:** Standing water was observed in the crawl space. See photos #2 and #9. Wet crawl spaces risk building damage from rot and insects and can cause interior mold or mildew. Roof and lot drainage repairs or improvements should be addressed as a first step to controlling water in the crawl space (see "Exterior"). Adding 1 or more sump pumps is necessary. This condition should then be monitored to determine if additional, potentially costly measures are necessary.

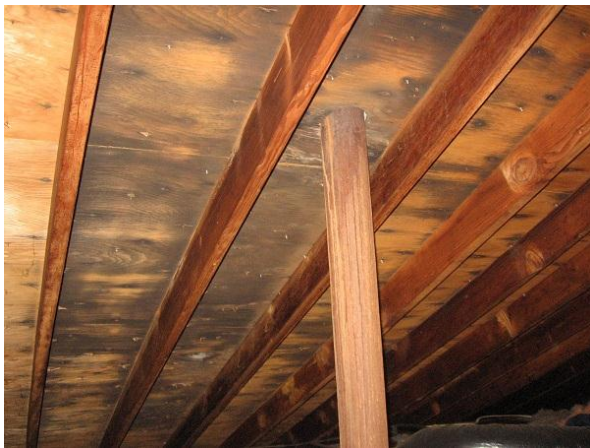
Photo #3

- **Repair:** Mildew or mold was found in various locations of the crawl and attic. See photo #3. This is usually due to improper ventilation. One (1) square foot of free vent area should be provided for every five hundred (500) square feet of crawl space. Proper ventilation helps control humidity and reduces the risk of rot. Crawl spaces can be vented to the building interior or exterior, depending on crawl space configuration. See also Ventilation pages.

- **Monitor:** 16" on-center rafter framing was noted.
- **Monitor, Repair:** Evidence of condensation was observed on the underside of the roof sheathing. See photo #3. This can weaken the sheathing and ultimately necessitate replacement. Improved roof and attic ventilation (see Insulation and Ventilation) can reduce condensation. During re-roofing, the sheathing should be investigated to determine if replacement is needed.
- **Repair:** Some evidence of roof leaks was observed at the attic stacks, etc. Please refer to the Roofing section of the report for recommendations.

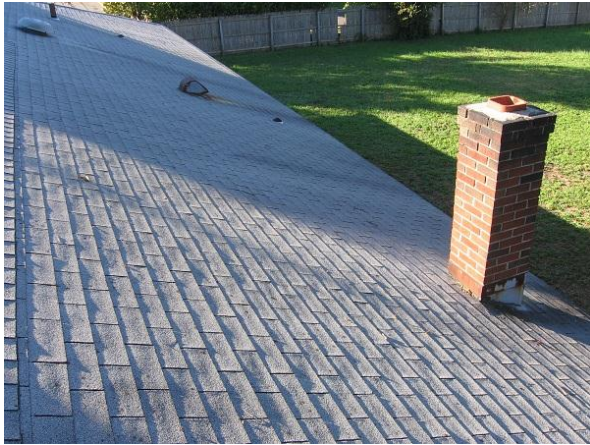
Photo #4

- **Repair:** The cap of the masonry chimney was cracked or damaged and should be replaced. See photo #4. The chimney flue should be checked for damage. Damaged flues can be unsafe.

- **Repair:** The masonry chimney needs re-pointing (replacing the mortar between the bricks) to avoid water damage.
- **Repair:** The cap of the masonry chimney was cracked or damaged and should be replaced. See photo #4. The chimney flue should be checked for damage. Damaged flues can be unsafe.
- **Repair:** A rain cap and vermin screen should be installed on the masonry chimney and the chimney flue should be checked for damage. See photo #4. Damaged flues can be unsafe.
- **Monitor:** The chimney is no longer in service. It could be removed down to a level below the roof line.

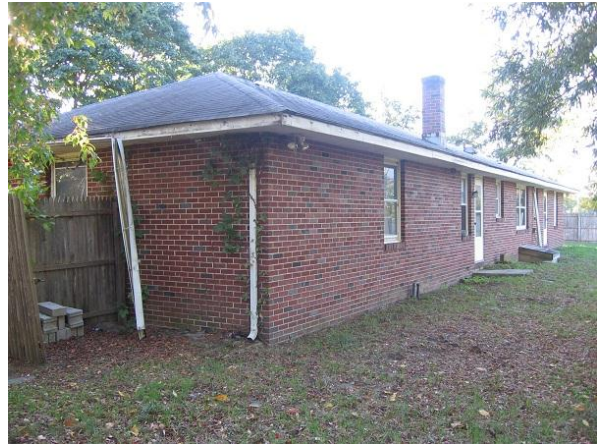
Photo #5

- **Repair:** Damaged or missing gutters at most areas should be repaired or replaced as necessary to avoid spilling roof runoff around the building – a potential source of water entry or water damage. See photo #5.

- **Repair:** The gutters require cleaning to avoid spilling roof runoff around the building – a potential source of water entry or water damage.
 - **Repair:** Damaged or missing gutters at most areas should be repaired or replaced as necessary to avoid spilling roof runoff around the building – a potential source of water entry or water damage. See photo #5.
 - **Repair:** Loose or damaged downspouts at all areas should be repaired promptly.
 - **Repair:** Missing elbows of the downspouts at most areas will need replacement.
 - **Repair:** It is recommended that gutters and downspouts be installed where missing to avoid spilling roof runoff around the building – a potential source of water entry or water damage. See also photos below.
-

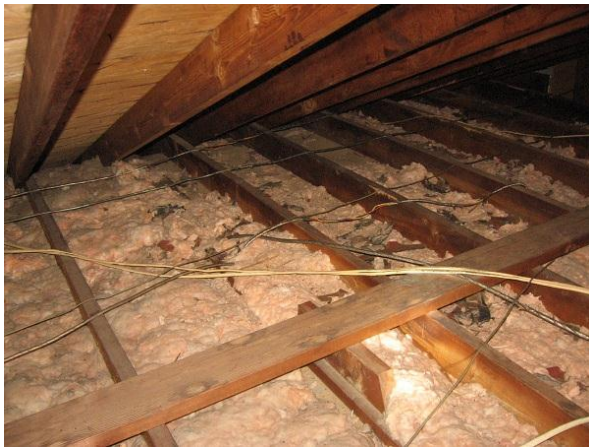
Photo #6

- **Repair:** Abandoned wiring throughout the attic should be replaced or appropriately terminated. See photo #6.
 - **Repair:** Damaged wiring throughout the attic should be replaced or appropriately repaired. See photo #7.

- **Repair:** Abandoned wiring throughout the attic should be replaced or appropriately terminated. See photo #6.
- **Repair:** Damaged wiring throughout the attic should be replaced or appropriately repaired. See photo #7.
- **Repair:** Wiring exposed on interior finishes at the garage should be relocated or protected by a rigid conduit.
- **Repair:** Improper electrical connections should be repaired. All electrical connections should be made inside junction boxes fitted with cover plates.
- **Repair:** All junction boxes in the attic should be fitted with cover plates, in order to protect the wire connections.
- **Repair:** The installation of the distribution wiring in the attic is non-standard. It is suspected that the installation was performed by an amateur, rather than a licensed electrician.

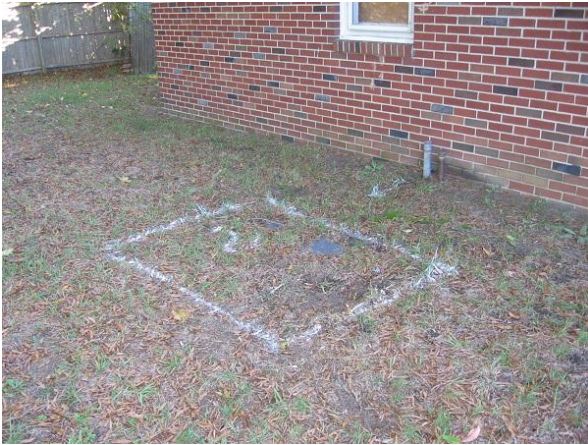
Photo #8

- **Repair:** Damaged attic ducting will need repairs.
 - **Major Concern, Repair:** It is suspected that an underground oil storage tank exists on the property at the rear yard. See photo #8. If the tank has leaked ***you could face a costly environmental cleanup*** task since the US EPA has indicated that leaky residential oil tanks are an environmental hazard for which Federal spill cleanup regulations could apply. Buried tanks which have not leaked can be opened, cleaned, and filled in-place or they can be removed entirely. ***Before purchasing the property you should have the tank or soil tested to assure that no leaks have occurred.*** If the tank is to continue in use it may be possible to purchase tank leak cleanup insurance, possibly through your oil company. Tank replacement with a newer (fiberglass) leak-resistant type or tank relocation indoors will also involve a significant expense.

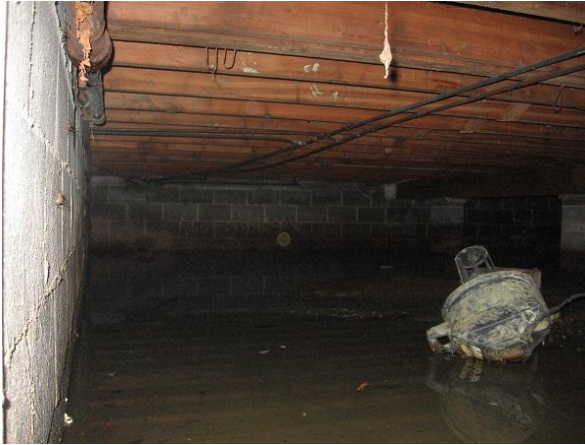
Photo #9

- **Repair:** Damaged crawl piping will need replacing or major re-piping.
 - **Repair:** The waste piping is leaking and damaged at the crawl. See photo #9.
