# Briar Lake

## Unit Owners' Association

Inspected: May 31, 2024 • Revised on: September 9, 2024  
Lebanon, PA

FULL RESERVE STUDY

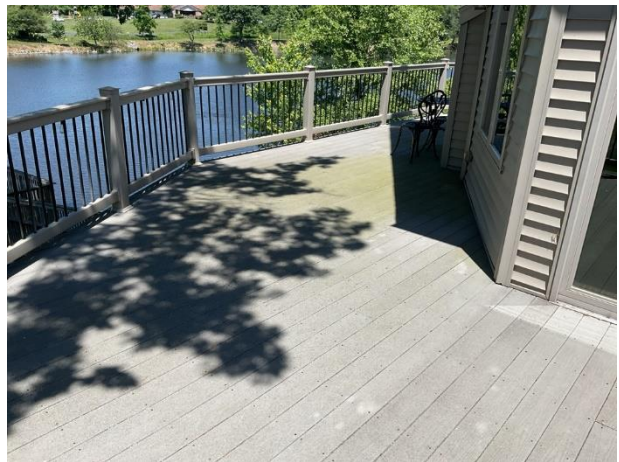
**Condition:** Fair overall with finish deterioration noted at the composite decking and vinyl railings.

Composite decking - Note surface deterioration and organic growth

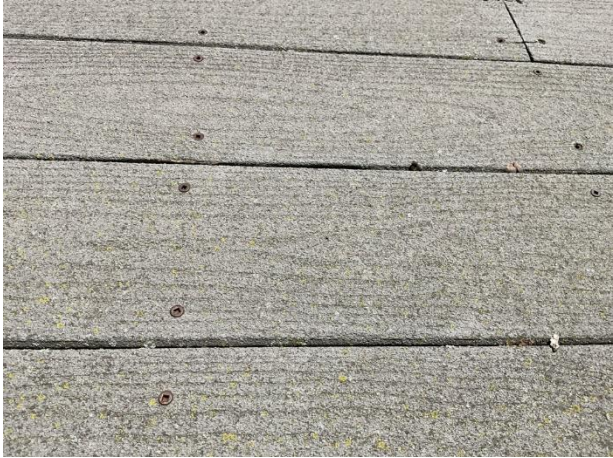
**Composite decking surface deterioration**

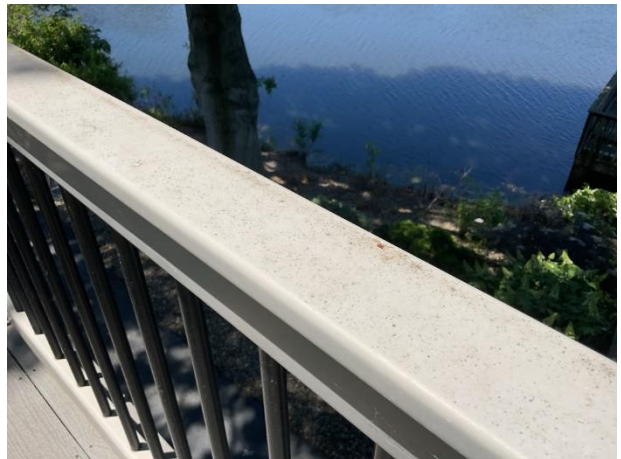
**Finish deterioration**

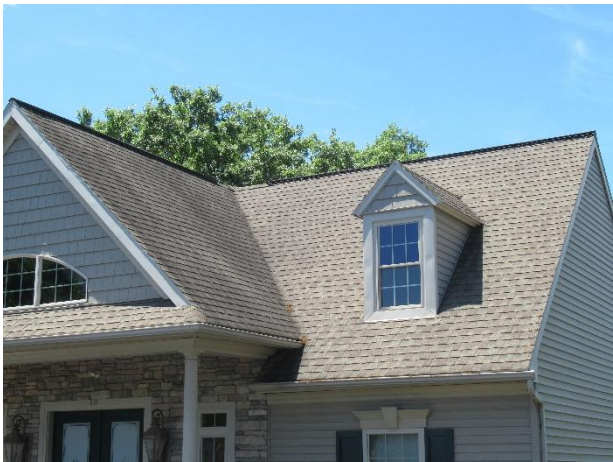
**Condition:** Fair overall with isolated shingle lift evident from our visual inspection from the ground. The Board informs us that there is an isolated leak at the roof. Fastener rust and finish deterioration is evident at the gutters and downspouts.

Asphalt shingle roof overview

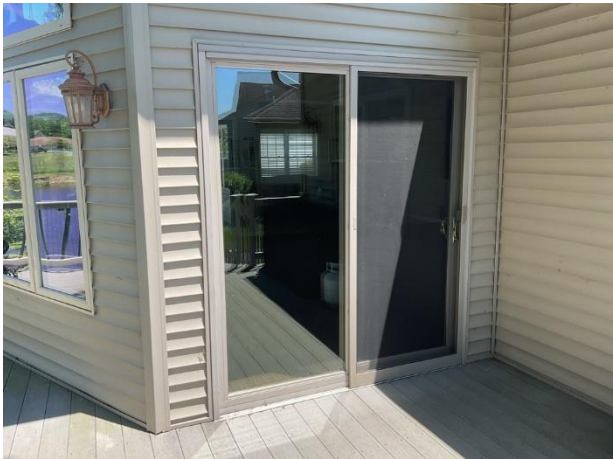
**Condition:** Good to fair overall with isolated fogged glass evident

**Sliding glass door**

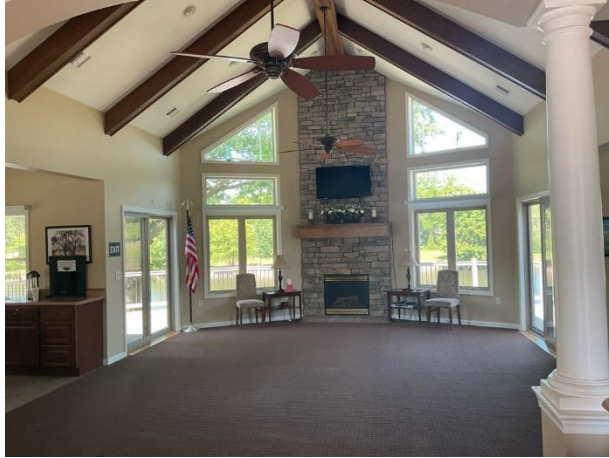
**Condition:** Good to fair overall with periodic frayed carpet at the edges. We have deferred the replacement of the carpet past our stated useful life due to the carpet's good overall condition.

**Carpet floor coverings overview**

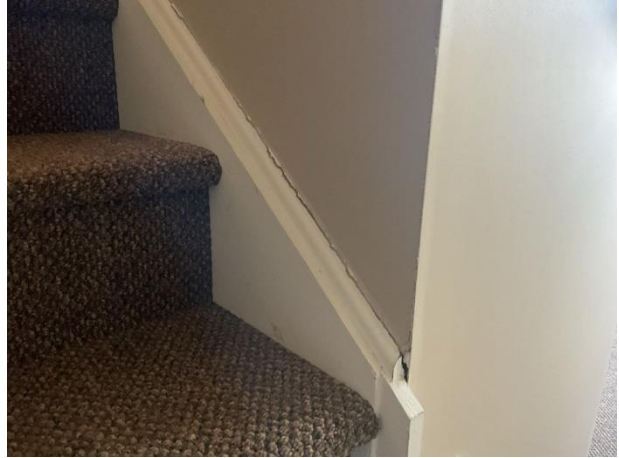
**Condition:** Good to fair overall with isolated damaged paint evident. We have deferred the repainting of the walls and ceilings at the clubhouse interior due to their good overall condition.

**Damaged paint finishes**

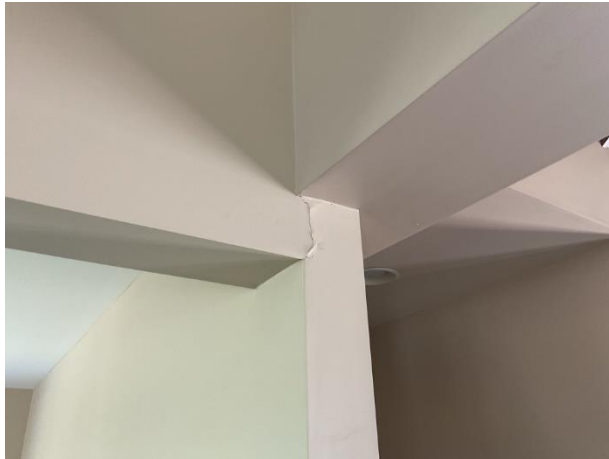
**Damaged paint finishes**

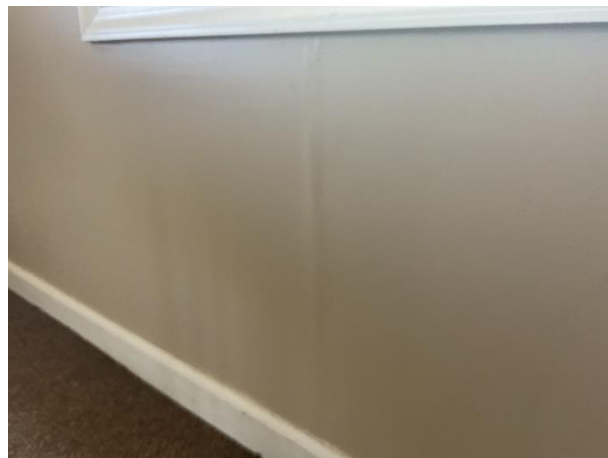
**Damaged paint finishes**

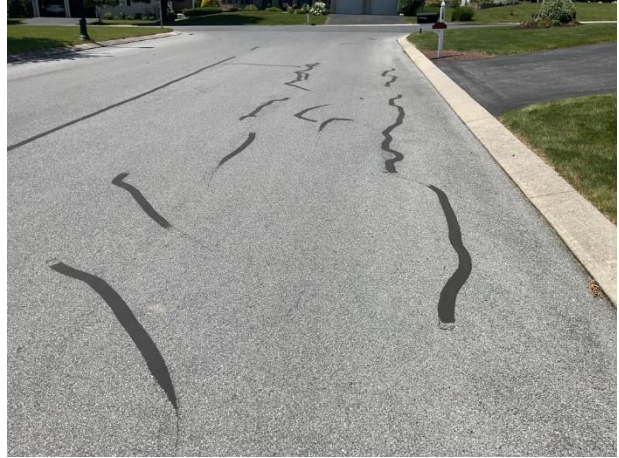
**Previously repaired cracks – Lantern Drive**

**Component Detail Notes:** Proposals should include mechanically routing and filling all cracks with hot emulsion. Repairs should also include patching at areas exhibiting settlement, potholes, or excessive cracking. The contractor should only apply seal coat applications at the parking area after repairs are completed. A seal coat does not bridge or close cracks, therefore, unrepaired cracks render the seal coat applications useless. These activities minimize the damaging effects of vehicle fluids, maintain a uniform and positive appearance, and maximize the useful life of the pavement.

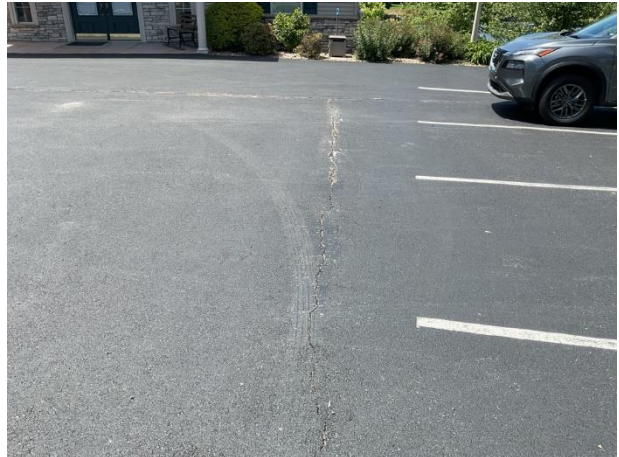
**Pavement cracks – Parking area**

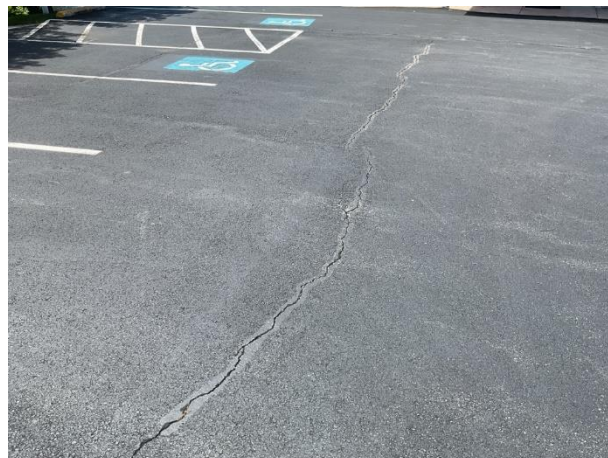
**Pavement cracks – Parking area**

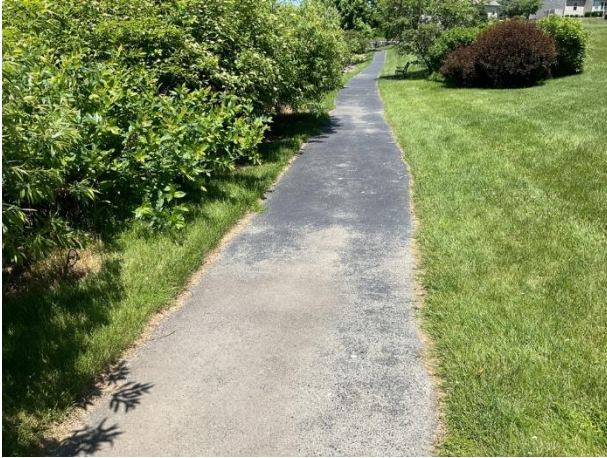
**Condition:** Good to fair overall with periodic cracks, settlement, patches and previous repairs evident. In isolated areas, we also noted sunken/settled areas that have resulted in standing water atop the walking paths.

**Asphalt pavement walking path - Note seal coat deterioration**

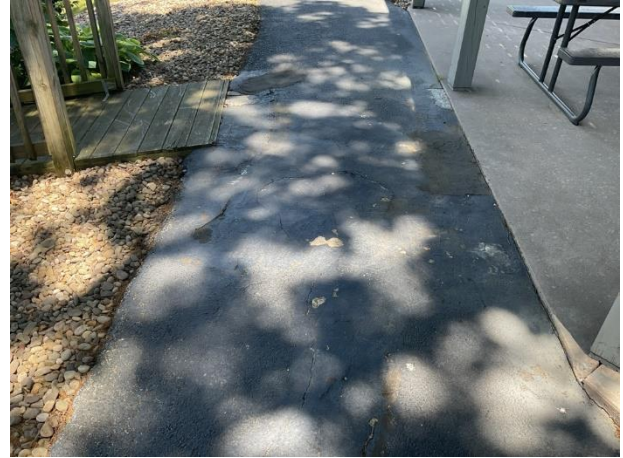
**Previous settlement repairs**

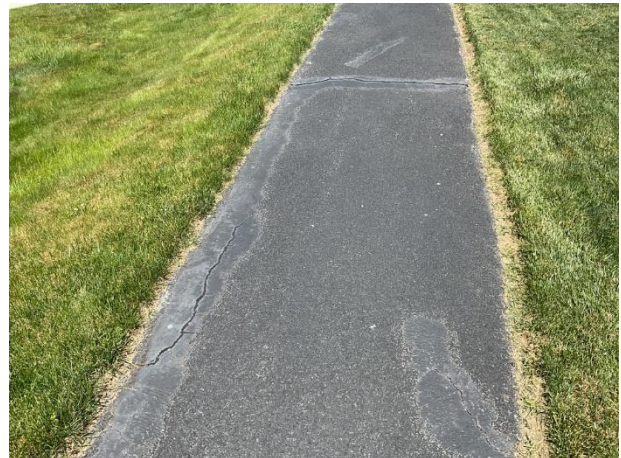
**Walking path cracks**

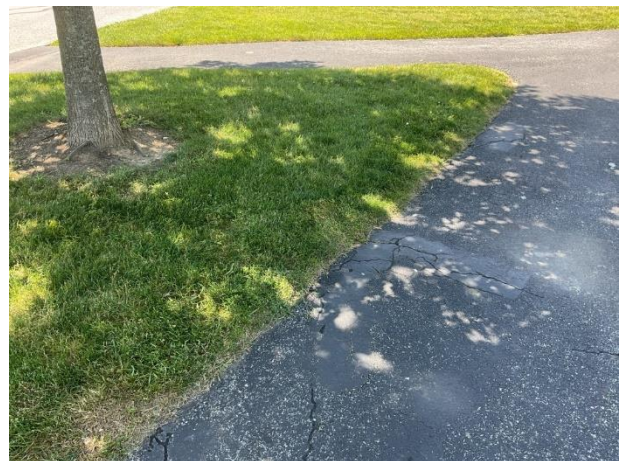
**Tree root intrusion**

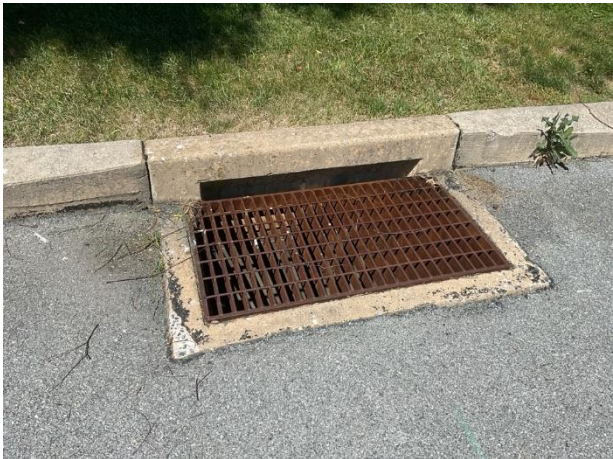
**Condition:** Good to fair overall with periodic collar damage evident.

Catch basin - Note settlement surrounding collar

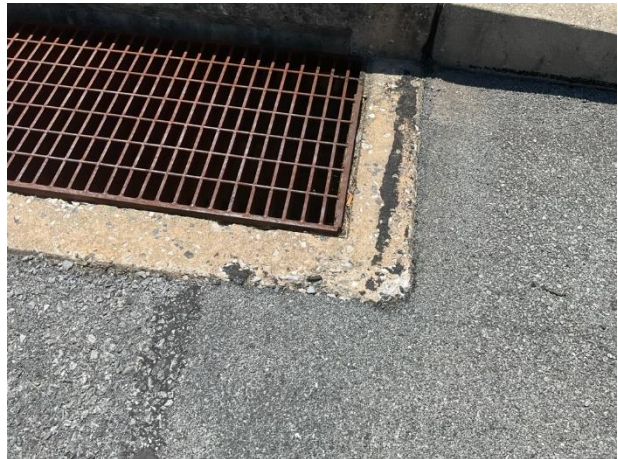
Concrete spalls

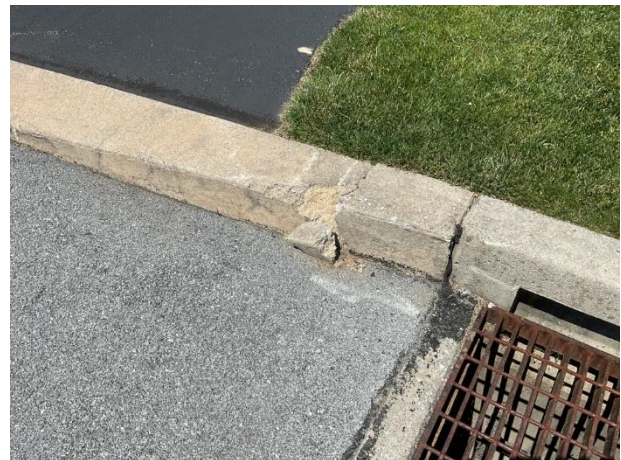
**History and Condition:** Good to fair overall with isolated cracks and spalled concrete evident. The Board does not report a history of repairs or replacements

Concrete spall

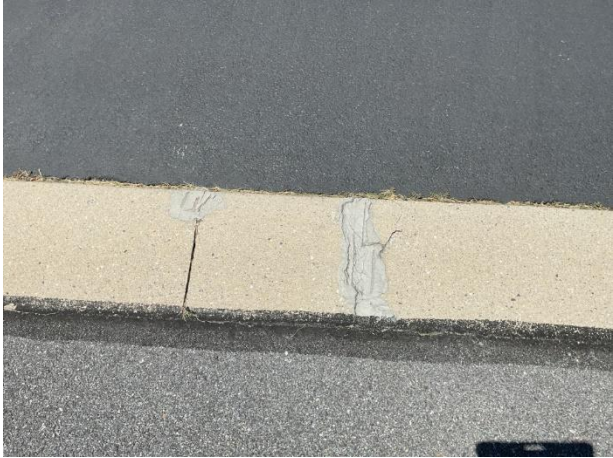
**Concrete cracks**

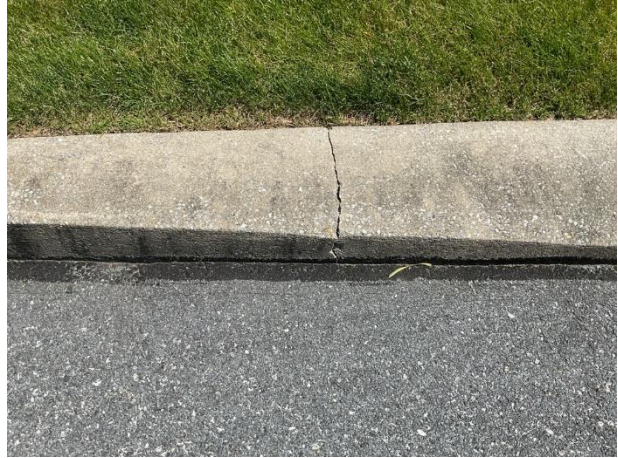
**Concrete crack**

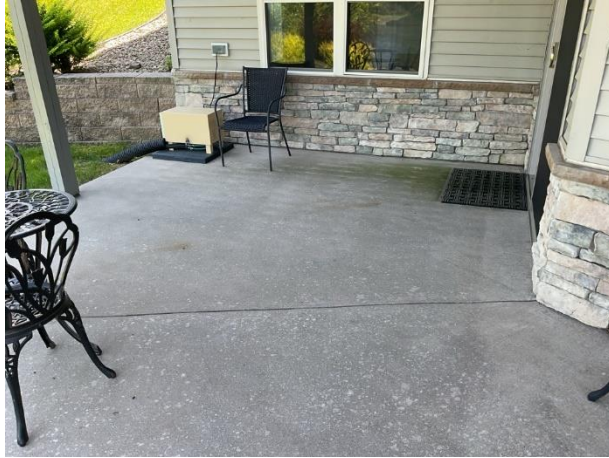
**Concrete patio - Note organic growth**

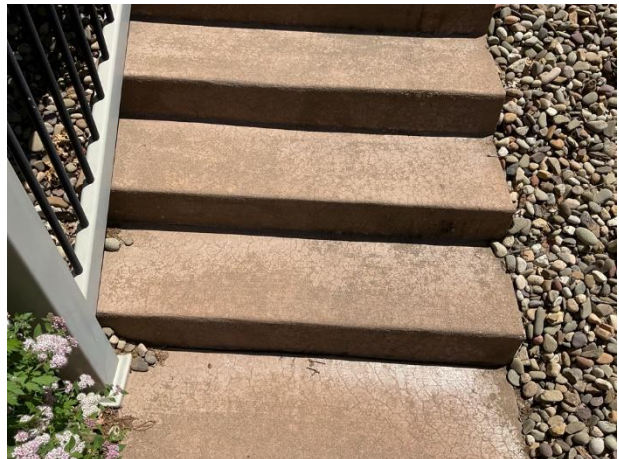
**Concrete stairs – Note finish deterioration**

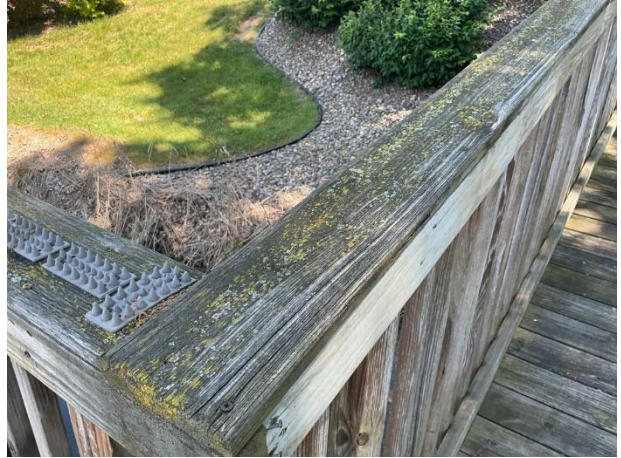
**Condition:** Fair overall with wood deterioration and organic growth evident

**Organic growth and wood deterioration**

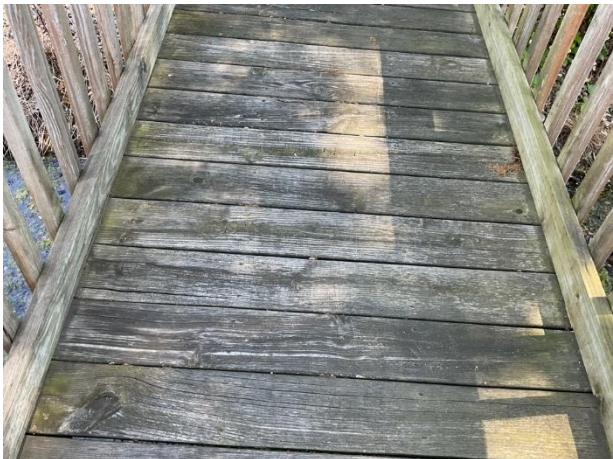
**Weathered wood decking and organic growth**

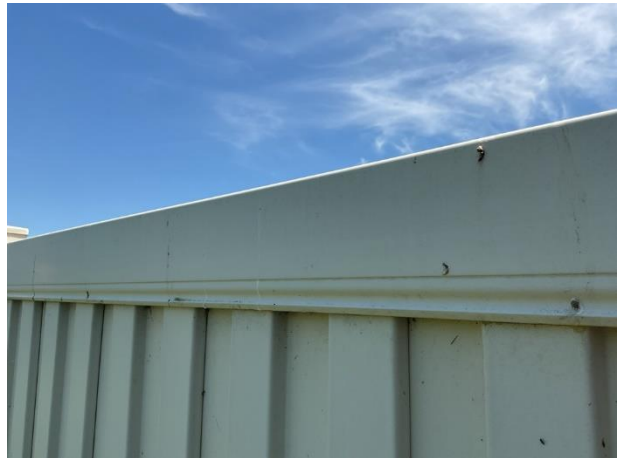
**Condition:** Fair overall with finish deterioration and isolated damage evident

Fence finish deterioration

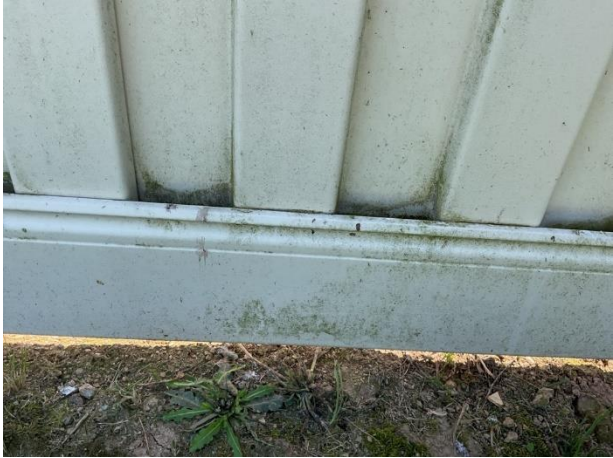
**Organic growth and finish deterioration**

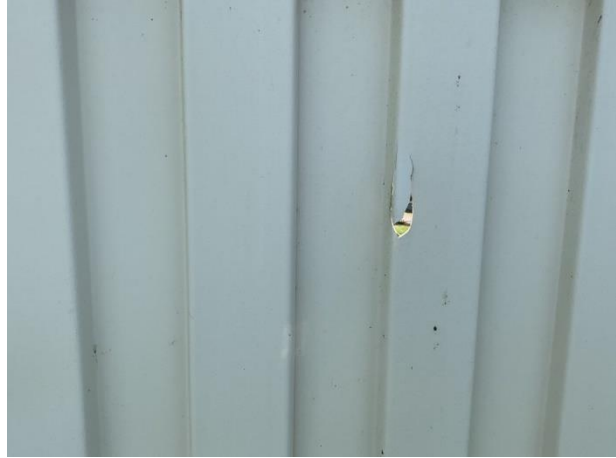
**Cracked vinyl**

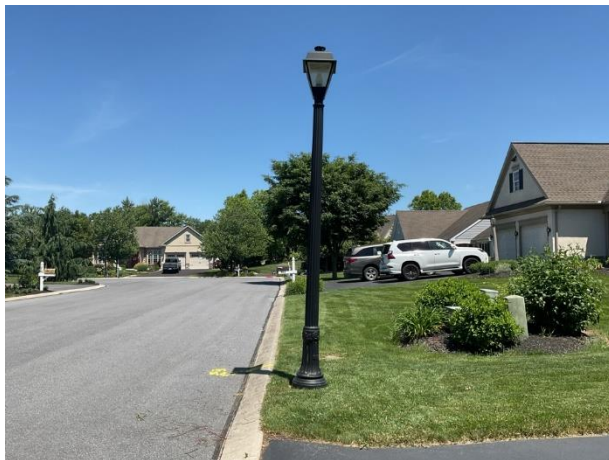
**Condition:** Fair overall with frequent leaning poles evident.

Light pole and fixture - note leaning pole

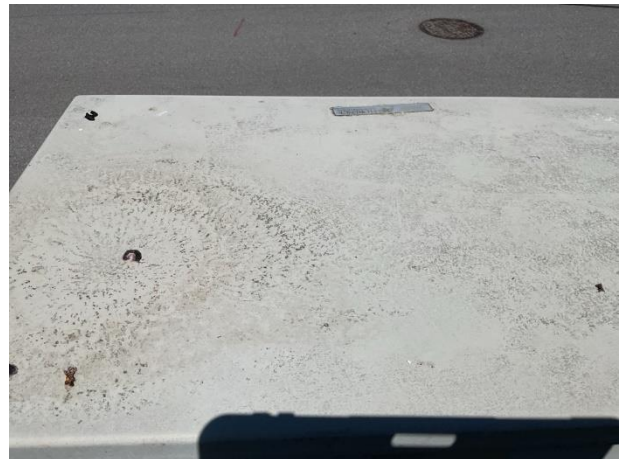
**Mailbox station finish deterioration**

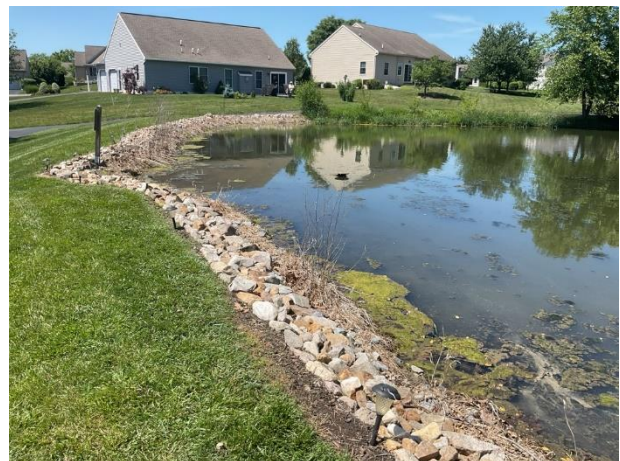
**Condition:** The main Lake is in good to fair overall condition. The Farm pond and upper pond are in fair overall condition with algae bloom and shoreline overgrowth noted.

**Farm pond shoreline**

**Useful Life:** Based on the visual condition, construction and adjacent deciduous trees, we recommend the Association anticipate the need to remove pond sediment up to every 30 years.

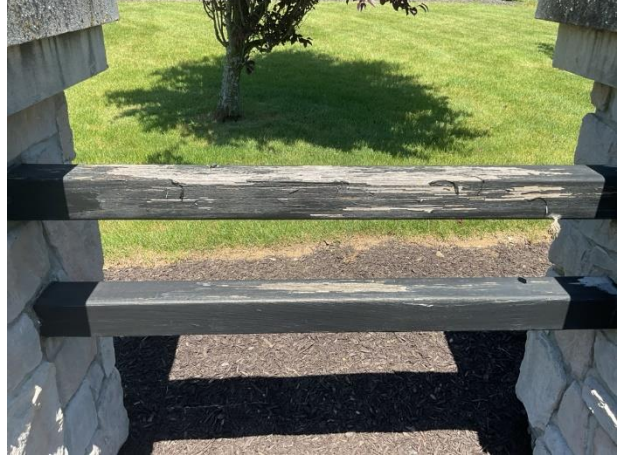
**Condition:** Fair overall deterioration noted at the sign and wood fencing

**Finish deterioration**

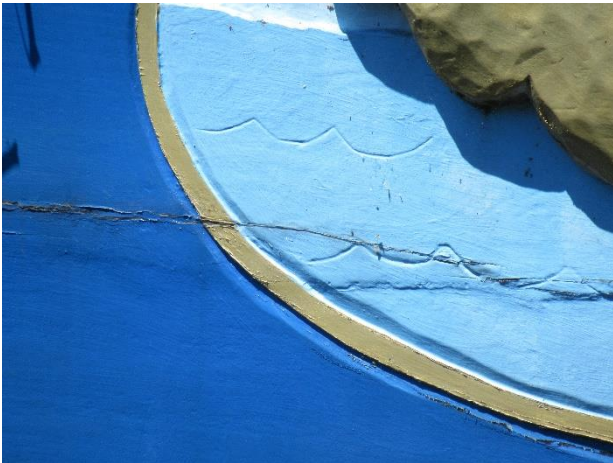
**Sign deterioration**

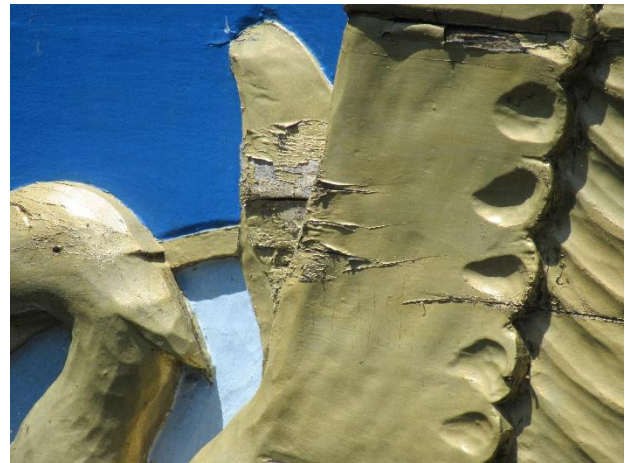
**Sign deterioration**

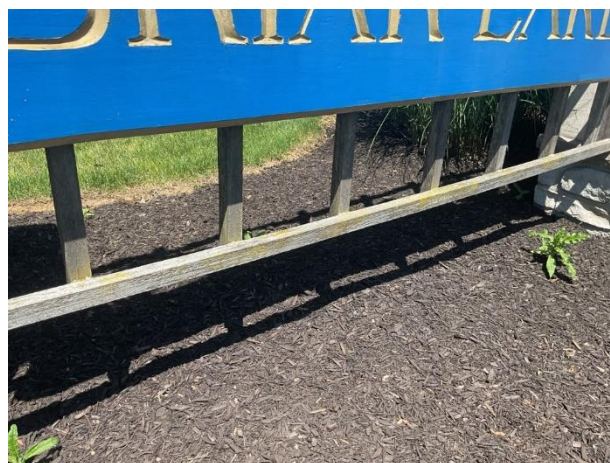
**Finish deterioration**

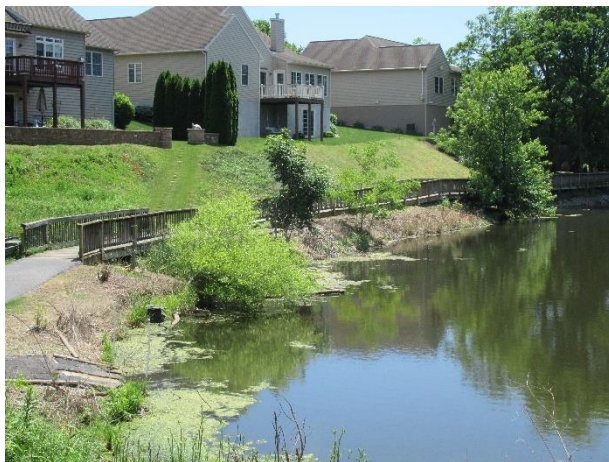
**Condition:** Fair to poor overall with wood deterioration, loose deck boards, and deterioration evident

Wood decking (replace with asphalt)

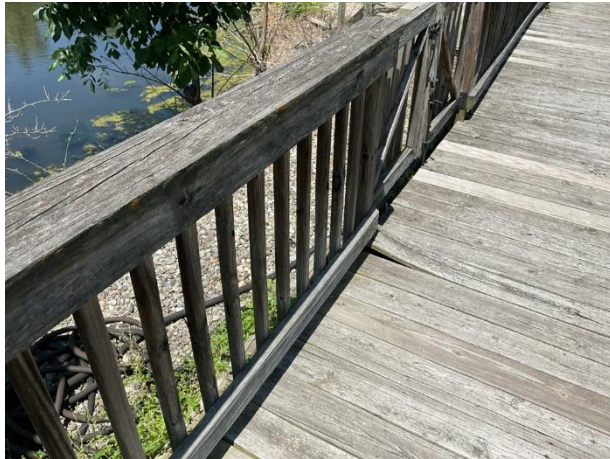
**Wood deterioration**

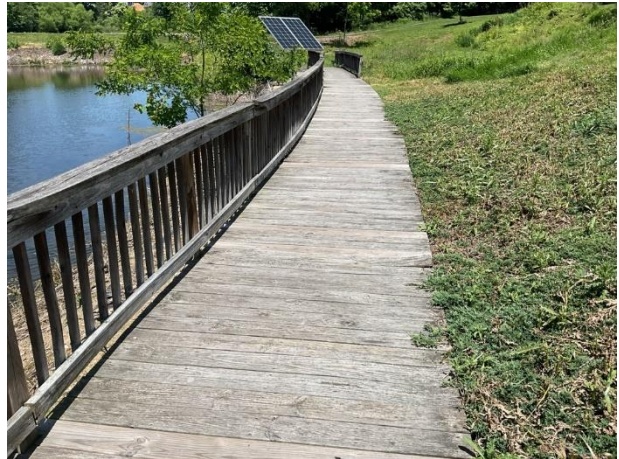
**Wood deterioration**

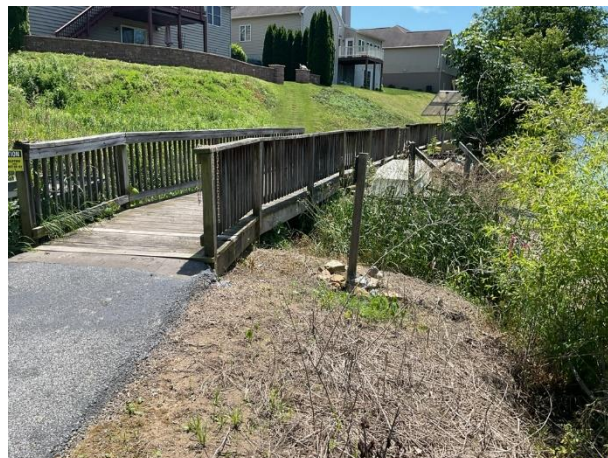
**Wetlands – Culvert to be added**

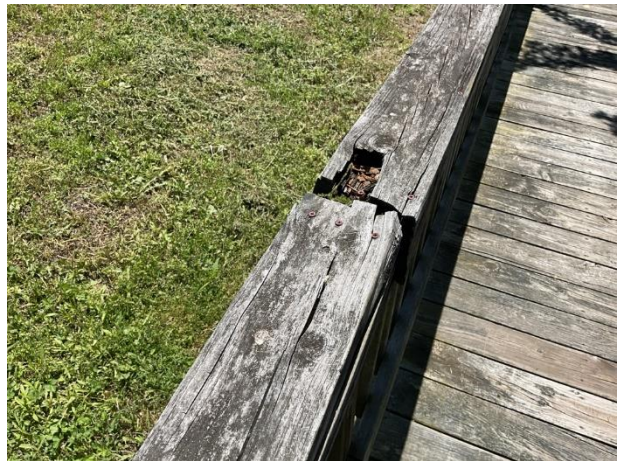
**Condition:** Fair to poor overall with wood deterioration, wood rot, loose deck boards, railing lean and organic growth evident

**Wood rot**

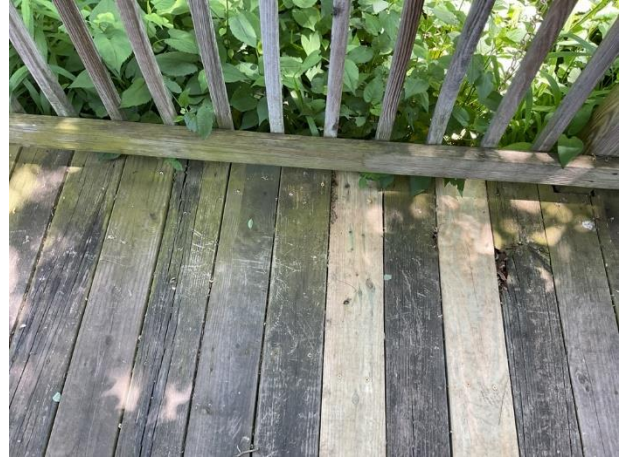
**Previous repairs, wood rot and organic growth**

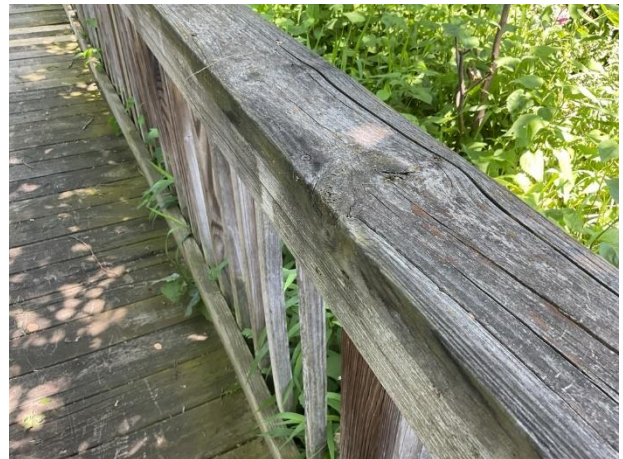
**Wood deteriorating**

**Useful Life:** We recommend subsequent replacement of the composite deck board and repairs and partial replacements to the wood structure up to every 25 years
