August 15, 2023

### Brookside HOA Property Evaluation

John Del Marto  
36336 N Old Woods Trail,  
Gurnee, IL 60031

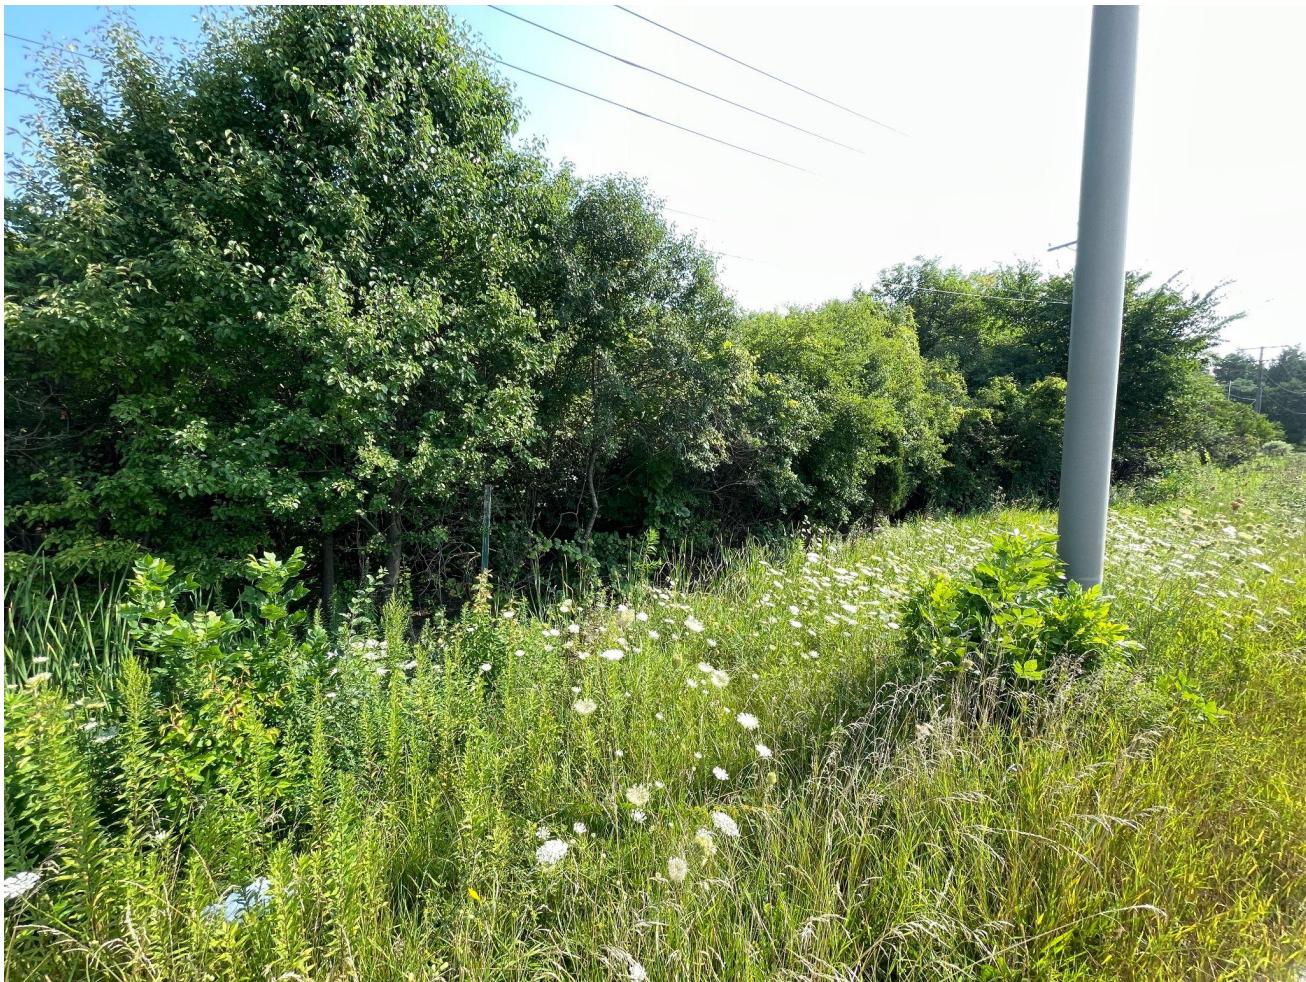
Approximately 20.4 acres. Overall the site is severely degraded from a native habitat, aesthetic, and stormwater capacity standpoint. Small pockets of native vegetation found within the site. Large sections of Lot I have buckthorn dead zones, where no other vegetation grows underneath large old buckthorn trees. Lot I has not been maintained for many years and will require investments in removal, maintenance, and monitoring to bring the lot back to proper functionality. Dominant species in the lot was Common Buckthorn (*Rhamnus cathartica*). Other species included Purple Loosestrife (*Lythrum salicaria*), Narrowleaf Cattails (*Typha angustifolia*), Rice Cut Grass (*Leersia oryzoides*), Reed Canary Grass (*Phalaris arundinacea*), Joe Pye Weed (*Eutrochium purpureum*). Noticeable lack of old growth native tree species located within the lot.

*Image 1. Facing south toward Lot I from Grand Ave.*

- **Remove Buckthorn.** The buckthorn has become so overgrown that it will be difficult to come up with a proper management plan. There were large sections of the property that could not be accessed because of the overgrowth.

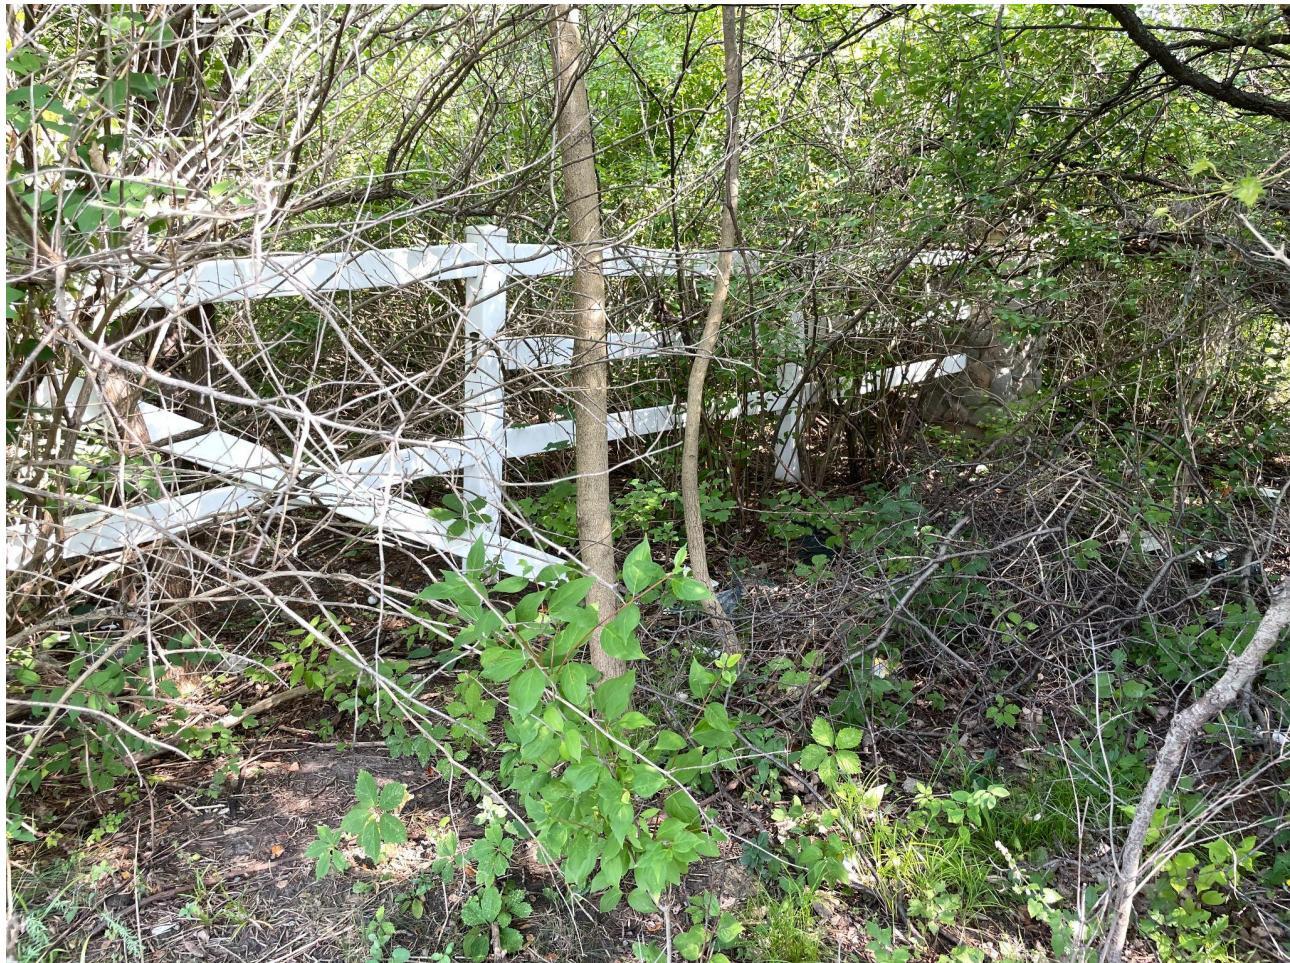
***Image 2. Facing south toward Lot 1 from Grand Ave. Overgrowth damaging fence.***

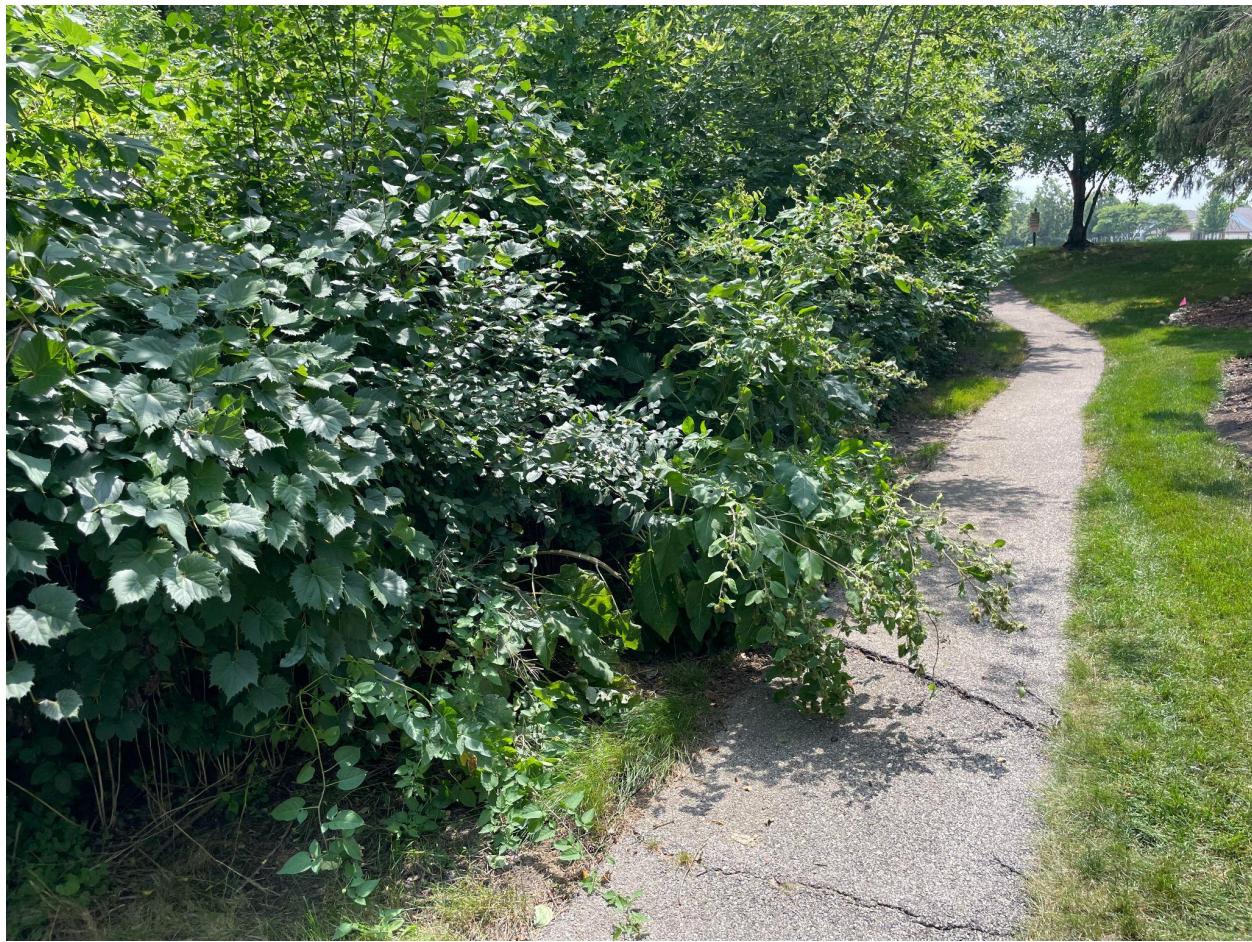
***Image 3. Lot 1 overgrowth. Very difficult to move through.***

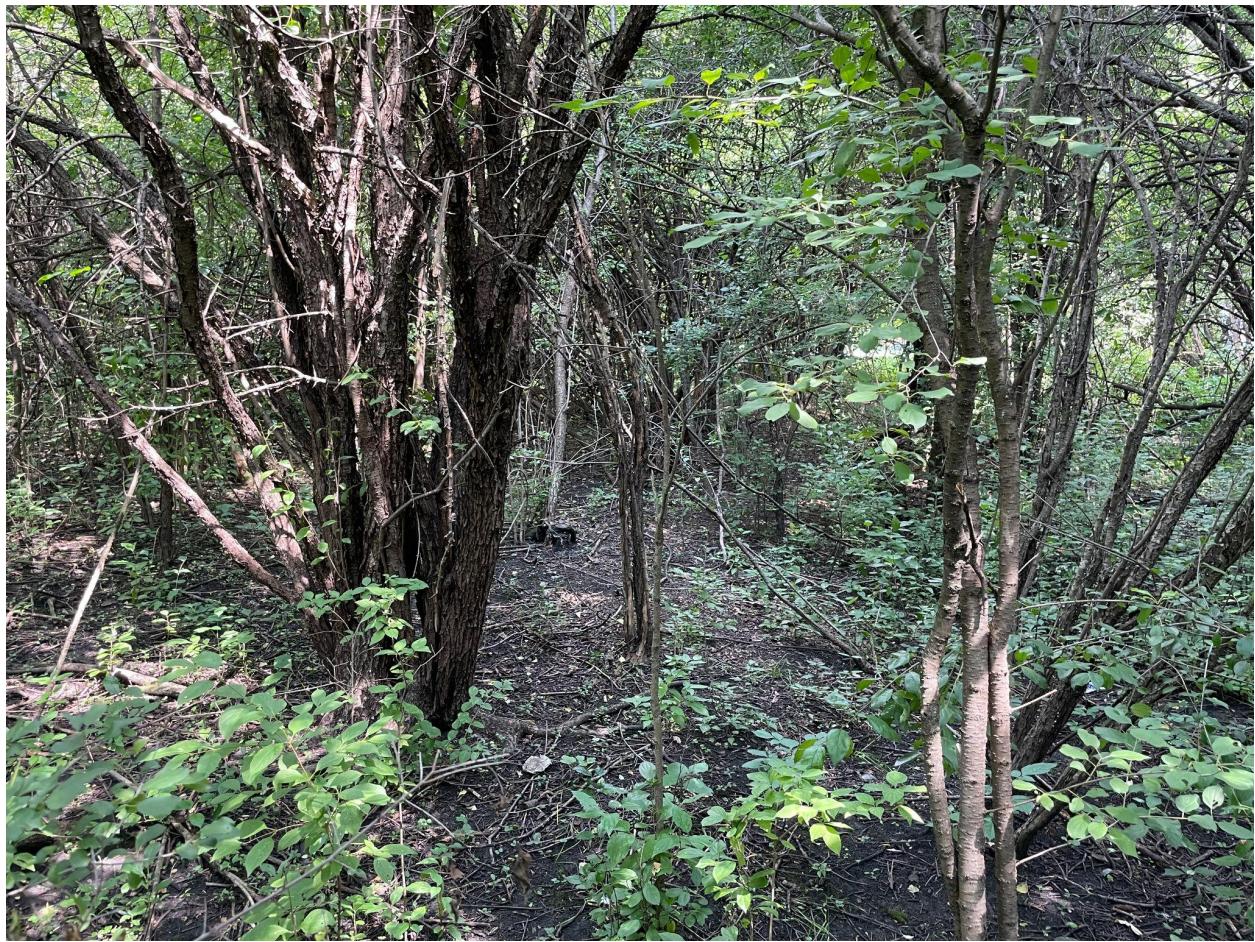
Approximately 10 acres. Overall the site is severely degraded from a native habitat, aesthetic, and stormwater capacity standpoint. Small pockets of native vegetation found within the site. Lot J has not been maintained for many years and will require investments in removal, maintenance, and monitoring to bring the lot back to proper functionality. Dominant species in the lot was Common Buckthorn (*Rhamnus cathartica*). Other species included Purple Loosestrife (*Lythrum salicaria*), Narrowleaf Cattails (*Typha angustifolia*), Rice Cut Grass (*Leersia oryzoides*), Reed Canary Grass (*Phalaris arundinacea*), Joe Pye Weed (*Eutrochium purpureum*). Noticeable lack of old growth native tree species located within the lot. Several flared end sections in Lot J have started to detach from their pipe. The concrete of other flared end sections have started to break apart.

***Image 4. Lot J overgrowth.***

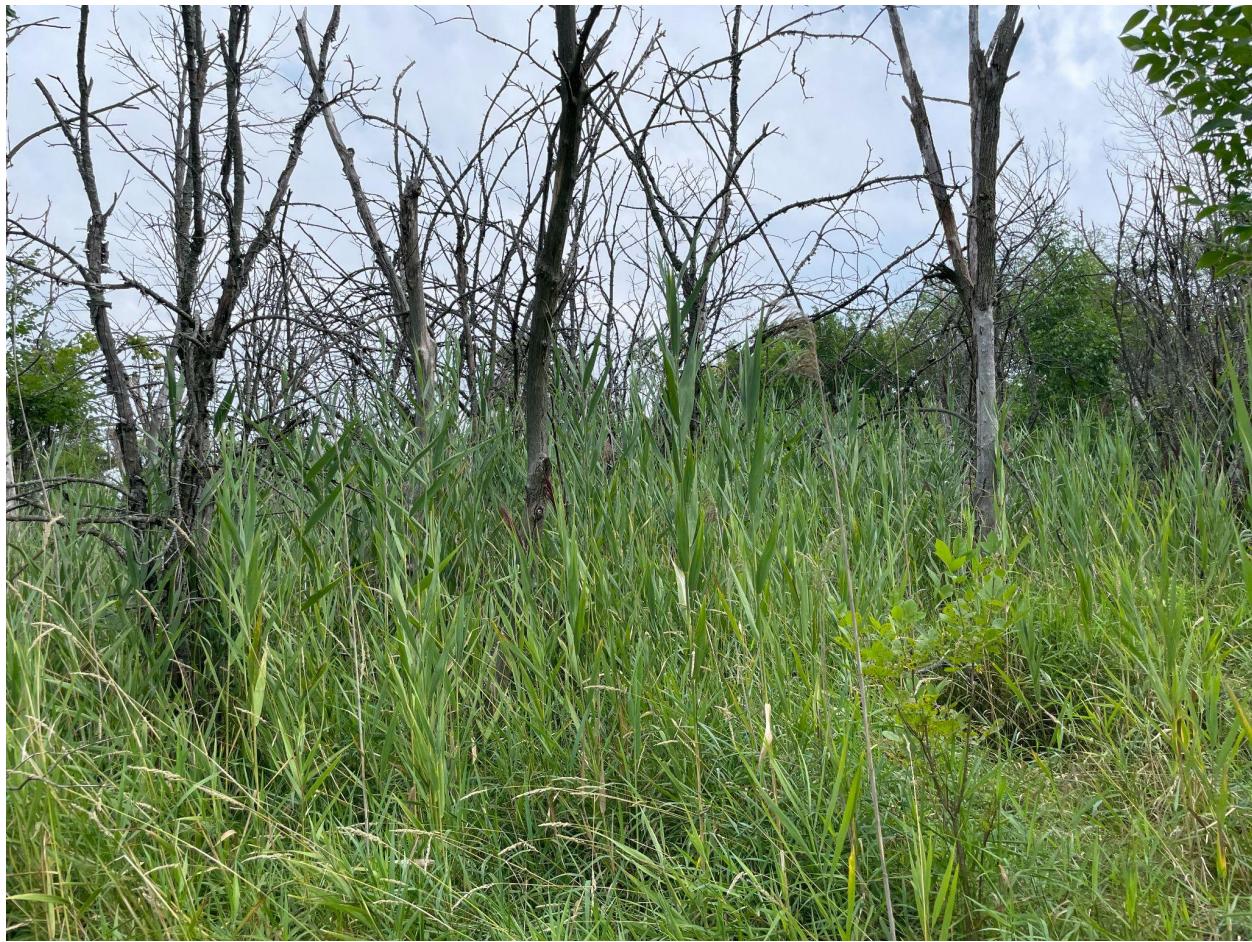
Approximately 5.14 acres. Overall the site is severely degraded from a native habitat, aesthetic, and stormwater capacity standpoint. Small pockets of native vegetation found within the site. Lot K has not been maintained for many years and will require investments in removal, maintenance, and monitoring to bring the lot back to proper functionality. Dominant species in the lot was Common Buckthorn (*Rhamnus cathartica*). Other species included Purple Loosestrife (*Lythrum salicaria*), Narrowleaf Cattails (*Typha angustifolia*), Rice Cut Grass (*Leersia oryzoides*), Reed Canary Grass (*Phalaris arundinacea*), Joe Pye Weed (*Eutrochium purpureum*). Noticeable lack of old growth native tree species located within the lot. Storm structures are in good condition.

***Image 6. Facing north toward Lot K. Phragmites encroaching in the lot. Dead trees most likely caused by drastic change in local hydrology***

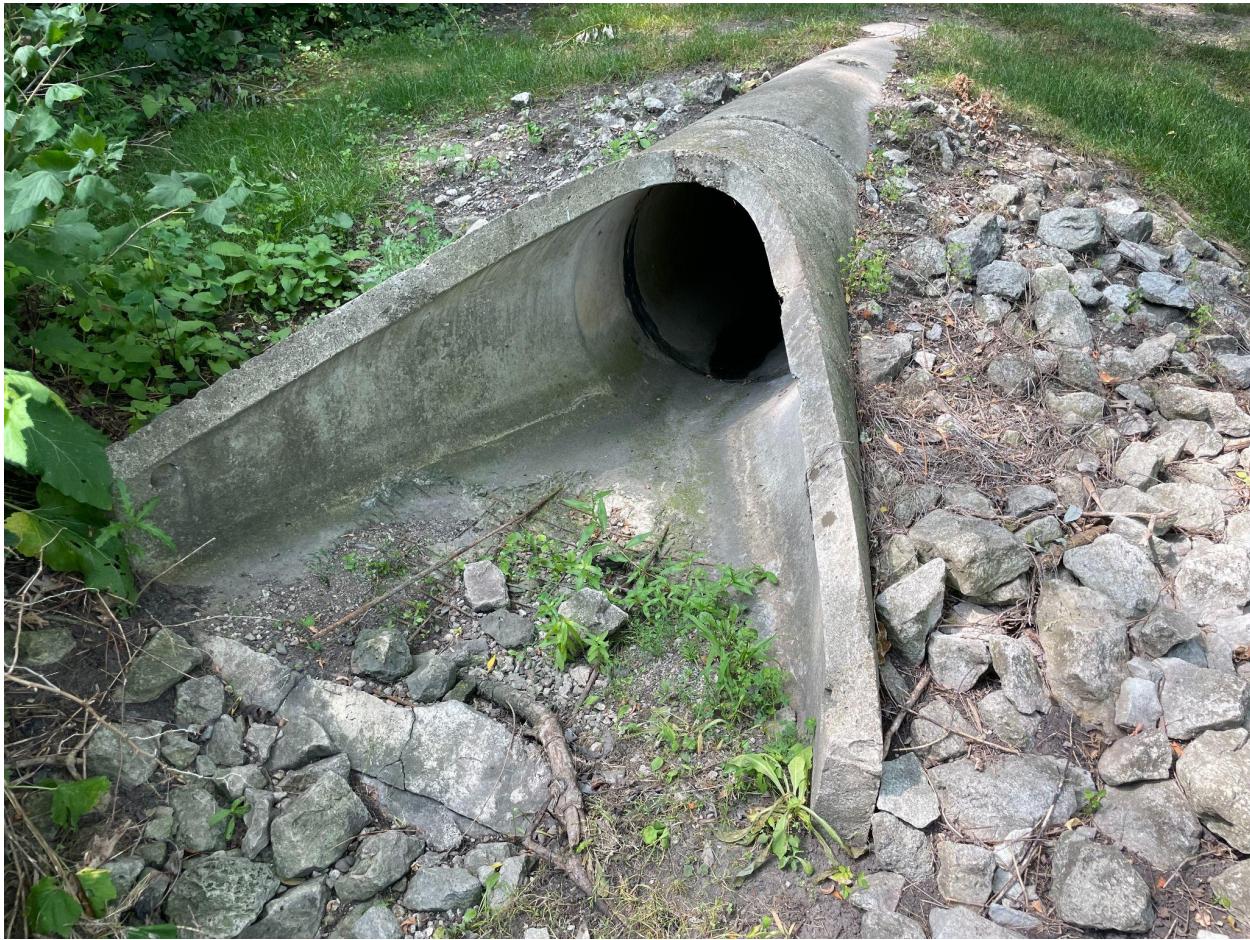
***Image 7: Facing north toward Lot J. Degraded concrete***

- **Establish Annual Stormwater Inspections.** Perform regular inspections of your storm water structures to assure that they are functioning properly.

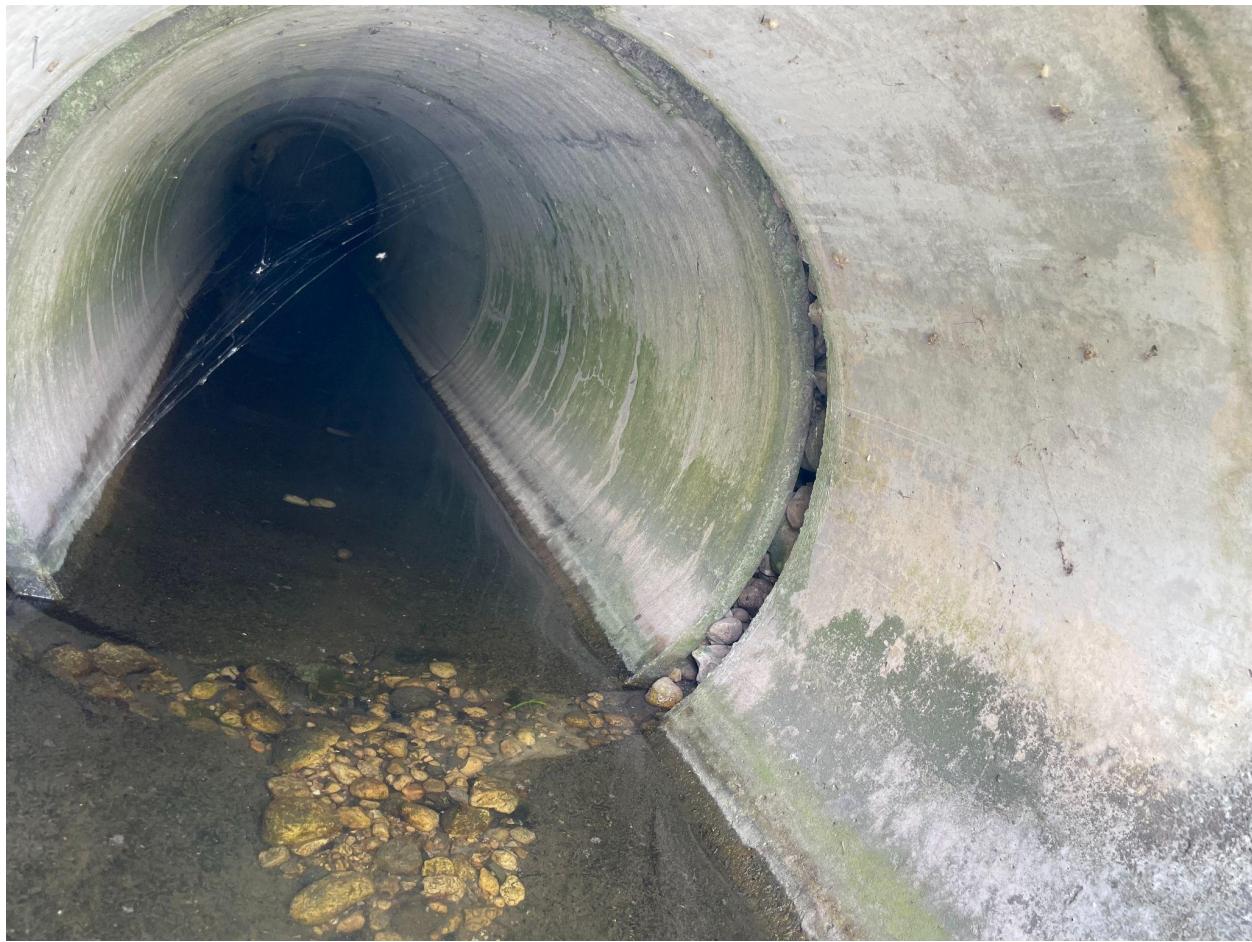
***Image 8: Lot J detached flared end section. Will cause significant erosion damage if not corrected.***
