STORMWATER MANAGEMENT COMMISSION

Meeting Minutes

Location: Brookside Subdivision, Unincorporated Gurnee, Lake County, IL

Topic: Resident concern about stormwater/changes to drainage within subdivision

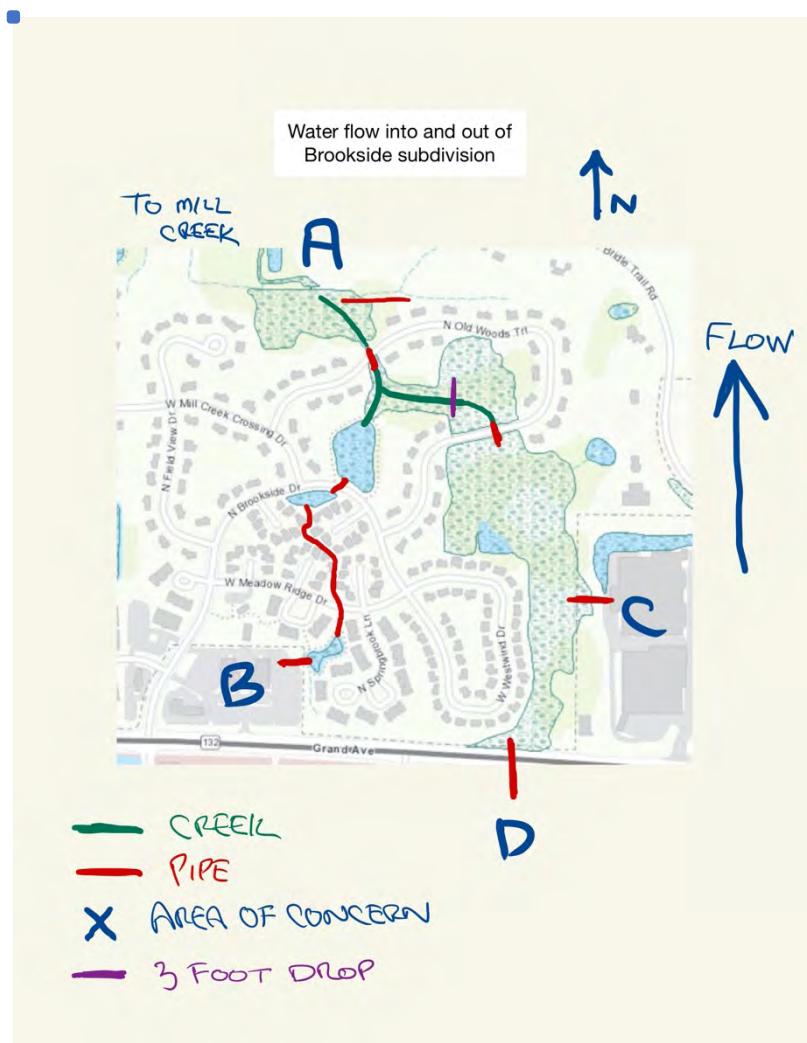
The diagram below illustrates the drainage path for the Brookside subdivision, which is on the north side of Grand Ave. west of Hunt Club Rd. There are 4 areas of concern labeled A, B, C and D in the diagram. A represents the drain for the neighborhood while B, C and D represent external water sources.

This is the drain for Brookside. It eventually flows into Mill Creek. Where the creek crosses the boundary between Brookside and Hunt Club Farms, which happens to include a bridle path, the creek appears to be obstructed on Hunt Club Farms property. This has caused the wooded area on the Brookside property to become much wetter, killing the trees which grow naturally. In approximately 1990 during the construction period, the creek was moved and a pond created on the Hunt Club Farms property. See the aerial photos below for a 1980 vs. 1993 comparison.

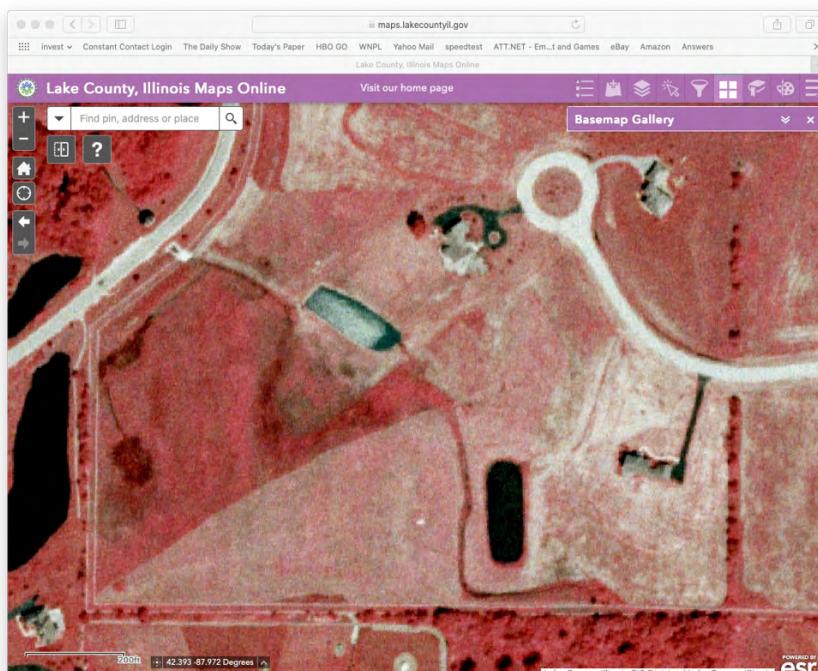
Area A North of Brookside in 1993
Owned by 17557 W. Bridle Trail Rd.

The creek from 1993 follows the property line and has contributed to wetland expansion on both sides of the property line.

- Diversion of an established creek around the newly created pond probably needed a permit. Was a permit issued?
- The second pond in which the creek flows has had a dam built to raise the water level in the pond. This has caused a backup of water in the area of the property line. The dam needs to be removed.
- A few years ago, new pipes were installed under the bridle path where it parallels N. Mill Creek Dr. Which contractor did that work and who approved it?

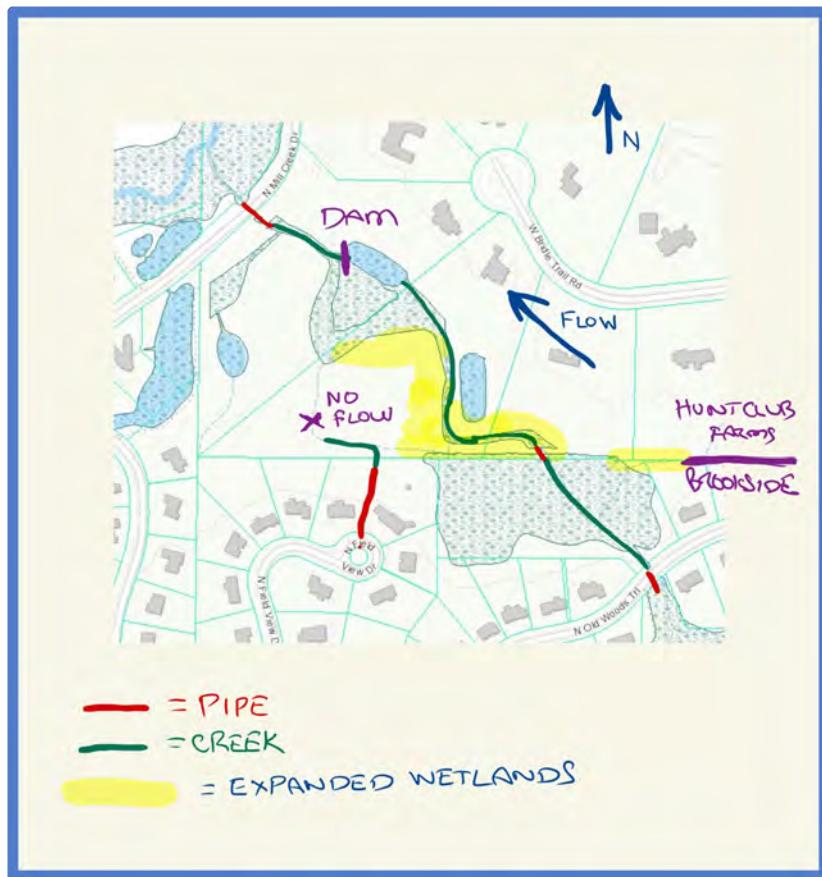
The diagram below illustrates the drainage path for the Brookside subdivision, which is on the north side of Grand Ave. west of Hunt Club Rd through the Hunt Club Farms subdivision and eventually to Mill Creek at the top left. There is a pipe under the bridle path between Brookside and Hunt Club Farms. It is a much smaller diameter than any other pipe in the drainage path and causes water to reach a higher level on Brookside property.

An obstruction has been built at the west end of the pond in the drainage path for Brookside. This obstruction raises the level of the water in the pond by 12-18 inches. In turn, the wetland area has expanded and has resulted in flooded land even during dry periods. Riprap was added to the pond shoreline at some point. It is now submerged. The obstruction must be removed and the original pond level restored.

Brookside Drive and Field View Drive drain through storm sewers and a culvert to the area marked NO FLOW. At one time this flow would have made it to Mill Creek, but no longer does. The water pools on the bridle path north of Brookside. This creek needs to be re-established. Once the obstruction is removed it could be connected to the main drainage creek.

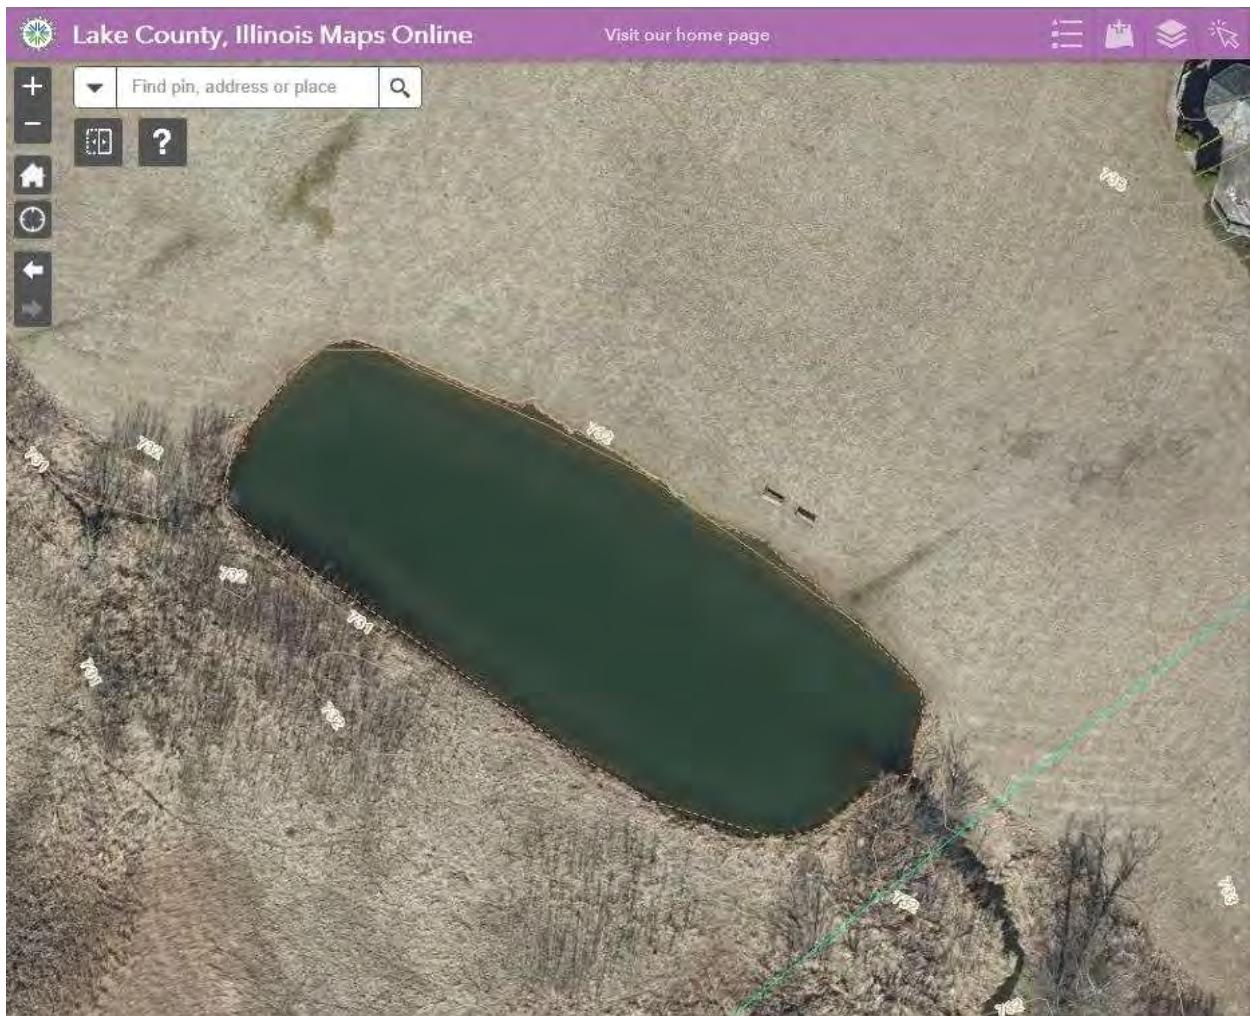
2018 pond limits aerial – See approximate shoreline highlighted with orange dashed line. Kept this line work for all years to see difference. -BLF
