Up Close Inspections

Home Inspection Report

Property Address:

Inspected on Fri, Jan 1 2021 at 12:00 PM

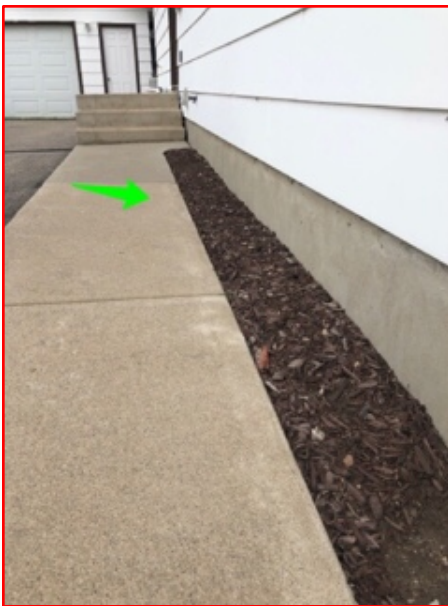
Figure 1-1

1) Observed some areas around foundation had negative grade. Recommend raising grade to facilitate water drainage away from foundation. Recommend repair

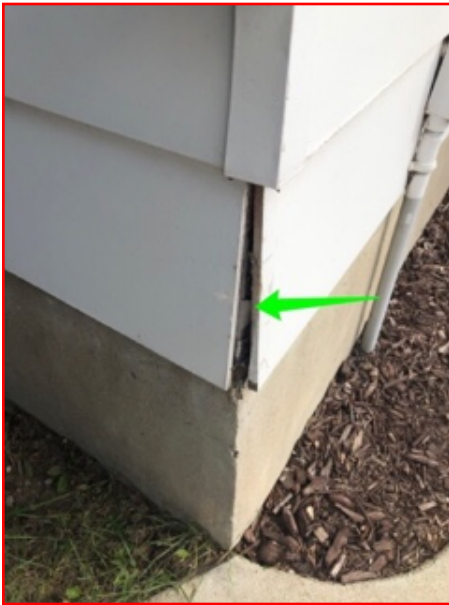
Figure 8-1

5) Observed several minor repairs required to exterior siding. Recommend repair

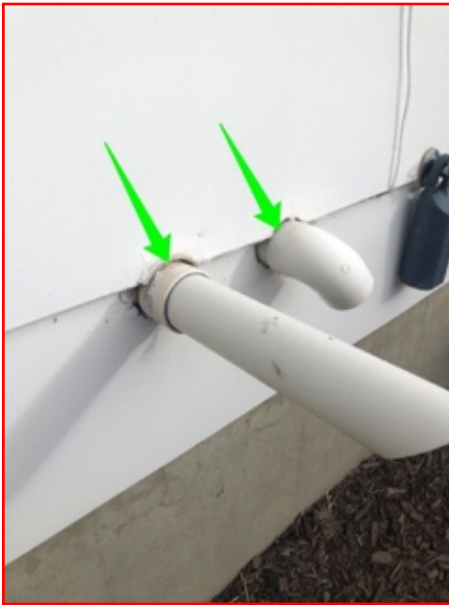
Figure 9-1

6) Observed some penetrations through exterior siding are not sealed. Recommend caulking to prevent water intrusion.

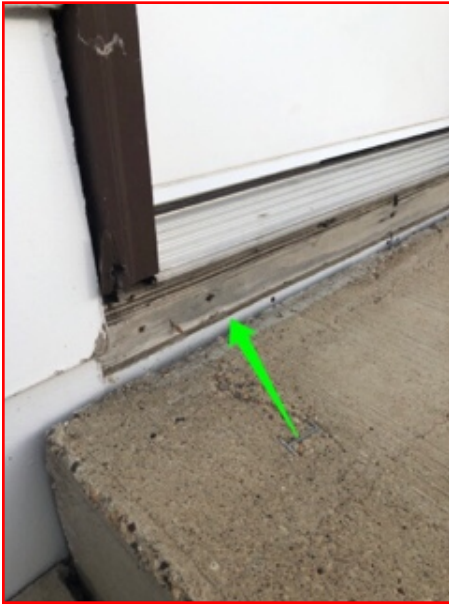
Figure 10-1

7) Observed exposed building materials at side entry door. Recommend installing exterior toe kick.

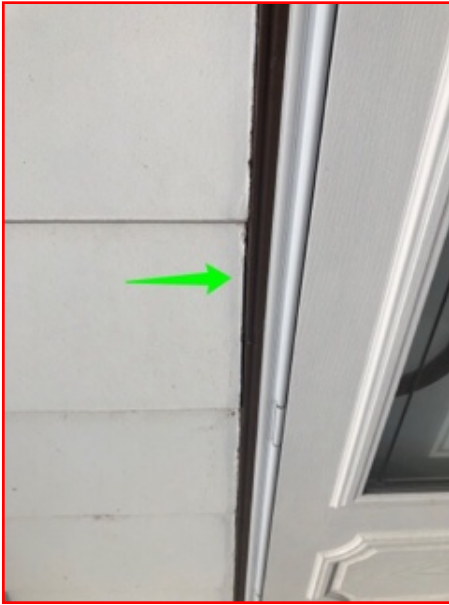
Figure 11-3

8) Observed some missing and deteriorated caulking around all windows and doors.
Recommend repair

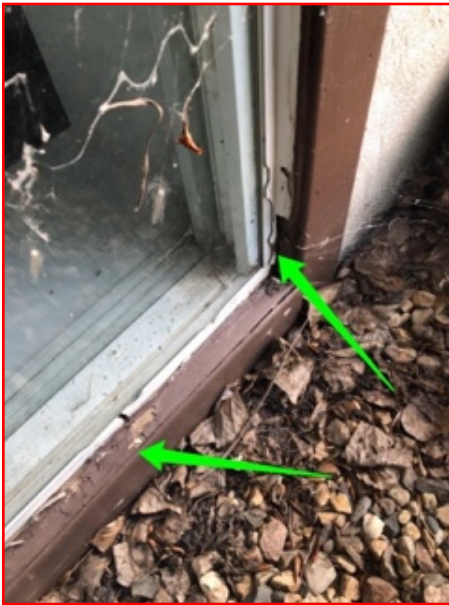
Figure 12-1

9) Observed wooden basement windows require maintenance and repair. Observed deteriorated wooden window frame. Recommend repair.

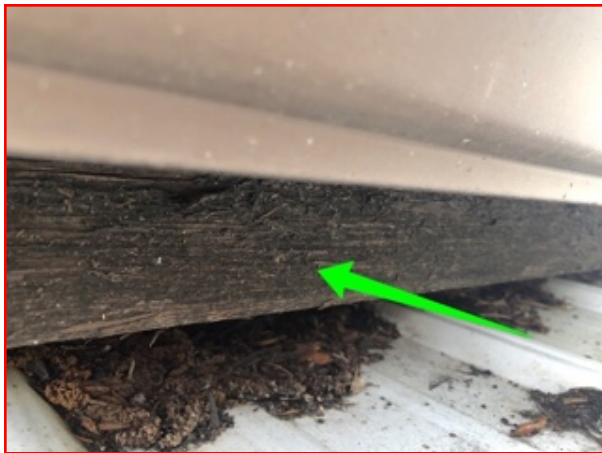
Figure 19-1

14) Observed wooden fascia on garage shows signs of visible deterioration, particularly above metal roofing addition. Recommend maintenance and repair.

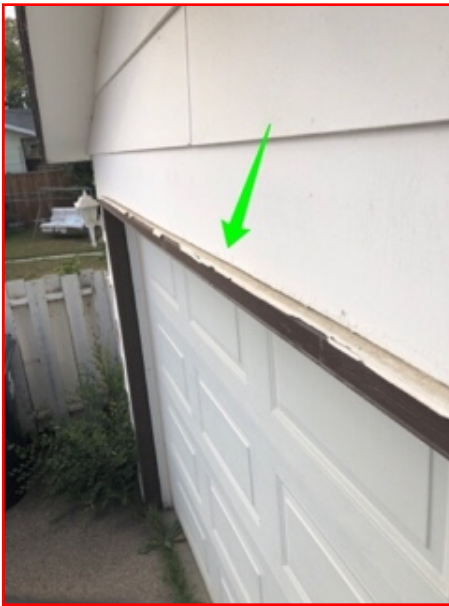
Figure 20-1

15) Observed broken vinyl drip flashings above doors on exterior of garage. Recommend repair.

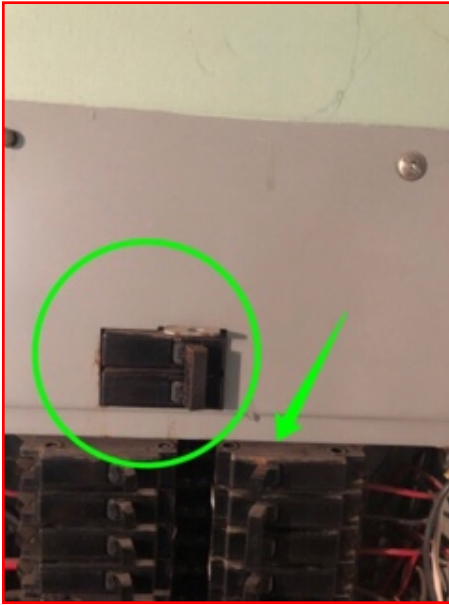
Figure 29-1

19) Observed minor rust and some water marks at electrical panel main breaker. Observed panel appears to be dated. Recommend having electrical panel inspected by qualified contractor.

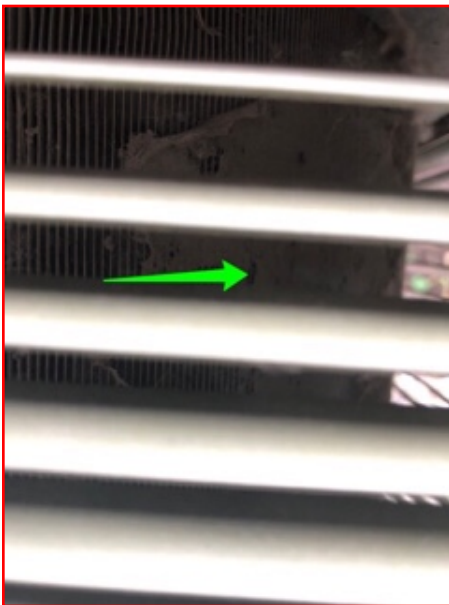
Figure 32-1

22) Observed some maintenance required on air-conditioning condenser. Recommend cleaning

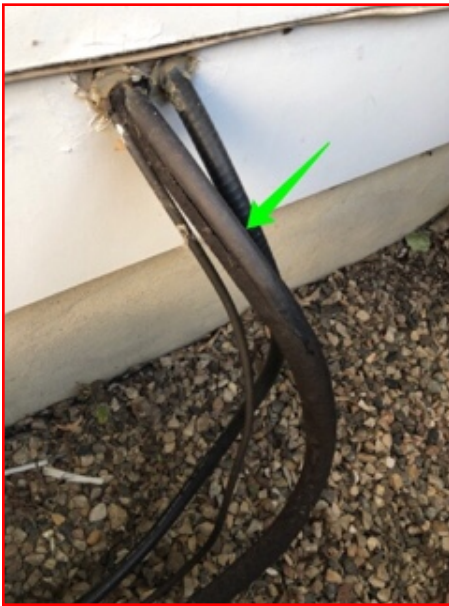
Figure 33-1

23) Observed insulation on air-conditioning return line has deteriorated. Recommend repair

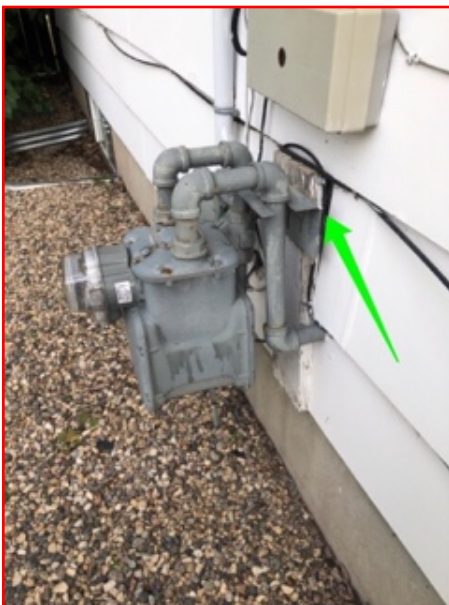
Figure 35-1

24) Observed natural gas meter appears to be pulling away from the structure. Recommend contacting the utility service provider for repair.

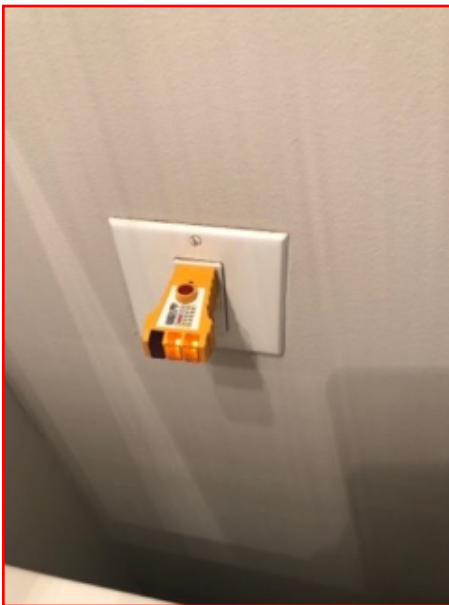
Figure 40-1

26) Observe main floor bathroom GFI plug does not trip when activated. Recommend repair

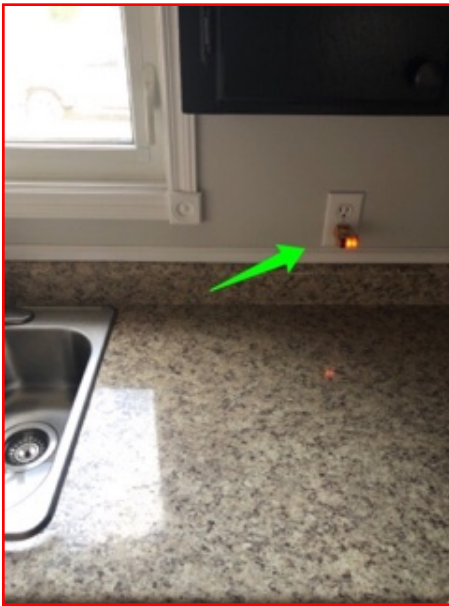
Figure 45-1

28) Observed kitchen countertop plugs are not GFI protected. Recommend repair

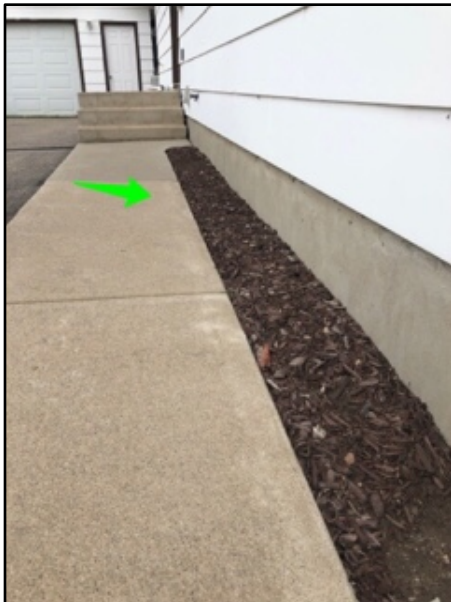
Figure 1-1

Observed some areas around foundation had negative grade. Recommend raising grade to facilitate water drainage away from foundation. Recommend repair

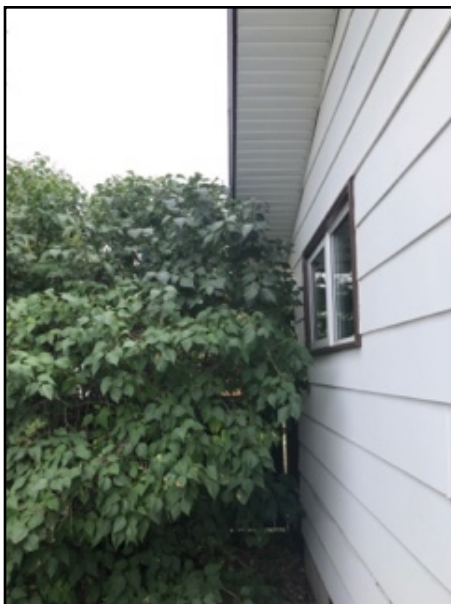
Figure 2-1

Observed some vegetation growing close to the structure. No visible problems at time of inspection, but recommend maintenance to prevent premature building material deterioration.

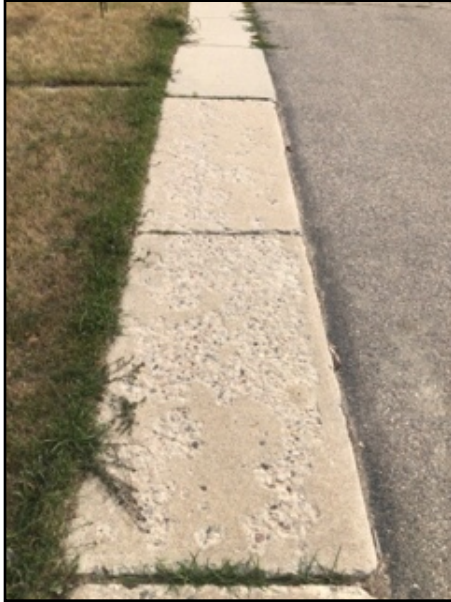
Figure 3-1

Observed some surface deterioration on concrete walkway. Recommend limiting salt usage during icy conditions.

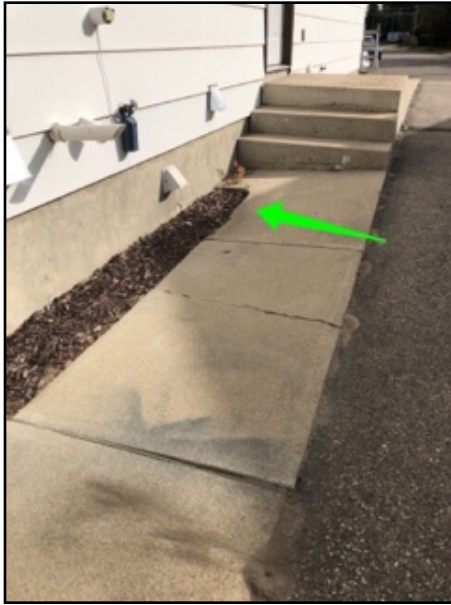
Figure 4-1

Observed two sections of concrete walkway appear to be sinking towards the foundation. Recommend raising to facilitate water drainage away from foundation.

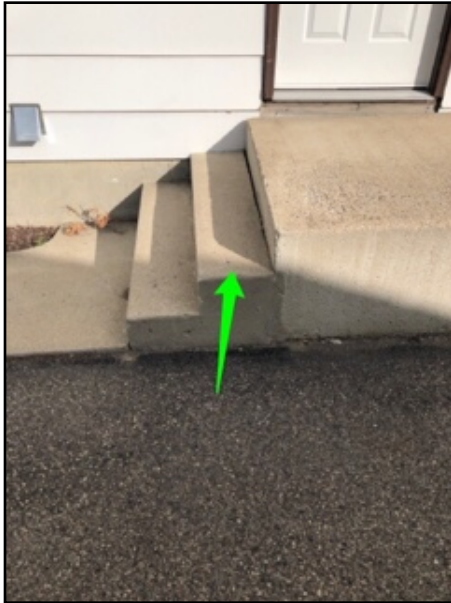
Figure 5-1

Observed concrete step at side of home has multiple cracks and appears to have had two risers added. Risers appear to be sinking and pulling away from main step. Recommend repair.

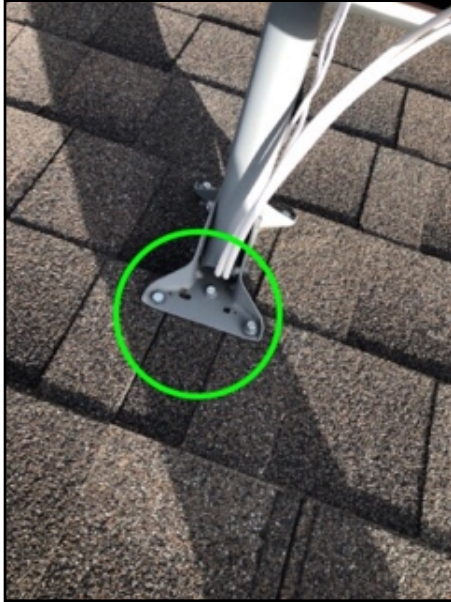
Figure 6-1

Observed some roof fasteners have missing and deteriorated caulking. Recommend ensuring all fasteners have adequate caulking installed.

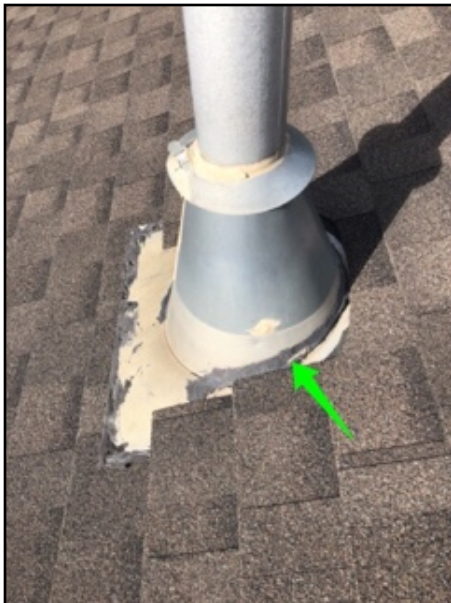
Figure 7-1

Observed metal chimney has excess caulking installed. Some physical deterioration. Recommend monitoring and maintenance.

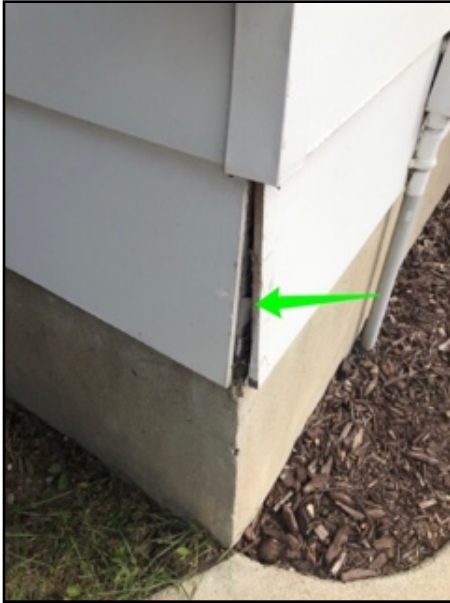
Figure 8-1

Observed several minor repairs required to exterior siding. Recommend repair

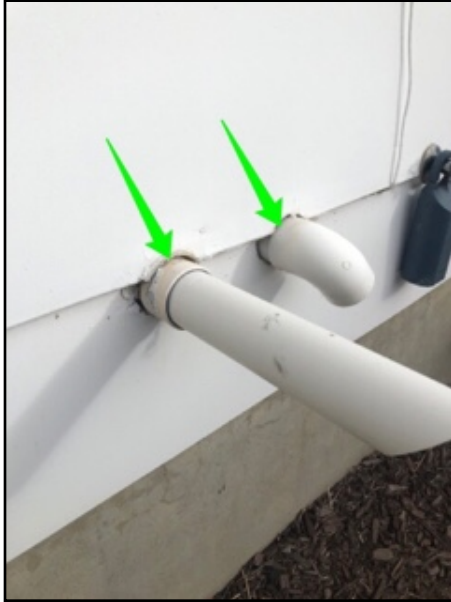
Figure 9-1

Observed some penetrations through exterior siding are not sealed. Recommend caulking to prevent water intrusion.

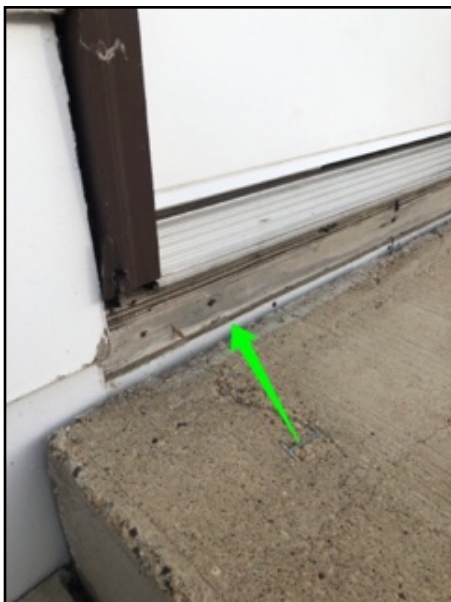
Figure 10-1

Observed exposed building materials at side entry door. Recommend installing exterior toe kick.

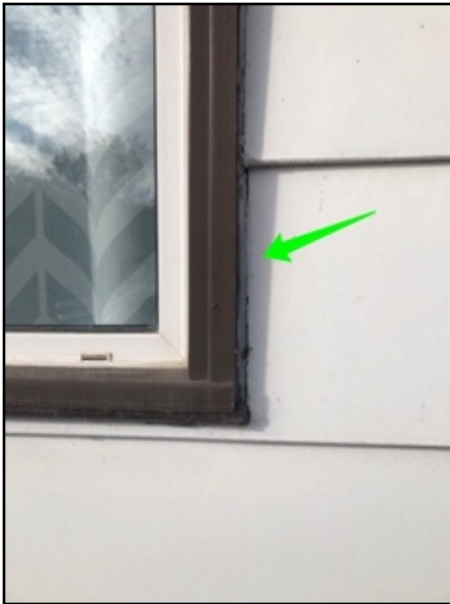
Figure 11-1

Observed some missing and deteriorated caulking around all windows and doors. Recommend repair

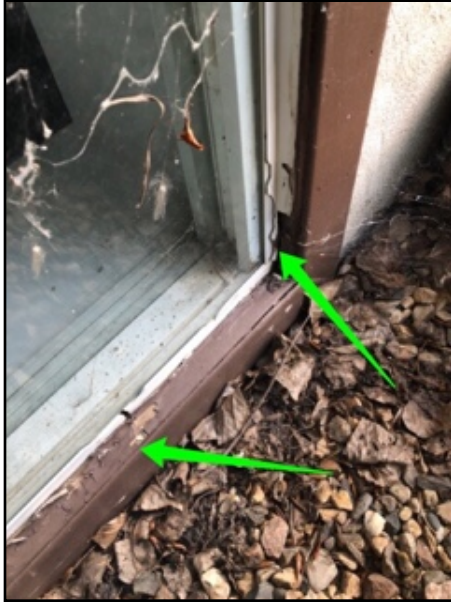
Figure 12-1

Observed wooden basement windows require maintenance and repair. Observed deteriorated wooden window frame. Recommend repair.

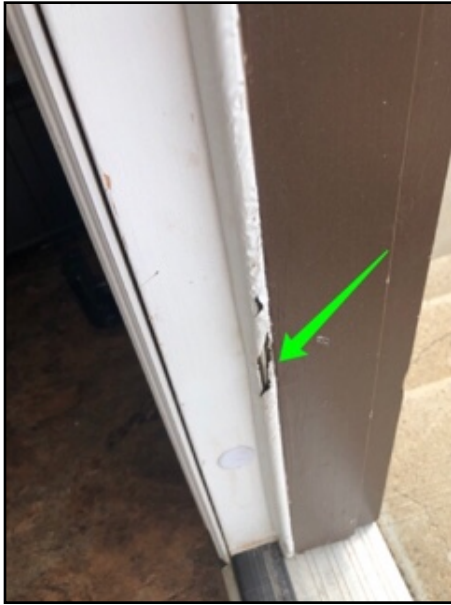
Figure 13-1

Observed side entry door has damaged and short weatherstripping. Recommend repair

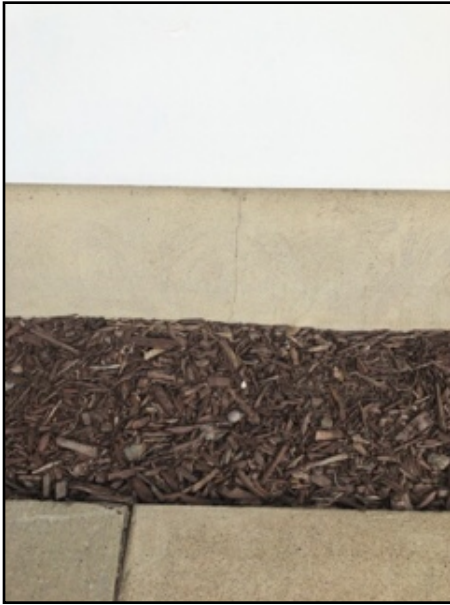
Figure 14-1

Observed multiple minor cracks in exterior foundation and foundation coating.
Recommend monitoring

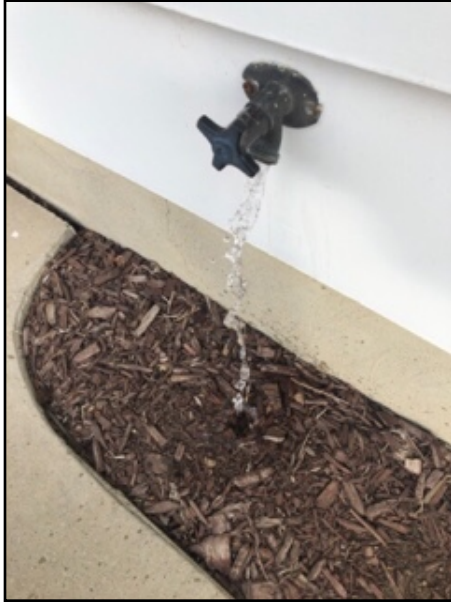
Figure 15-1

Observed exterior water faucets are not freeze proof. Recommend winterizing before the winter season.

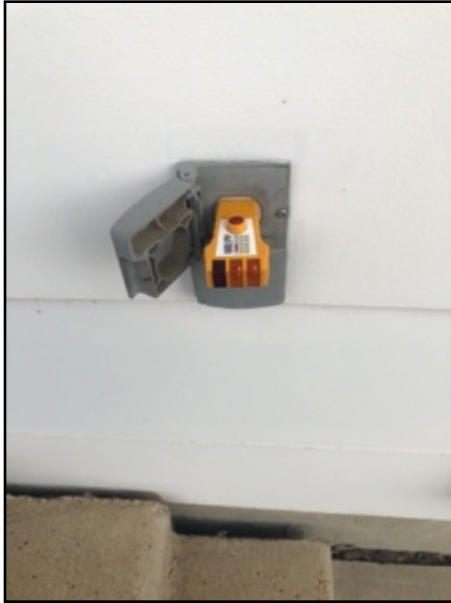
Figure 16-1

Observed exterior house plug is not GFI protected. Recommend repair

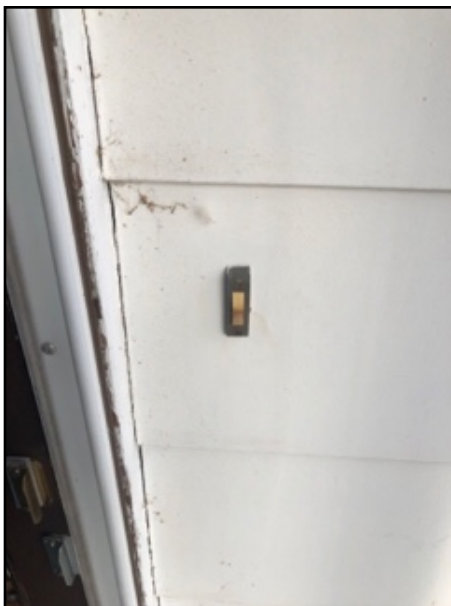
Figure 17-1

Observed front doorbell does not work. Recommend repair

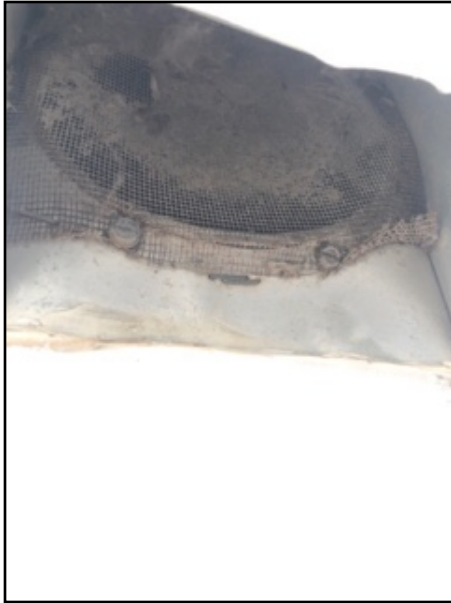
Figure 18-1

Observed exterior air intake hood requires maintenance. Recommend cleaning

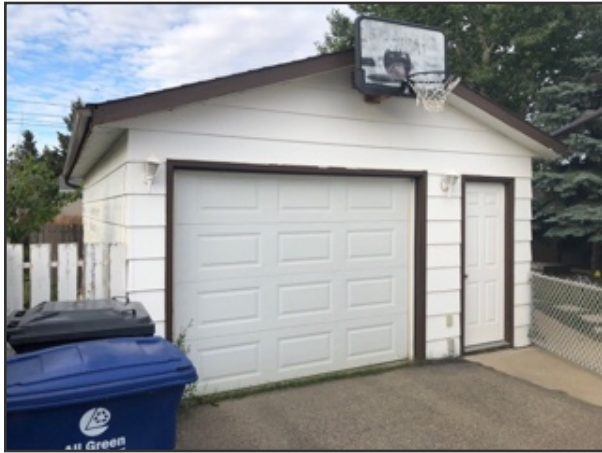
Observed wooden fascia on garage shows signs of visible deterioration, particularly above metal roofing addition. Recommend maintenance and repair.

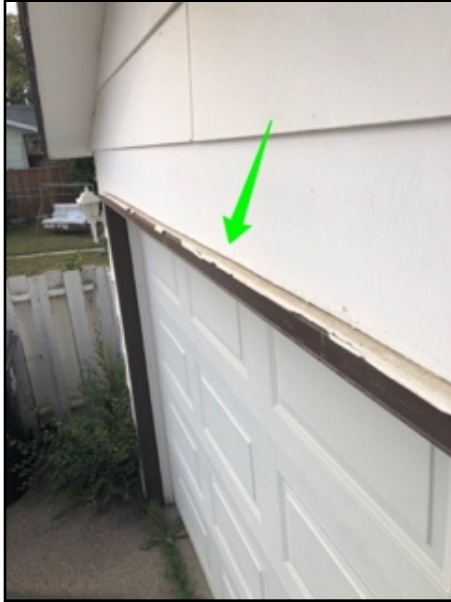
Figure 20-1

Comment 20:
Observed broken vinyl drip flashings above doors on exterior of garage.
Recommend repair.

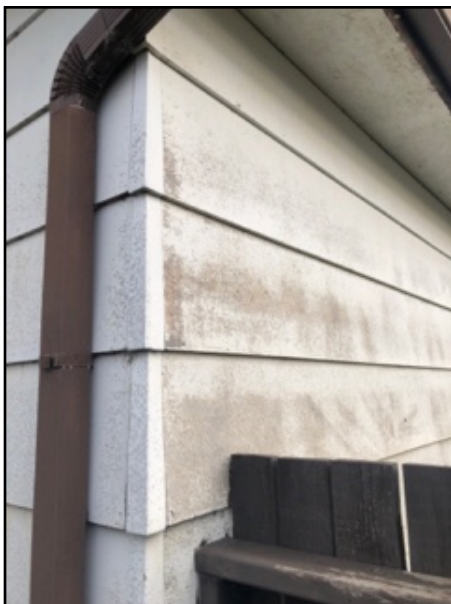
Figure 21-1

Comment 21:
Observed maintenance is required on exterior siding of garage. Recommend repair

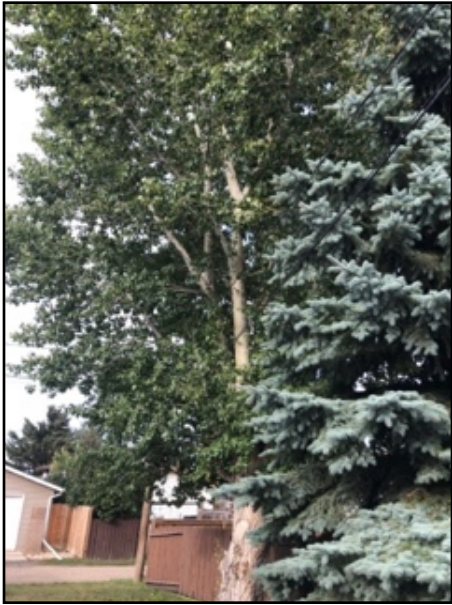
Figure 28-1

Observed overhead electrical service conductors run through a large tree. Recommend maintenance to prevent interruption of utility service.

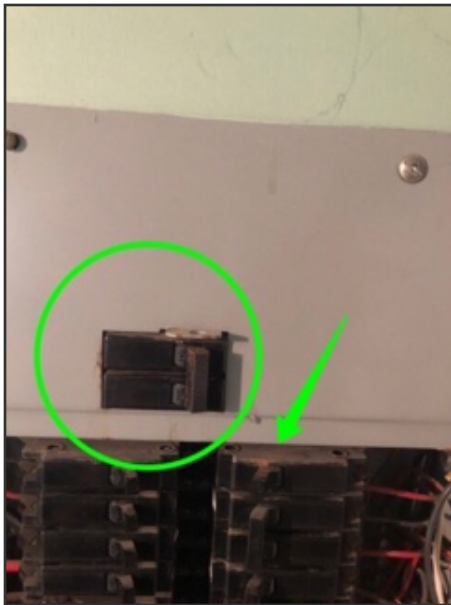
Figure 29-1

Observed minor rust and some water marks at electrical panel main breaker. Observed panel appears to be dated. Recommend having electrical panel inspected by qualified contractor.

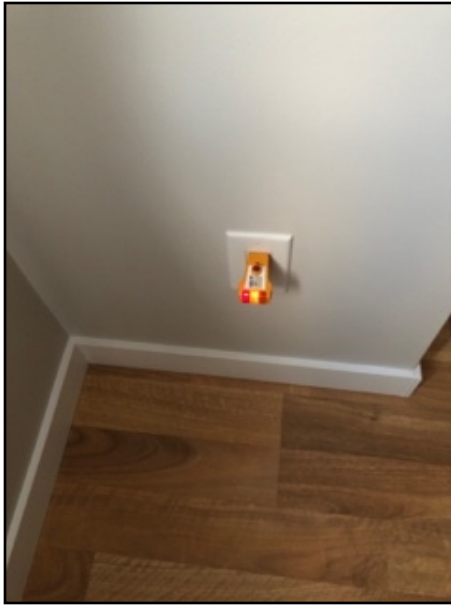
Figure 30-1

Observed multiple electrical plugs in living room have hot and neutral reversed.
Recommend repair

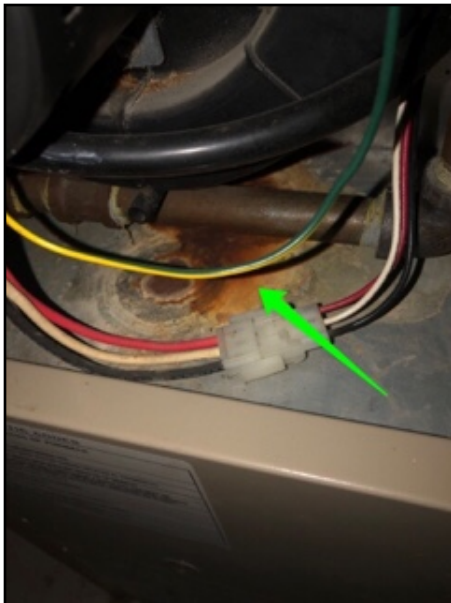
Figure 31-1

Observed some rust in furnace cabinet. Appeared dry at time of inspection.
Recommend monitoring

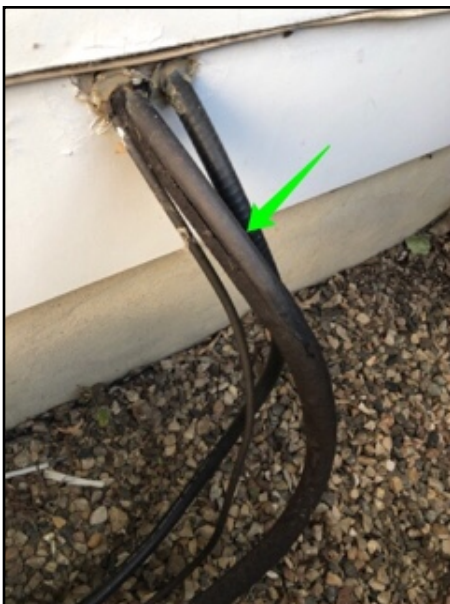
Figure 33-1

Observed insulation on air-conditioning return line has deteriorated.
Recommend repair

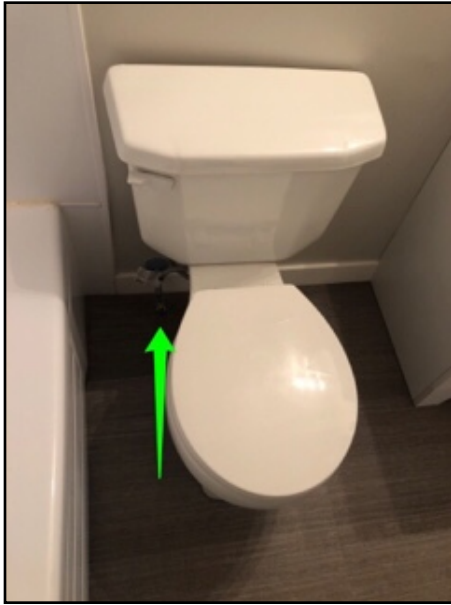
Figure 38-1

Observed main floor bathroom toilet is loose and water supply to toilet does not appear to turn on. Recommend repair

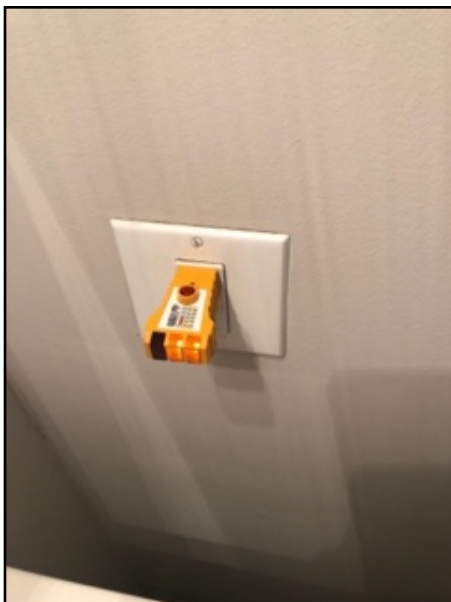
Figure 40-1

Observe main floor bathroom GFI plug does not trip when activated.
Recommend repair

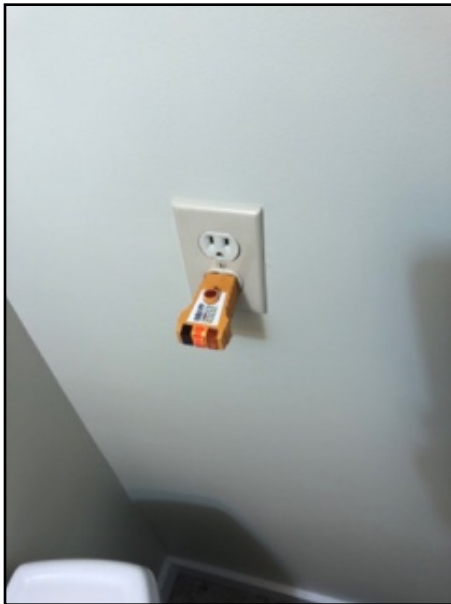
Figure 43-1

Observe basement bathroom electrical plug is not GFI protected and is not wired correctly. Recommend repair

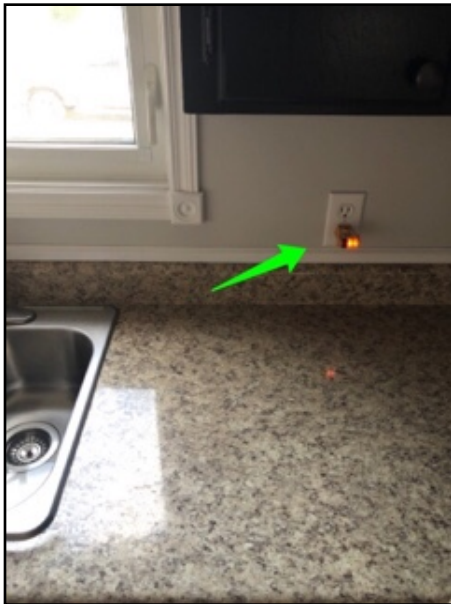
Figure 45-1

Observed kitchen countertop plugs are not GFI protected. Recommend repair
