Evaluation of Sanitary Sewers and Manholes

**City of Panorama Park
Scott County, Iowa
February 2020**

Project No. 19924000

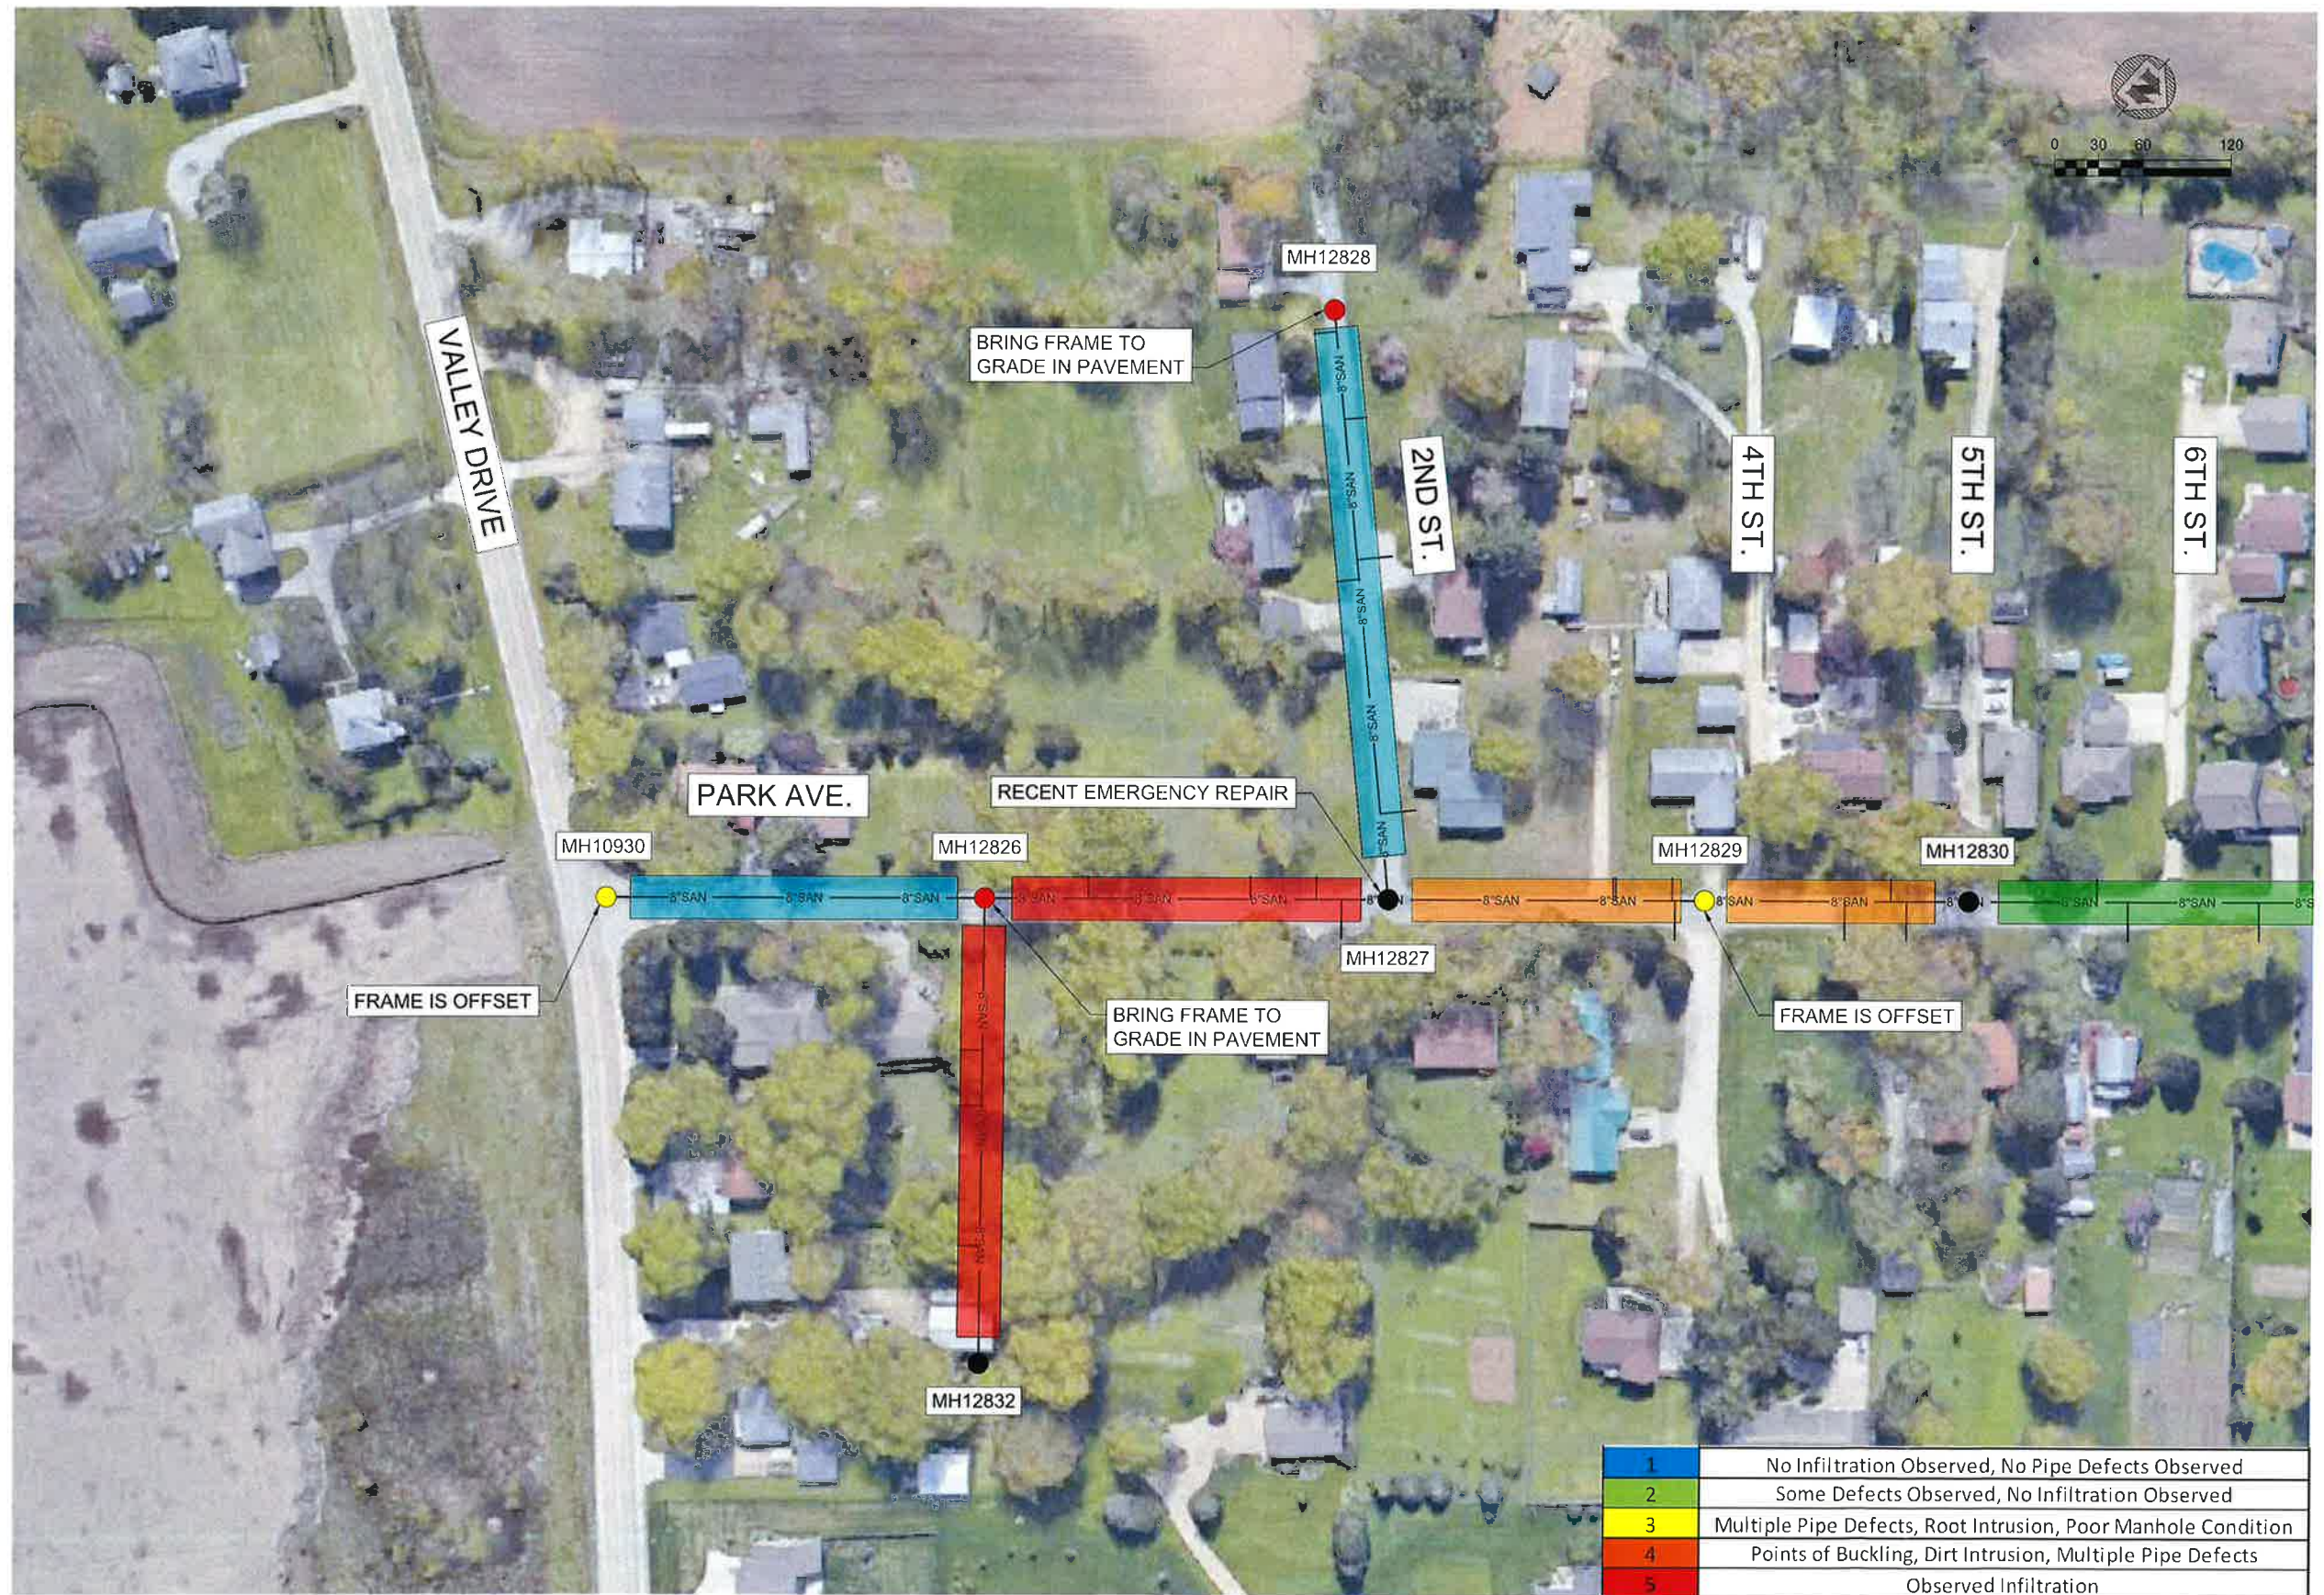
FIGURE ES-1. SANITARY SEWER PRIORITY RATING MAP

The result of MSA's investigation, evaluation, and rating is summarized in the following Sanitary Sewer Priority Rating Map. These maps establish a readily visible method for the City of Panorama Park to prioritize sanitary sewer system concerns.

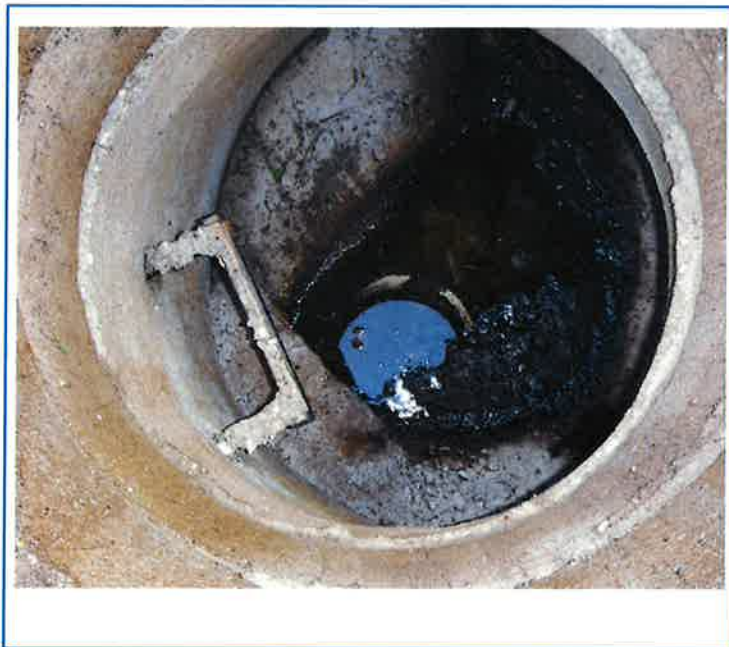
Picture Number 1

Measured Manhole Depth: 4.8 FT

NOTE: 0.5 FT BELOW GRADE

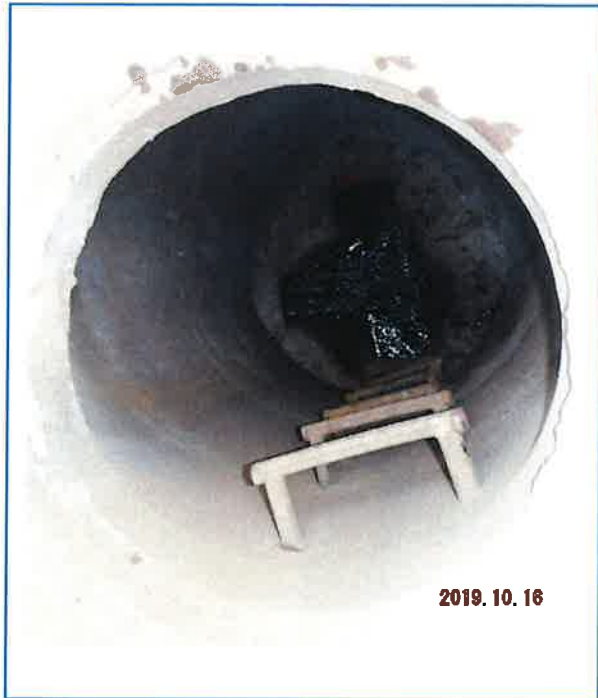
Picture Number 1

Measured Manhole Depth: 11.8 FT

OFFSET CHIMNEY

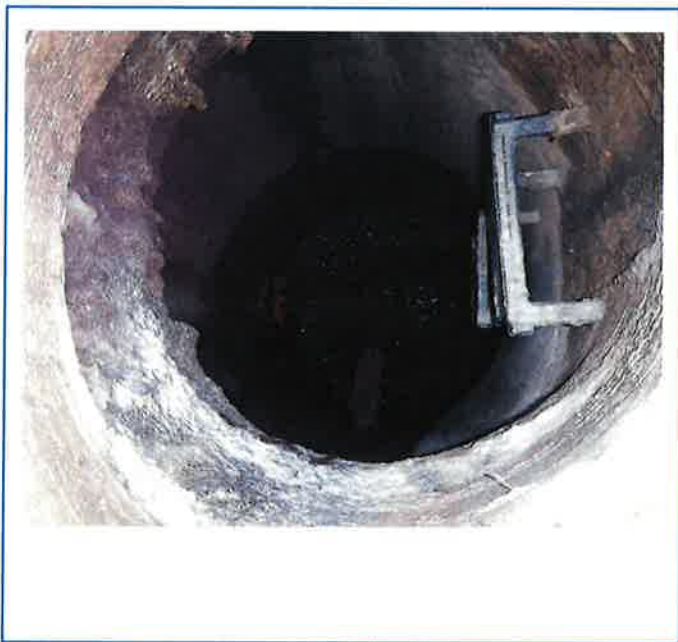
Picture Number 1

Measured Manhole Depth: 12.3 FT

OFFSET CHIMNEY

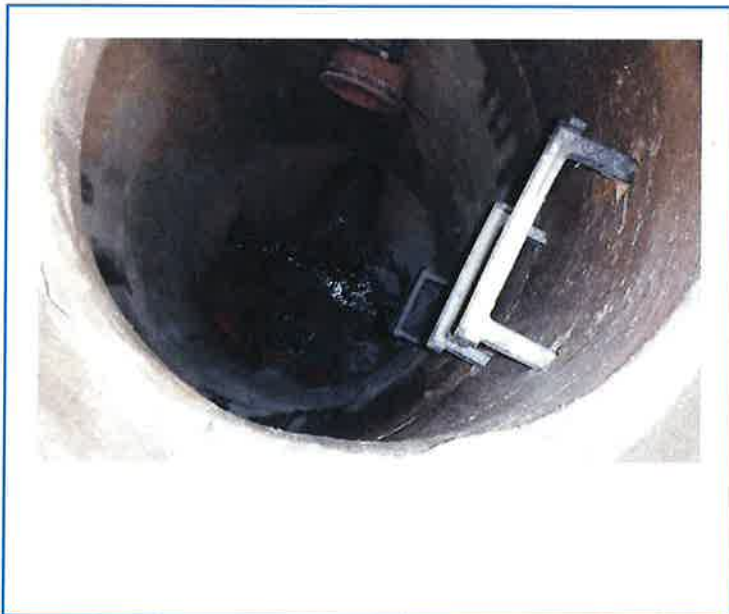
Picture Number 1

Measured Manhole Depth: 10.2 FT

DROP MANHOLE

NOTE: BRING TO GRADE

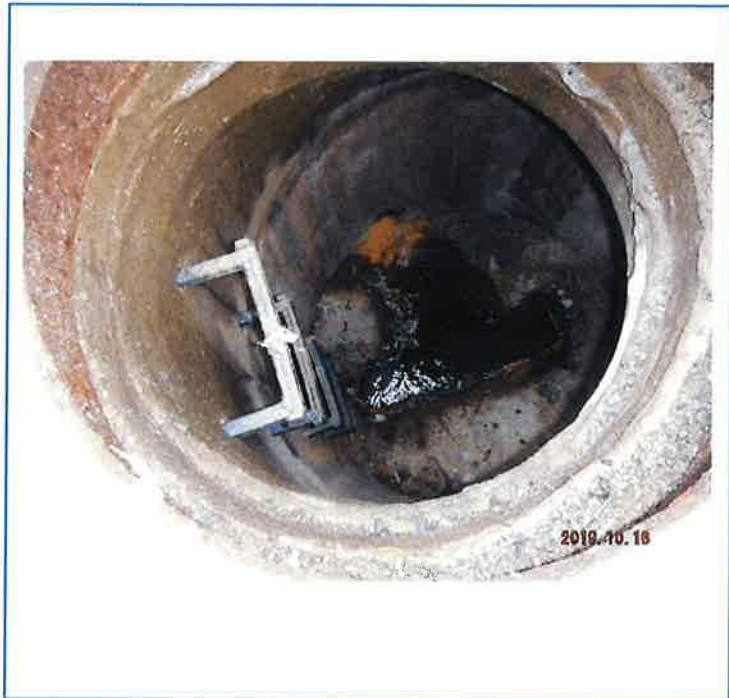
Picture Number 1

Measured Manhole Depth: 7.3 FT

NOTE: BRING TO GRADE

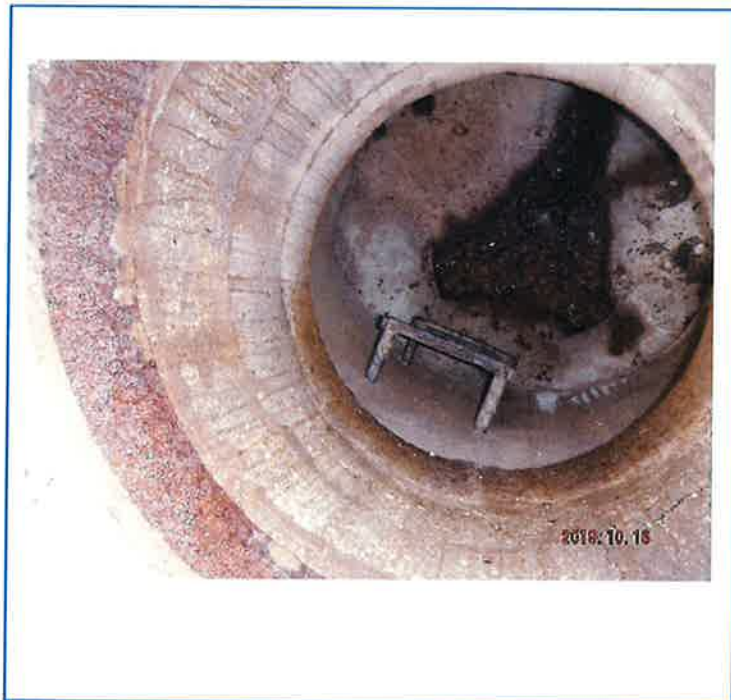
Picture Number 1

Measured Manhole Depth: 6.4 FT

NOTE: BRING TO GRADE

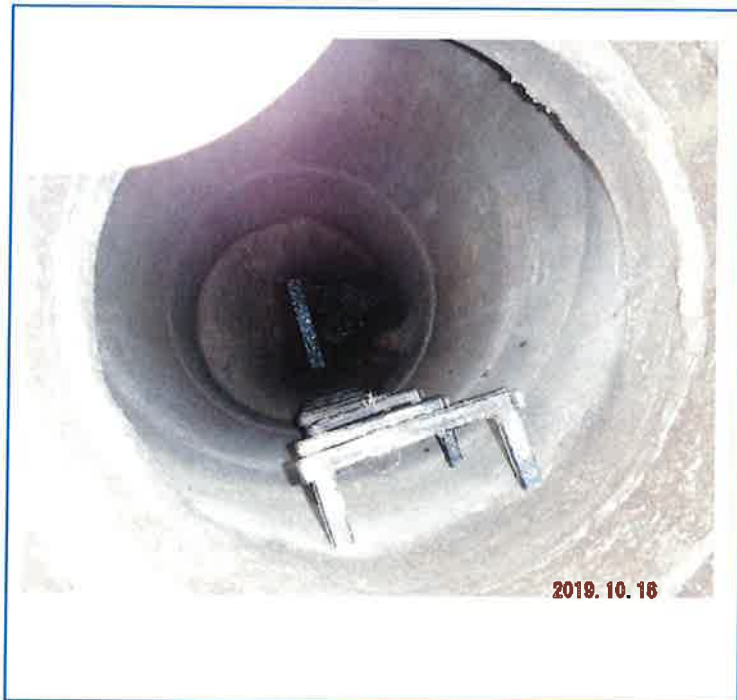
Measured Manhole Depth: 14.2 FT

OFFSET CHIMNEY

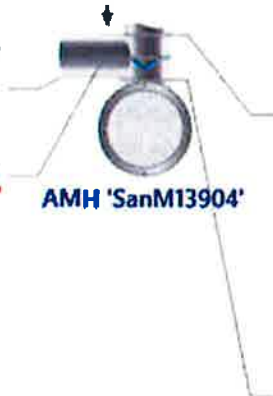
↓ At 338.7 ft. 12/2
FM - Fracture Multiple
Rating: 4
Category: Structural
Comments: At the joint.

↓ At 350.0 ft.
AMH - Manhole
Comments: Pipe in good condition.
Needs spot repair at 338.7 feet.

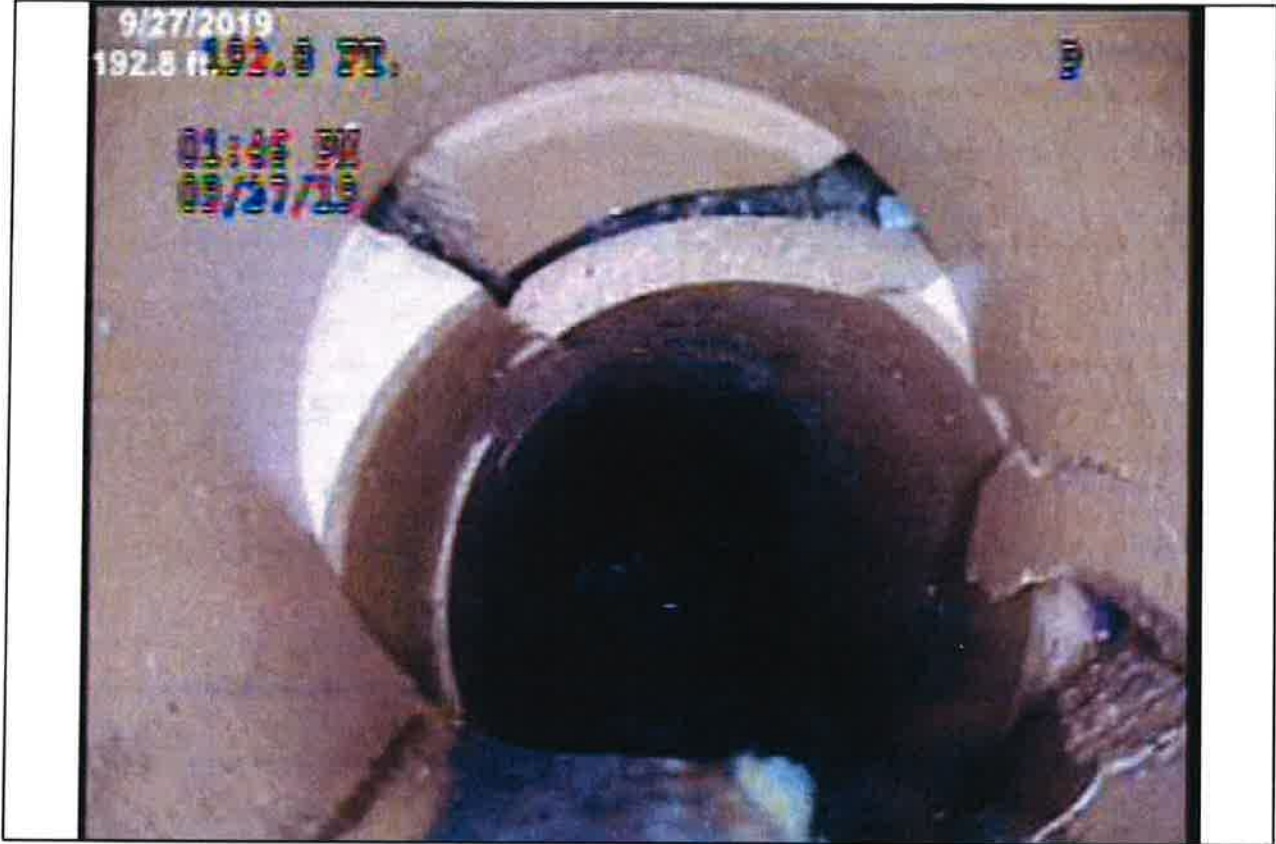
\\fileserver2\GraniteNet_Data\Media\Photos\Panorama Park-AMH 'SanM12829'-AMH 'SanM12827'-XP at
9/30/2019

At 193.9 ft.
AMH - Manhole
Comments: Ppe in good condition.
Pipe needs root cut. Pipe
is collapsed at 193 feet
from up stream manhole
12829. Needs to be
repaired!!!

MSA noted in reviewing the televising report one instance where the pipe has collapsed. This location has already been repaired by the City of Panorama Park.
