REPORT#: 24KY037

REPORT DATE: August 5, 2024

Truck Driver Killed After Semi-Trailer Wheel and Tire Cross Median, Strike Windshield

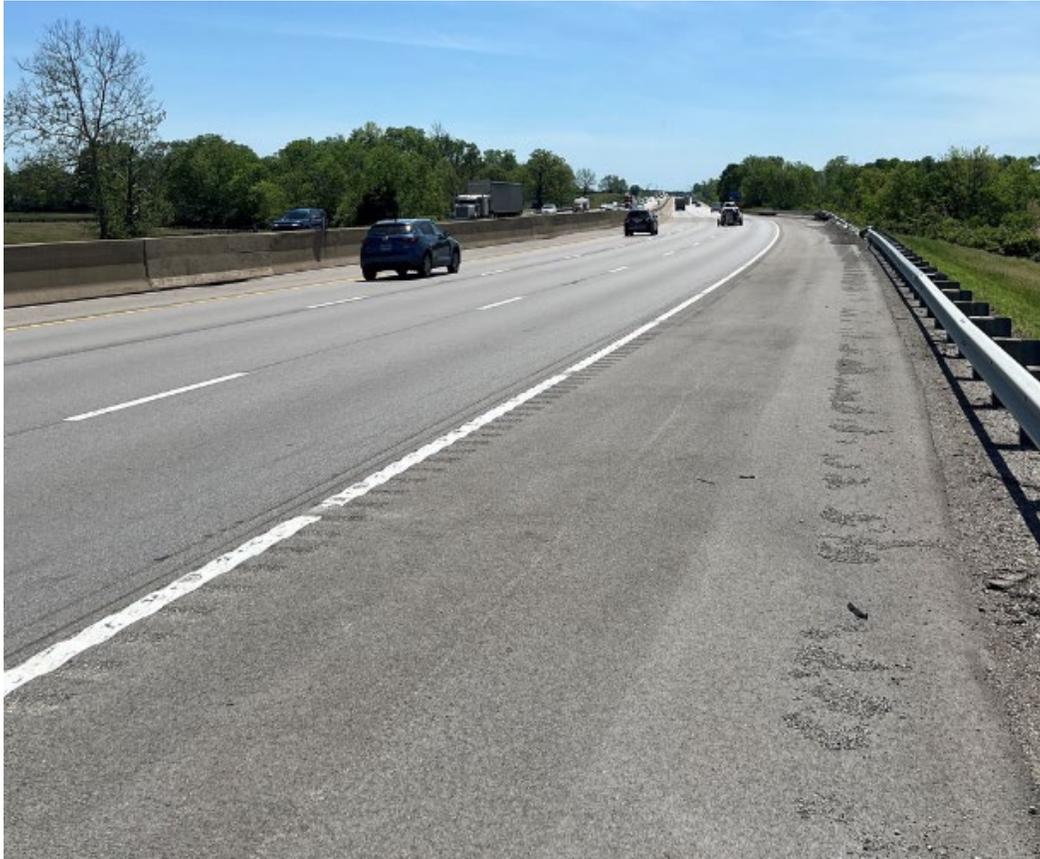
The incident initially began in the southbound lanes of a major six-lane interstate highway with a posted speed limit of 70 miles per hour (photo 1). Northbound and southbound travel lanes are separated by a concrete barrier; a standard W-beam guardrail is positioned on the right shoulder of the southbound lanes. The point of first contact occurred in the far-right lane as the commercial semi-truck and trailer traveled south. After initial contact, the truck veered right, where it struck the guardrail and came to final rest on the shoulder of the interstate (photo 2).

Photo 2. Photo showing the section of interstate where the incident occurred.
Photo property of Kentucky FACE.

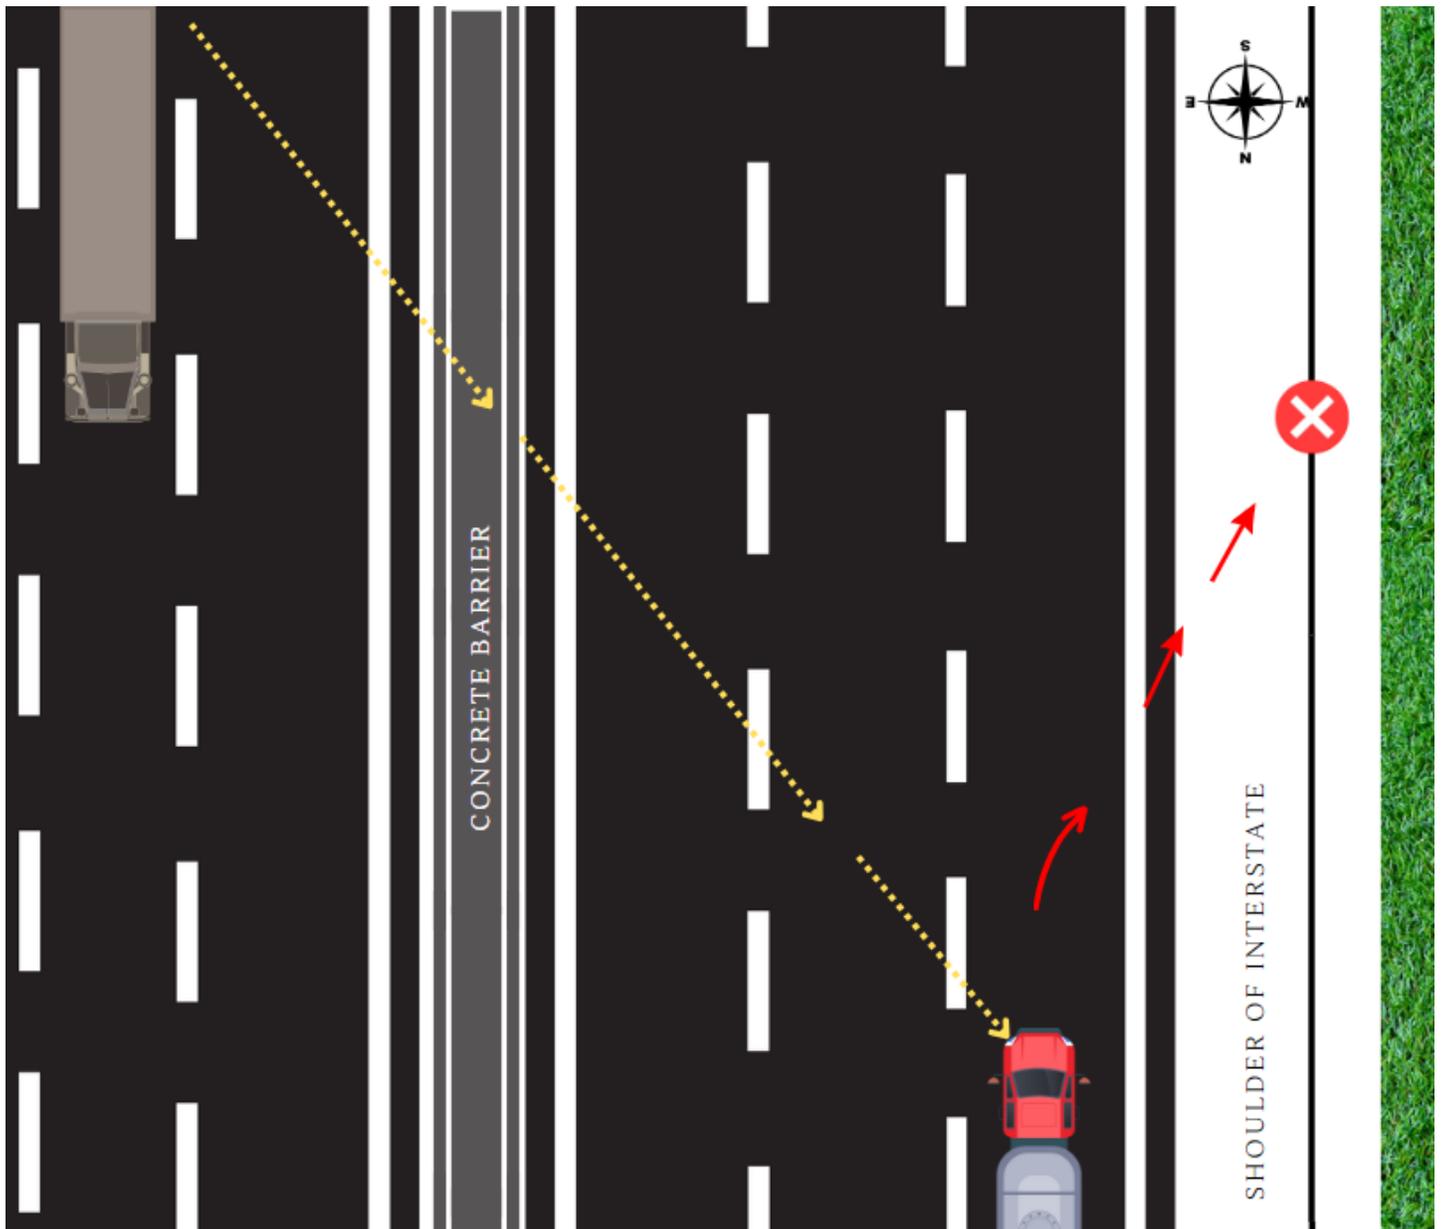
Diagram 1. Diagram showing victim’s direction and lane of travel (red semi-truck) and other involved vehicle’s direction of travel (brown semi-truck). The yellow dotted line represents the approximate path the wheel and tire combo traveled across the concrete barrier to strike the victim’s vehicle. The red arrows represent the approximate path the victim’s vehicle traveled after being struck. The red X represents final rest against the guardrail on the shoulder of the interstate. Diagram property of Kentucky FACE. *Note: Diagram is not to scale.*

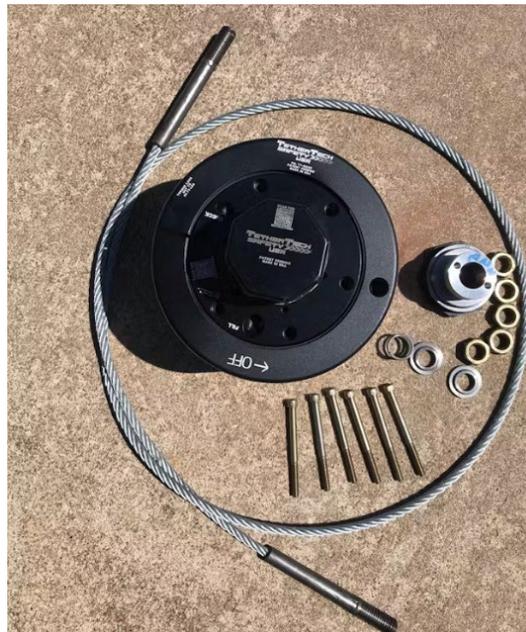
Photo 7. Photo showing the Tether Tech System. Photos obtained from www.fleetowner.com.

[Tether Tech Safety](#), an Oklahoma-based company, has created a product that aims to eliminate wheel separation due to bearing and/or wheel fastener failure. The hub system utilizes a steel cable that runs through the axle tube and tethers the wheel to the endcaps, eliminating the possibility of wheel separation when hub and/or wheel fasteners fail.⁵

Recommendation #1: Consider installing wheel separation prevention devices.

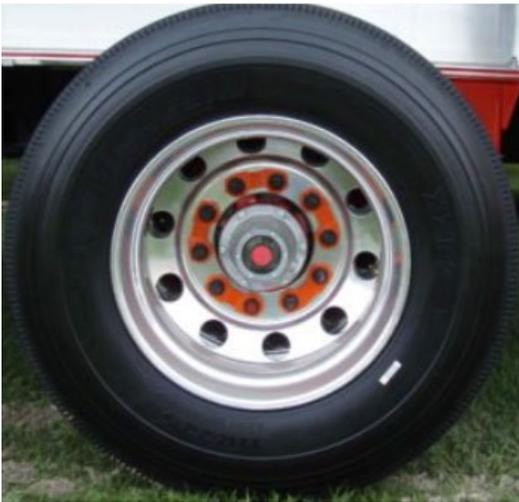
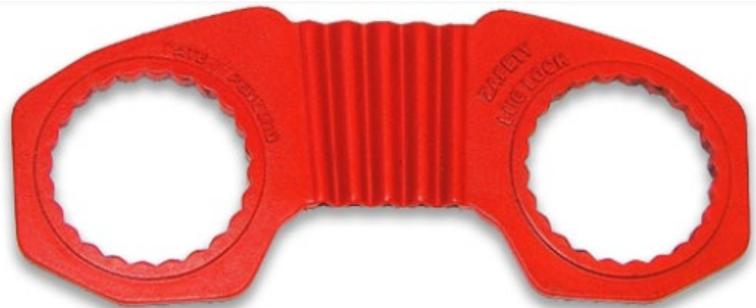
Photo 6. Photos showing [Zafety Lug Lock](#) device. Photos obtained from Zafetyluglock.com

[Zafety Lug Lock](#), a product designed and developed by Tafcan Consulting Ltd., aims to prevent wheel fasteners from backing off. The device is installed over two adjacent lug nuts and creates enough resistance between the two lug nuts to minimize their ability to rotate and fall off, thus preventing wheel fastener-related incidents.⁶

Kentucky FACE does not endorse any specific products, but investigators suggest that commercial carriers consider using wheel separation prevention devices to reduce the likelihood of wheel separation incidents.
